## **Wirralie Gold Mine**

### **Progressive Rehabilitation and Closure Plan**

Solomons Gold Pty Ltd

Revision: 3.0

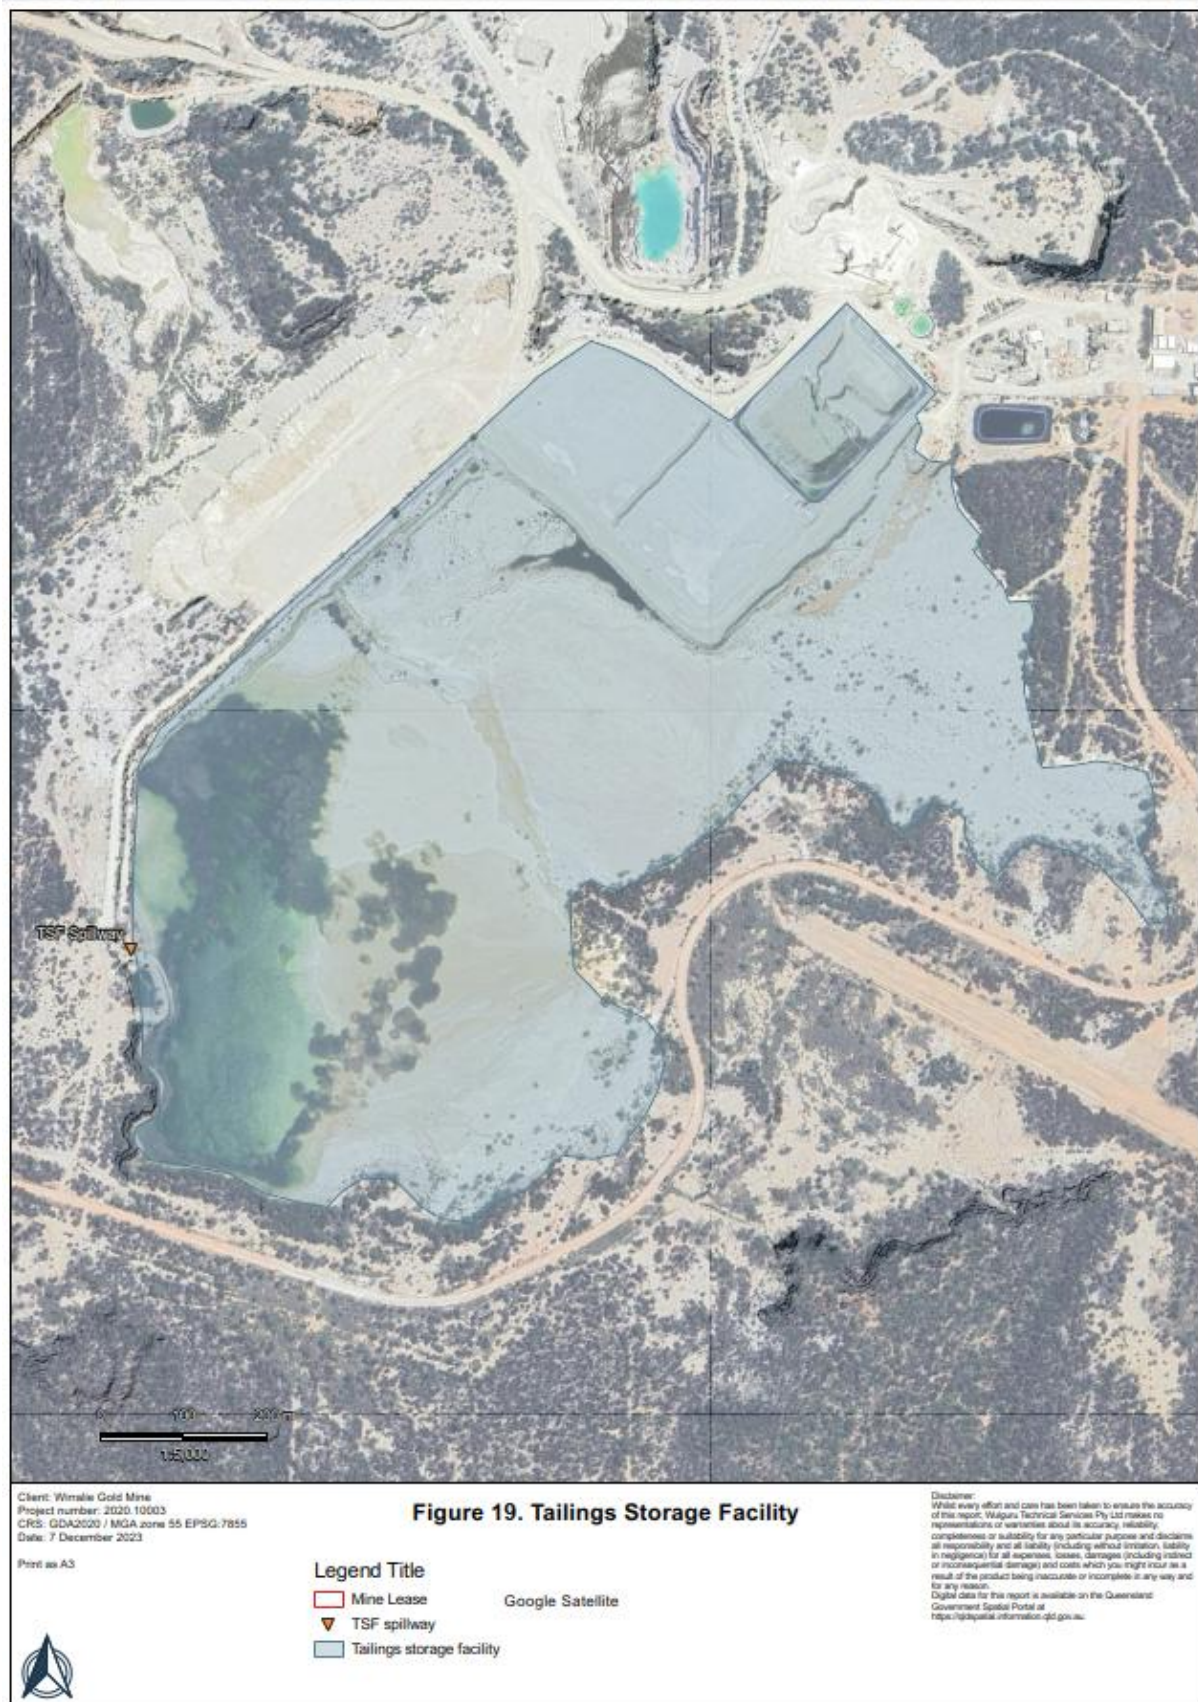
Figure 6-13 Tailings Storage Facility at WGM

The characteristics of the tailings are expected to result in fast consolidation of the deposited tailings such that rehabilitation earthworks can commence very soon after deposition ceases. Decant waters currently drain to the southern portion of the TSF, referred to as the TSF wetland. Current rehabilitation practices will require removal and treatment of the wetland waters via evaporation.

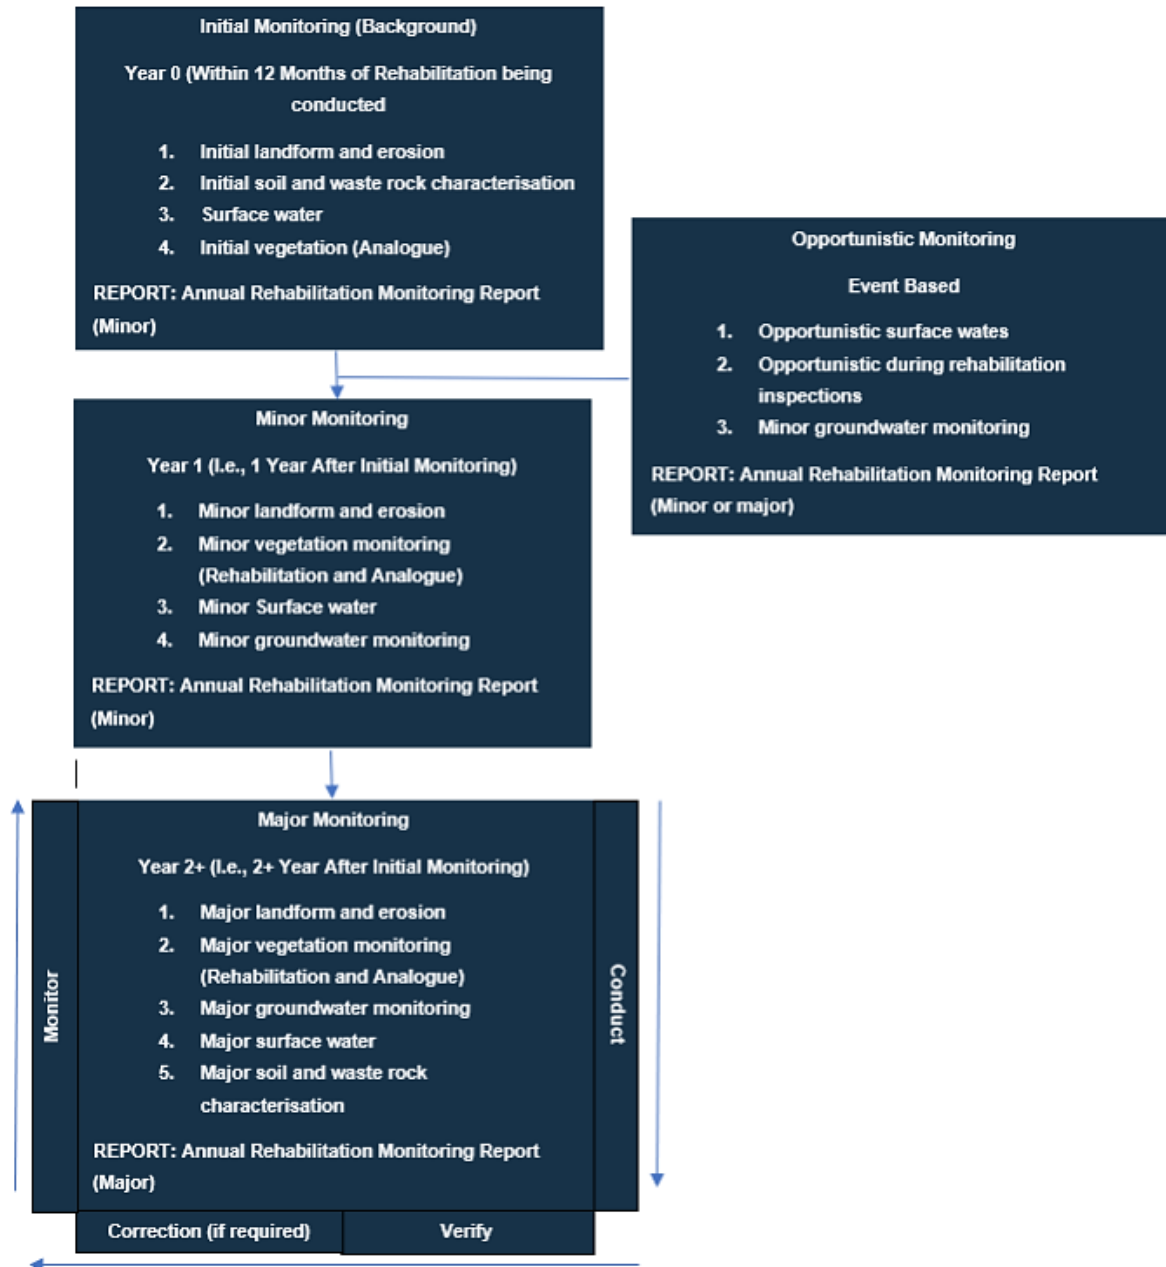
Figure 8-1 Wirralie Rehabilitation Monitoring Phases

The Rehabilitation Monitoring Program has been designed to demonstrate that rehabilitation milestones have been achieved. There are three main phases to the Project's rehabilitation monitoring program as displayed in **Figure 8-1**.
