# Wirralie Gold Mine

## TSF Rehabilitation Strategy

March 2014

prepared for Solomons Gold  
by Northern Resource Consultants

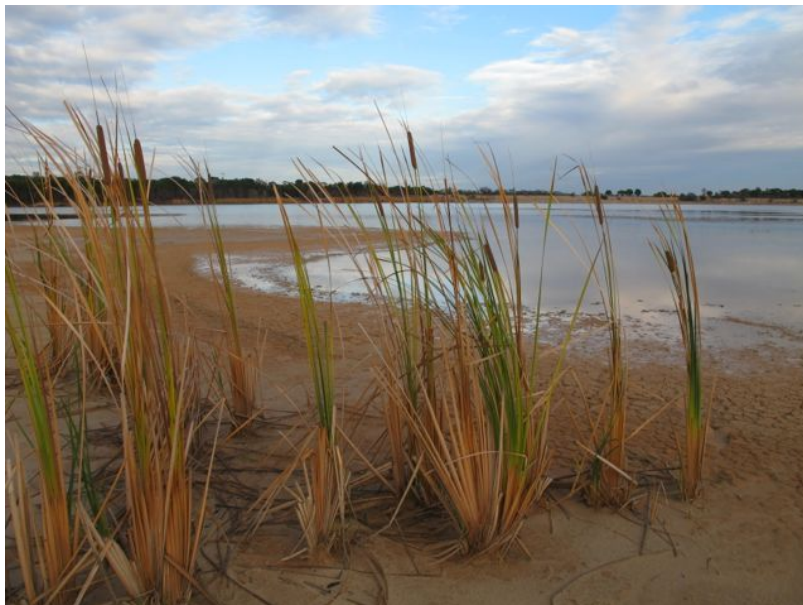
Figure 2: Wirralie TSF Semi-Permanent Water Storage (Photo taken February 2014).

Construction of the permanent wetland will commence during the closure phase once the heap leach and active tailings deposition have ceased. Surrounding the permanent water storage, there is an area of semi-permanent inundation. Some minor earthworks may be required in order to return the batter on the dam to a natural slope, as well as some minor stabilisation works. A number of water plant species (*Cyprus* sp., *Enchylaena tomentosa*, and *Typha* sp.) have already begun to colonise the perimeter of the dam. These will continue to be monitored during the next phase of the operation and if necessary these will be propagated for either seeding or direct planting as part of the rehabilitation of the wetland. Figure 2 below shows the existing water storage at the Wirralie TSF and some of the vegetation that has colonised around the perimeter of the storage. Figure 2: Wirralie TSF Semi-Permanent Water Storage (Photo taken February 2014). Water quality monitoring of the TSF will continue during the operational phase of mining and processing at Wirralie as required in the EA. Water quality objectives for the semi-permanent wetland will be developed prior to rehabilitation commencing. It is anticipated that ongoing monitoring of the water quality will continue during post closure until it can be demonstrated that these water quality objectives have been met and will continue to be met into the future.

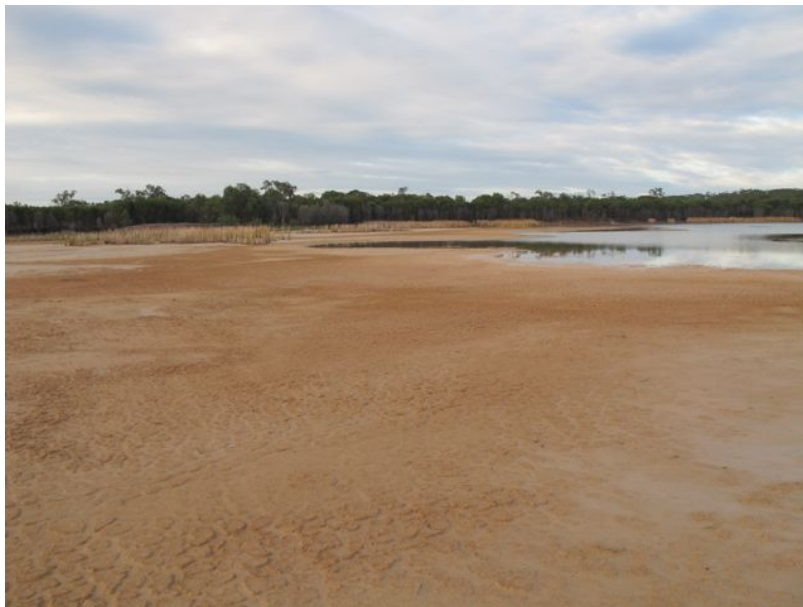
**Figure 3: Wirralie TSF Rehabilitation Trial Area (Photo taken February 2014).**

An area of approximately 3.5ha is immediately available within the existing TSF to commence rehabilitation trials and monitoring upon the recommencement of operations. This area is representative of the whole tailings storage facility and will therefore provide a suitable rehabilitation trial area. Figure 3 to Figure 5 below are recent photographs of the proposed tailings trial area and are indicative of the whole tailings storage facility.

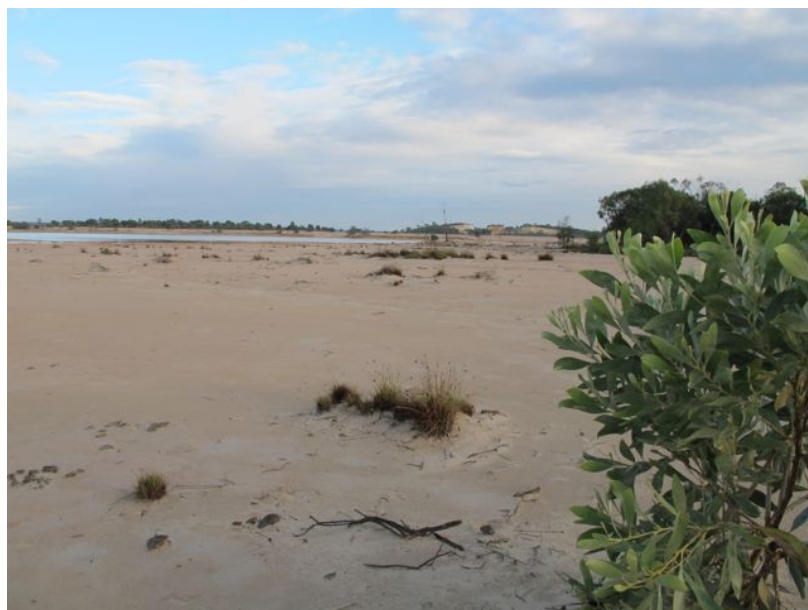
**Figure 4: Wirralie TSF Rehabilitation Trial Area (Photo taken February 2014).**

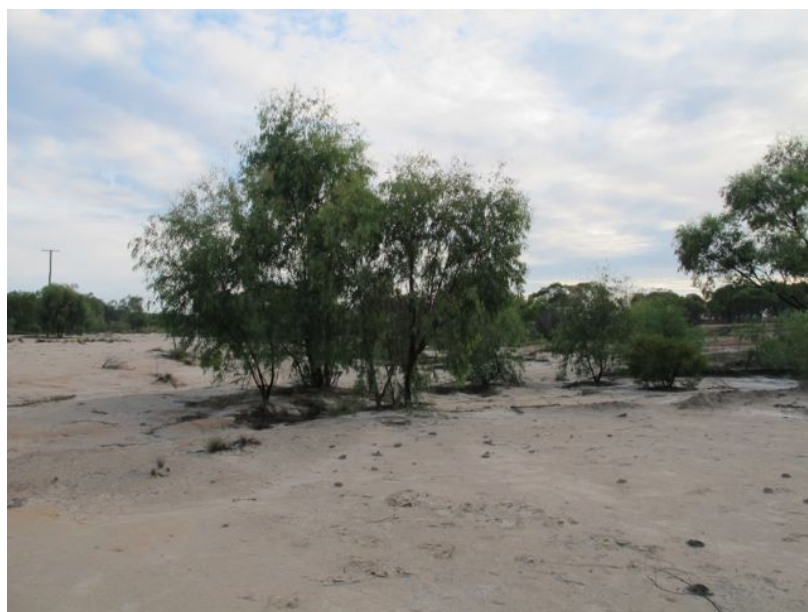
**Figure 5: Wirralie TSF Rehabilitation Trial Area (Photo taken February 2014).**
