# Environmental Report

## Kawana Sewage Treatment Plant Environmental Investigation

**Unitywater**

frc reference: 211109

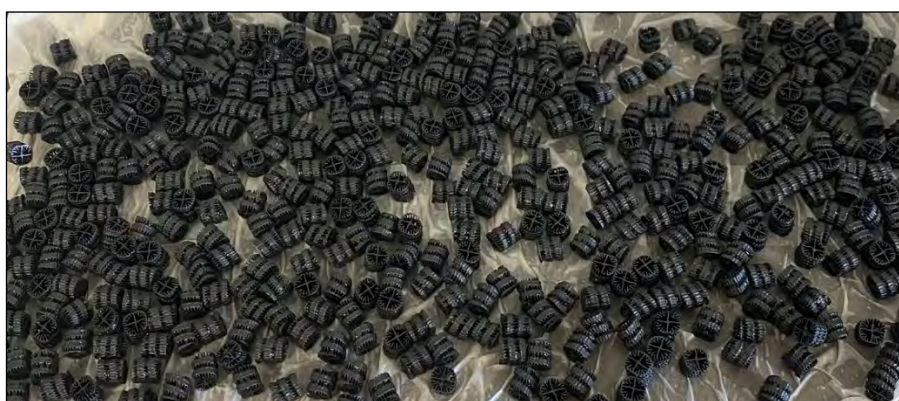
MBBR carriers are primarily made from high density polyethylene (HDPE) and are extremely persistent within the marine environment due to the lack of UV visible chromophores which resist photo-oxidative degradation.

Figure 2.2 Unused MBBR carriers.

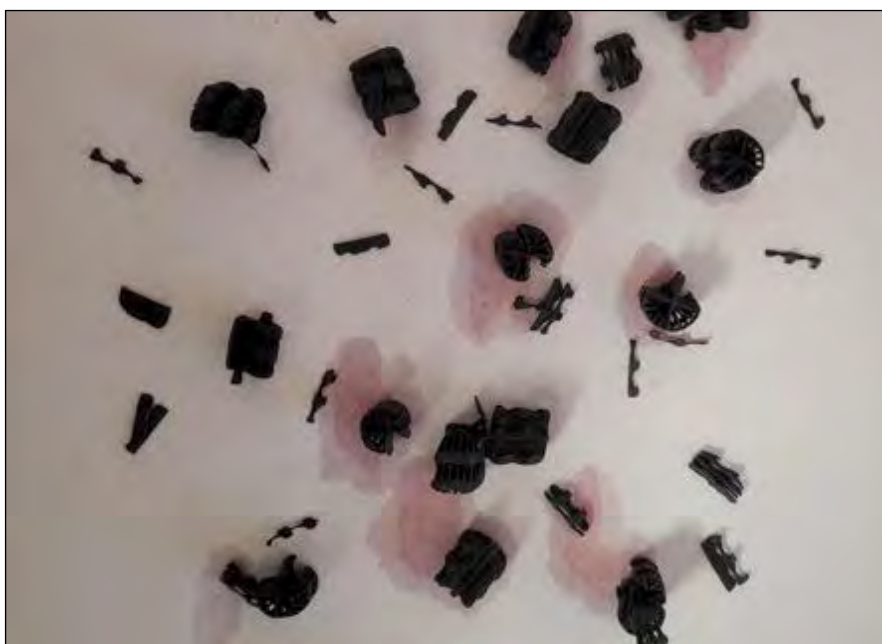
Figure 2.3 Broken down MBBR carriers.

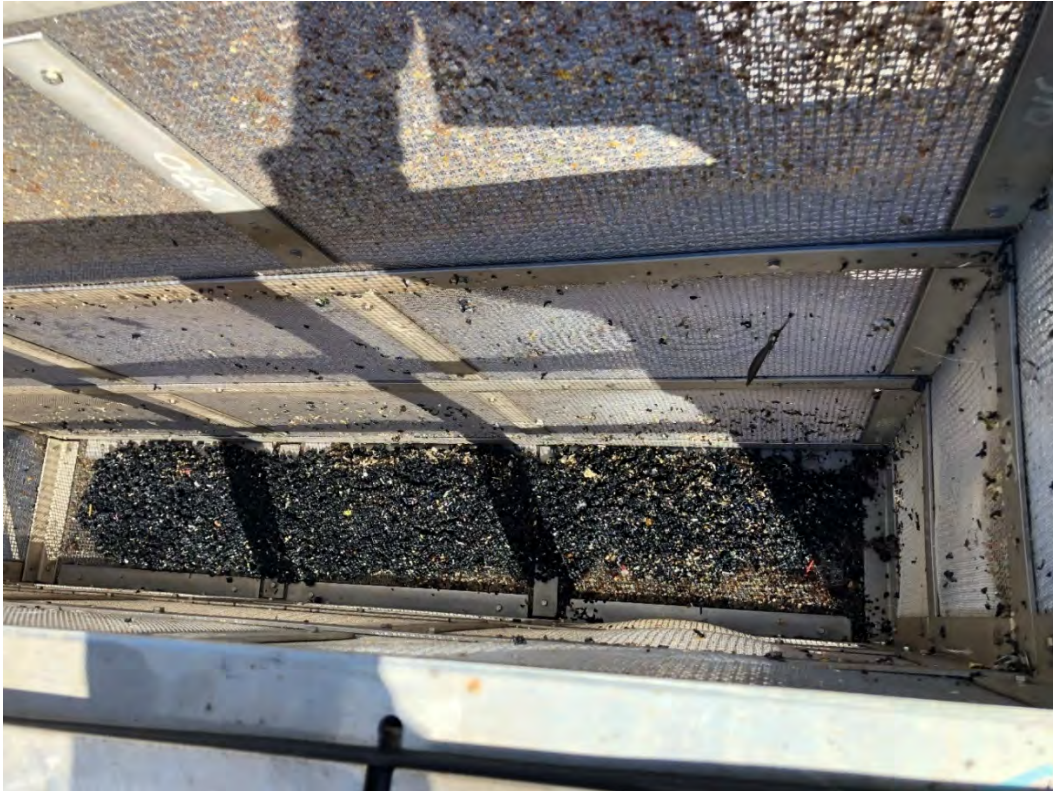
In addition to the basket screens, a system has been developed that removes and collects floating material from the surface of the clarifiers prior to reaching the basket screens (Figure 2). Following an initial trial in one clarifier in July 2021, this system was expanded to all four clarifiers. This system is less affected by high flows and has been successful in collecting broken MBBR plastic media before it reaches the CCT basket screens.

Figure 1 - Effluent Basket Screen with Captured MBBR Plastic Media Fragments (Aerial View)

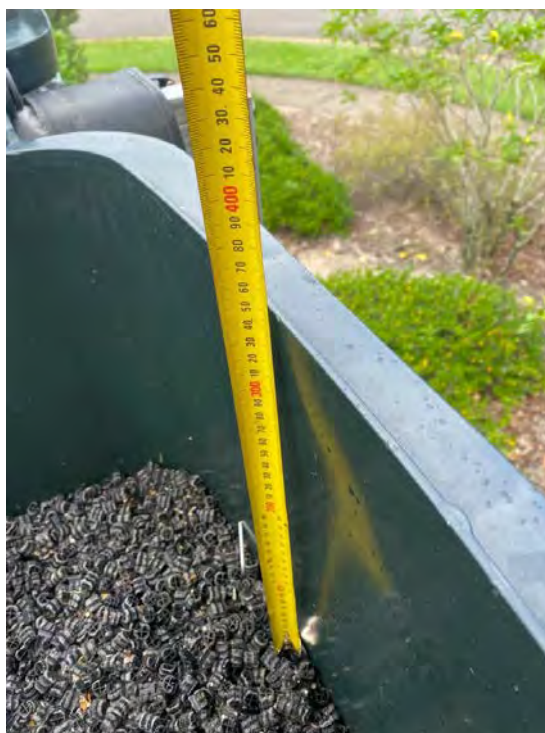
Figure 3: Measurement of material volume in wheelie bin

Material removed from the effluent basket screens and clarifier surface skimming systems was loaded into wheelie bins and the bulk volume estimated by measuring the distance from the top of each wheelie bin to the levelled material in the bin (Figure 3) and comparing to a volumetric calibration curve (**Error! Reference source not found.** Attachment 1). Bulk volume of material rather than mass was measured to eliminate variability from different material composition and changes in moisture level between samples.

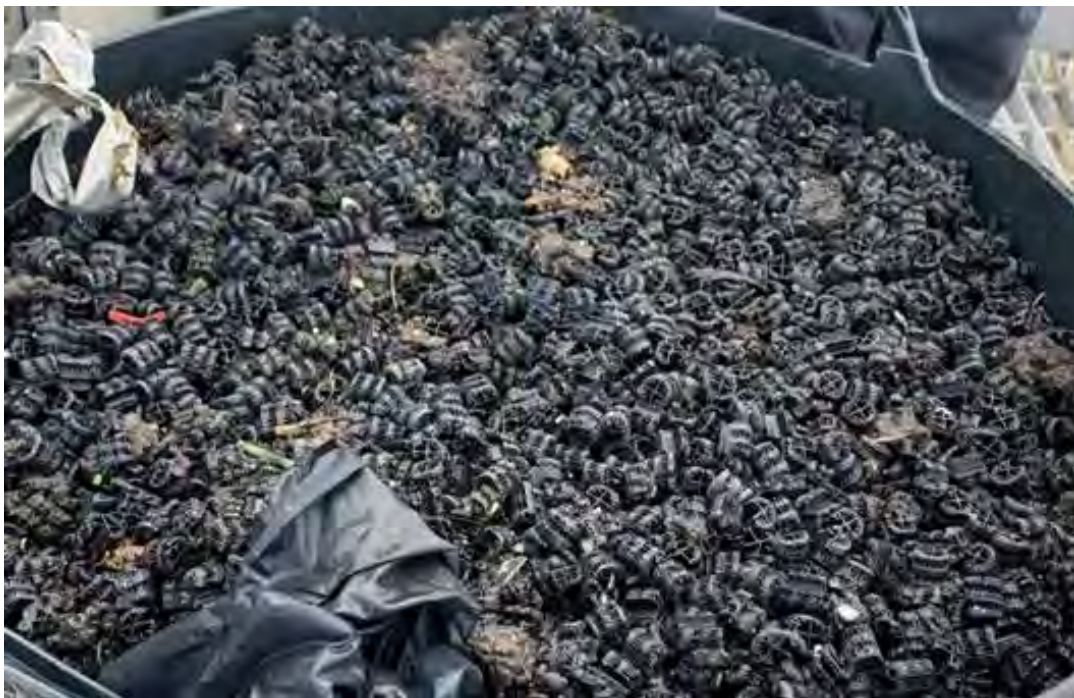
Figure 11 - Typical Screenings Sample

For particles greater than 1.18 mm, MBBR plastic was the dominant material type found in the screenings (Table 1 and Figure 9) with particles larger than 9.5 mm significantly outweighing all other size fractions.

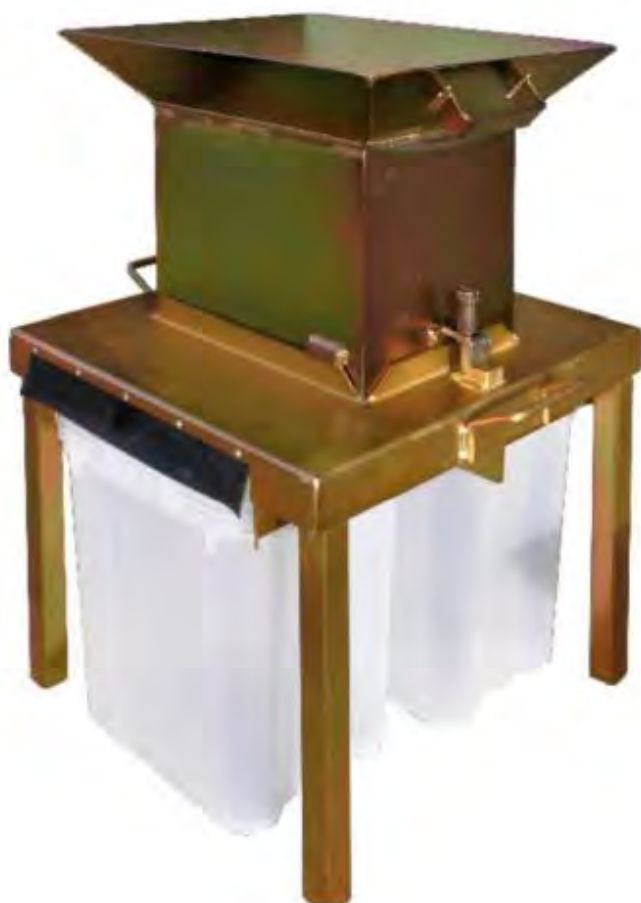
Figure 1 – Riffle/Splitter box.

- The sample splitting process was then repeated, removing half the resultant subsamples with each successive split, until five (5) representative subsamples of the required test portion mass were obtained.

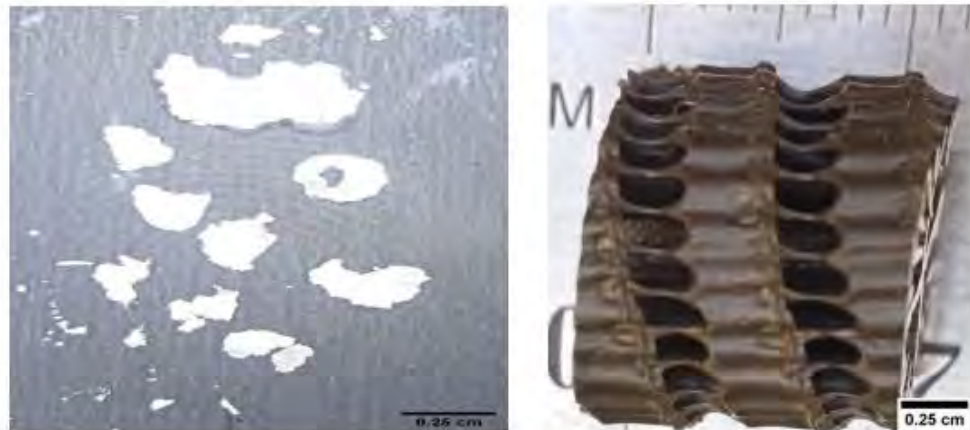
**Fig 5 & 6.** Fragments in the effluent and MBBR unit

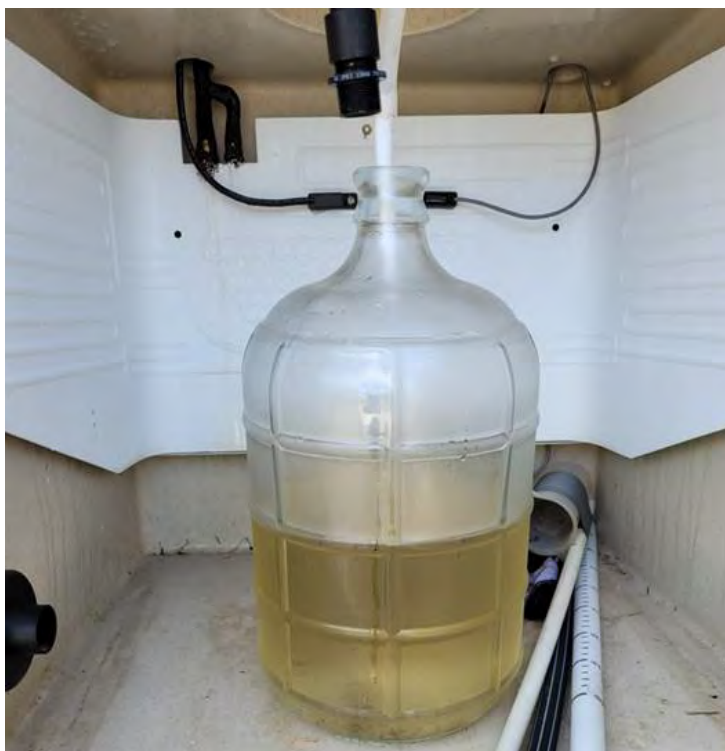
**Figure 3 - Glass Sample Container Inside Auto Sampling Machine**

Liquid samples were collected and stored in non-plastic containers (Figure 3 and Figure 4), however the samples were inevitably exposed to some plastic materials, most notably the collection hose for the auto-sampler. With the hydraulic residence time of the STP limited to much less than 1 day, the liquid samples were taken over the same 24-hour period. However, because the sludge residence time in the STP is much greater than 24 hours and is well mixed, aligning to the same 24-hour sampling period was not possible for the biosolids and therefore 4 biosolids samples were analysed on dates suitable for sampling. The samples were sent to the University of Newcastle for microplastics analysis, described further in this report.

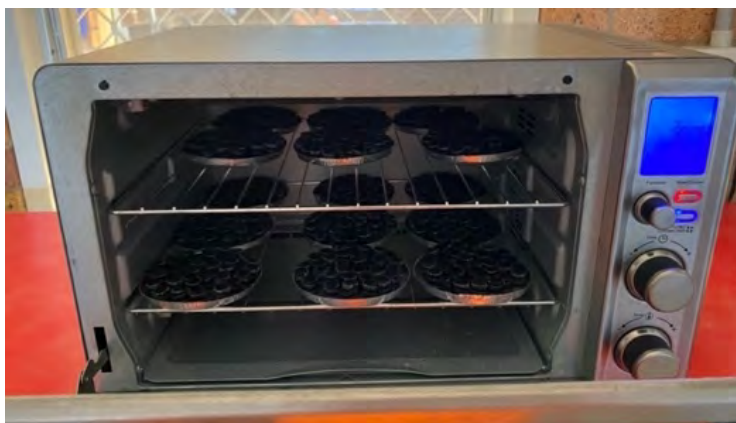
Figure 1: Oven Drying the Carrier Samples

Each sample of carriers was distributed evenly across a set of 5 aluminium trays, with the orientation of carriers consistent across samples. The samples were oven dried (Figure 1) at 60° for approximately 3 hours, or until they were dry to touch.

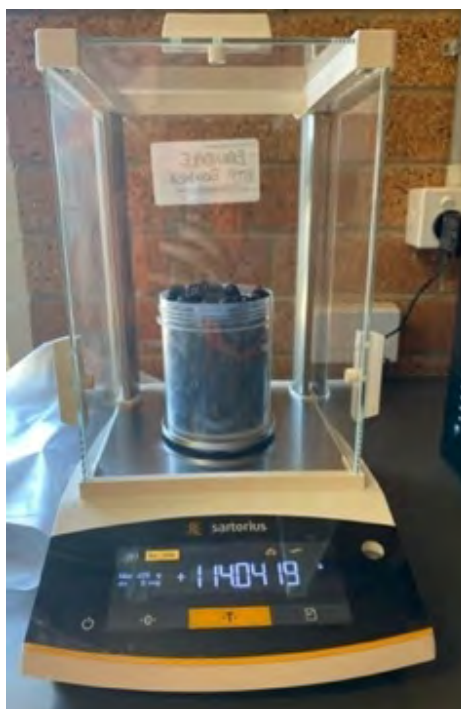
Figure 2: Weighing the Carrier Samples

Once dried, carriers in each sample were counted and they were left to cool for approximately 5 minutes. Each sample was then weighed and the average mass per carrier calculated. These values were compared to the control sample of unused carriers to analyse changes in carrier mass.

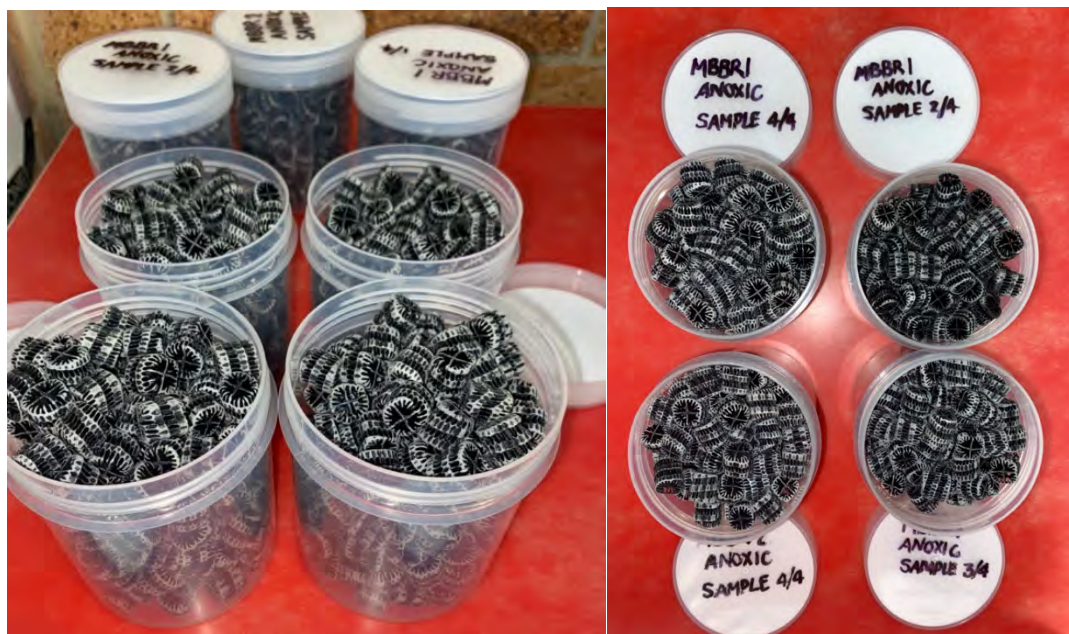
Following biofilm removal from the in-service carriers, the MBBR carriers were visually compared, noting the degree of “whitening” of the carriers (Figure 3 and Figure 4). The “whitening” appeared to be more prominent on carriers from the anoxic zone which were also more visibly rounded and with less rigidity compared to the carriers from aerobic zone. Figure 5 shows the First Sample of unused carriers following chemical treatment where whitening was not observed. The in-service carriers were all whole carriers showing signs of wear, such as rounding of edges.

Figure 3: MBBR Carriers from Anoxic Tank

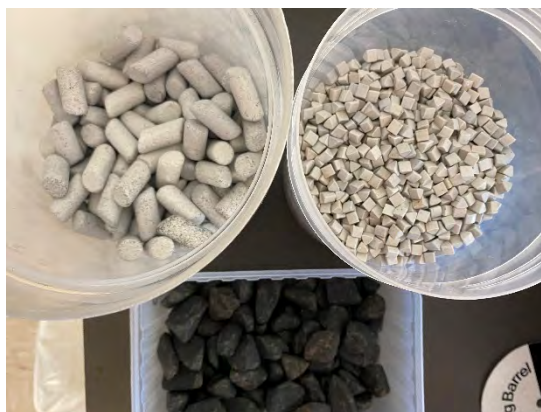
Figure 2 - Examples of Porcelain Ceramic and Blue Metal Grinding Media Types

The selection of grinding media was a 'trial and error' process with the aim to replicate visual characteristics of the in-service carriers, such as specific locations of wear and whitening of the carriers. Figure 3 shows a comparison between an in-service carrier, shown below on the left, and a test carrier, shown on the right, highlighting rounding of the edges of the in-service carrier. Figure 4 highlights the whitening characteristic of in-service carriers.

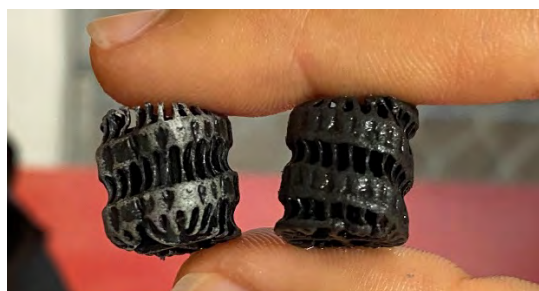
Figure 3 - Comparison of Edge Rounding of In-Service and Test Carrier

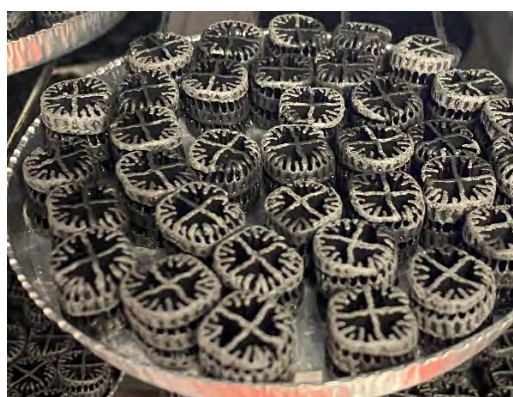
Figure 4 - Whitening Characteristic of In-Service Carriers

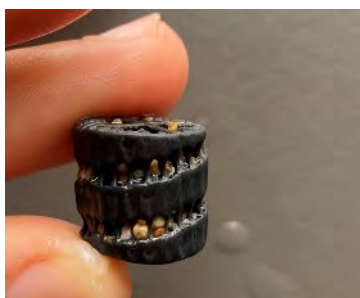
carriers (Figure 5), creating difficulties in measuring (weighing) the carriers. Test with blue metal gravel and coarse sand was discontinued.

Figure 5 - Coarse Sand Grinding Media Trapped in Carrier

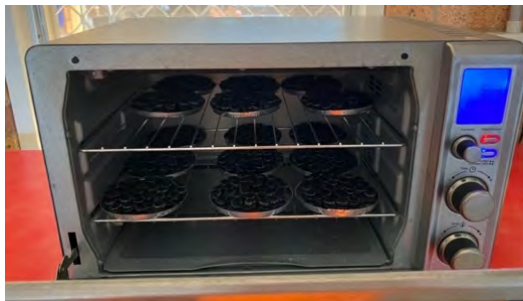
Figure 6 - Oven Drying Carrier Samples

When collecting the wear testing results, the carriers were removed from the rotary tumblers, placed in a colander having 4mm square holes, rinsed with water to remove worn material, and left to air dry for approximately 15 minutes. They were then laid out in sets of aluminium trays and placed in an oven (Figure 6) to dry at 60°C for approximately 2 hours, or until carriers were dry to touch.

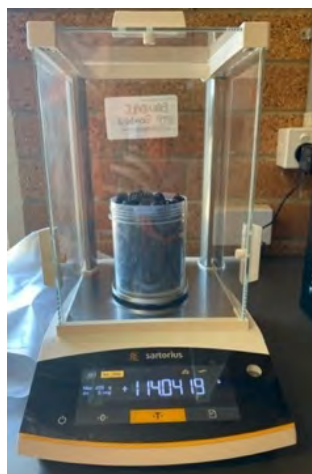
Figure 7 - Weighing the Carrier Samples

Once dried, the number of carriers in each sample were counted and left to cool for approximately 5 minutes. Each sample was weighed using a Sartorius Lab Instruments Model BCE224I-1S (Figure 7) and these values were compared to the original mass to calculate a percentage of mass loss. This process was repeated weekly.

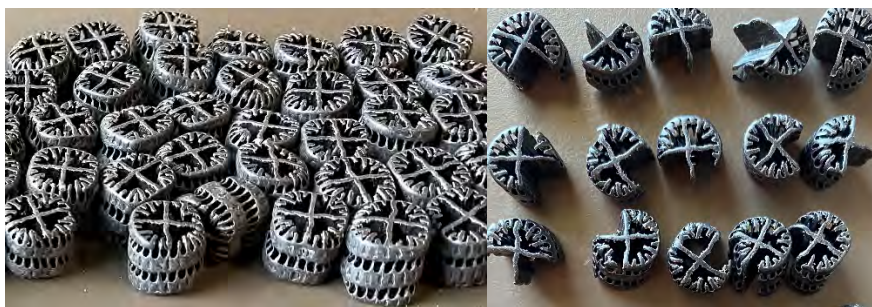
When recording the experimental results, it was important to understand the two forms of degradation that were being observed: wear and breakage. A definition was adopted to distinguish between the two mechanisms. Wear was defined as the mass loss where it was difficult to discern individual broken fragments by the naked eye, and this estimated to be around less than 500 µm particle size, typically resulting in rounding of the carrier edges. Breakage on the other hand was defined as separated particulates greater than approximately 2mm. The result of wear and breakage on the remaining Hel-X carrier is shown in Figure 8.

Figure 8 - Characterisation of Carrier Degradation Mechanisms: Wear (L) and Breakage (R)

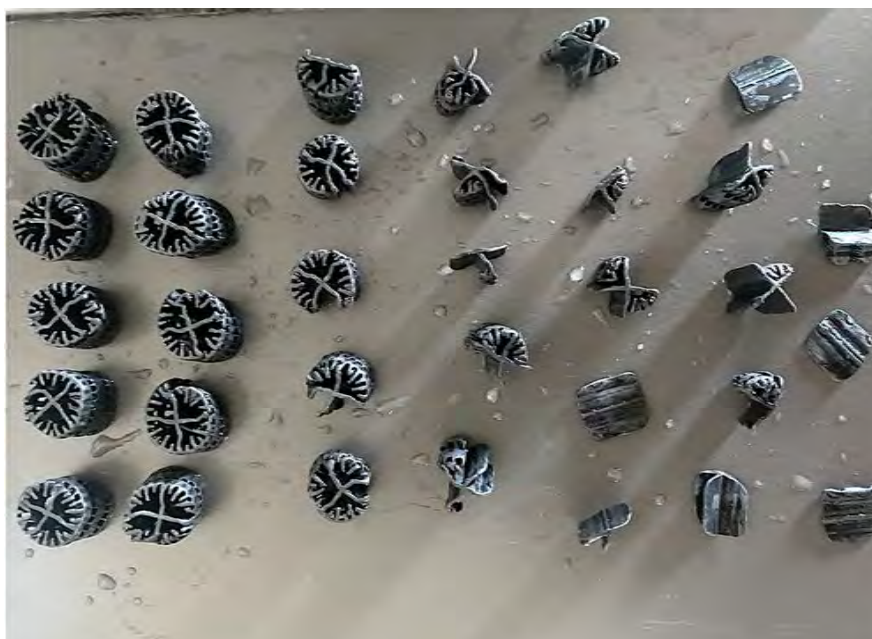
With both wear and breakage mechanisms were observed of the in-service Hel-X carriers. Wear of the Hel-X carriers was observed in sampled carriers from the MBBR tanks, with all sampled carriers showing some degree of wear. Breakage (as well as wear) was identified in the carrier fragments collected fortnightly from the basket style screens and surface skimming system. In order for the carriers to escape the MBBR tanks, a section of the carrier had to be broken away to allow it to pass through the bioreactor submerged screens. Generally, this required at least one quadrant of the cylindrical carrier to be removed. With both wear and breakage mechanisms acting on the in-service carriers, the rotary tumbler test treated all particles separated from the main cross-sectional base of the Hel-X carrier as a form of mass loss and analysis was carried out on this basis. To ensure that there would always be a consistent number of carriers present from the beginning to the end of testing, these bases were included in the mass. **Error! Reference source not found.** illustrates typical carrier degradation, with carriers on the left-hand side of the picture showing limited degradation at the early stage of the test and carriers on the right-hand side towards the end of the test, showing carrier bases remaining but sections of the carrier peripheral broken off.

Figure 9 – Degradation of Hel-X Carriers Throughout Rotary Tumbler Test (L to R: progressive through test)

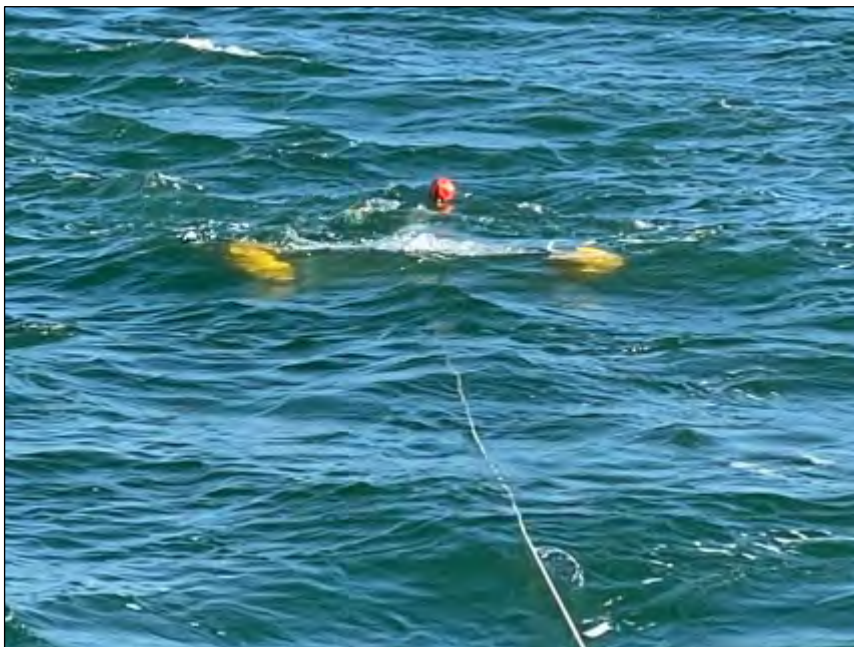
Figure 2.3 Surface manta trawl in operation.

A 'manta' net was used to sample surface and bottom water near the diffuser and at the control site at Raper Shoal (Figure 2.1 and Figure 2.2). The mouth of the manta net was 50 by 90 cm and it was towed for 1 km in a series of loops focussed on each site (Figure 2.3). Two 1 km long samples of surface and bottom water were collected at each site, a total of 8 trawls. The total volume of water sampled in each trawl was approximately 450,000 L (Table 2.1). All samples from potentially impacted sites were analysed. Where there was a positive identification of black polyethylene fragments in a sample from a potentially impacted site, then the equivalent sample from a control site was analysed. The samples that were analysed are listed in Table 2.1.

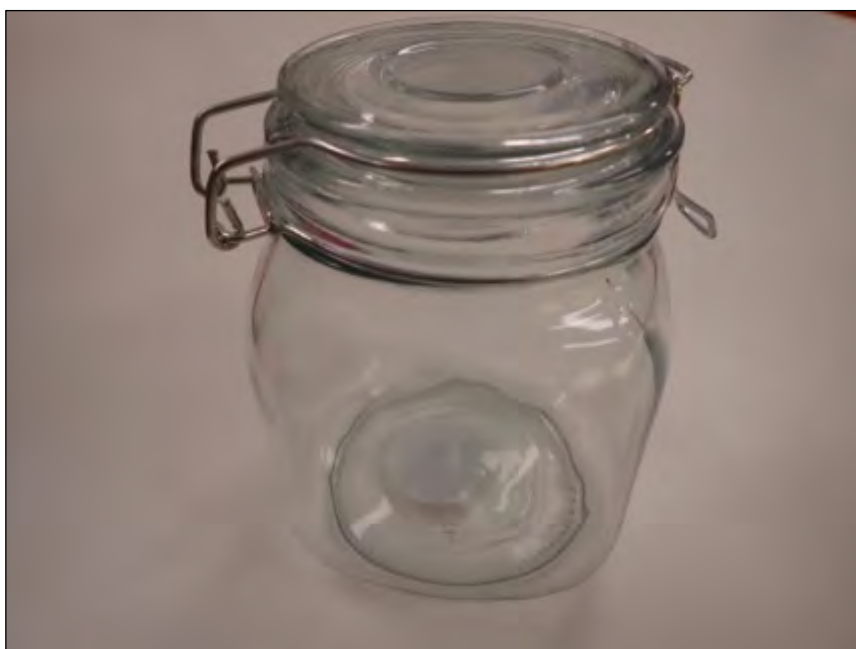
Figure 2.4 1L glass jar, used to hold sediment samples.

Two sediment samples were collected from each site. Beach sediment samples were collected at the high tide mark using a metal trowel, on 17 April 2022 (Table 2.2). Ocean sediment samples were collected on SCUBA on 19 April 2022, at similar depths at both the impact and control sites (Table 2.2). The top 2 to 5 cm of sediment was collected and placed in sealed 1 L glass jars (Figure 2.4). All samples from potentially impacted sites were analysed. Where there was a positive identification of black polyethylene fragments in a sample from a potentially impacted site, then the equivalent sample from a control site was analysed. The samples that were analysed are listed in Table 2.2.
