# Thalanga Copper Mines Pty Ltd

## Draft Transitional Environmental Program Highway Reward Mine

#### Background

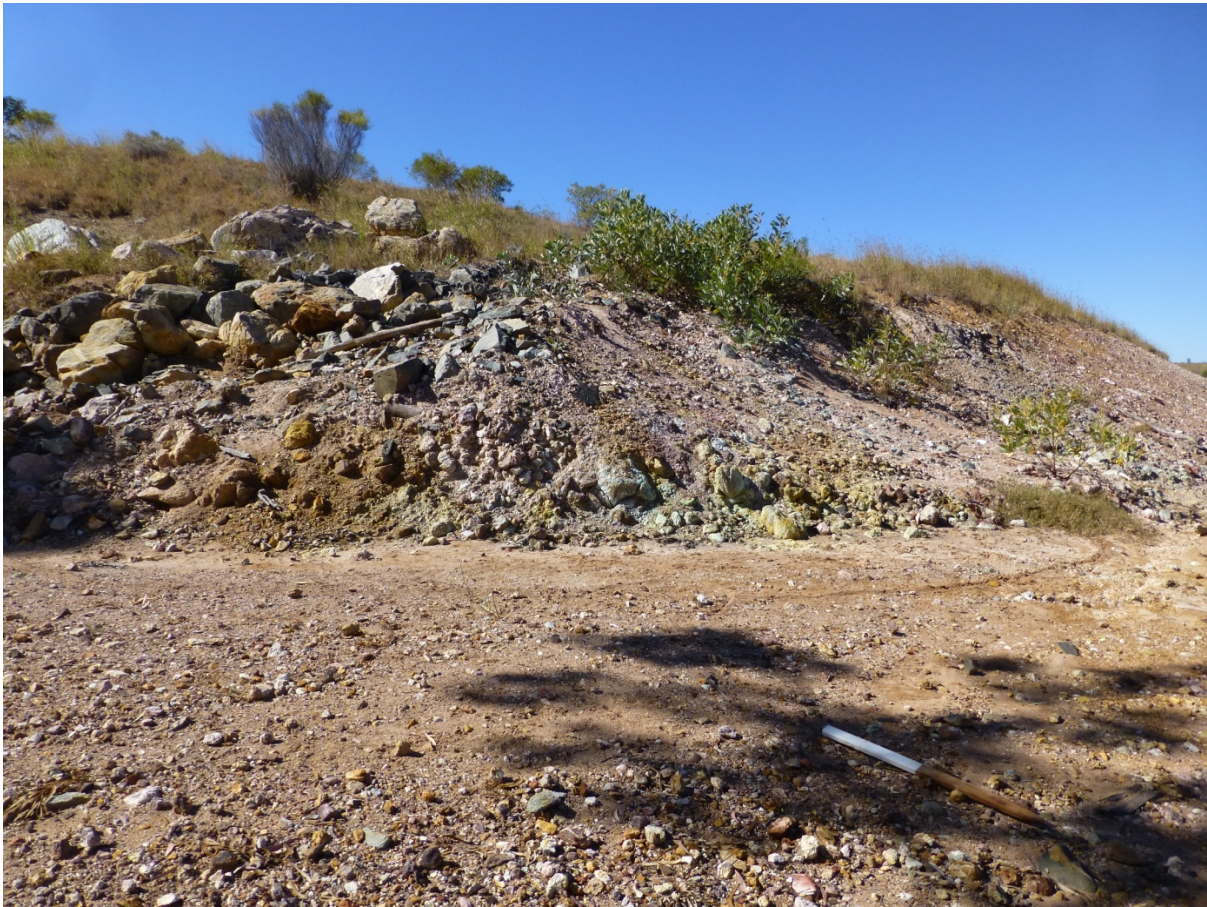
**Figure 3**      **Potential Highway Waste Rock Dump Seepage**

The investigation noted that several previously unknown seeps appeared to be leaching high-acidity water from the base of the Highway waste rock dump into the flow path to the SW6 sampling site (Figure 3). This contaminated water contained high concentrations of Total Cu as well as low pH water and indicated acid rock drainage formation. A recently eroded structure was also showing signs of sulphide oxidation along the drain in question (Figure 4).

The site in question is situated at the north-western end of the Highway waste rock dump and was exposed during maintenance works to recut a drain in late 2011. The yellow discolouration and signs of bubbling indicate exposed sulphidic material is oxidising, producing acid rock drainage (ARD). Solutions to this are to remove exposed boulders containing sulphides to the pit void and cap the remaining sulphidic material to prevent oxygen access. This would provide an effective solution if the exposed sulphidic material is the sole source of ARD. The JV is concerned however, that this may not provide a long-term solution if the waste rock dump contains stored acidity and is leaching the ARD. As a result, a TEP has been proposed to provide time for the JV to monitor water quality and flows from the site. This will enable the JV to determine whether the ARD is being produced from localised rainfall seeping over the sulphidic material or whether the ARD is from dump seepage and thus requires a different long-term solution.

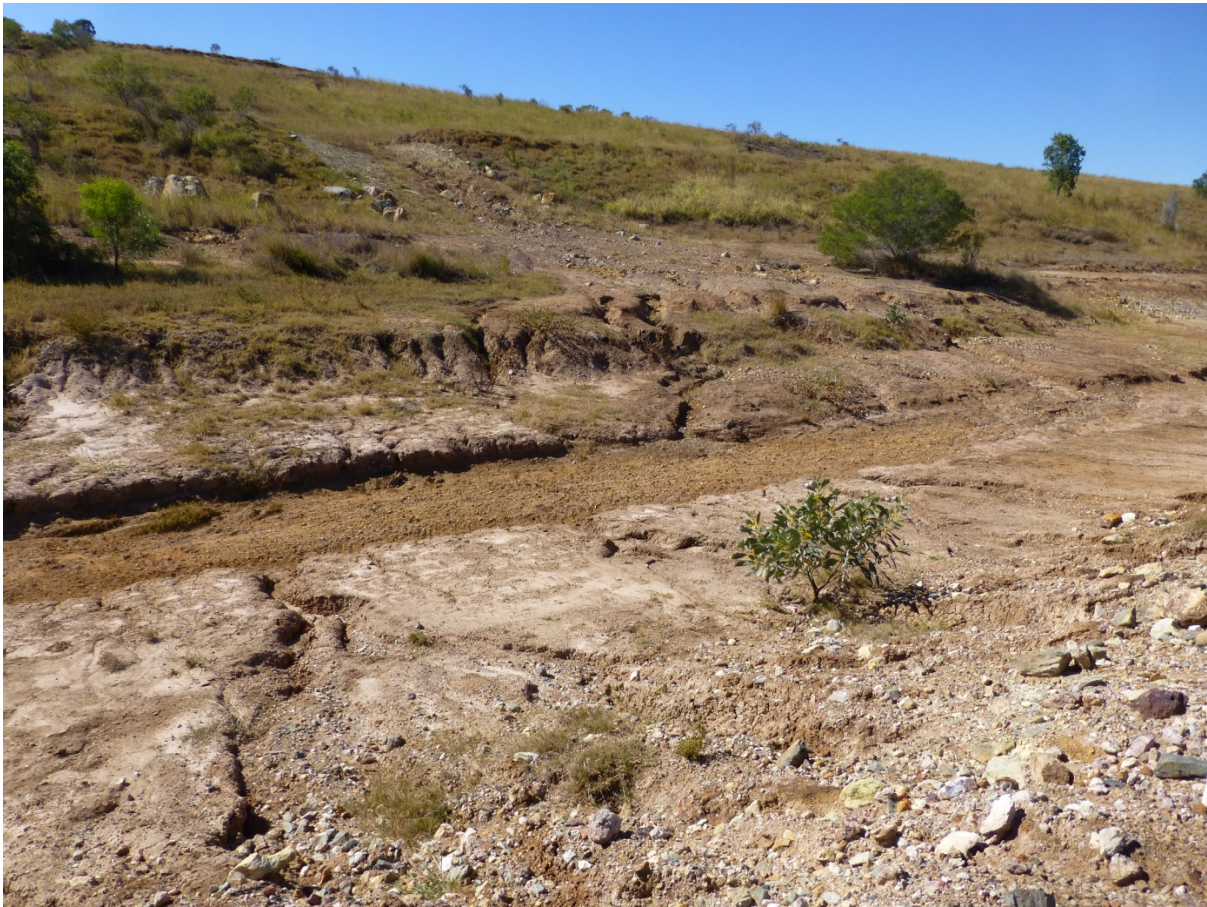
**Figure 4**                      **Eroded Structure with Exposed Sulphides**

The yellow discolouration above the drain again shows evidence of ARD formation. In this case the drop structure which was repaired in 2012 has eroded, exposing the sulphides. As a localised source of ARD this area is undergoing reconstruction in 2013 to provide a stable long-term solution for this problem.

Other potential sources of contamination along this drain are to be investigated during the coming wet seasons. Given the ephemeral nature of surface flows at the site and the short flow periods experienced, at least two wet seasons are proposed to allow the JV to find all sources of contamination through an on-site upstream monitoring program. This will then be followed by a works program to remedy the problems. Areas where the capping surface over the Highway and Reward waste rock dumps is known to be bare of vegetation are already scheduled for recapping and revegetation in the 2013 works program currently underway.

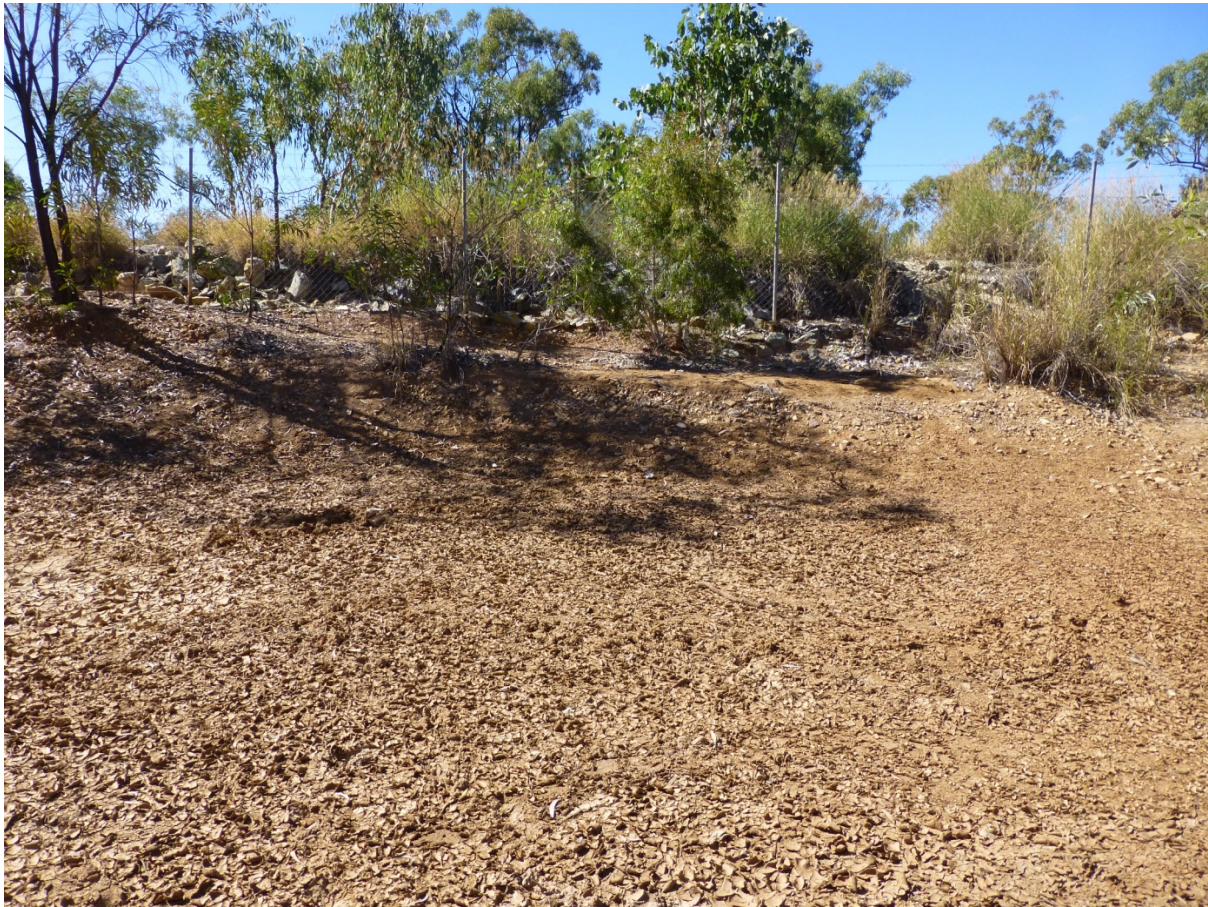
**Figure 5**                      **SW5 Flow Path from the site**

Figure 5 shows the previous flow path between the site and the SW5 sample site. This flow on site has already been redirected into the pit void to eliminate the possibility of contamination on site flowing overland towards SW5 and then Policemans Creek to the immediate west of the site. A line of rocks just inside the fence line appear to contain sulphides as evidenced by yellow discolouration. As such these rocks are being removed to the pit void during the 2013 works program on site to prevent environmental harm for occurring. The TEP program proposes to monitor the site to demonstrate, over the coming wet seasons, that no contaminated flow from the site now runs towards SW5.
