# Highway Reward

## Surface Water Trends Analysis

**June 2016**  
prepared for  
Highway Reward

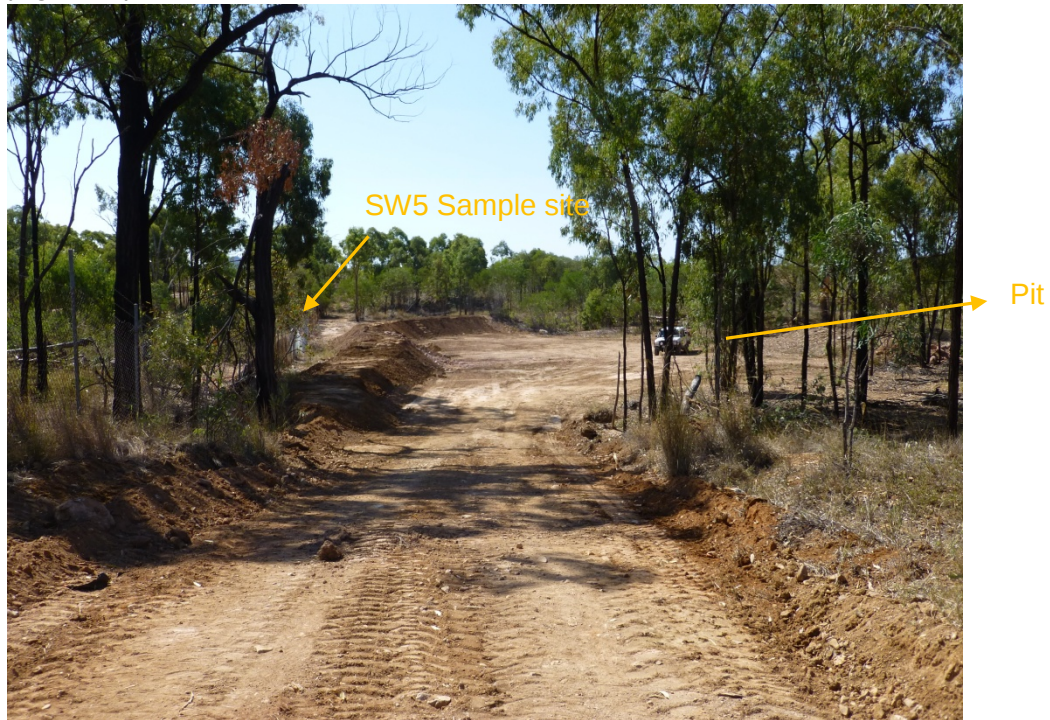
Earthworks blocked surface water flows from the mine site towards SW5 in June/July 2014 (Figure 15).

Figure 15: Diversion bund on western side of lease

Flows from mining infrastructure (Reward Dump) that did report to SW5 are now diverted into the Pit. Flows from Reward Dump diverted to the pit are discussed in the following section.

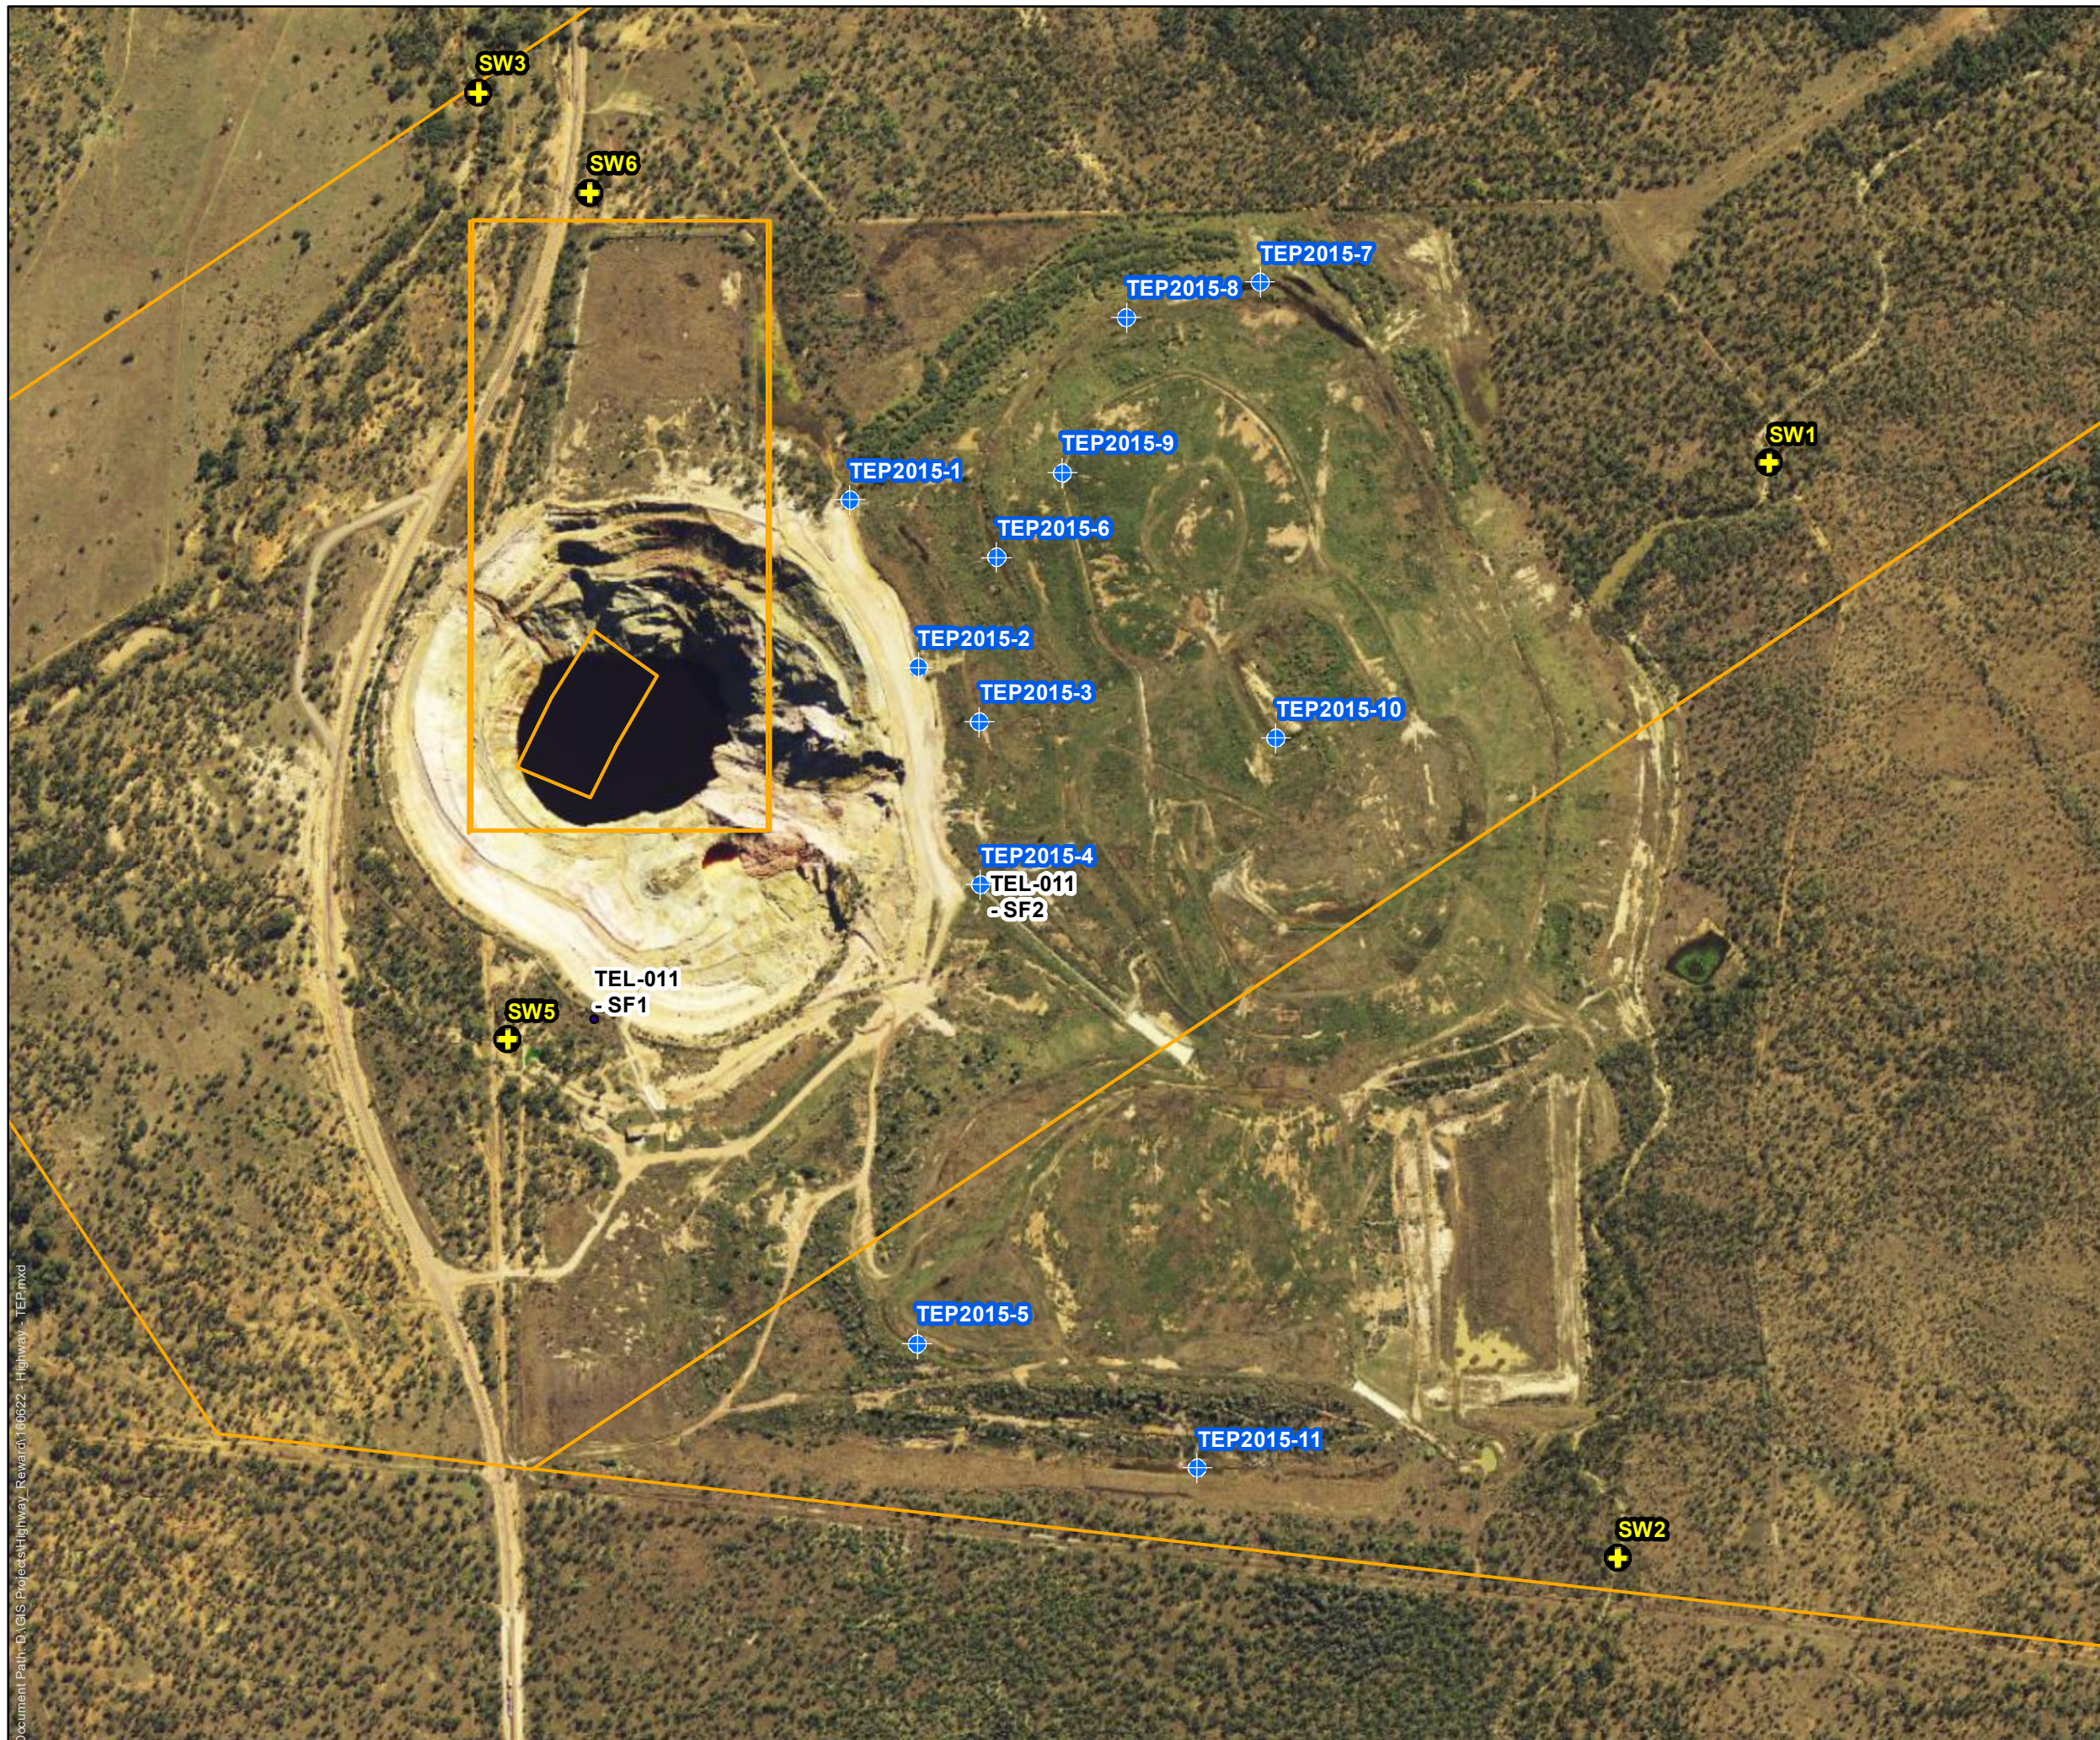
Map of TEP Sites

### TEP MONITORING POINTS
