# Thalanga Copper Mines Pty Ltd

## **Re: Transitional Environment Program (TEP) MAN17020**

In accordance with the commitments made in the TEP please accept this report on site surface water flows at the Highway Reward mine. This report covers the period from 9 December 2013 until 9 June 2014. The TEP sites were sampled fortnightly during the notional wet season from 1 December until 30 March. This period was characterised by low rainfall on site with occasional short duration showers and storms and no real monsoonal influence recorded.

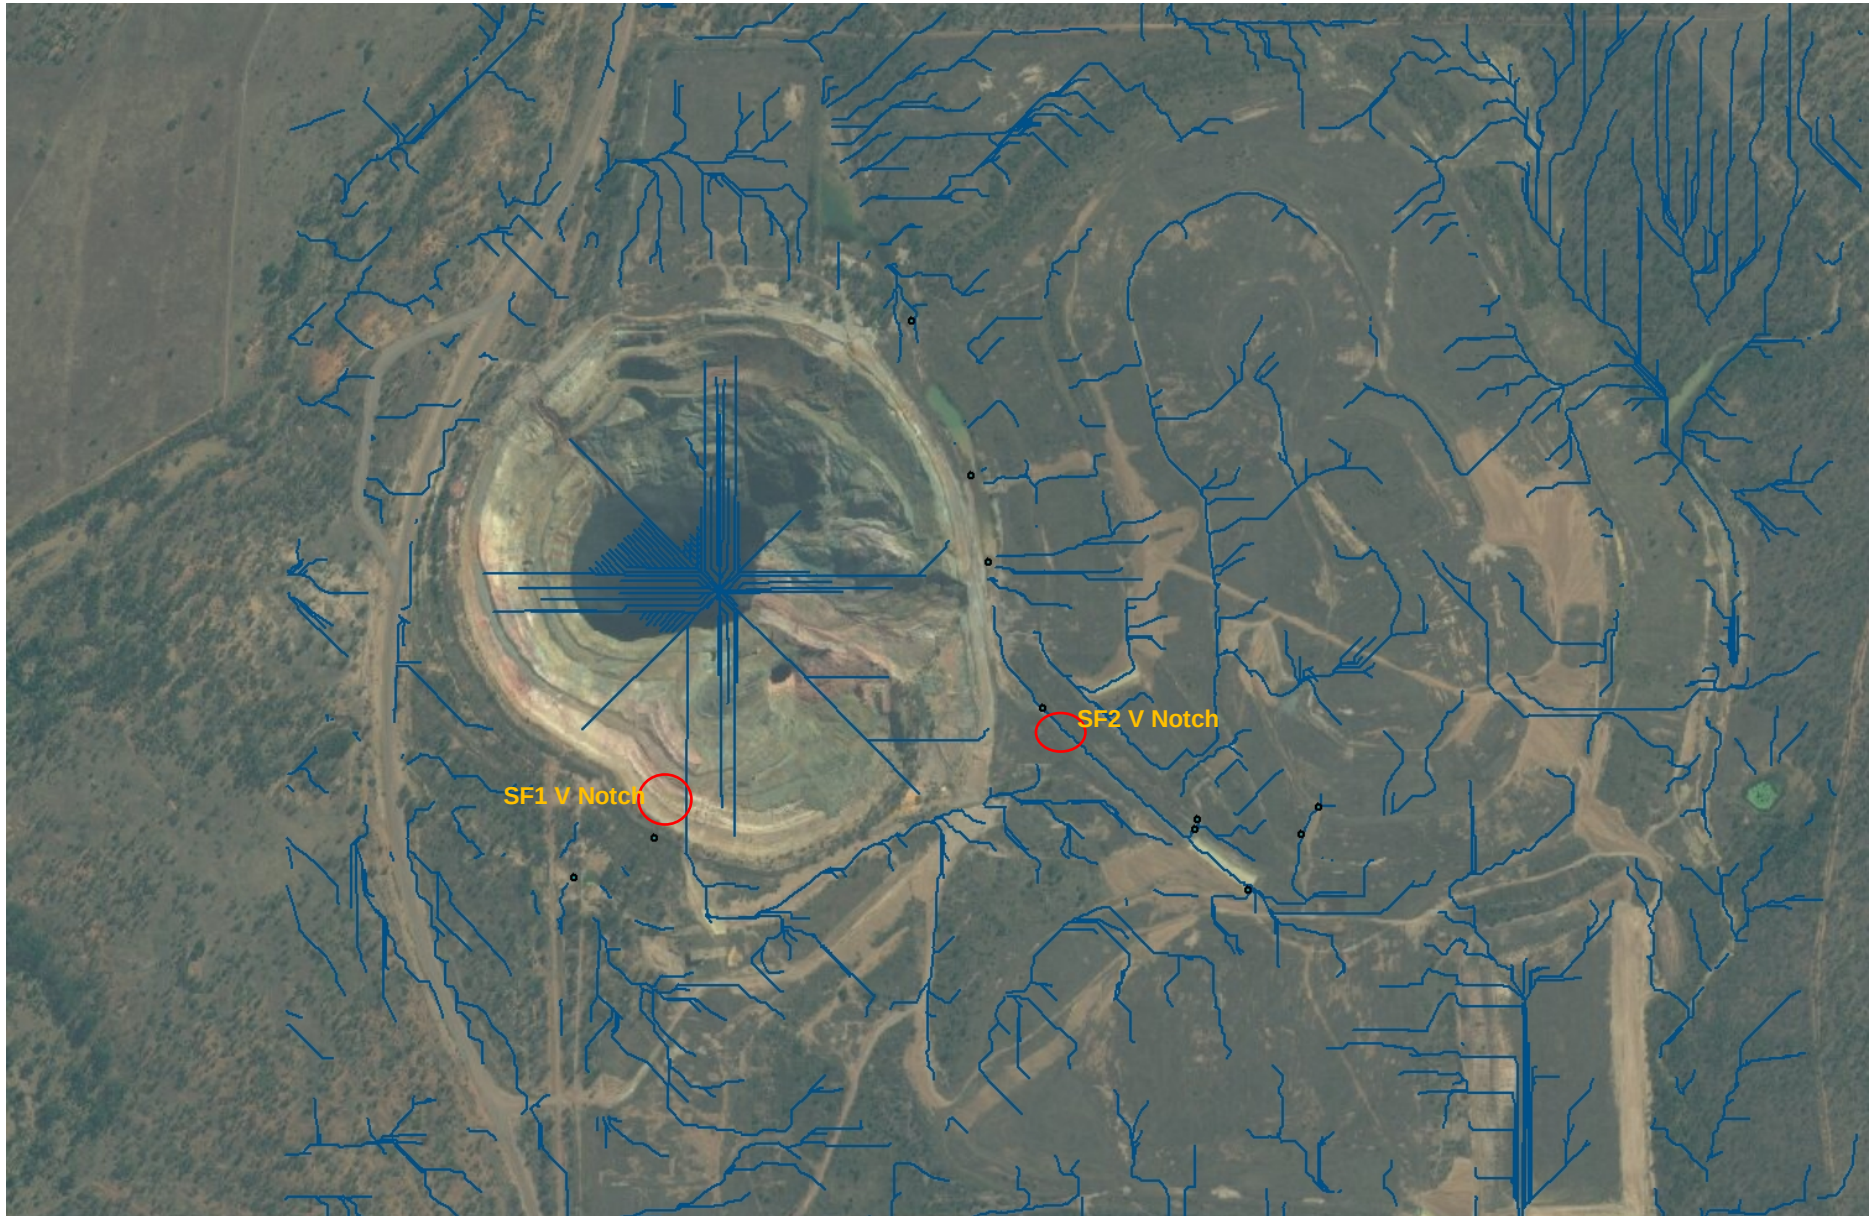
Figure 2 Site Flow Lines and Sample Points

Investigative surface water sampling including flow measurements at specific locations has been instigated to provide data on the sources of contamination noted in the submitted draft TEP document and to inform the TEP reports. The sampling program is described in Appendix One. The TEP sample points are also shown in Figure 2 as green dots with black outlines and numbered in Figure 3.

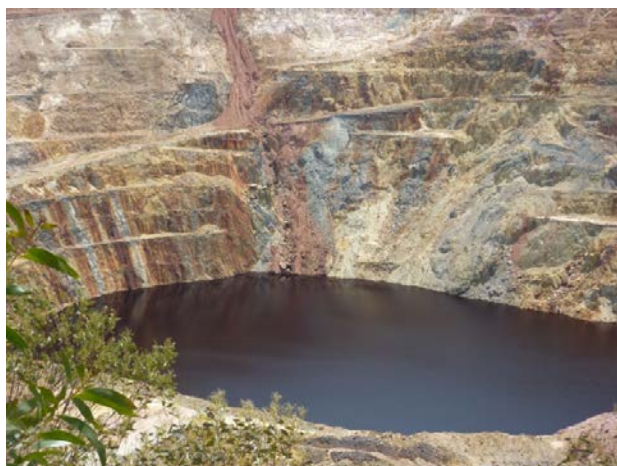
**Figure 5**            **Pit Water Height September 11**

Figure 5 shows the pit water height in September 2011 and Figure 6 shows the water level in February 2014. An estimated level increase of between 1 and 3 metres may have occurred over this 2.5 year period.

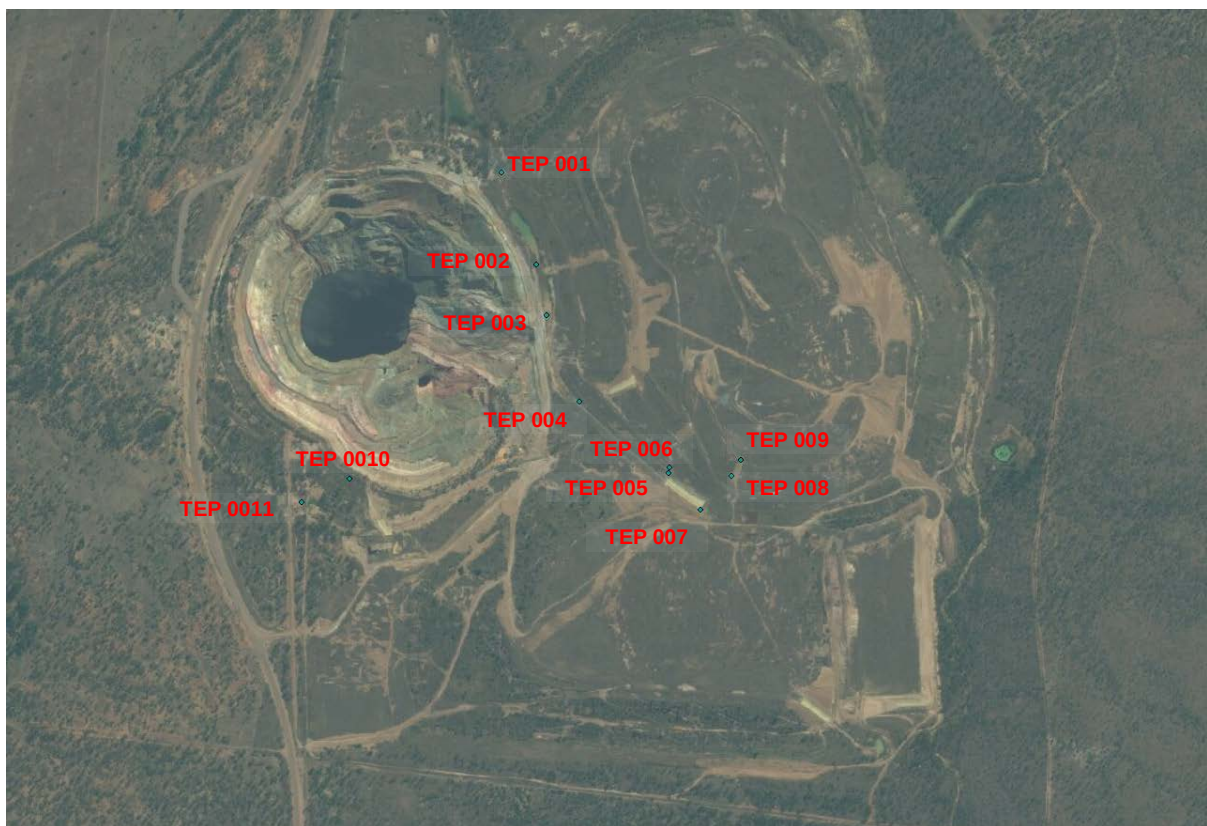
Figure 7      Sample Locations

The location of each proposed sample site is shown in Figure 7 below. These are show in more detail later in the report along with sampling requirements. Sampling is proposed fortnightly during the wet season (1 November - 30 April) and monthly during the dry season each year. It is anticipated that the sample sites will be dry on many occasions. At these times, the results (dry) shall be recorded and no samples taken.

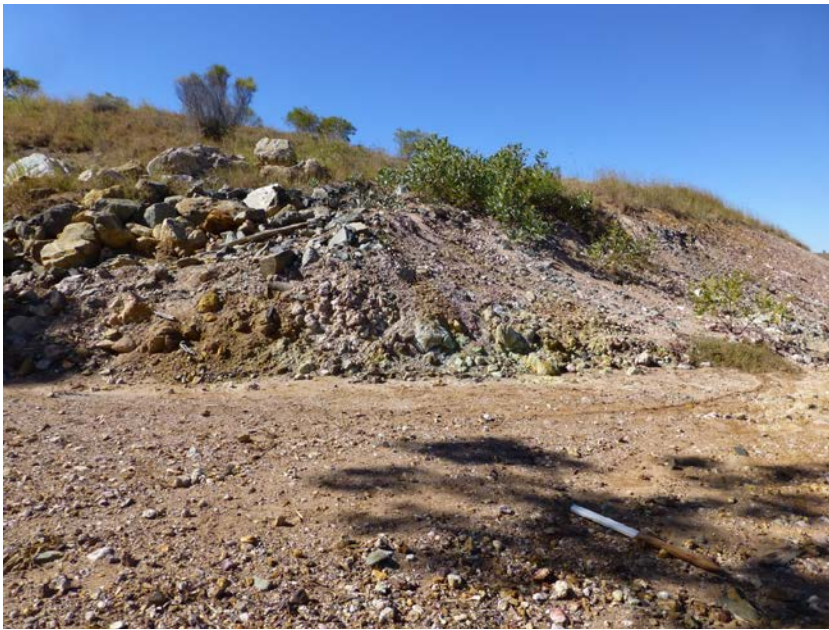
**Figure 8**      **TEP001**

TEP 001 is designed to sample the ARD leachate emanating from the NE corner of the base of the Highway waste rock dump (HWRD). This leachate has been shown to contain high concentrations of acidity and copper at times but is expected to only result in low flows. The contaminated leachate may be due to surface sulphide oxidation of influent rainfall from rocks containing visible sulphides (the yellow stained rocks in Figure 8) or it may be due to seepage of ARD from within the HWRD.

The flow pattern at 001 replicated those at 002 and 003. The reduction in acidity (single sample) also followed the pattern shown at 002. The single flow event recorded and the lack of additional acidity generation may indicate that there is no seepage at this site with surface contamination upstream being the main source of acidity. However as with the other sites, additional sampling is required to confirm this.

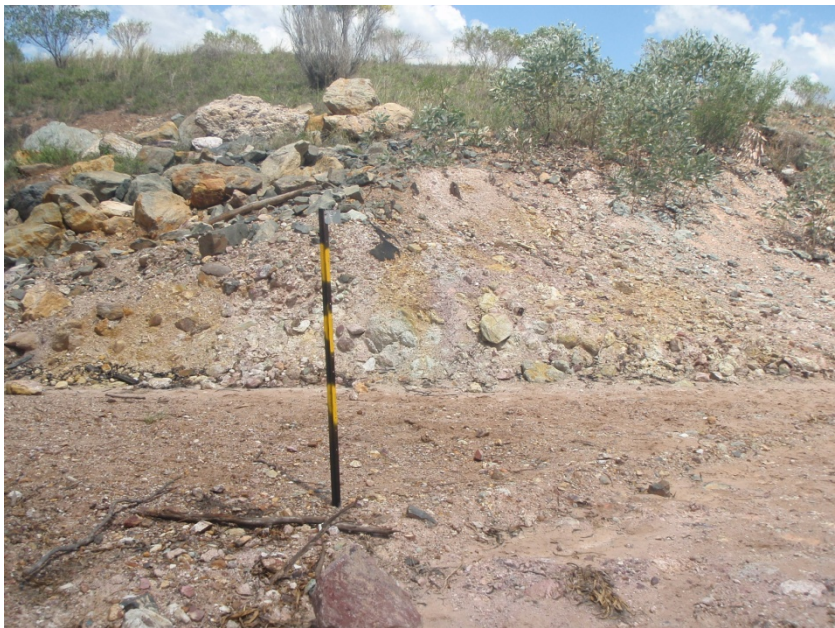
**Figure 9            Seepage collection**

A catch drain and sample sump has been constructed at this point to ensure that all seepage is captured and seepage flows can be measured. The seep collection drain only directs surface flows from either side of the NE point of the dump to a central location where the sump is situated. The approximated location is drawn in Figure 9. The length of the drain is approximately 10 m (5 m either side of the sump).

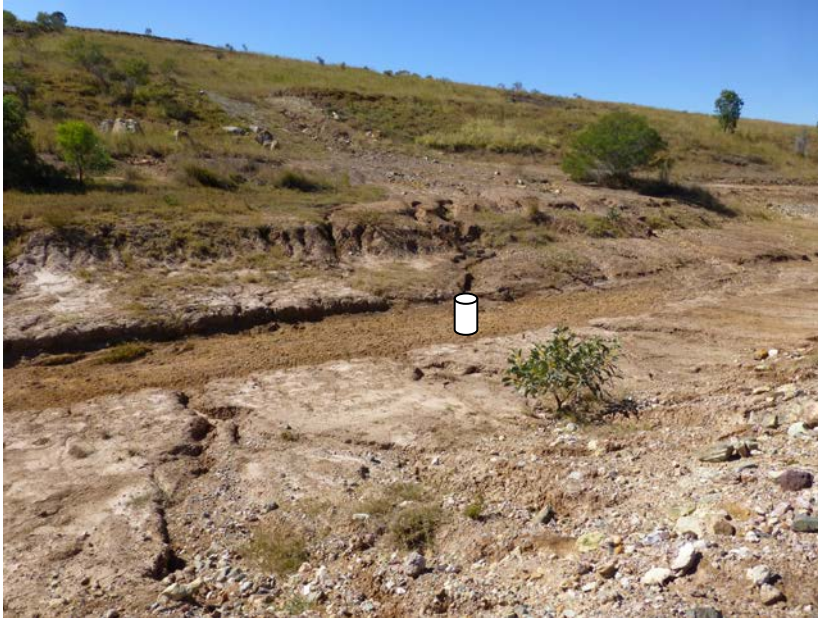
TEP 002 is the drain east of the HWRD and immediately north of the eroded drop structure where exposed sulphidic material can be seen oxidising

For flow measurement, a small sump is envisaged in the drain as shown in Figure 10 with flow collection as per TEP 001.

TEP site 002 follows the pattern of minimal surface flow established at 003. The reduced acidity (compared to 003) may indicate that no additional sources are present between 003 and 002 however additional sampling is required to confirm this.

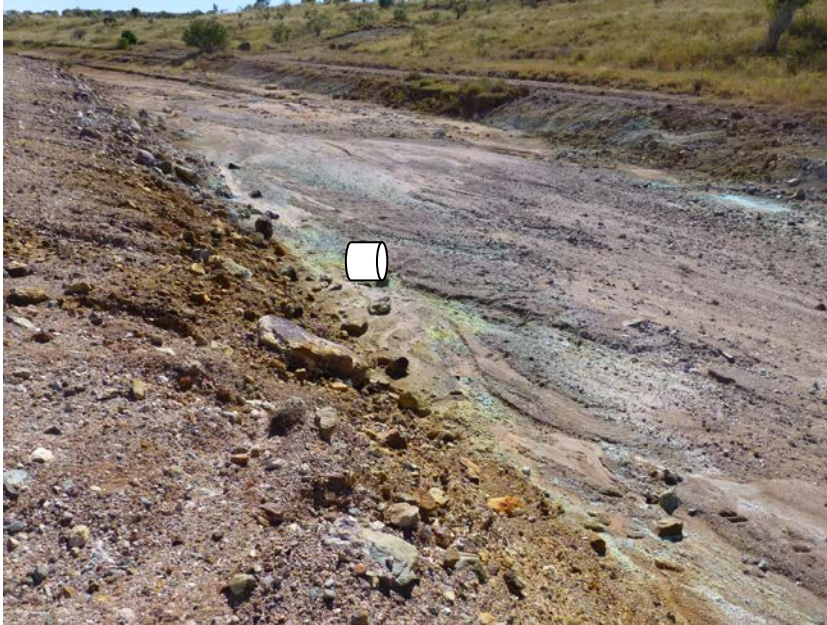
Figure 11` TEP 003

TEP 003 is immediately north of sulphide oxidation staining coming from the road to the west of the drain. A small sump has been dug to facilitate flow measurement.

TEP site 003 reflected the lack of rainfall and flow. The single acidity reading shows an increase from the weir upstream at 004. This indicates a potential source of acidity at or immediately upstream of 003. Additional sampling is required to confirm this.

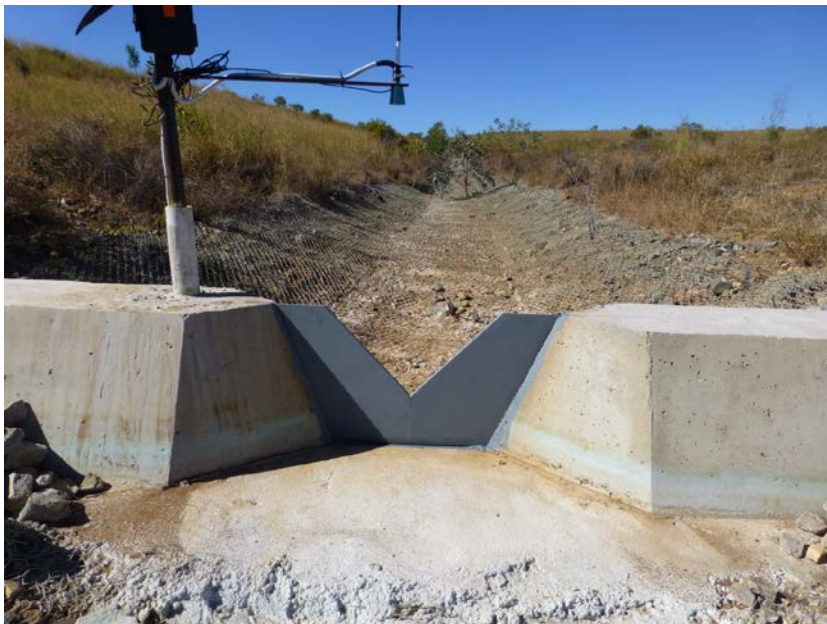
**Figure 12**

TEP 004 is the V notch weir. Flow is recorded automatically by the monitoring station.

A sample can be collected from behind the v notch plate.

In Table 2 it can be seen that surface flow was only recorded on two occasions, in January and again in February. Pondered water was sufficient to allow pH to be read on four occasions. Each pH was below 5 indicating an upstream acidity source. The acidity concentrations recorded ranged from 116 mg/L to 195 mg/L also indicating an upstream source of acidity.

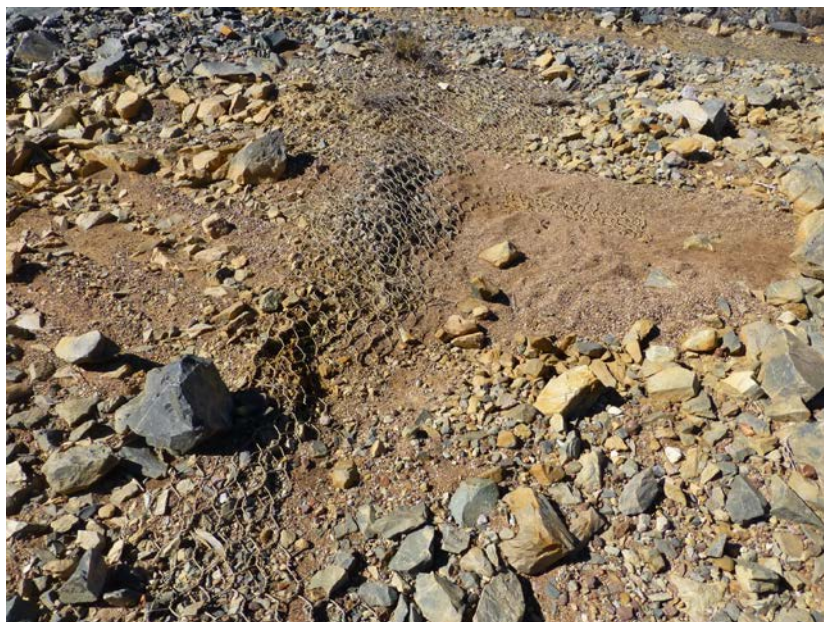
Figure 13                      TEP 005

TEP 005 is designed to sample the first obvious inputs to the gabion (and eventually revetment mattress) drain intersecting the HWRD and the Reward WRD (RWRD). The drain which flows into the main drain has two sources - above and to the immediate left of the drain (looking upwards TEP 006) coming down the left hand side of the drain TEP 005. A small sump has been dug in the yellow stained flow path for collection of samples and flow measurements.

Sample sites 005 and 006 are below and on northern side of the revetment mattress drain. The sites did not provide enough flow to obtain flow measurements and only provided ponded water on a few occasions. However the higher acidities (398mg/L at 006 and 747 mg/L at 005) indicate upstream sources of acidity. Site inspection upstream showed bare yellow patches of earth north of the revetment mattress, possibly jarosite staining. This has been programmed for capping in the 2014 earthworks program.

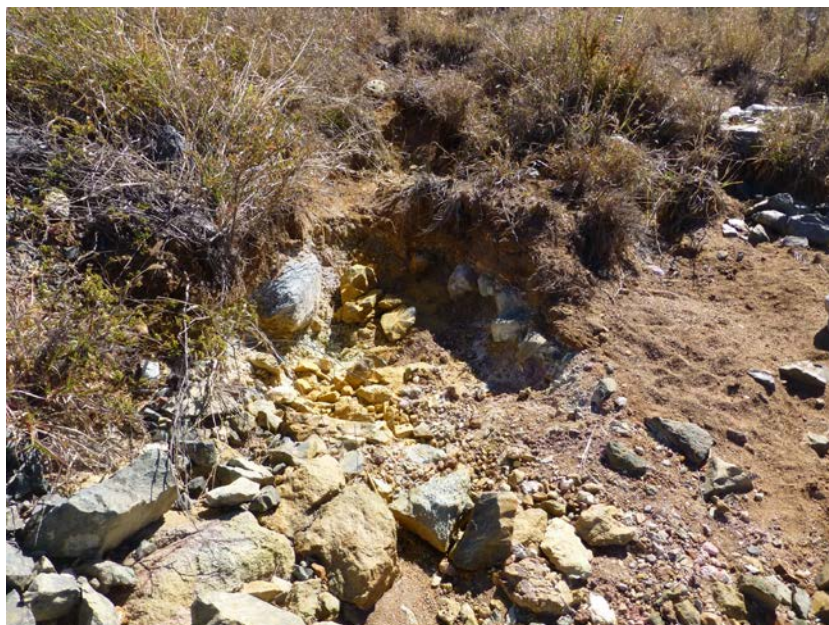
Figure 14

TEP is to the immediate north of the gabion drain and collects surface flows which run alongside the revetment mattress and report into the gabion drain above TEP 005.

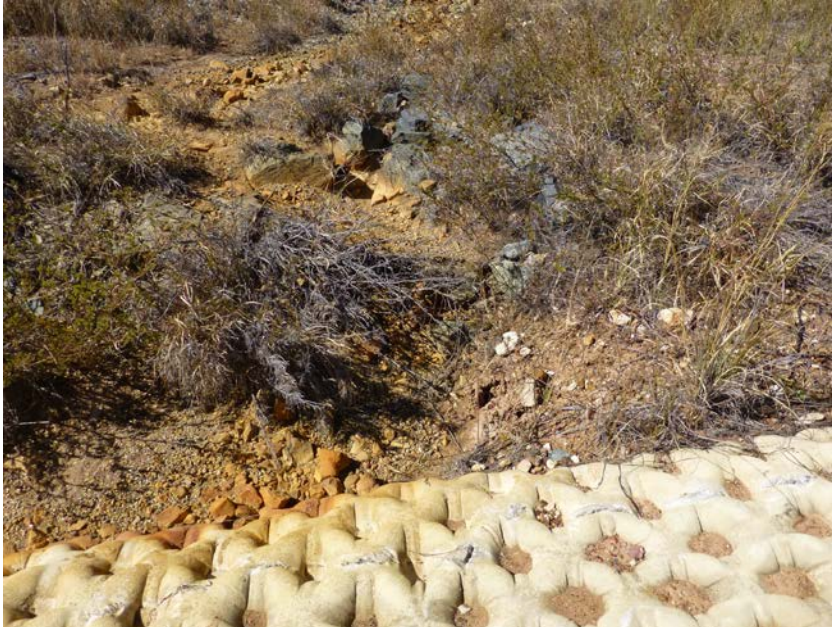
**Figure 15** TEP 007

TEP 007 is at the top of the revetment mattress where sulphide oxidation appears to be taking place. A small sump has been dug to facilitate sampling and flow measurement.

Again at this site there was no flow and insufficient ponding to even obtain a pH sample. This site will be moved for the next TEP sampling season.

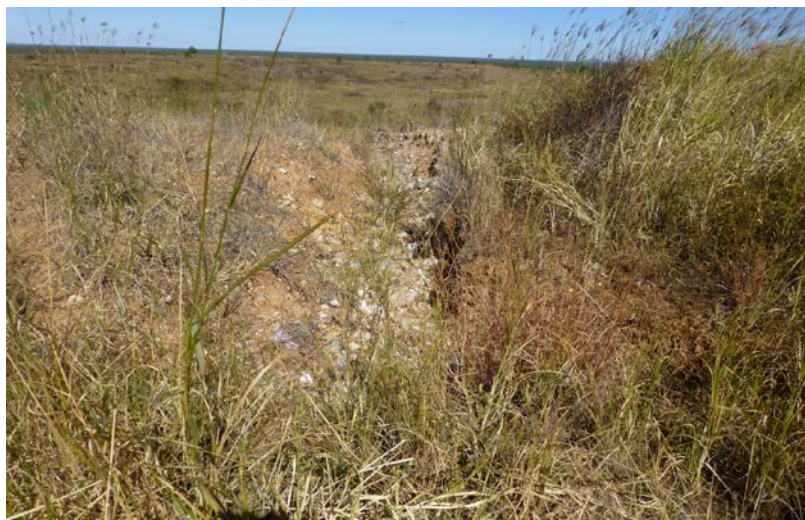
Figure 16 TEP 008

TEP 008 is at the base of an eroding flow path immediately above the revetment mattress drain and flowing into it. TEP 009 is at the top of the structure / flow path.

At these sites there was no flow and insufficient ponding to even obtain a pH sample. These sites will be moved for the next TEP sampling season.

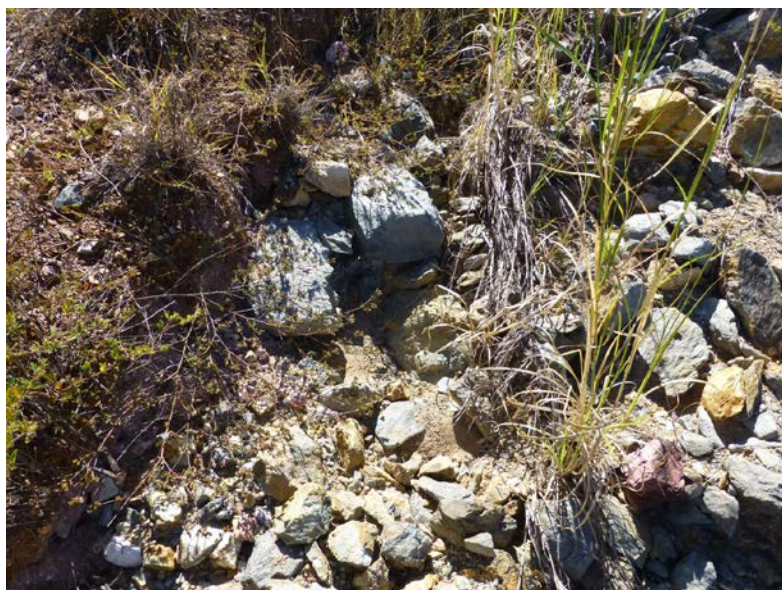
Figure 17 TEP 008 Close

Samples can be collected in flow paths along the rocks and drops and similarly flow measurement collected. (TEP 009 also)

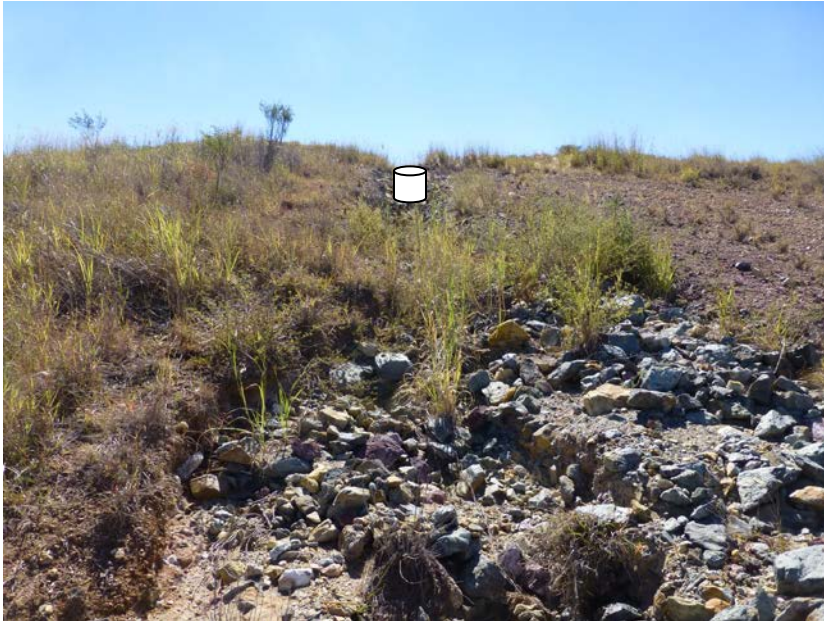
**Figure 18        TEP 009**

TEP 009 is at the top of the flow path used for TEP 008.

A sample sump / collection point near the top of the "structure is used - along a "natural" flow path.

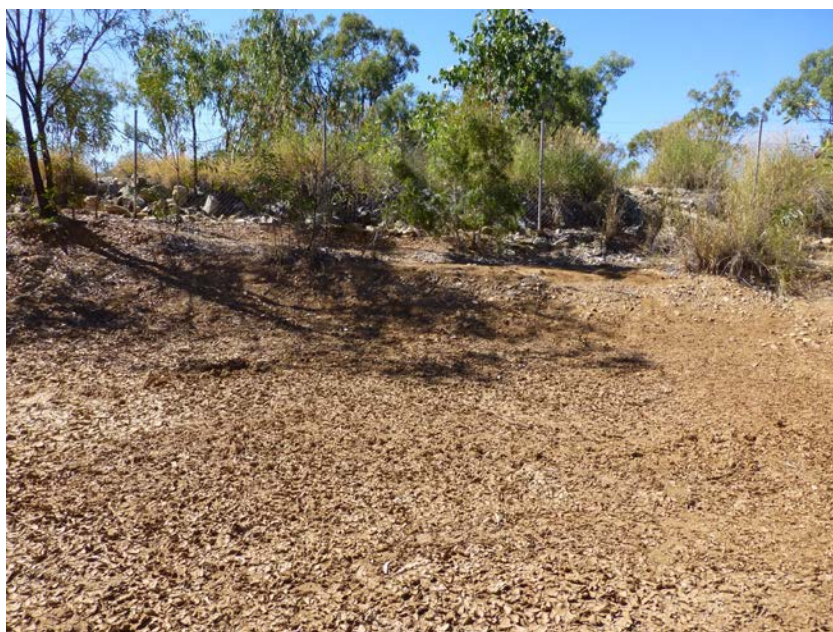
**Figure 19**            **TEP 011**

TEP 011 is a sample point immediately to the west of the fenced lease boundary and along the flow path to the official SW5 point.

It is envisaged that TEP 011 will be dry or will only contain localised flows (i.e. not specifically from the mine site). Hence the sampling in dry conditions will involve recording that no flow is present and taking a photographic record towards the site as per Figure 19. In the event that there is water at TEP 011, a sample shall be taken.

Site 011 did not record flows from the site off lease towards SW5. The low acidities and pH approaching 7 recorded from localised ponded water reflects this and hopefully shows the benefits of site earthworks over the previous year's, capturing site water and diversion into the pit thus preventing off site pollution in this area. Further sampling hopefully will confirm this.
