# Thalanga Copper Mines Pty Ltd

## **Re: Transitional Environment Program (TEP) MAN17020**

In accordance with the commitments made in the TEP please accept this report on site surface water flows, pit water and TEP investigations at the Highway Reward mine. This report covers the period from 9 June 2014 until 9 December 2014. This period was characterised by extremely low rainfall on site with virtual drought conditions applying. Table 1 shows the monthly rainfall, with 50.95 mm falling over six months. Of this 25.42 mm fell on 6 December.

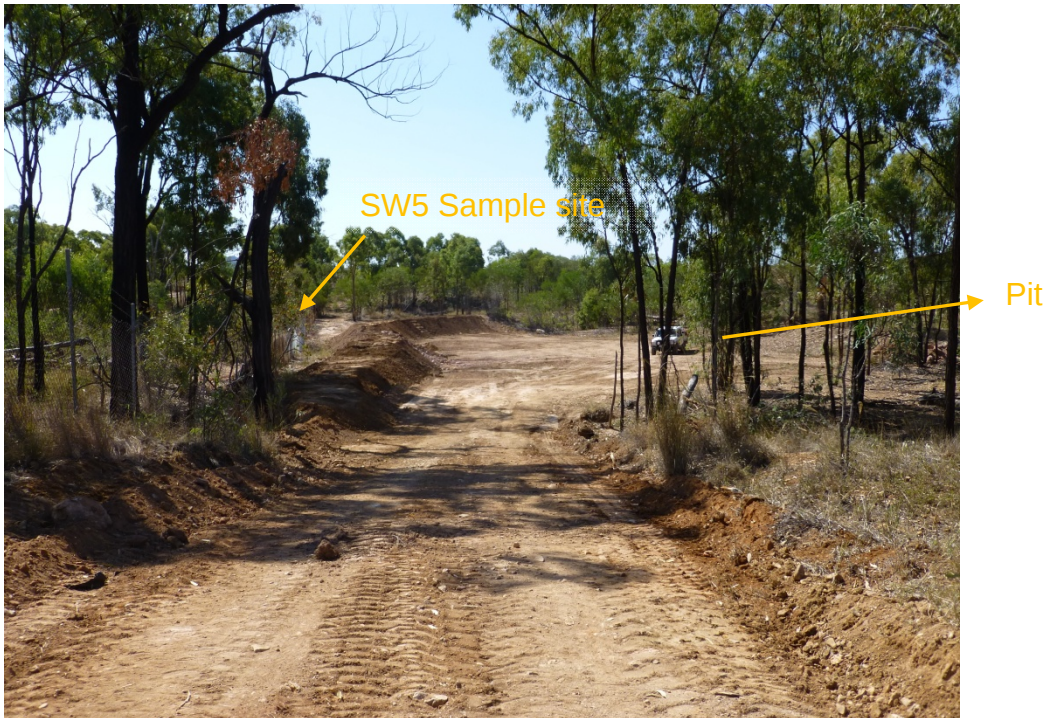
**Plate 1**      **Diversion bund western side of lease**

Surface water flows from the mine site towards SW5 were blocked during earthworks in June/July 2014.

Plate 1 above shows the diversion bund installed to prevent surface water flowing from the mine site to the west of the lease area.

Following the earthworks to prevent surface water flowing from the site towards SS7 (Plate 1), additional stream sediment sampling has been undertaken to ensure that all contamination has been removed from this area. Samples were taken along the former flow path between the site, SS7 and the Gregory Development Road (Table 2). Samples were

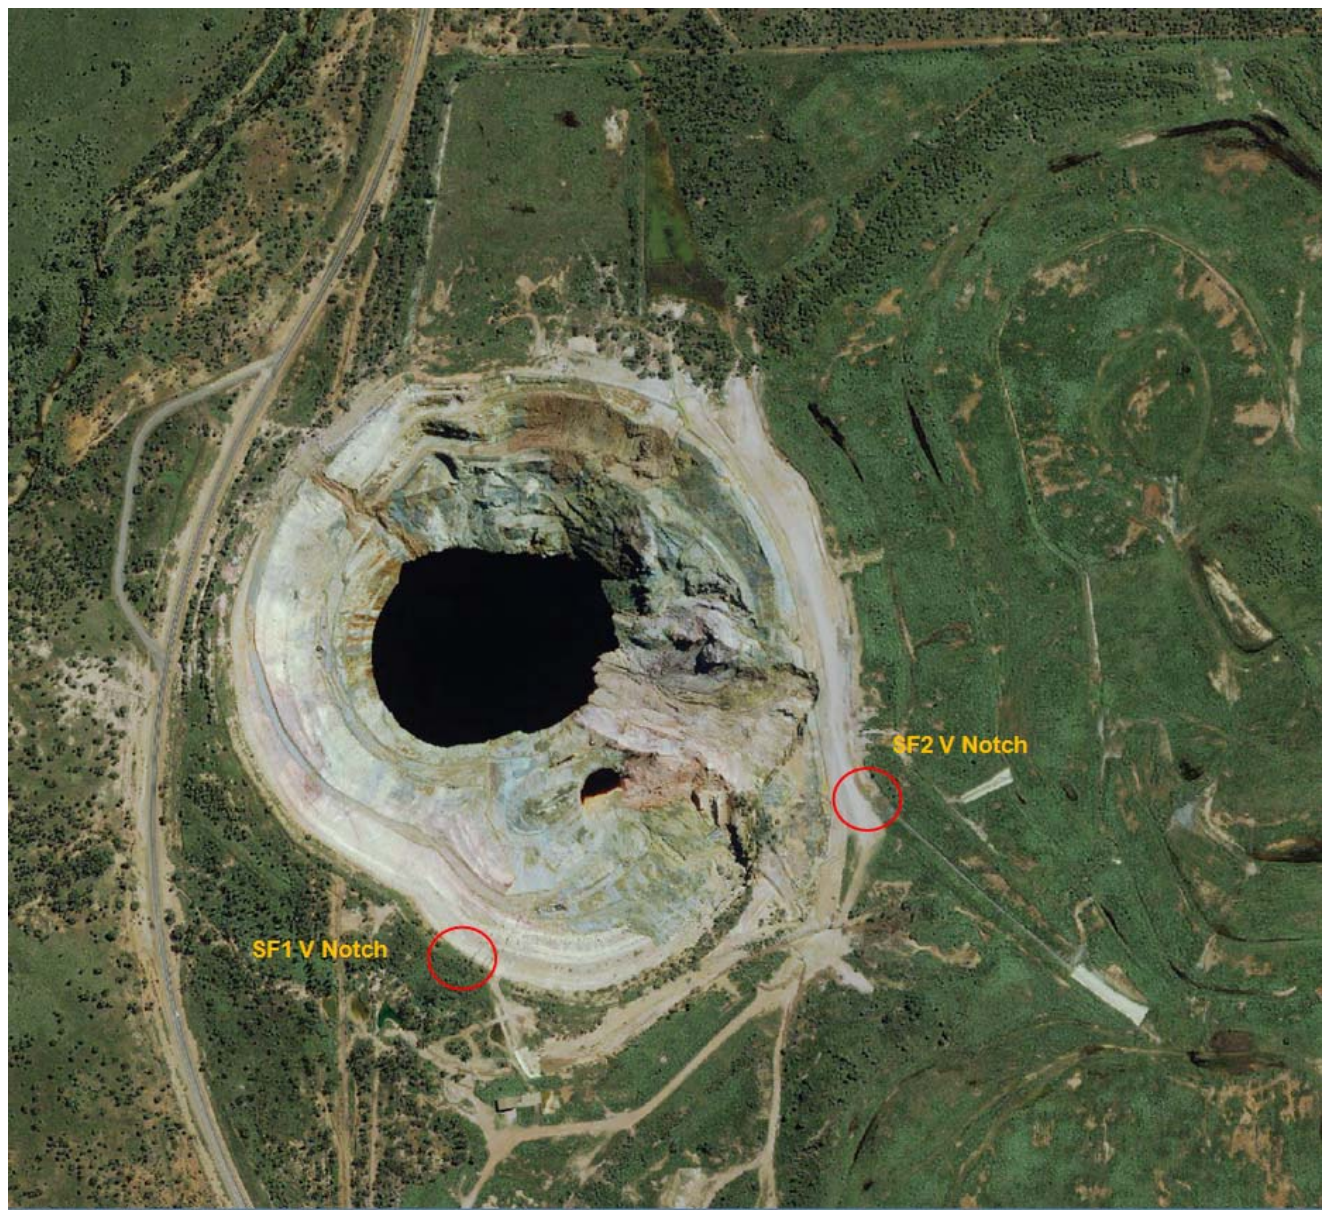
The flow path towards SW6 runs along the western side of the base of the Highway Waste rock dump. Flows along this path were measured at SF2 (TEP site 004) and after rainfall, downstream of that at TEP sample sites 003, 002 and 001. These sites are shown in Figure 1 and Figure 2.

Flow Monitoring Locations Highway Reward

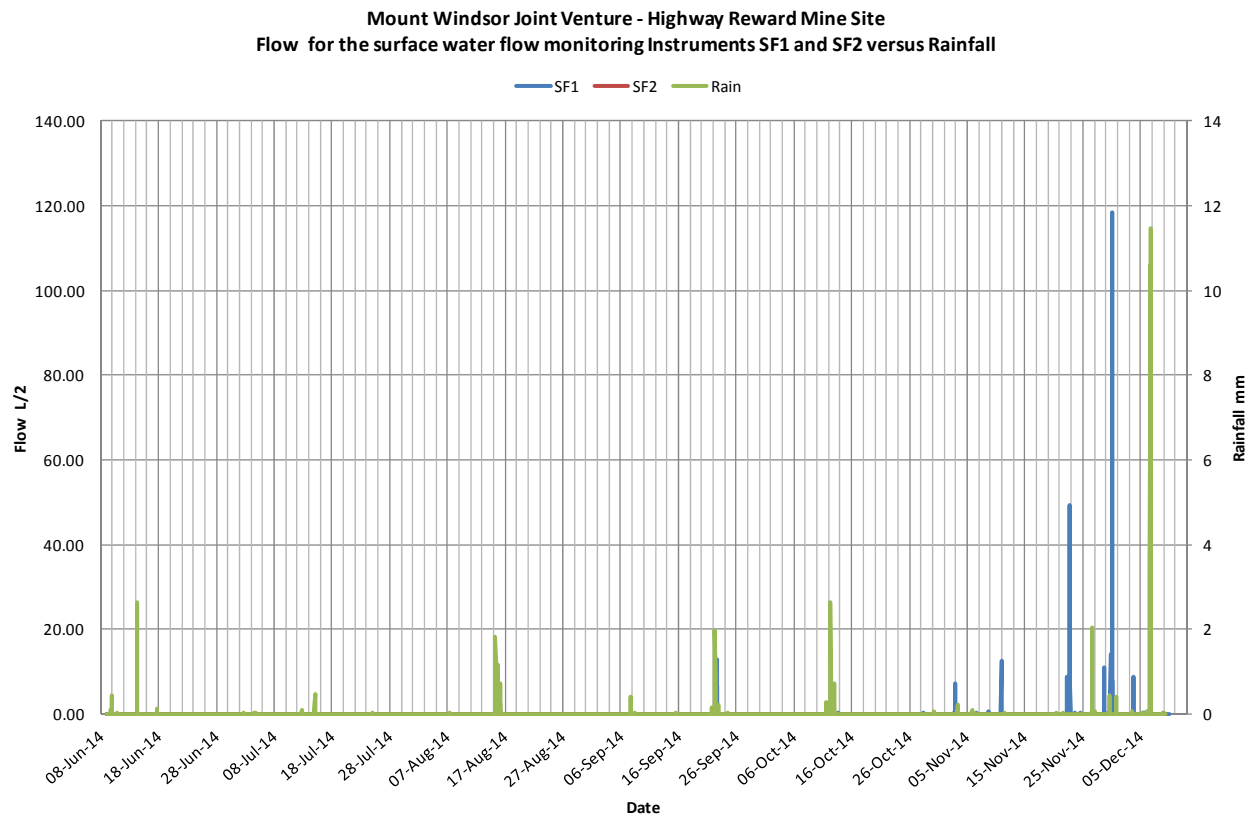
**Figure 3**      **Flows and Rainfall**

The pit v notch SF1 has shown minimal flow into the pit consistent with the lack of rain on site (Figure 3).

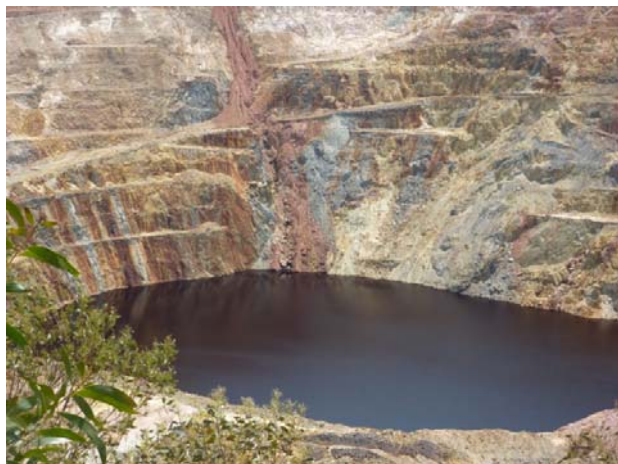
**Plate 2**      **Pit Water Height September 2011**

Plate 2 shows the pit water height in September 2011, Plate 3 shows the water level in February 2014, Plate 4 in August 2014 and Plate 5 in October 2014. An estimated level decrease of 500 mm has occurred in the past six months.

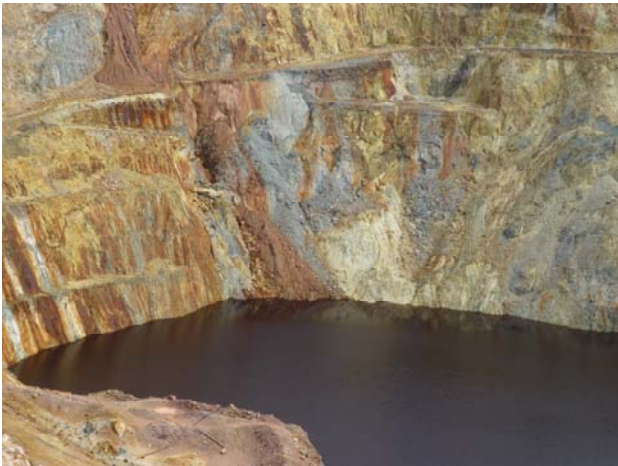
**Plate 3**

**Pit Water Height February 2014**

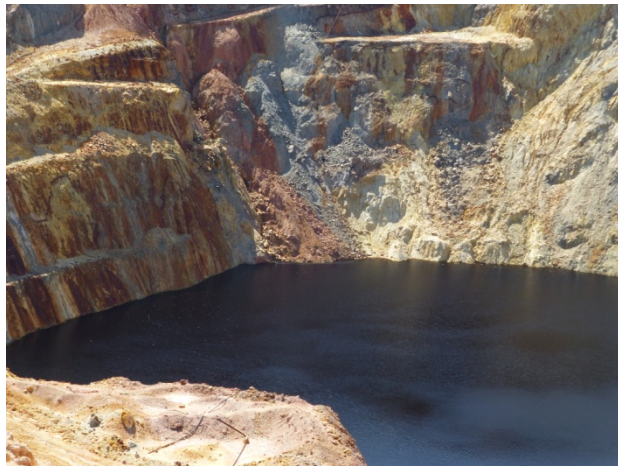
**Plate 4**

**Pit Water Height August 2014**

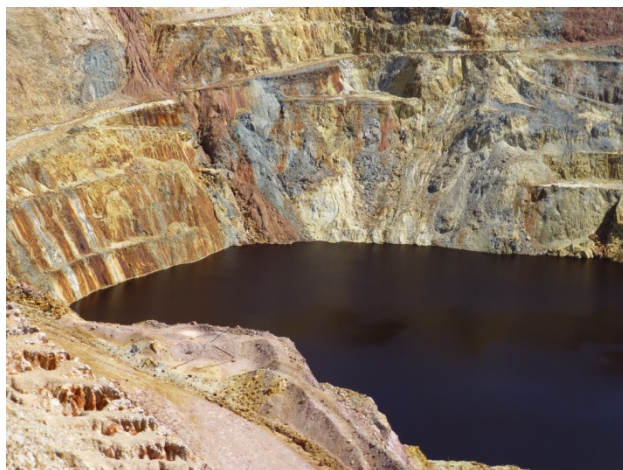
**Plate 5**

**Pit Water Height October 2014**

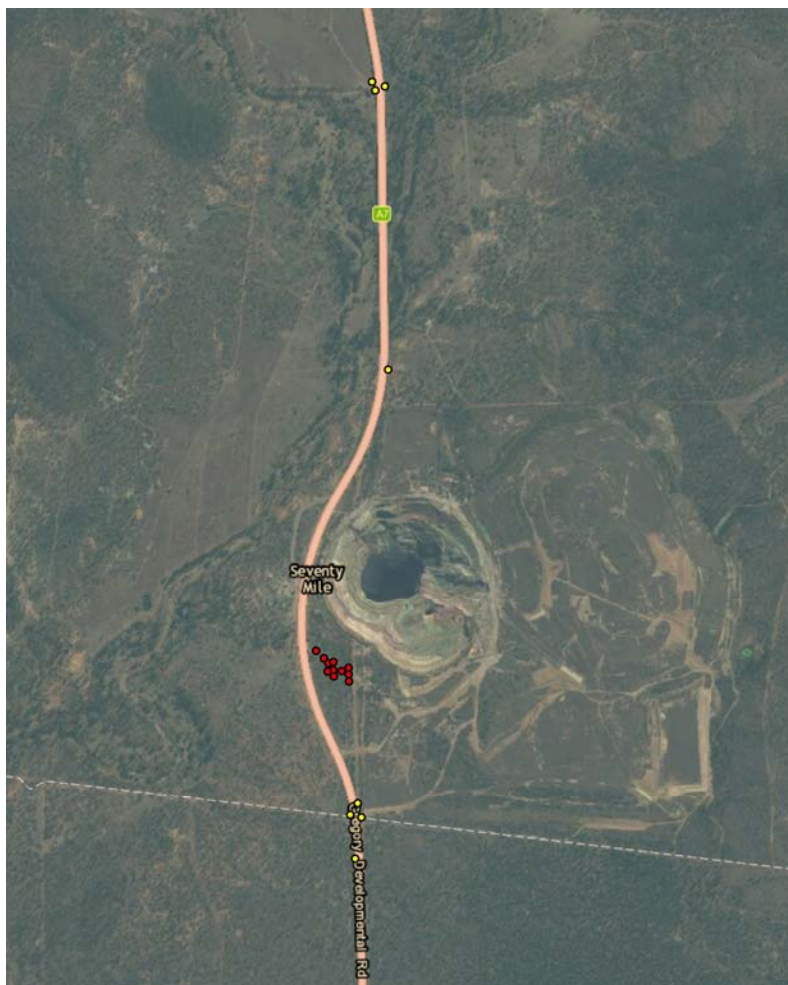
**Figure 4 SS Sampling**

also taken north and south of the site at Gregory Development Road runoff points to evaluate whether road runoff could be contributing to contamination at SS7 (Table 3).

In Figure 4, the SS7 sites are shown as red dots and the road runoff sites are shown as yellow dots.
