# Highway Reward

Transitional Environment Program  
MAN17020 - Surface water and  
sediment quality report

**December 2016**

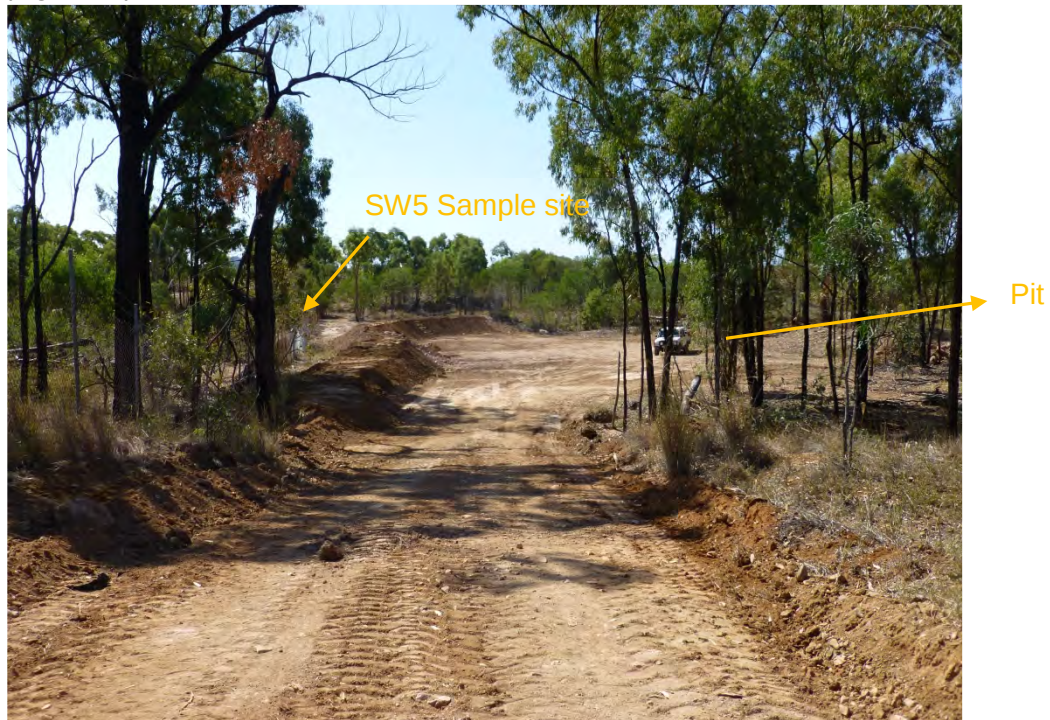
Figure 15: Diversion bund on western side of lease

Earthworks blocked surface water flows from the mine site towards SW5 in June/July 2014 (Figure 15).

Flows from mining infrastructure (Reward Dump) that did report to SW5 are now diverted into the Pit. Flows from Reward Dump diverted to the pit are discussed in the following section.

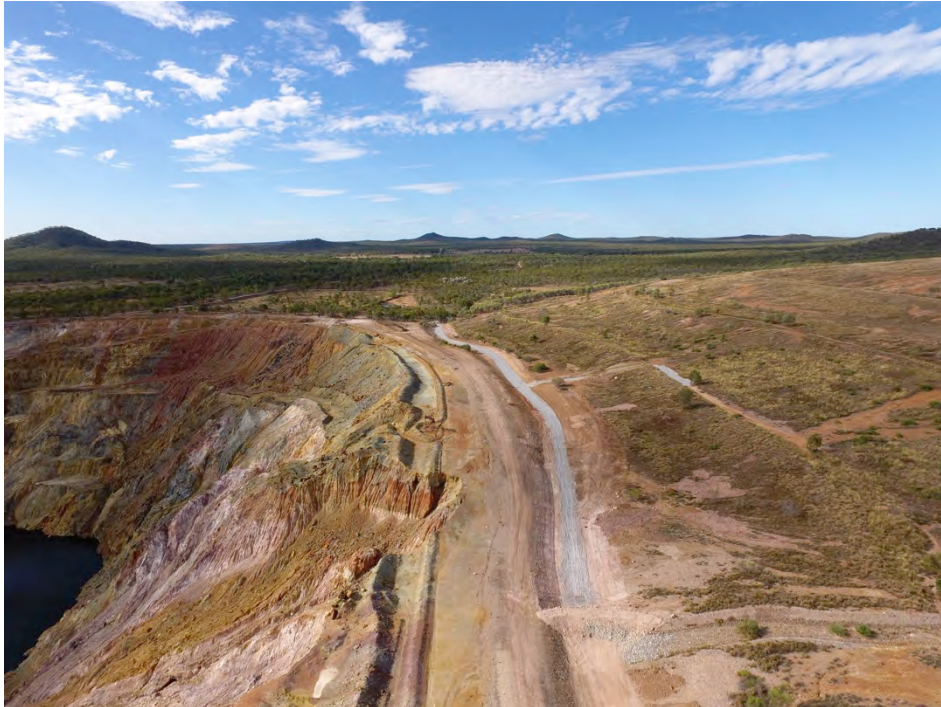
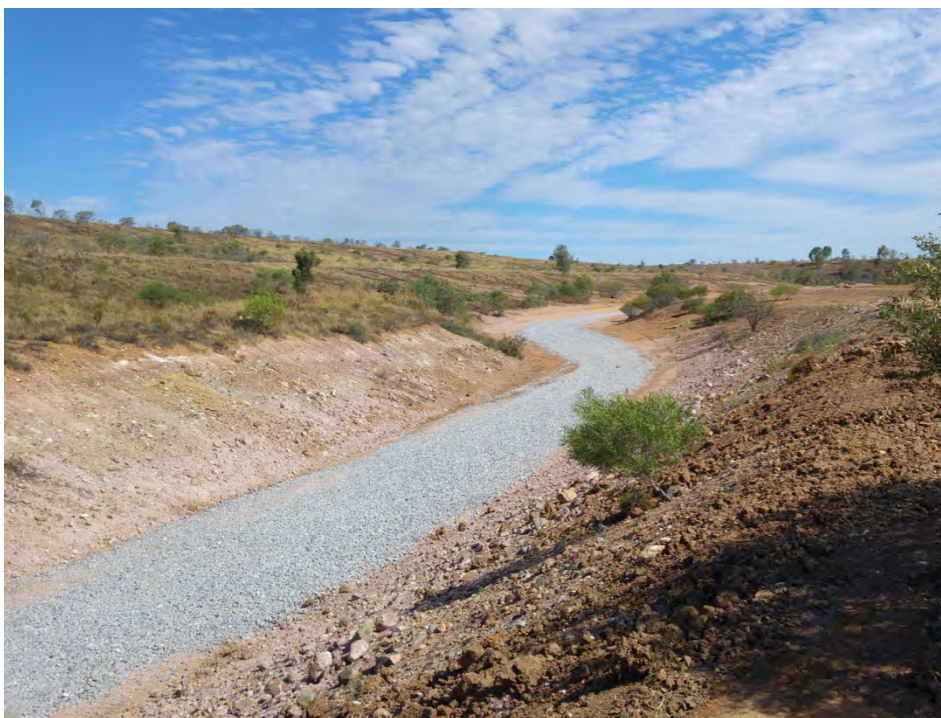
Figure 1: Elevated view of main drain with lime rock armouring.

Figure 2: Main drain with lime rock armouring.

Installation of lime rock armouring along the main drain was a commitment detailed in the approved amended TEP to address the eroded main drainage structure with exposed sulphides. NRC can confirm that the works to install lime rock armouring along the main drain were completed as of 11 November 2016. Figure 1 and Figure 2 demonstrates the completed main drain.

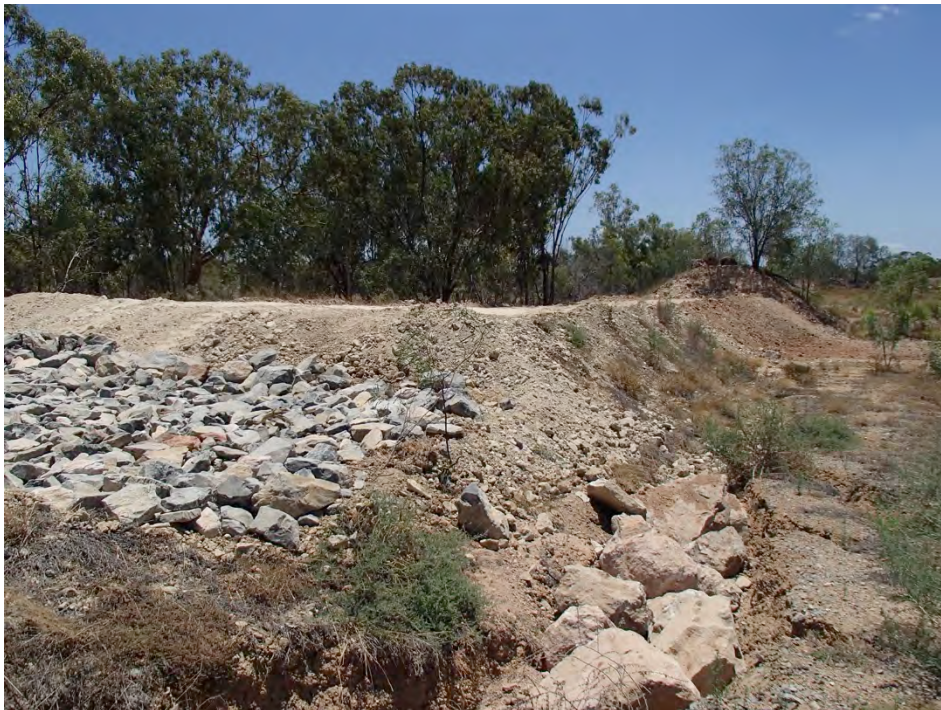
Figure 3: Completed reprofiling and repair works to western storage.

Sealing of the western storage area channel was a requirement under the TEP which was undertaken to ensure that adequate containment of runoff could be achieved. Works included reprofile and repair of drainage to prevent water egress and were completed as of 11 November 2016. Figure demonstrates the works completed.

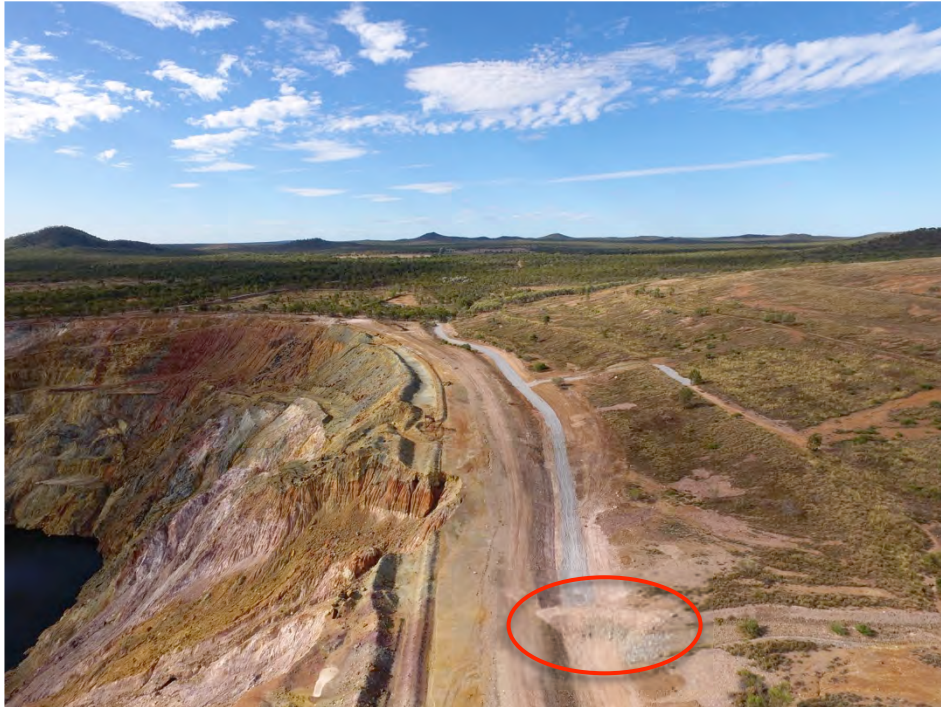
Figure 4: Installation of diversion bund to direct flow to the main pit (circled in red).

Diversion of the remaining upstream catchment (42.69ha) was committed to and completed as of 11 November 2016 to ensure that flow captured is diverted to the main pit. Figure 4 demonstrates the completed diversion (circled in red).

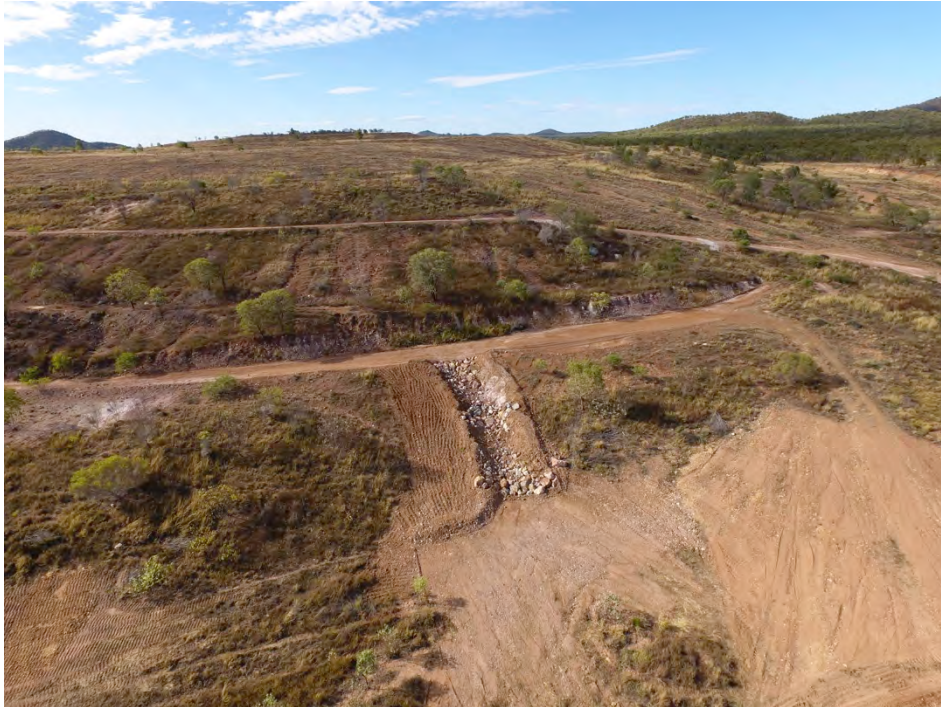
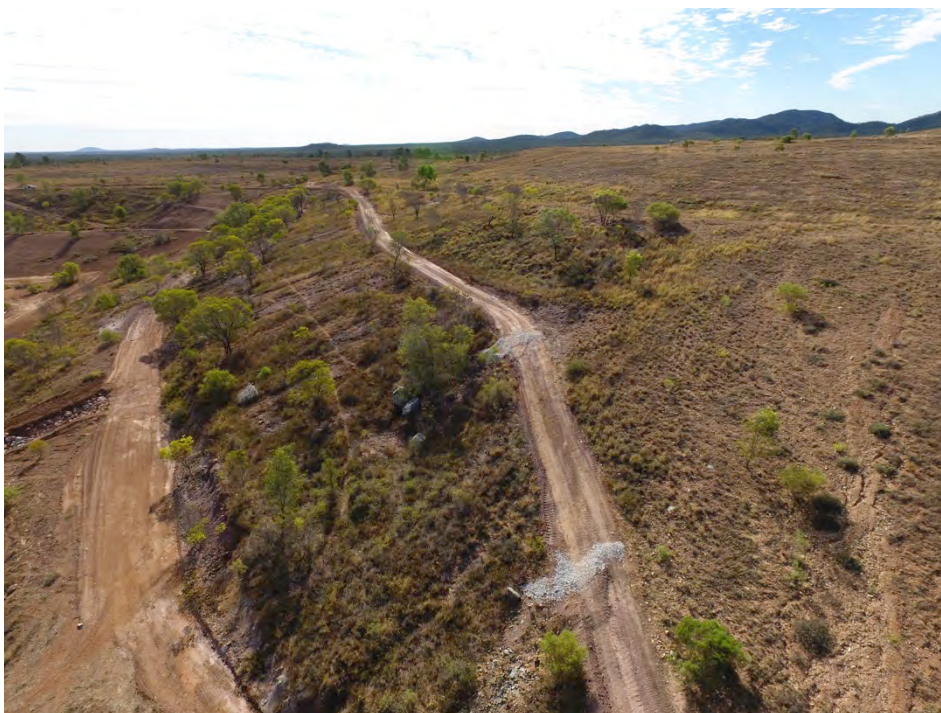
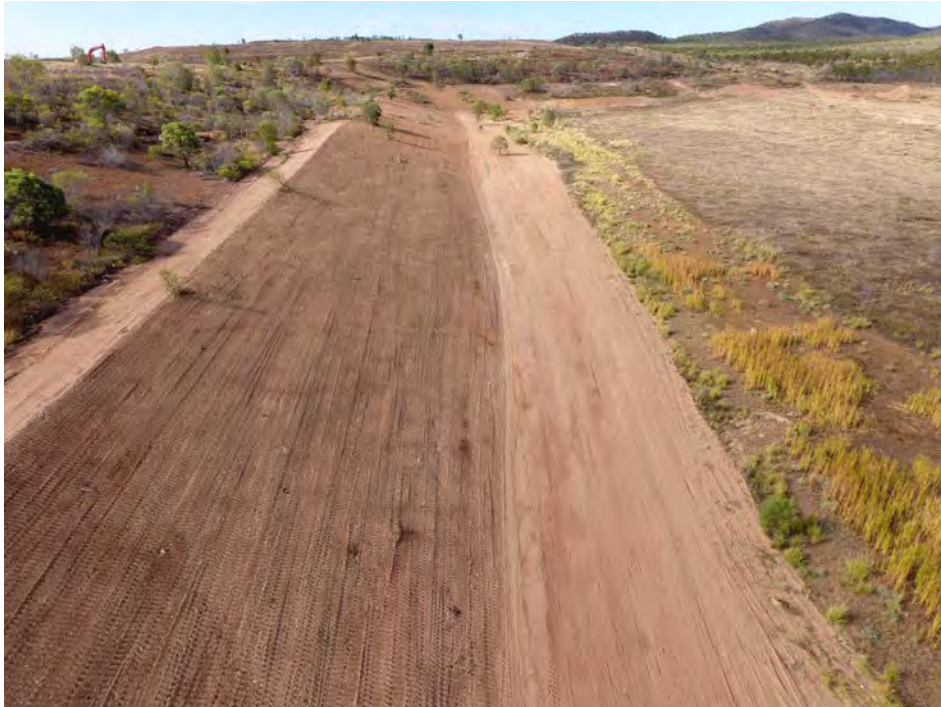
The non-compliance identified was in relation to erosion of potentially acid forming material between waste rock dumps known as Highway and Reward. NRC can advise that restoration works have been undertaken to rectify the non-compliance with evidence presented in Figure 5, Figure 6 and Figure 7.

Figure 5: Evidence of erosion protection measure restoration works to eroded areas.

Figure 6: Evidence of erosion protection measure restoration works to eroded areas.

Figure 7: Evidence of restoration works to eastern batter of dump known as Reward.

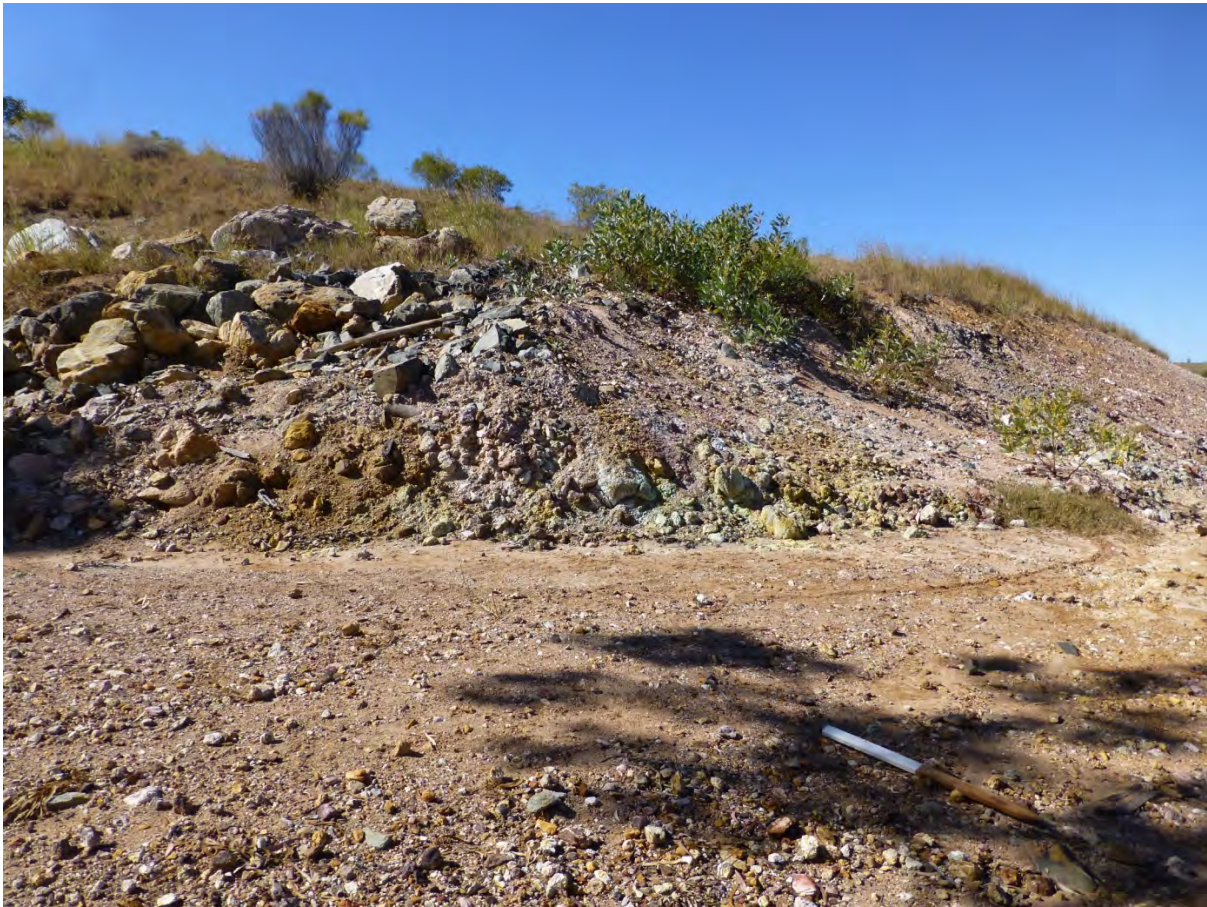
**Figure 3**      **Potential Highway Waste Rock Dump Seepage**

The investigation noted that several previously unknown seeps appeared to be leaching high-acidity water from the base of the Highway waste rock dump into the flow path to the SW6 sampling site (Figure 3). This contaminated water contained high concentrations of Total Cu as well as low pH water and indicated acid rock drainage formation. A recently eroded structure was also showing signs of sulphide oxidation along the drain in question (Figure 4).

The site in question is situated at the north-western end of the Highway waste rock dump and was exposed during maintenance works to recut a drain in late 2011. The yellow discolouration and signs of bubbling indicate exposed sulphidic material is oxidising, producing acid rock drainage (ARD). Solutions to this are to remove exposed boulders containing sulphides to the pit void and cap the remaining sulphidic material to prevent oxygen access. This would provide an effective solution if the exposed sulphidic material is the sole source of ARD. The JV is concerned however, that this may not provide a long-term solution if the waste rock dump contains stored acidity and is leaching the ARD. As a result, a TEP has been proposed to provide time for the JV to monitor water quality and flows from the site. This will enable the JV to determine whether the ARD is being produced from localised rainfall seeping over the sulphidic material or whether the ARD is from dump seepage and thus requires a different long-term solution.

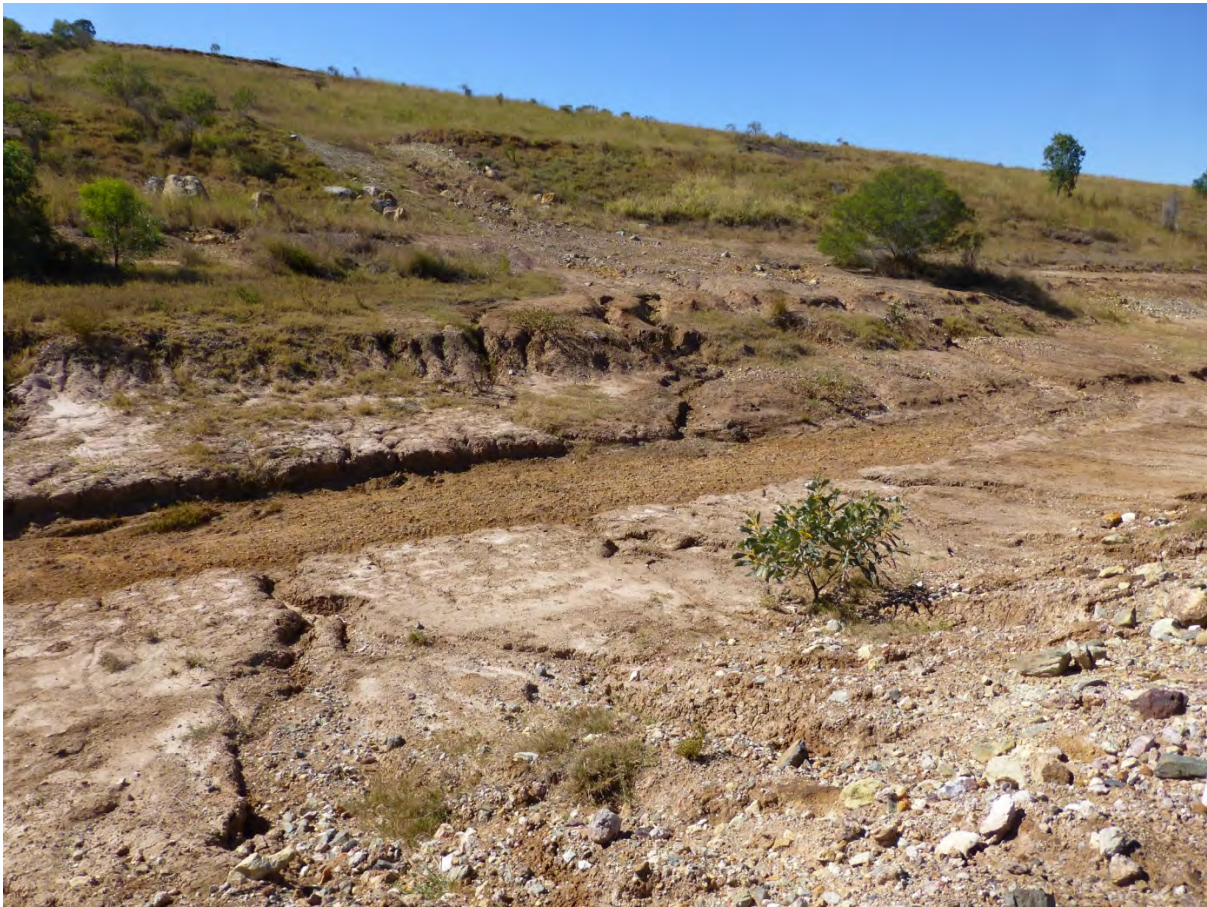
**Figure 4**                      **Eroded Structure with Exposed Sulphides**

The yellow discolouration above the drain again shows evidence of ARD formation. In this case the drop structure which was repaired in 2012 has eroded, exposing the sulphides. As a localised source of ARD this area is undergoing reconstruction in 2013 to provide a stable long-term solution for this problem.
