# **Transitional Environmental Program:**

## **MAN 17560**

Periodic Report (1 March 2018)

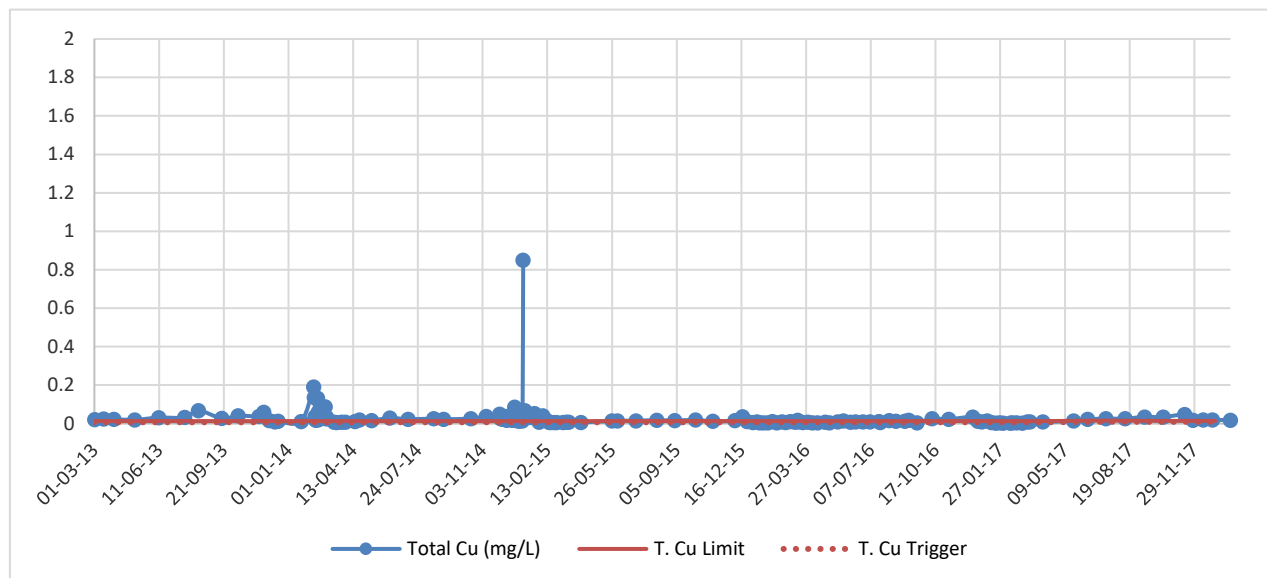
**Figure A-9: Total Copper at GPA2 (2013-2018)**
