Teys Australia Beenleigh Pty Ltd

Transitional Environmental Program (TEP)
MAN17840

Stormwater Management

MILESTONE 4 REPORT

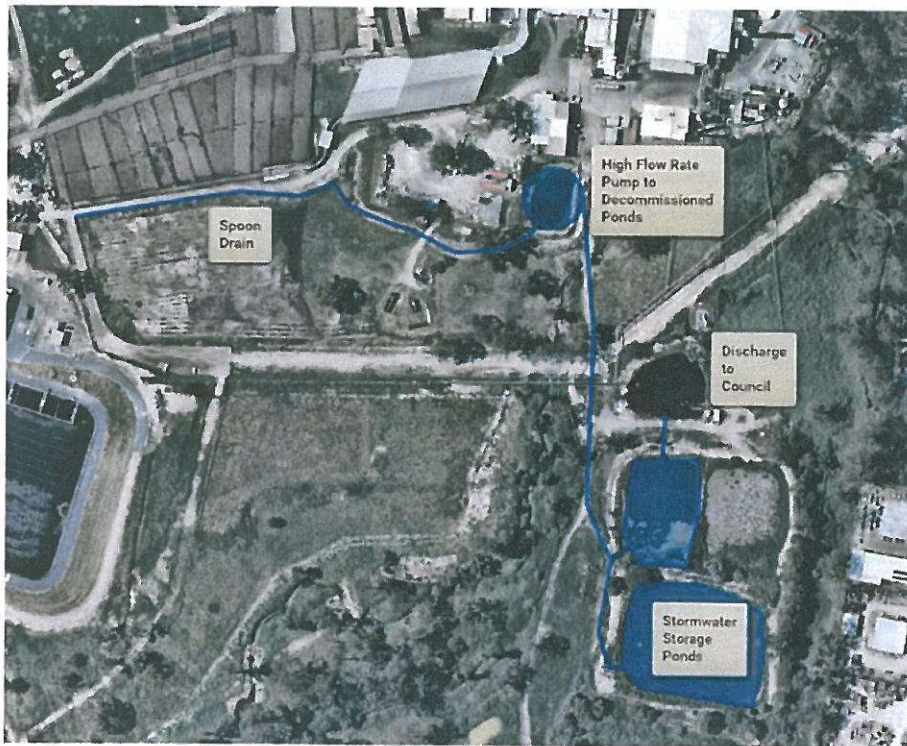
Eastern Stormwater Concept Design: Pumping from the Eastern Catchment Pond to the Stormwater storage ponds.

- The installation of a high flow rate pump station on the Eastern Catchment Pond to pump contaminated stormwater into the decommissioned waste water treatment ponds; and,
- A spoon/catchment drain to the west of the eastern stormwater pond and south of the cattle holding pens to direct all contaminated stormwater to the eastern stormwater pond.

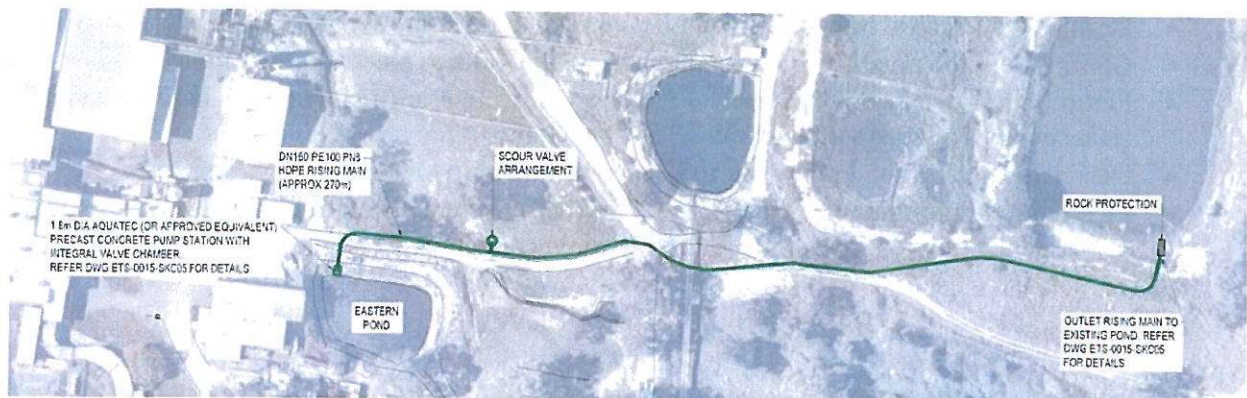
Figure 2 – Eastern Pond Pump Station and Rising Main

During, and following, a significant down pour, an in situ pump installed to the pond will transfer stormwater from this eastern catchment pond to Teys decommissioned waste water treatment lagoons (referring to Figure 2 below). The specifications for this pump have been explicitly developed to cater to the specific limitation of the pond volume – ie. Although the pond is smaller

than the required volume the pump will be able to dewater the pond at a rate which ensures it will not overtop in a 1 in 20 year 24-hour event, with consideration for contingency arrangement. Figure 2, below, illustrates the location and specification of the dewatering infrastructure, including pump station and rising main layout.

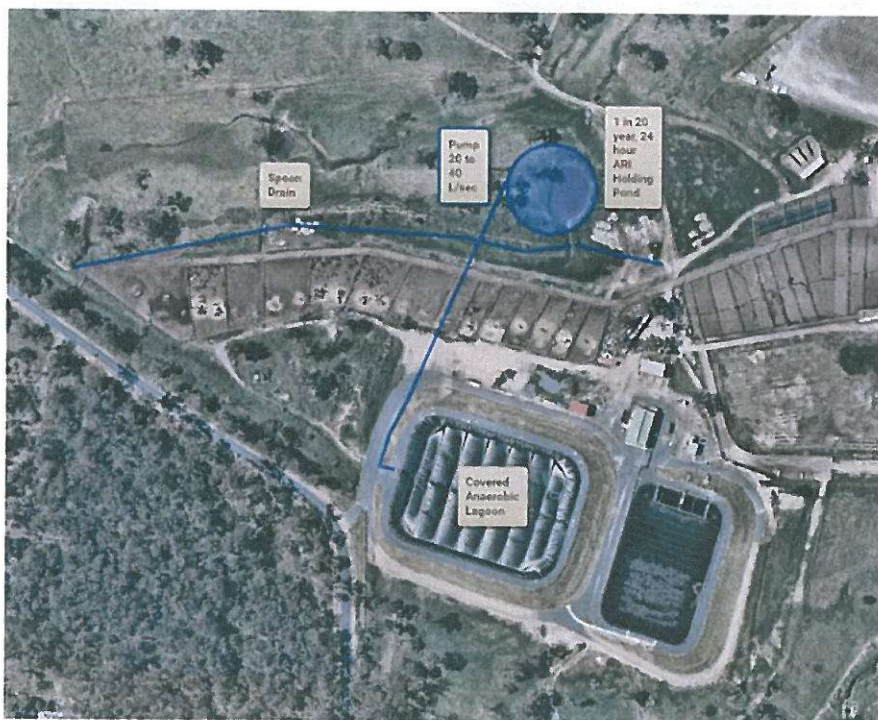
Western Catchment Stormwater Concept Design: Pumping from Western Catchment Pond to the CAL

- The construction of a pond for capture of overland run off from the cattle holding pens on the western side of the property, via spoon drain. This is, designed to capture downpour anticipated of a 1 in 20 year 24-hour ARI; and,
- Ancilliary infrastructure to transfer potentially contaminated run off to Teys existing Covered Anaerobic Lagoon (CAL) at the Waste Water Treatment Plant (WWTP).

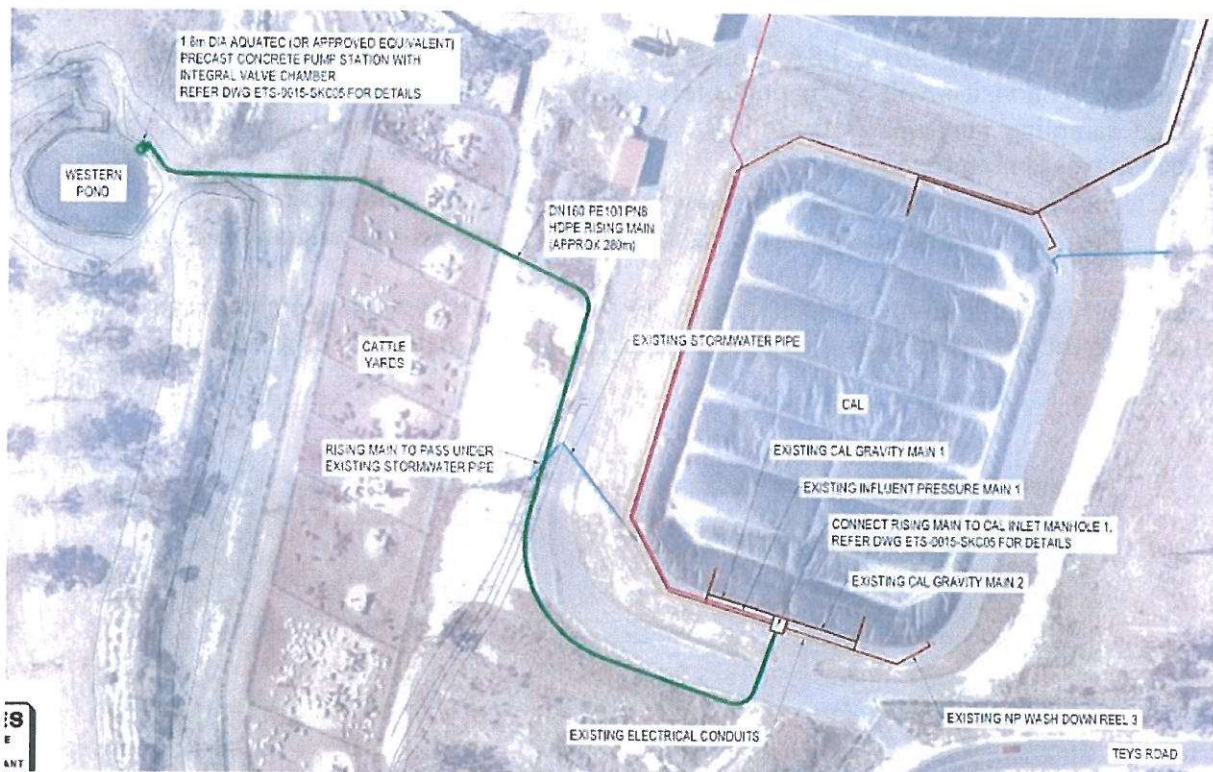
Western Pond Pump Station and Rising Main

The pump station to be installed on the western catchment lagoon will pump directly into the CAL for wastewater treatment. After consultation with wastewater experts and a review of the existing wastewater infrastructure, the pump rate to the CAL will be limited to reduce the impact of lukewarm, low contaminant stormwater on the anaerobic treatment performance. Introducing a low temperature, low contaminated stormwater stream into Teys' operating CAL system any higher than 20-40 litres per second will significantly impact on the treatment performance of the entire wastewater treatment system and pose a significant risk to assets design limits. Teys will ensure all details of managing the stormwater system will be included in the final stormwater management plan, provided as part of Milestone 11.

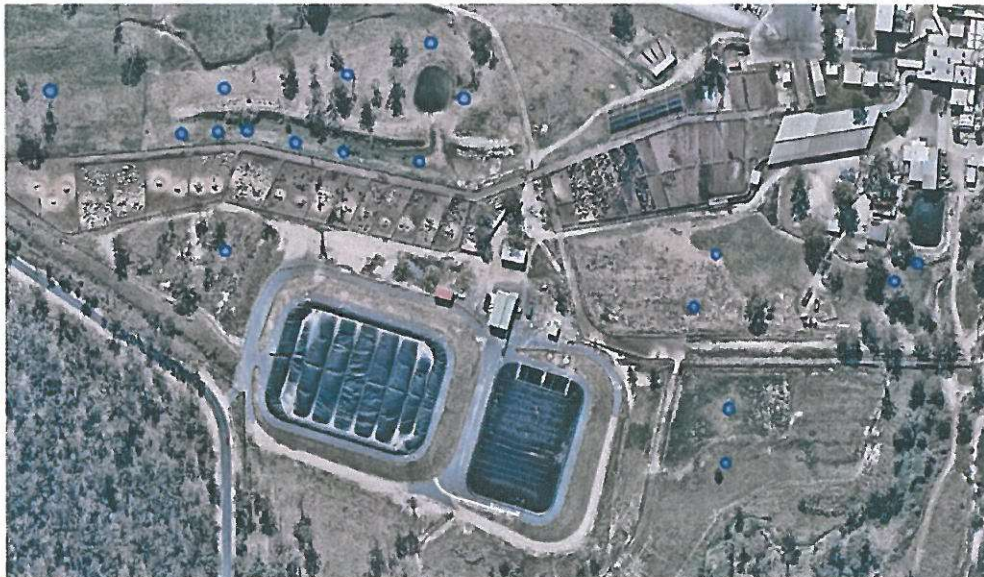
Figure 3: Location of the 18 Geotech test pits dug on 2 June 2016 by FSA consulting.

On Thursday 2 June 2016, FSA Consulting completed geotechnical works at Teys Australia Beenleigh. The visit involved digging a total of 18 test pits from one to four metres in depth for ground sampling purposes (refer to figures 3, 4 and 5). The methodology for test pit location selection was chosen based on:

- The vicinity of the test pit to the eastern and western storm water dams.
- The vicinity of the test pit to the catchment area of eastern and western storm water dams.

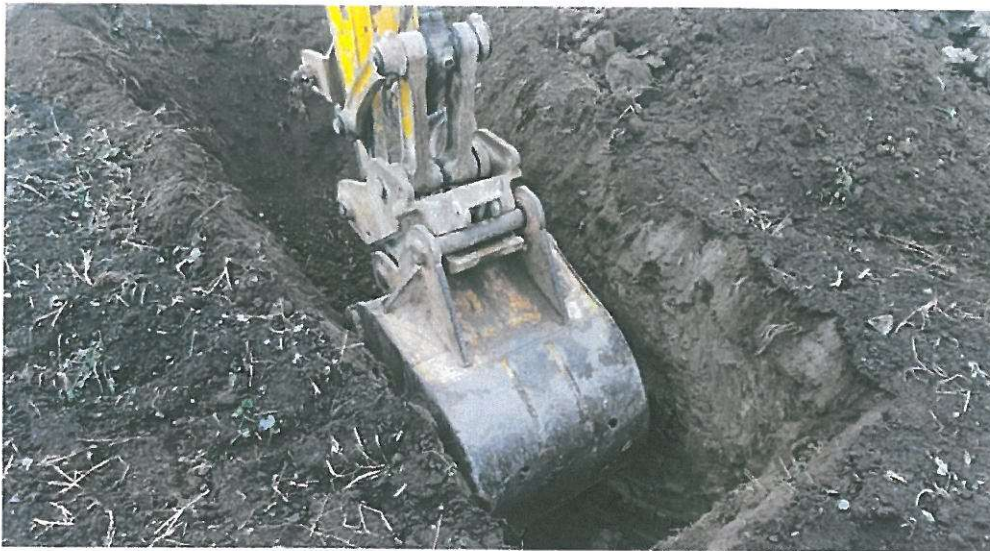
Figure 4: Example photo of test pit progress.

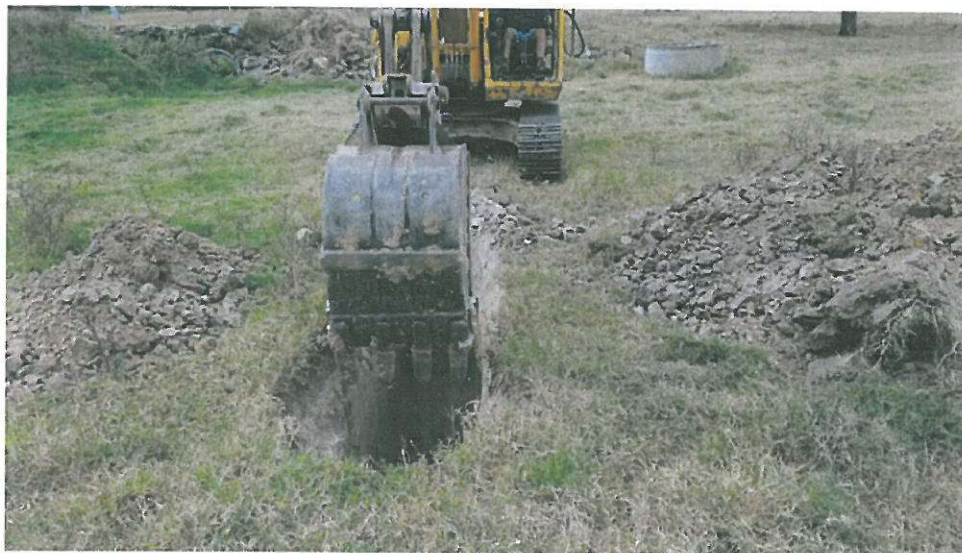
Figure 5: Example photo of test pit progress.

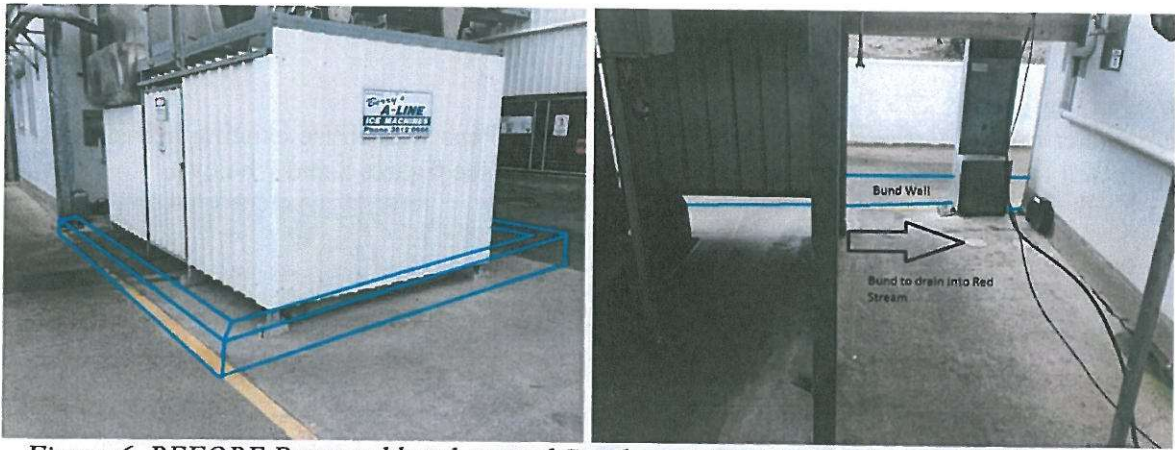
Figure 6. BEFORE Proposed bund around Steriliser Water Tank featured in TEP M6 Report.

The proposed bunding around the steriliser water tank and drainage point of bund that appeared in Milestone 6 as Figure 12 and Figure 13 has now been complete as shown in before and after images below.

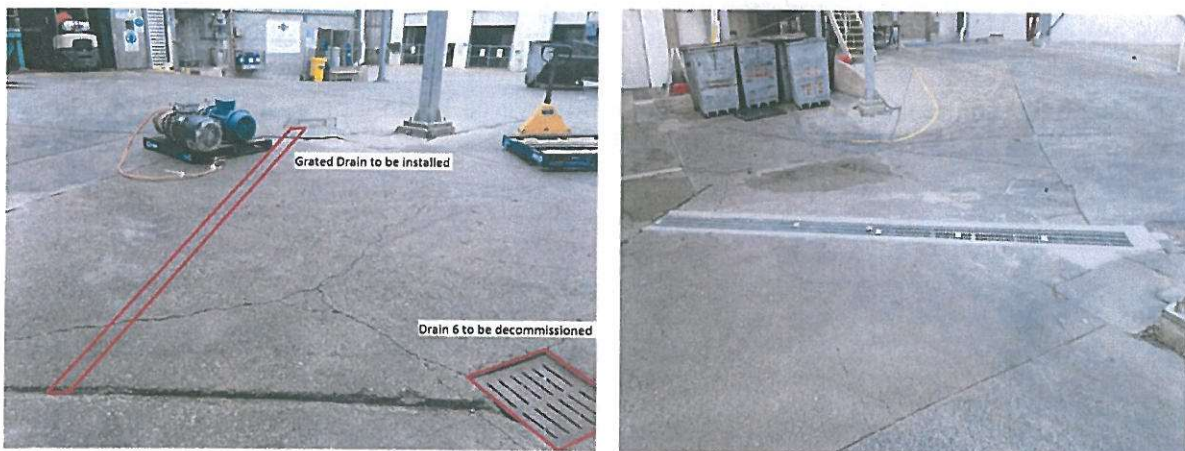
BEFORE and AFTER Installation of grated drain in hard stand area to capture potentially

contaminated surface stormwater.

Decommissioning of two stormwater drains, as outlined in Teys Australia's M6 submission. These drains have been decommissioned and concrete sealed to prevent potentially contaminated stormwater entering the proposed stormwater system. In addition, a grated drain was installed to capture stormwater from the hard stand area & directed to the WWTP.

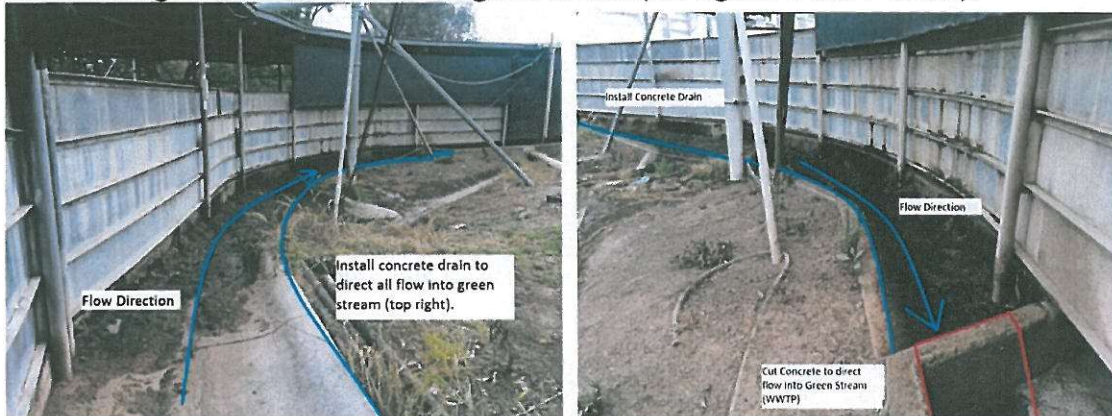
Figure 8 BEFORE. Proposed concrete drainage to be installed and direct potentially contaminated streams to the wastewater treatment system.

Stormwater on the northern side of the Covered Cattle Pens will utilise existing infrastructure and be directed through a concrete drain to the green stream (see figures 8 and 9 below).

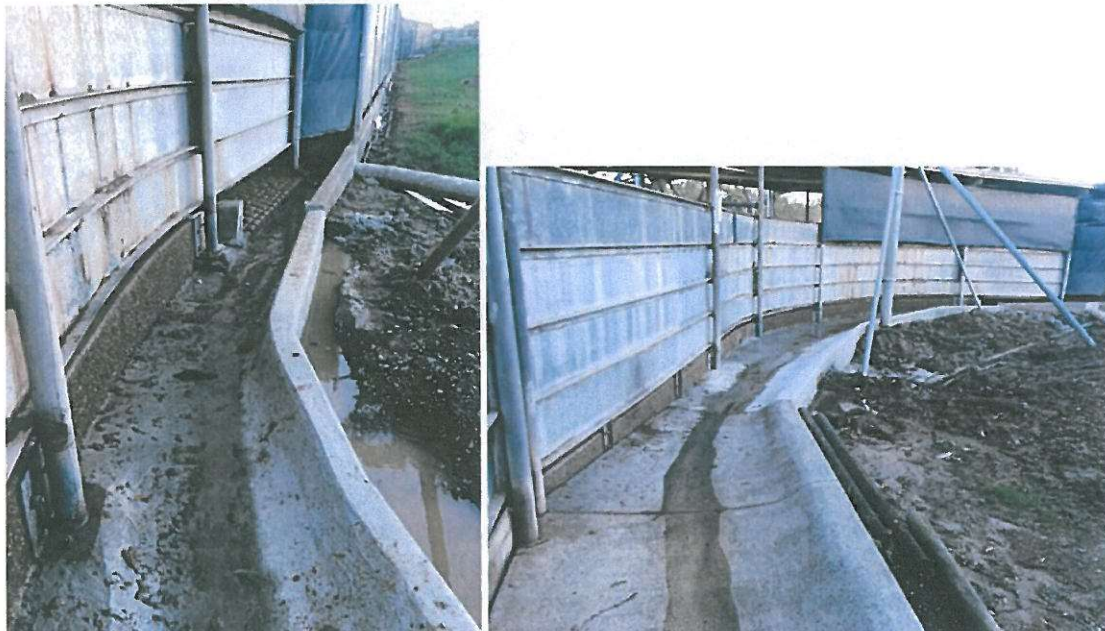
Figure 9 AFTER. Completion of the bunding on the eastern side of the cattle yard.

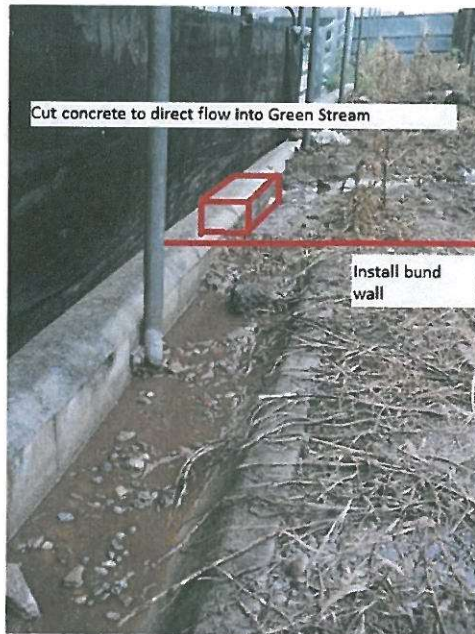
Figure 10. BEFORE Installation of concrete drain to divert all flow to the green stream.

A concrete bund wall was also constructed on the western side of the truck wash. This will ensure that potentially contaminated stormwater from the covered holding pens, is directed into the waste water treatment system (refer to figure 10 and 11 below).

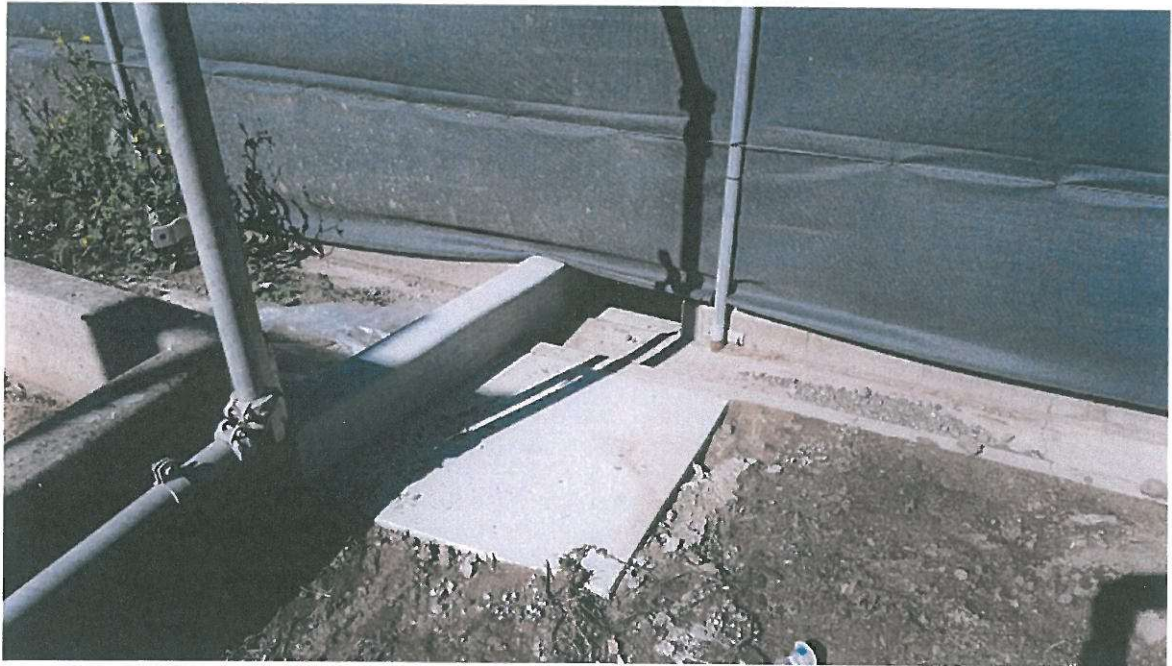
Figure 11. AFTER Western side of the covered yard including bund wall.

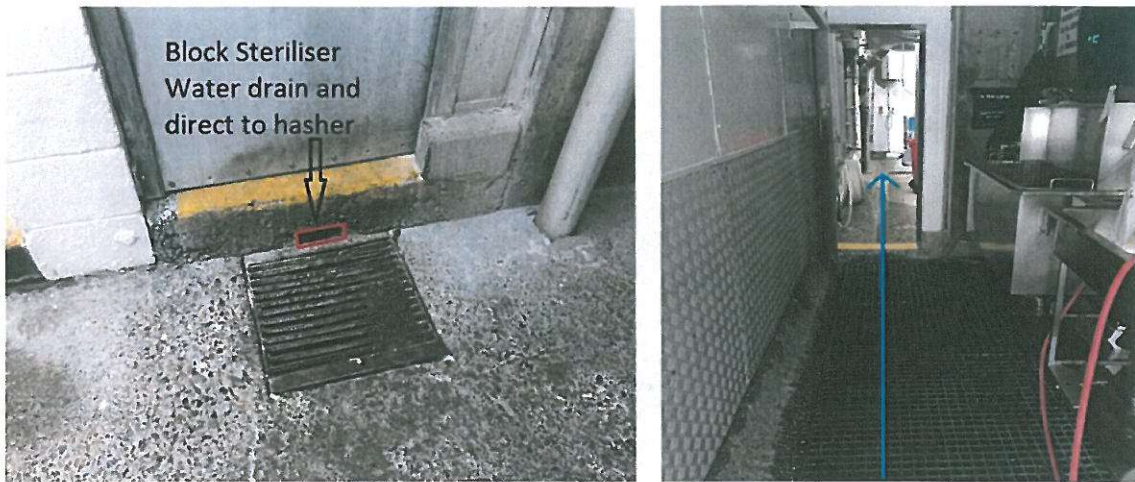
Figure 12. BEFORE Proposed Paunch Room Entry Steriliser Water Drain as featured in Figure 10 of M6 Report and Entry Steriliser Water Drain Diversion Path back to Hasher Room

An investigation conducted as part of Milestone 1 identified a minor integration of hot steriliser water into the contaminated stormwater system. At submission of the M4 report, this portion of the overall diversion of stormwater is 50%.
