Mount Veteran Mill  
Transitional Environmental Program  
Final Report  
December 2014

Report No: MGT 14.02.02\_13  
Prepared for: MGT Mining Ltd  
Prepared by: Biotropica Australia Pty Ltd

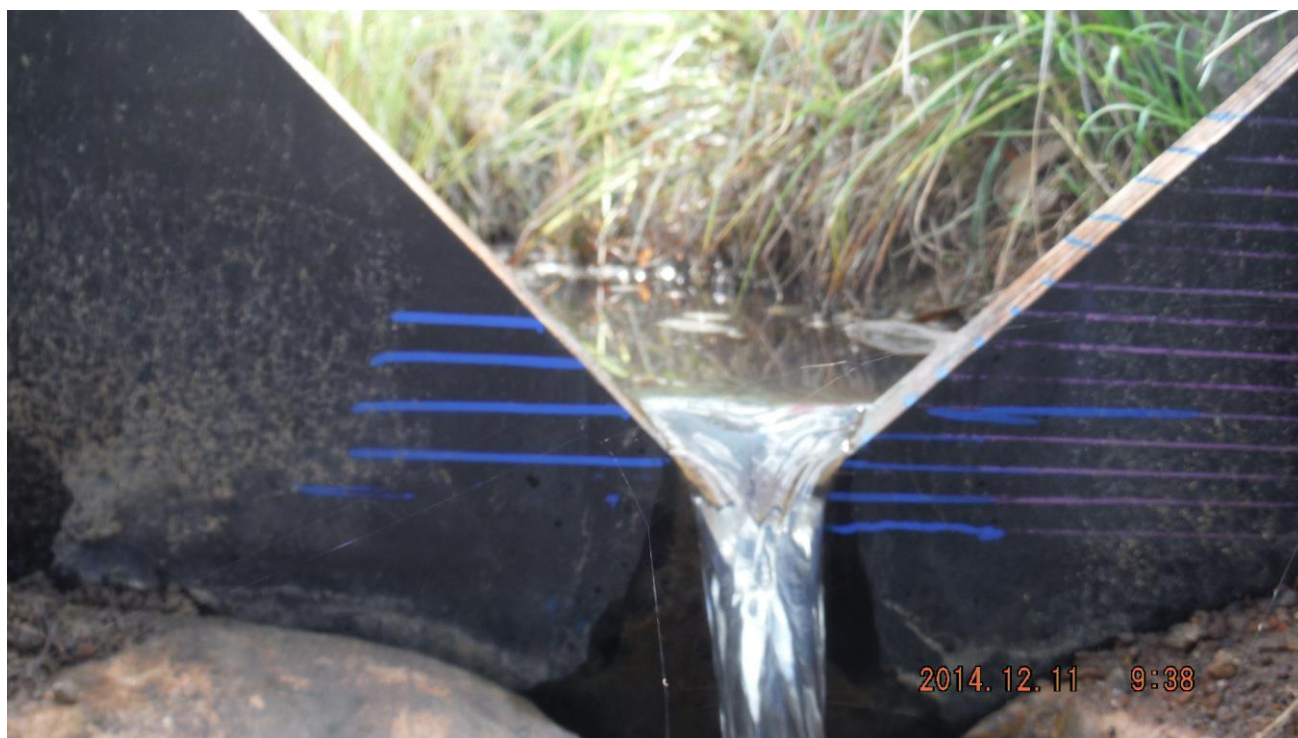
Figure 1: V-notch weir water level as at report date

As at 11<sup>th</sup> December 2014, the level of water at the v-notch weir remains at approximately 2cm (refer Figure 1). However this reading was taken before the catch drain and return system was completed (14<sup>th</sup> December 2014). It is expected that the water level at the v-notch weir will now decrease. The flow at the v-notch weir will continue to be monitored once each week until flow ceases.

The photographs show that the level of water at the v-notch weir decreased from 3.2cm to 2cm by the interim report on 15<sup>th</sup> November 2014. This did not meet the requirements of the TEP that flow at the v-notch weir ceased by 1<sup>st</sup> December 2014.

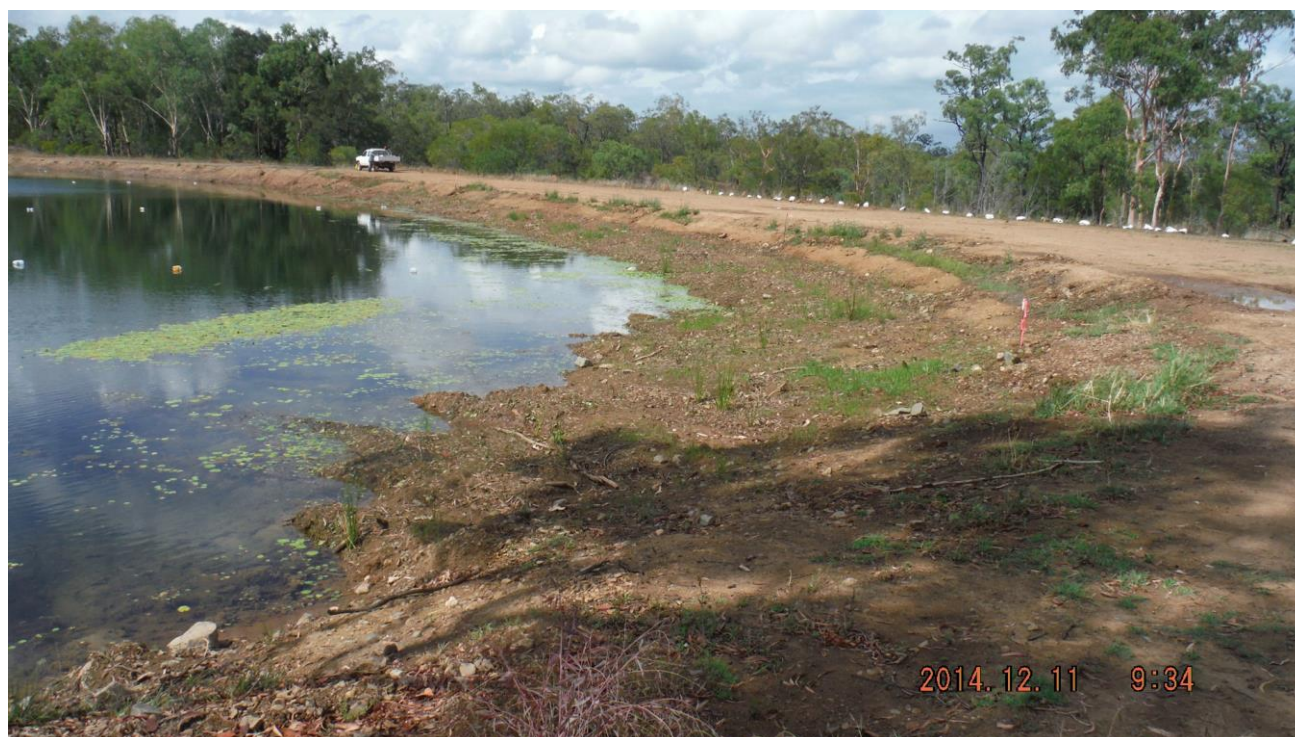
Figure 2: Reduced water level in TSF.

As a result of water being transferred from the TSF to the Mill Pond, the water level in the TSF has reduced. Figure 2 shows that there is now approximately 2m between the top of the dam wall and the water level. This meets the design storage allowance, extreme storage allowance and freeboard requirements as calculated by Fraser Osborn and set out in the TEP application.
