#### **TEP MAN19660 – Kenya CPP Noise Barrier & December Noise Monitoring Results**

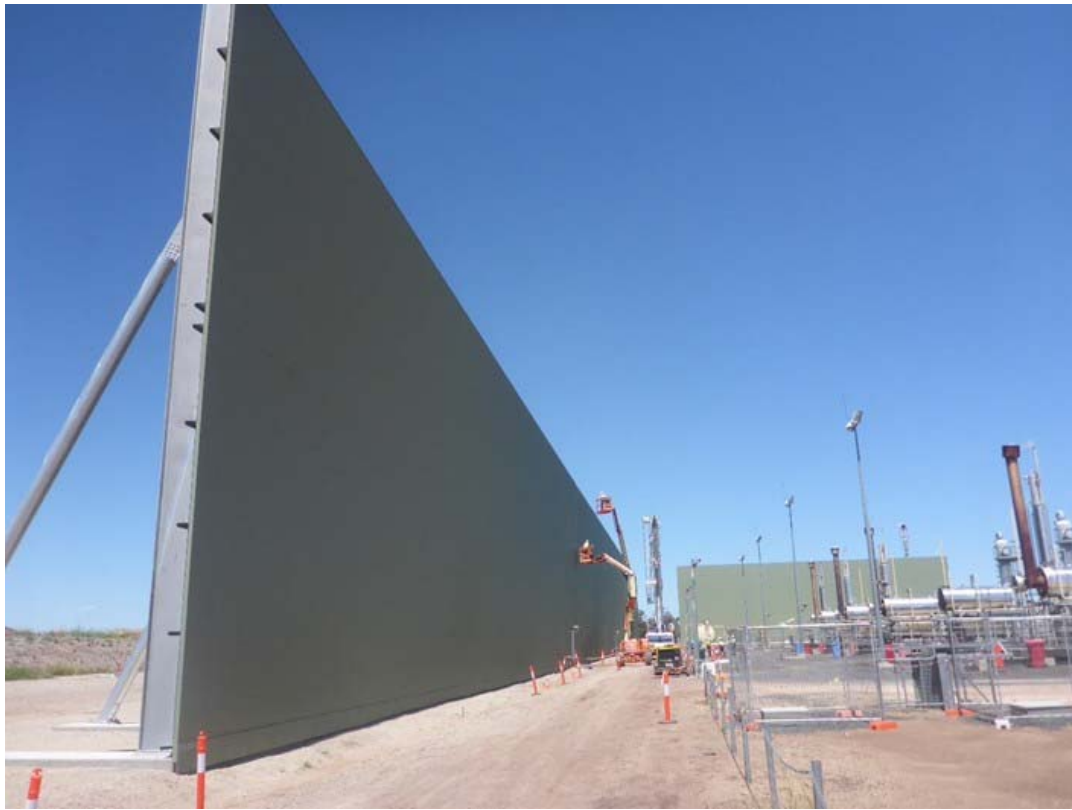
Figure 1 – Completed Kenya CPP noise barrier

Construction of the Kenya CPP noise barrier was completed on Wednesday 6 December 2017. Figure 1 attached shows a photo of the completed barrier.

The highest level that was monitored from the Kenya CPP was assessed at 23dB(A) at the representative location on 7 December at 3:45am. Meteorological conditions at the time were light south east to south westerly winds, which are typically associated with elevated levels from the Kenya CPP (i.e. >28dBA). Further monitoring is required to quantify barrier performance, however the December monitoring results suggest that the barrier is providing a reduction in noise levels from the Kenya CPP at the Nothdurft residence.

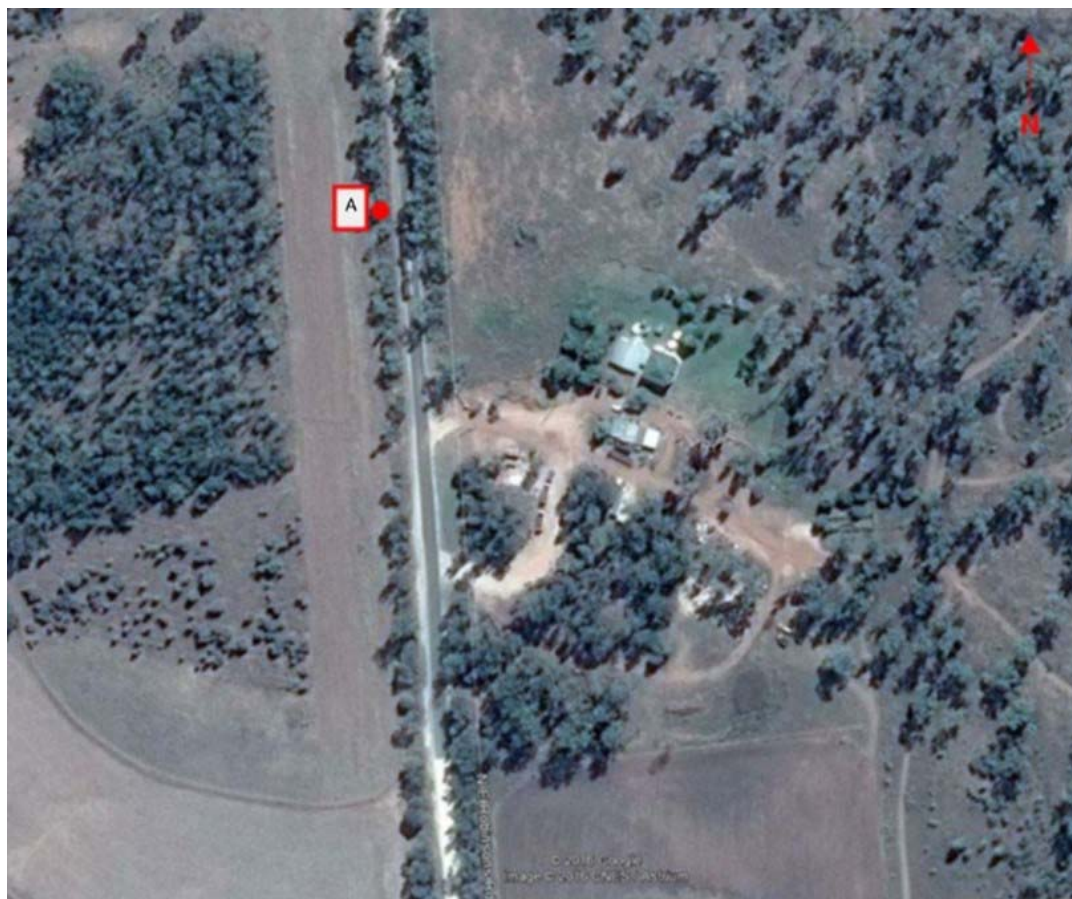
Figure 2 – Road Reserve Noise Monitoring Location

In order to comply with the TEP Monitoring Requirement 2, noise monitoring was completed for a period of 1 week following completion of the barrier, between 6 and 13 December 2017. A calibrated 01dB Cube Sound Analyser was deployed in the agreed representative location in the road reserve adjacent to the Nothdurft residence (refer Figure 2 attached). Noise measurements were recorded at 15 minute intervals and included audio files to allow for post measurement analysis and identification of noise sources and noise source contribution. The equipment setup and analysis methodology was identical to EPO STAT1085 and ASK Consulting's EPO Audit report (8894R03V01) can be referred to for any additional details, including calibration certificates.
