**TEC COAL PTY LTD**

# Environmental Investigation Report – Meandu Mine

14 SEPTEMBER 2018

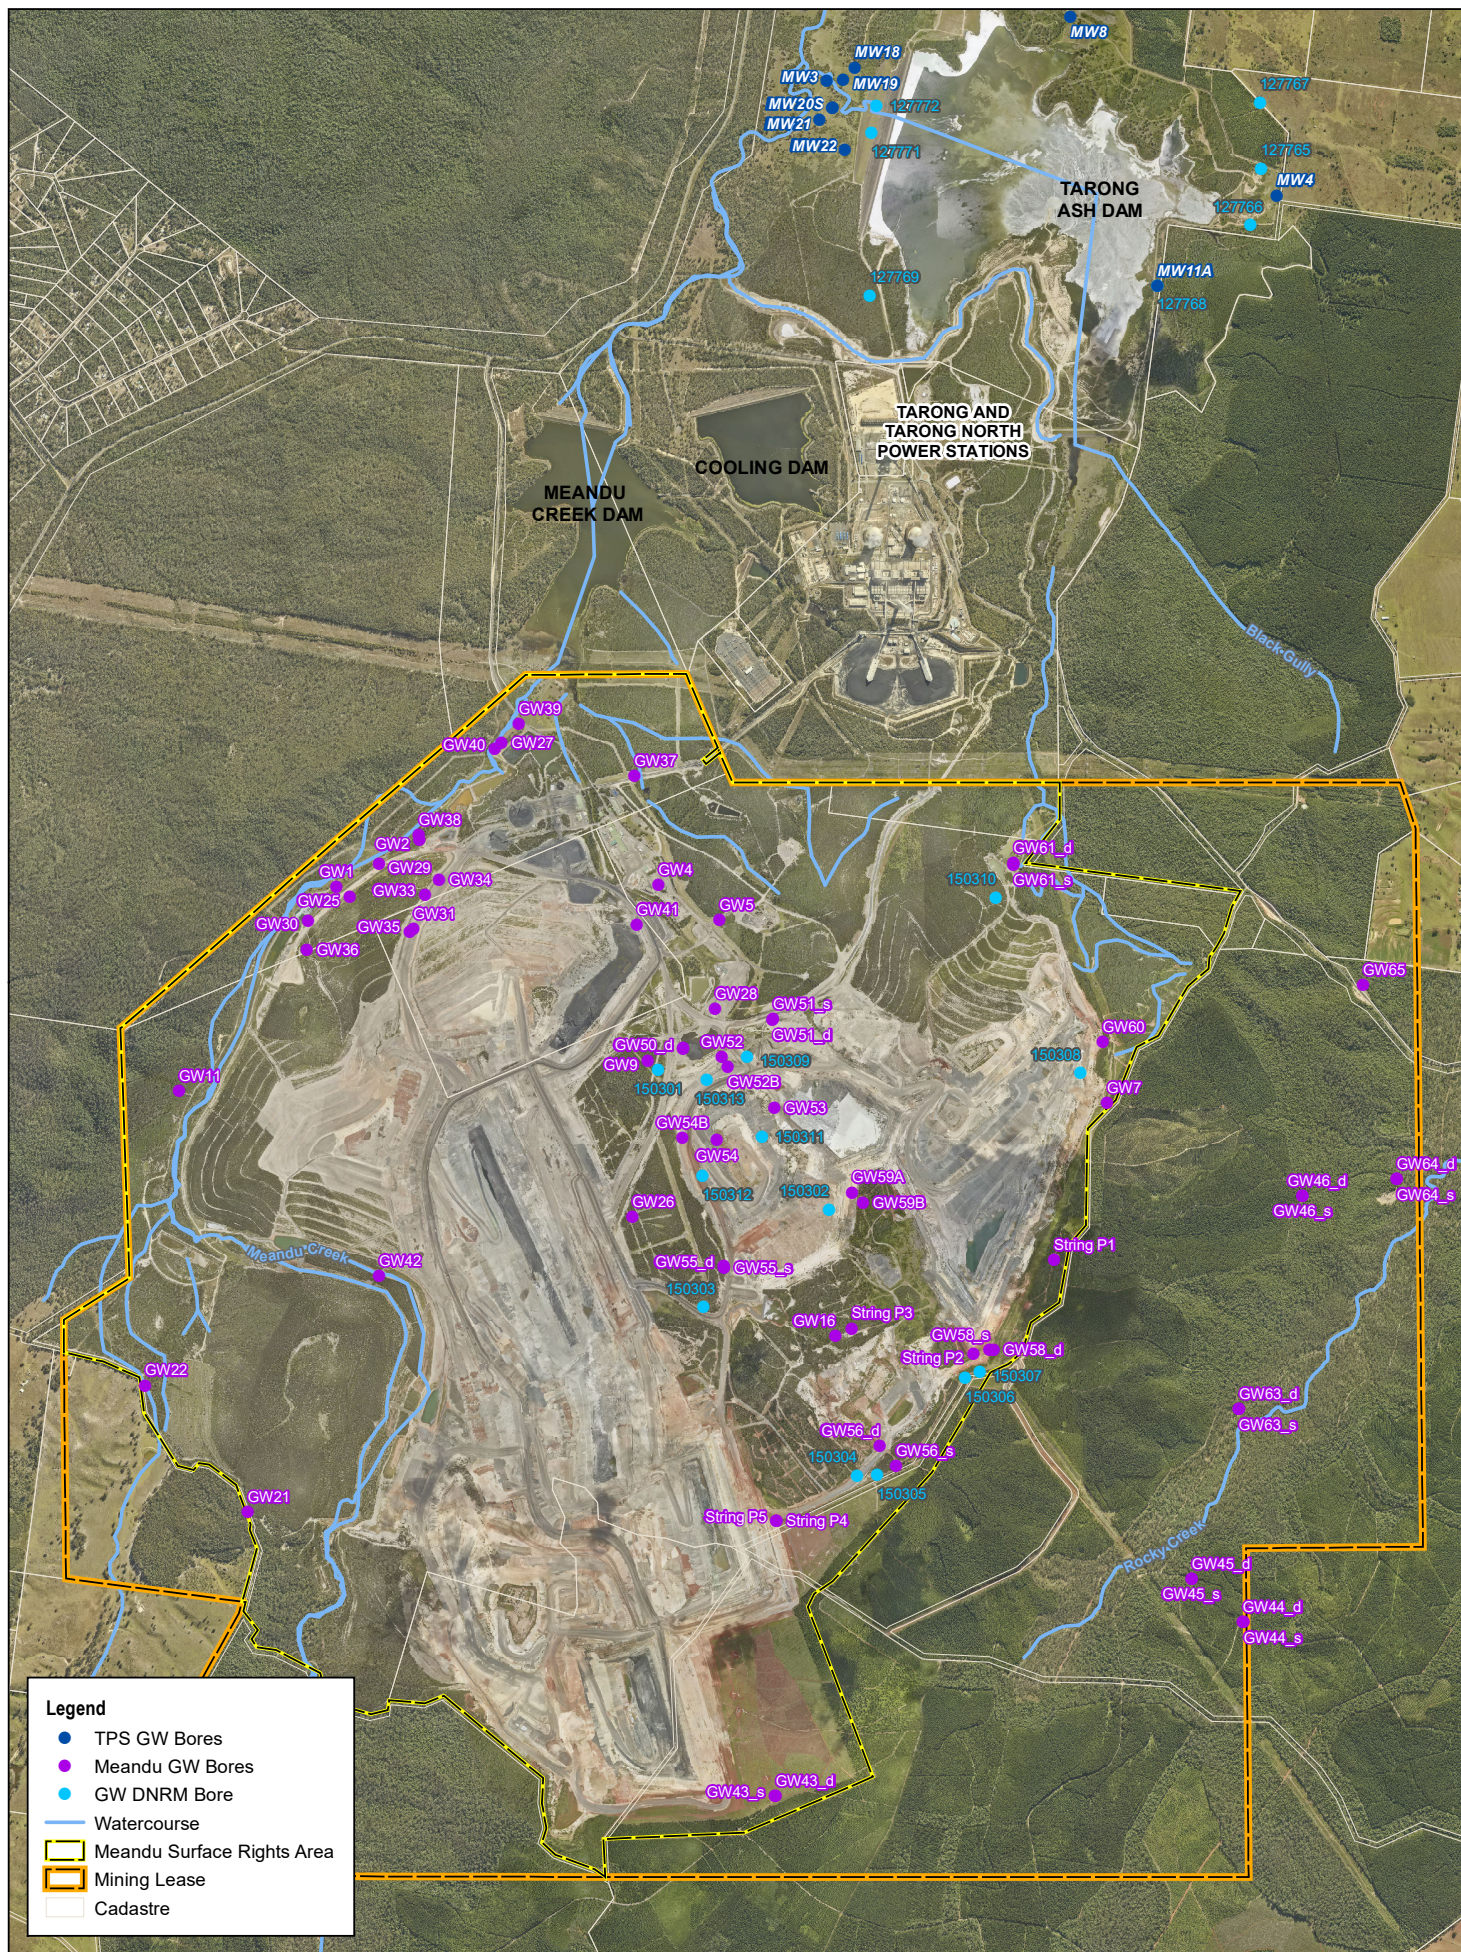
Figure 2.5 Groundwater monitoring network

The groundwater monitoring network is shown in Figure 2.5. Further information is provided in Section 4.3 of this Environmental Investigation Report.

The location of these bores is shown on Figure 2.5. The locations for compliance monitoring from EA (EPML00709113) are presented in Table 2.5.

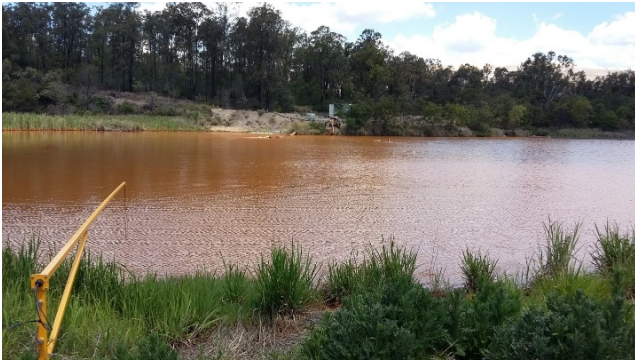
- Installation of a containerised (portable) lime-dosing system to lime-dose Ramp 7 and Bullgang Corner seepage water at RD7, to target a pH in the range 7-8. RD7 overflows to RD8. RD8 was also set as the primary source of water for the CHPP to maximise the re-use of the AMD water from RD8 to the CHPP.

*Photo 2.3 RD7 showing lime-dosing container in the distance and water monitoring station in the foreground*

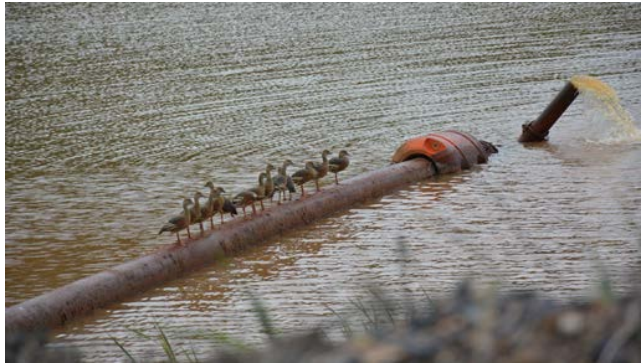
*Photo 2.4 RD7 lime-dosing recirculation line*

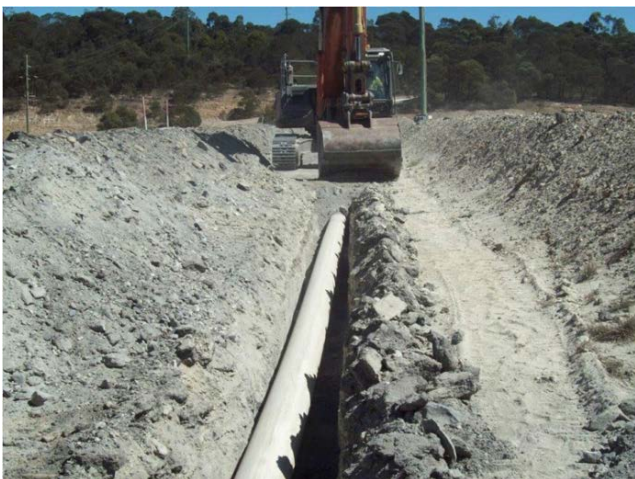
RD27 was constructed during financial year 2018 and collects mine impacted water expressing from the toe of the North-West Backfilled Pit, that is then lime-treated in RD27 and pumped to other dams or directed to site facilities for re-use, predominantly for haul road watering (Photo 2.5 and Photo 2.6).

*Photo 2.5 Construction of pipework*

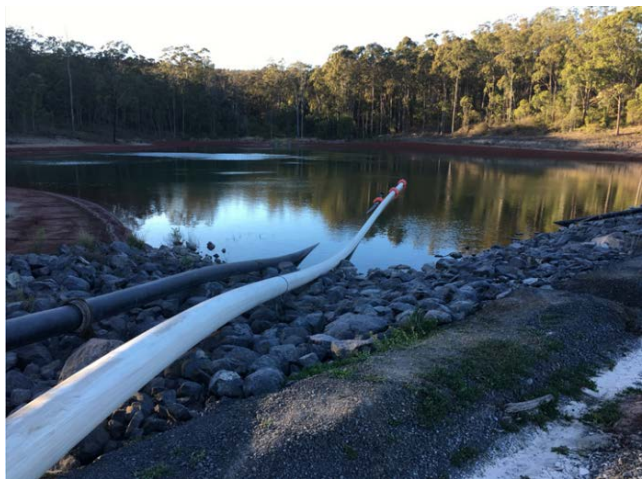
*Photo 2.6 Pipeline in RD26*

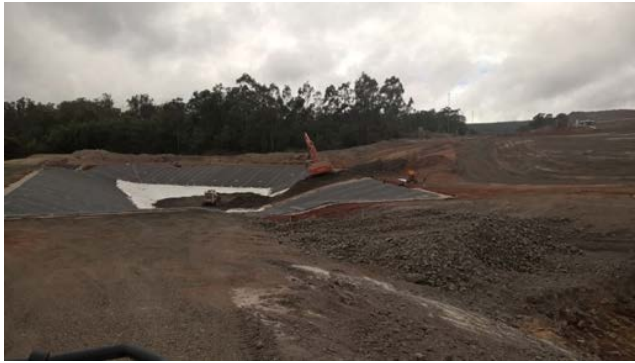
*Photo 2.7 RD27 during construction*

Photo 2.7 and Photo 2.8 show RD27 during construction and at completion respectively.

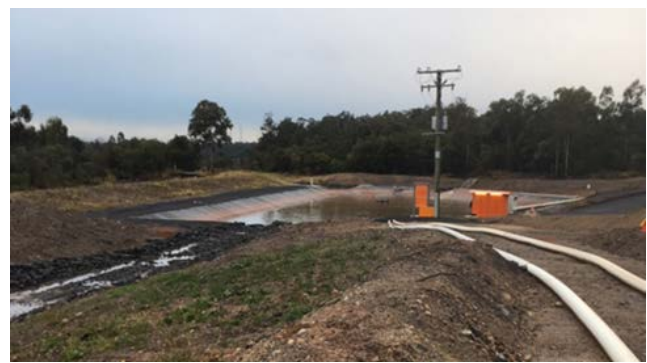
*Photo 2.8 RD27 at completion*

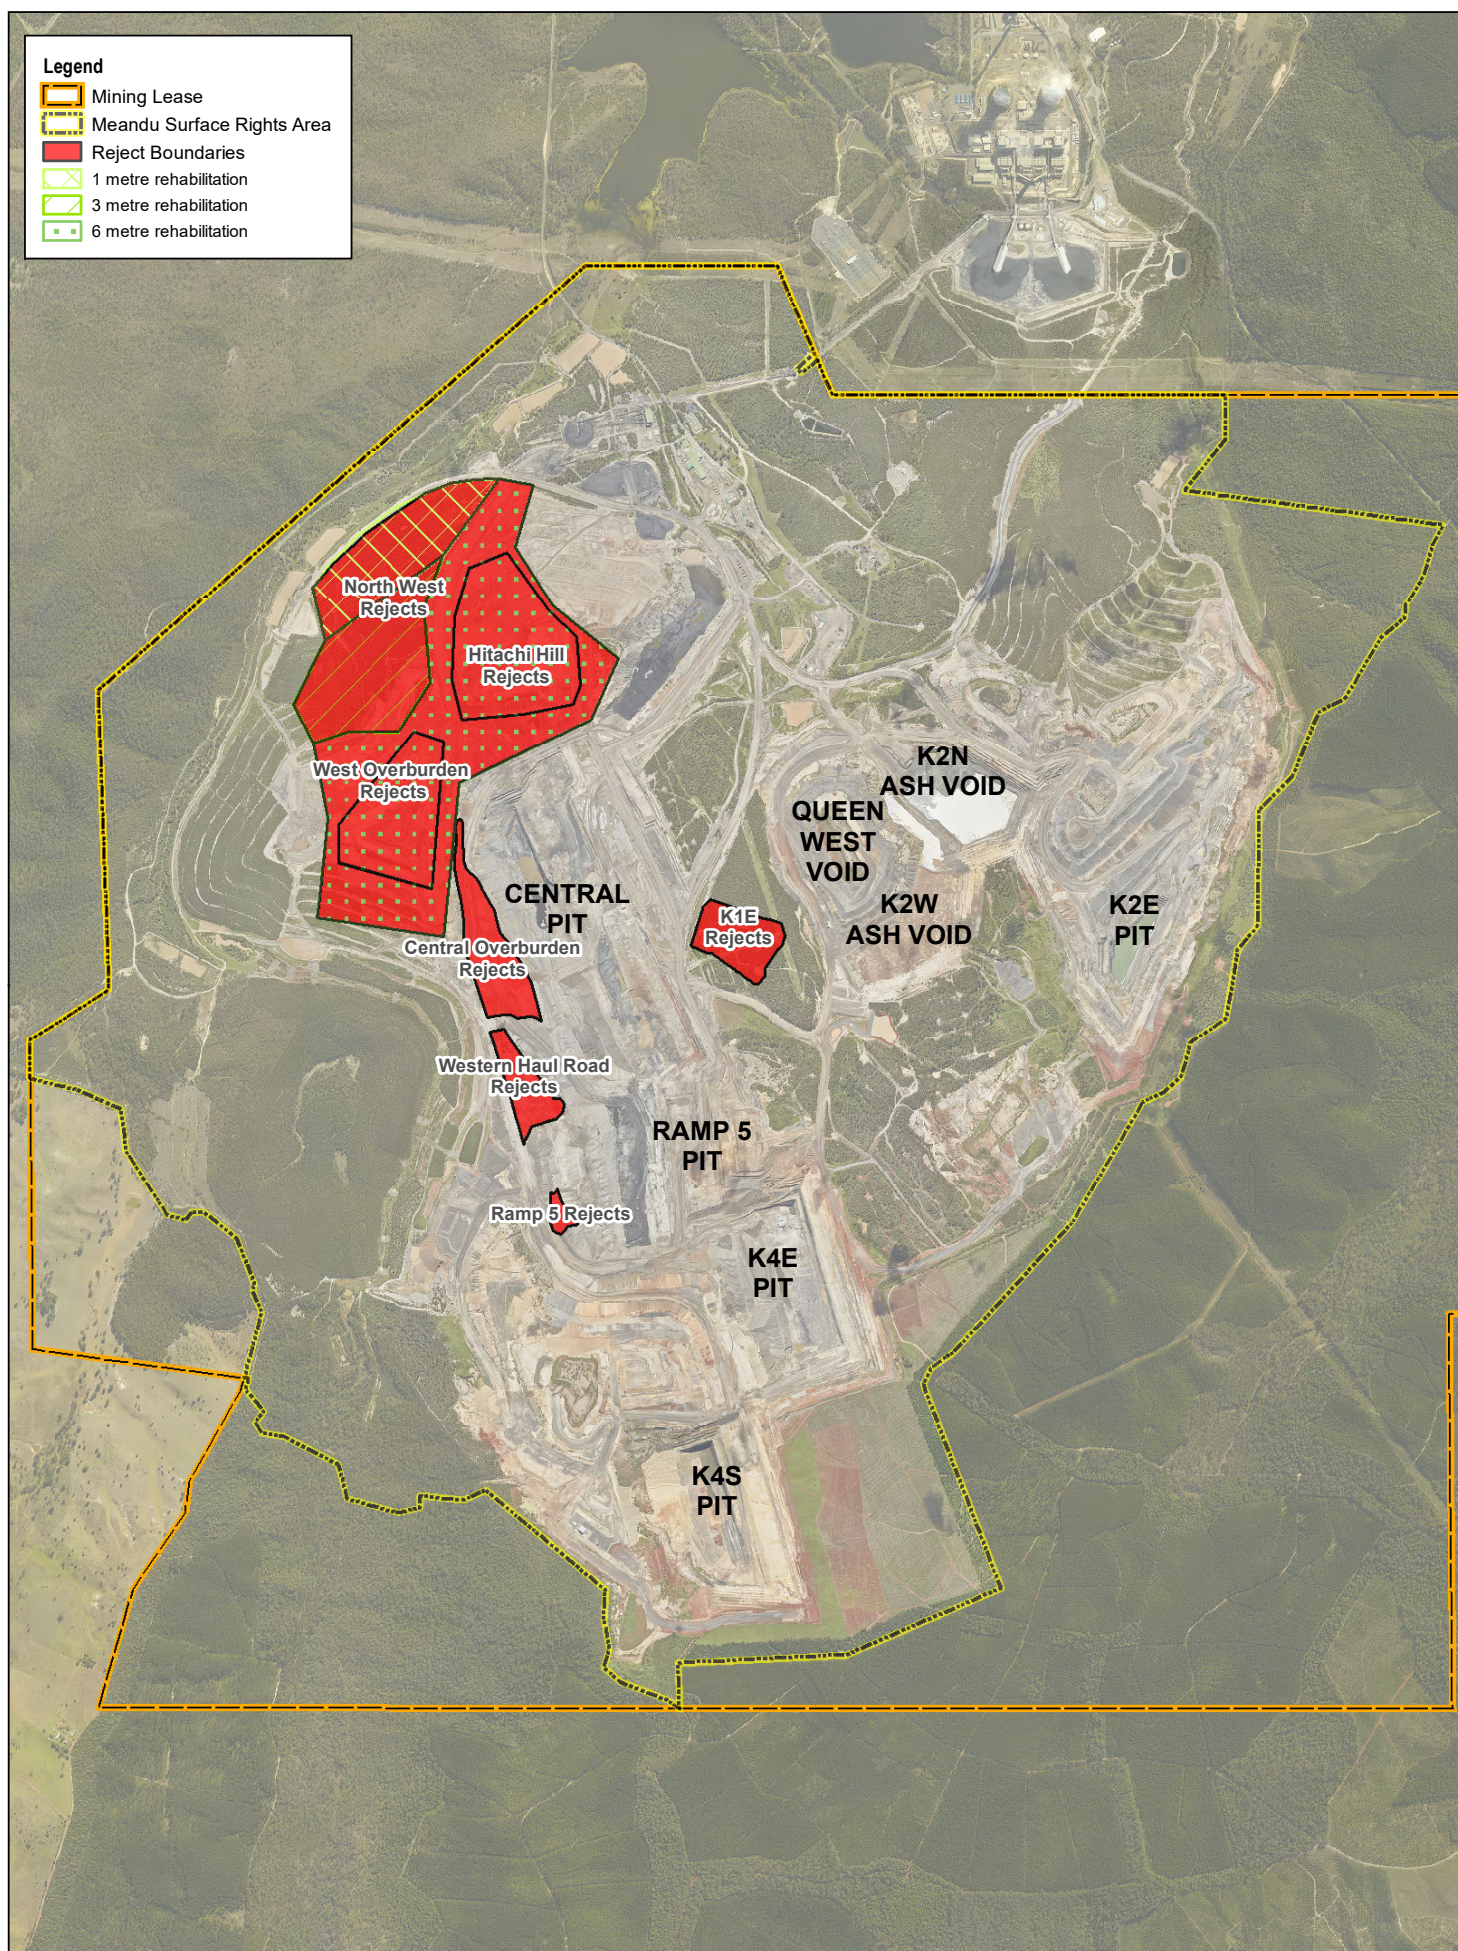
Coal rejects were initially placed into small cells and then into RSA1 to the west of the North-West Backfilled Pit (refer Figure 3.2). RSA1 was initially constructed on top of natural ground that allows surface runoff and seepage to report onto Ramp 7 haul road, into RD7 and into the upper ephemeral area of Meandu Creek via RD8 and RD2.

In addition to the test results noted in Table 3.7, reject samples collected from Hitachi Hill (location shown in Figure 3.2) in March 2016 were also analysed. At the time of collection (March 2016) these samples had a neutral in-field pH. However, after exposure to atmospheric conditions in sample containers at the site for six months, the samples were found to have a pH of < 3. This suggests that if rejects are co-mingled and progressively encapsulated they are unlikely to oxidise and produce acidity. In contrast, if rejects are left exposed to atmospheric conditions (in the range 3 to 6 months) they will oxidise and produce acidity.

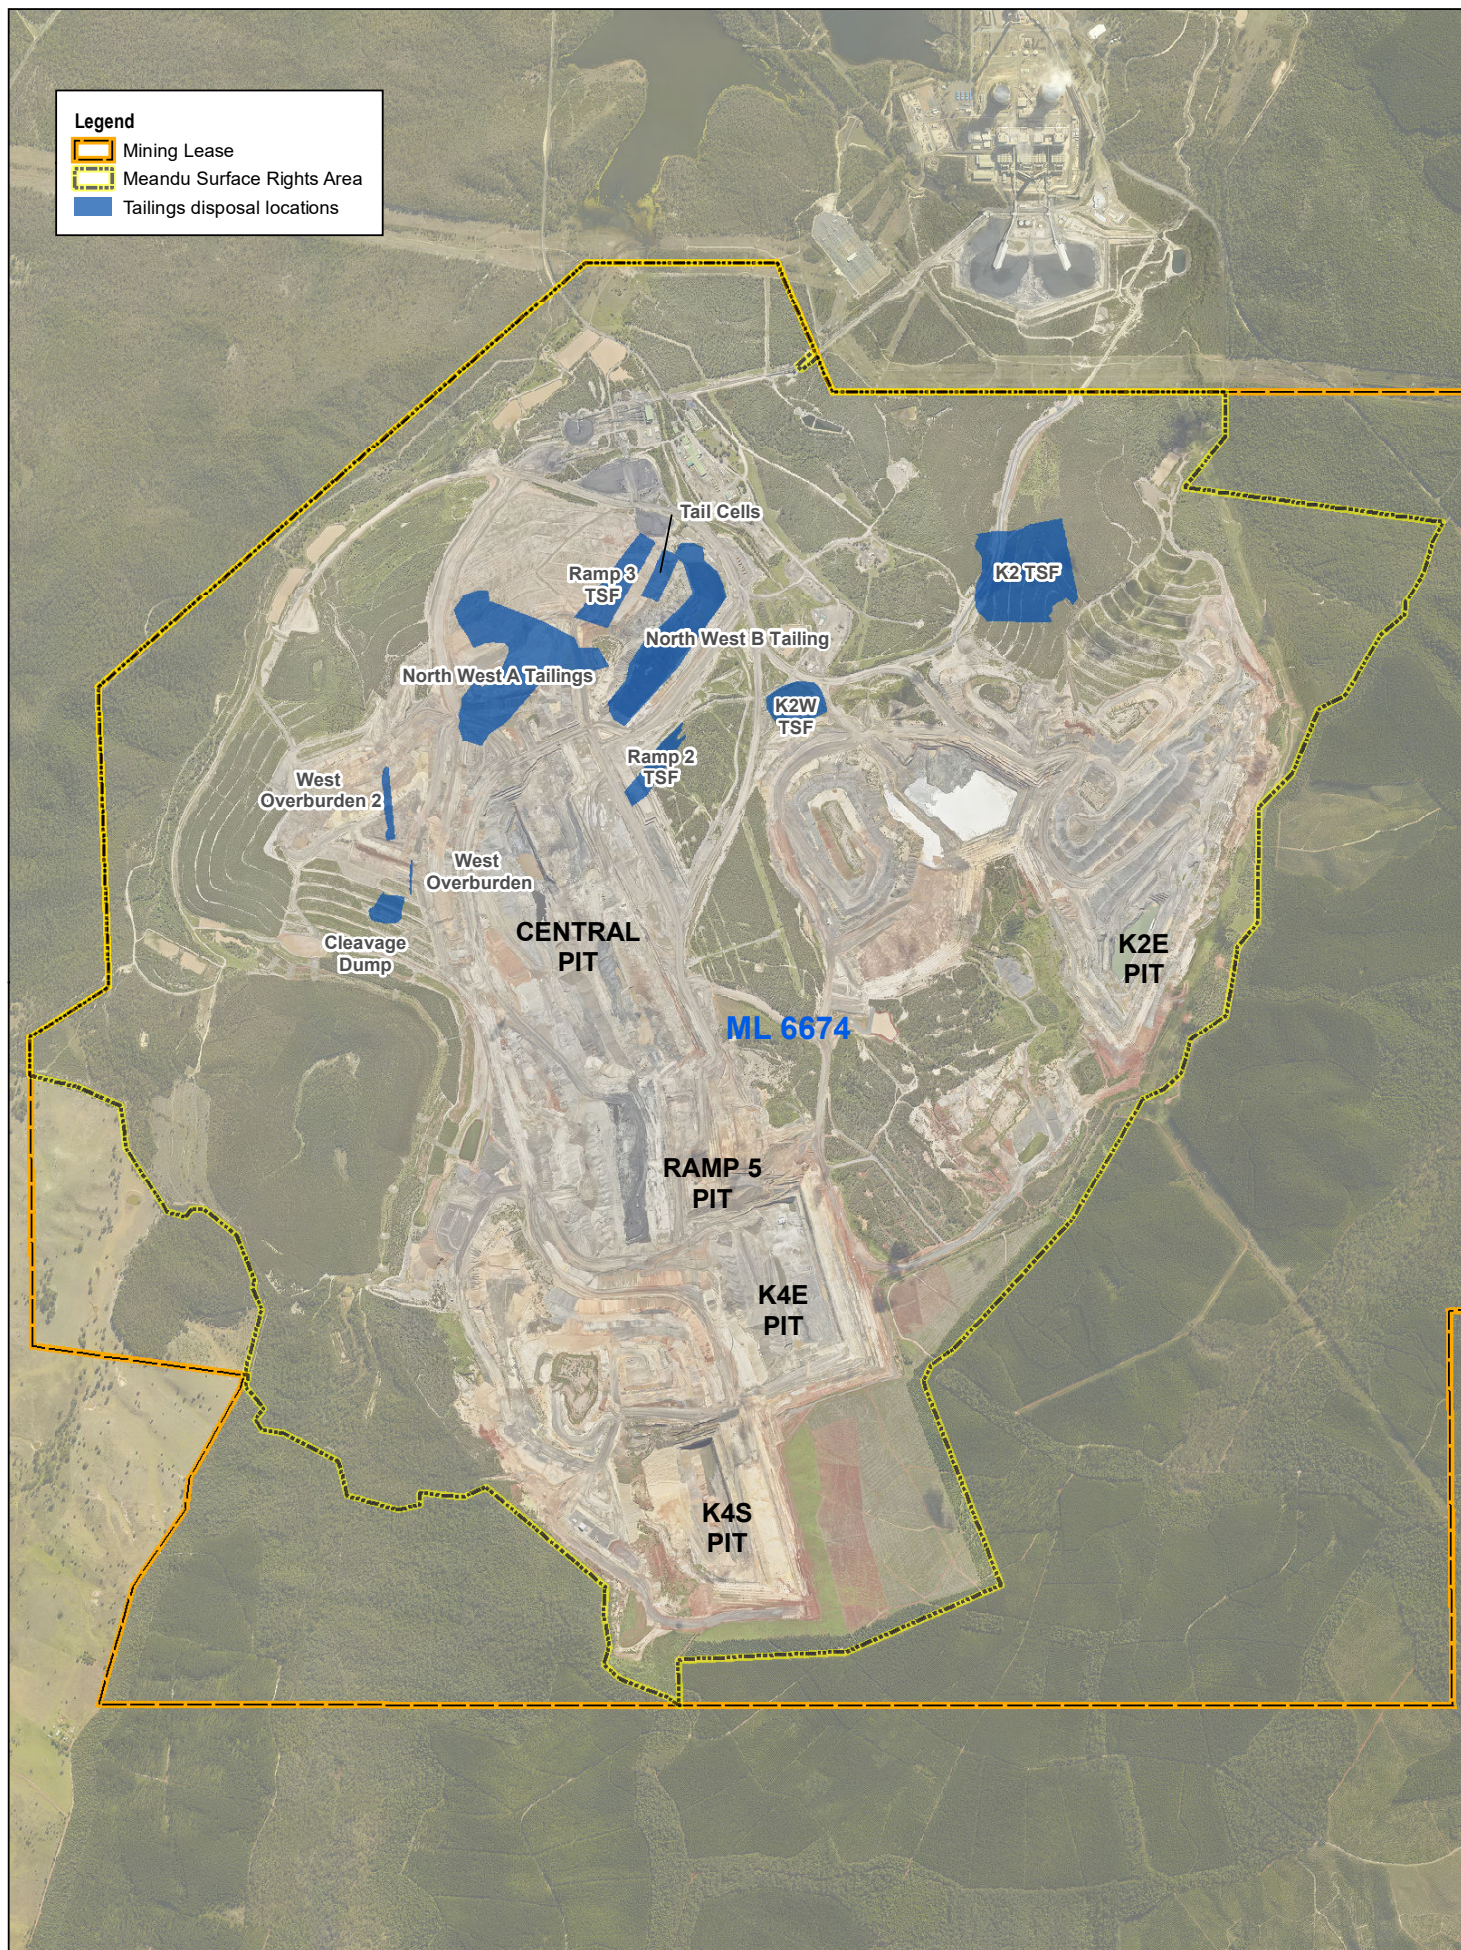
Map: PS102396\_FigR\_Tailings\_r1v4

Disposal locations for tailings at the Meandu Mine are outlined in Table 3.3 and shown on Figure 3.3. Tailings were initially placed into in-pit cells in the North-West A pit (North-West A tailings) and then into a valley fill tailings storage facility in the Black Creek catchment (K2 TSF) from 1986 to 1995 (refer Figure 3.3). Tailings were pumped to the TSF from the CHPP.

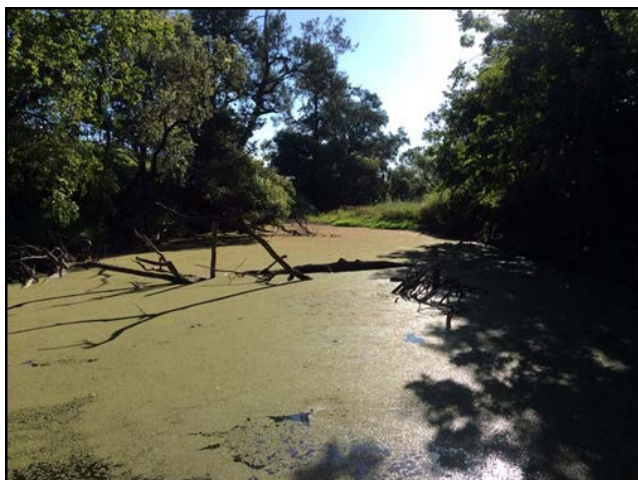
Comparative sites on Barker Creek were characterised as isolated pools disconnected from waterways upstream and downstream (Photo 7.1), or dry creek beds. The riparian vegetation was significantly impacted by vegetation clearing associated with the adjacent land uses (cropping and grazing). In-stream habitats had features providing structure and shelter for aquatic fauna (including bank vegetation, a variety of in-stream vegetation and woody debris) but they lacked a variety of flow regimes (riffles, runs and glides), depth profiles and channel sinuosity (bends, bars and straight sections). External impacts were moderate and mostly associated with the adjacent land clearing that has reduced the presence and continuity of riparian vegetation. Other apparent impacts included stock access and poor connectivity to other waterways.

*Photo 7.1 Isolated pool at comparative site C1B on Barker Creek*

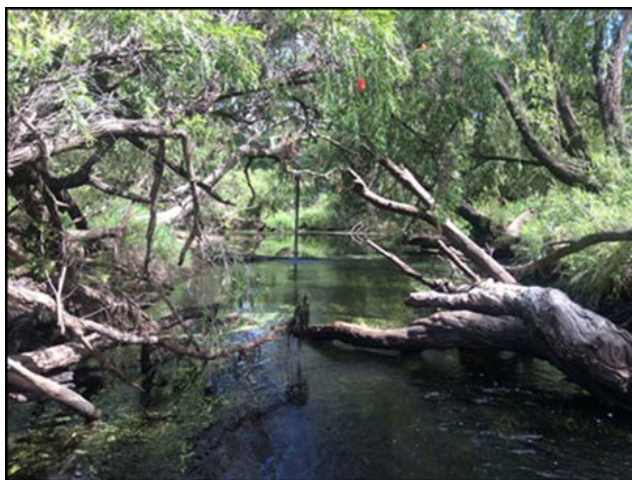
The comparative site on Barambah Creek (site SW36) was characterised as a flowing pool located approximately 5 km downstream from Bjelke-Petersen Dam. Flows are released from the dam for downstream uses (including drinking water), resulting in a perennial flow regime. The riparian vegetation was impacted by vegetation clearing associated with the adjacent land uses (cropping and grazing) and a road corridor and road bridge that crossed above the site. In-stream habitats had a significant number of features providing excellent structure and shelter for aquatic fauna (including bank vegetation, a variety of in-stream vegetation including submerged aquatic plants, woody debris as well as a variety of flow regimes (including pool, glide, run, and riffle), depth profiles and channel sinuosity (Photo 7.2). External impacts were moderate and mostly associated with adjacent land clearing that has reduced the presence and continuity of riparian vegetation. Some human impact from recreational fishing and camping was also apparent.

*Photo 7.2 A wide variety of connected aquatic habitat types at comparative site SW36 on Barambah Creek*

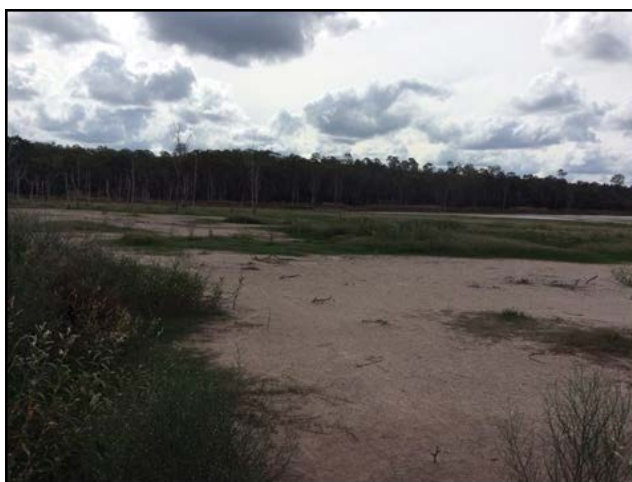
The sites located on Meandu Creek upstream of Meandu Creek Dam were characterised as isolated pools disconnected from waterways upstream and downstream. The riparian vegetation was impacted by vegetation clearing associated with the adjacent land use (mining activities) (Photo 7.4). In-stream habitats had a number of features providing some structure and shelter for aquatic fauna, but sites were typically dominated by one or two main habitat features (predominantly in-stream vegetation) and they lacked the variety of habitat associated with different flow regimes and channel sinuosity. External impacts were high and mostly associated with the adjacent land use (Meandu Mine); channel modifications have changed the natural flow and function of the waterway and the natural source of water feeding the sites. It is understood that seepage into the reaches adjacent to the mine is currently managed by pumping out the pools regularly into RD7.

*Photo 7.4 Poor riparian cover due to vegetation clearing at site CM2*

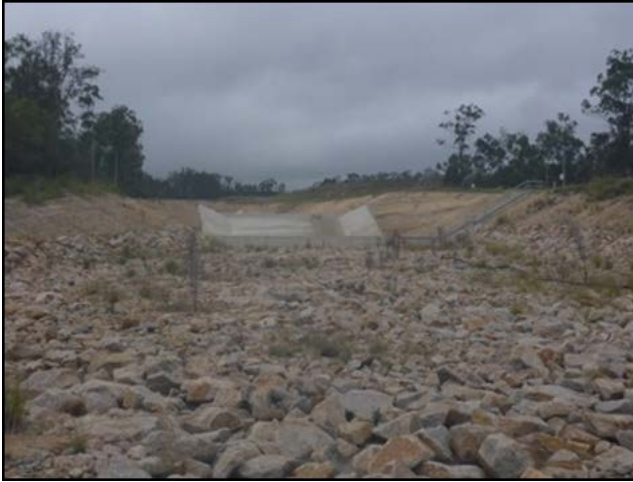
*Photo 7.5 Highly modified diversion channel at Black Creek site BC2*

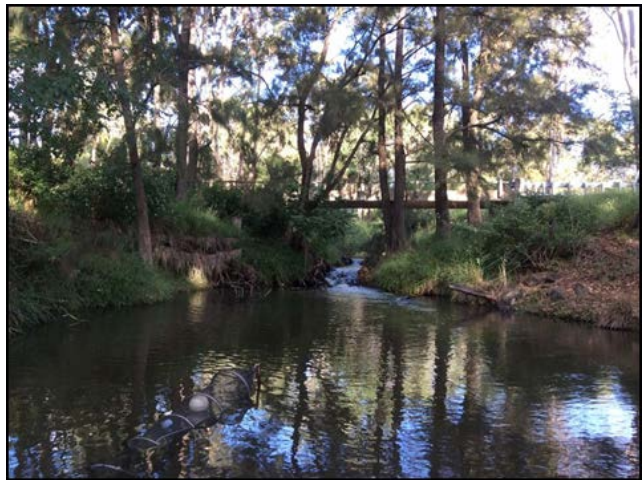
*Photo 7.7 A representative site (MC5 / W2), with a well-connected channel and a variety of aquatic habitat types but some impacts from vegetation clearing and a road bridge*

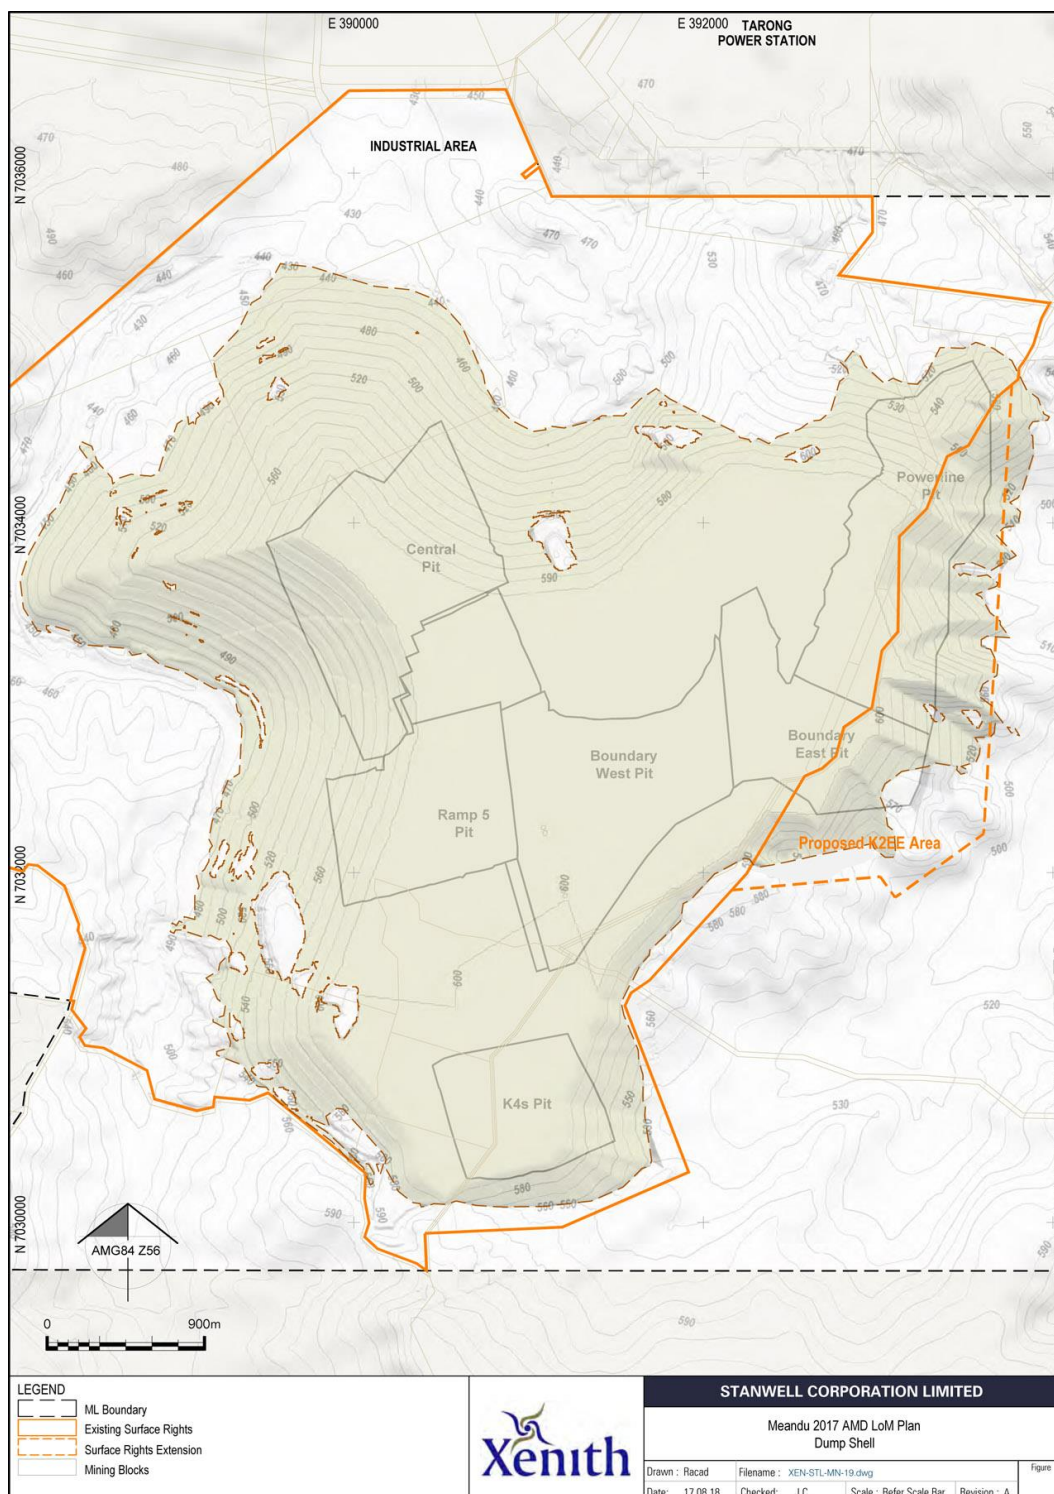
**Figure 5.9 – Meandu Mine Dump Shell**

The dump limits are defined by a dump shell. The dump shell used in the haulage model is shown in Figure 5.9. The construction of the dump must progress in a logical sequence. To assist in controlling this progress, the dump is divided into smaller sections that can be used to apply dependency rules.

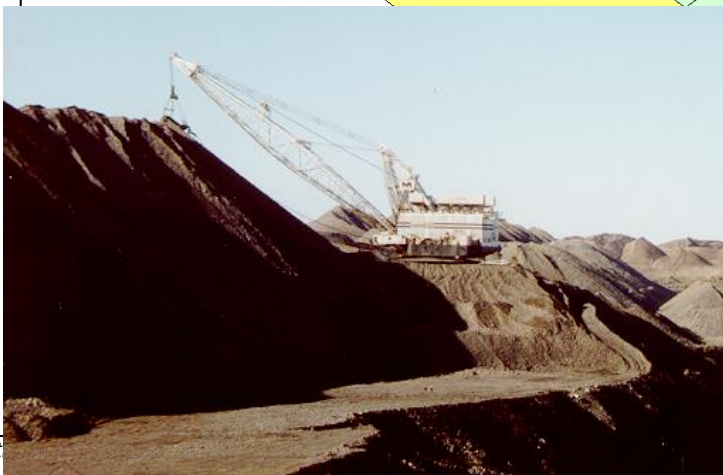
The dragline returns to the lower bench level, and commences removing the top of the remaining block. The material is dumped to the back of the final lower spoilpile.

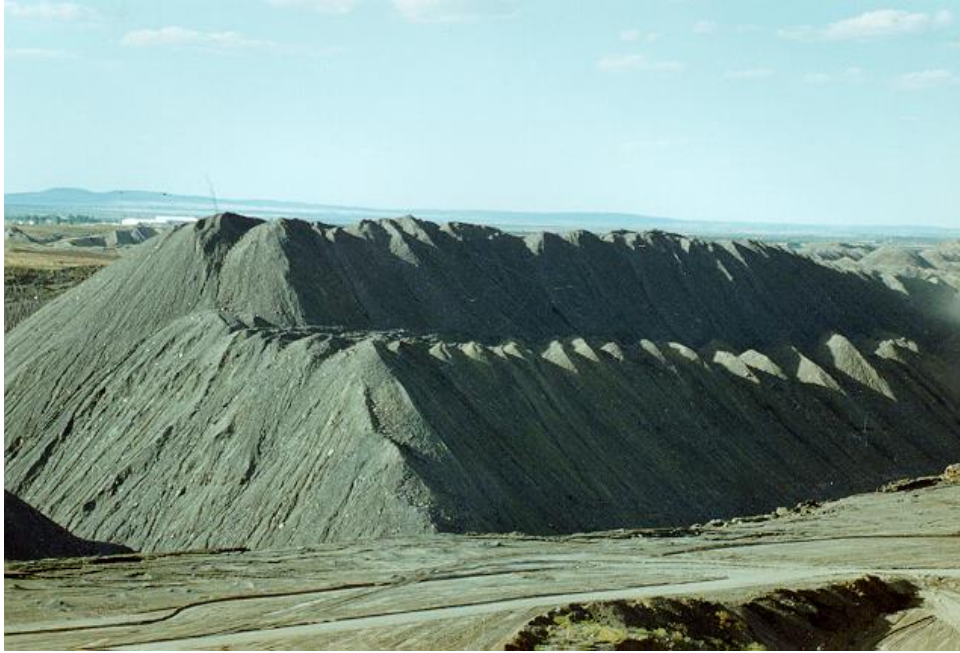
The completed pit after coal mining is shown in the sections below. The completed spoilpile consists of a high pullback spoilpile, and a lower main spoilpile.

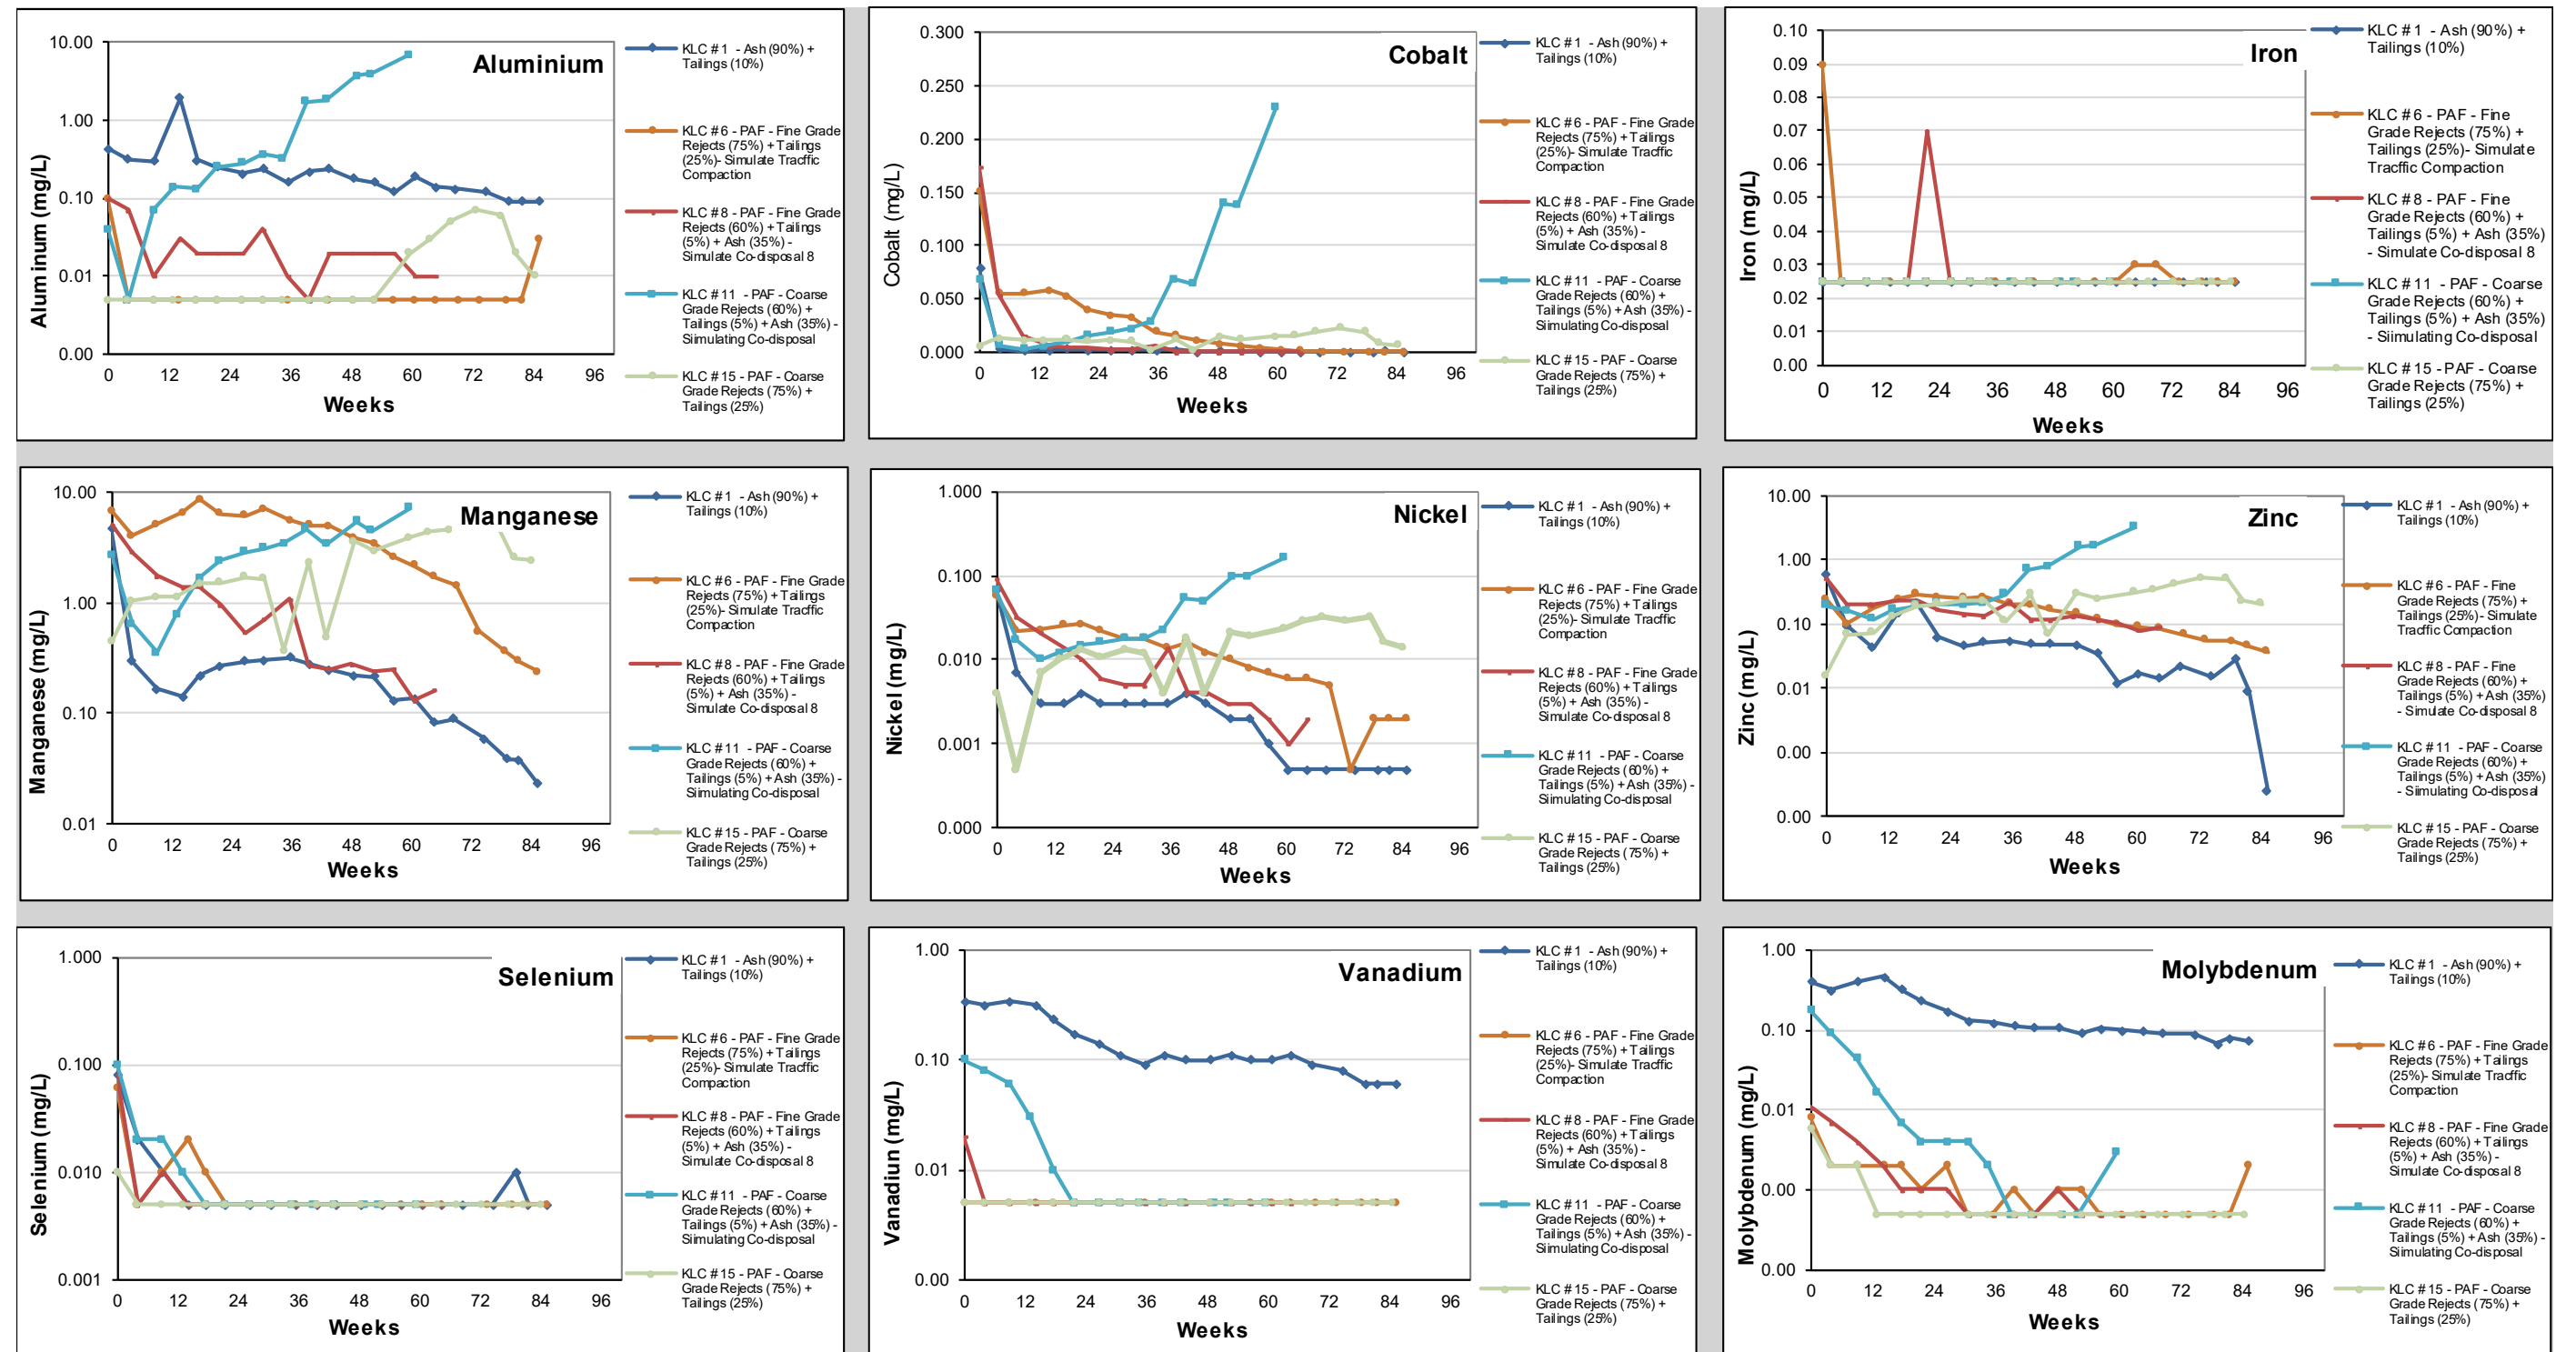
Figure 4-3: KLC results for tailings and tailings bearing samples

- **Figure 4-1 and 4-2** for reject, ash and tailings samples
- **Figure 4-3 and 4-4** for samples mixed with tailings
- **Figure 4-5 and 4-6** for overburden samples
- **Figure 4-7a and 4-8** for samples mixed with overburden.

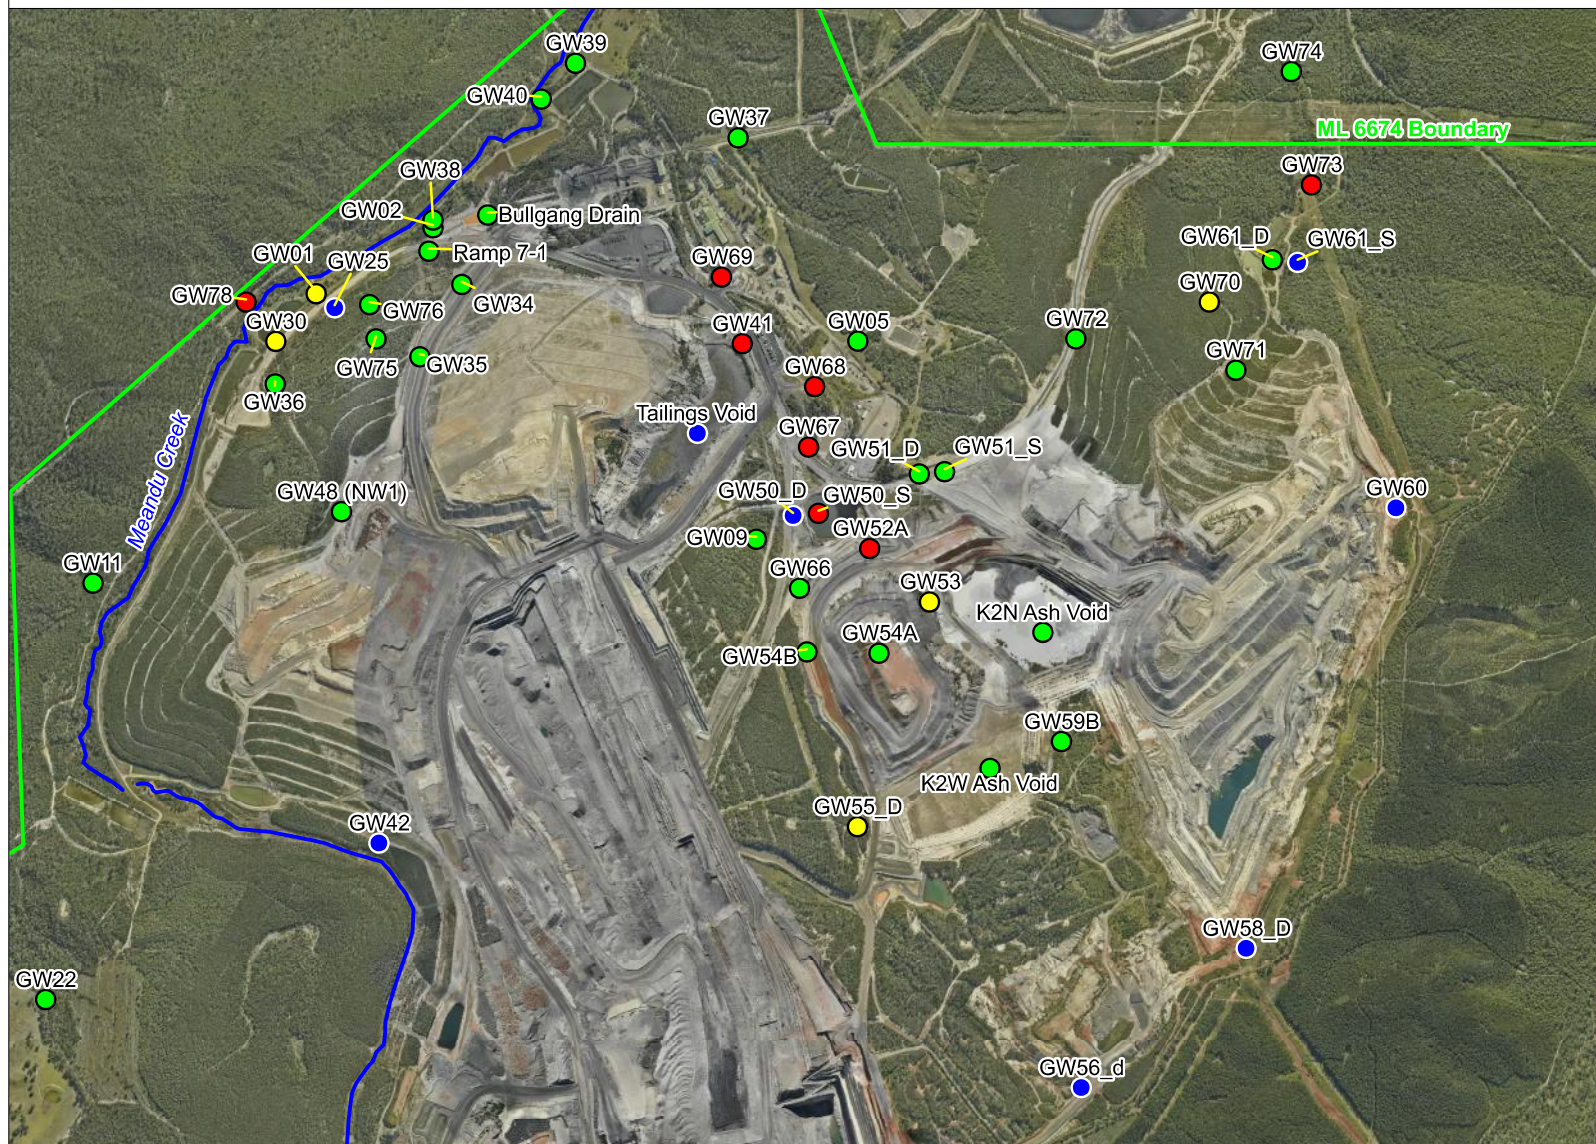
- >2,000  $\mu\text{S}/\text{cm}$
- 2,000 to <5,000  $\mu\text{S}/\text{cm}$
- 5,000 to <10,000  $\mu\text{S}/\text{cm}$
- >10,000  $\mu\text{S}/\text{cm}$

| DRAWN<br><b>JWB</b> | DATE<br><b>Aug 2018</b> | TITLE<br><b>Groundwater<br/>Electrical Conductivity (EC) Data</b> | |
