**TEC COAL PTY LTD**

# Environmental Investigation Report – Meandu Mine

14 SEPTEMBER 2018

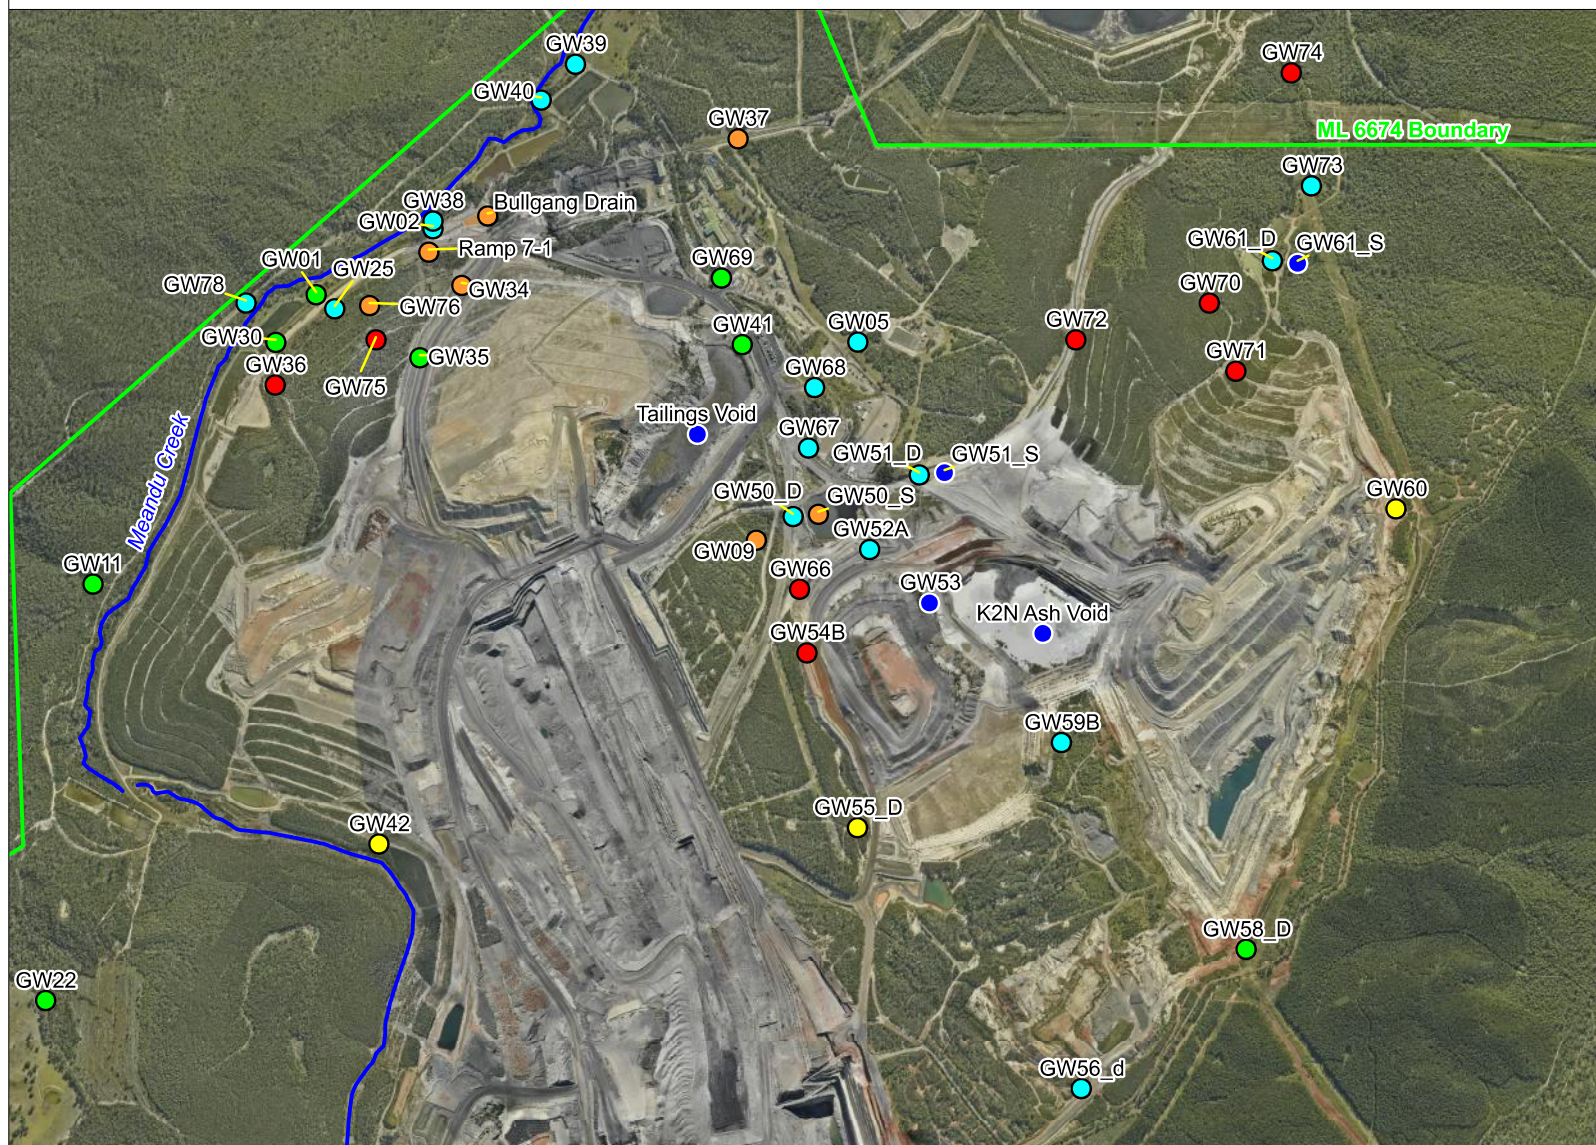
- < LOR
- >LOR to < 5 mg/L
- 5 to <10 mg/L
- 10 to <20 mg/L
- 20 to <50 mg/L
- >50 mg/L

| DRAWN<br>JWB | DATE<br>Aug 2018 | TITLE<br>Groundwater<br>Dissolved Iron (Fe) Data | |

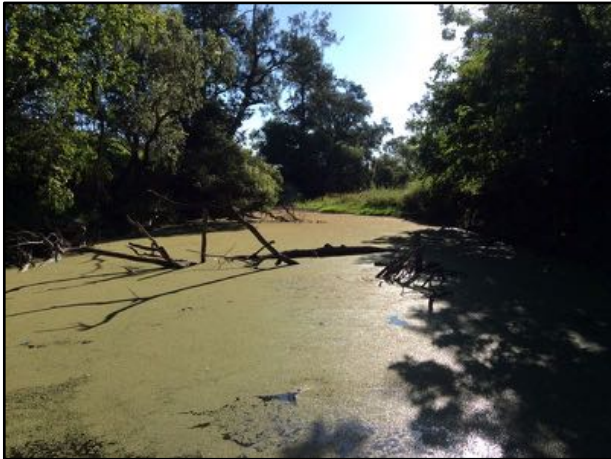
Figure 6.1 Isolated pool at comparative site C1B on Barker Creek

In general, comparative sites on Barker Creek were characterised as isolated pools disconnected from waterways upstream and downstream (Figure 6.1), or dry creek beds. The riparian vegetation was significantly impacted by vegetation clearing associated with the adjacent land uses (cropping and grazing). In-stream habitats had a number of features providing structure and shelter for aquatic fauna (including bank vegetation, a variety of in-stream vegetation and woody debris) but they lacked a variety of flow regimes (riffles, runs and glides), depth profiles and channel sinuosity (bends, bars and straight sections). External impacts were moderate and mostly associated with the adjacent land clearing that had reduced the presence and continuity of riparian vegetation. Other apparent impacts included stock access and poor connectivity to other waterways.

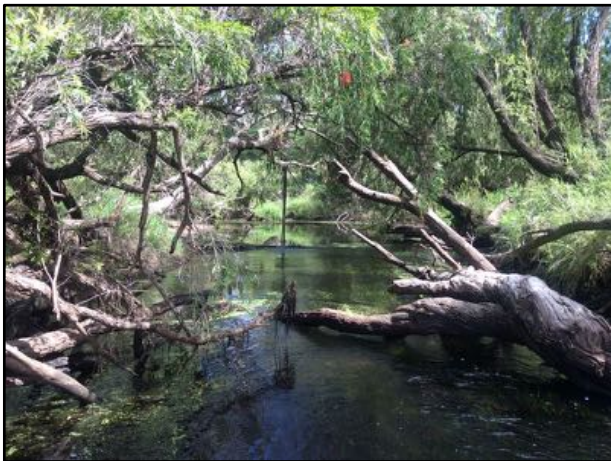
Figure 6.2 A wide variety of connected aquatic habitat types at comparative site SW36 on Barambah Creek

The comparative site on Barambah Creek (site SW36) was characterised as a flowing pool located approximately 5 km downstream from Bjelke-Petersen Dam. Flows are released from the dam for downstream uses (including drinking water), resulting in a perennial flow regime. The riparian vegetation was impacted by vegetation clearing associated with the adjacent land uses (cropping and grazing) and a road corridor and road bridge that crossed above the site. In-stream habitats had a significant number of features providing excellent structure and shelter for aquatic fauna (including bank vegetation, a variety of in-stream vegetation including submerged aquatic plants, woody debris as well as a variety of flow regimes (including pool, glide, run, and riffle), depth profiles and channel sinuosity (Figure 6.2). External impacts were moderate and mostly associated with adjacent land clearing that has reduced the presence and continuity of riparian vegetation. Some human impact from recreational fishing and camping was also apparent.

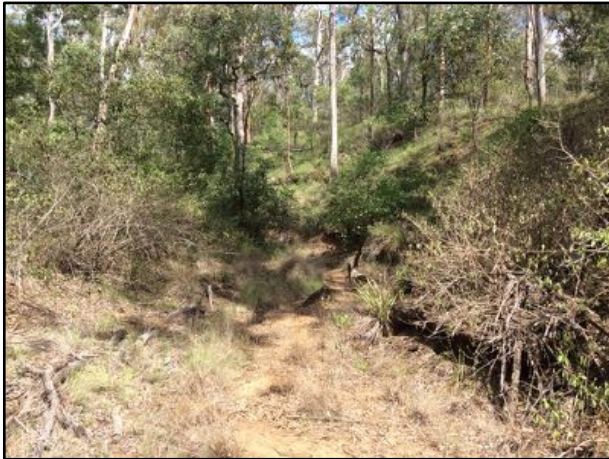
Figure 6.3 Ephemeral drainage channel with good riparian cover at site MCUS2 on Meandu Creek upstream of the mine

Upstream sites on Meandu Creek were characterised as ephemeral drainage channels (Figure 6.3). The riparian vegetation was in good condition due to minimal impacts from the surrounding land use (sites were within the Yarraman State Forest). In-stream habitat was not assessed in the dry conditions, and it is unlikely that the waterways would hold water for long periods even after rain. External impacts were low given the surrounding area was intact native forest; the most apparent impact was humans accessing the State Forest for recreational activities.

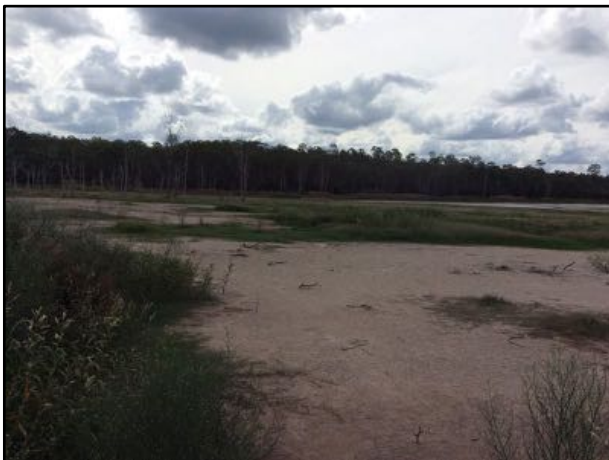
Figure 6.4 Poor riparian cover due to vegetation clearing at site CM2

The sites located on Meandu Creek upstream of Meandu Creek Dam were characterised as isolated pools disconnected from waterways upstream and downstream. The riparian vegetation was impacted by vegetation clearing associated with the adjacent land use (mining activities) (Figure 6.4). In-stream habitats had a number of features providing some structure and shelter for aquatic fauna, but sites were typically dominated by one or two main habitat features (predominantly in-stream vegetation) and they lacked the variety of habitat associated with different flow regimes and channel sinuosity. External impacts were high and mostly associated with the adjacent land use (Meandu Mine); channel modifications have changed the natural flow and function of the waterway and the natural source of water feeding the sites. It is understood that in 2016 and 2017 seepage into the reaches adjacent to the mine was managed by pumping out the pools regularly into RD7 (though currently pumping is very infrequent, and is expected to remain rare in 2019).

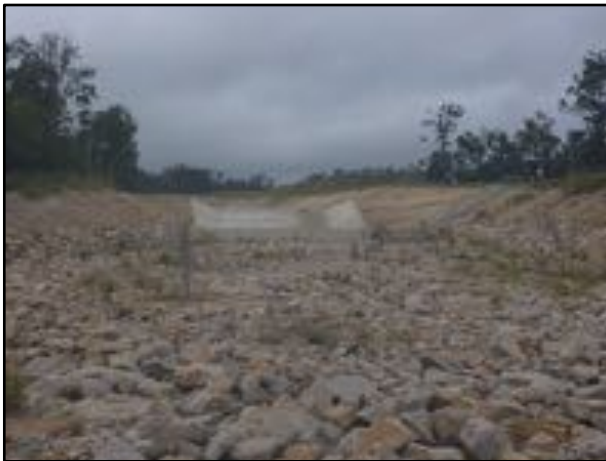
Figure 6.5 Highly modified diversion channel at Black Creek site BC2

The sites on Black Creek were both characterised as large pools significantly altered from their natural states and not connected to waterways further upstream and downstream. The riparian vegetation was impacted by vegetation clearing associated with the adjacent land uses (Tarong and Tarong North power stations) and the construction of the Black Creek diversion channel (Figure 6.5). While Black Creek Dam provides some habitat for aquatic flora and fauna, in the constructed channel downstream of the dam the habitat is entirely engineered.

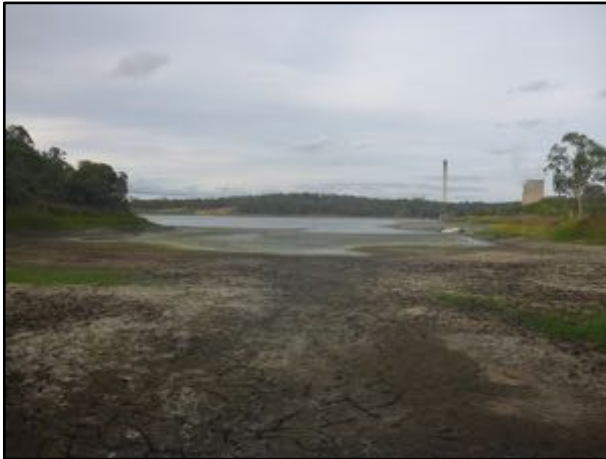
Figure 6.6 Low water level at Meandu Creek Dam

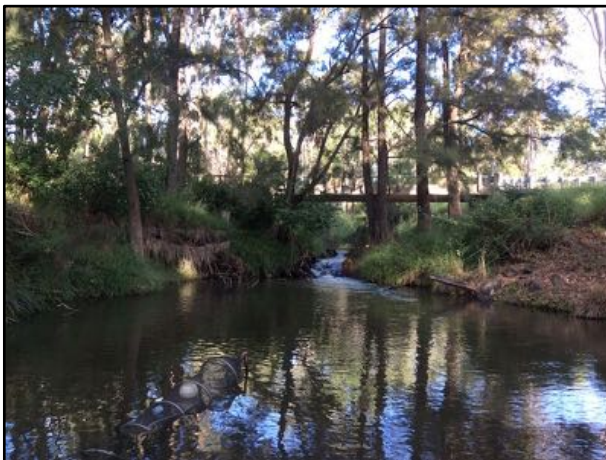
Figure 6.7 A representative site (MC5 / W2), with a well-connected channel and a variety of aquatic habitat types but some impacts from vegetation clearing and a road bridge

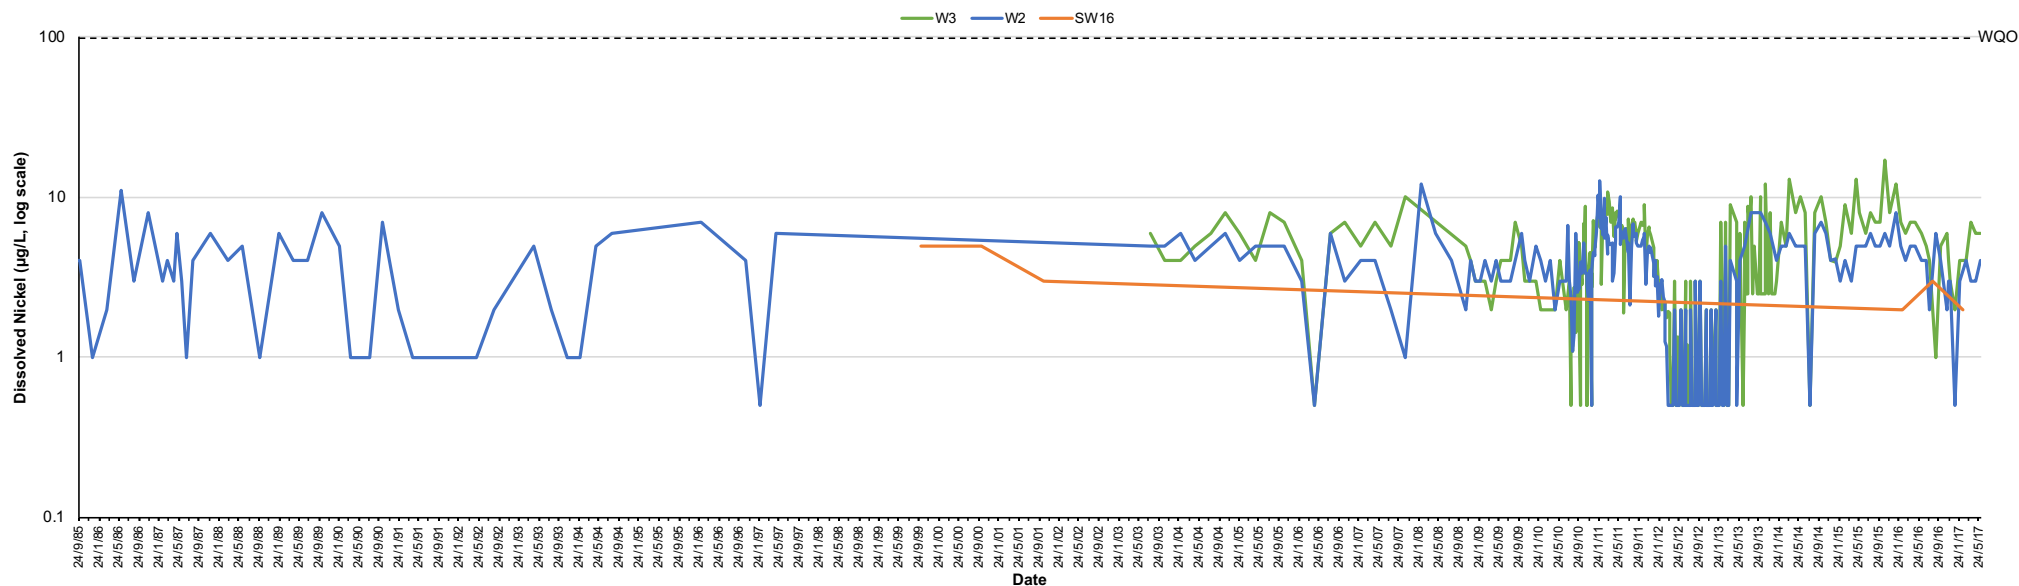
Figure C.18 Dissolved nickel in water at sites on Meandu Creek Dam (W3) and on Meandu Creek downstream of Meandu Creek Dam (W2 and SW16) from 1984–2017

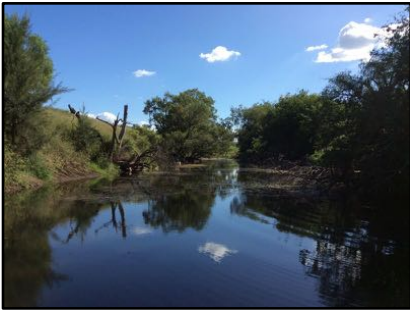
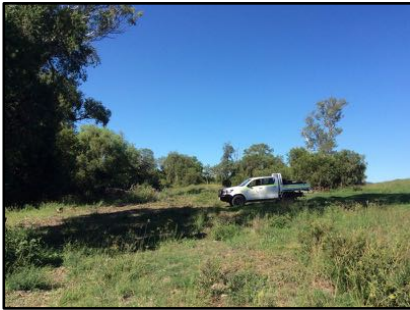
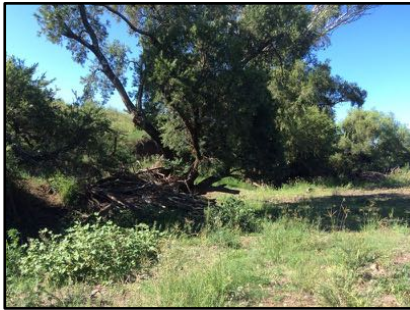
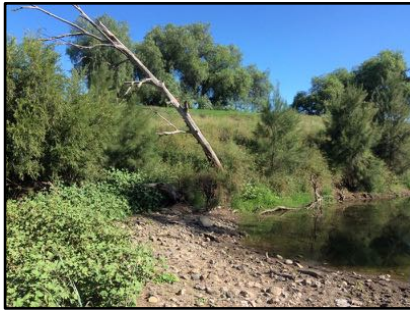
| Aquatic Habitat Description | | | |
|---|---|---|---|
| <p>Site C1 was located on Barker Creek upstream of the Barker Creek and Meandu Creek confluence. This site consisted of a wide, deep pool (approximately 15 m wide and 1.2 m deep) that was not flowing and disconnected from waterways upstream and downstream.</p> | | | |
| Riparian condition: poor | In-stream condition: fair | Substrate: | External impacts: high |

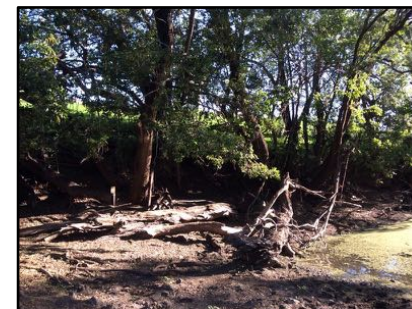
Right bank:

Site C1B was located on Barker Creek upstream of the Barker Creek and Meandu Creek confluence. This site consisted of a wide, deep pool (approximately 15 m wide and 1 m deep) that was not flowing and disconnected from waterways upstream and downstream.

The in-stream aquatic habitat condition was fair. The site was an isolated pool, significantly impacted by the surrounding land use activities but the following key habitat features were present, providing structural complexity and shelter for aquatic fauna:

The most apparent impact at the site was the surrounding land clearing that has significantly altered the landscape and caused a reduction in the presence and continuity of riparian vegetation.

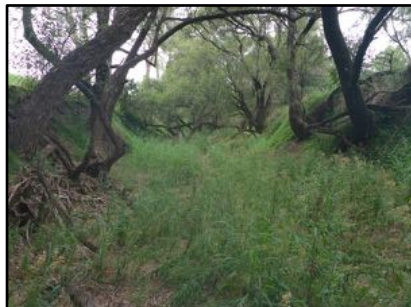
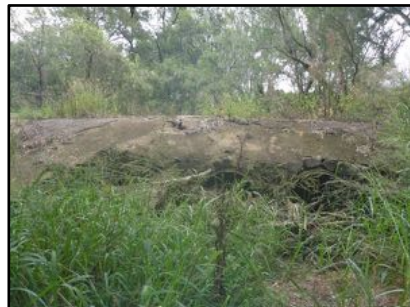
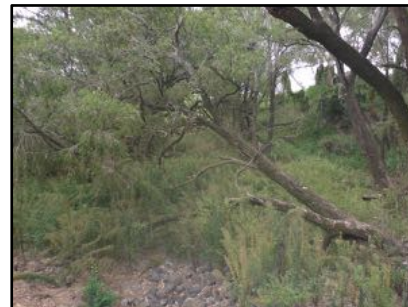
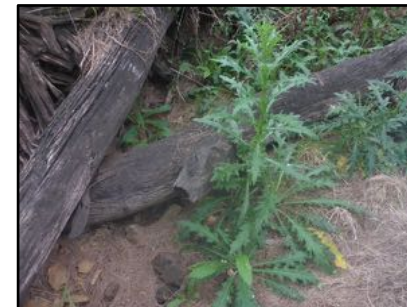
### C2 / SW19

Site C2/SW19 was located on Barker Creek upstream of the Barker Creek and Meandu Creek confluence. This site consisted of a dry channel approximately 8 m wide and disconnected from waterways upstream and downstream. A road crossed over the waterway in the middle of the site.

The most apparent impact at the site was the adjacent land clearing, which has caused a reduction in the presence and continuity of riparian vegetation and the subsequent shading and protection it would normally provide.

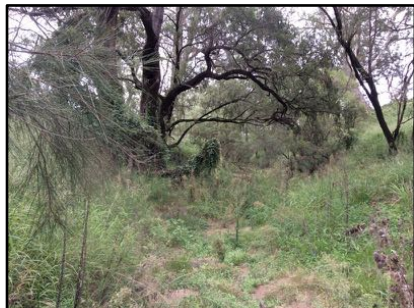
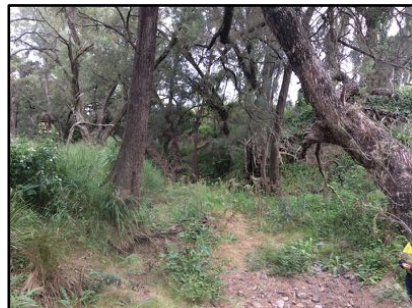
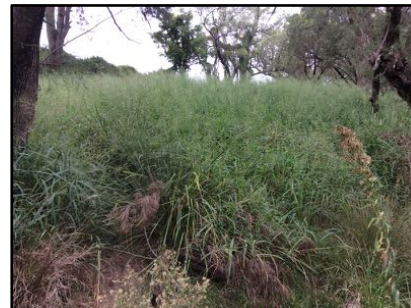
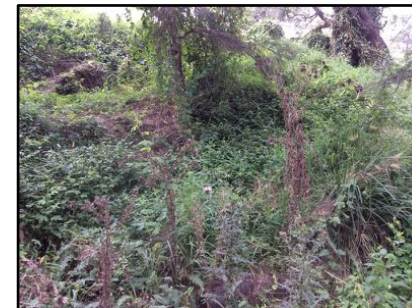
### C3

Site C3 was located on Barker Creek upstream of the Barker Creek and Meandu Creek confluence. This site consisted of a dry channel approximately 12 m wide and disconnected from waterways upstream and downstream.

The most apparent impact at the site was the adjacent land clearing, which has caused a reduction in the presence and continuity of riparian vegetation and the subsequent shading and protection it would normally provide.

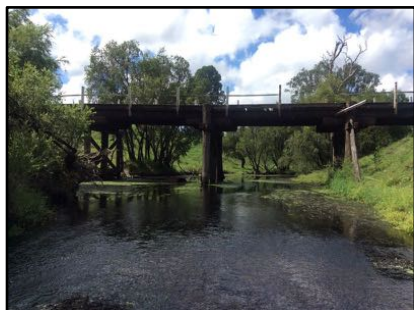
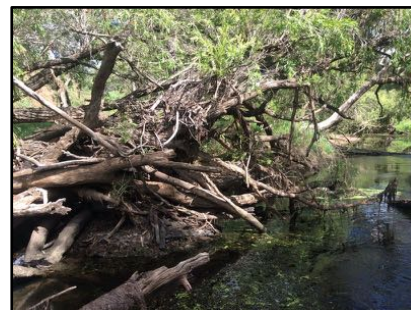
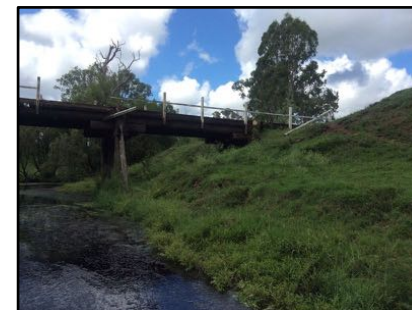
### SW36

Site SW36 was located on Barambah Creek downstream of Bjelke-Petersen Dam. This site consisted of a large, connected pool approximately 8 m wide with slow to moderate flow (average 0.2 m/s). An old road bridge crossed over the waterway through the middle of the site. The site was well connected to waterways further upstream and downstream.

The in-stream aquatic habitat condition was excellent with the following key habitat features present, providing structural complexity and shelter for aquatic fauna:

The most apparent impact at the site was the old road bridge crossing over the site and the adjacent vehicle track, which has caused some disturbance to the riparian vegetation continuity and changes to the natural flow regime. There was also evidence of recreation camping on the left bank.

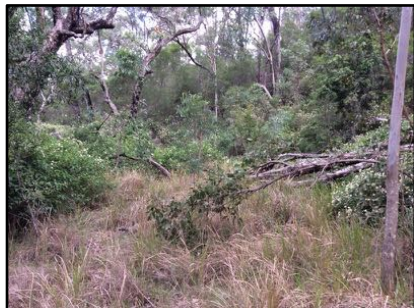
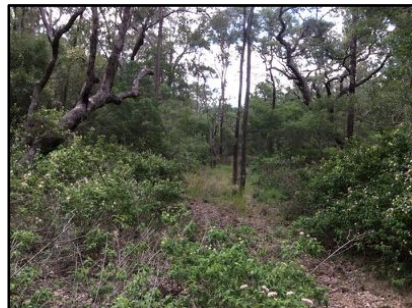
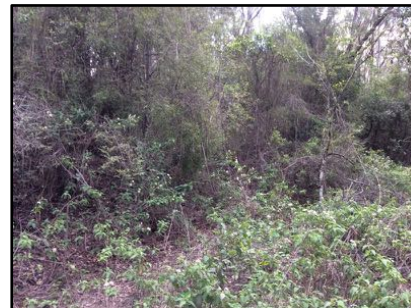
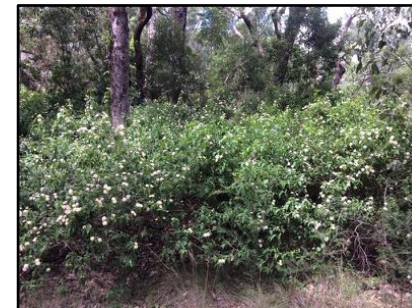
### MCUS1

Site MCUS1 was located on Meandu Creek upstream of Meandu Mine and the Tarong power stations. This site consisted of a dry undefined channel disconnected from waterways upstream and downstream.

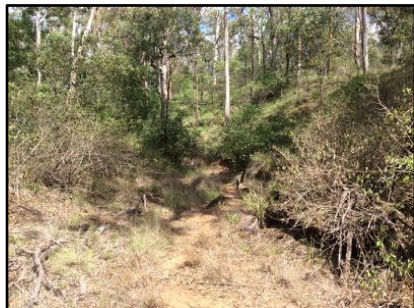
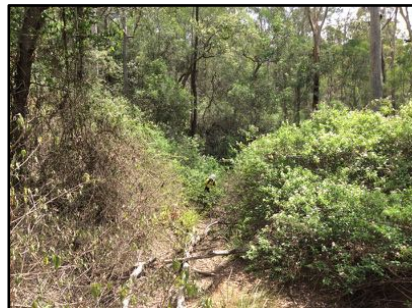
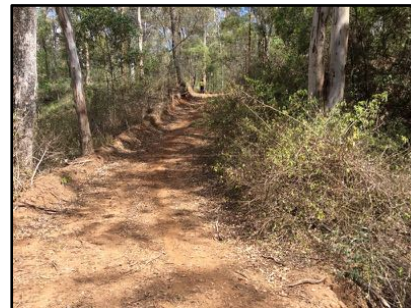
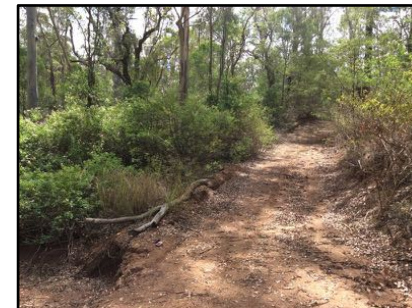
### MCUS2

Site MCUS2 was located on Meandu Creek upstream of Meandu Mine and the Tarong power stations. This site consisted of a dry channel disconnected from waterways upstream and downstream.

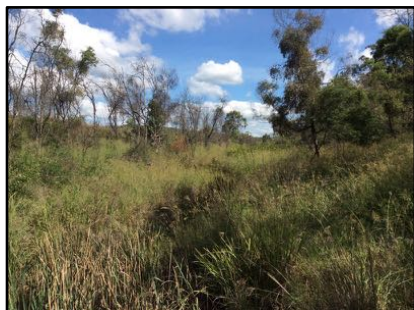
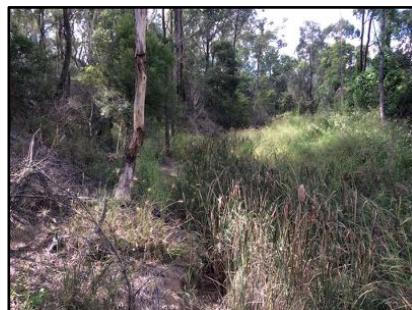
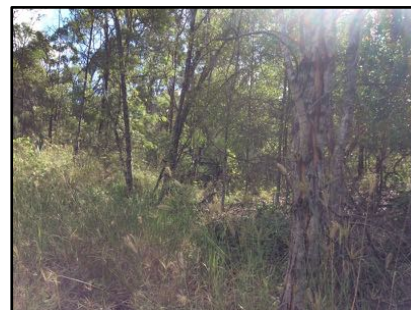
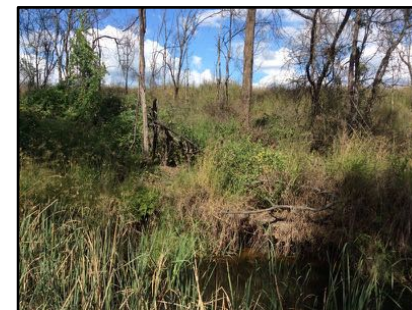
### MCA1 / MC6

Site MCA1/MC6 was located on a diverted section of Meandu Creek upstream of Meandu Creek Dam and the main Meandu Mine discharge point (RD2) and the Tarong power stations. This site consisted of a wide, deep pool (approximately 5 m wide and 1.4 m deep) that was not flowing and disconnected from waterways upstream and downstream.

The in-stream aquatic habitat condition was fair. The site was an isolated pool, significantly impacted by the surrounding industrial activities but the following key habitat features were present, providing structural complexity and shelter for aquatic fauna:

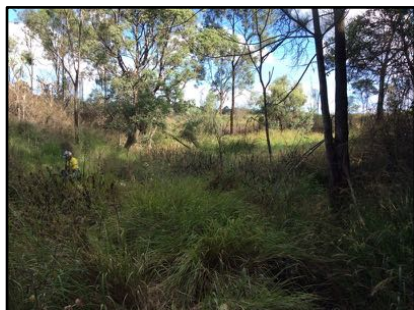
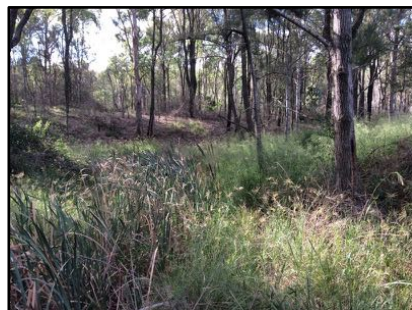
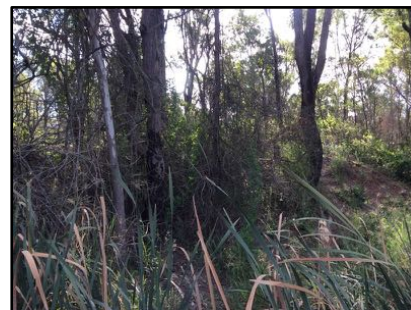
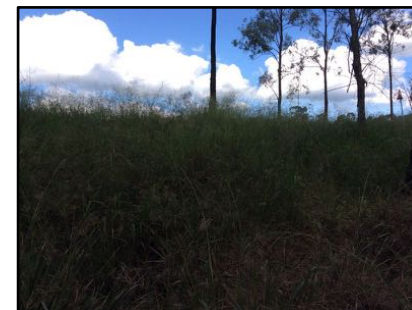
### MCA2 / MC1

Site MCA2/MC1 was located on a natural (un-diverted) section of Meandu Creek upstream of Meandu Creek Dam and of the main Meandu Mine discharge point (RD2) and the Tarong power stations. This site consisted of a narrow, pool (approximately 2 m wide and 1 m deep) that was not flowing and disconnected from waterways upstream and downstream.

The in-stream aquatic habitat condition was fair. The site was an isolated pool, significantly impacted by the surrounding industrial activities and the in stream aquatic habitat was dominated by extreme growth of aquatic plants (predominantly Cumbungi) that were choking the waterway and causing a build-up of sedimentation. No filamentous algae was present.

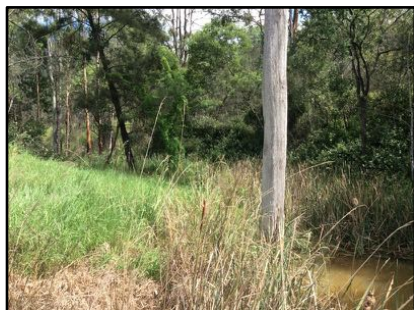
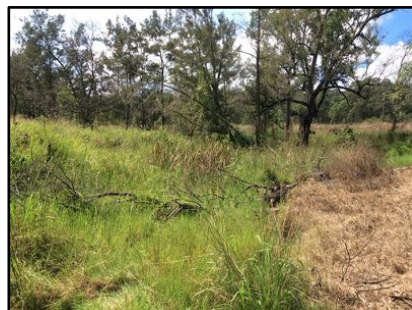
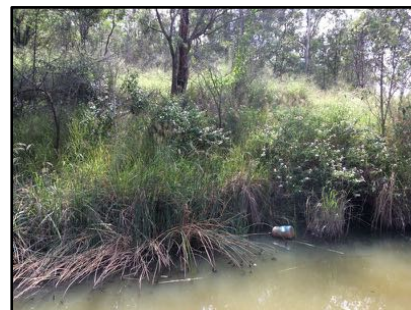
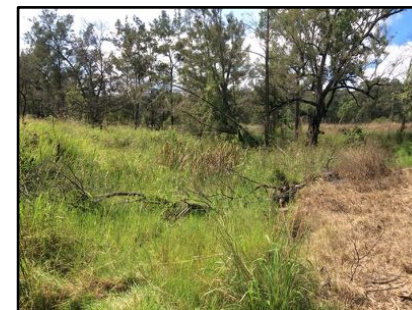
### MCA3 / MC5

Site MCA3/MC5 was located on a diverted section of Meandu Creek upstream of Meandu Creek Dam and of the main Meandu Mine discharge point (RD2) and the Tarong power stations. This site consisted of a wide (6 m) and deep (1.6 m) pool that was not flowing and disconnected from waterways upstream and downstream.

The in-stream aquatic habitat condition was fair. The site was an isolated pool, significantly impacted by the surrounding industrial activities but the following key habitat features were present, providing structural complexity and shelter for aquatic fauna:

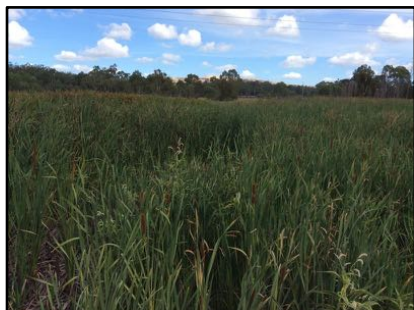
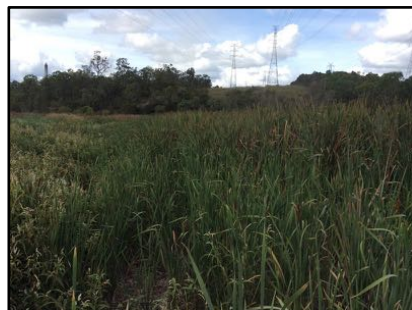
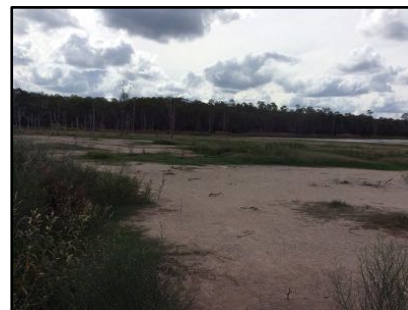
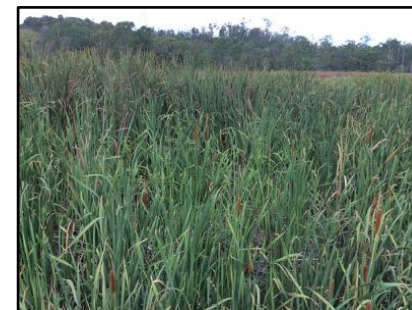
### CM2

Site CM2 was located on Meandu Creek at the Meandu Mine inlet to Meandu Creek Dam and downstream of the main Meandu Mine discharge point (RD2). This site consisted of a narrow (2 m) and shallow (0.2 m) pool. While there was no flow at the time of the survey, the site appeared connected to waterways further upstream and downstream.

The in-stream aquatic habitat condition was poor. Water levels were low and the in-stream aquatic habitat was dominated by significant growth of aquatic plants (predominantly Cumbungi) that were choking the waterway and causing a build-up of sedimentation.

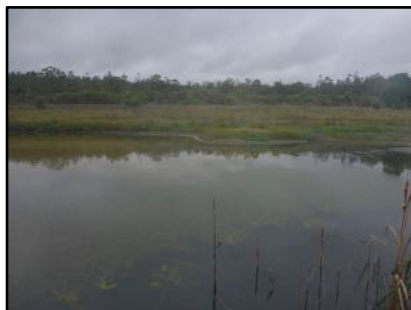
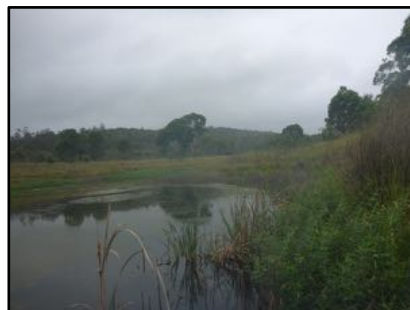
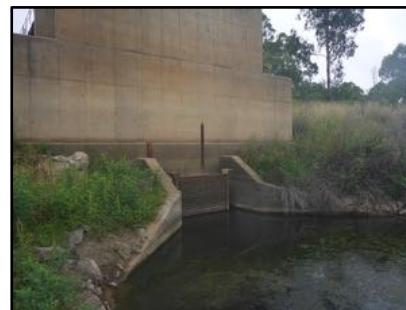
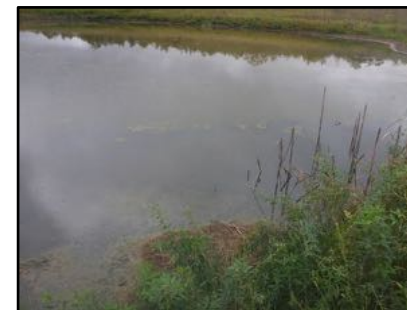
### BC1

Site BC1 was located on Black Creek Dam; an on-stream storage dam for Meandu Mine stormwater drainages (discharged from RD17B) as well as stormwater discharge from the Tarong power stations. This site consisted of a large pool of water within the Black Creek Valley not connected to waterways upstream or downstream.

The in-stream aquatic habitat condition was fair. The site was an isolated pool, significantly impacted by the surrounding land use activities with little bank vegetation (except for some scattered aquatic plants around the water's edge) or in stream habitat features providing structural complexity and shelter for aquatic fauna. Filamentous algae was present.

The most apparent impact at the site was the surrounding industrial activity that has significantly altered the natural structure and function of the channel and caused a reduction in the presence and continuity of riparian vegetation. Lack of connectivity to upstream and downstream waterways was another apparent impact.

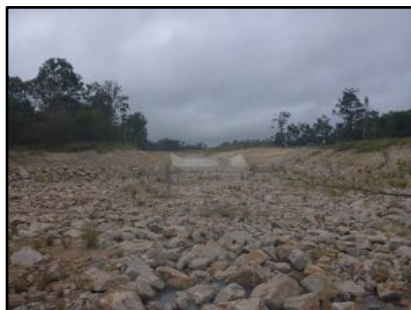
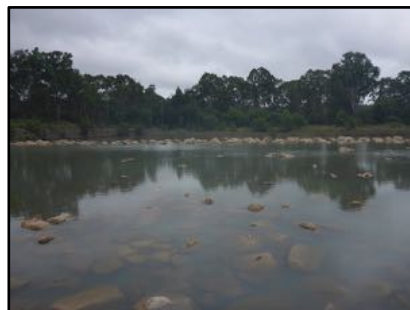
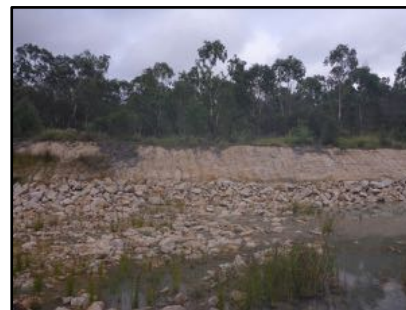
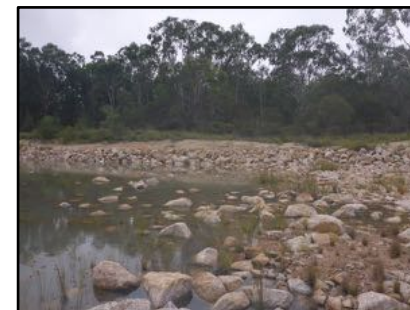
### BC2

Site BC2 was located at the most downstream point of the diverted section of Black Creek before the Black Creek and Meandu Creek confluence. This site consisted of a large artificial wetland (wetted width approximately 70 m) downstream of several sedimentation ponds that was not connected to waterways upstream or downstream.

The in-stream aquatic habitat condition was fair. The site was an isolated pool, significantly impacted by the surrounding land use activities with little bank vegetation or in stream vegetation. In-stream substrates provided the majority of the available habitat features providing some structural complexity and shelter for aquatic fauna. Filamentous algae was present.

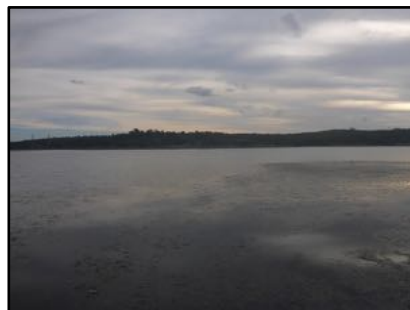
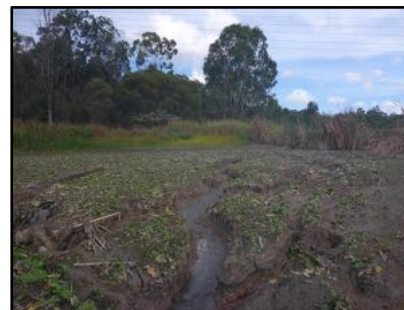
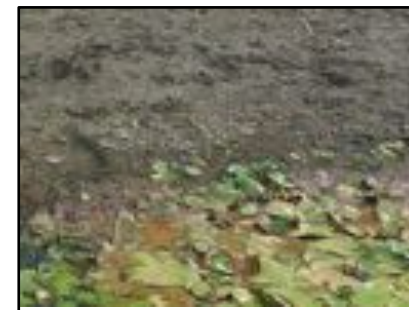
Potential iron oxide sheen on water:

Meandu Creek Dam is a constructed waterbody located at the site of the Tarong power stations and receives licensed process waters from the Tarong Power Station, Tarong North Power Station and Meandu Mine as well as stormwater drainage from the power stations and Meandu Mine. The dam was a large pool of water connected to waterways further upstream and downstream via various inlets, outlets and waterway channels.

The in-stream aquatic habitat condition was good. The dam contained extensive beds of submerged, emergent and floating aquatic vegetation as well as large woody debris, which were providing structural complexity and shelter for aquatic fauna. Water levels were low so bank vegetation (providing shading and overhanging / trailing-bank habitat) was minimal.

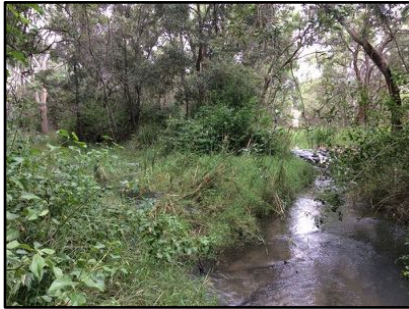
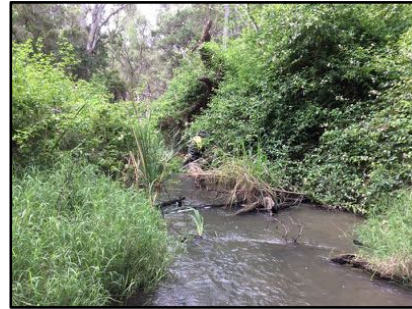
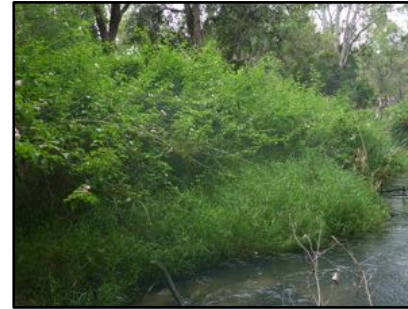
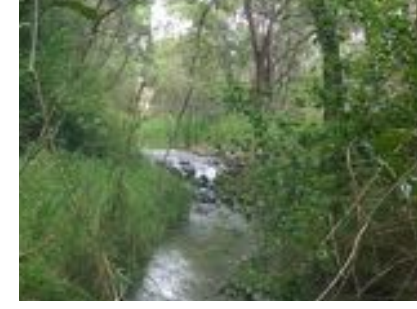
### MCDOUT

Site MCDOUT was located on Meandu Creek at the confluence of Meandu Creek and the W3 Meandu Creek Dam outlet channel. This site consisted of a narrow pool approximately 3 m wide with fast flow (average 0.2 m/s). The site was connected to waterways downstream but upstream of the site was dry (i.e. the water at site was purely discharge water).

The in-stream aquatic habitat condition was fair. The site was predominately a narrow fast-flowing pool and the following key habitat features were present, providing structural complexity and shelter for aquatic fauna:

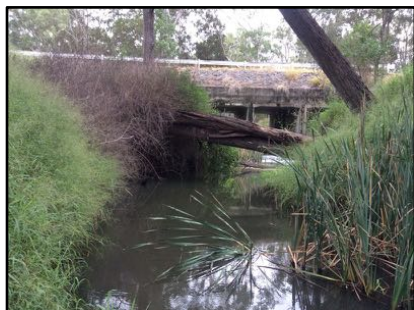
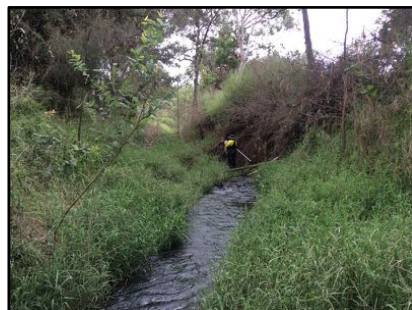
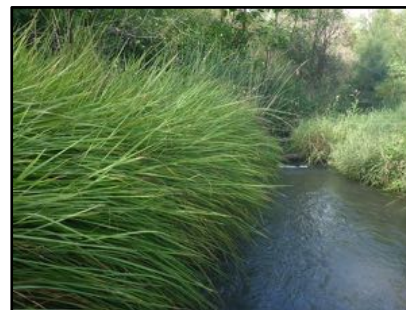
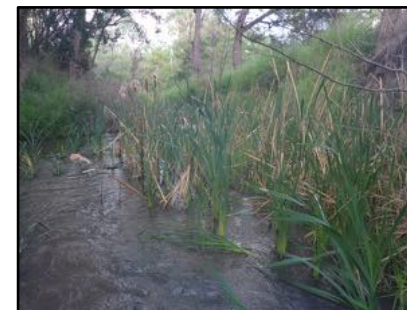
### MC500

Site MC500 was located on Meandu Creek approximately 0.5 km downstream of the W3 Meandu Creek Dam outlet in Meandu Creek. This site consisted of a pool between 2.5 m wide (downstream section) and 10 m wide (upstream section) with slow to moderate flow (average 0.2 m/s). A road bridge crossed above the waterway at the upstream end of the site. The site was well connected to waterways further upstream and downstream.

The in-stream aquatic habitat condition was good with the following key habitat features present, providing structural complexity and shelter for aquatic fauna:

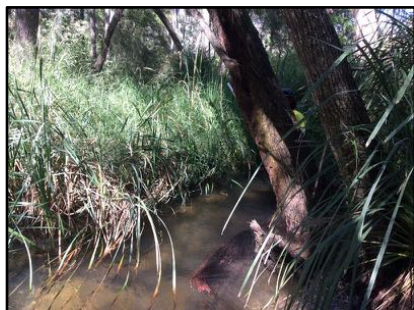
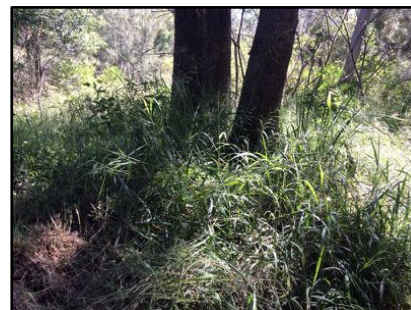
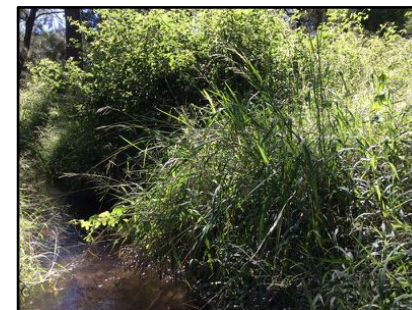
### MC2

Right bank erosion:

Site MC2 was located on Meandu Creek approximately 2 km downstream of the W3 Meandu Creek Dam outlet into Meandu Creek. This site consisted of a narrow pool approximately 3 m wide with moderate to fast flow (average 0.2 m/s). The site was well connected to waterways further upstream and downstream.

The in-stream aquatic habitat condition was fair. The site was predominately a straight shallow pool with moderate flow and the following key habitat features present, providing structural complexity and shelter for aquatic fauna:

The most apparent impact at the site was the land clearing adjacent to the left bank, which has caused a reduction in the presence and continuity of riparian vegetation.

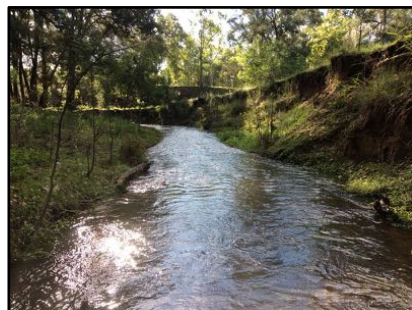
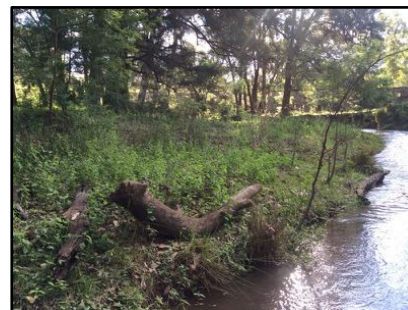
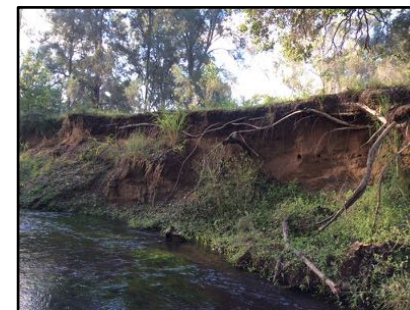
Right bank erosion:

Site MC5/W2 was located on Meandu Creek approximately 5 km downstream of the W3 Meandu Creek Dam outlet into Meandu Creek. This site consisted of a pool between 3 m and 9 m wide with moderate flow (average 0.2 m/s). A road bridge crossed the waterway at the downstream end of the site. The site was well connected to waterways further upstream and downstream.

The in-stream aquatic habitat condition was good with the following key habitat features present, providing structural complexity and shelter for aquatic fauna:

The most apparent impact at the site was the adjacent land clearing, which has caused a reduction in the presence and continuity of riparian vegetation and reduced bank stability leading to large areas of severe erosion. Stock access was also an evident impact.

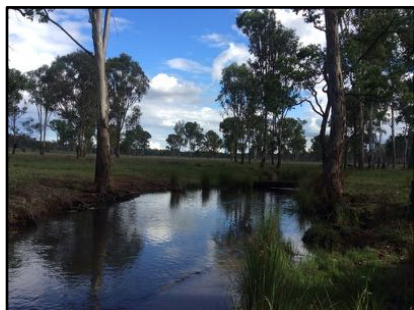
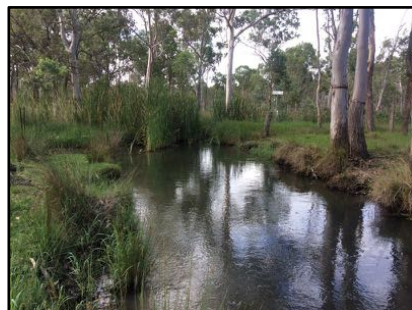
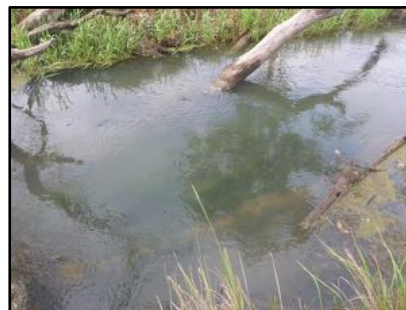
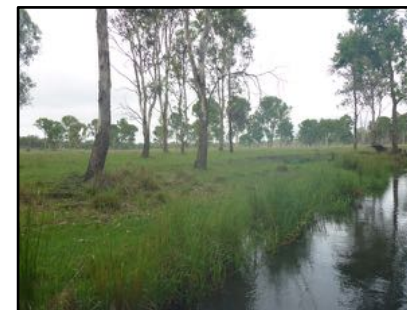
### MC15

Site MC15 was located on Meandu Creek approximately 15 km downstream of the W3 Meandu Creek Dam outlet into Meandu Creek. This site consisted of a narrow pool approximately 4 m wide with moderate flow (average 0.2 m/s). A road crossing was located at the downstream end of the site. The site was well connected to waterways further upstream and downstream.

The in-stream aquatic habitat condition was fair. The site was predominately a straight shallow pool with moderate flow and the following key habitat features were present, providing structural complexity and shelter for aquatic fauna:

The most apparent impact at the site was the adjacent land clearing, which has caused a reduction in the presence and continuity of riparian vegetation and the subsequent shading and protection it would normally provide. Stock access was also an evident impact.

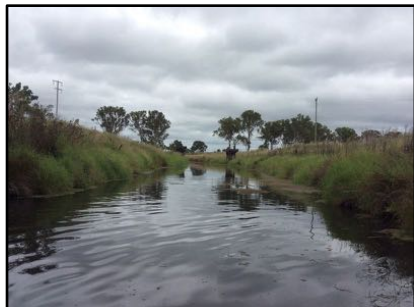
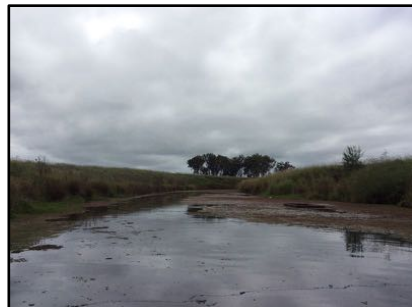
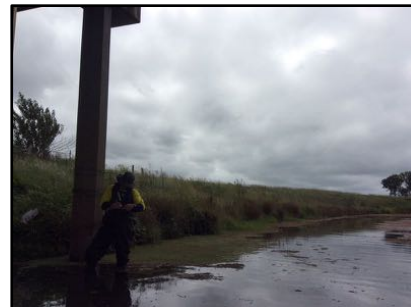
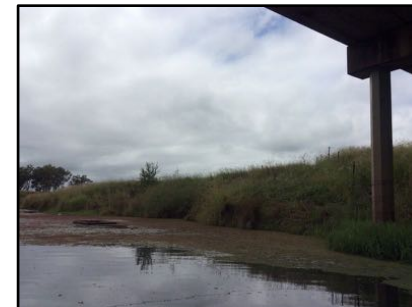
### MC20 / SW16

Site MC20 was located on Meandu Creek approximately 20 km downstream of the W3 Meandu Creek Dam outlet into Meandu Creek. This site consisted of a connected pool approximately 10 m wide with slow flow (average 0.1 m/s). A road bridge crossed above the waterway in the middle of the site. The site was well connected to waterways further upstream and downstream.

The in-stream aquatic habitat condition was poor. The site was predominately a straight shallow pool with slow flow and the following key habitat features were present, providing structural complexity and shelter for aquatic fauna:

The most apparent impact at the site was the adjacent land clearing, which has caused a reduction in the presence and continuity of riparian vegetation and the subsequent shading and protection it would normally provide. The road bridge crossing above that site has also impacted the bank stability and the natural flow regime of the waterway. Rubbish present at the site is indicative of recreational human impacts.

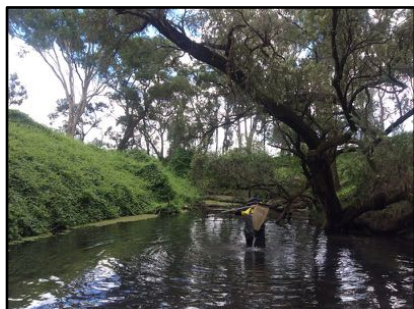
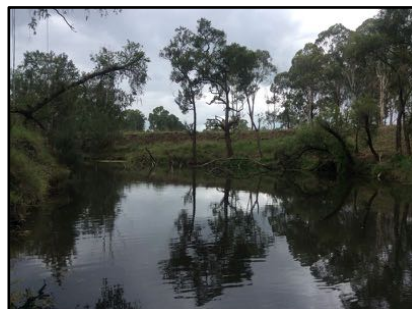
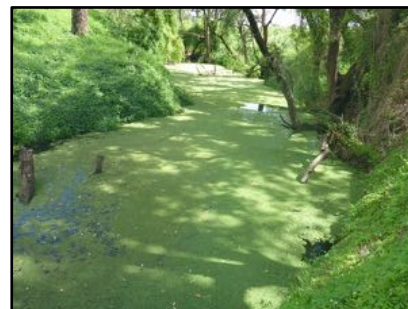
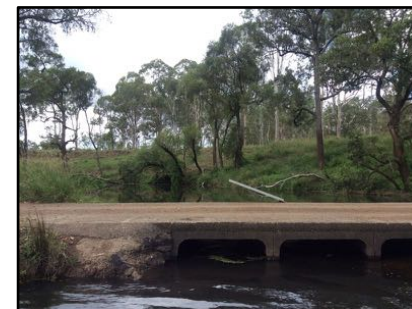
### MC25

Road crossing through site:

Site MC25 was located on Barker Creek approximately 3 km downstream of the Barker Creek and Meandu Creek confluence and approximately 25 km downstream of the W3 Meandu Creek Dam outlet into Meandu Creek. This site consisted of a large, connected pool approximately 11 m wide with slow flow (average 0.1 m/s). A road crossed through the middle of the site. The site was well connected to waterways further upstream and downstream.

The in-stream aquatic habitat condition was fair with the following key habitat features were present, providing structural complexity and shelter for aquatic fauna:

The most apparent impact at the site was the road crossing through the site and the adjacent vehicle track, which has caused some disturbance to the riparian vegetation continuity, lowered bank stability and changed the natural flow regime. The in-stream culvert under the road seems to provide sufficient connectivity to allow flow. There was also evidence of recreation swimming at the site. An inlet from an unknown source was also present and flowing at the time.
