JBS Townsville

**Environmental Evaluation Of Wastewater Irrigation**

Part 2 - **Groundwater** - Interim Report

**Bio-Track Pty Ltd**

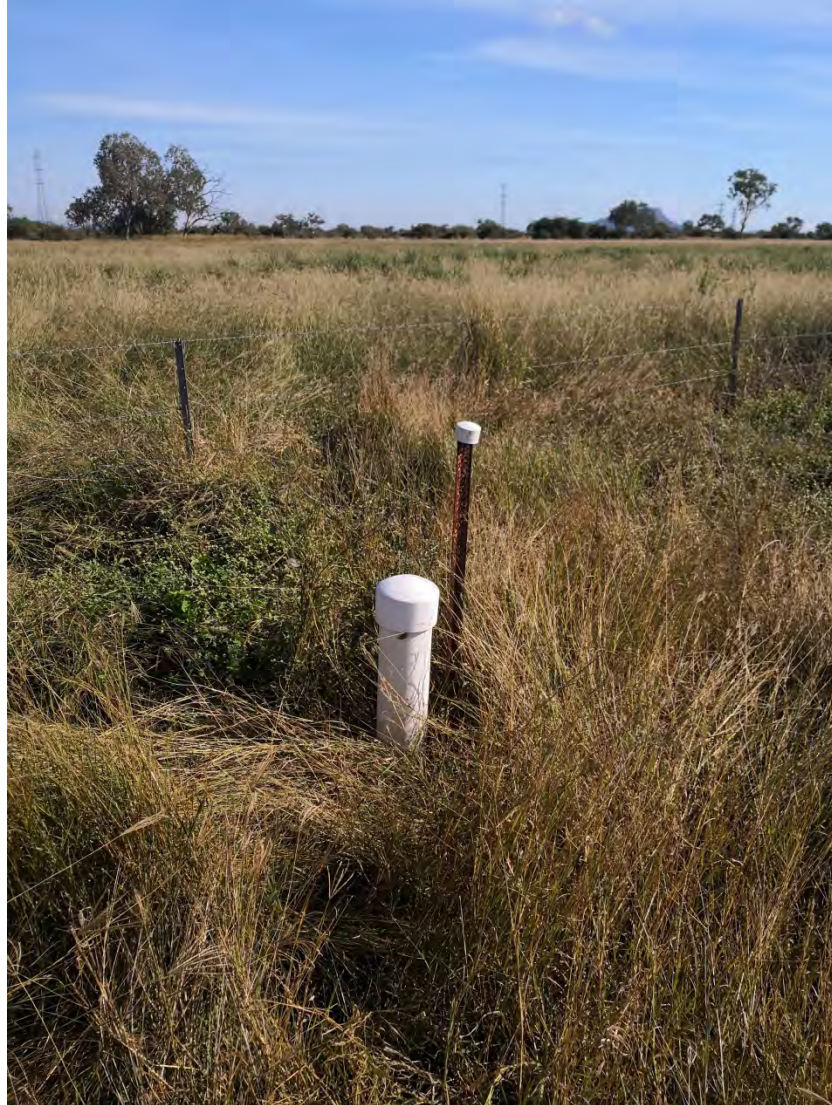
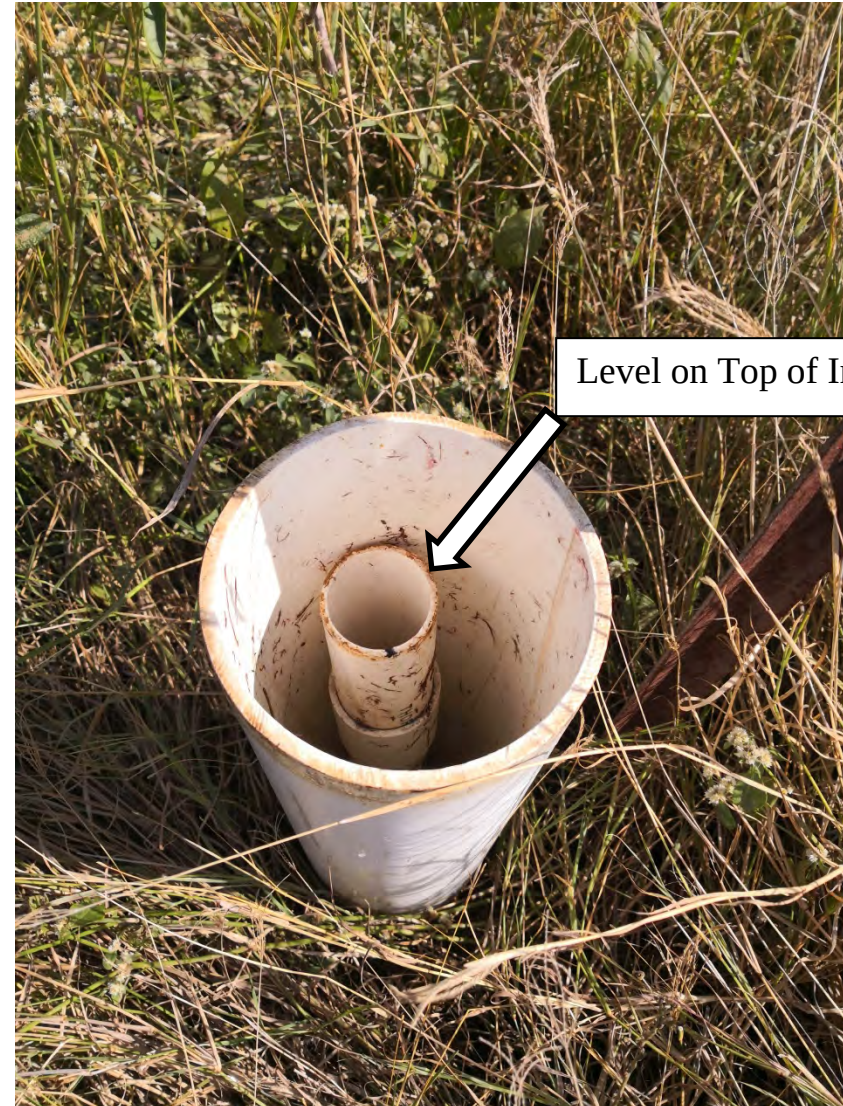
## Monitoring Bore – P2

Level on Top of Internal Pipe

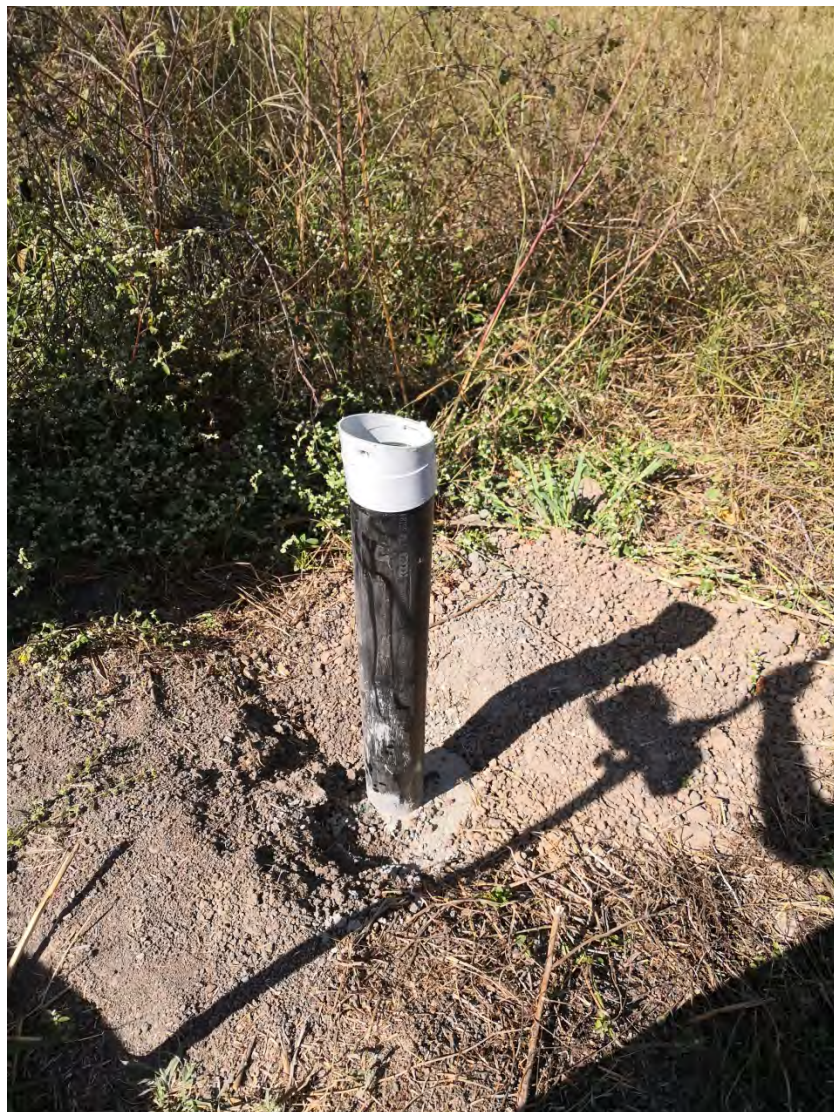
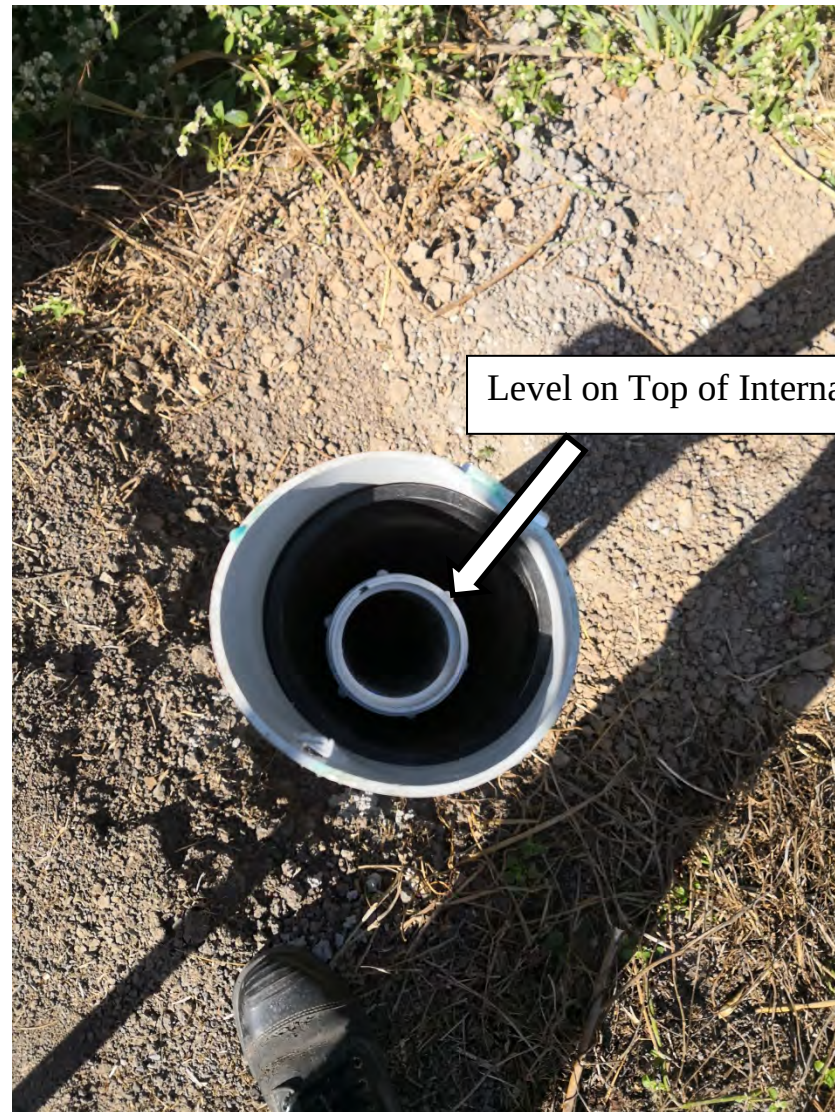
Monitoring Bore – TMB 2

Level on Top of Internal Pipe
