JBS Townsville

Environmental Evaluation Of Surface Water

Interim Report

DES CA4544; 101/0008424

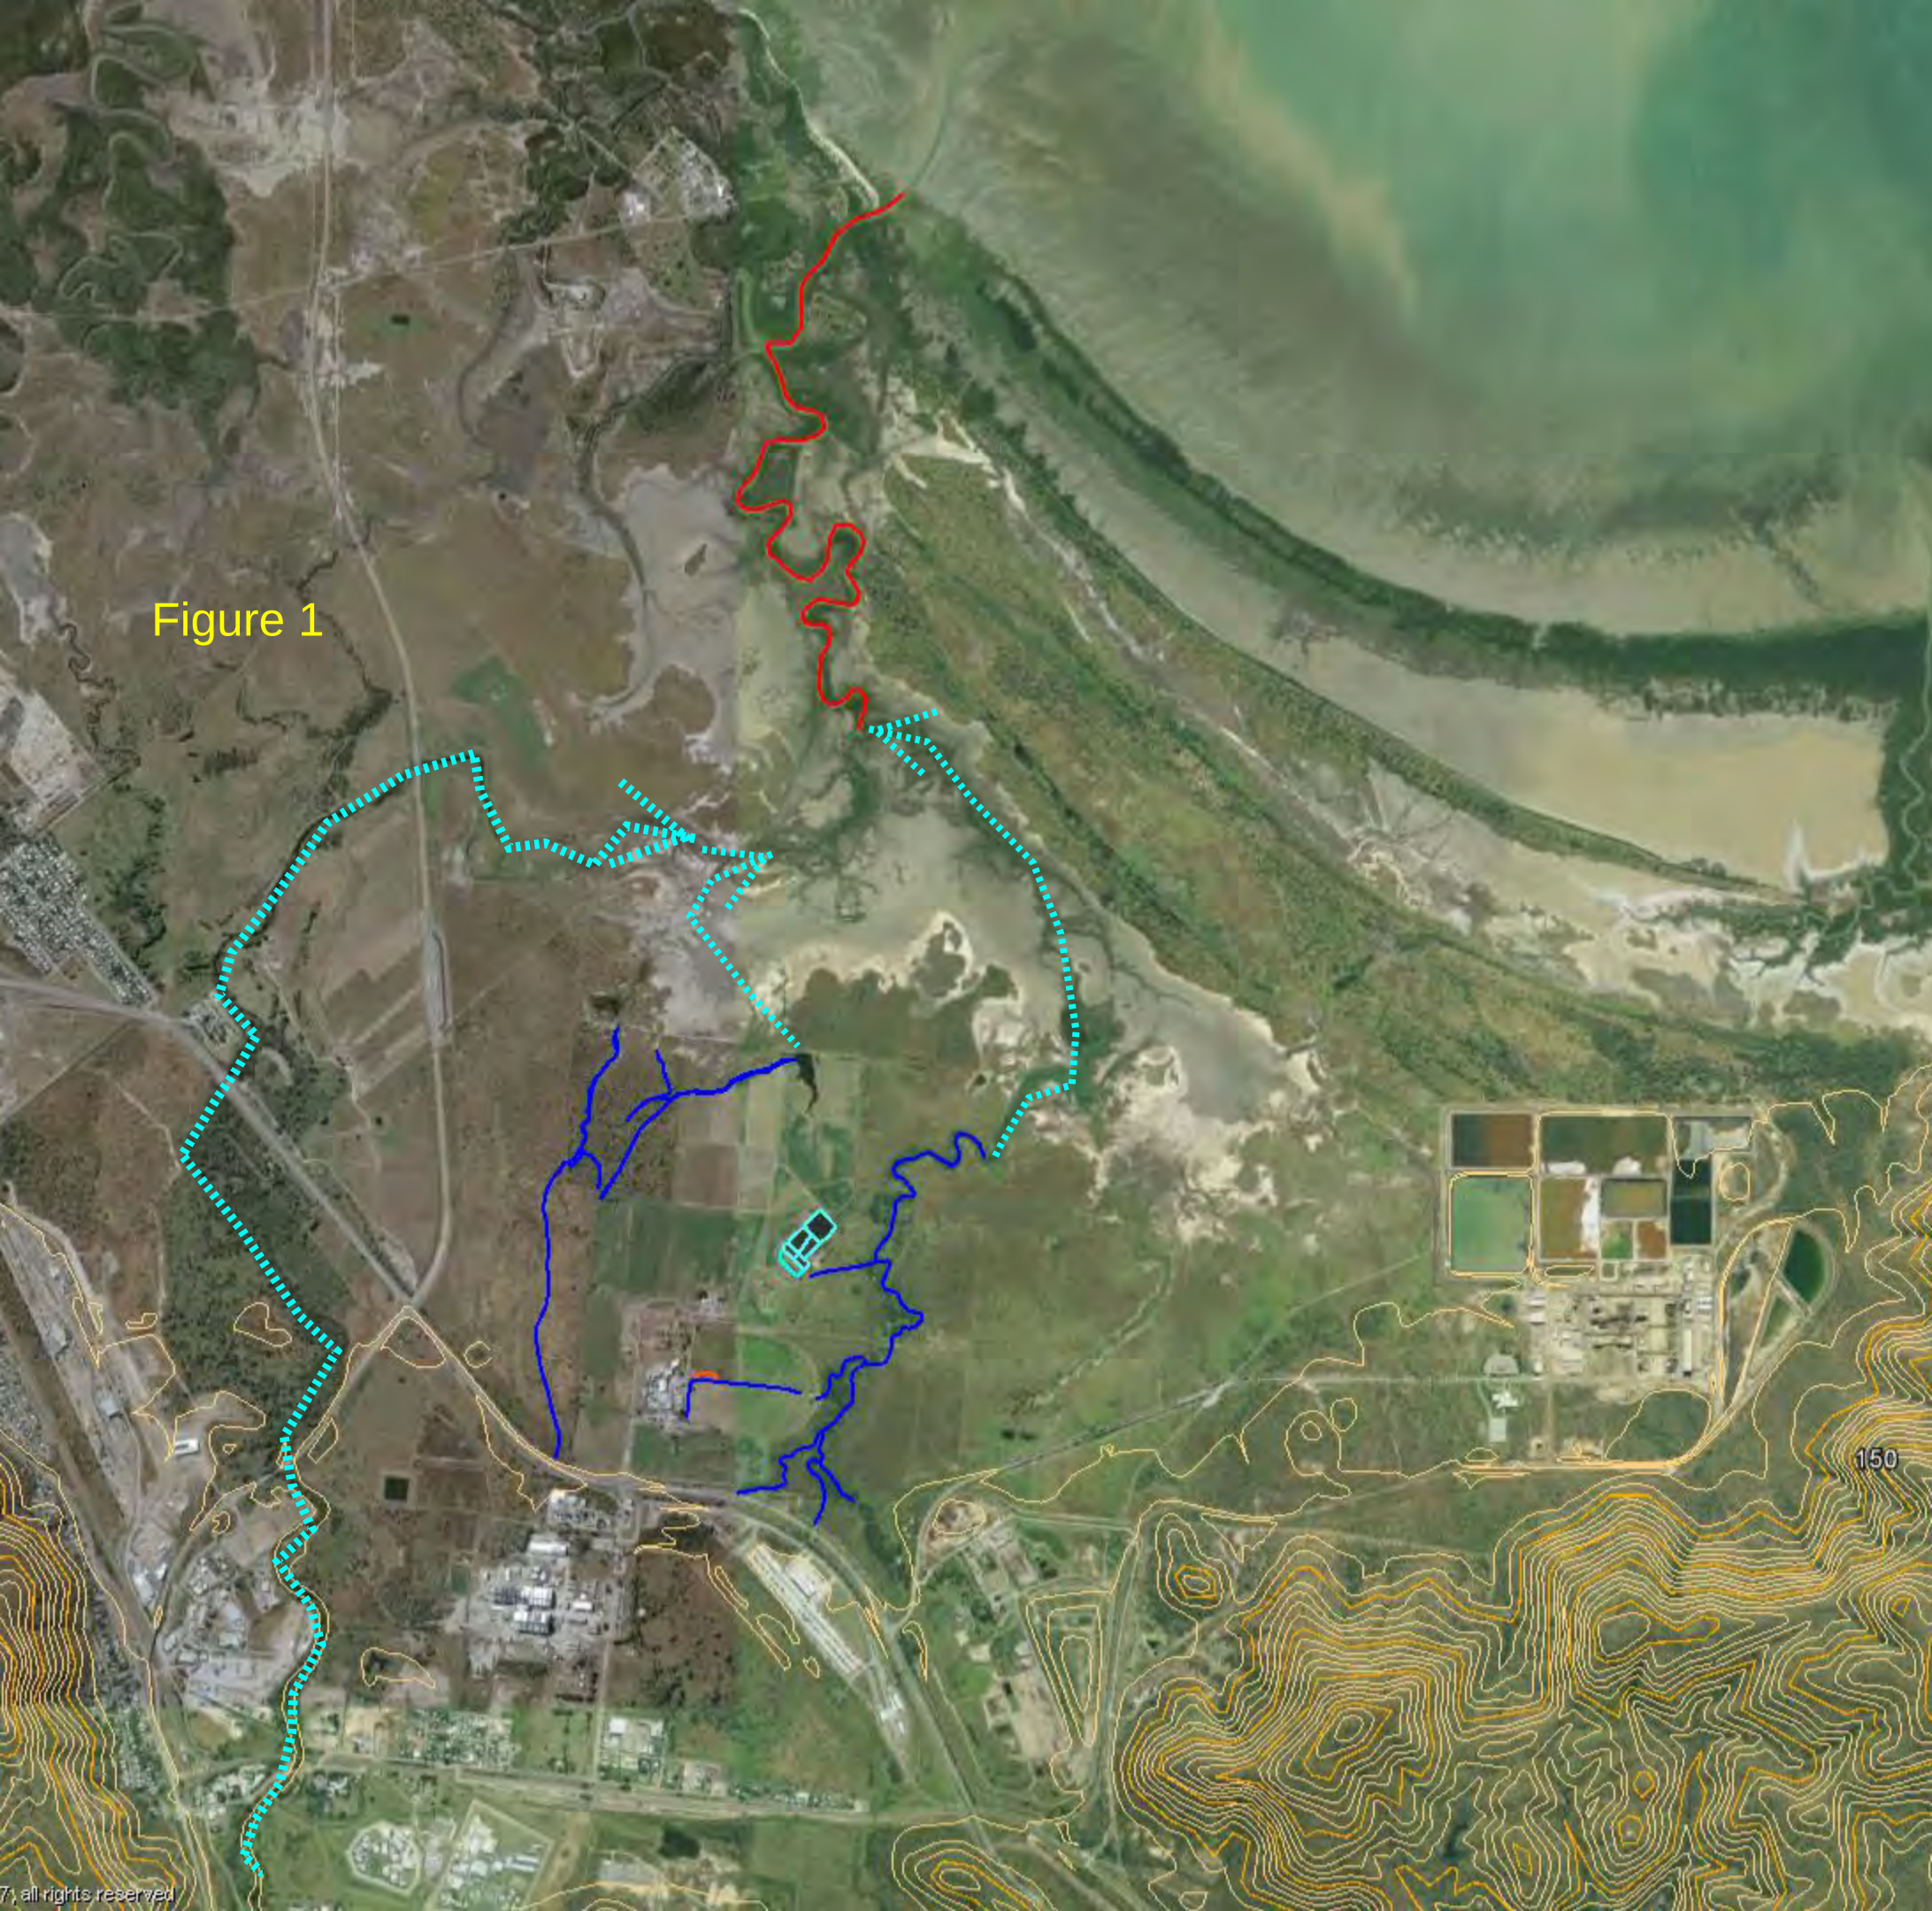
Figure 1 shows the regional catchment. Figures 2 and 3 shows the surfaces, shaded according to their flow path. The flow paths are:

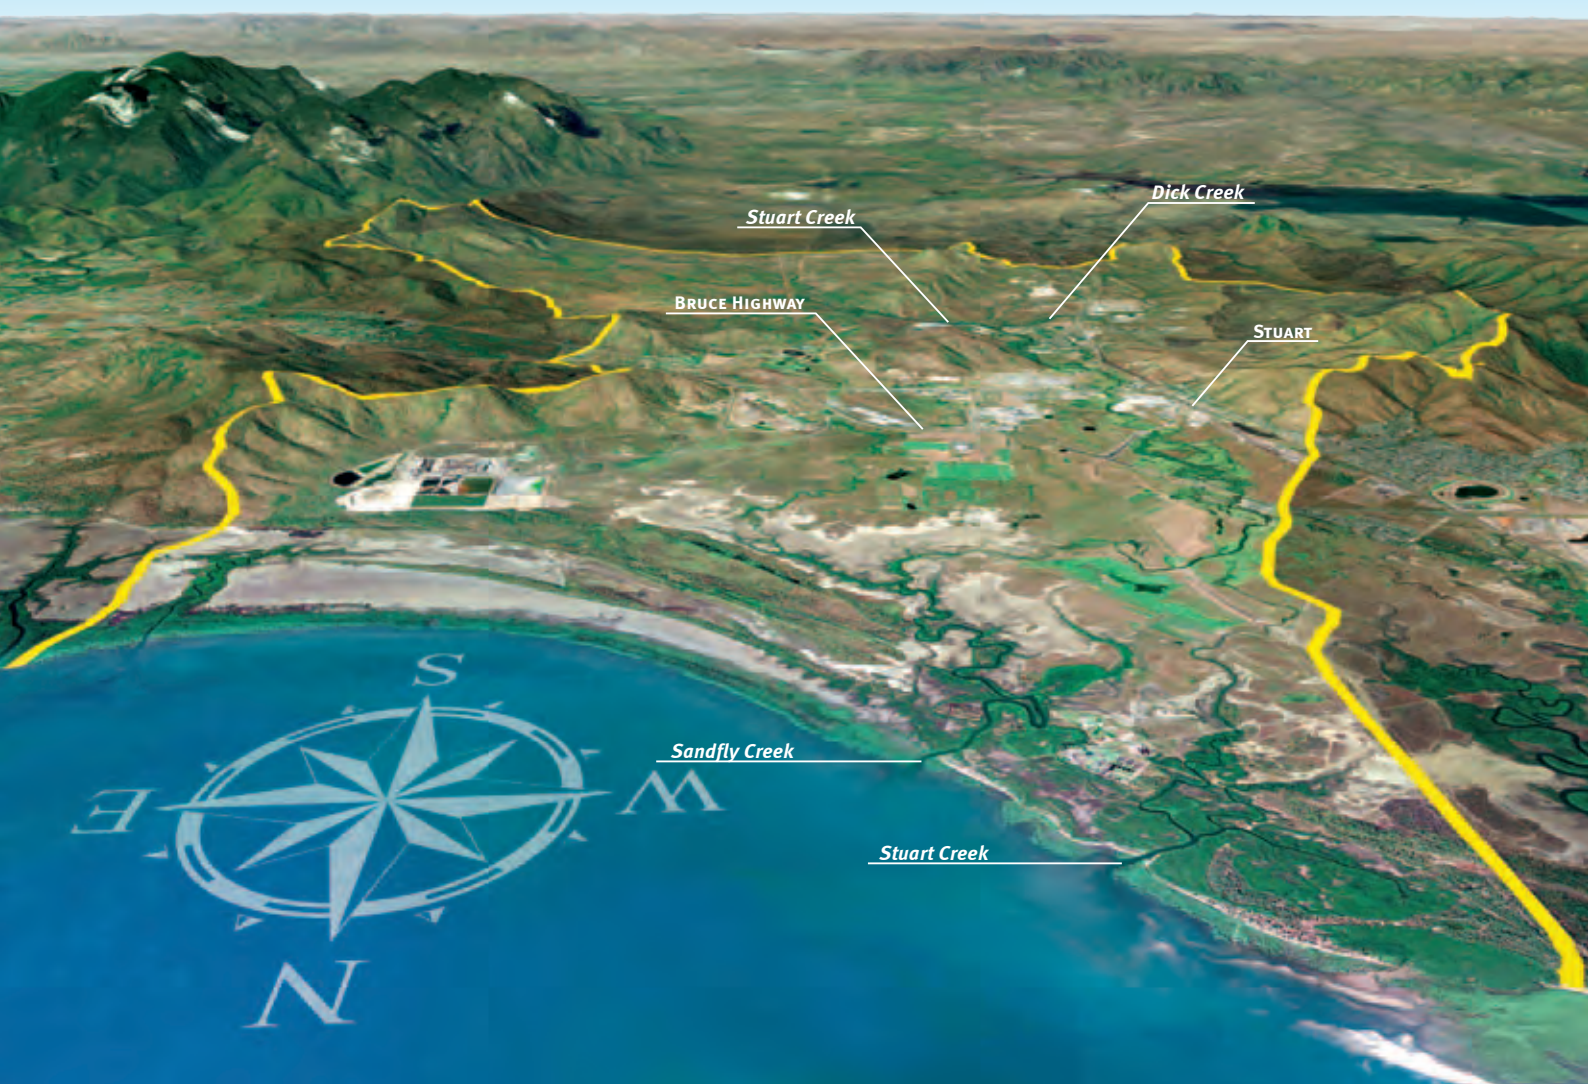
*The Stuart Creek Sub Basin includes the Stuart Creek and Sandfly Creek catchments. There are also a number of smaller waterways that have been included in the catchments of these larger creeks.*
