Orica Australia Pty Ltd

Detailed Site Investigation

Yarwun Manufacturing Facility  
30 Reid Road, Yarwun, QLD

52877 109702 R001 Rev 0

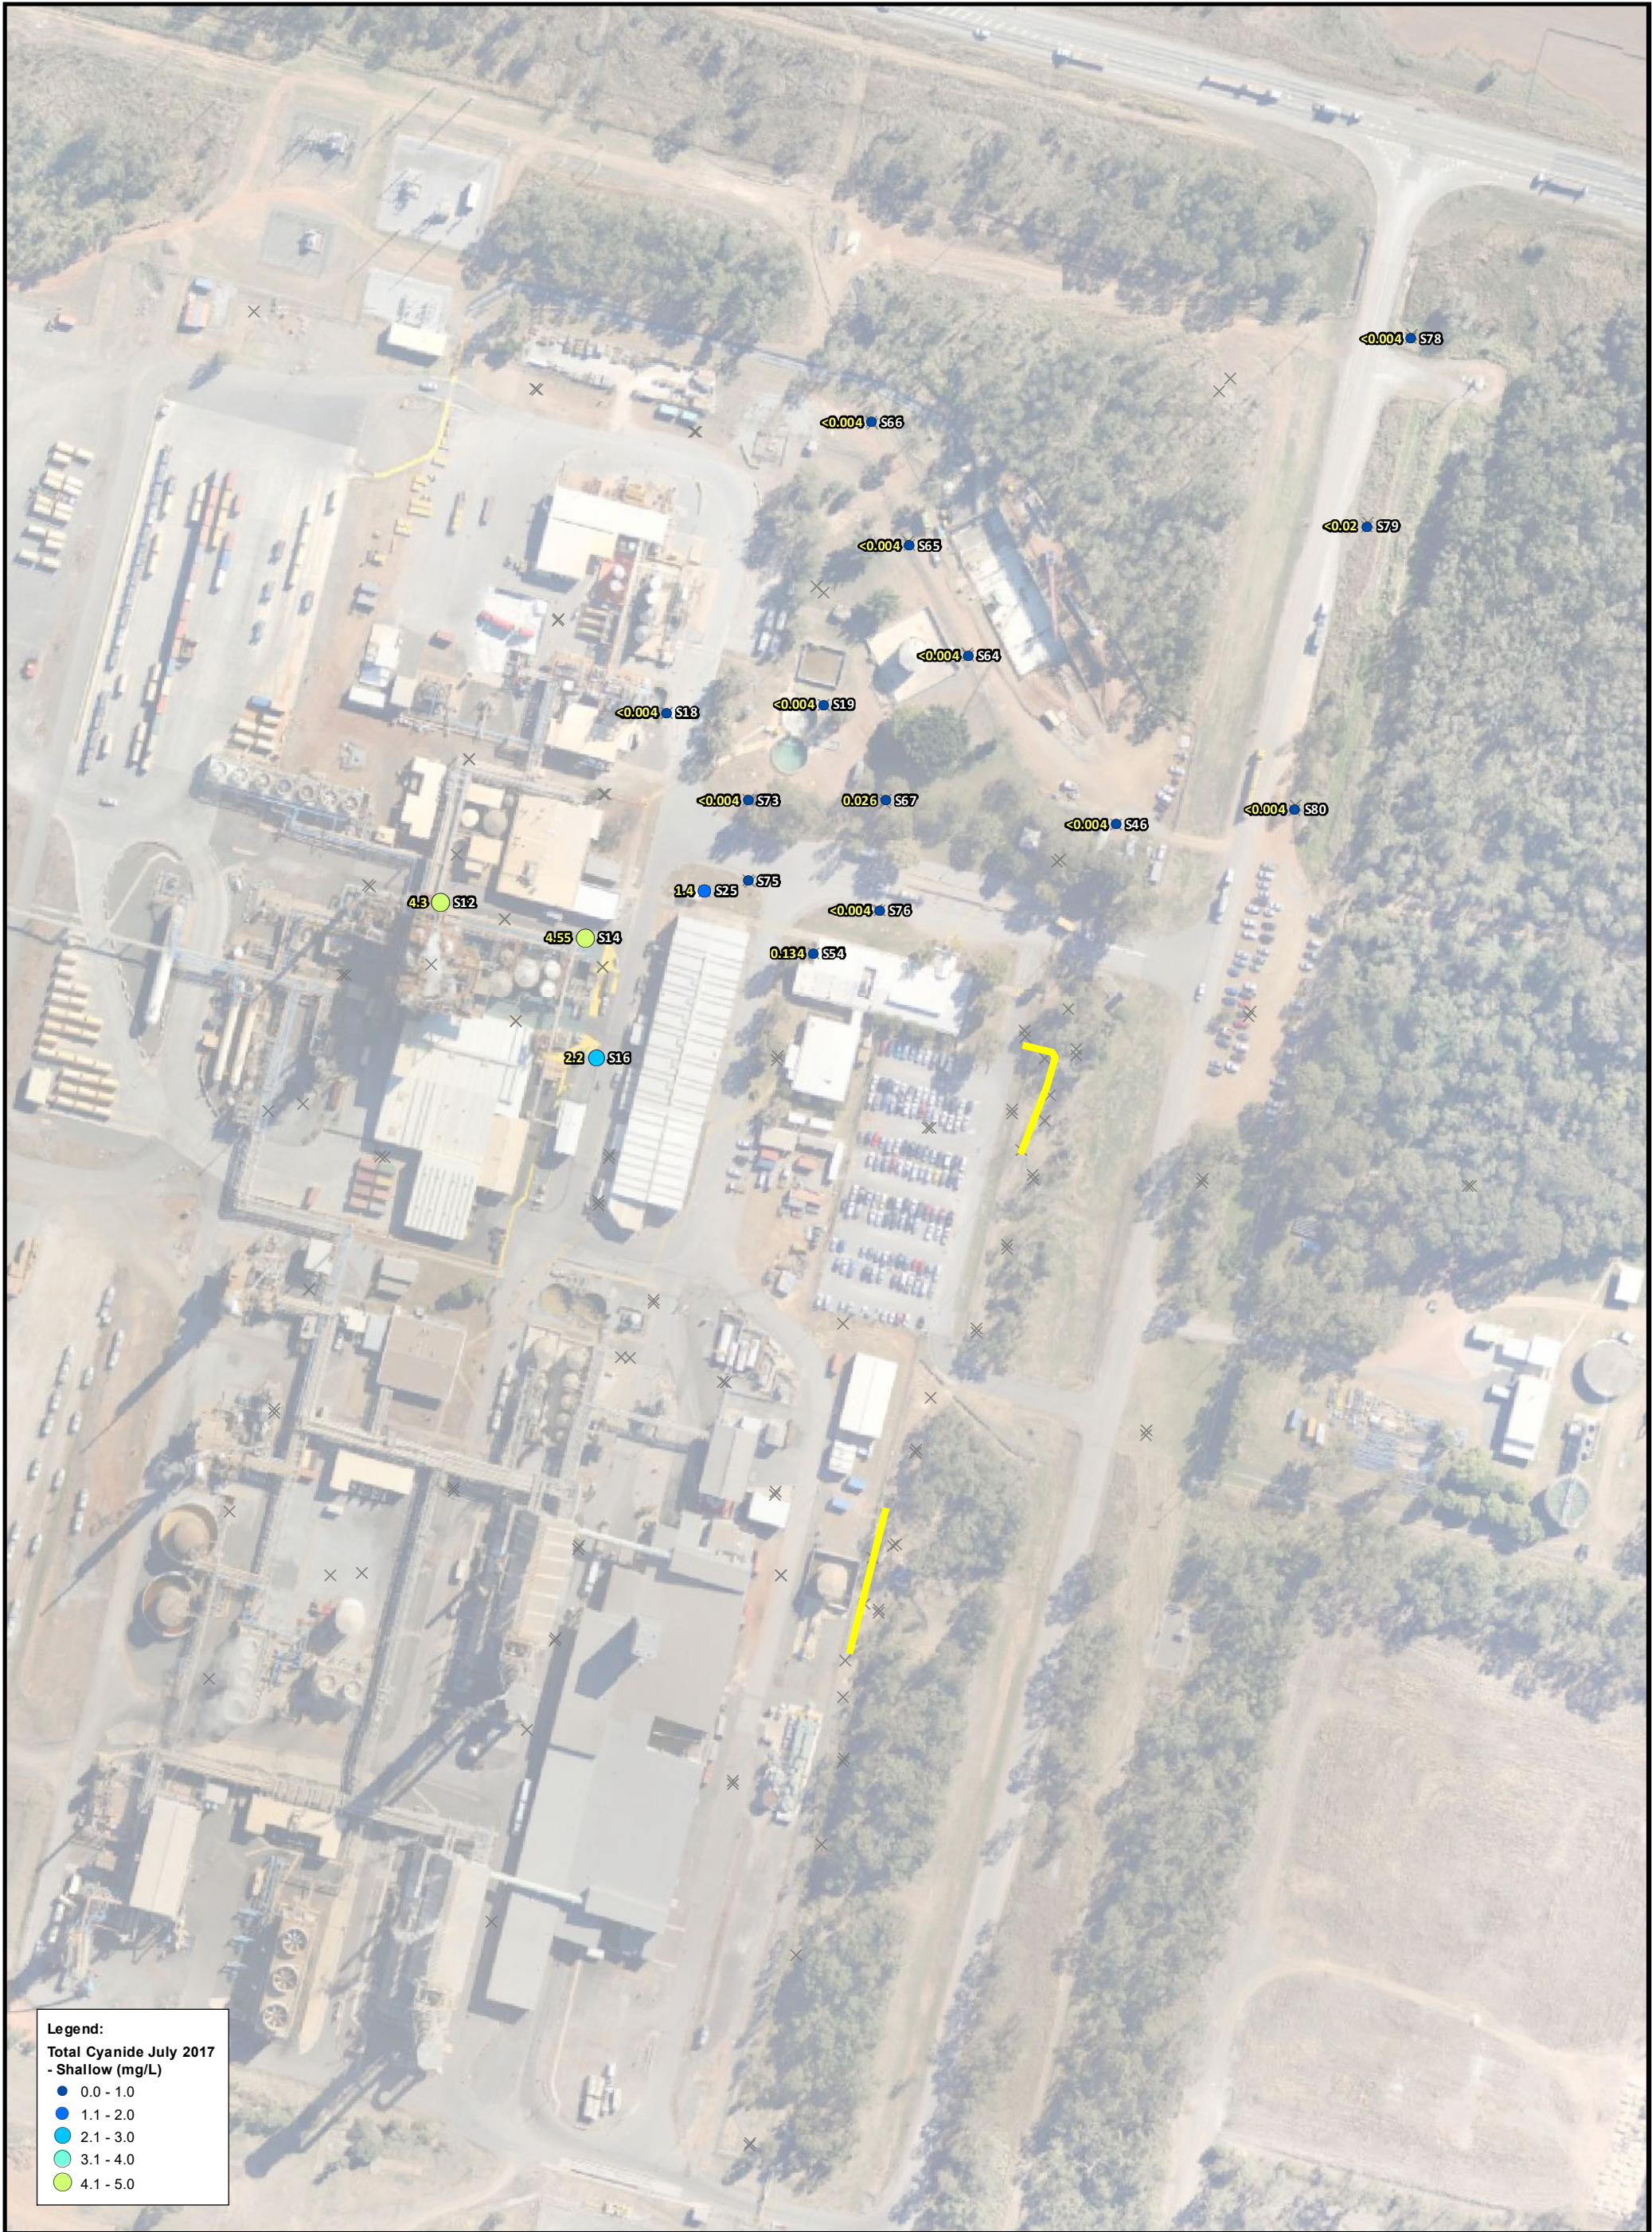
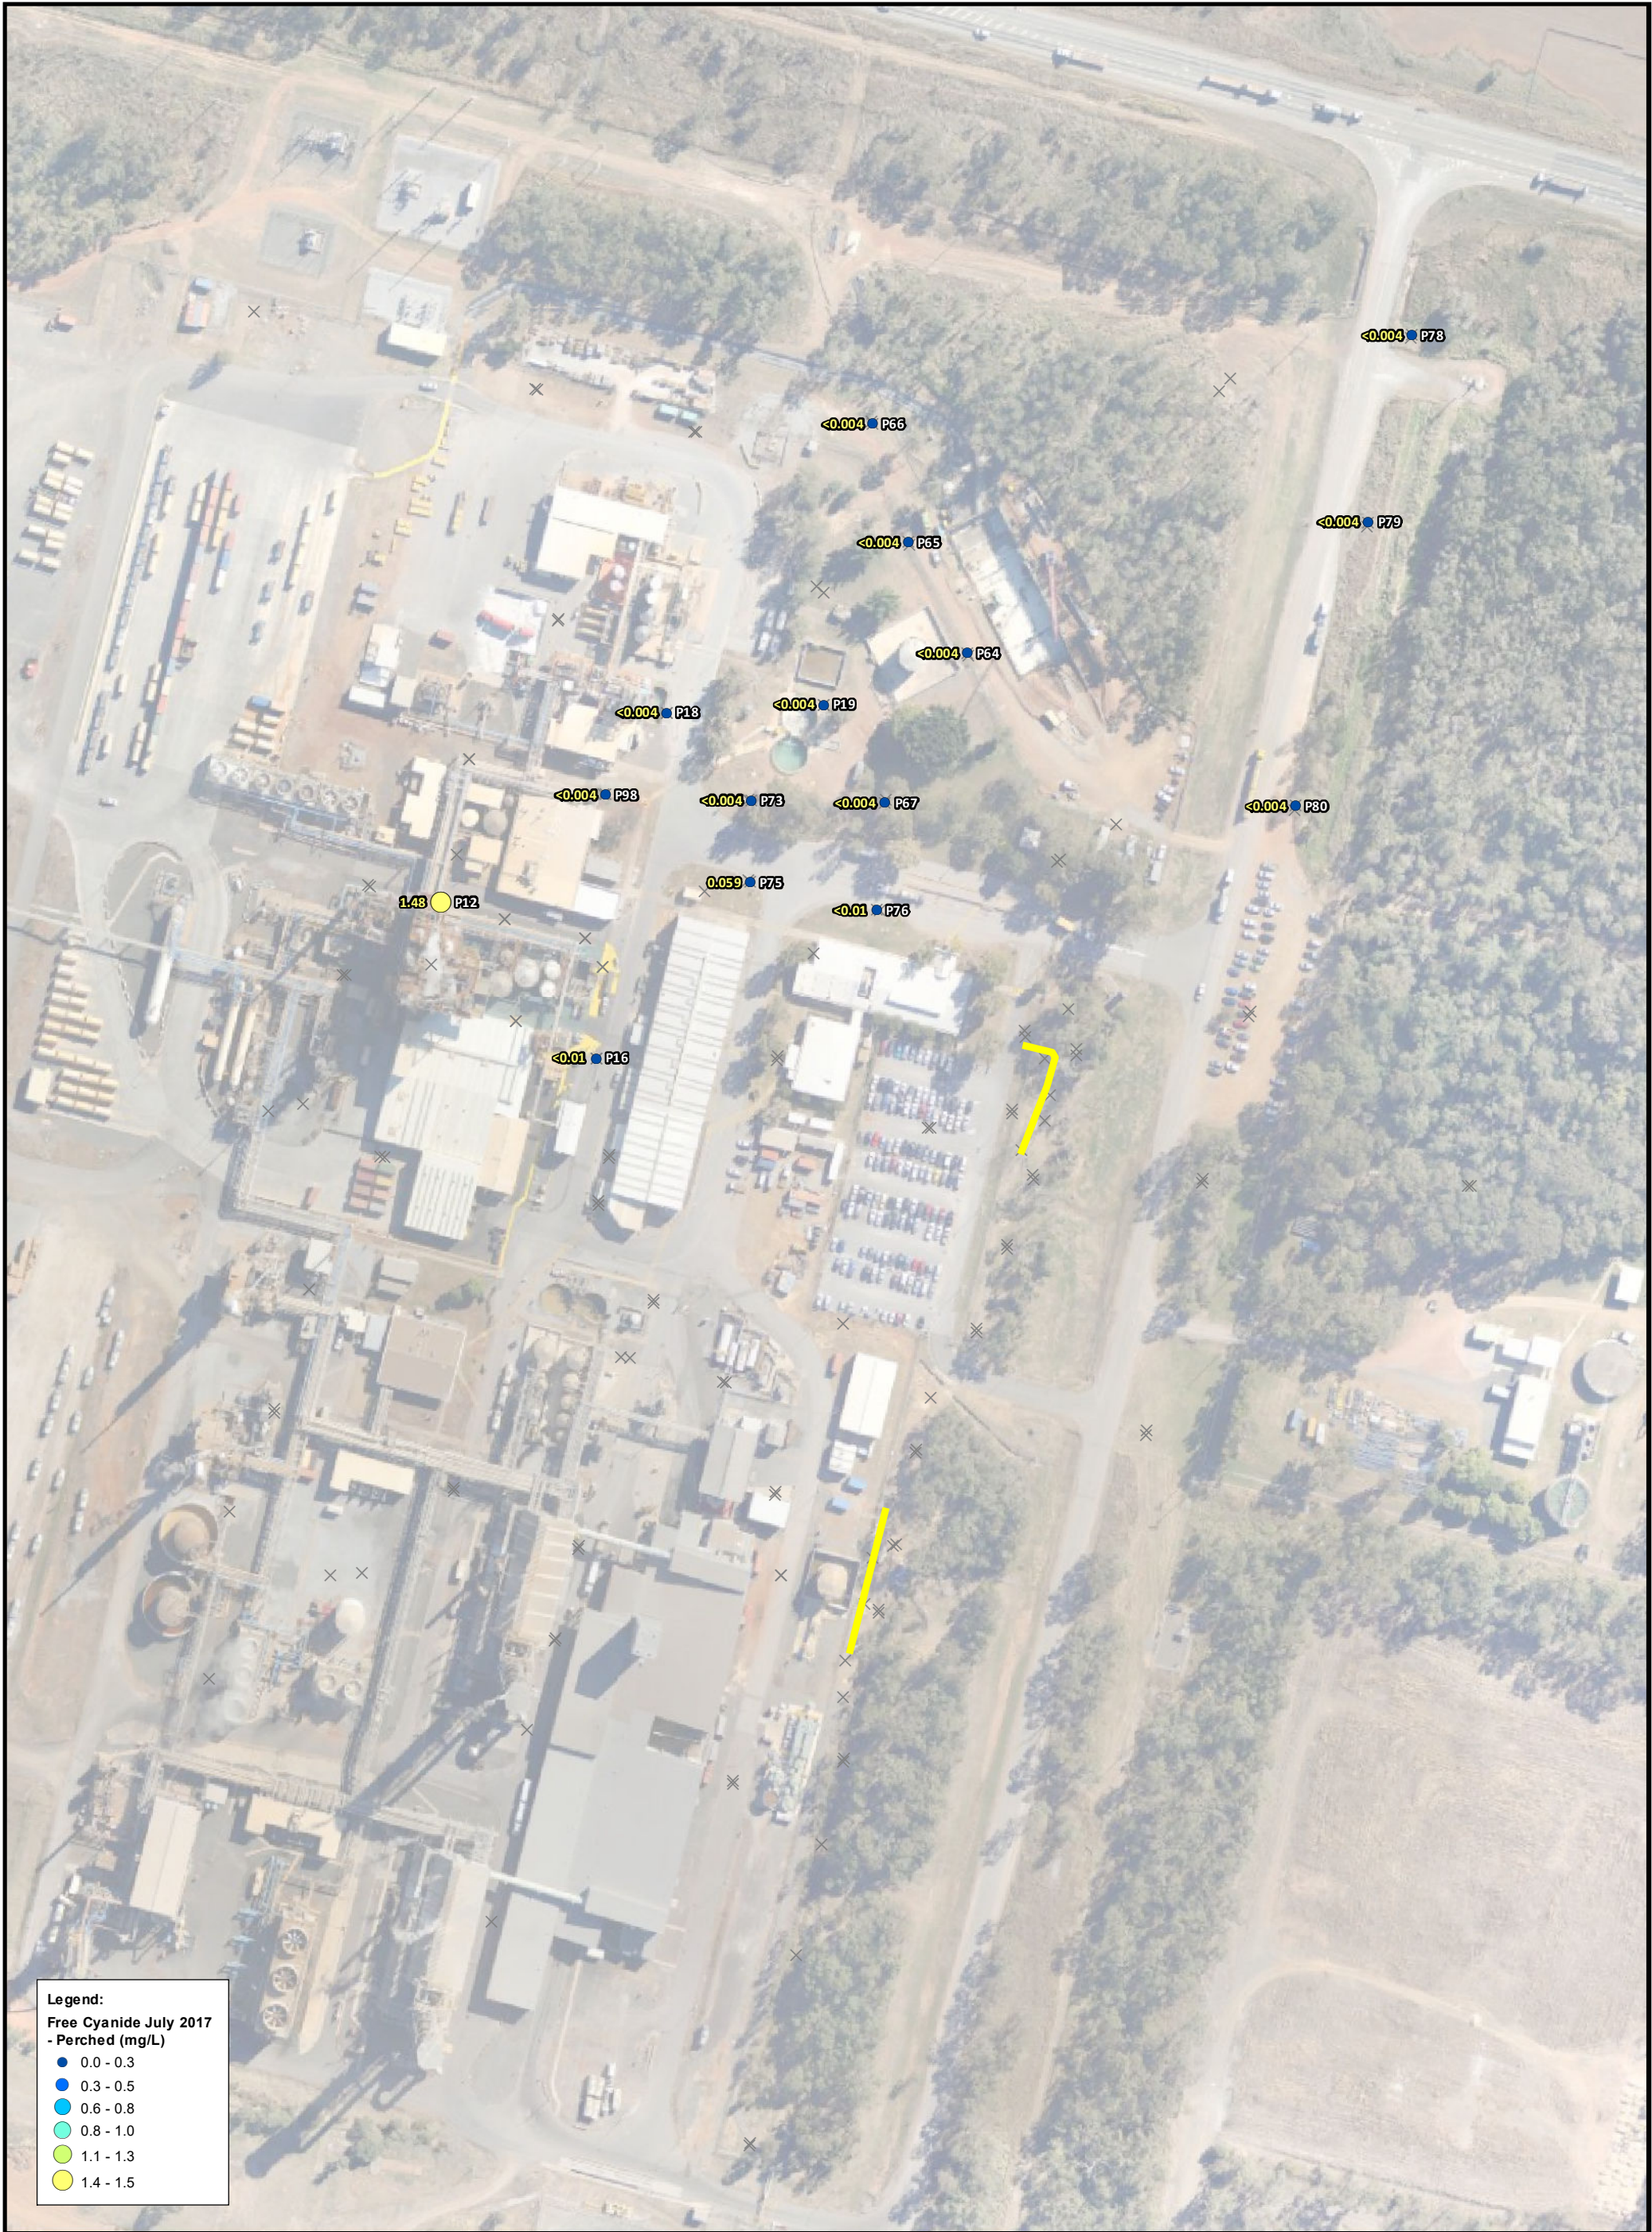
The following sections provide a discussion of the most recent groundwater monitoring results as these results are considered to best approximate contamination conditions at the time of this report. Historical results are assessed on an annual basis as part of the annual groundwater monitoring reports. Groundwater monitoring analytical data for July 2017 is shown in **Figures 5-7**.
