Orica Australia Pty Ltd

Conceptual Site Model

Yarwun Manufacturing Facility  
30 Reid Road, Yarwun, QLD

52877 110916 R002 Rev 0

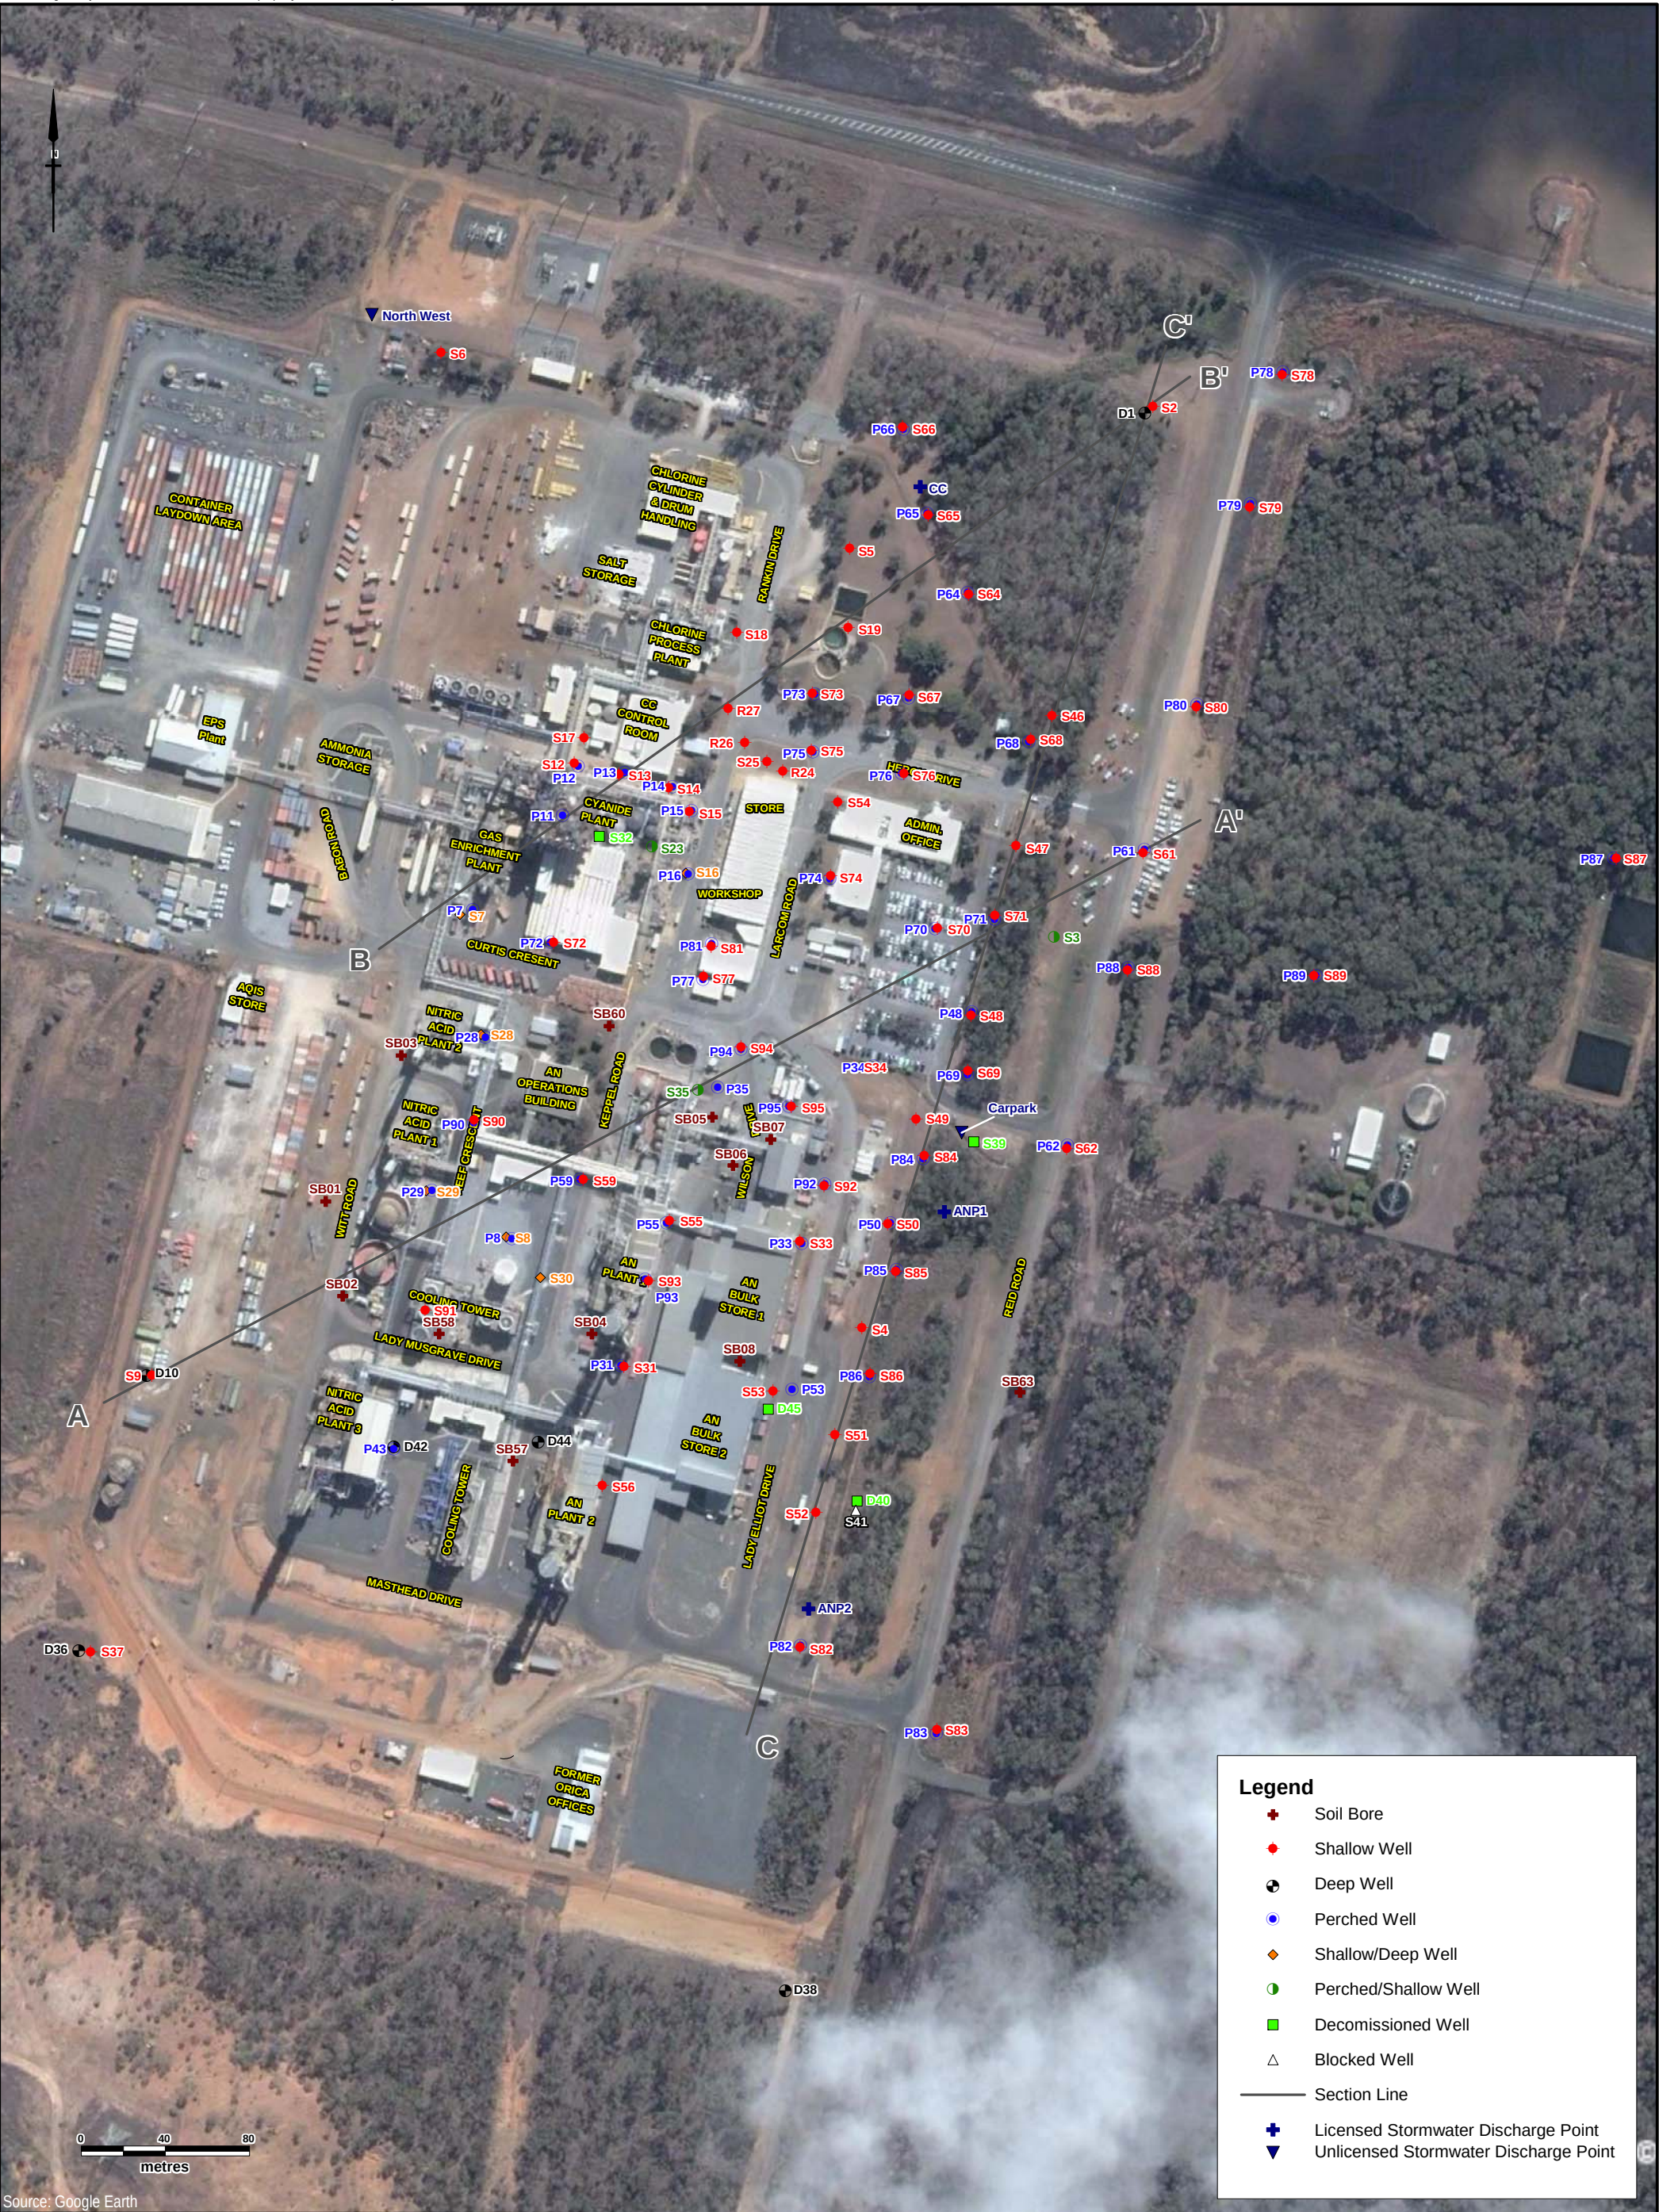
| Client<br><br>ORICA AUSTRALIA PTY LTD | Project<br><br>STAGE 3 SOIL AND GROUNDWATER INVESTIGATION<br>YARWUN PRODUCTION FACILITY, GLADSTONE QUEENSLAND | | | Title<br><br>SITE LAYOUT, BOREHOLE AND GROUNDWATER<br>MONITORING WELL LOCATIONS | |

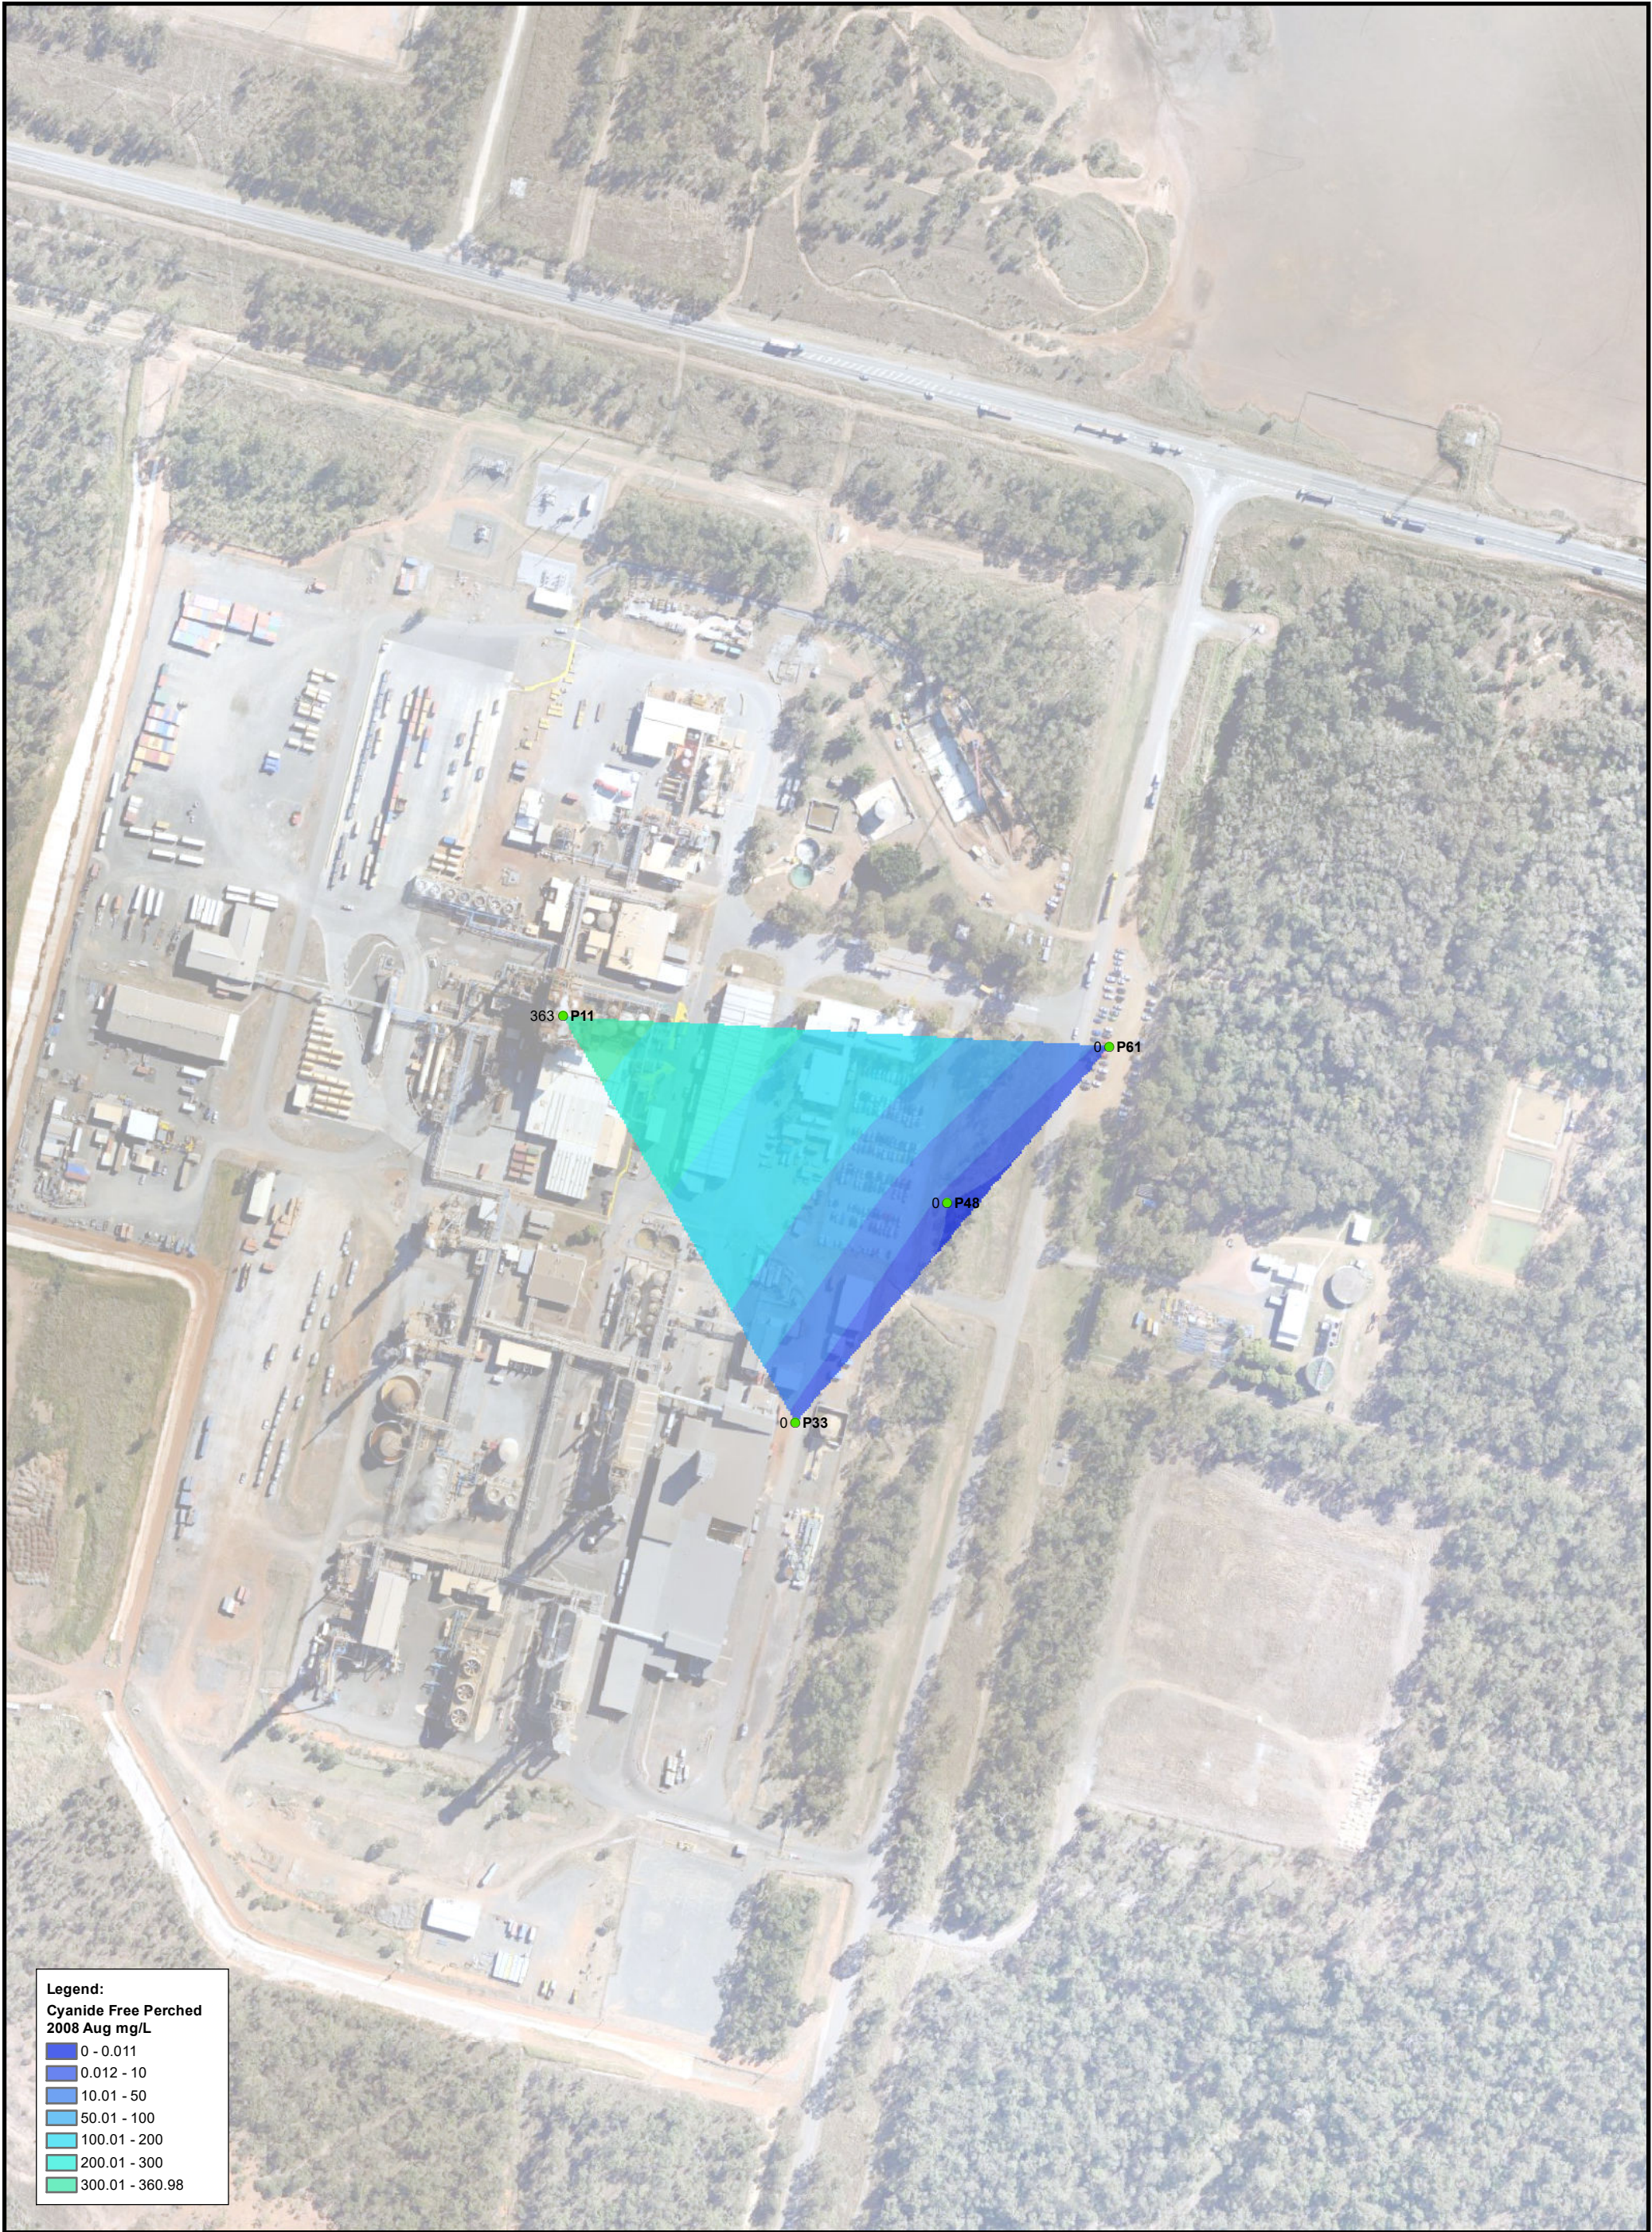
Client: Orica Australia Pty Ltd  
Project: 30 Reid Road, Yarwun, QLD (Lot 138 on CTN2123)  
Job No: 52877 File Name: 52877\_nn\_CNFreePd\_2008Aug

**Legend:**  
**Cyanide Free Perched**  
**2008 Aug mg/L**

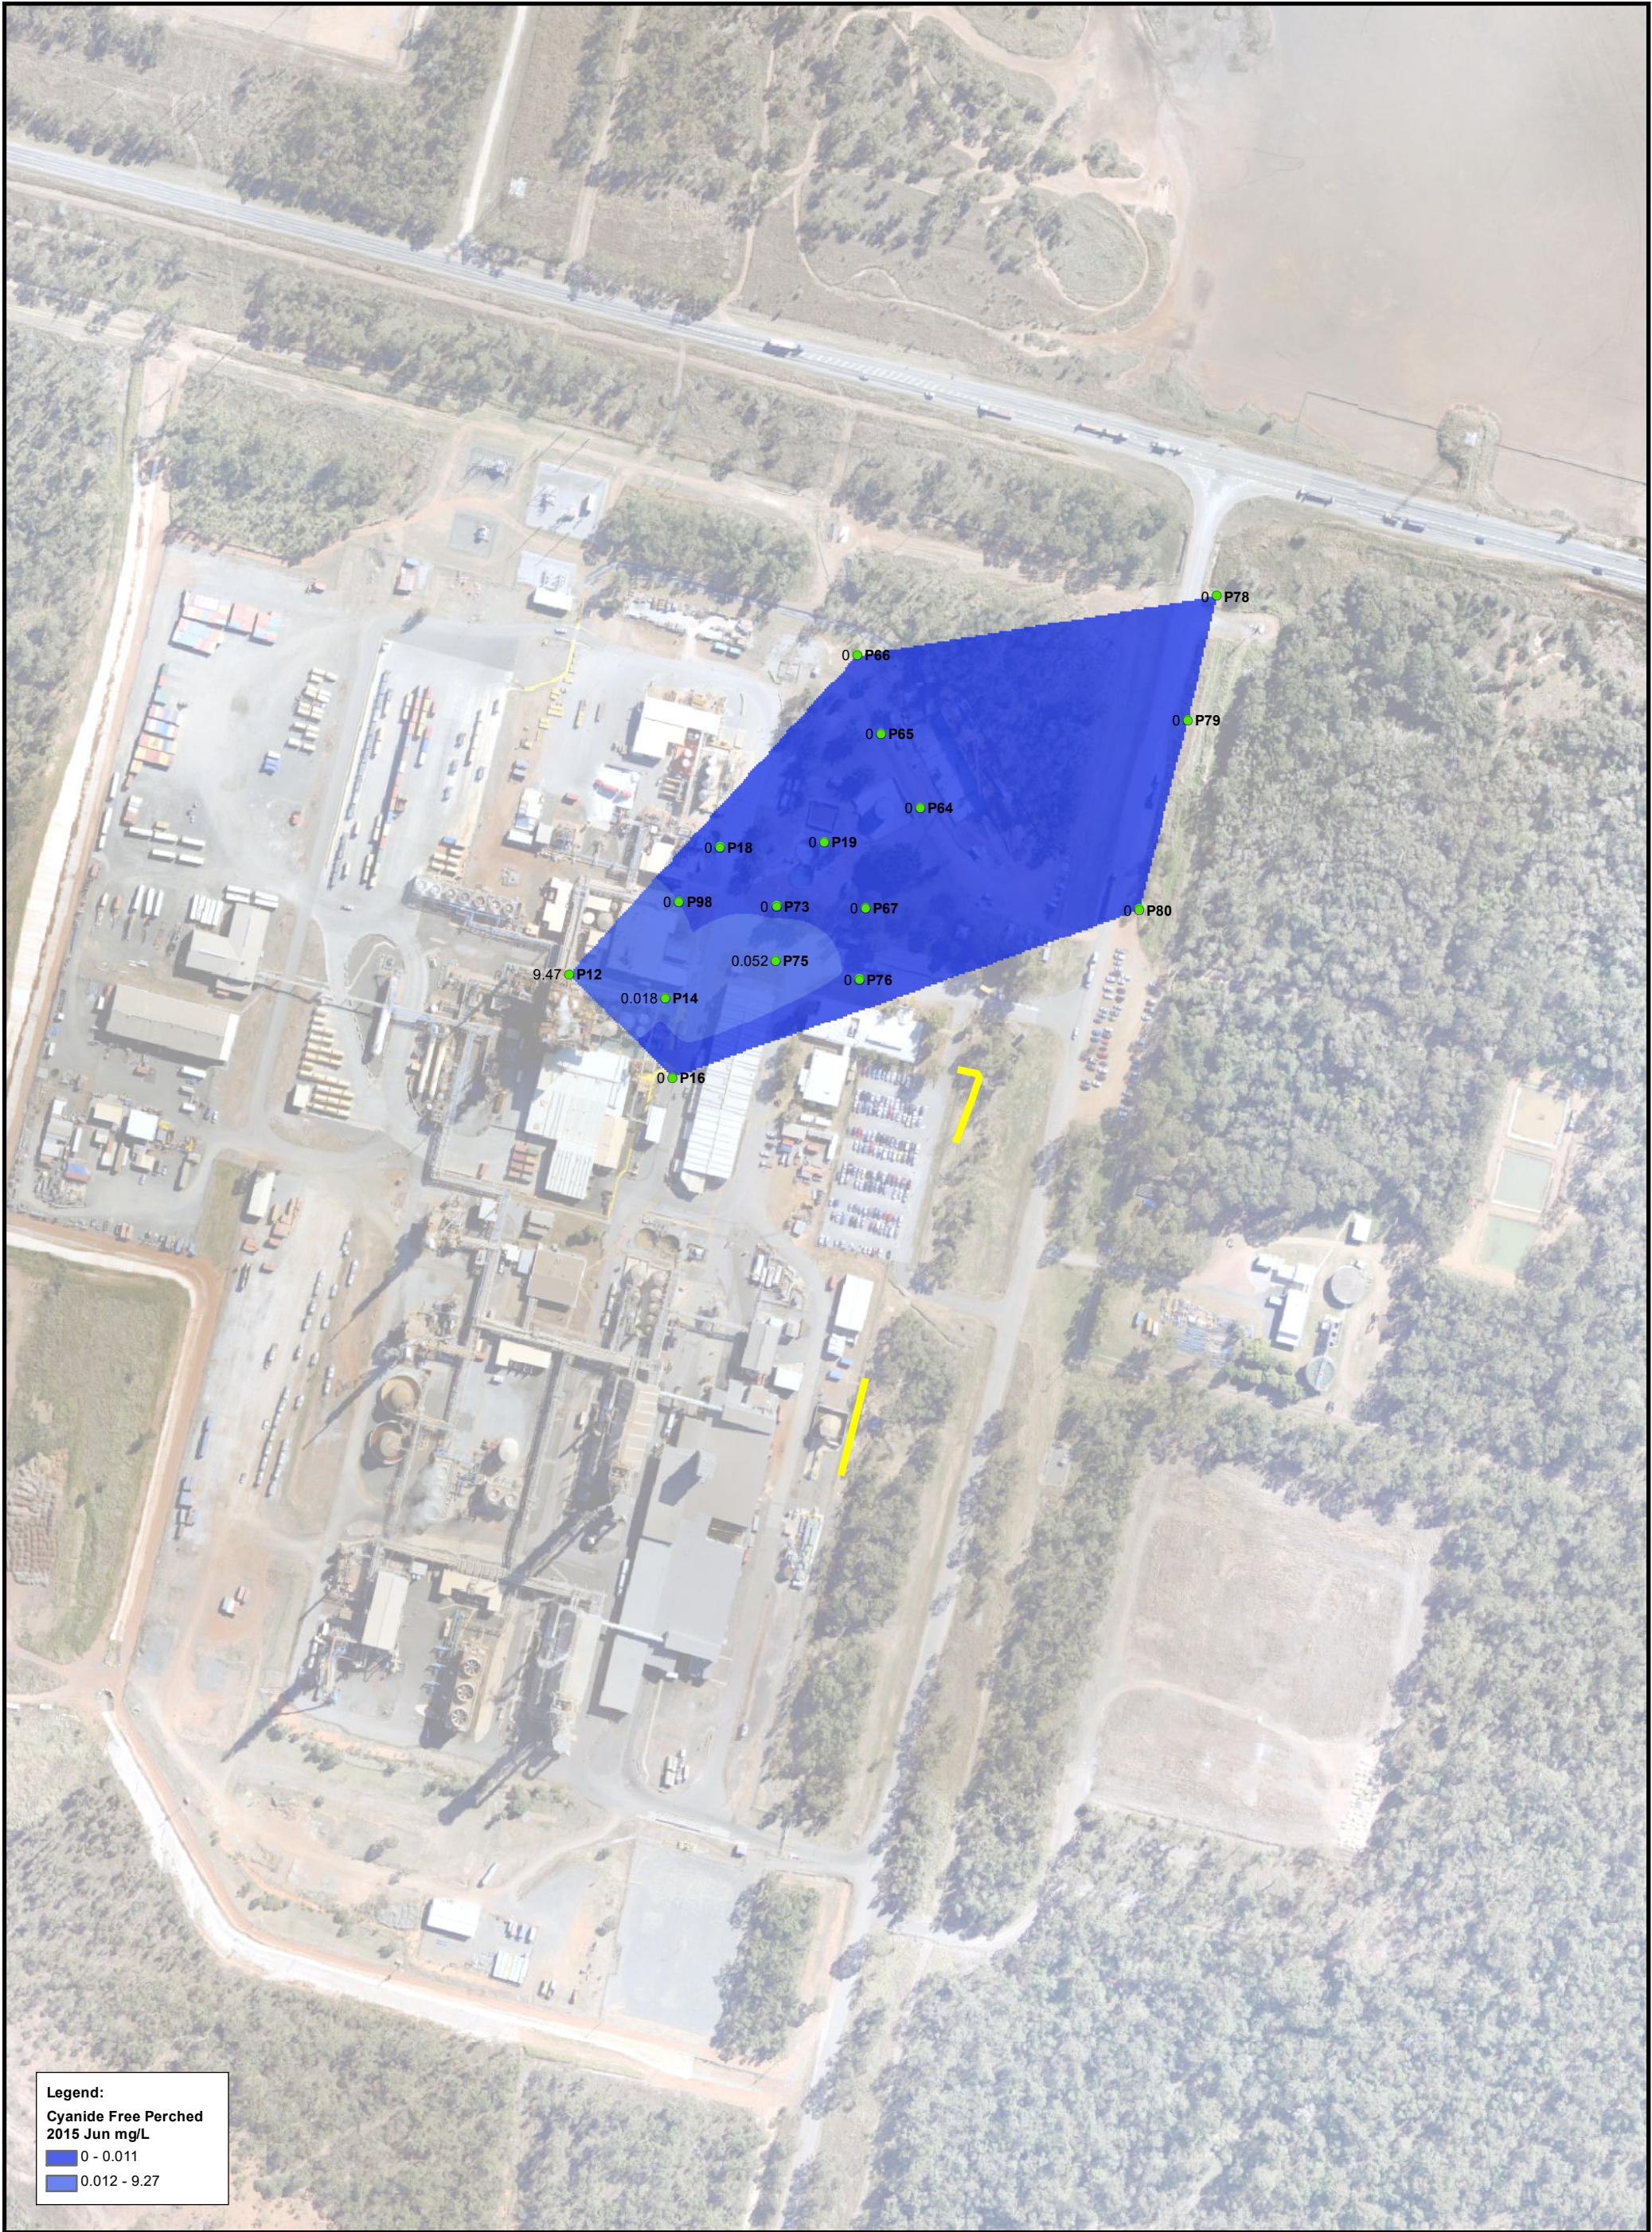
Legend:  
Cyanide Free Perched  
2015 Jun mg/L  
0 - 0.011  
0.012 - 9.27

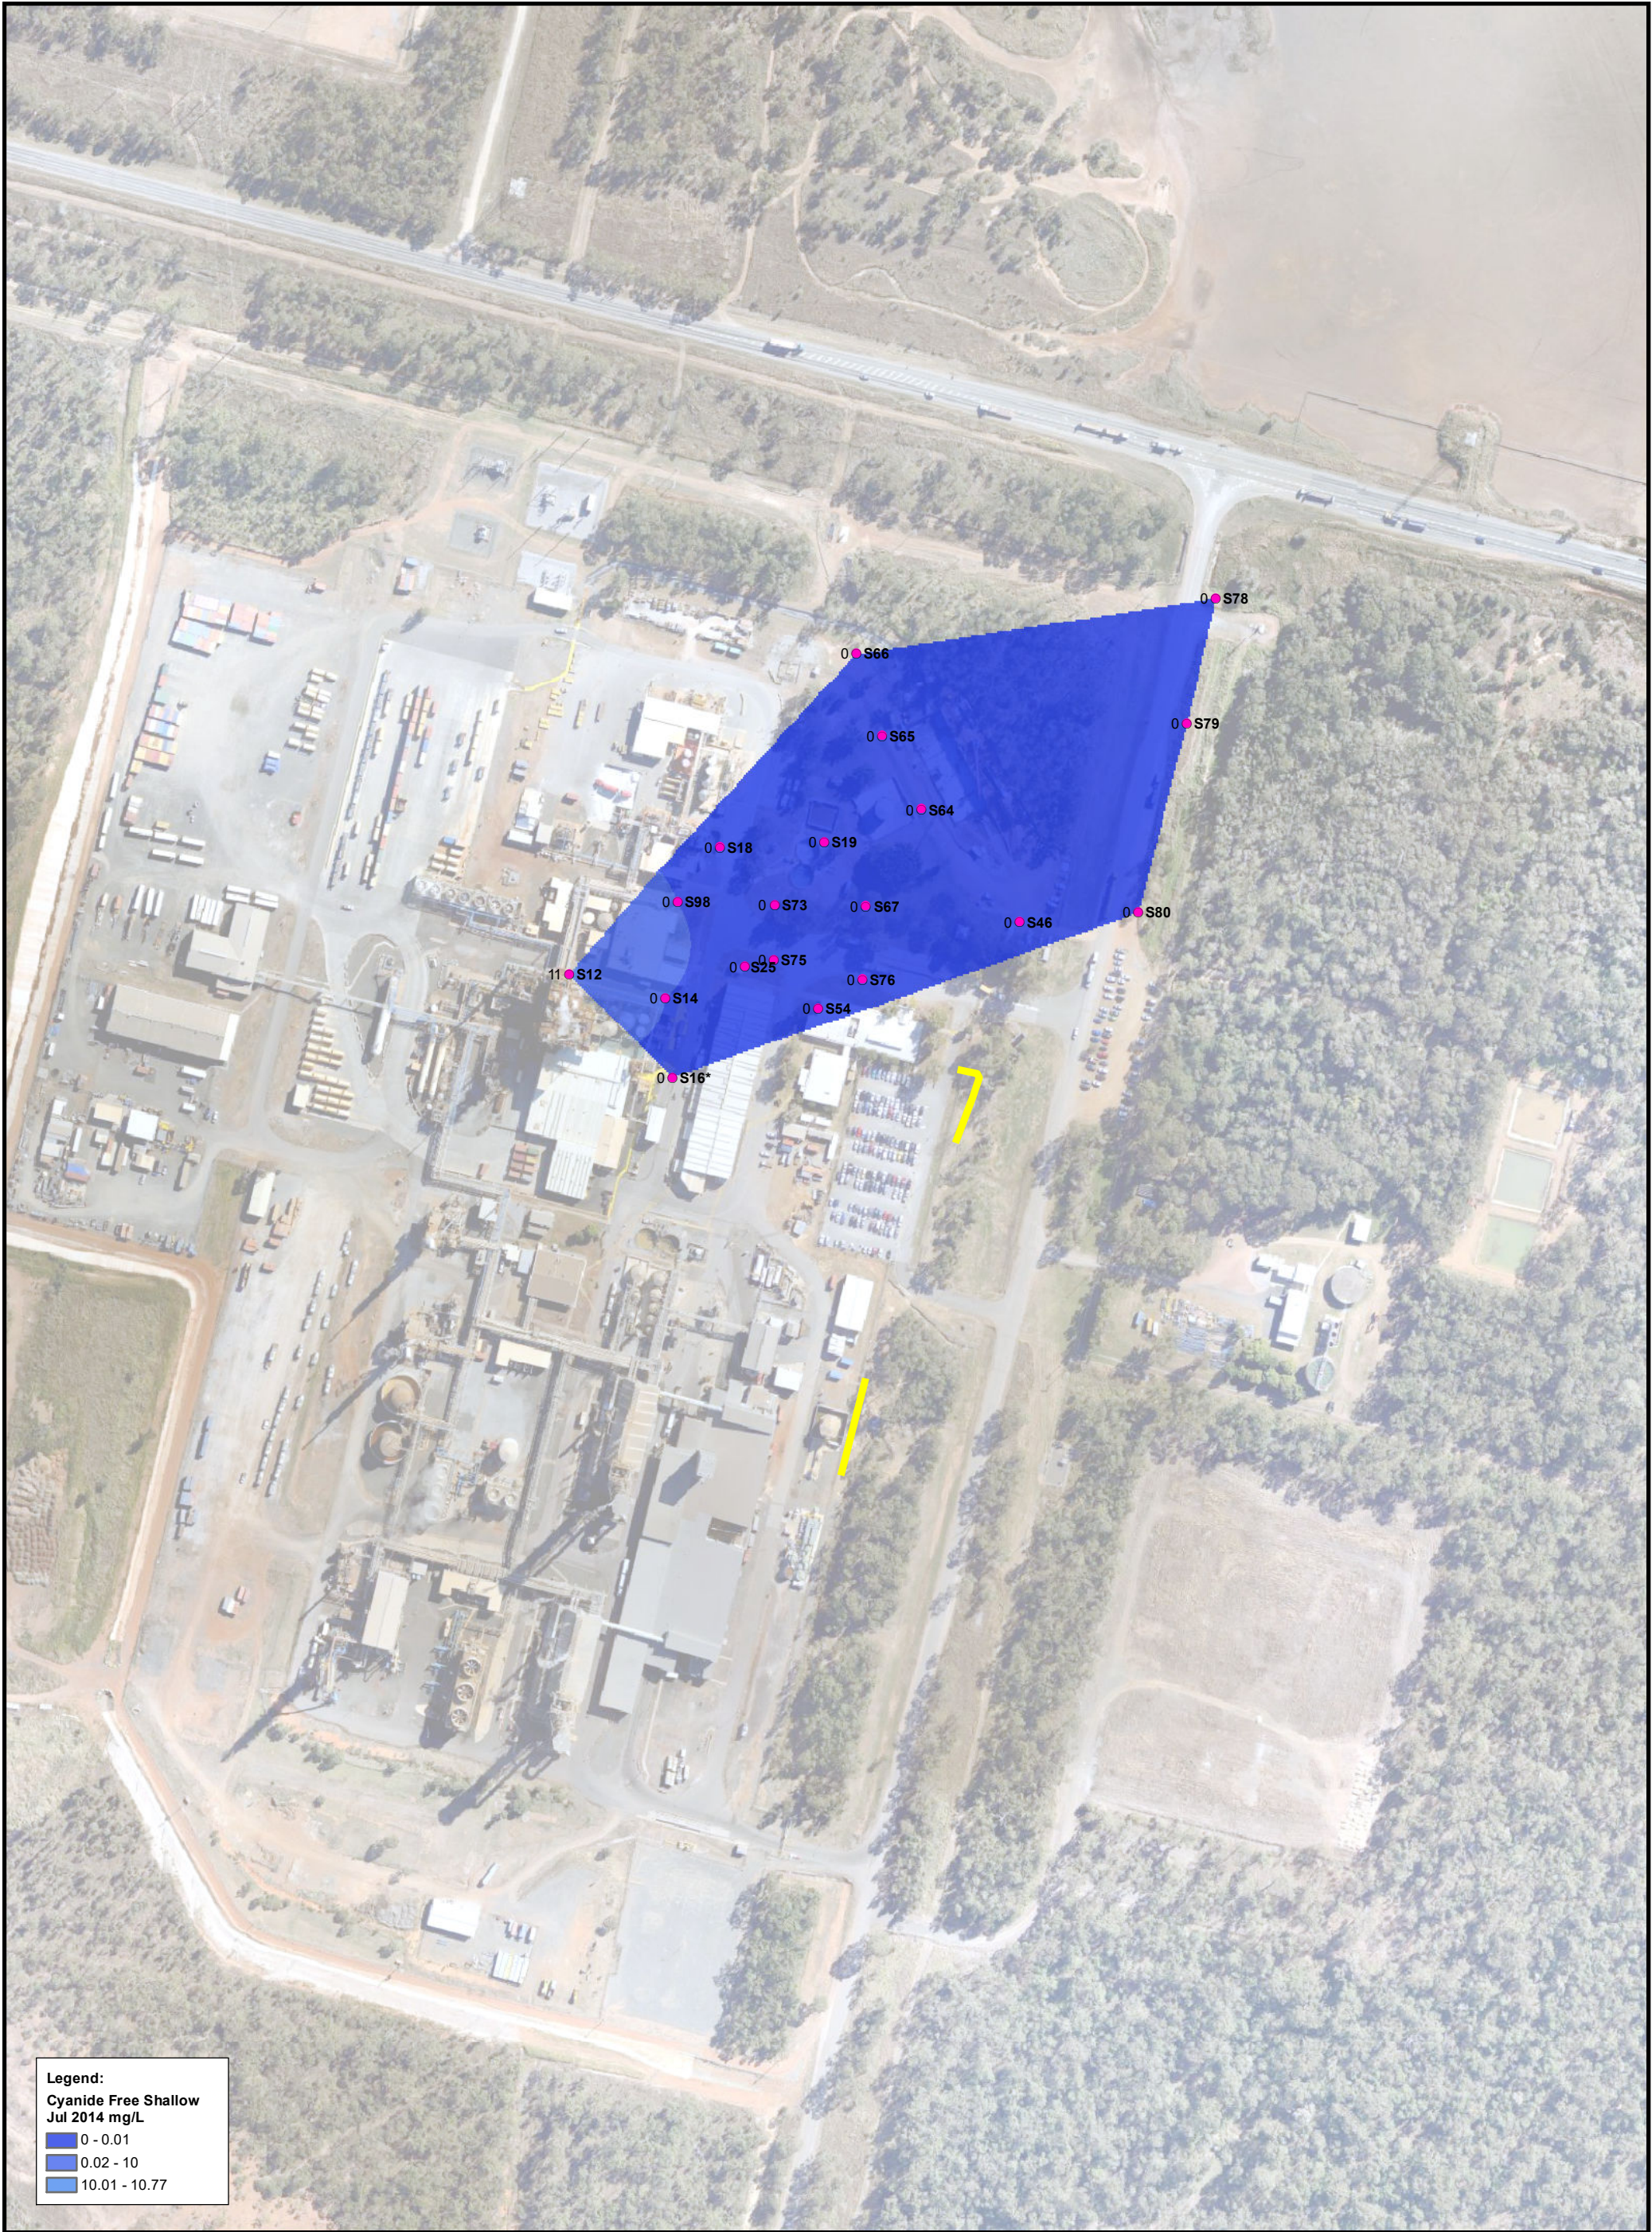
Client: Orica Australia Pty Ltd  
Project: 30 Reid Road, Yarwun, QLD (Lot 138 on CTN2123)  
Job No: 52877 File Name: 52877\_nn\_CNFreeSh\_2014Jul

Legend:  
Cyanide Free Shallow  
Jul 2014 mg/L  
0 - 0.01  
0.02 - 10  
10.01 - 10.77

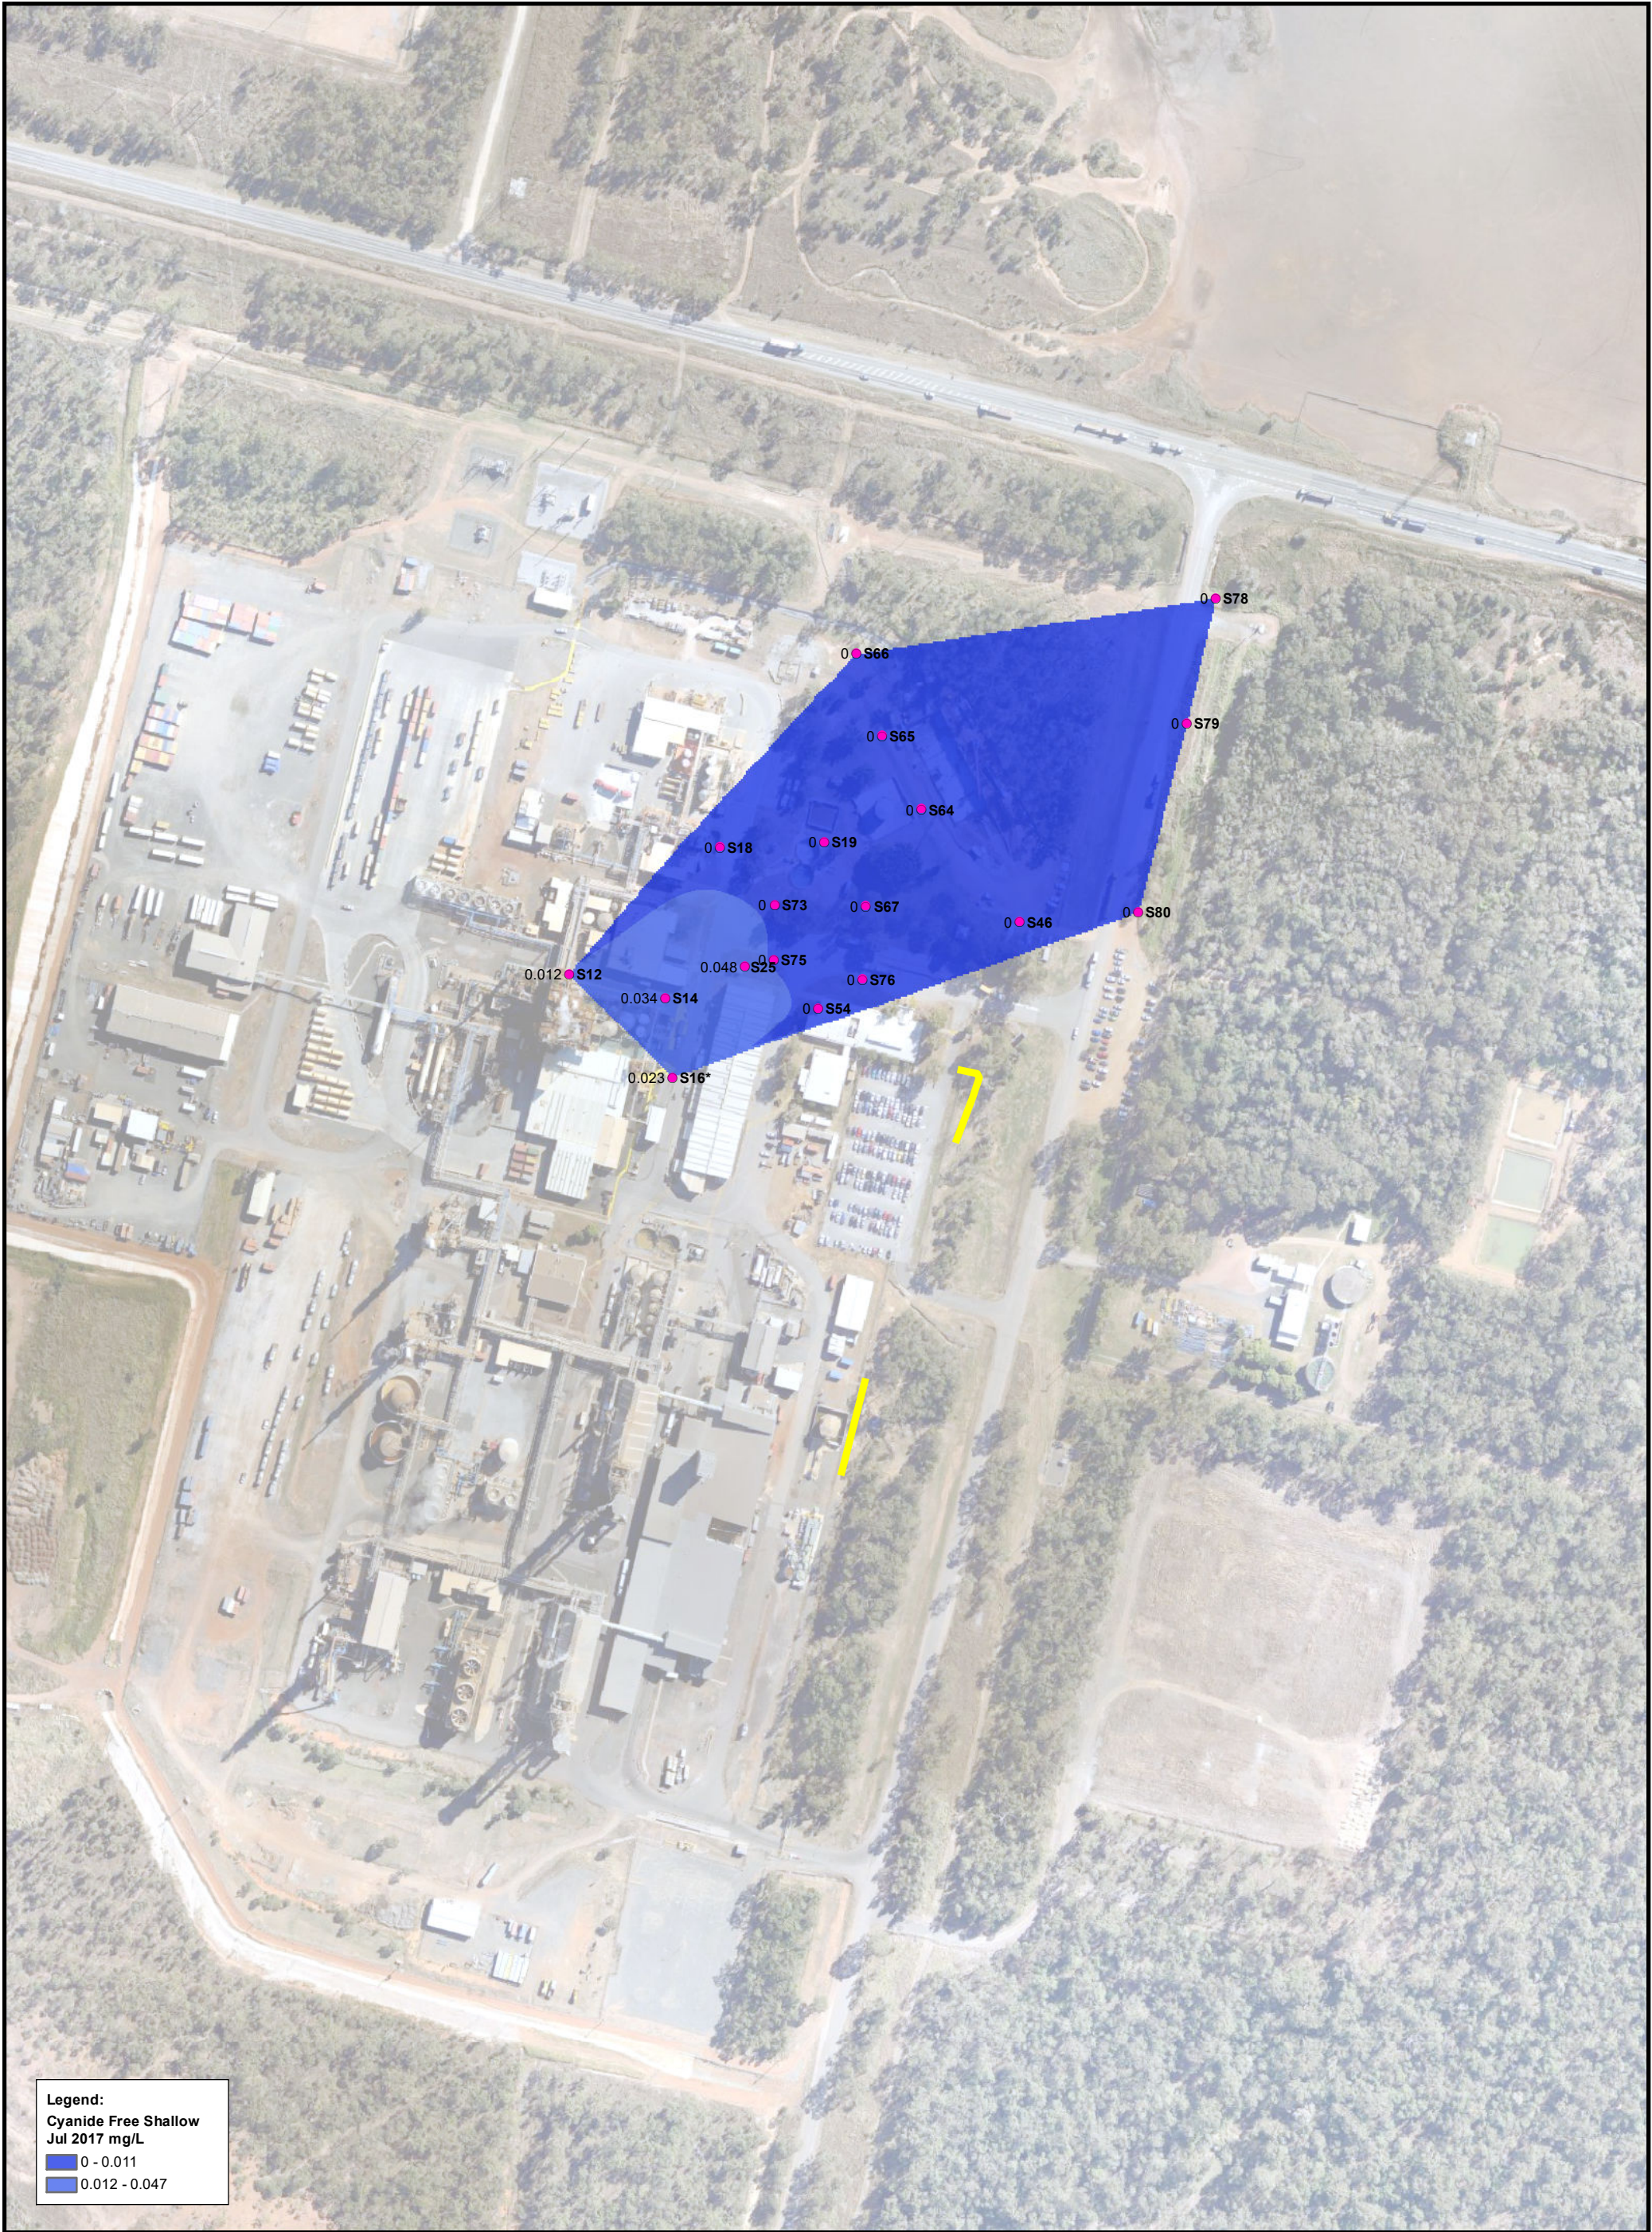
Client: Orica Australia Pty Ltd  
Project: 30 Reid Road, Yarwun, QLD (Lot 138 on CTN2123)  
Job No: 52877 File Name: 52877\_nn\_CNFreeSh\_2017Jul

Legend:  
Cyanide Free Shallow  
Jul 2017 mg/L  
0 - 0.011  
0.012 - 0.047

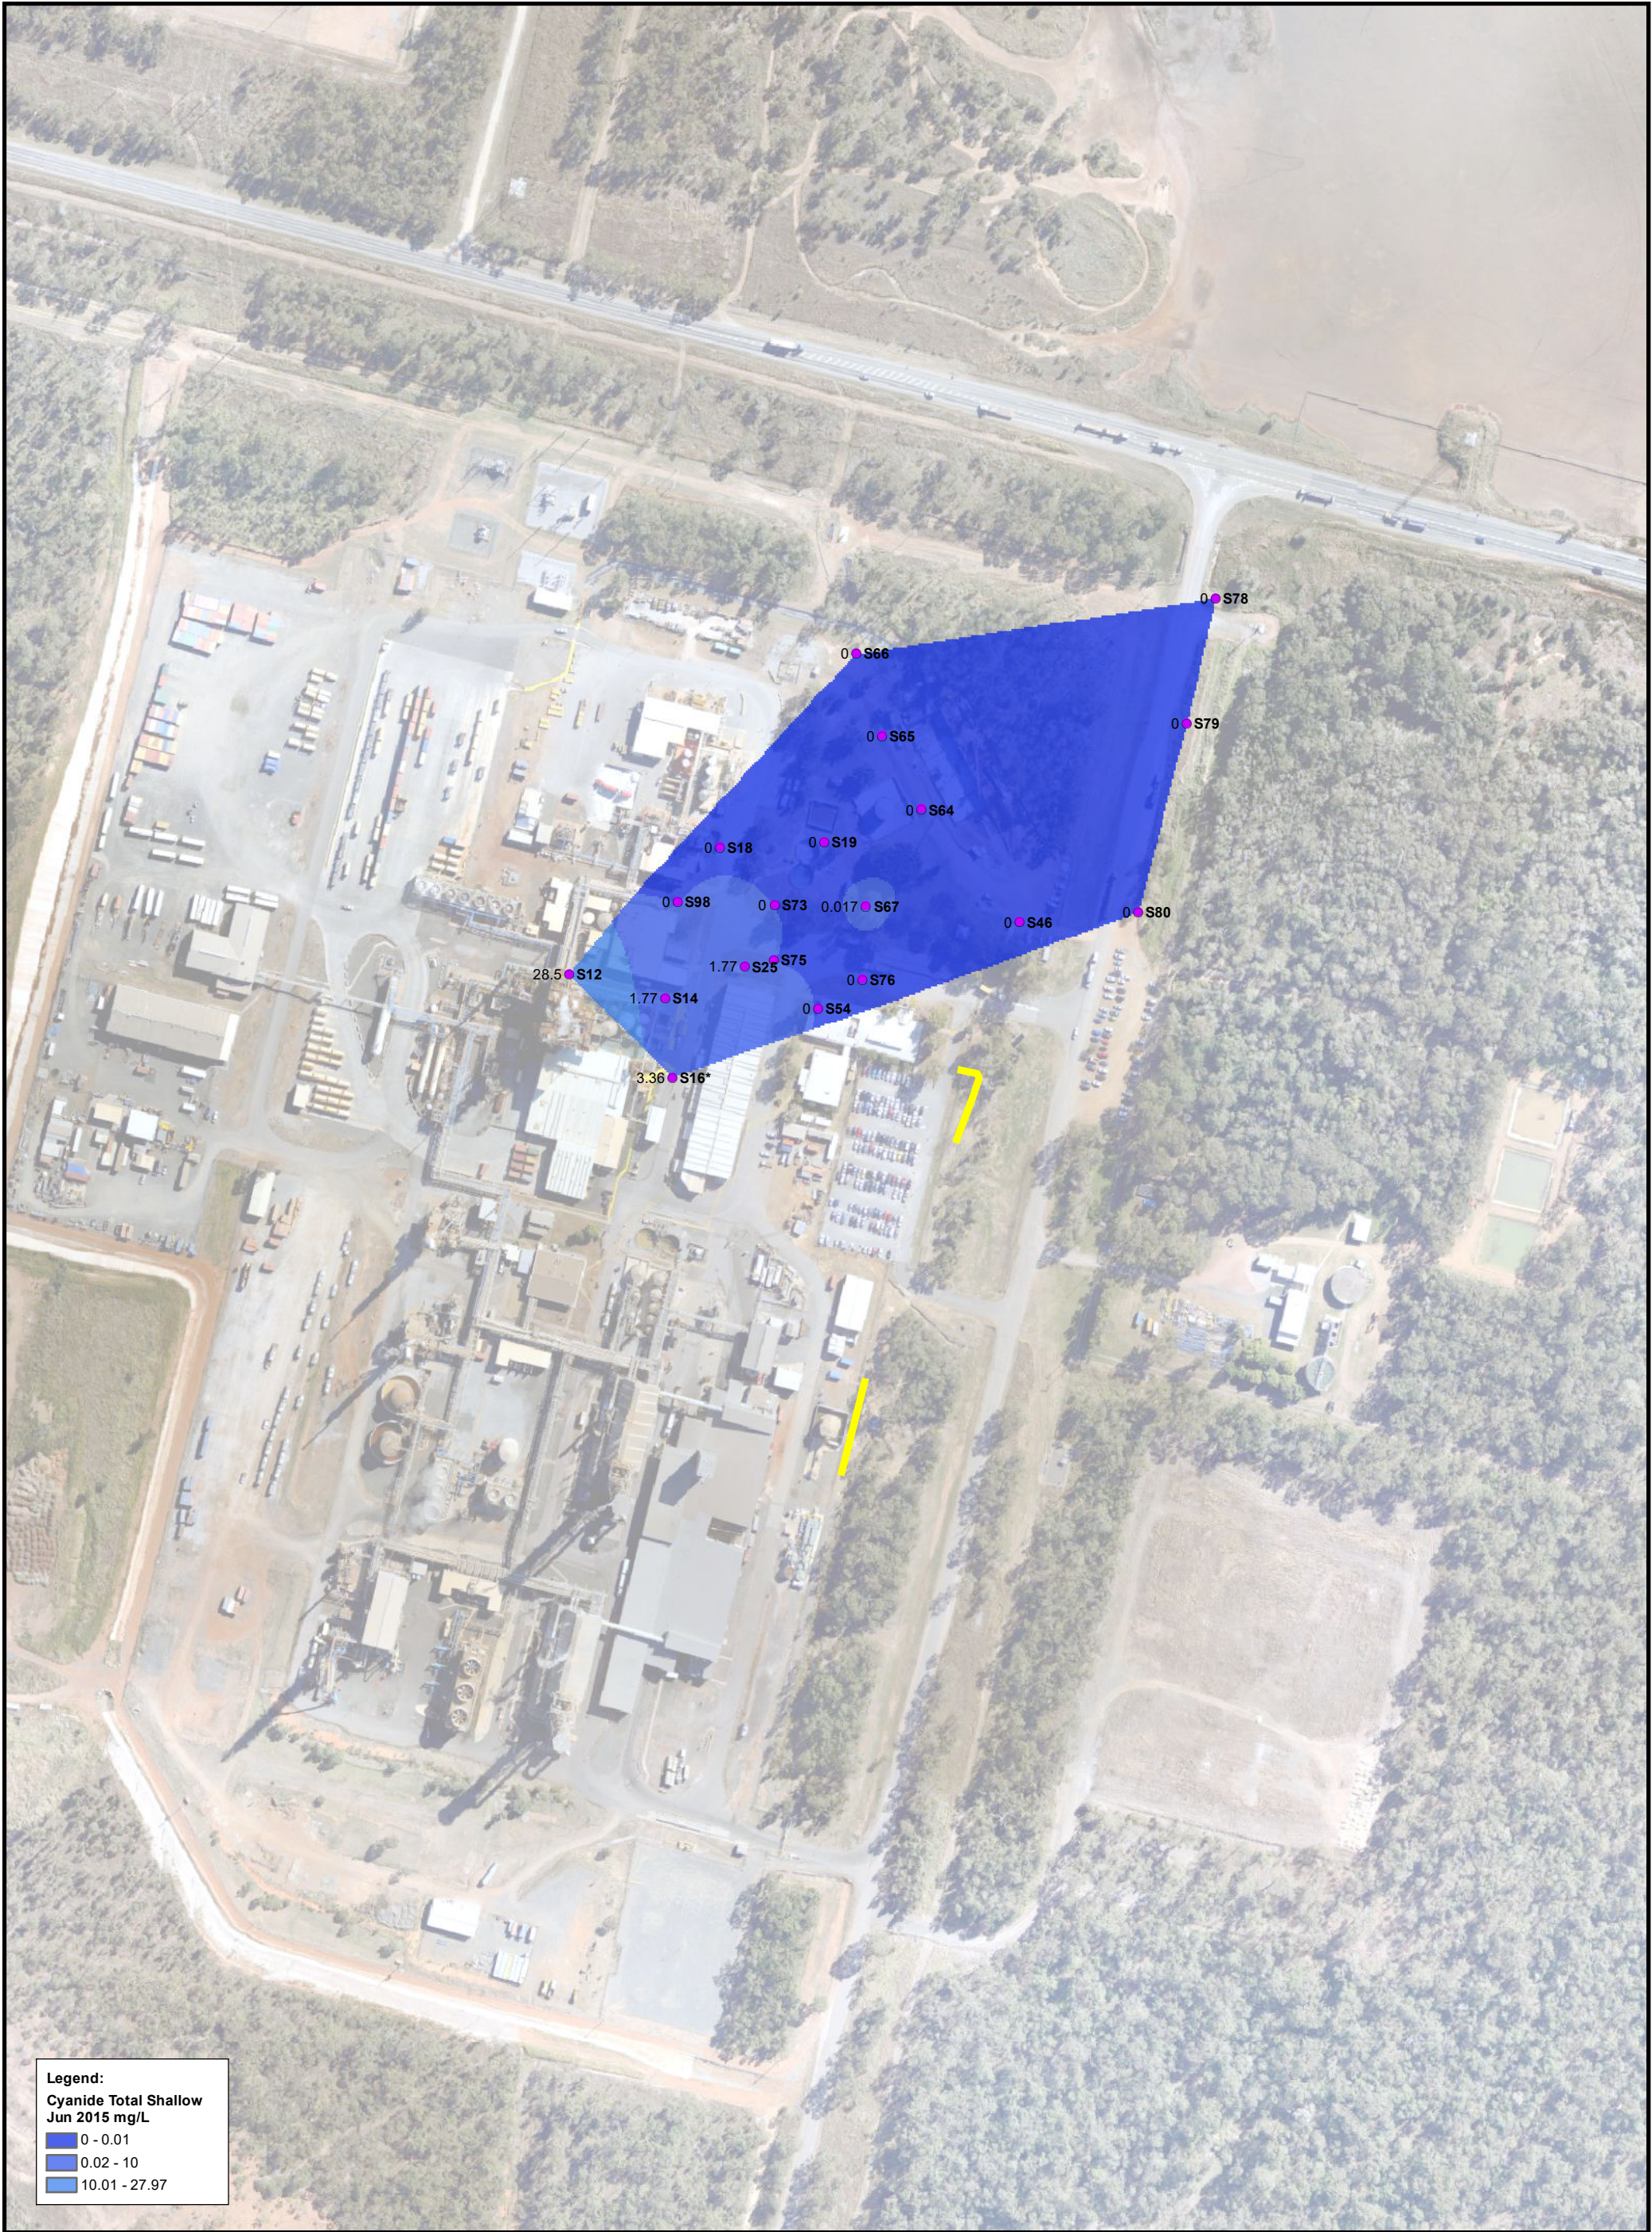
**JBS&G** Figure: Cyanide Total Shallow  
2014 Jul mg/L

**Legend:**  
**Cyanide Total Shallow**  
**Jun 2015 mg/L**  
0 - 0.01  
0.02 - 10  
10.01 - 27.97
