# Thalanga Environmental Evaluation

Hydrogeology

**March 2019 Progress Report**

Cromarty Resources

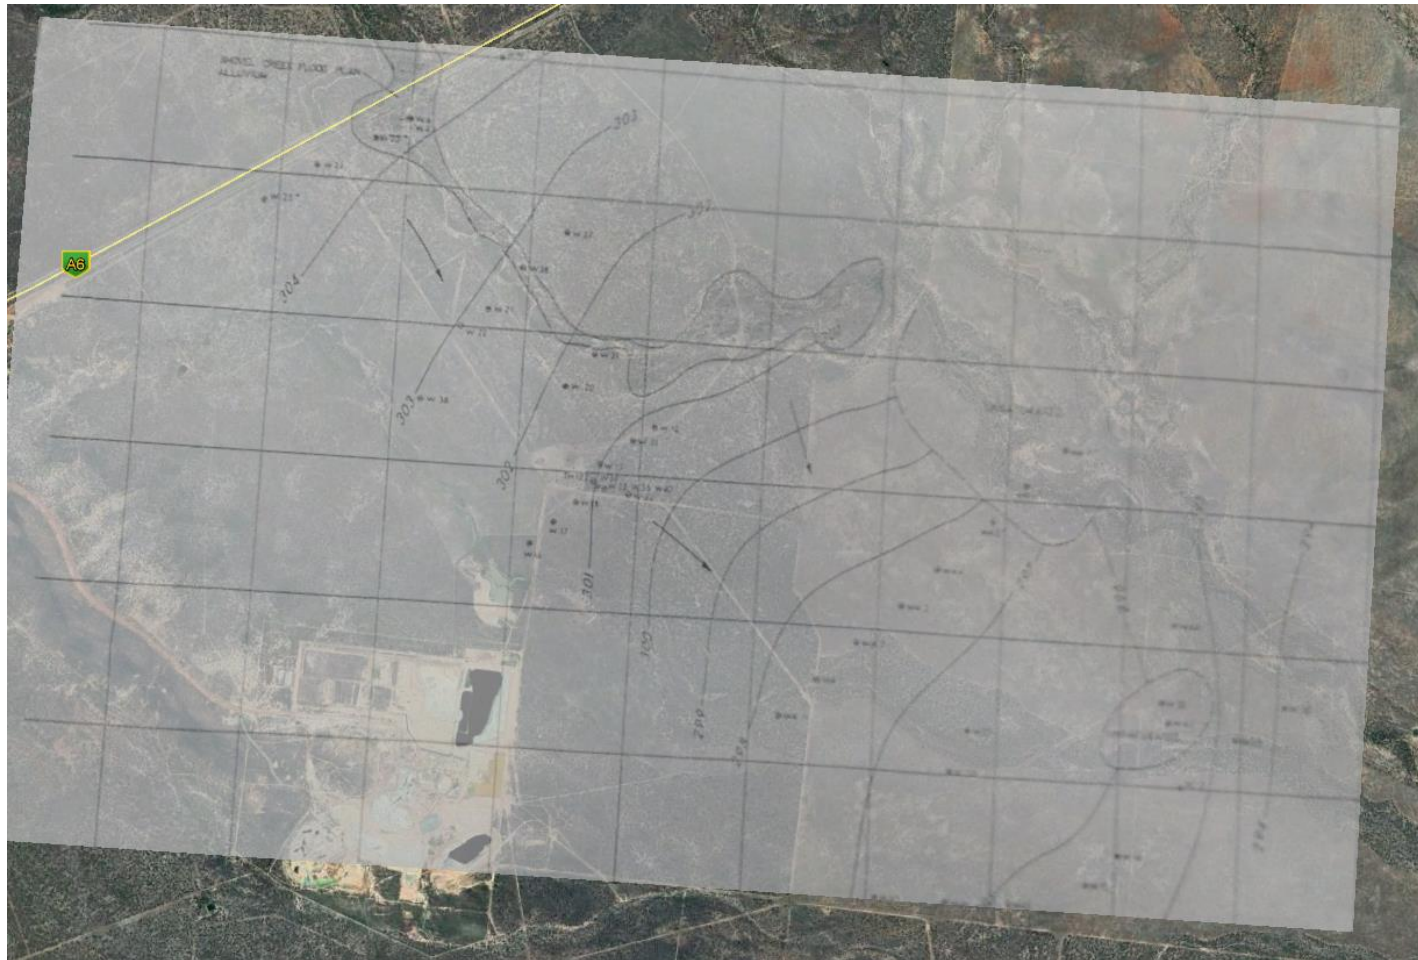
Figure 7 Modified extract from AGC (1988) showing potentiometric map with groundwater flow directions within the Campaspe Formation

As for the Campaspe Formation, detailed hydrogeological information is available through the drilling and pumping tests of the Thalanga bore field. AGC (1988) provided a potentiometric map showing the groundwater flow directions within the Campaspe Formation, approximately 1km to 2km northeast of the Thalanga mine site (Figure 7). Groundwater levels for a large number of these early bores have been measured throughout the initial mine development and subsequent tailings backfill of the underground workings. The water level records for these bores are presented in Appendix B.

Initial pre-mining groundwater flow has been discussed in the Pre-mining baseline conditions section. Figure 7 shows the measured groundwater gradients through the Campaspe Formation in the east of the mine lease. Additional interpreted groundwater gradients across the pre-mining Thalanga site have been added to a pre-mining 1978 aerial photograph (State of Queensland, 2014), (Figure 39).

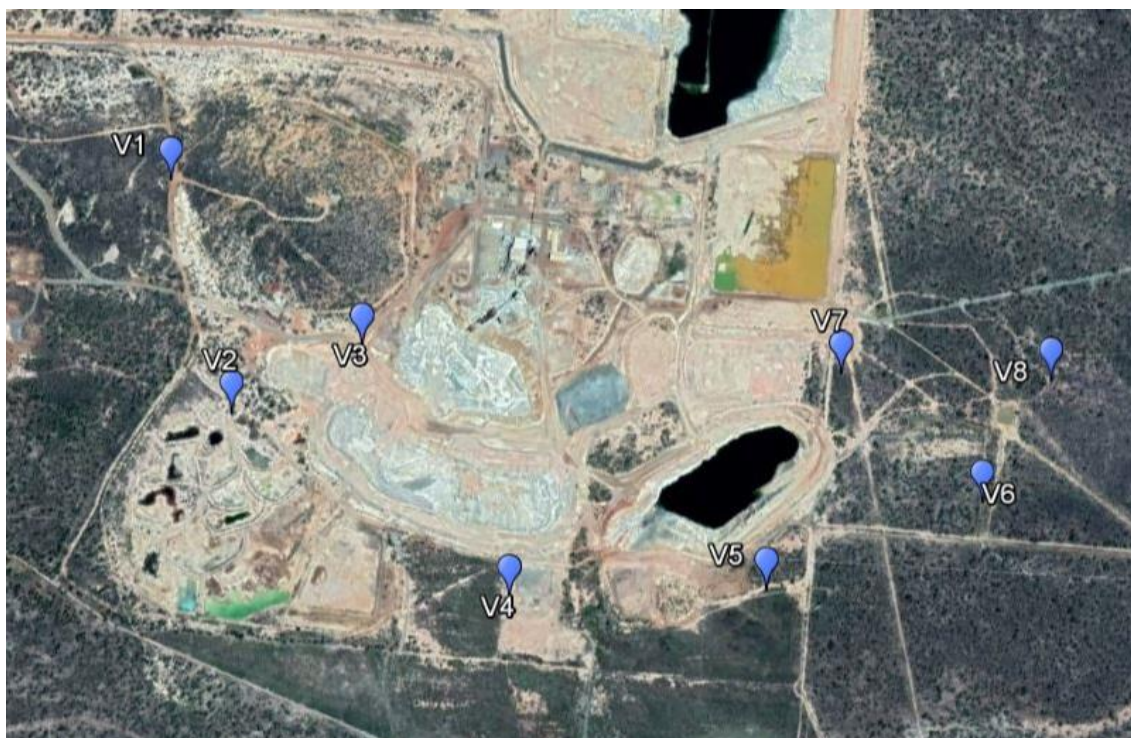
Figure 15 Location of the 2003 V series bores to monitor the impact of underground tailings deposition

The appearance of a pond in the Central Pit prompted the installation of 8 deep (V1, V2, V3, V4, V5, V6B, V7B and V8B) and 3 shallow (V6A, V7A and V8A) monitoring bores in 2003. The bores were designed to monitor the impact of tailings backfill (Table 2 and Figure 16), however due to subsidence issues locations V7A/B and V8A/B soon became non-operational.

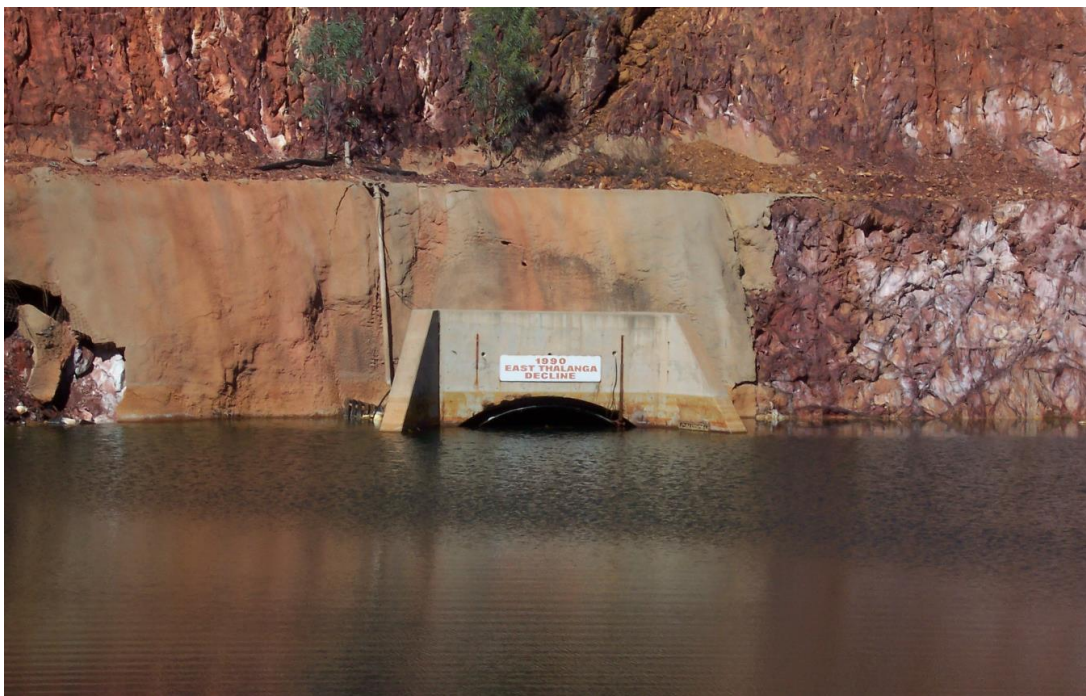
Figure 17 Flooded East Thalanga decline within the Central Pit in 2006. Flood level at approximately RL 308m, inferred from a comparison between mine plans and available topographic maps

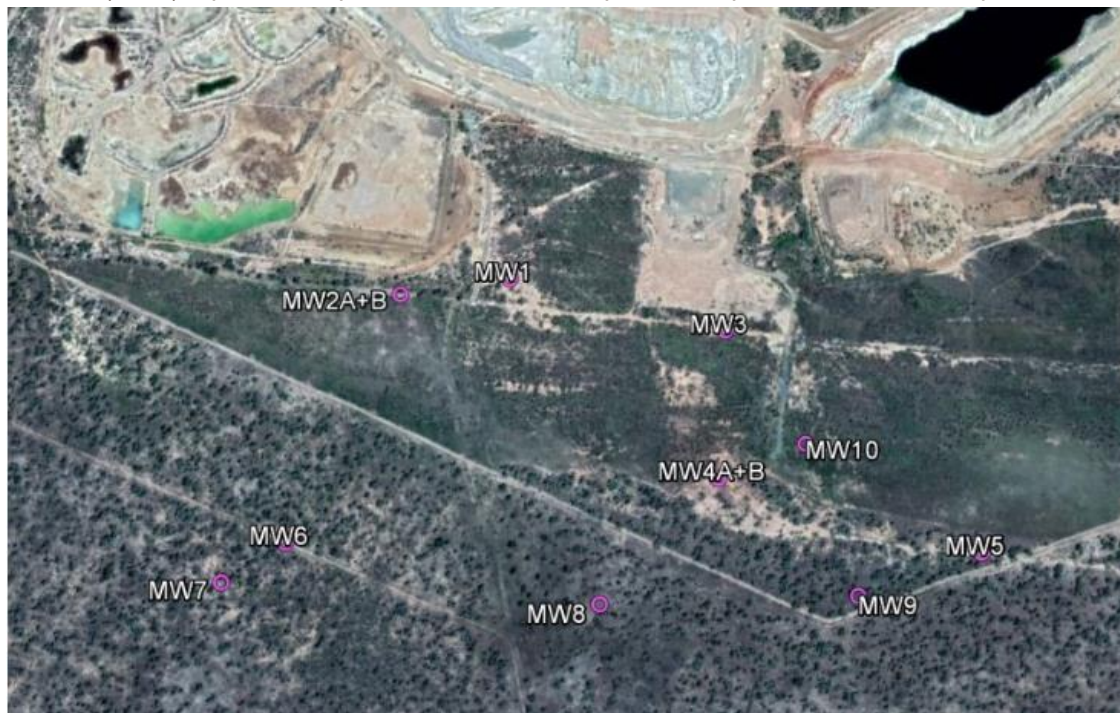
Figure 18 Locations of perched aquifer bores south of the Central Pit

Kendall (1990) reported the presence of a shallow perched aquifer in the southern portion of the

Figure 18). The removal of the West WRD produced an area of permanently ponding acid water in the footprint of the former WRD. To investigate the presence of perched, near surface aquifer sections in the vicinity of the former West WRD, ten shallow and two deeper bores were installed in 2001 (MW-1, MW-2A/B, MW-3, MW-4A/B, MW-5, MW-6, MW-7, MW-8, MW-9 and MW-10). Only two of the shallow bores recorded water at a level between 1.55m and 1.7m, the rest of the other eight shallow bores remained dry (URS, 2002). The two shallow bores containing water were MB-2A and MB-3, closest to the former West WRD and the East WRD respectively. Both locations can be considered impacted due to hydraulic ground loading effects introduced by the prolonged presence of the former WRDs. Initially described in the study of soil mechanics, it is now widely acknowledged that surface loading can impact on the groundwater environment (see, for example, Rodhe & Bockgard, 2006 and Rasmussena & Moteb, 2007). The deeper bore sections both reported groundwater with water levels between 10.7m and 13.61m below ground level, this was despite the remaining Central Pit still being empty at this stage.

Besides the initial measurements following installation there appear to be no additional measurements from MW-1, MW-2A/B, MW-3, MW-4A/B, MW-5, MW-6, MW-7, MW-8, MW-9 and MW-10.

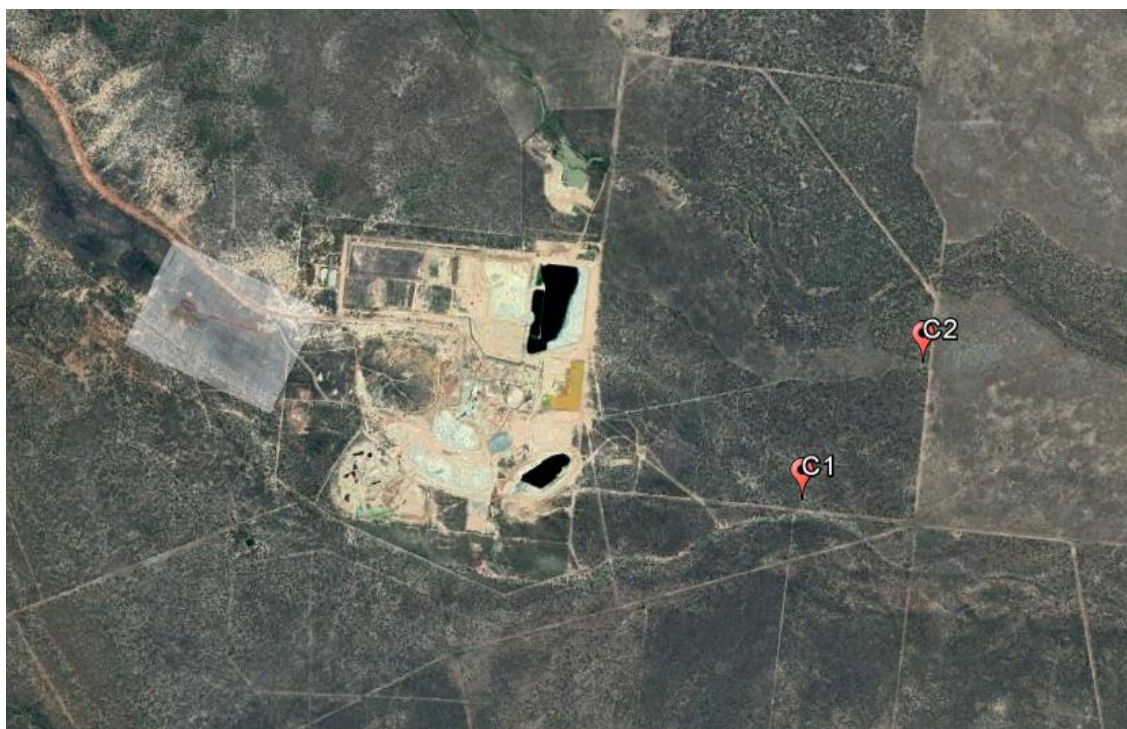
Figure 19 Location of C1 and C2 (installed in 2008) with regards to the Thalanga mine site

Rob Lait reported that in pit deposition of process waters to the pit rim had resulted in elevated groundwater tables at the Vomacka location (RLA 2008B). In addition, in early March 2008 Kagara staff reported that water had expressed at the eastern deeps subsidence area. That surface water expression was explained with the impacts of a particularly good 2007/2008 wet season. However, the unexpected surface water expression also evoked fears that artificially raising groundwater tables through process water discharge to the Central Pit could impact on the nearby Campaspe Formation (RLA 2008A). This fear prompting the installation of 2 new monitoring bores C1 and C2 (Figure 19) to the east of the Thalanga mine site.

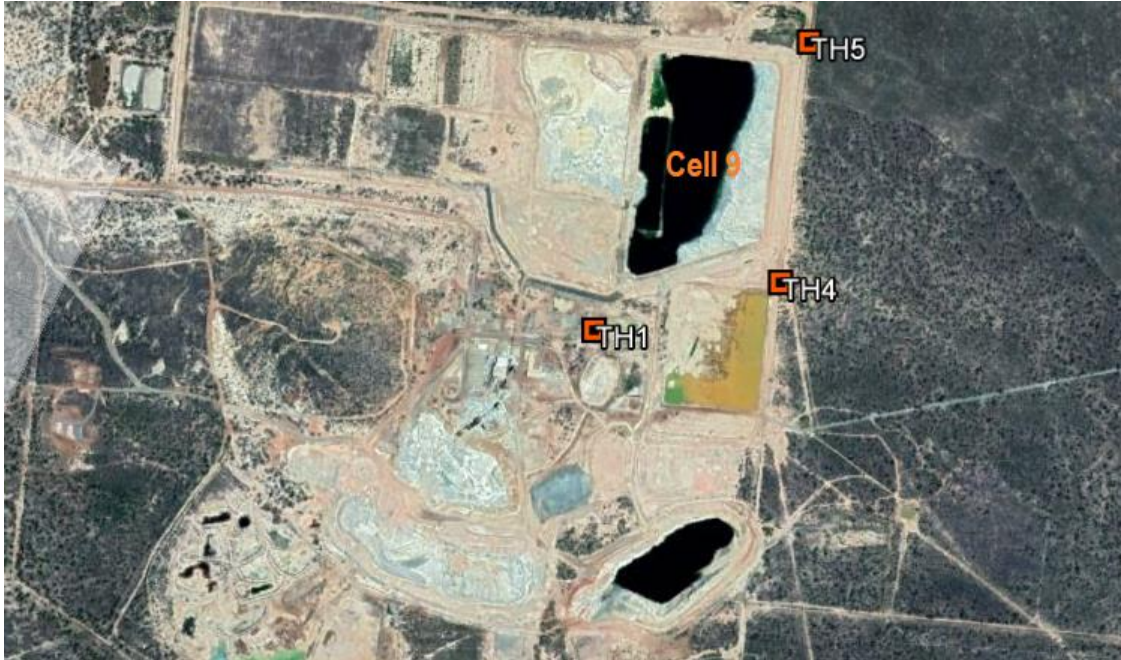
Figure 20 Location of TH1, TH4 and TH5 (installed in 2008) with regards to tailings cell 9

Three additional bores (TH1, TH4 and TH5) were placed in the vicinity of the new tailings cell 9 (Figure 20). Process tailings of the Balcooma ore were stored in the previously constructed Cell 8 and new Cell 9, adjacent to the south and east of the existing tailings cell 7.

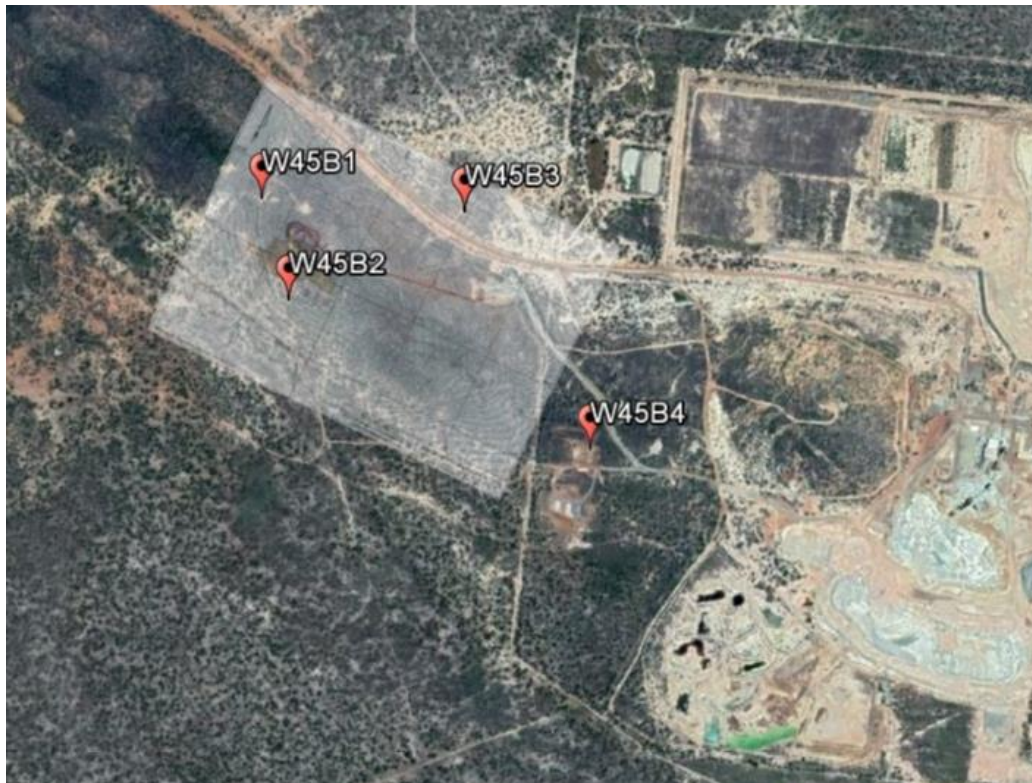
Figure 26 Locations of the four monitored West 45 bores

Phase Four also saw renewed underground interests at Thalanga. Activities included the initial dewatering of the West 45 deposit approximately 1500m North West from the Central Pit between 2011 and 2012. Rob Lait & Associates (2010, 2011a) installed four monitoring bores and two pumping bores to assess the hydrogeology and assist the dewatering of the West 45 deposit (Figure 26 and Table 4).

The bores were installed to a depth of between 79 and 91m with signs of weathering ranging from 3m to 22m below ground level. According to the drill logs (Appendix C), larger groundwater interceptions occurred in the fractured quartz eye rhyolite of the uneconomical part of the orebody (W45B1, ~15L/sec) and the bottom of the foot-wall rhyolite (W45B3, ~10L/sec). The bore solely intersecting the hanging wall dacite (W45B2) yielded only 0.46L/sec. While W45B4 was installed in an alternating sequence of ore deposit type quartz eye rhyolite, footwall rhyolite and hanging wall dacite yielded approximately 5L/sec.

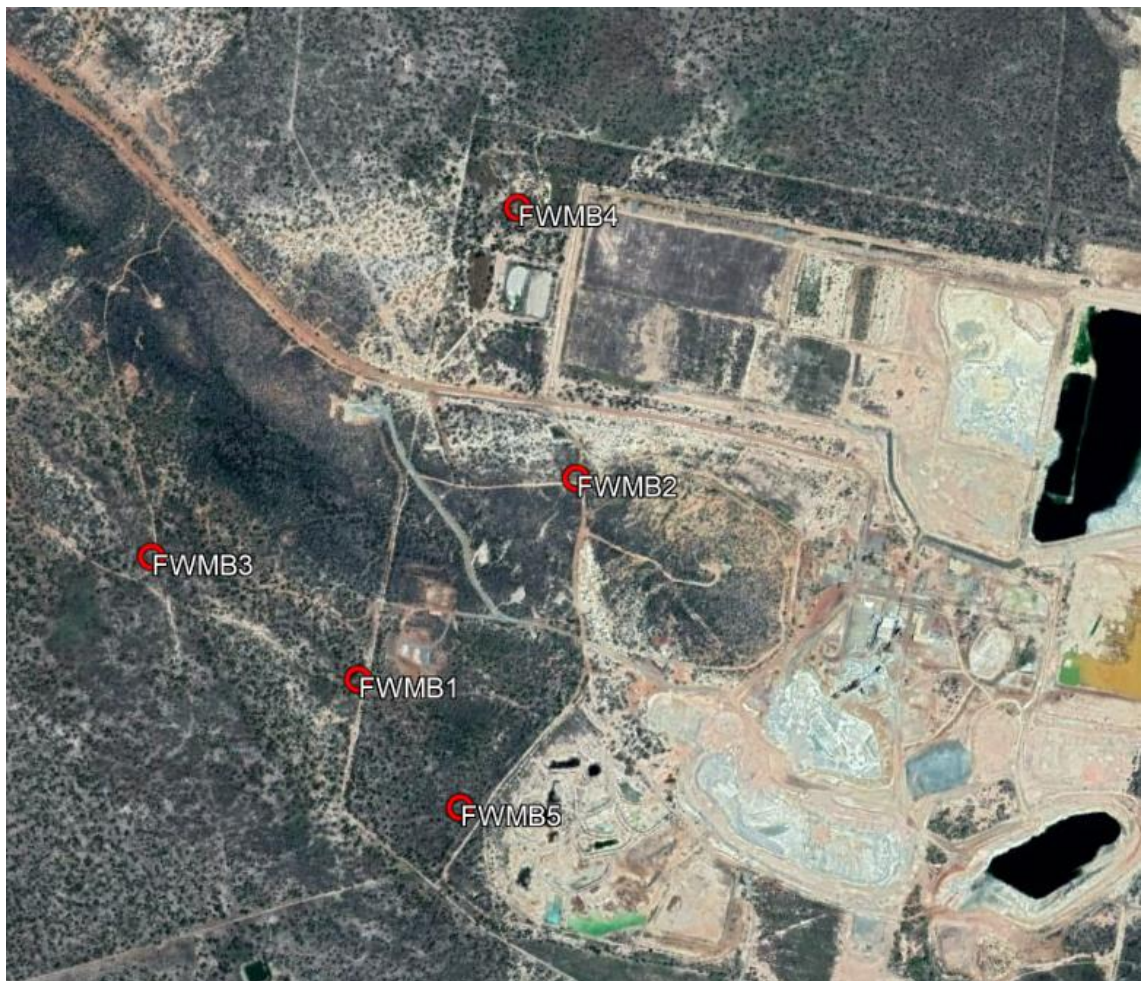
Figure 29 Locations of the Far West monitoring bores

Groundwater occurred only in very few fractures between a depth of 19m to 57m, and airlift flow was at times too small to be measured or dried up soon after being encountered. The drying up of encountered groundwater flows is typical of compartmentalised, small capacity aquifers (bore logs in Appendix D)

The weathered horizon reached depths between 2m and 28m with no groundwater associated. Importantly, none of the Far West bores encountered groundwater below the depth of 57m, essentially confirming the generally lower fracture density of the rock at depth, as suggested by Barrett et al. (1982) and Rob Lait & Associates (2010).

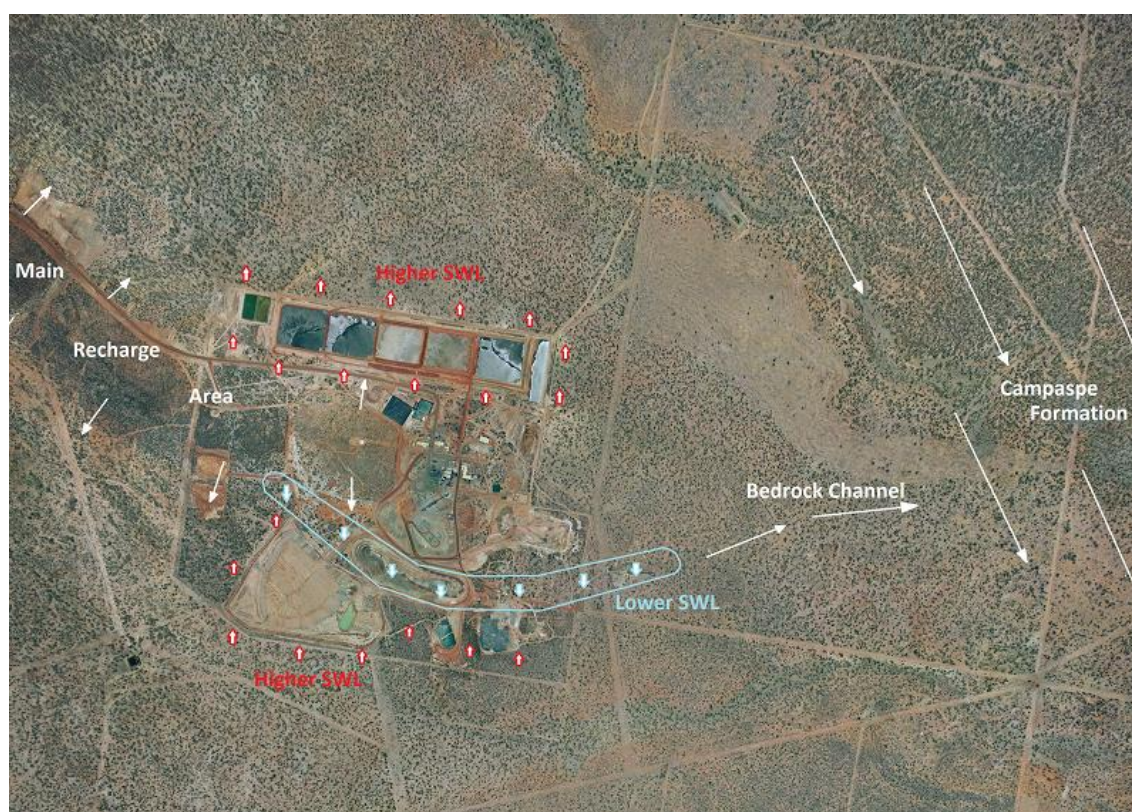
Figure 40 Conceptual groundwater situation at Thalanga during Phase One, 1989-1998 (modified exert from State of Queensland, 2012)

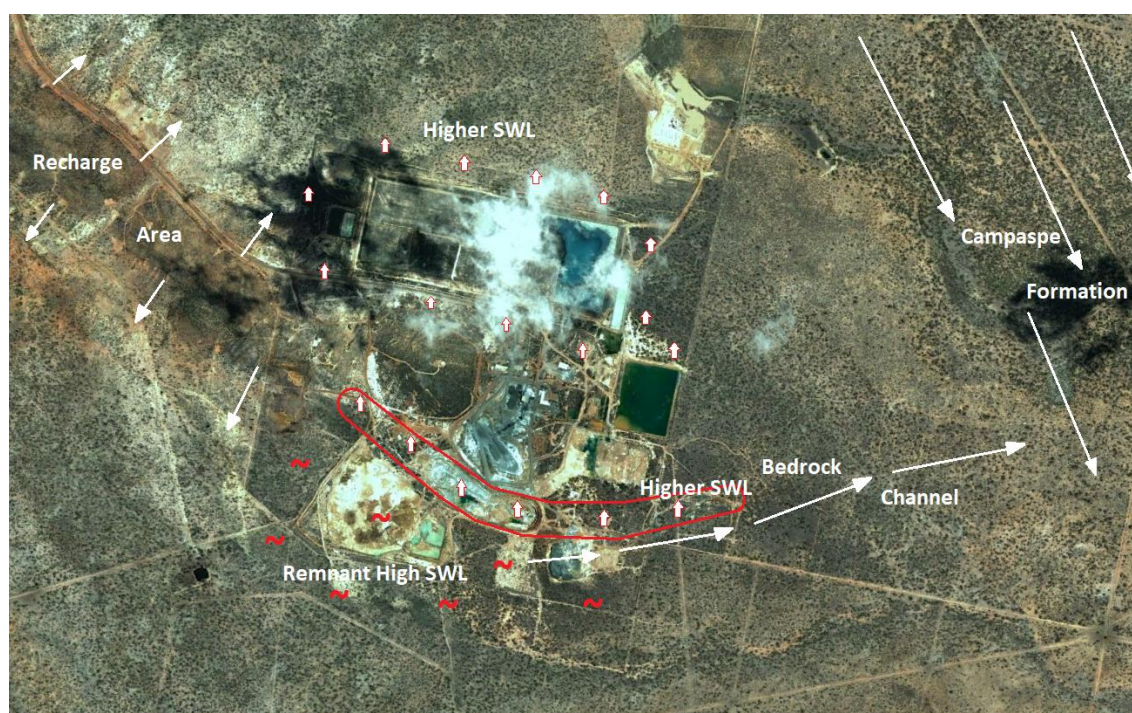
Figure 41 Conceptual groundwater situation at Thalanga during Phase Two, 1998-2006 (2004 background image, modified from Digital Globe, Google Earth accessed February 2019)

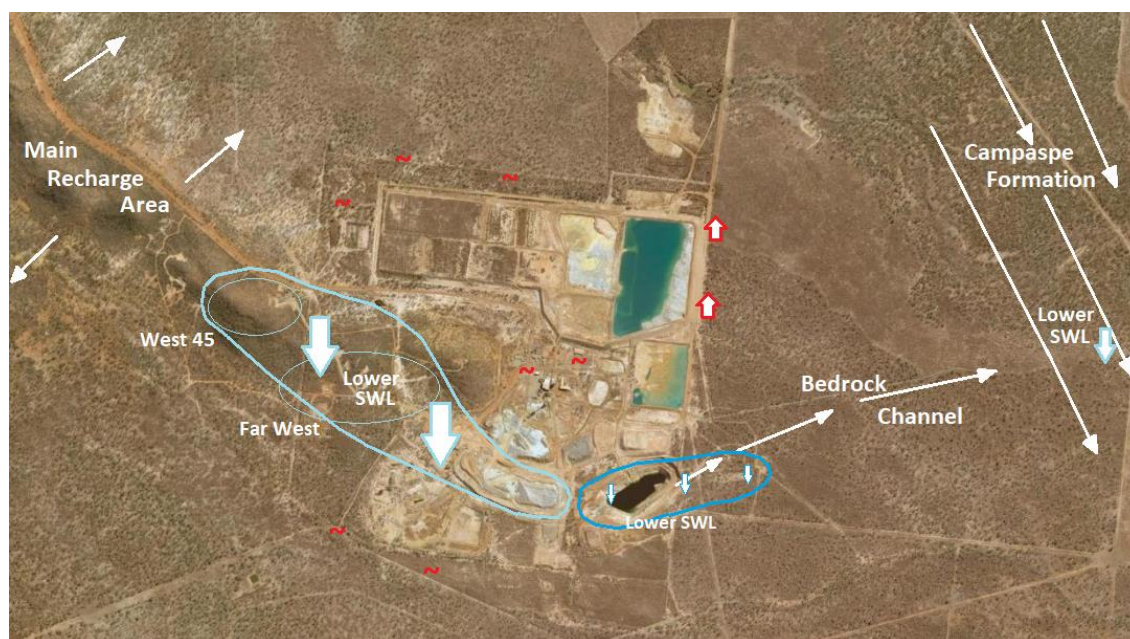
Figure 45 Conceptual groundwater situation at Thalanga during Phase Five, 2012-2019  
(Background image from State of Queensland 2016)
