# Anglo Coal (Dawson) Limited

## Environmental Evaluation Report

### Dawson Mine North Environmental Evaluation

**November 2017**

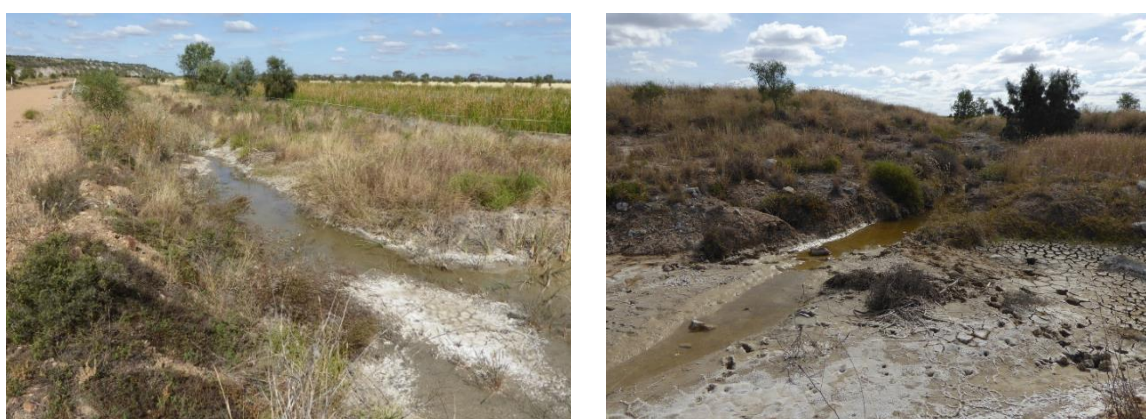
There was a salt crust within this drain that indicated the seepage had entered the Clean Water Drain and drained into the natural downstream reaches of Rock Hole Gully Creek during periods of flow (Refer to Figure 1.2 and Figure 1.3).

**Figure 1.2 (L to R) Seepage Water in Erosion and Sediment Control Drain (29/06/2017), Erosion and Sediment Control Drain Confluence with Clean Water Drain (29/06/2017)**

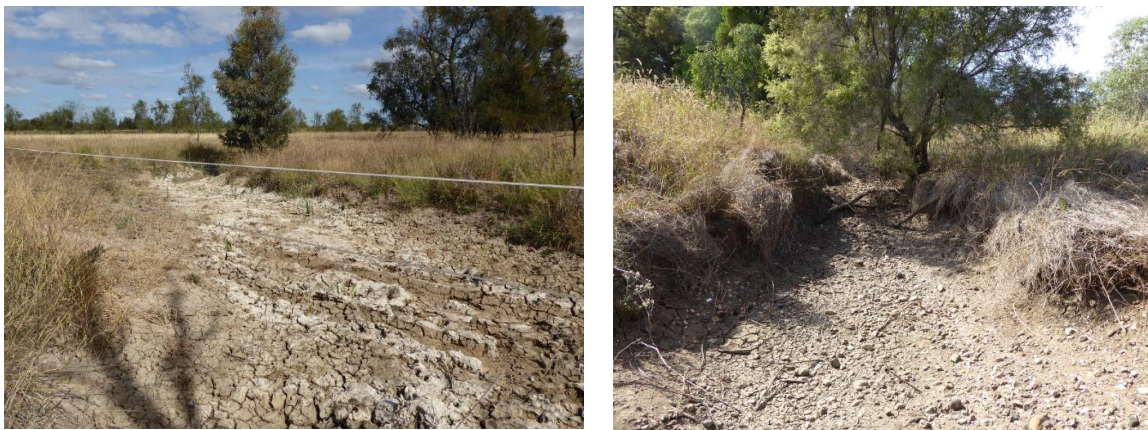
The salt crust was observed downstream for several hundred metres within the Rock Hole Gully Creek bed, across both Dawson mining lease ML5656 and a small section of Lot 27 on FN187 that is not covered by the mining lease, however is owned in freehold by Dawson Mine as buffer land. Dawson Mine has granted a licence to a neighbouring grazier to agist cattle on this freehold land. There was no salt crust observed at the Rock Hole Gully Creek Downstream monitoring station (Refer to Figure 1.3).

**Figure 1.3 (L to R) ML5656 Boundary with Lot 27 on FN187 about 800m Downstream of Clean Water Drain (29/06/2017), Rock Hole Creek Gully Downstream Monitoring Station (29/06/2017)**

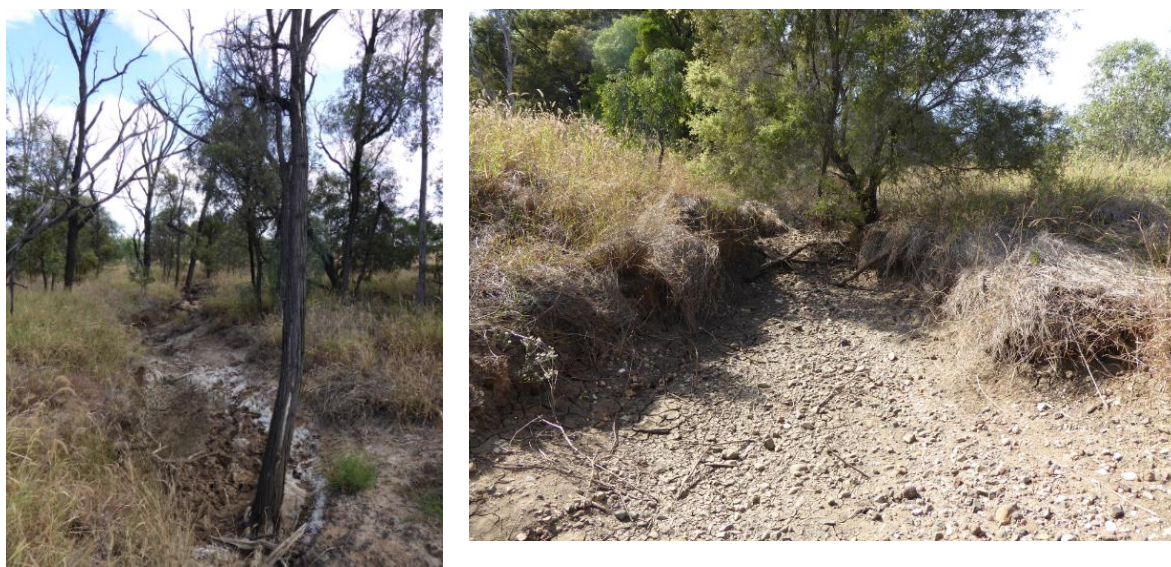
Standing dead trees (Refer to Figure 4.5) suggest that the community is characterised by scattered mature and regrowth brigalow with little to no upper or lower shrub layers and a ground layer dominated by Buffel grass *Pennisetum ciliare*. Other species along Rock Hole Gully Creek include regrowth of *Brachychiton rupestris*, *eremophila mitchellii*, *Bursaria incana*, *Geijera parviflora*. These species are characteristic of the preclear regional ecosystems 11.4.8, 11.4.9a.

Figure 4.5 (L to R) Standing Dead Trees within the Rock Hole Gully Creek Upstream of the initial ML5656 Mining Lease Boundary (29/06/2017), Rock Hole Gully Creek Downstream Monitoring Location (29/06/2017)

Some dieback of riparian canopy trees within the vicinity of Site 1/4, located within the mining lease, has occurred, possibly partly as a result of the saline seepage. However, it is noted that Dawson Mine has advised that these trees had died back a considerable time ago and that they are not dissimilar to other areas of dieback within the mining lease.

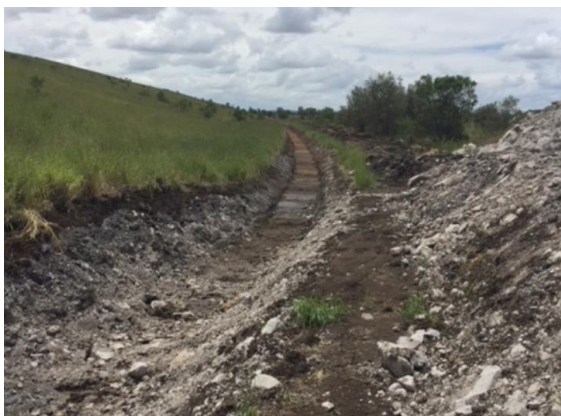
**Figure 5.1 Southern Drain (Looking East) (22/11/2017)**

- Installation of dewatering pump to transfer stored water from Industrial Dam 5 into the seepage interception drainage system to be conveyed to the Dawson North void.
- Installation of a shallow groundwater seepage monitoring bores immediately south and west of the out of pit spoil dump.
- The Dawson Mine water management plan has been updated to include monitoring of electrical conductivity (telemetry or in-situ probe readings) of flows entering the natural reach of Rock Hole Gully Creek (Sample Location 4 U/S) as soon as practicable after every flow event (when triggered by flow in the downstream Rock Hole Gully Creek telemetry station) for at least one full wet season.

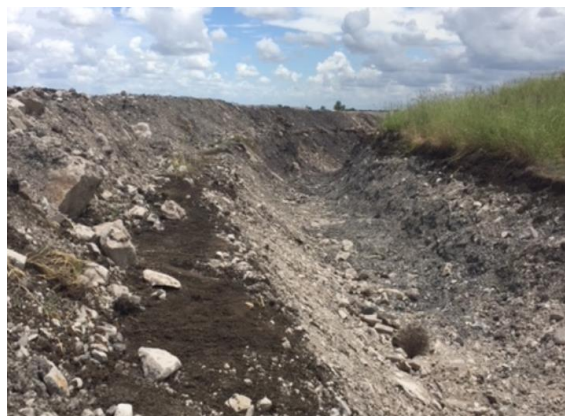
**Figure 5.2 Southern Drain Approaching South-West Corner (Looking West) (22/11/2017)**

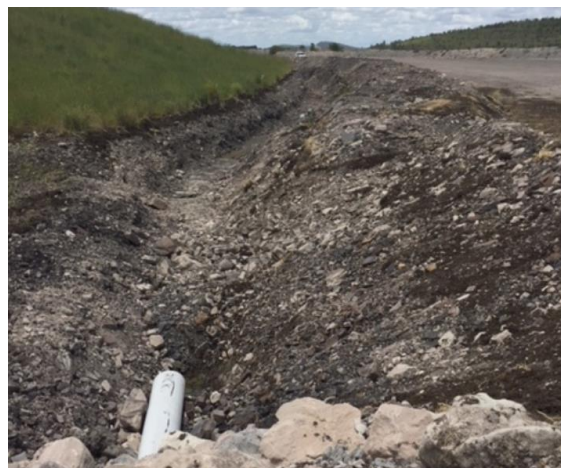
**Figure 5.3 Southern Drain Approaching Pipe Culvert at the Western Dump Toe (Looking South) (22/11/2017)**

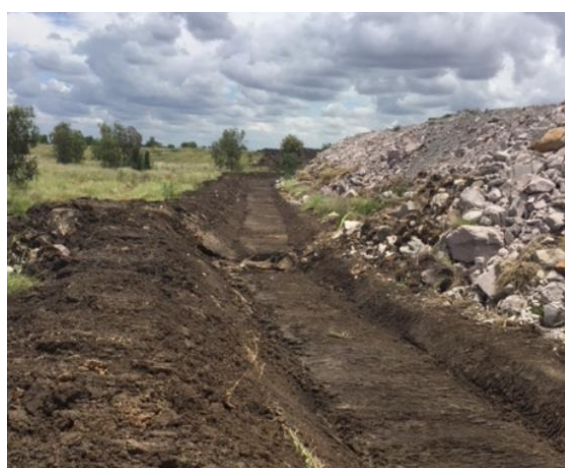
**Figure 5.4 Western Drain - on Western Side of Haul Road (Looking North) (22/11/2017)**

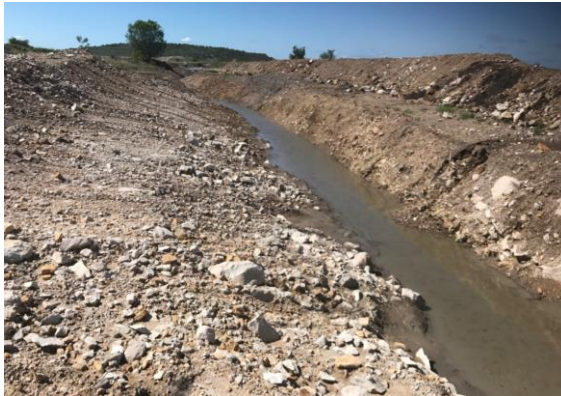
**Figure 5.5 Western Drain (Looking North) (25/10/2017)**
