# Progressive Rehabilitation and Closure Plan

## WARWICK LIMESTONE MINE

AUQ00238A

**WARWICK LIMESTONE MINE –  
PROGRESSIVE REHABILITATION AND  
CLOSURE PLAN**

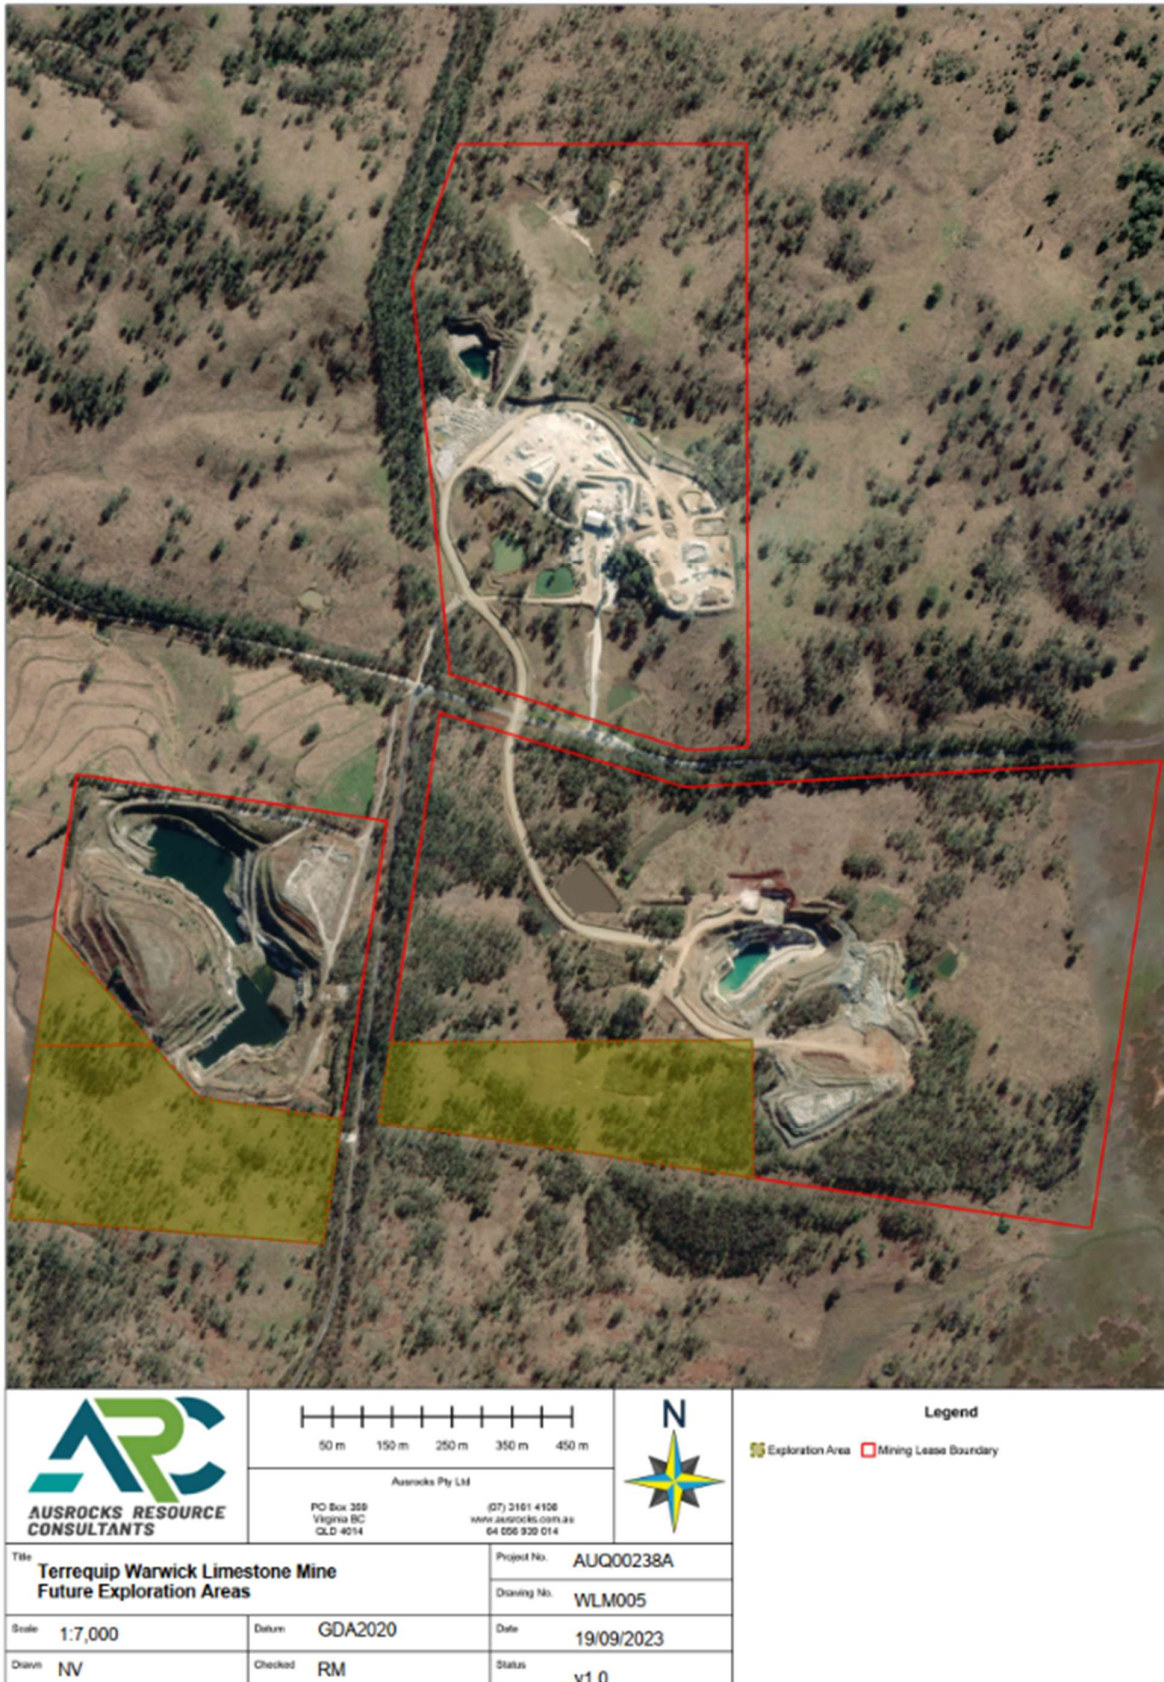
Figure 6: Resource exploration areas at Warwick Limestone

Undisturbed mining leases ML50236 and ML50239 are known to contain limestone resource, extending south from the East-West pit (ML50083). Future exploration works will be conducted to determine viability of these resources (**Figure 6**).

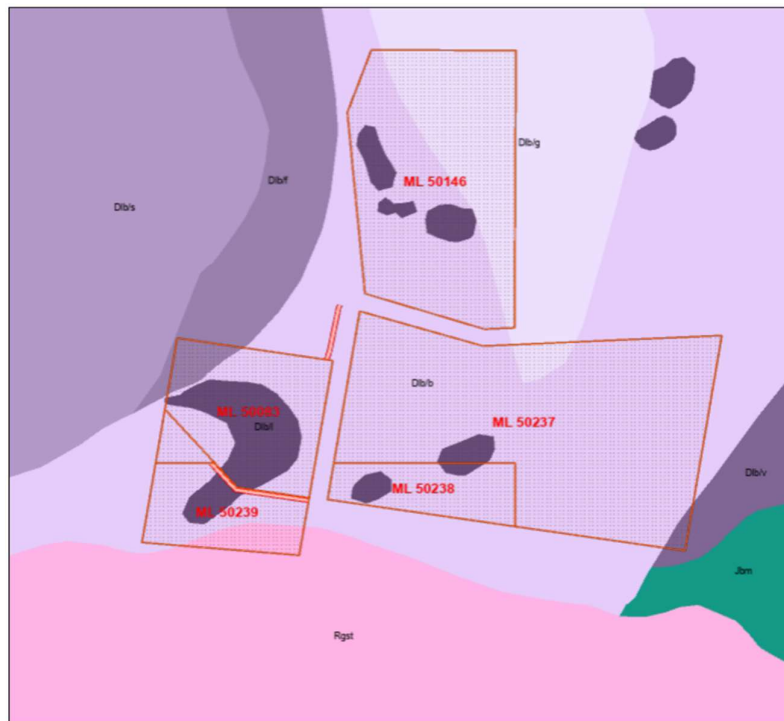
Figure 8: Site geology<sup>12</sup>

Limestones in the area have been metamorphosed and fault-dissected to form small, scattered, steeply dipping lenses of coarse-grained marbles. The marble is mostly near white and generally contains fractures coated with an iron oxide film. There are also large patches of grey marble and a streaky grey-white variety. The host Rosenthal Creek Formation consists of sandstones, siltstones, and volcanic rocks, intersected by green andesite dykes. The marbles are generally massive with no visible bedding as they are likely near vertical to steeply dipping. At places along the western side of ML50083, there is a steep dipping contact between the marbles and the dark greenish-grey shale that strikes roughly north-south. It appears that no limestone occurs beyond this contact. The depth of the marble has not been determined.

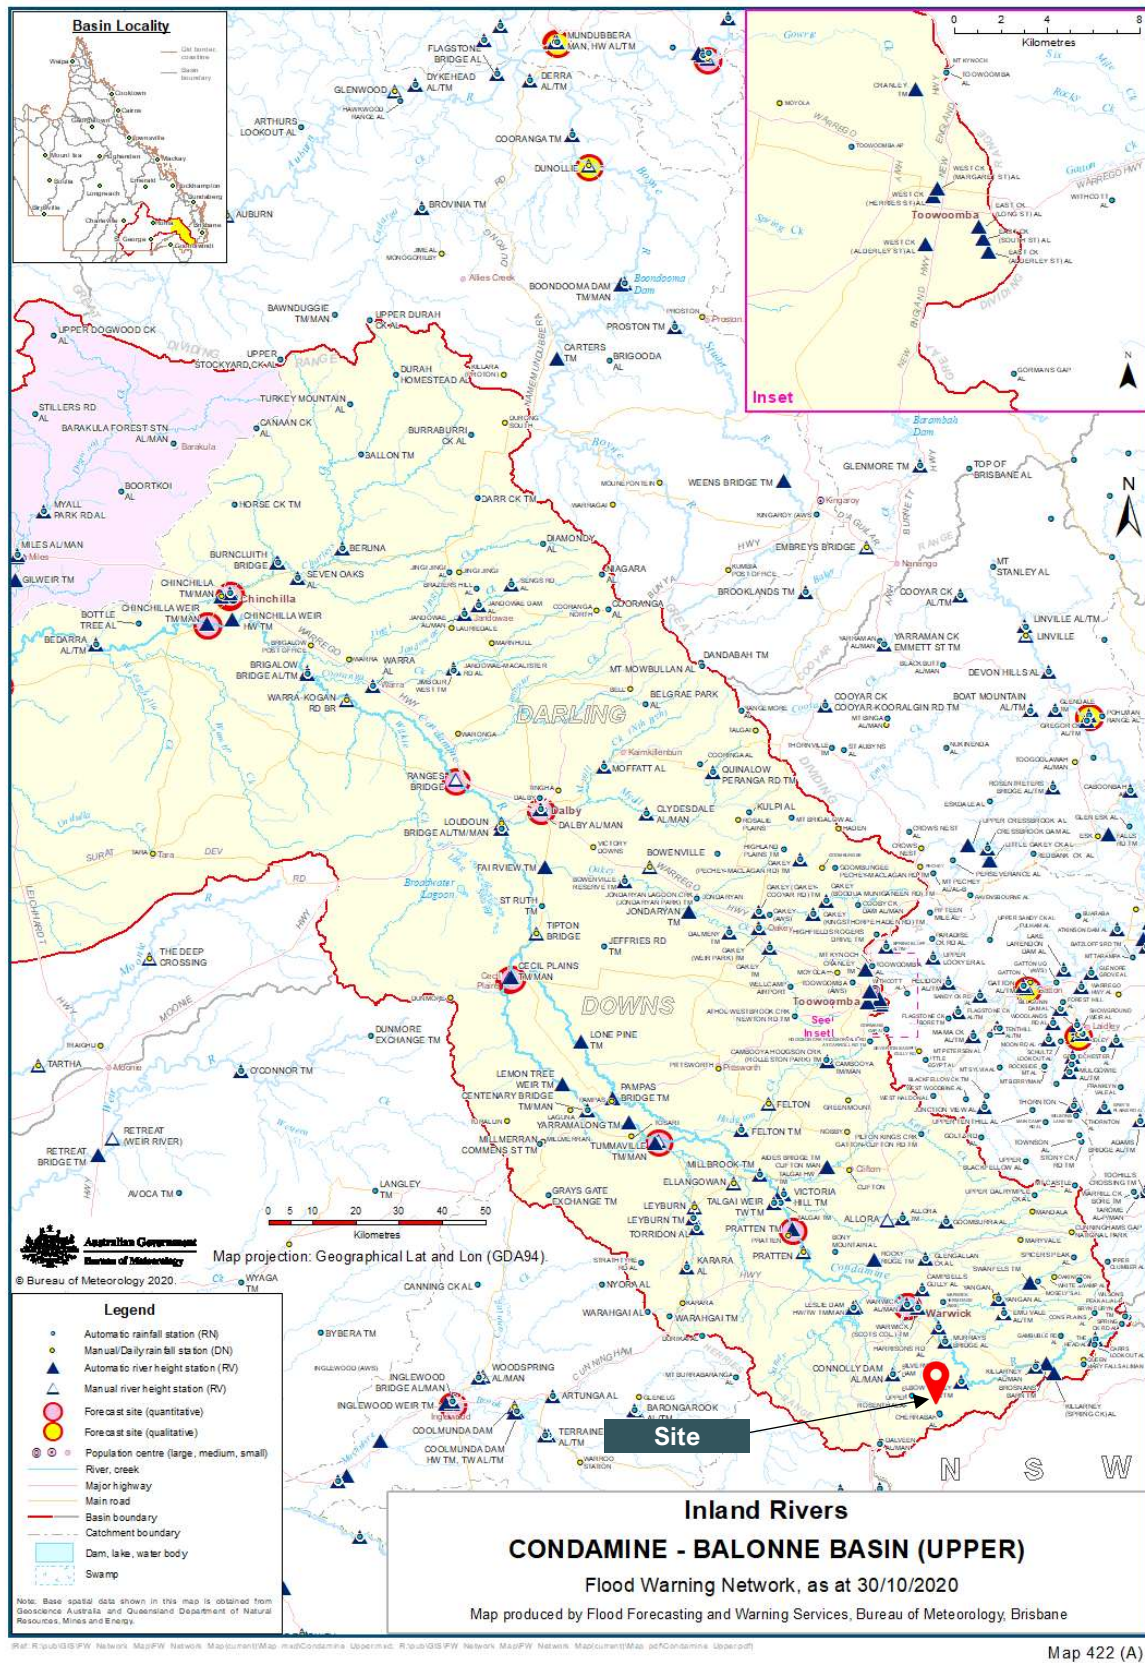
Figure 9: Catchment area and main watercourses

Warwick Limestone is located on the southern-most boundary of the Condamine-Balonne River basin (**Figure 9**). This results in the formation of headwaters for minor unmapped tributaries connecting to Little John Creek and the Condamine River.

The Project is located within the Condamine-Balonne River basin which spans a total area of 143,900km<sup>2</sup> comprising 14.4% of the Murray-Darling Basin<sup>13</sup> (**Figure 9**). The primary surface water resources include the Maranoa, Condamine, and Balonne rivers as well as numerous wetlands, natural lakes, and man-made reservoirs and dams. Minor waterways in the basin include the Cogoon River, Merivale River, Dogwood Creek, and Bungil Creek.

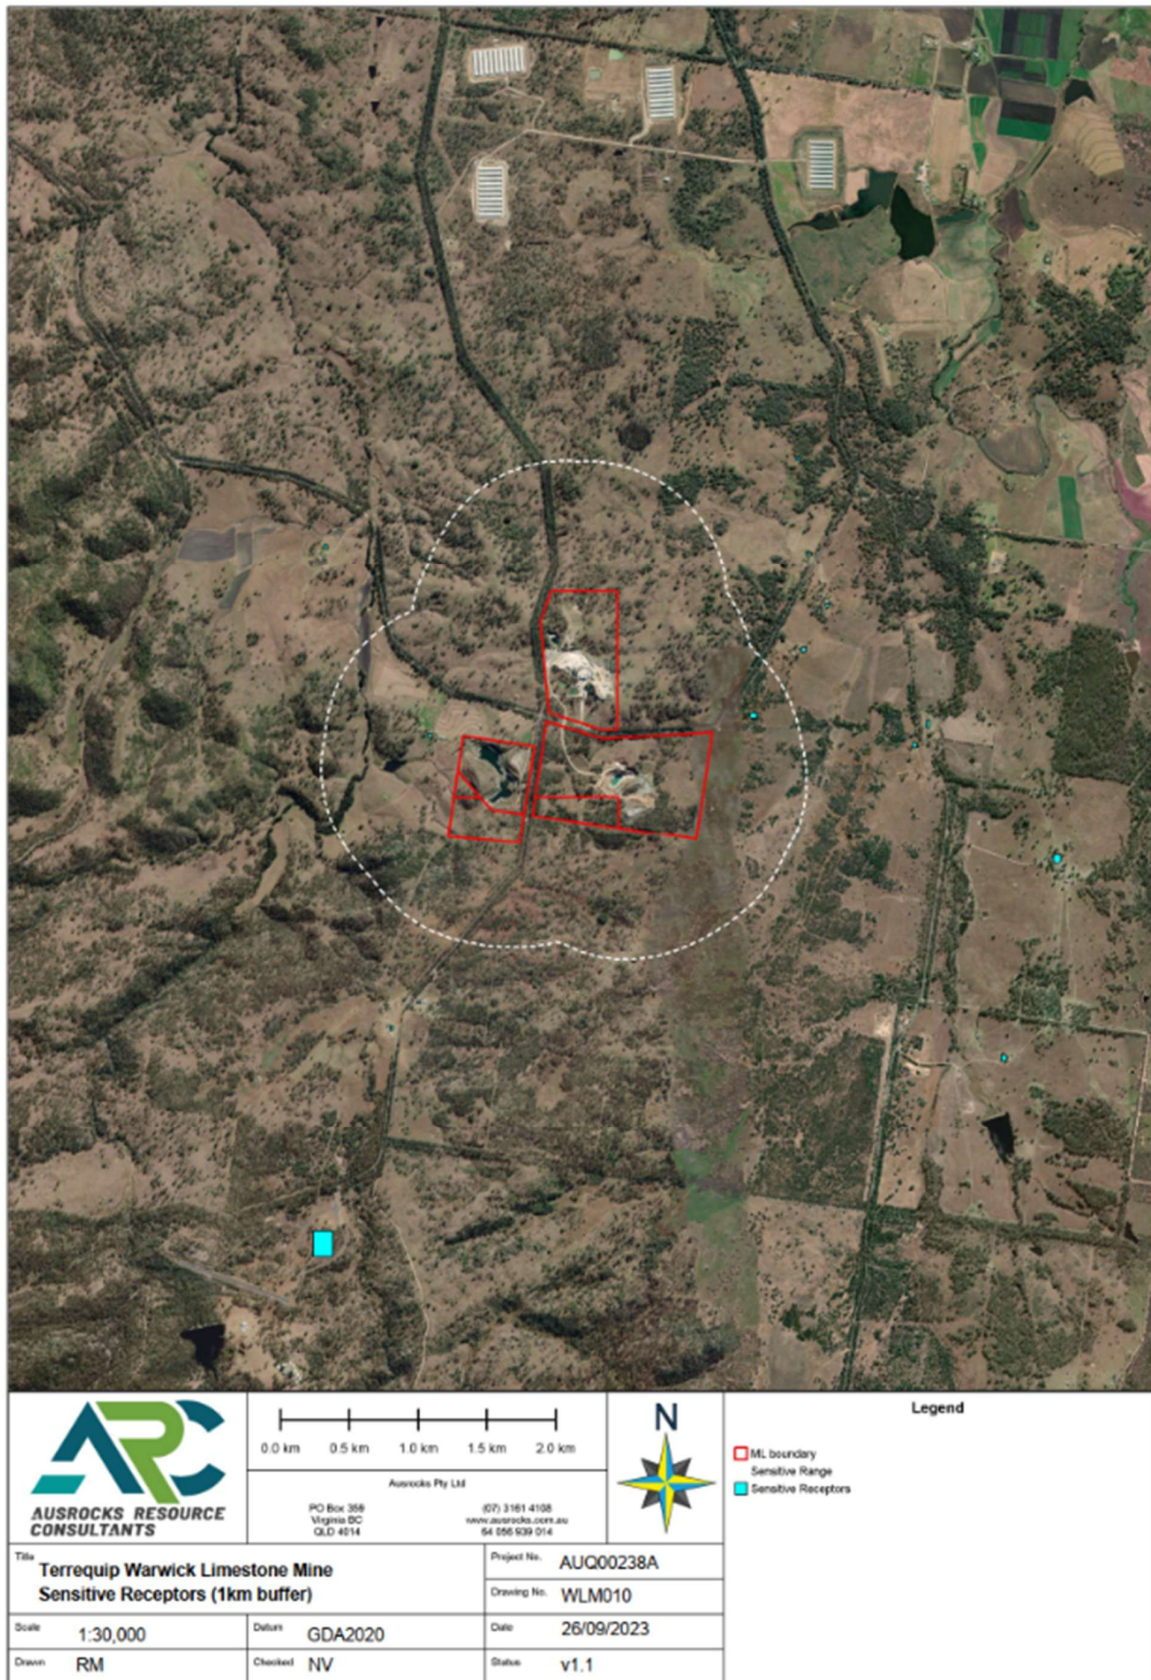
Figure 17: Identified neighbours within 1km of the mining tenements of Warwick Limestone

Key stakeholders include the landholders on which the mine operates. There are no nearby neighbours in adjoining lots and no other community members to consult. **Figure 17** illustrates the location of sensitive receptors (neighbours) within a 1km buffer of the mining lease boundaries.

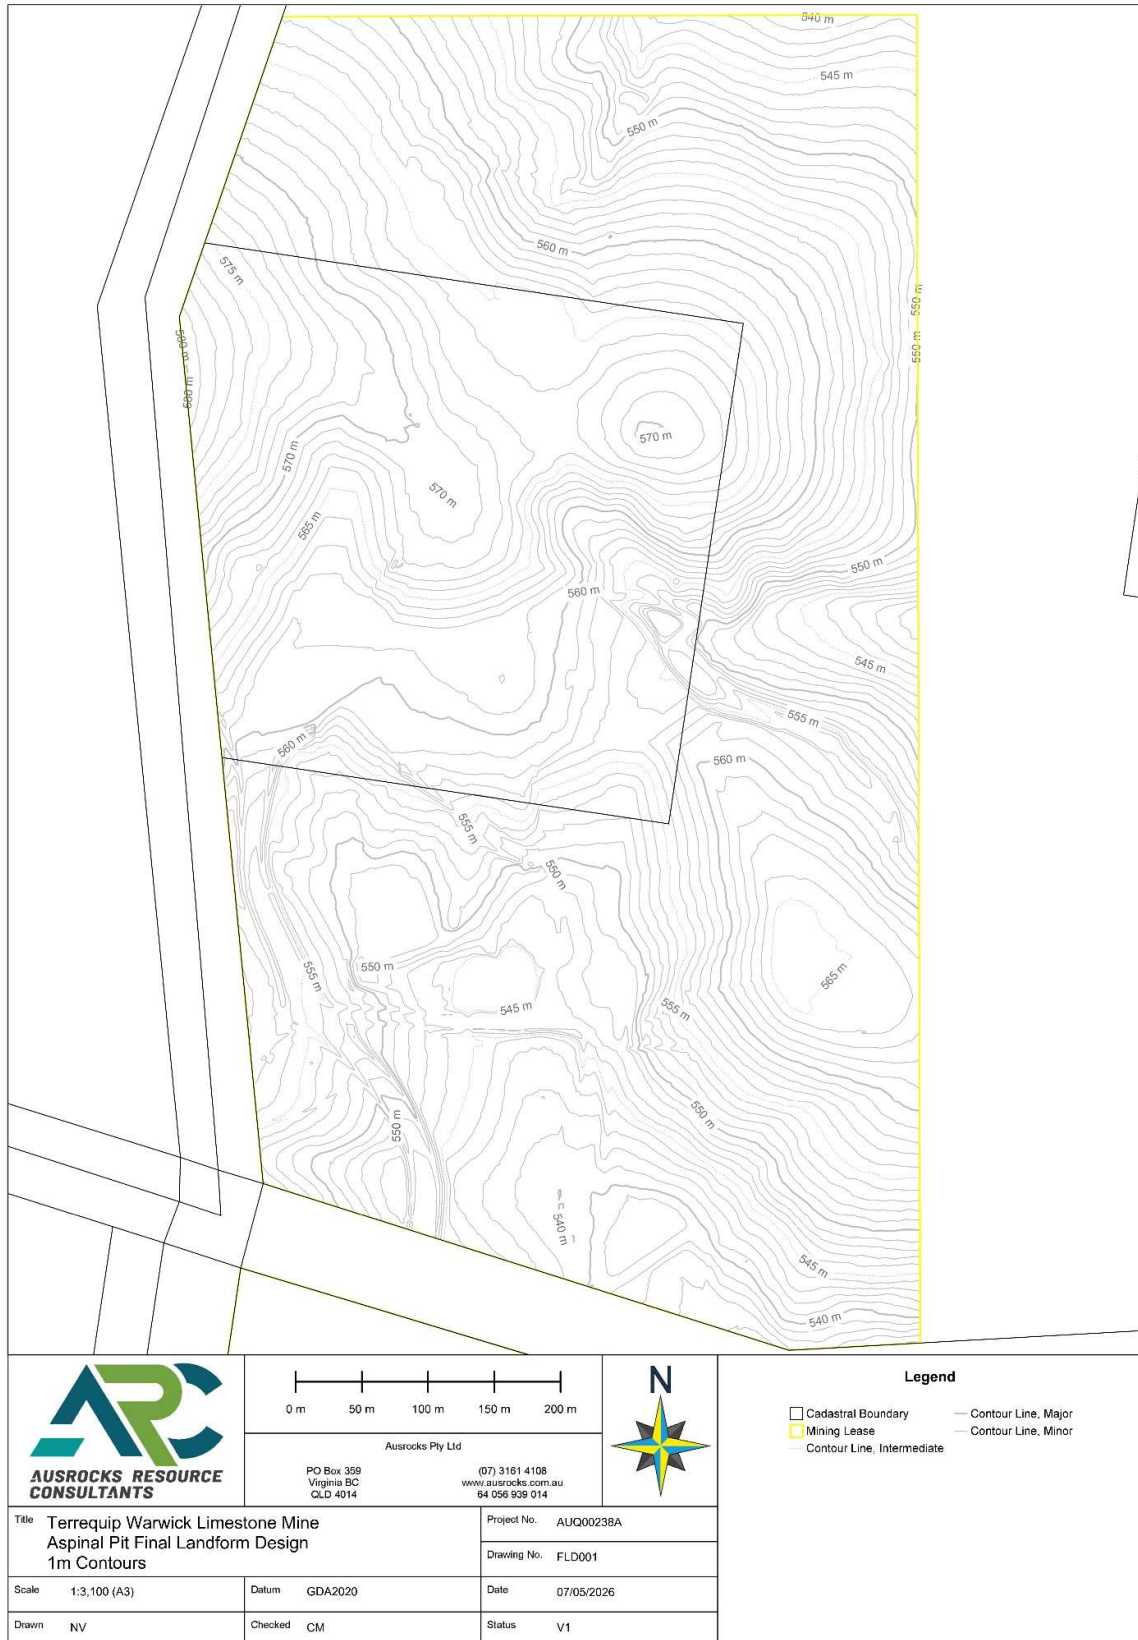
Figure 20: Aspal Pit Final Landform Design (1m contours)

**Figure 20 to Figure 22** illustrate the final landform contours of each pit area.

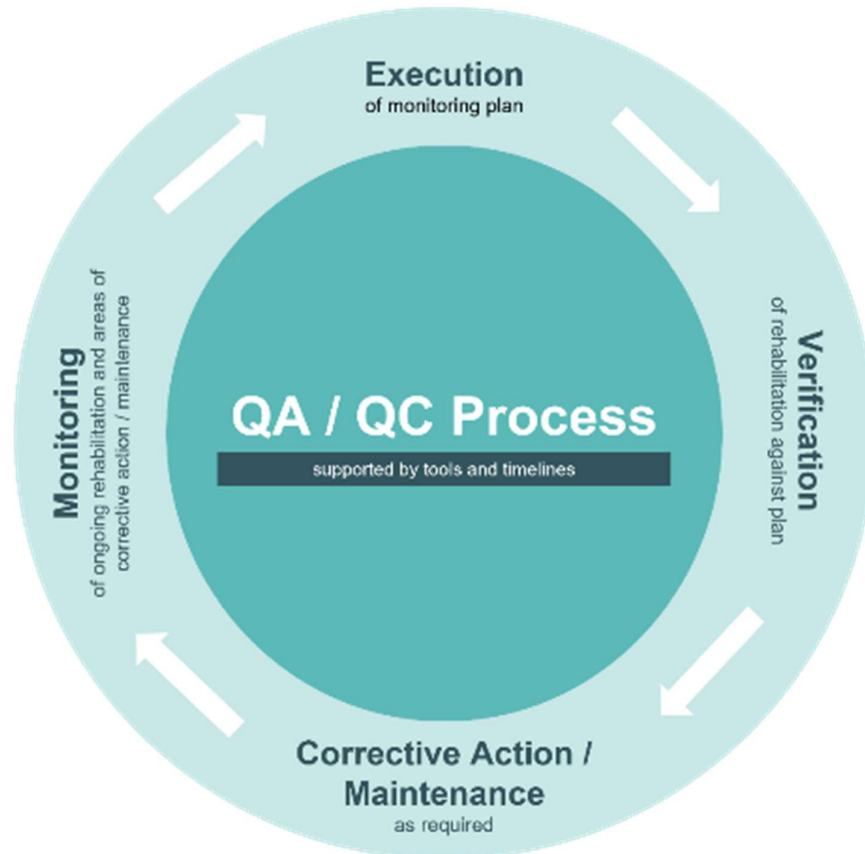
Figure 29: Quality assurance and quality control processes to be followed to support ongoing rehabilitation monitoring at Warwick Limestone

- verification of how the execution was conducted in accordance with rehabilitation measures;
- if required, the implementation of corrective action/maintenance in rehabilitation areas; and
- further rehabilitation monitoring of rehabilitation and corrected/maintained areas.

The QA/QC process allows for repetition for an execution/verification/monitoring approach to ensure rehabilitation areas continue to progress towards achieving rehabilitation milestones and future certification.
