# **Report on the Soil Survey of Leases of the Warwick Limestone Quarry**

Prepared for: Ausrocks

Revision 1.0 (Final report)

Revision date: 16/09/2022

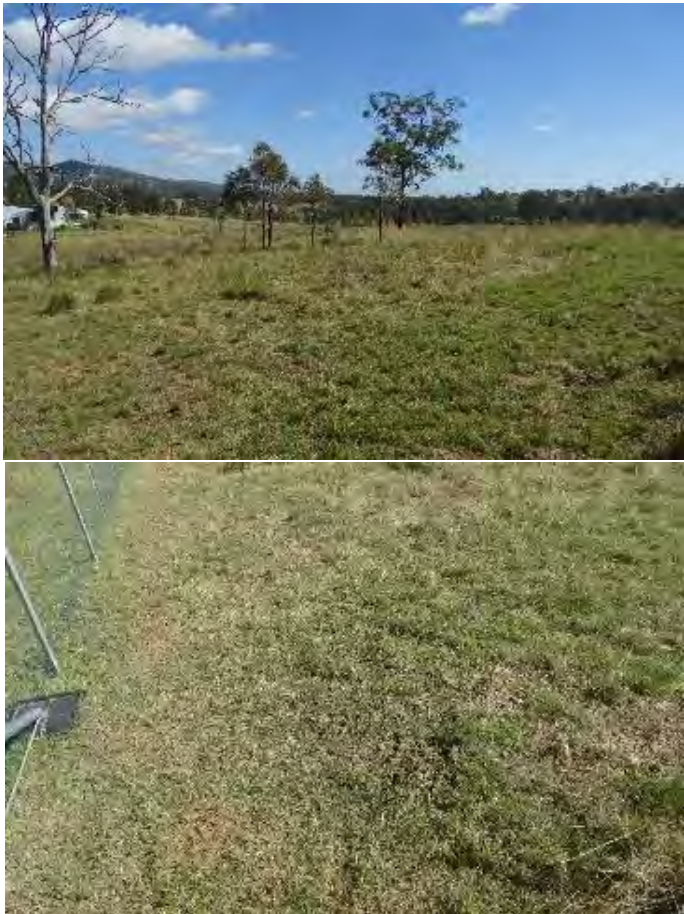
| Site number | Description | Photos |
|---|---|---|
| <p>Site ID: TW01<br/> <b>Location:</b> S28.39514° E152.10617°<br/> <b>Described by:</b> Dan Rattray<br/> <b>Date:</b> 22/03/2022<br/> <b>Geology:</b> Bald hill formation, Mafites<br/> <b>Landform pattern:</b> Low Hills<br/> <b>Element:</b> Midslope<br/> <b>Permeability:</b> Moderately permeable<br/> <b>Microrelief:</b> None<br/> <b>Drainage:</b> Well drained<br/> <b>Rock outcrop:</b> Slightly rocky<br/> <b>Surface coarse fragments:</b> Nil<br/> <b>Surface condition:</b> Firm<br/> <b>Disturbance:</b> Extensive clearing<br/> <b>Sample site:</b> Nil</p> | <p><b>Australian Soil Classification (ASC): Red Dermosol</b></p> <p><b>A1</b> Reddish brown (5YR 4/4) silty light clay with weak polyhedral structure, to 0.2m, clear change to;</p> <p><b>B21</b> Yellowish red (5YR 4/6) medium clay with moderate polyhedral structure, with many yellow and black mottles, common manganese, to 0.65m, diffuse change to;</p> <p><b>B22</b> Brownish Yellow (10YR 6/8) silty medium clay with weak polyhedral structure, with many red mottles, to 0.95m, diffuse change to;</p> <p><b>C</b> Brownish Yellow (10YR 6/8) silty light clay with weak polyhedral structure, to 1.5m.</p> | |

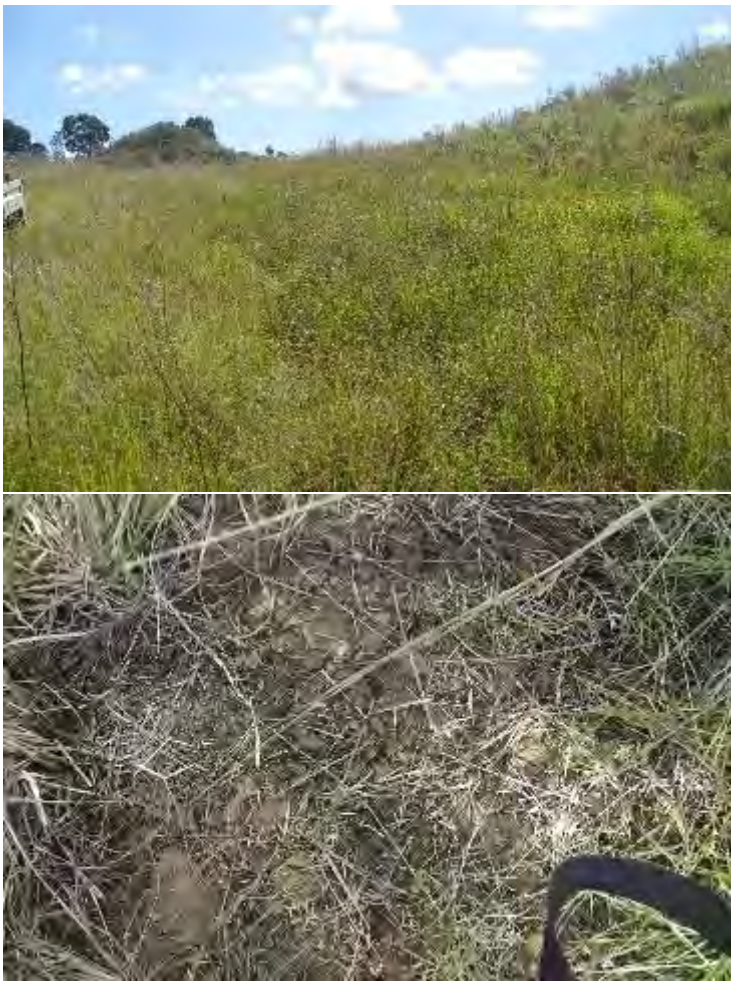
| Site number | Description | Photos |
|---|---|---|
| <p> <b>Site ID:</b> TW02<br/> <b>Location:</b> S28.39620° E152.10601°<br/> <b>Described by:</b> Dan Rattray<br/> <b>Date:</b> 22/03/2022<br/> <b>Geology:</b> Bald hill formation, Mafites<br/> <b>Landform pattern:</b> Low Hills<br/> <b>Element:</b> Midslope<br/> <b>Permeability:</b> Slowly permeable<br/> <b>Microrelief:</b> None<br/> <b>Drainage:</b> Imperfectly drained<br/> <b>Rock outcrop:</b> Slightly rocky<br/> <b>Surface condition:</b> Firm<br/> <b>Disturbance:</b> Extensive clearing<br/> <b>Sample site:</b> Nil </p> | <p><b>ASC: Brown Dermosol</b></p> <p><b>A1</b> Very dark greyish brown (2.5Y 3/2) silty light clay with moderate polyhedral structure, many small gravel on surface, to 0.15m, clear change to;</p> <p><b>B2</b> Oliver brown (2.5Y 4/4) medium clay with weak polyhedral structure, common medium gravel, with many yellow and grey mottles, a few manganese, to 0.45m, clear change to;</p> <p><b>B3</b> Dark grey (2.5Y 4/1) light clay with massive nil structure, with many yellow and red mottles, to 0.6m, gradual change to;</p> <p><b>C</b> Dark grey (2.5Y 4/1) fine sandy light clay, to 1.5m.</p> | |

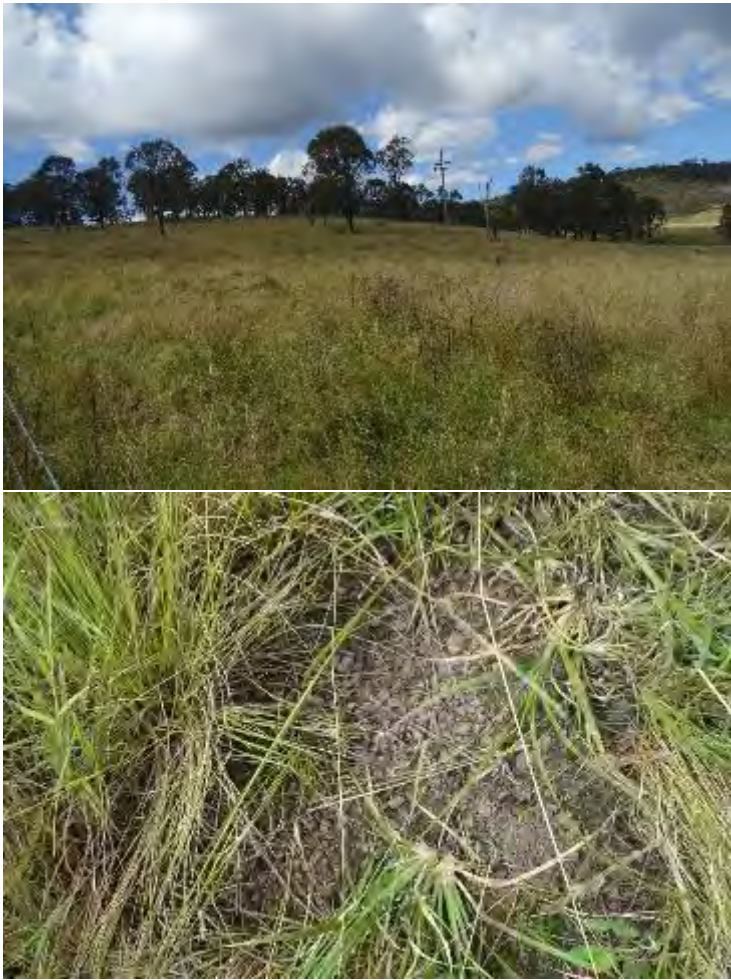
| Site number | Description | Photos |
|---|---|---|
| <p> <b>Site ID:</b> TW03<br/> <b>Location:</b> S28.39717° E152.10642°<br/> <b>Described by:</b> Dan Rattray<br/> <b>Date:</b> 22/03/2022<br/> <b>Geology:</b> Bald hill formation, Mafites<br/> <b>Landform pattern:</b> Low Hills<br/> <b>Element:</b> Midslope<br/> <b>Permeability:</b> Moderately permeable<br/> <b>Microrelief:</b> None<br/> <b>Drainage:</b> Well drained<br/> <b>Rock outcrop:</b> No bedrock exposed<br/> <b>Surface condition:</b> Firm<br/> <b>Disturbance:</b> Extensive clearing<br/> <b>Sample site:</b> Nil </p> | <p><b>ASC: Red Dermosol</b></p> <p><b>A1</b> Very dark greyish brown (2.5Y 3/2) silty light clay with moderate polyhedral structure, many small gravel on surface, to 0.15m, clear change to;</p> <p><b>B2</b> Yellowish red (5YR 4/6) medium clay with weak polyhedral structure, common medium gravel, with many yellow and black mottles, a few manganese, to 0.45m, clear change to;</p> <p><b>B3</b> Dark grey (2.5Y 4/1) light clay with massive nil structure, with many yellow mottles, to 0.6m, gradual change to;</p> <p><b>C</b> Dark grey (2.5Y 4/1) fine sandy light clay, to 1.5m.</p> | |

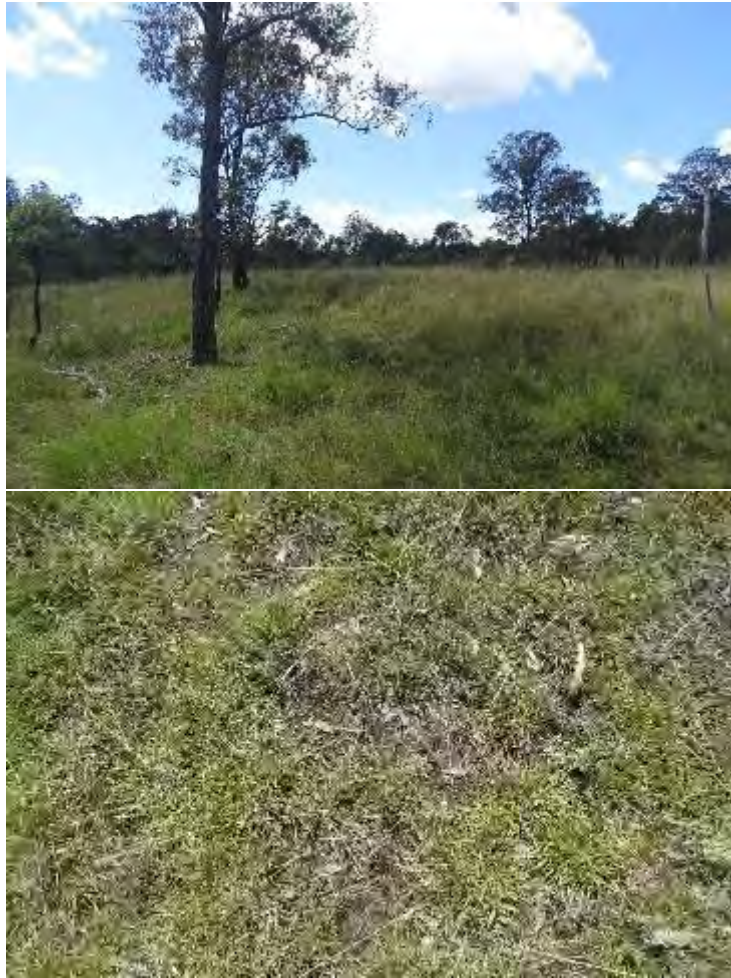
| Site number | Description | Photos |
|---|---|---|
| <p> <b>Site ID:</b> TW04<br/> <b>Location:</b> S28.39957° E152.10568°<br/> <b>Described by:</b> Dan Rattray<br/> <b>Date:</b> 22/03/2022<br/> <b>Geology:</b> Bald hill formation, Mafites<br/> <b>Landform pattern:</b> Low Hills<br/> <b>Element:</b> Bottom hill<br/> <b>Permeability:</b> Slowly permeable<br/> <b>Microrelief:</b> None<br/> <b>Drainage:</b> Poorly drained<br/> <b>Rock outcrop:</b> No bedrock exposed<br/> <b>Surface condition:</b> Firm<br/> <b>Disturbance:</b> Extensive clearing<br/> <b>Sample site:</b> Nil </p> | <p><b>ASC: Grey Tenosol</b></p> <p><b>A1</b> Dark brown (10YR 3/3) loamy sand with massive nil structure, common small gravel, to 0.15m, clear change to;</p> <p><b>B2</b> Light brownish grey (10YR 6/2) loamy sand with massive nil structure, common small gravel, to 0.6m, diffuse change to;</p> <p><b>B31</b> Light yellowish brown (10YR 6/4) coarse sandy clay with massive nil structure, many small gravel, to 0.9m, clear change to;</p> <p><b>B32</b> Yellowish brown (10YR 5/6) clayey sand with massive nil structure, common small gravel, with abundant grey and a few black mottles, common iron-manganese, to 1.2m.</p> | |

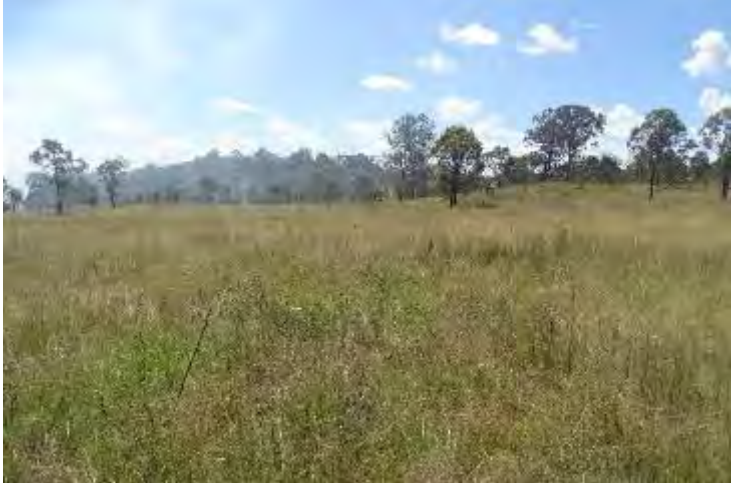
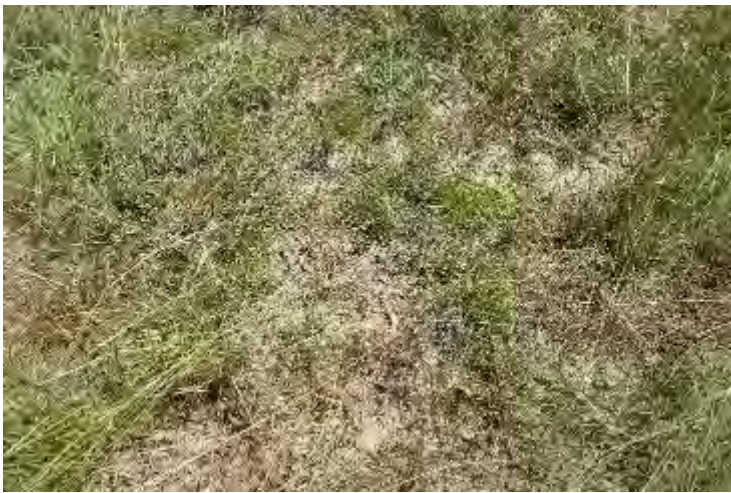
| Site number | Description | Photos |
|---|---|---|
| <p> <b>Site ID:</b> TW05<br/> <b>Location:</b> S28.40045° E152.10563°<br/> <b>Described by:</b> Dan Rattray<br/> <b>Date:</b> 22/03/2022<br/> <b>Geology:</b> Bald hill formation, Mafites<br/> <b>Landform pattern:</b> Low Hills<br/> <b>Element:</b> Bottom hill<br/> <b>Permeability:</b> Moderately permeable<br/> <b>Microrelief:</b> None<br/> <b>Drainage:</b> Well drained<br/> <b>Rock outcrop:</b> No bedrock exposed<br/> <b>Surface condition:</b> Loose<br/> <b>Disturbance:</b> Extensive clearing<br/> <b>Sample site:</b> <b>SITE 1</b> </p> | <p><b>ASC: Brown Tenosol</b></p> <p><b>Description</b></p> <p><b>A1</b> Brown (10YR 4/3) loamy sand, non-coherent structure, abundant small gravel on surface and common through horizon, to 0.35m, clear change to;</p> <p><b>B2</b> Brown (10YR 5/3) loamy sand, non-coherent structure, common small gravel, to 0.6m, diffuse change to;</p> <p><b>C</b> Brown (7.5YR 5/3) clayey sand, non-coherent structure, abundant small gravel, to 1.5m.</p> | |

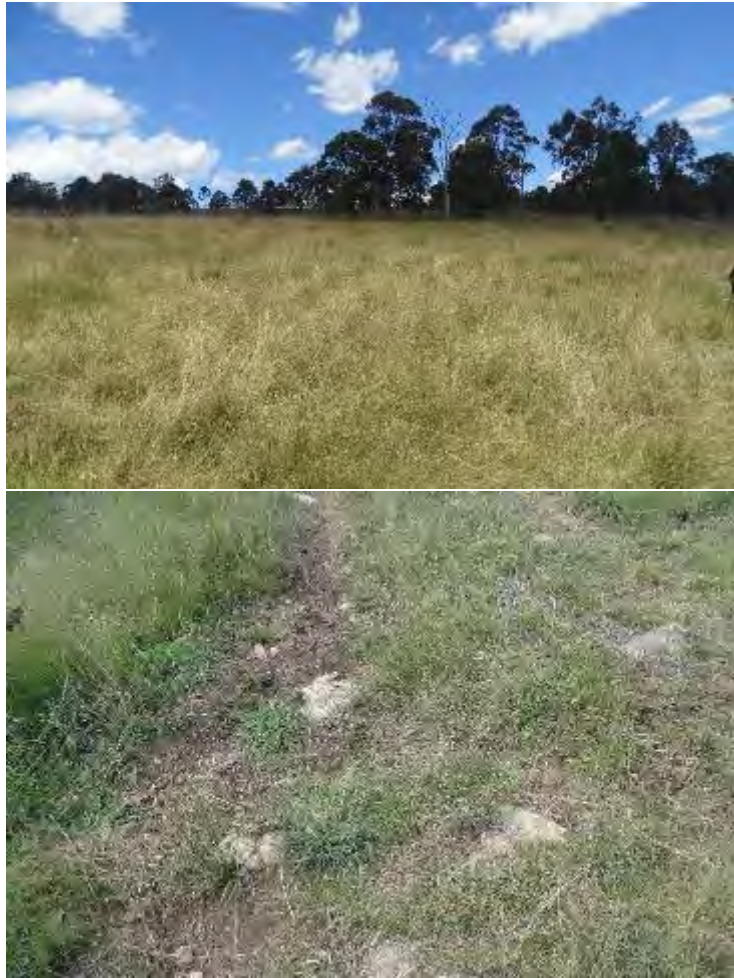
| Site number | Description | Photos |
|---|---|---|
| <p>Site ID: TW06<br/> Location: S28.39923° E152.10736°<br/> Described by: Dan Rattray<br/> Date: 22/03/2022<br/> Geology: Bald hill formation, Limestone<br/> Landform pattern: Low Hills<br/> Element: Midslope<br/> Permeability: Moderately permeable<br/> Microrelief: None<br/> Drainage: Imperfectly drained<br/> R Rock outcrop: Rocky<br/> Surface condition: Firm<br/> Disturbance: Extensive clearing<br/> Sample site: Nil</p> | <p><b>ASC: Brown Dermosol</b></p> <p><b>A1</b> Very dark greyish brown (10YR 3/2) heavy clay with strong polyhedral structure, a few small and medium gravel, to 0.2m, clear change to;</p> <p><b>B2</b> Dark brown (10YR 3/3) heavy clay with moderate polyhedral structure, with a few red mottles, to 0.5m, clear change to;</p> <p><b>B3</b> Olive brown (2.5Y 4/3) heavy clay with weak polyhedral structure, many small gravel, with common dark mottles, a few manganese, to 0.9m.</p> <p>Refusal on rock</p> | |

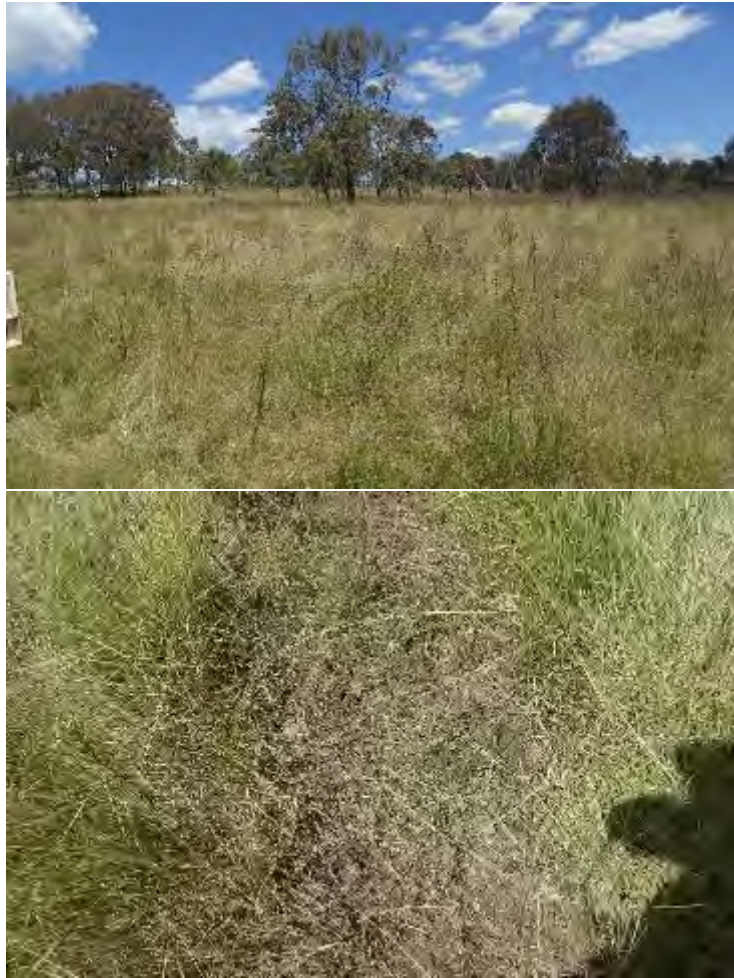
| Site number | Description | Photos |
|---|---|---|
| <p> <b>Site ID:</b> TW07<br/> <b>Location:</b> S28.39933° E152.10901°<br/> <b>Described by:</b> Dan Rattray<br/> <b>Date:</b> 22/03/2022<br/> <b>Geology:</b> Bald hill formation, Mafites<br/> <b>Landform pattern:</b> Low Hills<br/> <b>Element:</b> Midslope<br/> <b>Permeability:</b> Moderately permeable<br/> <b>Microrelief:</b> None<br/> <b>Drainage:</b> Imperfectly drained<br/> <b>Rock outcrop:</b> No bedrock exposed<br/> <b>Surface condition:</b> Firm<br/> <b>Disturbance:</b> Extensive clearing<br/> <b>Sample site:</b> Nil </p> | <p><b>ASC: Red Dermosol</b></p> <p><b>A1</b> Very dark greyish brown (10YR 3/2) loam with weak polyhedral structure, to 0.15m, abrupt change to;</p> <p><b>B21</b> Reddish brown (5YR 4/4) medium clay with moderate polyhedral structure, with common grey mottles, to 0.45m, gradual change to;</p> <p><b>B22</b> Dark yellowish brown (10YR 4/4) medium clay with moderate polyhedral structure, many medium gravel, a few manganese, to 0.7m, clear change to;</p> <p><b>R</b> Grey (10YR 5/1) basalt.</p> | |

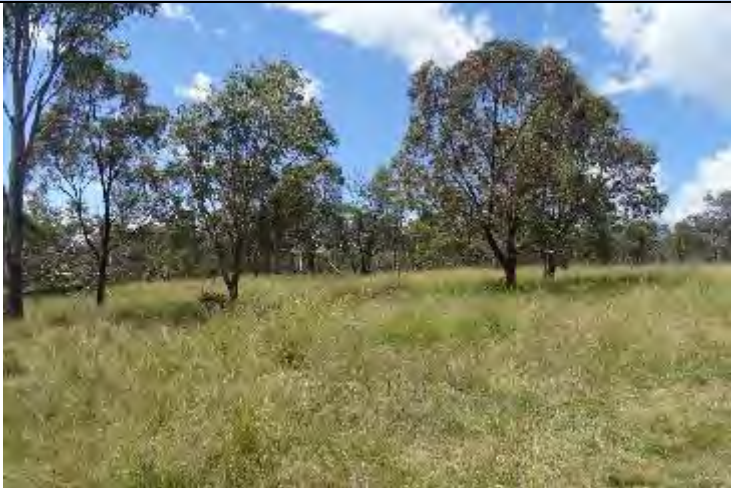
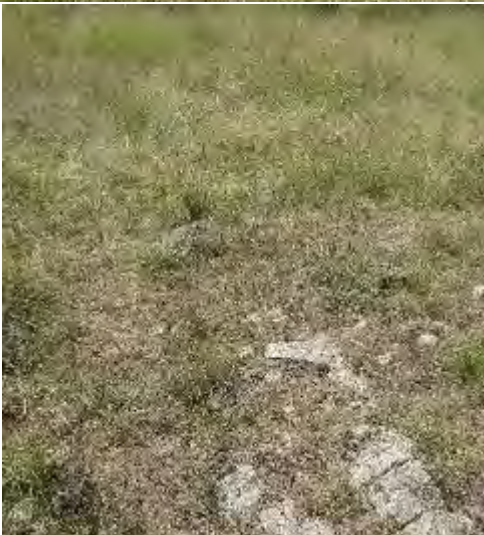
| Site number | Description | Photos |
|---|---|---|
| <p> <b>Site ID:</b> TW08<br/> <b>Location:</b> S28.40059° E152.10947°<br/> <b>Described by:</b> Dan Rattray<br/> <b>Date:</b> 22/03/2022<br/> <b>Geology:</b> Stanthorpe Granite<br/> <b>Landform pattern:</b> Low Hills<br/> <b>Element:</b> Midslope<br/> <b>Permeability:</b> Moderately permeable<br/> <b>Microrelief:</b> None<br/> <b>Drainage:</b> Well drained<br/> <b>Rock outcrop:</b> Rocky<br/> <b>Surface condition:</b> Loose<br/> <b>Disturbance:</b> Extensive clearing<br/> <b>Sample site:</b> Nil </p> | <p><b>ASC: Brown Tenosol</b></p> <p><b>A11</b> Dark brown (10YR 3/3) loamy sand with massive nil structure, common medium gravel, to 0.25m, clear change to;</p> <p><b>A12</b> Yellowish brown (10YR 5/6) loamy sand with massive nil structure, many medium gravel, to 0.5m, abrupt change to;</p> <p><b>R</b> White (7.5YR 8/1) granite.</p> | |

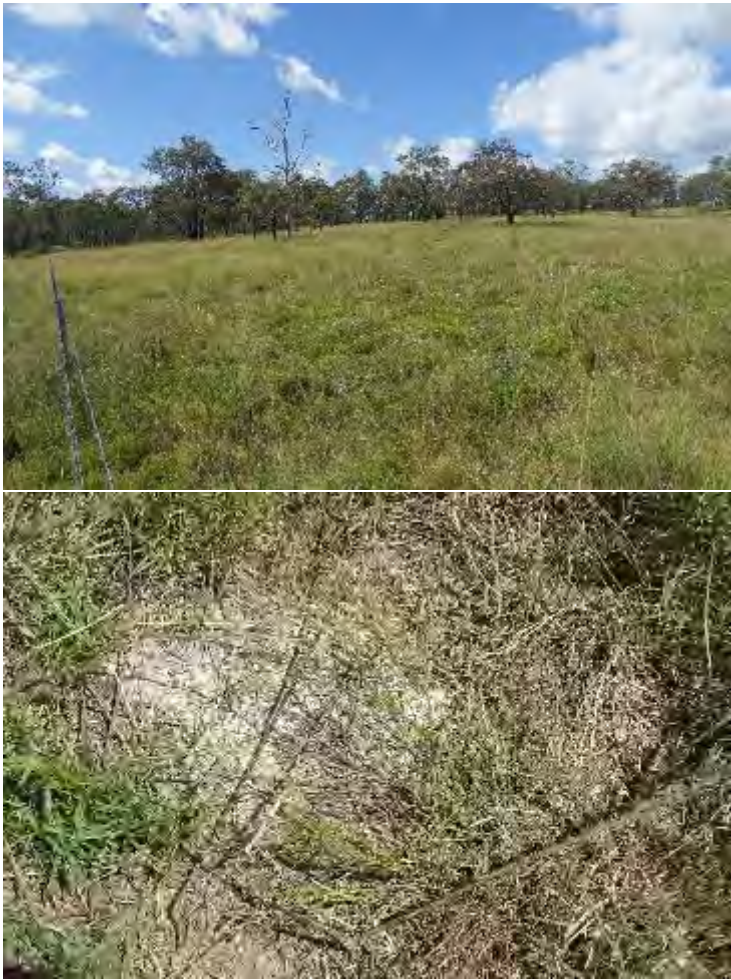
| Site number | Description | Photos |
|---|---|---|
| <p> <b>Site ID:</b> TW09<br/> <b>Location:</b> S28.40133° E152.10933°<br/> <b>Described by:</b> Dan Rattray<br/> <b>Date:</b> 22/03/2022<br/> <b>Geology:</b> Standthorpe Granite<br/> <b>Landform pattern:</b> Low Hills<br/> <b>Element:</b> Top<br/> <b>Permeability:</b> Moderately permeable<br/> <b>Microrelief:</b> None<br/> <b>Drainage:</b> Well drained<br/> <b>Rock outcrop:</b> No bedrock exposed<br/> <b>Surface condition:</b> Loose<br/> <b>Disturbance:</b> Extensive clearing<br/> <b>Sample site:</b> Nil </p> | <p><b>ASC: Brown Tenosol</b></p> <p><b>A1</b> Dark brown (10YR 3/3) loamy sand with massive nil structure, common medium gravel, to 0.15m, abrupt change to;</p> <p><b>B2</b> Yellowish brown (10YR 5/4) loamy sand with massive nil structure, many medium gravel, to 0.4m, clear change to;</p> <p><b>C</b> Reddish yellow (7.5YR 6/8) clayey sand with massive nil structure, abundant medium gravel, to 0.9m.</p> | |

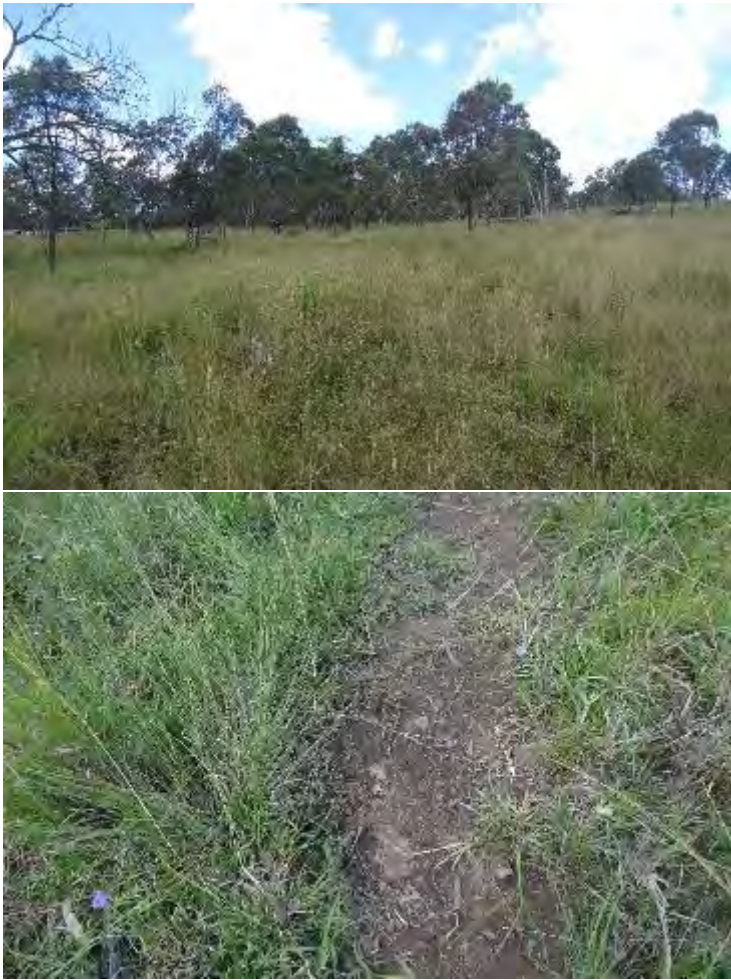
| Site number | Description | Photos |
|---|---|---|
| <p> <b>Site ID:</b> TW10<br/> <b>Location:</b> S28.39955° E152.10967°<br/> <b>Described by:</b> Dan Rattray<br/> <b>Date:</b> 22/03/2022<br/> <b>Geology:</b> Bald hill formation, Mafites<br/> <b>Landform pattern:</b> Low Hills<br/> <b>Element:</b> Midslope<br/> <b>Permeability:</b> Moderately permeable<br/> <b>Microrelief:</b> None<br/> <b>Drainage:</b> Imperfectly drained<br/> <b>Rock outcrop:</b> No bedrock exposed<br/> <b>Surface condition:</b> Firm<br/> <b>Disturbance:</b> Extensive clearing<br/> <b>Sample site:</b> <b>SITE 2</b> </p> | <p><b>ASC: Brown Sodosol</b></p> <p><b>A1</b> Very dark brown (10YR 2/2) sandy loam with weak polyhedral structure, a few small gravel, to 0.2m, abrupt change to;</p> <p><b>B2</b> Yellowish brown (10YR 5/6) medium heavy clay with weak polyhedral structure, many small gravel, with common dark mottles, a few manganese, to 1.3m.</p> | |

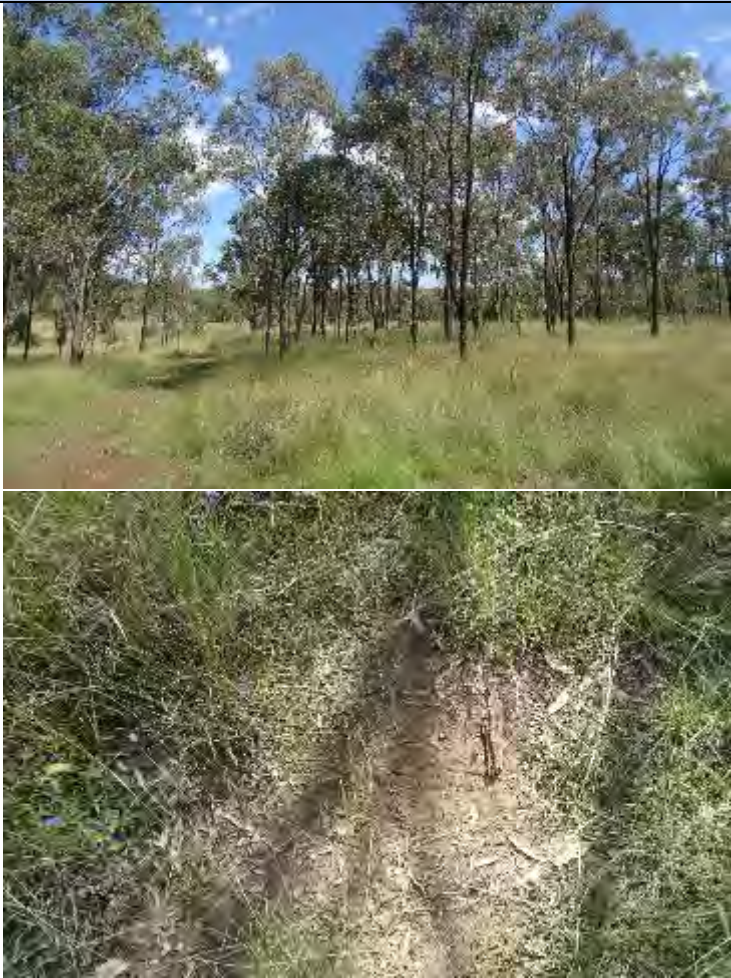
| Site number | Description | Photos |
|---|---|---|
| <p>Site ID: TW012<br/> Location: S28.39507° E152.11448°<br/> Described by: Dan Rattray<br/> Date: 22/03/2022<br/> Geology: Bald hill formation, Mafites<br/> Landform pattern: Low Hills<br/> Element: Drainage line<br/> Permeability: Slowly permeable<br/> Microrelief: None<br/> Drainage: Imperfectly drained<br/> Rock outcrop: No bedrock exposed<br/> Surface coarse fragments: A few large pebbles<br/> Surface condition: Self mulching<br/> Disturbance: Extensive clearing<br/> Sample site: <b>SITE 3</b></p> | <p><b>ASC: Brown Vertosol</b></p> <p><b>Description</b></p> <p><b>A1</b> Very dark brown (7.5YR 2.5/3) heavy clay with strong angular blocky structure, a few large pebbles on surface, to 0.1m, gradual change to;</p> <p><b>B21</b> Brown (7.5YR 4/2) heavy clay with moderate angular blocky structure, a few carbonates, to 0.8, gradual change to;</p> <p><b>B22</b> Brown (7.5YR 4/3) heavy clay with weak angular blocky structure, many medium gravel, with a few dark mottles, common carbonates and manganese concretions, to 1.3m, clear change to;</p> <p><b>C</b> Brown (7.5YR 4/3) silty light clay (siltstone), massive structure, with many yellow and red mottles, to 1.4m.</p> | |

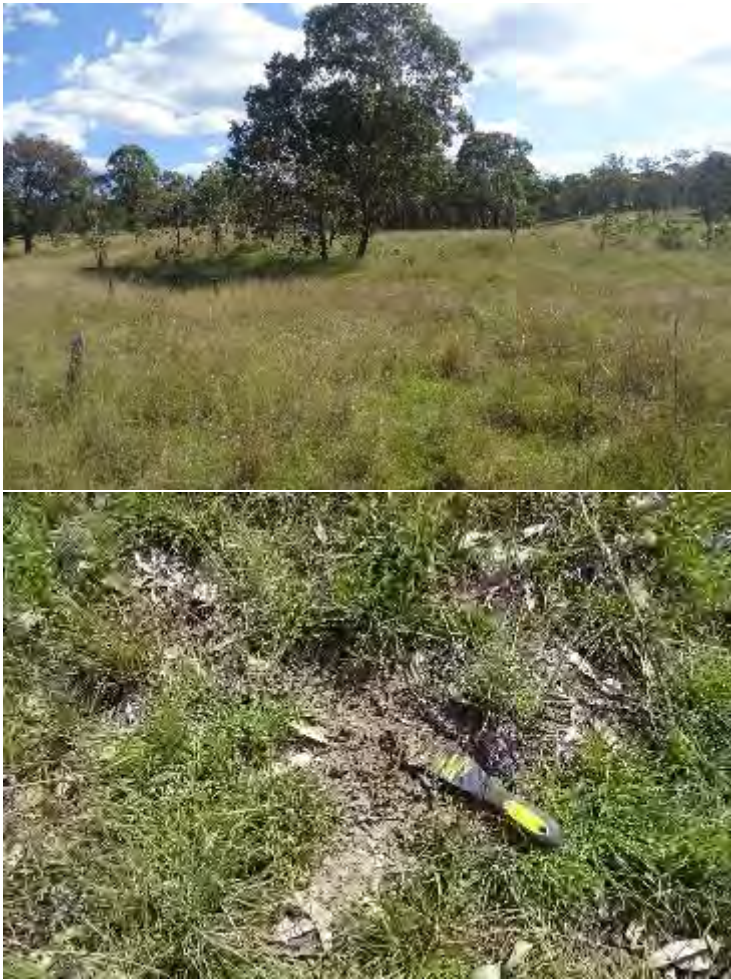
| Site number | Description | Photos |
|---|---|---|
| <p> <b>Site ID:</b> TW14<br/> <b>Location:</b> S28.39759° E152.11390°<br/> <b>Described by:</b> Dan Rattray<br/> <b>Date:</b> 22/03/2022<br/> <b>Geology:</b> Bald hill formation, Mafites<br/> <b>Landform pattern:</b> Low Hills<br/> <b>Element:</b> Midslope<br/> <b>Permeability:</b> Slowly permeable<br/> <b>Microrelief:</b> None<br/> <b>Drainage:</b> Imperfectly drained<br/> <b>Rock outcrop:</b> Slightly rocky<br/> <b>Surface condition:</b> Loose<br/> <b>Disturbance:</b> Extensive clearing<br/> <b>Sample site:</b> Nil </p> | <p><b>ASC: Brown Sodosol</b></p> <p><b>A1</b> Brown (10YR 5/3) sandy clay with weak granular structure, common medium gravel, to 0.2m, abrupt change to;</p> <p><b>B2</b> Strong brown (7.5YR 5/8) medium clay with weak polyhedral structure, many medium gravel, with many grey mottles, a few carbonates, to 0.8m, clear change to;</p> <p><b>B3</b> Strong brown (7.5YR 5/8) medium clay with massive nil structure, abundant medium and large gravel, with many grey mottles, a few carbonates, to 1.2m, clear change to;</p> <p><b>C</b> Yellowish brown (10YR 5/4) sandstone with massive nil structure, to 1.4m.</p> | |

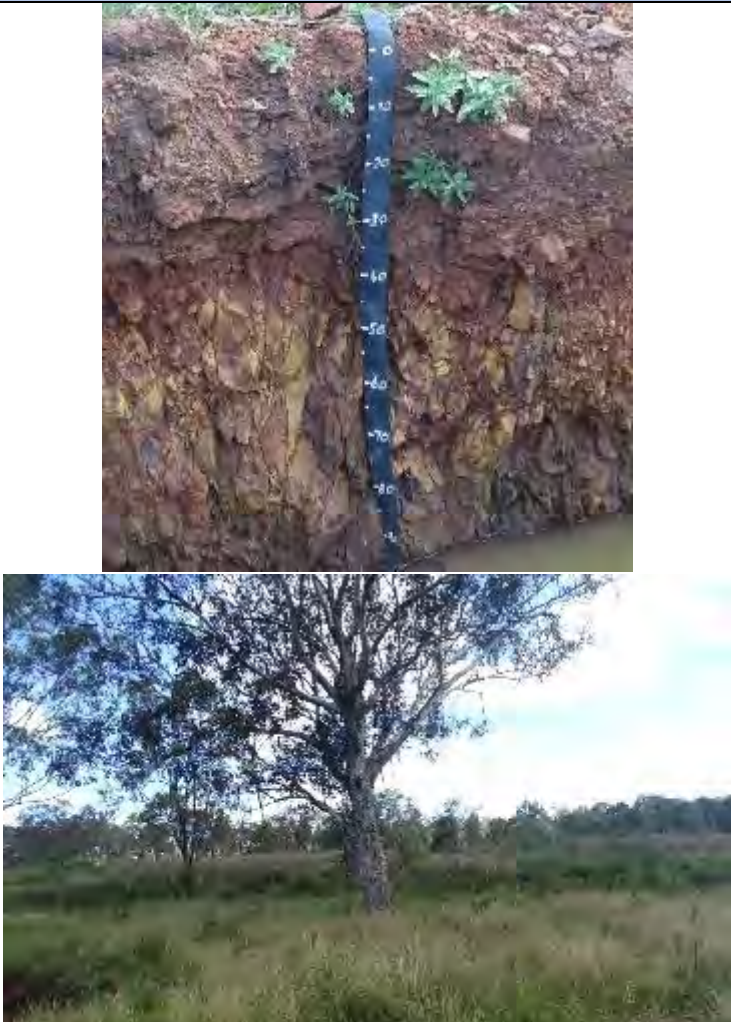
| Site number | Description | Photos |
|---|---|---|
| <p> <b>Site ID:</b> TW15<br/> <b>Location:</b> S28.39841° E152.11585°<br/> <b>Described by:</b> Dan Rattray<br/> <b>Date:</b> 22/03/2022<br/> <b>Geology:</b> Bald hill formation, Mafites<br/> <b>Landform pattern:</b> Low Hills<br/> <b>Element:</b> Midslope<br/> <b>Permeability:</b> Moderately permeable<br/> <b>Microrelief:</b> None<br/> <b>Drainage:</b> Imperfectly drained<br/> <b>Rock outcrop:</b> No bedrock exposed<br/> <b>Surface condition:</b> Firm<br/> <b>Disturbance:</b> Extensive clearing<br/> <b>Sample site:</b> Nil </p> | <p><b>ASC: Brown Dermosol</b></p> <p><b>A1</b> Very dark brown (7.5YR 2.5/3) heavy clay with strong angular blocky structure, a few large gravel on surface, to 0.1m, gradual change to;</p> <p><b>B21</b> Brown (7.5YR 4/2) heavy clay with moderate angular blocky structure, a few carbonates, to 0.8m, gradual change to;</p> <p><b>B22</b> Brown (7.5YR 4/3) heavy clay with weak angular blocky structure, many medium gravel, with a few dark mottles, common carbonates, to 1.3m, clear change to;</p> <p><b>C</b> Brown (7.5YR 4/3) silty light clay with massive angular blocky structure, with many yellow mottles, to 1.4m.</p> | |

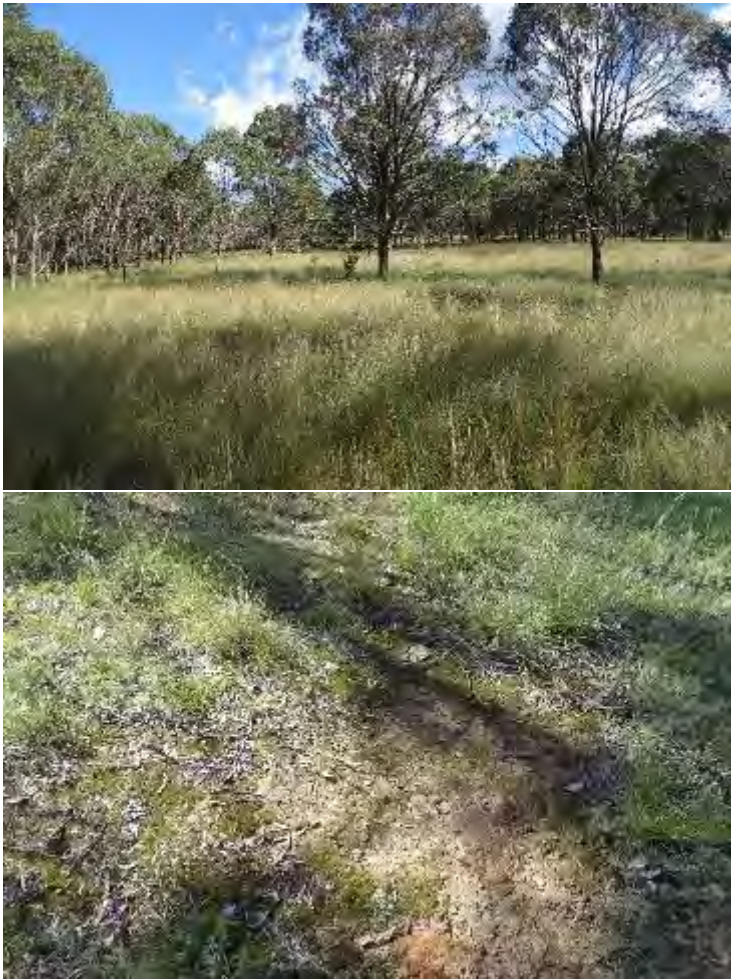
| Site number | Description | Photos |
|---|---|---|
| <p> <b>Site ID:</b> TW16<br/> <b>Location:</b> S28.39867° E152.11313°<br/> <b>Described by:</b> Dan Rattray<br/> <b>Date:</b> 22/03/2022<br/> <b>Geology:</b> Bald hill formation, Mafites<br/> <b>Landform pattern:</b> Low Hills<br/> <b>Element:</b> Top<br/> <b>Permeability:</b> Moderately permeable<br/> <b>Microrelief:</b> None<br/> <b>Drainage:</b> Imperfectly drained<br/> <b>Rock outcrop:</b> No bedrock exposed<br/> <b>Surface condition:</b> Firm<br/> <b>Disturbance:</b> Extensive clearing<br/> <b>Sample site:</b> Nil </p> | <p><b>ASC: Brown Sodosol</b></p> <p><b>A1</b> Very dark brown (7.5YR 2.5/3) loamy sand with weak granular structure, common small gravel, to 0.25m, abrupt change to;</p> <p><b>B2</b> Strong brown (7.5YR 5/6) medium clay with weak polyhedral structure, many small and medium gravel, with a few grey mottles, to 0.6m, abrupt change to;</p> <p><b>R</b> White (7.5YR 8/1) coarse grained rock.</p> | |

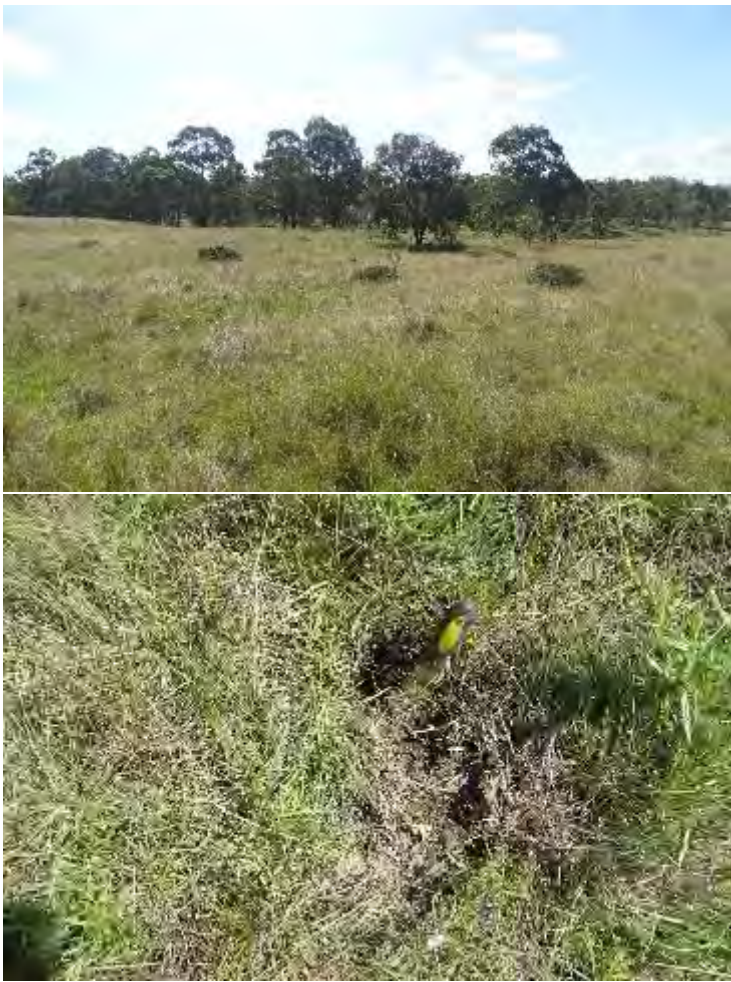
| Site number | Description | Photos |
|---|---|---|
| <p> <b>Site ID:</b> TW17<br/> <b>Location:</b> S28.39849° E152.11398°<br/> <b>Described by:</b> Dan Rattray<br/> <b>Date:</b> 22/03/2022<br/> <b>Geology:</b> Bald hill formation, Mafites<br/> <b>Landform pattern:</b> Low Hills<br/> <b>Element:</b> Top<br/> <b>Permeability:</b> Slowly permeable<br/> <b>Microrelief:</b> None<br/> <b>Drainage:</b> Imperfectly drained<br/> <b>Rock outcrop:</b> Slightly rocky<br/> <b>Surface condition:</b> Firm<br/> <b>Disturbance:</b> Extensive clearing<br/> <b>Sample site:</b> Nil </p> | <p><b>ASC: Brown Sodosol</b></p> <p><b>A1</b> Brown (10YR 5/3) sandy loam with weak granular structure, common medium gravel, to 0.2m, abrupt change to;</p> <p><b>B2</b> Strong brown (7.5YR 5/8) medium clay with weak polyhedral structure, many medium gravel, common carbonates, to 1.2m.</p> | |

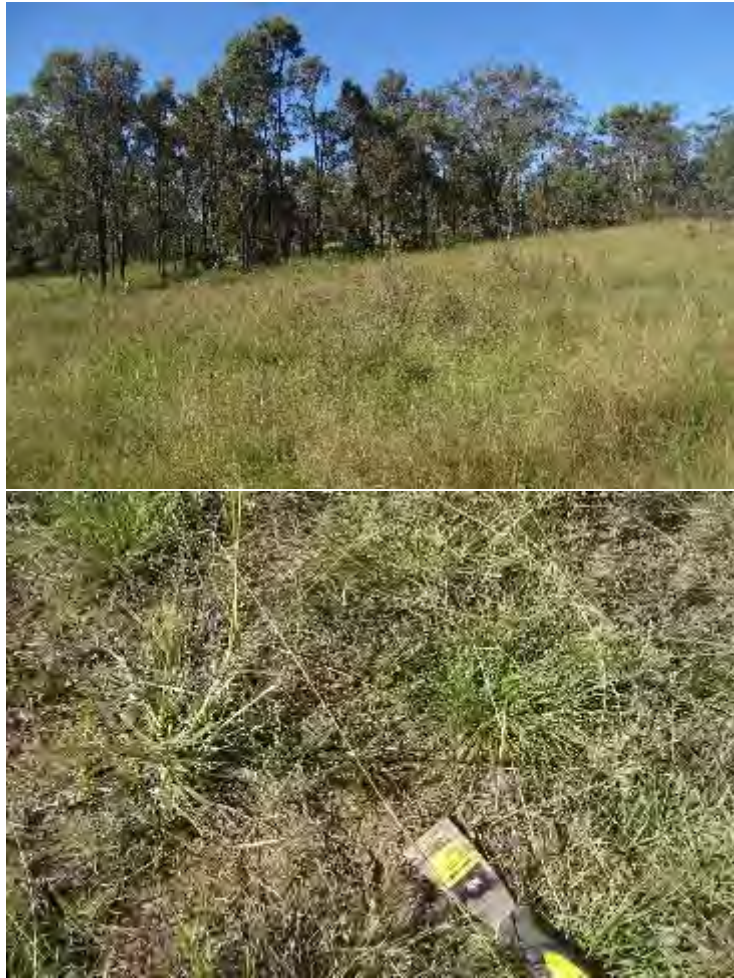
| Site number | Description | Photos |
|---|---|---|
| <p> <b>Site ID:</b> TW18<br/> <b>Location:</b> S28.39973° E152.11497°<br/> <b>Described by:</b> Dan Rattray<br/> <b>Date:</b> 22/03/2022<br/> <b>Geology:</b> Bald hill formation, Mafites<br/> <b>Landform pattern:</b> Low Hills<br/> <b>Element:</b> Top<br/> <b>Permeability:</b> Moderately permeable<br/> <b>Microrelief:</b> None<br/> <b>Drainage:</b> Moderly drained<br/> <b>Rock outcrop:</b> No bedrock exposed<br/> <b>Surface condition:</b> Hardsetting<br/> <b>Disturbance:</b> Extensive clearing<br/> <b>Sample site:</b> Nil </p> | <p><b>ASC: Red Sodosol</b></p> <p><b>A1</b> Brown (7.5YR 5/4) clayey sand with weak granular structure, common medium gravel, to 0.3m, abrupt change to;</p> <p><b>B2</b> Red (2.5YR 4/6) medium clay with weak polyhedral structure, many small gravel, with many dark/grey mottles, common manganese, to 1.4m.</p> | |

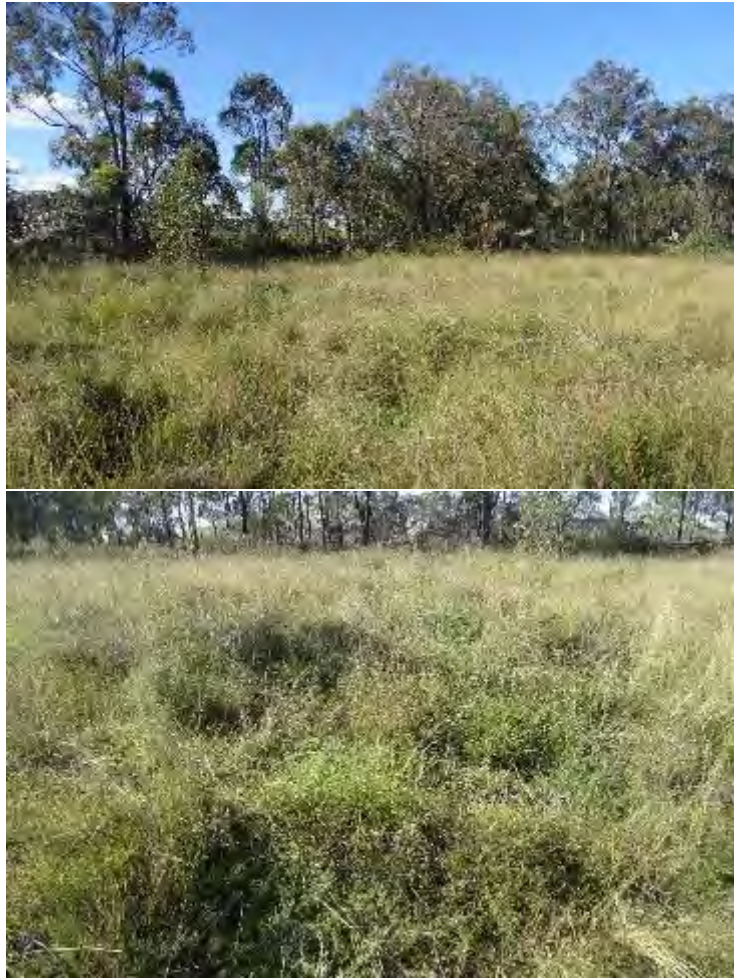
| Site number | Description | Photos |
|---|---|---|
| <p> <b>Site ID:</b> TW19<br/> <b>Location:</b> S28.40040° E152.11841°<br/> <b>Described by:</b> Dan Rattray<br/> <b>Date:</b> 23/03/2022<br/> <b>Geology:</b> Bald hill formation, Mafites<br/> <b>Landform pattern:</b> Low Hills<br/> <b>Element:</b> Top<br/> <b>Permeability:</b> Moderately permeable<br/> <b>Microrelief:</b> None<br/> <b>Drainage:</b> Imperfectly drained<br/> <b>Rock outcrop:</b> Slightly rocky<br/> <b>Surface condition:</b> Firm<br/> <b>Disturbance:</b> Extensive clearing<br/> <b>Sample site:</b> Nil </p> | <p><b>ASC: Red Sodosol</b></p> <p><b>A1</b> Very dark brown (7.5YR 2.5/3) sandy loam with moderate polyhedral structure, a few medium gravel, to 0.15m, abrupt change to;</p> <p><b>B2</b> Dark Red (2.5YR 3/6) light clay with moderate polyhedral structure, a few medium gravel, with a few yellow mottles, to 0.7m, abrupt change to;</p> <p><b>B3</b> Strong brown (7.5YR 5/6) light clay with massive nil structure, many medium and large gravel, with abundant grey/yellow mottles, to 1.3m.</p> | |

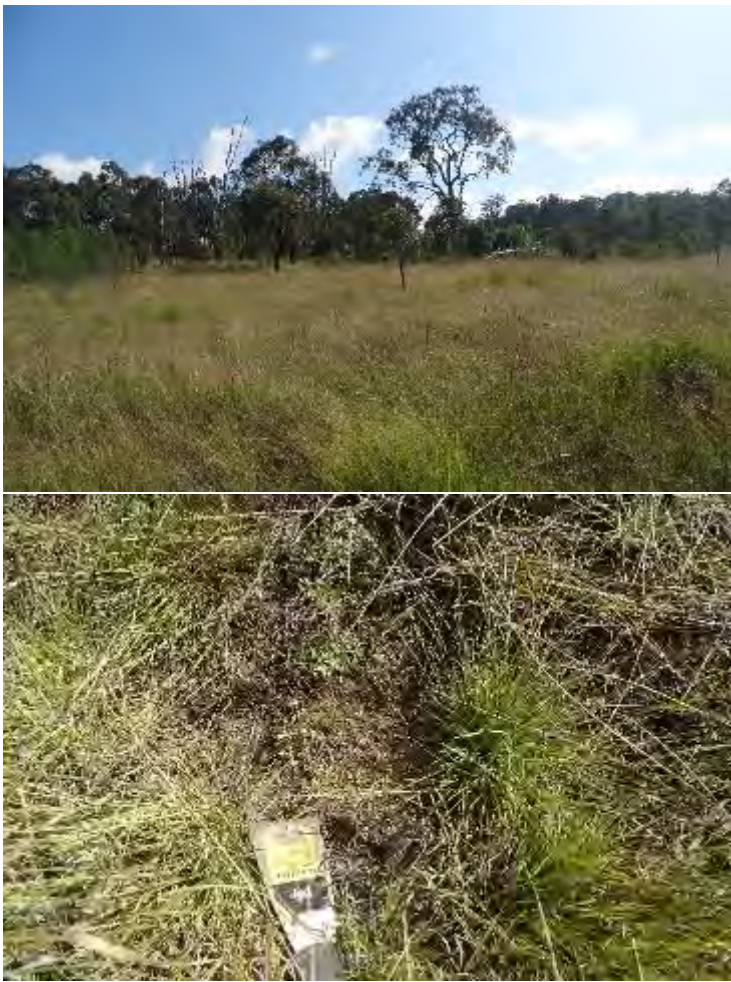
| Site number | Description | Photos |
|---|---|---|
| <p> <b>Site ID:</b> TW20<br/> <b>Location:</b> S28.40087° E152.12279°<br/> <b>Described by:</b> Dan Rattray<br/> <b>Date:</b> 23/03/2022<br/> <b>Geology:</b> Bald hill formation, Mafites<br/> <b>Landform pattern:</b> Low Hills<br/> <b>Element:</b> Bottom hill<br/> <b>Permeability:</b> Moderately permeable<br/> <b>Microrelief:</b> None<br/> <b>Drainage:</b> Poorly drained<br/> <b>Rock outcrop:</b> No bedrock exposed<br/> <b>Surface condition:</b> Loose<br/> <b>Disturbance:</b> Extensive clearing<br/> <b>Sample site:</b> Nil </p> | <p><b>ASC: Grey Tenosol</b></p> <p><b>A11</b> Dark greyish brown (10YR 4/2) loamy sand with weak granular structure, abundant small gravel on surface, to 0.3m, abrupt change to;</p> <p><b>A12</b> Pale brown (10YR 6/3) clayey sand with weak granular structure, many medium gravel, to 0.6m, clear change to;</p> <p><b>C</b> Pale brown (10YR 6/3) medium clay with massive nil structure, abundant medium gravel, with abundant red mottles, to 1.2m.</p> | |

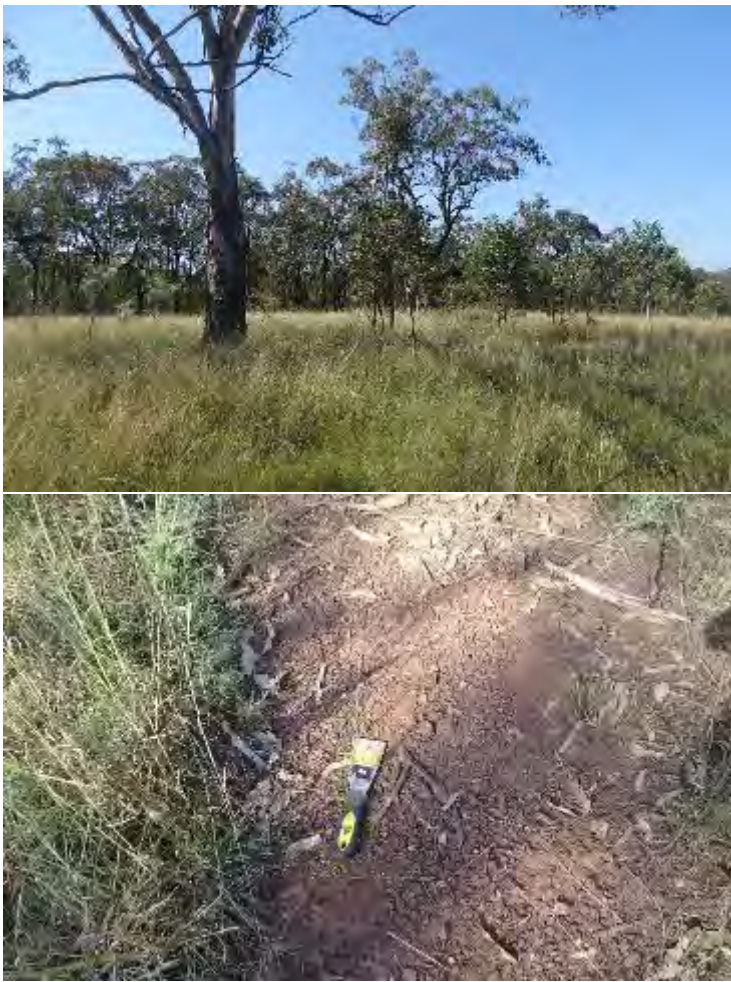
| Site number | Description | Photos |
|---|---|---|
| <p> <b>Site ID:</b> TW21<br/> <b>Location:</b> S28.39871° E152.12395°<br/> <b>Described by:</b> Dan Rattray<br/> <b>Date:</b> 23/03/2022<br/> <b>Geology:</b> Bald hill formation, Mafites<br/> <b>Landform pattern:</b> Low Hills<br/> <b>Element:</b> Top<br/> <b>Permeability:</b> Moderately permeable<br/> <b>Microrelief:</b> None<br/> <b>Drainage:</b> Imperfectly drained<br/> <b>Rock outcrop:</b> Rocky<br/> <b>Surface condition:</b> Hardsetting<br/> <b>Disturbance:</b> Extensive clearing<br/> <b>Sample site:</b> Nil </p> | <p><b>ASC: Red Sodosol</b></p> <p><b>A1</b> Dark reddish brown (5YR 3/4) silty light clay with weak granular structure, many small and medium gravel on surface, to 0.2m, abrupt change to;</p> <p><b>B2</b> Yellowish red (5YR 4/6) medium clay with moderate polyhedral structure, with a few yellow mottles, a few manganese, to 0.6m, clear change to;</p> <p><b>R</b> Reddish yellow (5YR 6/8) ironstone.</p> | |

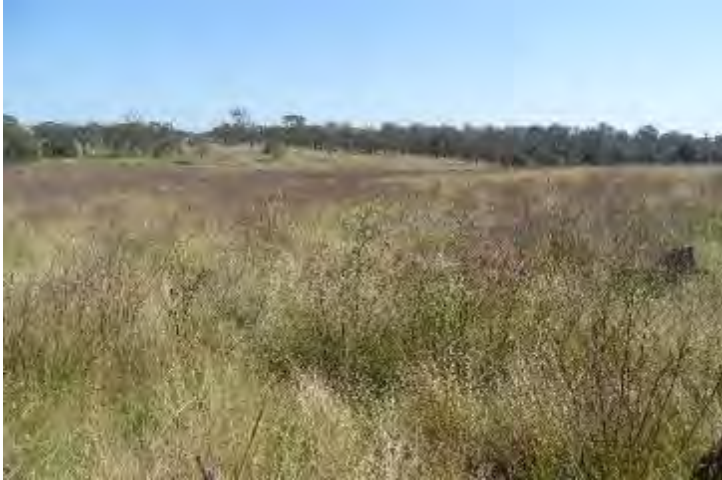
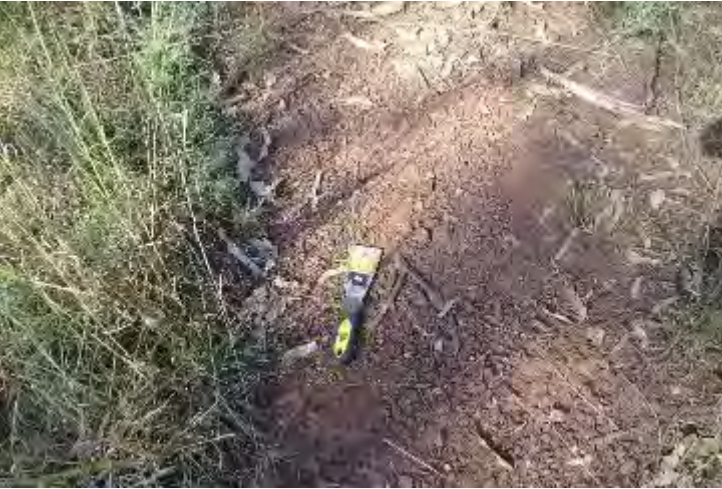
| Site number | Description | Photos |
|---|---|---|
| <p>Site ID: TW22<br/> Location: S28.39809° E152.12277°<br/> Described by: Dan Rattray<br/> Date: 23/03/2022<br/> Geology: Bald hill formation, Mafites<br/> Landform pattern: Low Hills<br/> Element: Broad valley<br/> Permeability: Slowly permeable<br/> Microrelief: None<br/> Drainage: Imperfectly drained<br/> Rock outcrop: No bedrock exposed<br/> Surface coarse fragments: A few medium pebbles<br/> Surface condition: Firm<br/> Disturbance: Complete clearing<br/> Sample site: <b>SITE 4</b></p> | <p><b>ASC: Red Sodosol</b></p> <p><b>Description</b></p> <p><b>A1</b> Very dark brown (7.5YR 2.5/3) clay loam with weak granular structure, a few medium pebbles on surface, to 0.3m, clear change to;</p> <p><b>B2</b> Yellowish red (5YR 4/6) medium clay with moderate polyhedral structure, many manganese concretions, to 1.0m, diffuse change to;</p> <p><b>B3</b> Dark reddish brown (5YR 3/4) silty light clay (siltstone) with moderate polyhedral structure, with abundant yellow and dark mottles and common carbonates, to 1.4m.</p> | |

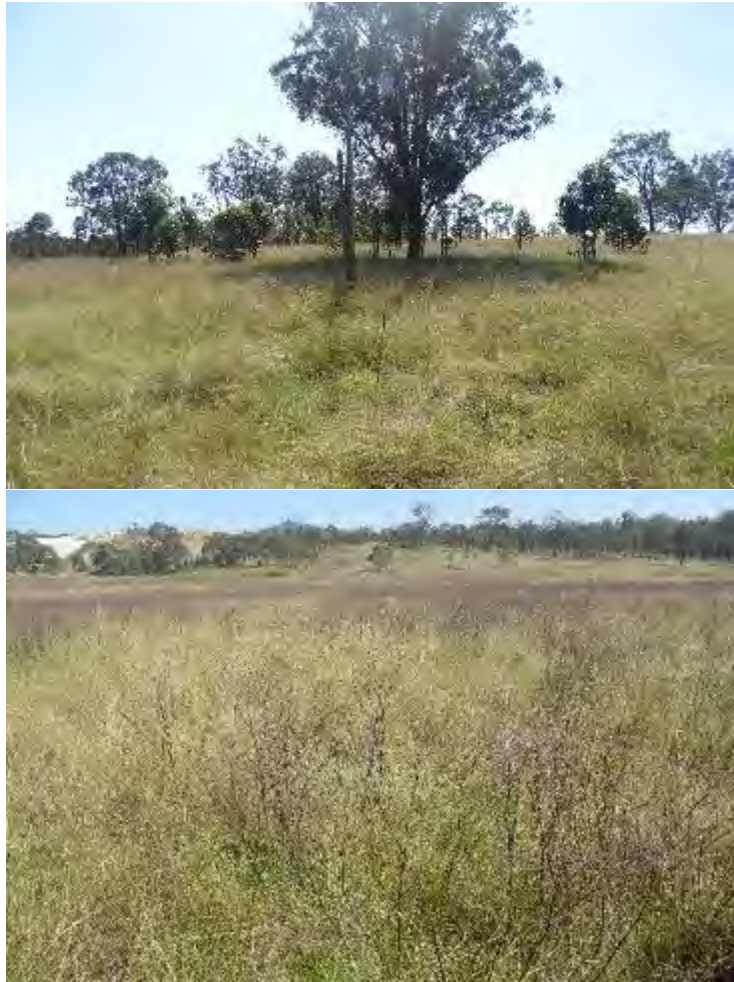
| Site number | Description | Photos |
|---|---|---|
| <p> <b>Site ID:</b> TW23<br/> <b>Location:</b> S28.39726° E152.12283°<br/> <b>Described by:</b> Dan Rattray<br/> <b>Date:</b> 23/03/2022<br/> <b>Geology:</b> Bald hill formation, Mafites<br/> <b>Landform pattern:</b> Low Hills<br/> <b>Element:</b> Midslope<br/> <b>Permeability:</b> Moderately permeable<br/> <b>Microrelief:</b> None<br/> <b>Drainage:</b> Poorly drained<br/> <b>Rock outcrop:</b> No bedrock exposed<br/> <b>Surface condition:</b> Loose<br/> <b>Disturbance:</b> Extensive clearing<br/> <b>Sample site:</b> Nil </p> | <p><b>ASC: Brown Sodosol</b></p> <p><b>A1</b> Dark brown (7.5YR 3/4) loamy sand with weak granular structure, to 0.2m, abrupt change to;</p> <p><b>B2</b> Strong brown (7.5YR 5/6) medium clay with weak polyhedral structure, a few medium gravel, with common dark mottles, common manganese, to 0.5m, clear change to;</p> <p><b>R</b> Grey (10YR 5/1) basalt.</p> | |

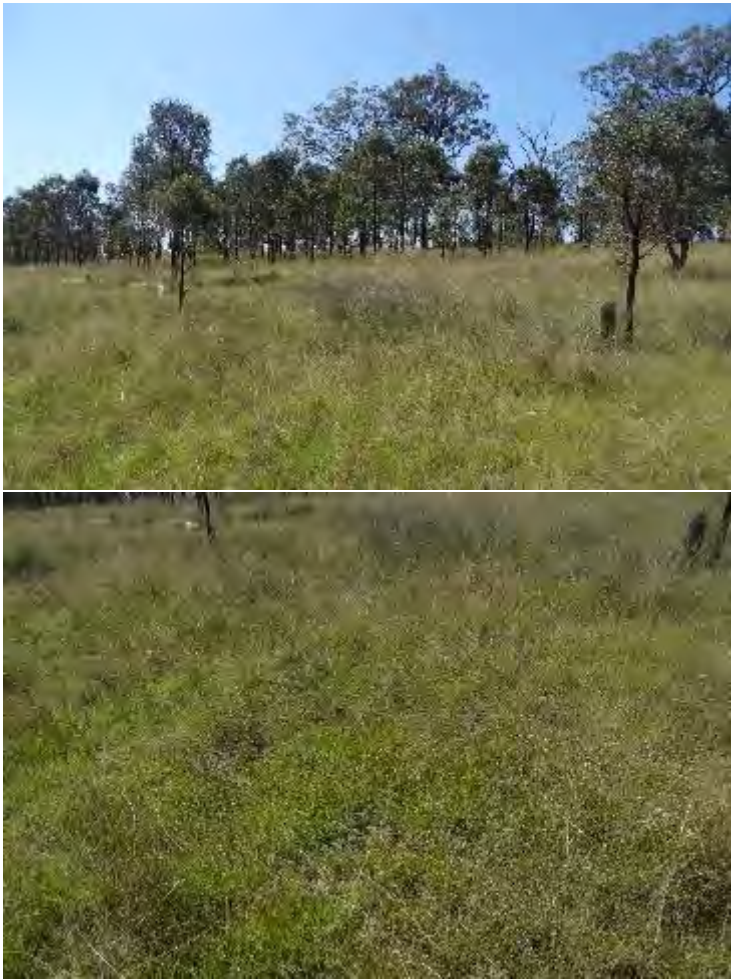
| Site number | Description | Photos |
|---|---|---|
| <p> <b>Site ID:</b> TW24<br/> <b>Location:</b> S28.39622° E152.12287°<br/> <b>Described by:</b> Dan Rattray<br/> <b>Date:</b> 23/03/2022<br/> <b>Geology:</b> Bald hill formation, Mafites<br/> <b>Landform pattern:</b> Low Hills<br/> <b>Element:</b> Midslope<br/> <b>Permeability:</b> Moderately permeable<br/> <b>Microrelief:</b> None<br/> <b>Drainage:</b> Imperfectly drained<br/> <b>Rock outcrop:</b> No bedrock exposed<br/> <b>Surface condition:</b> Firm<br/> <b>Disturbance:</b> Extensive clearing<br/> <b>Sample site:</b> Nil </p> | <p><b>ASC: Brown Sodosol</b></p> <p><b>A1</b> Very dark greyish brown (10YR 3/2) loam with weak granular structure, a very few medium gravel on surface, to 0.3m, abrupt change to;</p> <p><b>B2</b> Yellowish brown (10YR 5/6) light clay with weak polyhedral structure, with many grey/red mottles, a few manganese, to 0.8m, clear change to;</p> <p><b>R</b> Very dark grey (10YR 3/1) basalt.</p> | |
