# **Report on the Soil Survey of Leases of the Warwick Limestone Quarry**

Prepared for: Ausrocks

Revision 1.0 (Final report)

Revision date: 16/09/2022

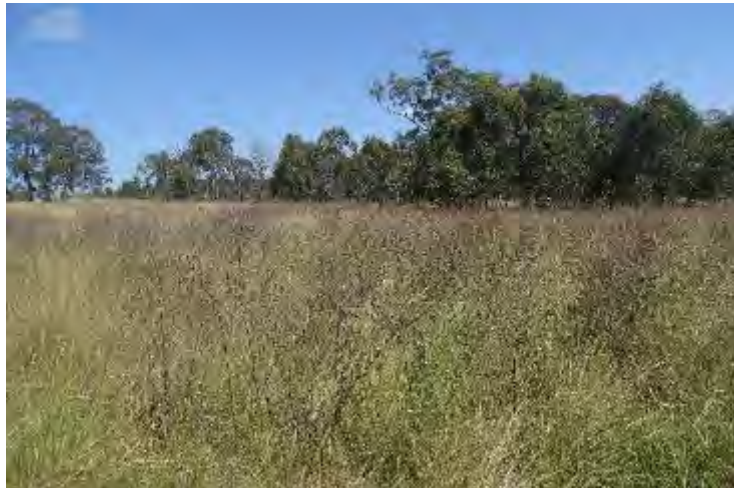
| Site number | Description | Photos |
|---|---|---|
| <p> <b>Site ID:</b> TW26<br/> <b>Location:</b> S28.39490° E152.12432°<br/> <b>Described by:</b> Dan Rattray<br/> <b>Date:</b> 23/03/2022<br/> <b>Geology:</b> Bald hill formation, Mafites<br/> <b>Landform pattern:</b> Low Hills<br/> <b>Element:</b> Bottom hill<br/> <b>Permeability:</b> Moderately permeable<br/> <b>Microrelief:</b> None<br/> <b>Drainage:</b> Poorly drained<br/> <b>Rock outcrop:</b> No bedrock exposed<br/> <b>Surface condition:</b> Firm<br/> <b>Disturbance:</b> Extensive clearing<br/> <b>Sample site:</b> Nil </p> | <p><b>ASC: Brown Dermosol</b></p> <p><b>A1</b> Very dark brown (10YR 2/2) silty light clay with weak polyhedral structure, to 0.2m, clear change to;</p> <p><b>B2</b> Very dark greyish brown (10YR 3/2) medium clay with strong polyhedral structure, common small and medium gravel, a few manganese, to 0.4m, gradual change to;</p> <p><b>B3</b> Dark yellowish brown (10YR 4/6) medium clay with weak polyhedral structure, abundant medium gravel, with abundant dark/grey mottles, many manganese, to 0.8m, gradual change to;</p> <p><b>R</b> Very dark greyish brown (10YR 3/2) basalt.</p> | |

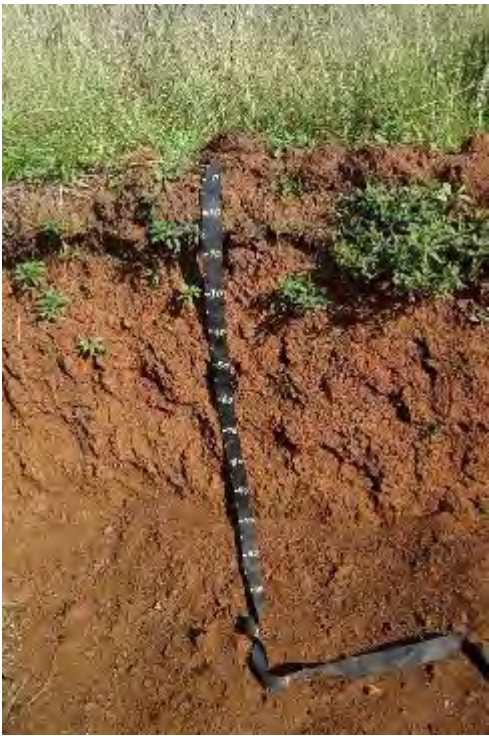
| Site number | Description | Photos |
|---|---|---|
| <p> <b>Site ID:</b> TW27<br/> <b>Location:</b> S28.39543° E152.11651°<br/> <b>Described by:</b> Dan Rattray<br/> <b>Date:</b> 23/03/2022<br/> <b>Geology:</b> Bald hill formation, Mafites<br/> <b>Landform pattern:</b> Low Hills<br/> <b>Element:</b> Bottom hill<br/> <b>Permeability:</b> Moderately permeable<br/> <b>Microrelief:</b> None<br/> <b>Drainage:</b> Well drained<br/> <b>Rock outcrop:</b> No bedrock exposed<br/> <b>Surface condition:</b> Firm<br/> <b>Disturbance:</b> Extensive clearing<br/> <b>Sample site:</b> Nil </p> | <p><b>ASC: Sodosol</b></p> | |

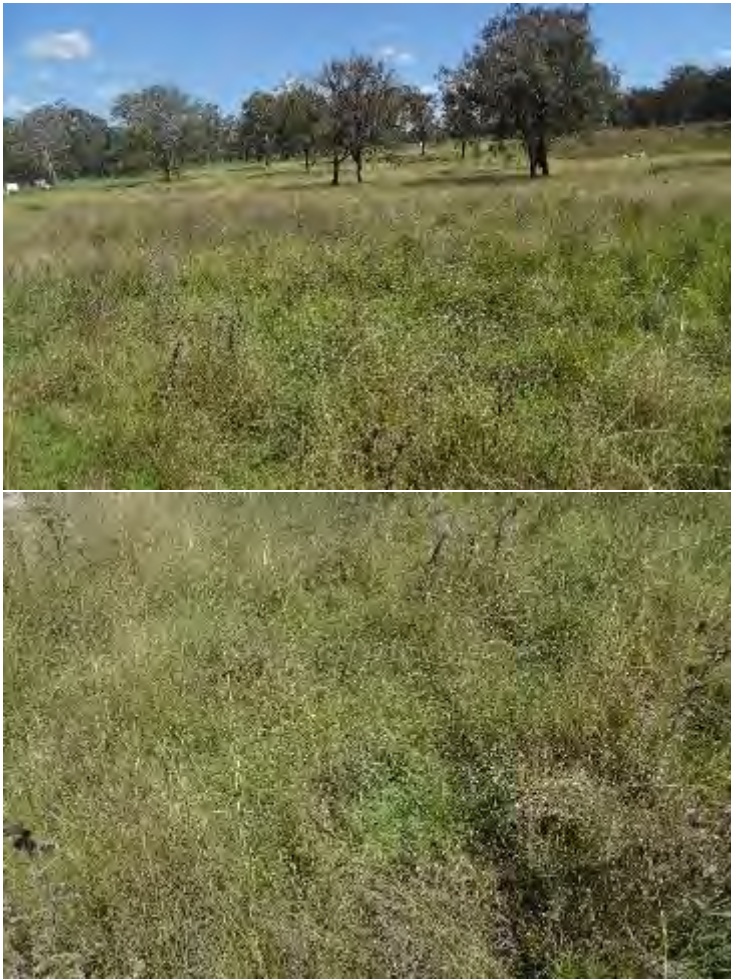
| Site number | Description | Photos |
|---|---|---|
| <p> <b>Site ID:</b> TW31<br/> <b>Location:</b> S28.39240° E152.11491°<br/> <b>Described by:</b> Dan Rattray<br/> <b>Date:</b> 23/03/2022<br/> <b>Geology:</b> Bald hill formation, Mafites<br/> <b>Landform pattern:</b> Low Hills<br/> <b>Element:</b> Bottom hill<br/> <b>Permeability:</b> Moderately permeable<br/> <b>Microrelief:</b> None<br/> <b>Drainage:</b> Imperfectly drained<br/> <b>Rock outcrop:</b> No bedrock exposed<br/> <b>Surface condition:</b> Firm<br/> <b>Disturbance:</b> Extensive clearing<br/> <b>Sample site:</b> Nil </p> | <p><b>ASC: Black Vertosol</b></p> <p><b>A1</b> Black (10YR 2/1) heavy clay with strong subangular blocky structure, a few medium gravel, to 0.1m, clear change to;</p> <p><b>B2</b> Black (10YR 2/1) heavy clay with strong subangular blocky structure, a few small gravel, common manganese, to 0.3m, clear change to;</p> <p><b>B3</b> Dark yellowish brown (10YR 4/4) heavy clay with strong subangular blocky structure, with many dark mottles, to 1.4m.</p> | |

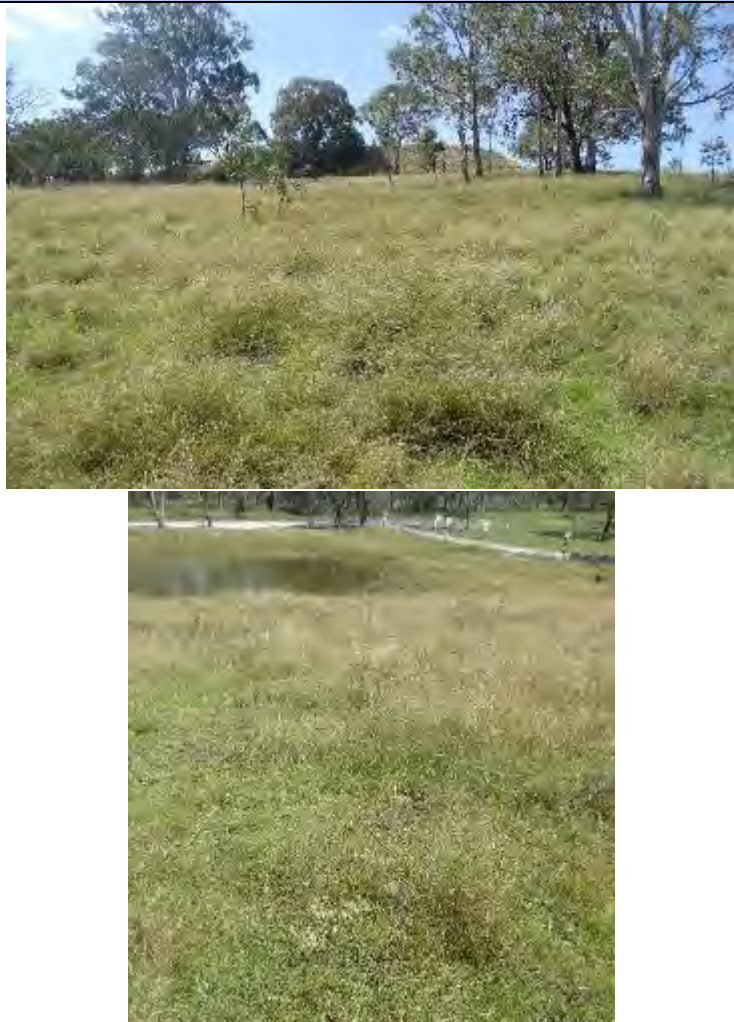
| Site number | Description | Photos |
|---|---|---|
| <p> <b>Site ID:</b> TW32<br/> <b>Location:</b> S28.39273° E152.11577°<br/> <b>Described by:</b> Dan Rattray<br/> <b>Date:</b> 23/03/2022<br/> <b>Geology:</b> Bald hill formation, Mafites<br/> <b>Landform pattern:</b> Low Hills<br/> <b>Element:</b> Midslope<br/> <b>Permeability:</b> Moderately permeable<br/> <b>Microrelief:</b> None<br/> <b>Drainage:</b> Imperfectly drained<br/> <b>Rock outcrop:</b> Slightly rocky<br/> <b>Surface condition:</b> Firm<br/> <b>Disturbance:</b> Extensive clearing<br/> <b>Sample site:</b> Nil </p> | <p><b>ASC: Brown Dermosol</b></p> <p><b>A1</b> Very dark brown (10YR 2/2) silty medium clay with moderate subangular blocky structure, common cobbles on surface, to 0.1m, clear change to;</p> <p><b>B2</b> Dark brown (7.5YR 3/3) heavy clay with moderate subangular blocky structure, with common dark mottles, a few manganese, to 0.4m, abrupt change to;</p> <p><b>R</b> White (10YR 8/1) limestone.</p> | |

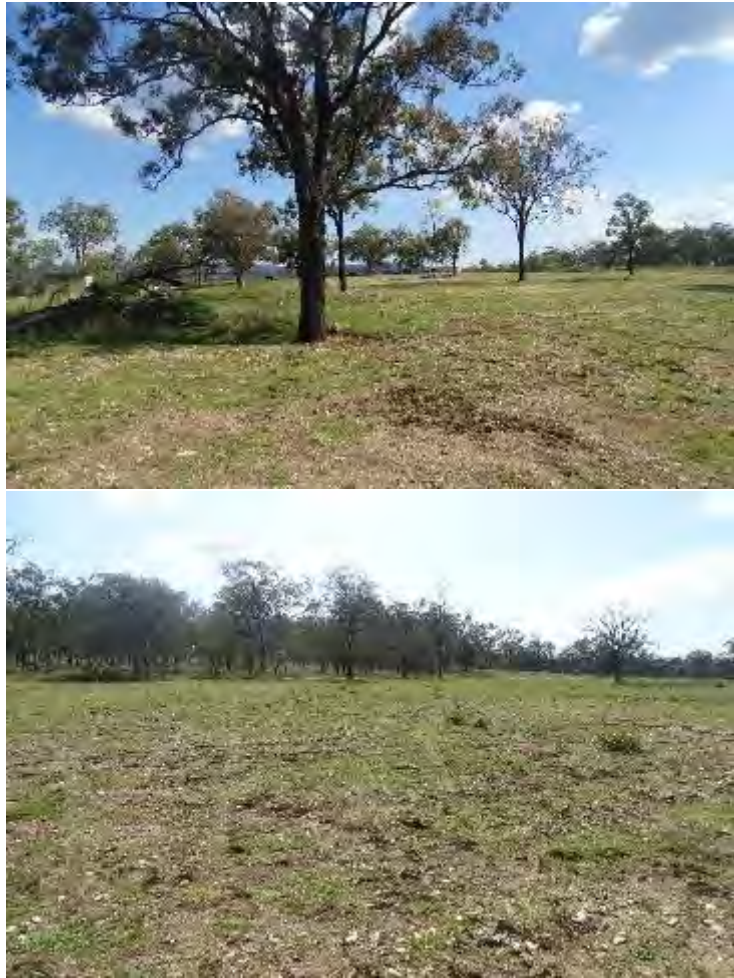
| Site number | Description | Photos |
|---|---|---|
| <p>Site ID: TW34<br/> Location: S28.38752° E152.11503°<br/> Described by: Dan Rattray<br/> Date: 23/03/2022<br/> Geology: Bald hill formation, Gabbroid<br/> Landform pattern: Low Hills<br/> Element: Midslope<br/> Permeability: Moderately permeable<br/> Microrelief: None<br/> Drainage: Imperfectly drained<br/> Rock outcrop: No bedrock exposed<br/> Surface condition: Firm<br/> Disturbance: Extensive clearing<br/> Sample site: <b>SITE 6</b></p> | <p><b>ASC: Rehabilitation (Grey Anthroposol)</b></p> <p><b>A1</b> Dark brown (10YR 3/3) sandy clay with moderate polyhedral structure, many medium and large gravel on surface, to 0.4m, abrupt change to;</p> <p><b>B2</b> Dark greyish brown (10YR 4/2) heavy clay, to 0.85m, gradual change to;</p> <p><b>B3</b> Dark yellowish brown (10YR 4/6) heavy clay, common small gravel, to 1.5m.</p> | |

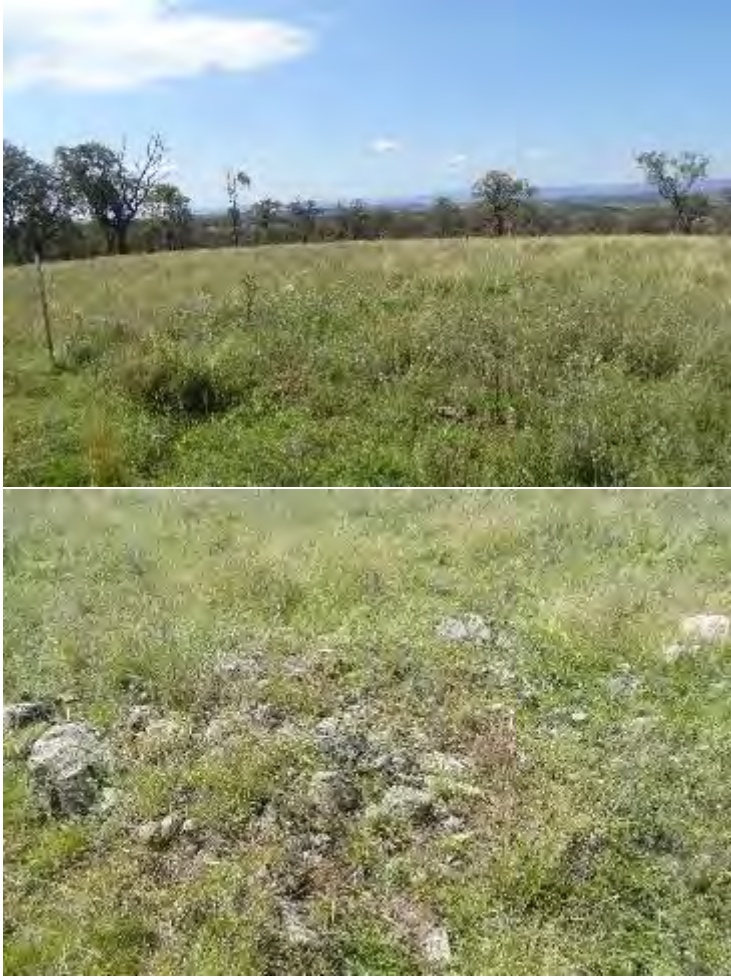
| Site number | Description | Photos |
|---|---|---|
| <p>Site ID: TW35<br/> <b>Location:</b> S28.38775° E152.11591°<br/> <b>Described by:</b> Dan Rattray<br/> <b>Date:</b> 23/03/2022<br/> <b>Geology:</b> Bald hill formation, Mafites<br/> <b>Landform pattern:</b> Low Hills<br/> <b>Element:</b> Top<br/> <b>Permeability:</b> Moderately permeable<br/> <b>Microrelief:</b> None<br/> <b>Drainage:</b> Imperfectly drained<br/> <b>Rock outcrop:</b> Rocky<br/> <b>Surface condition:</b> Firm<br/> <b>Disturbance:</b> Extensive clearing<br/> <b>Sample site:</b> Nil</p> | <p><b>ASC: Red Sodosol</b></p> <p><b>A1</b> Very dark brown (7.5YR 2.5/3) clay loam with weak polyhedral structure, to 0.1m, clear change to;</p> <p><b>B2</b> Dark reddish brown (5YR 3/4) medium clay with moderate polyhedral structure, common small and medium gravel, with a few yellow mottles, to 0.6m, abrupt change to;</p> <p><b>B3</b> Yellowish brown (10YR 5/6) silty sand with massive nil structure, with many red/yellow mottles, many manganese, to 1.3m.</p> | |

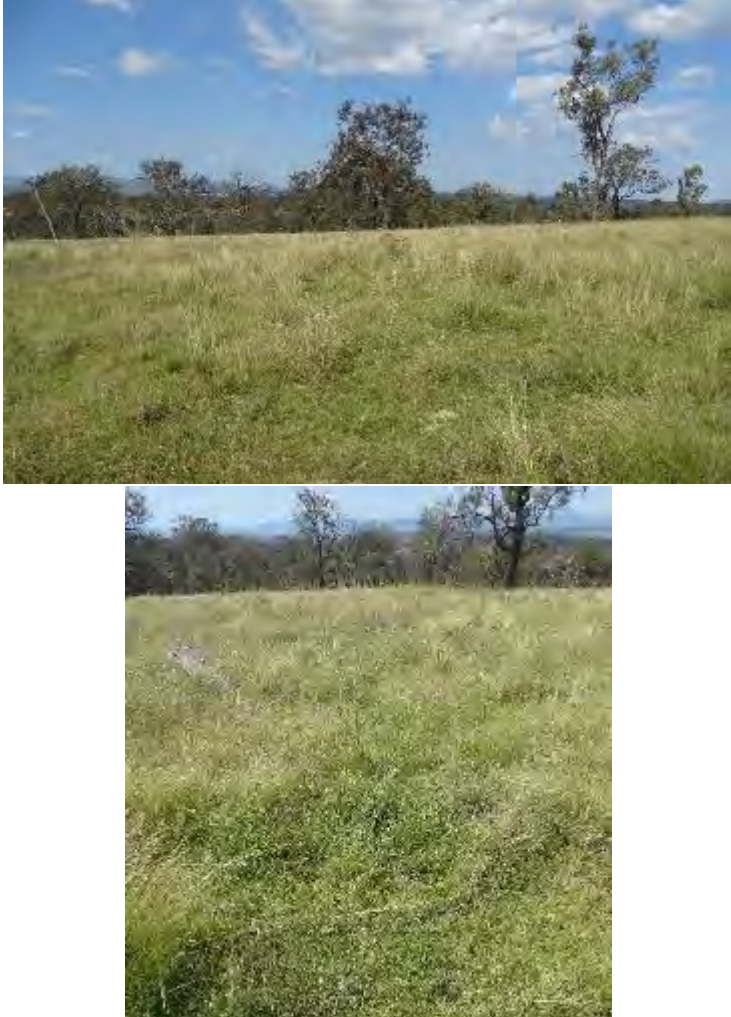
| Site number | Description | Photos |
|---|---|---|
| <p> <b>Site ID:</b> TW36<br/> <b>Location:</b> S28.38717° E152.11632°<br/> <b>Described by:</b> Dan Rattray<br/> <b>Date:</b> 23/03/2022<br/> <b>Geology:</b> Bald hill formation, Mafites<br/> <b>Landform pattern:</b> Low Hills<br/> <b>Element:</b> Midslope<br/> <b>Permeability:</b> Moderately permeable<br/> <b>Microrelief:</b> None<br/> <b>Drainage:</b> Imperfectly drained<br/> <b>Rock outcrop:</b> No bedrock exposed<br/> <b>Surface condition:</b> Firm<br/> <b>Disturbance:</b> Extensive clearing<br/> <b>Sample site:</b> Nil </p> | <p><b>ASC: Brown Sodosol</b></p> <p><b>A1</b> Very dark brown (7.5YR 2.5/3) clay loam with weak polyhedral structure, to 0.15m, clear change to;</p> <p><b>B2</b> Dark brown (7.5YR 3/4) medium clay with moderate subangular blocky structure, with common dark mottles, a few manganese, to 0.5m, abrupt change to;</p> <p><b>R</b> White (10YR 8/1) limestone.</p> | |

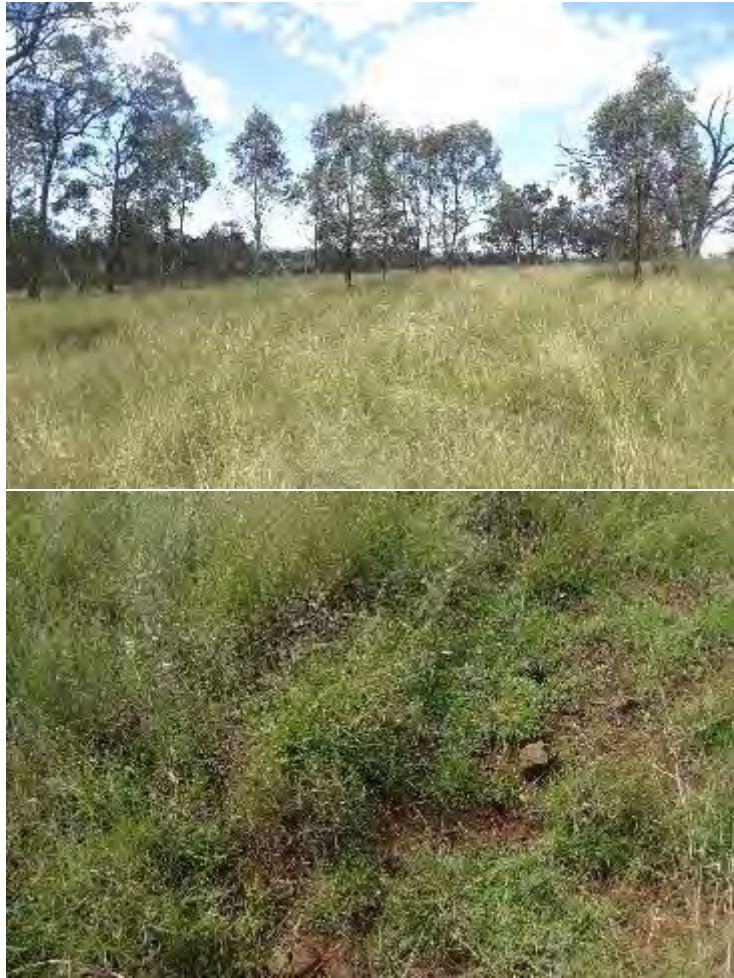
| Site number | Description | Photos |
|---|---|---|
| <p> <b>Site ID:</b> TW37<br/> <b>Location:</b> S28.38623° E152.11707°<br/> <b>Described by:</b> Dan Rattray<br/> <b>Date:</b> 23/03/2022<br/> <b>Geology:</b> Bald hill formation, Mafites<br/> <b>Landform pattern:</b> Low Hills<br/> <b>Element:</b> Bottom hill<br/> <b>Permeability:</b> Moderately permeable<br/> <b>Microrelief:</b> None<br/> <b>Drainage:</b> Imperfectly drained<br/> <b>Rock outcrop:</b> Slightly rocky<br/> <b>Surface condition:</b> Firm<br/> <b>Disturbance:</b> Extensive clearing<br/> <b>Sample site:</b> Nil </p> | <p><b>ASC: Brown Sodosol</b></p> <p><b>A1</b> Very dark brown (7.5YR 2.5/3) clay loam with weak polyhedral structure, to 0.15m, clear change to;</p> <p><b>B2</b> Dark brown (7.5YR 3/4) medium clay with moderate subangular blocky structure, with common dark mottles, a few manganese, to 0.5m, abrupt change to;</p> <p><b>R</b> White (10YR 8/1) limestone.</p> | |

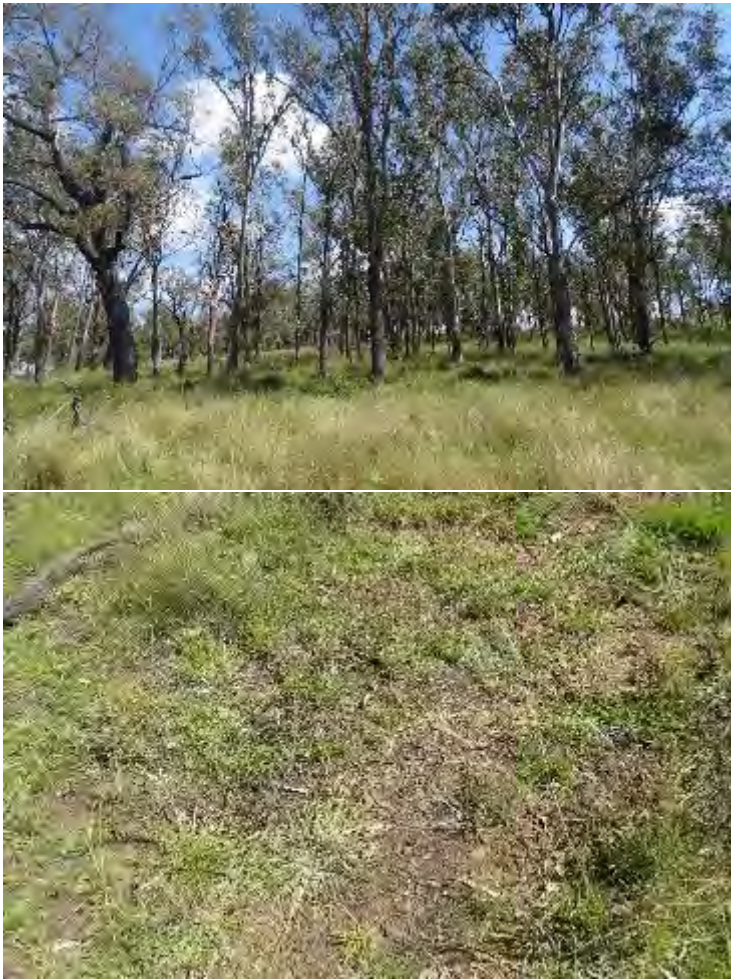
| Site number | Description | Photos |
|---|---|---|
| <p>Site ID: TW40<br/> Location: S28.38563° E152.11299°<br/> Described by: Dan Rattray<br/> Date: 23/03/2022<br/> Geology: Bald hill formation, Mafites<br/> Landform pattern: Low Hills<br/> Element: Top<br/> Permeability: Moderately permeable<br/> Microrelief: None<br/> Drainage: Imperfectly drained<br/> Rock outcrop: No bedrock exposed<br/> Surface condition: Firm<br/> Disturbance: Extensive clearing<br/> Sample site: <b>SITE 5</b></p> | <p><b>ASC: Brown Sodosol</b></p> <p><b>A1</b> Very dark greyish brown (10YR 3/2) silty light clay with weak polyhedral structure, many medium gravel on surface, to 0.1m, abrupt change to;</p> <p><b>B21</b> Dark yellowish brown (10YR 4/6) silty medium clay with weak polyhedral structure, a few medium gravel, common manganese, to 0.6m, gradual change to;</p> <p><b>B22</b> Yellowish brown (10YR 5/6) fine sandy medium clay with moderate polyhedral structure, a few medium gravel, common carbonates, to 1.05m, gradual change to;</p> <p><b>B3</b> Yellowish brown (10YR 5/6) clayey sand with massive nil structure, a few medium gravel, with many grey mottles, to 1.35m.</p> | |
