WARWICK LIMESTONE  
MINE  
GEOTECHNICAL  
RISK ASSESSMENT AND  
MANAGEMENT  
for

| Title | Warwick Limestone Mine: Geotechnical Risk Assessment and Management |
| Date | June 2019 |

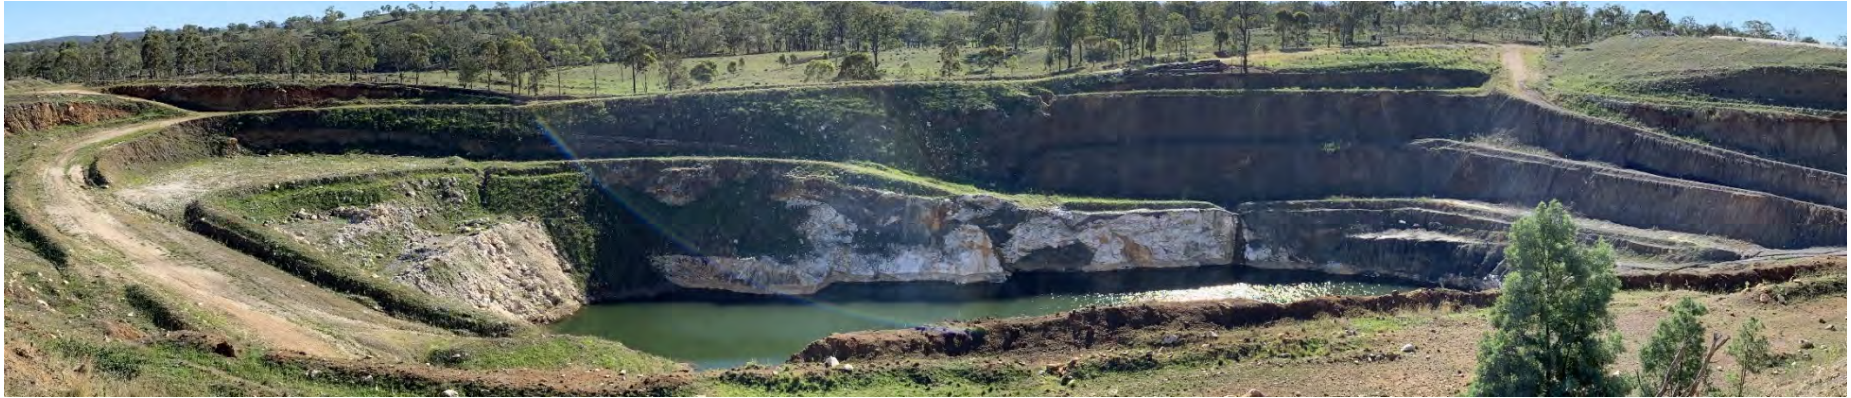
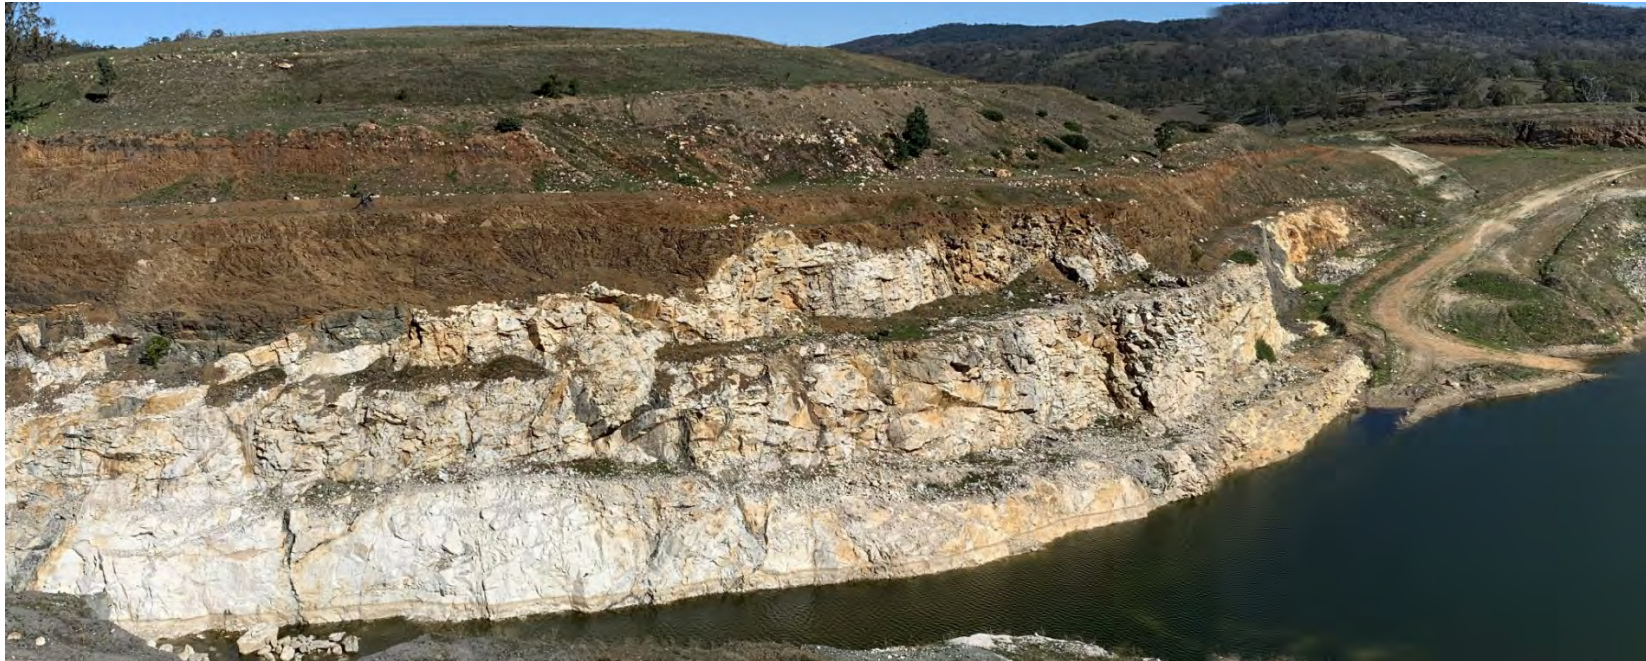
**Figure 1.** (a) North and (b) South walls at the west end of East-West pit. Waste rock dump WRD 1 is behind the crest. The west ramp (right) may be retained.

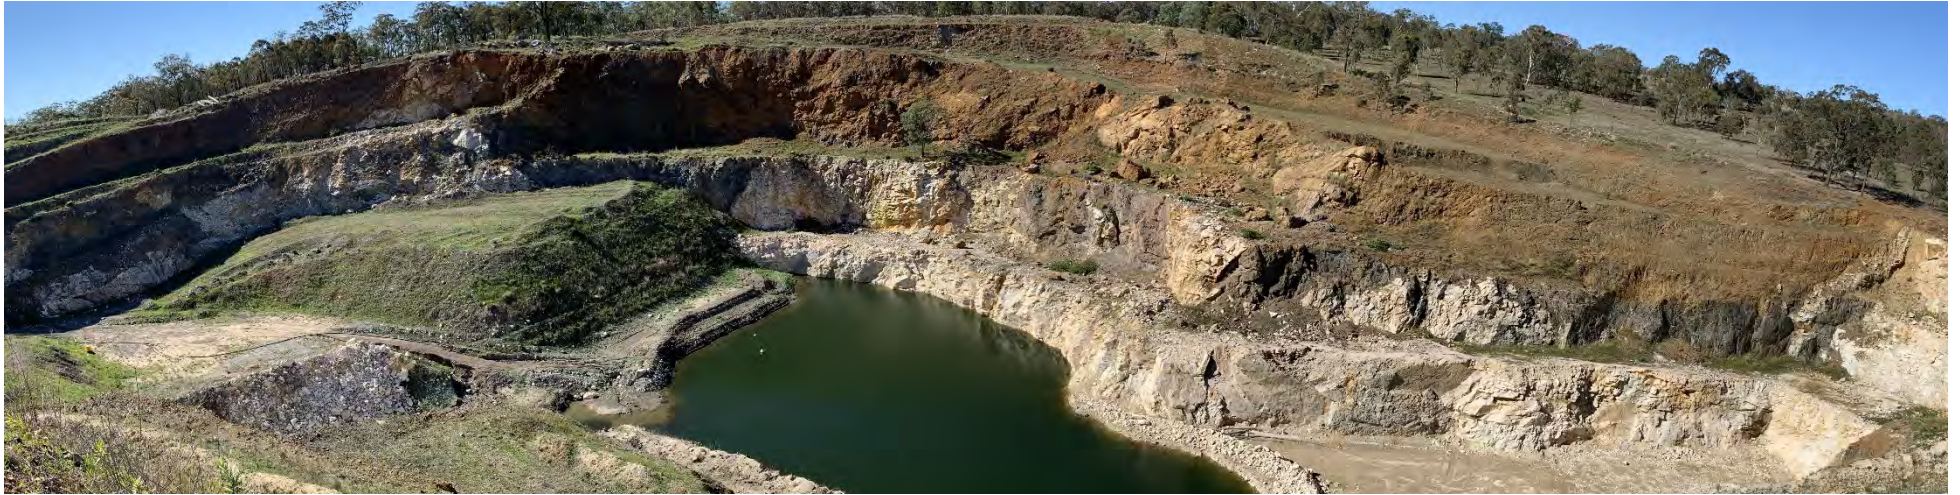
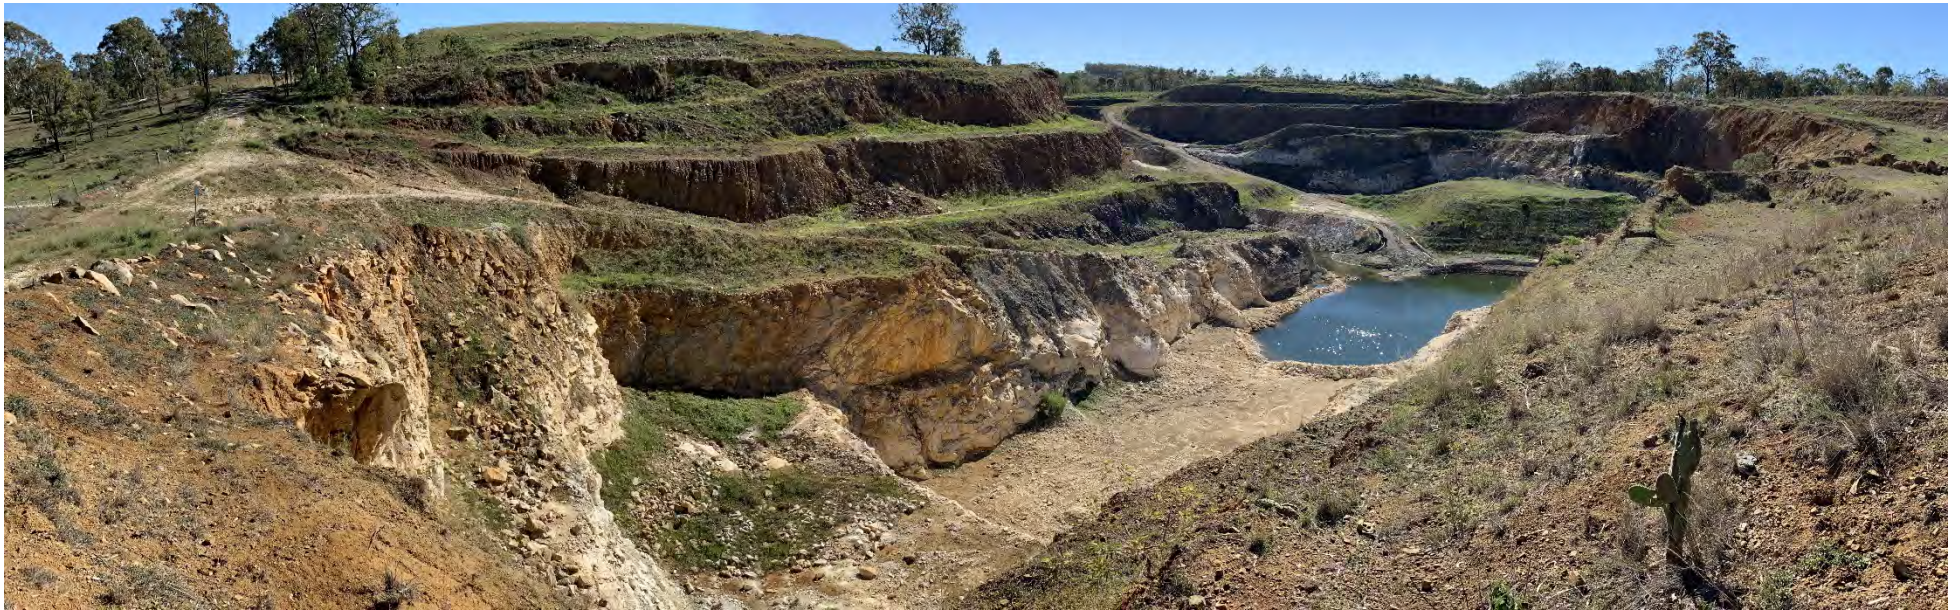
**Figure 2.** (a) Northeast and (b) Southwest walls at the south end of East-West pit. Waste rock dump WRD 1 is behind the crest.

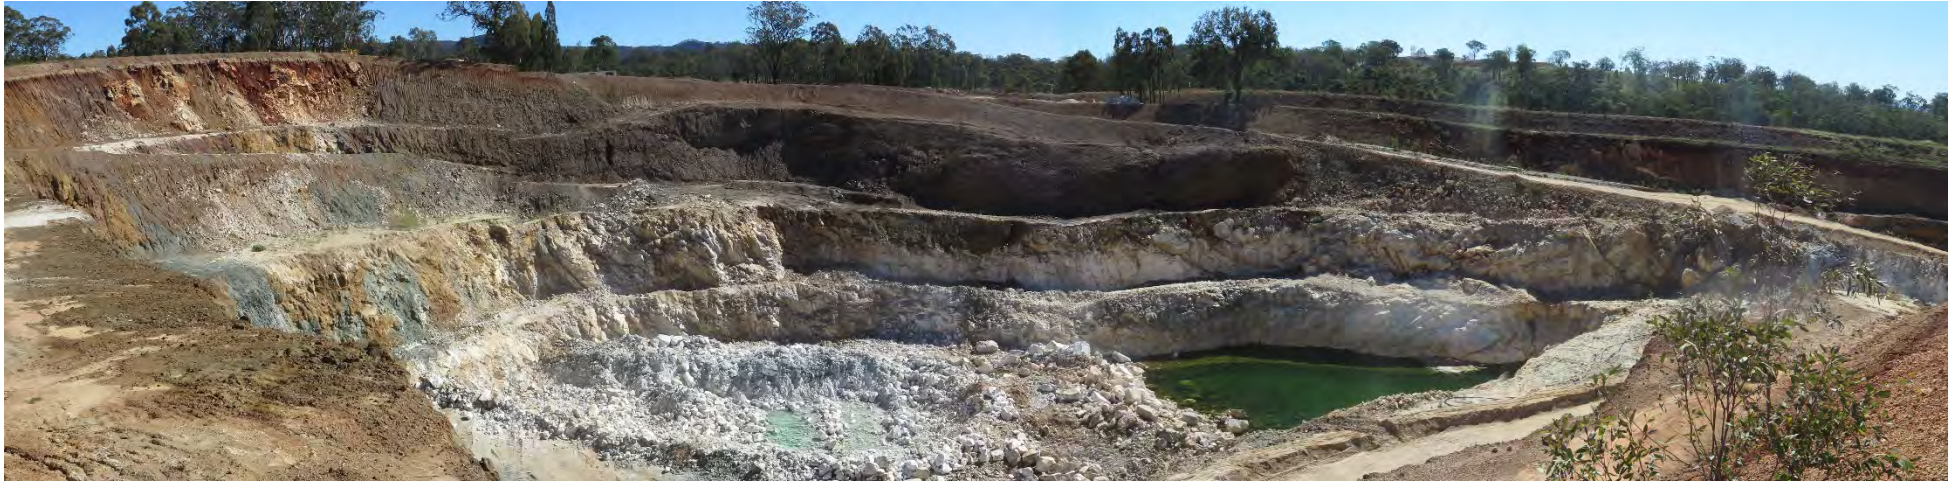
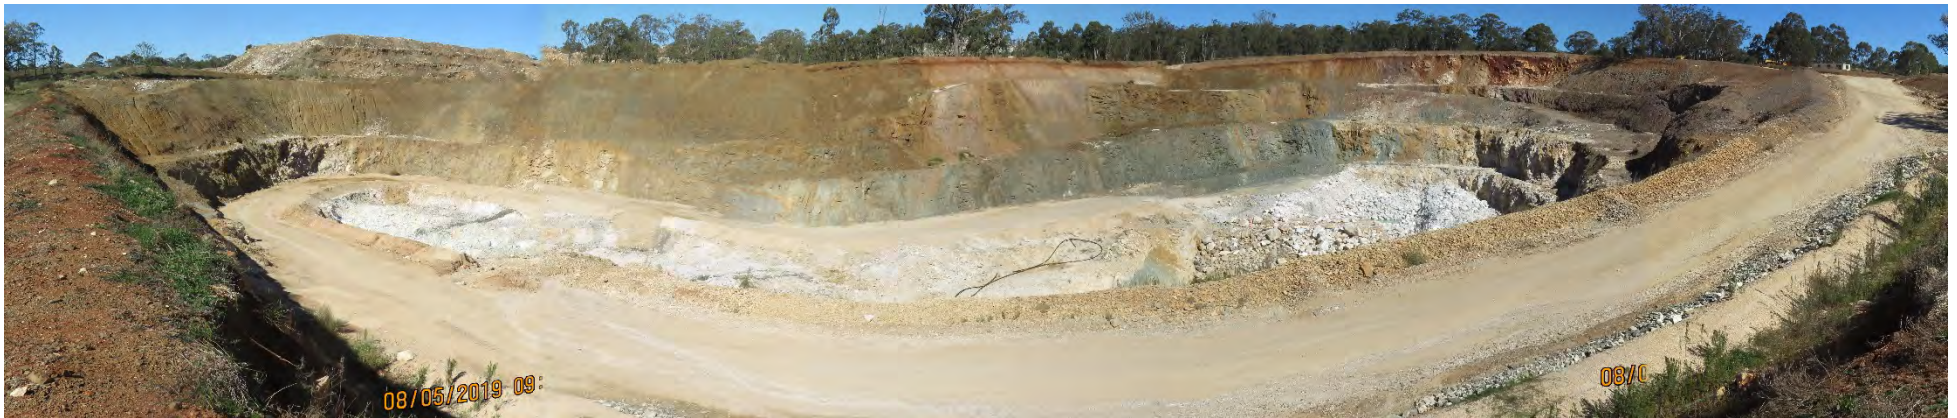
**Figure 3.** (a) North and (b) South walls of Phoenix pit. The main ramp is to be retained.

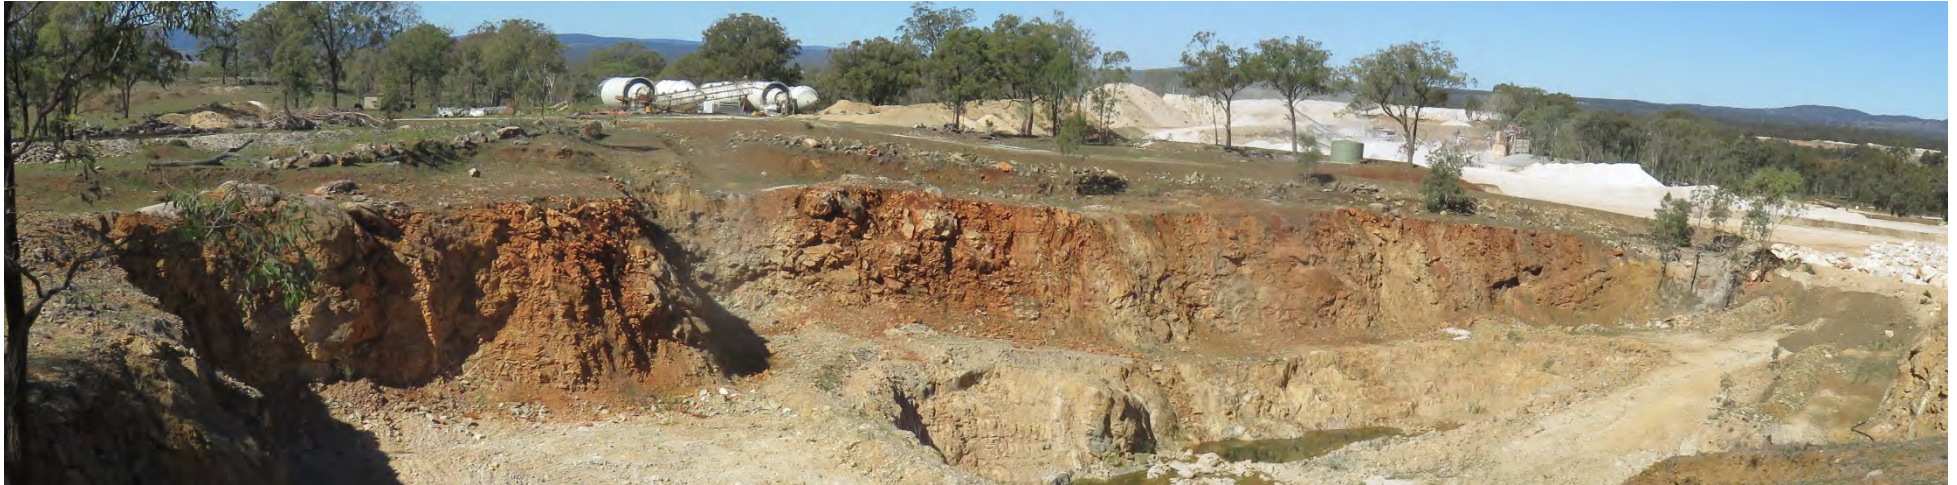
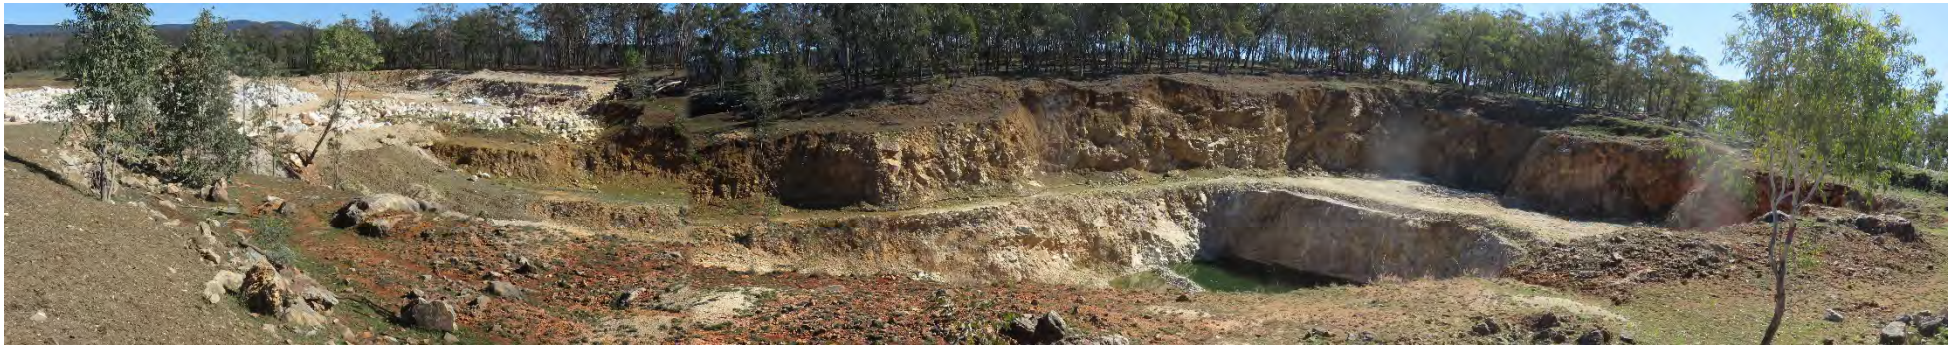
**Figure 4.** (a) East and (b) West walls of Aspinal pit. The pit to be partially filled thereby reducing the slope angles .

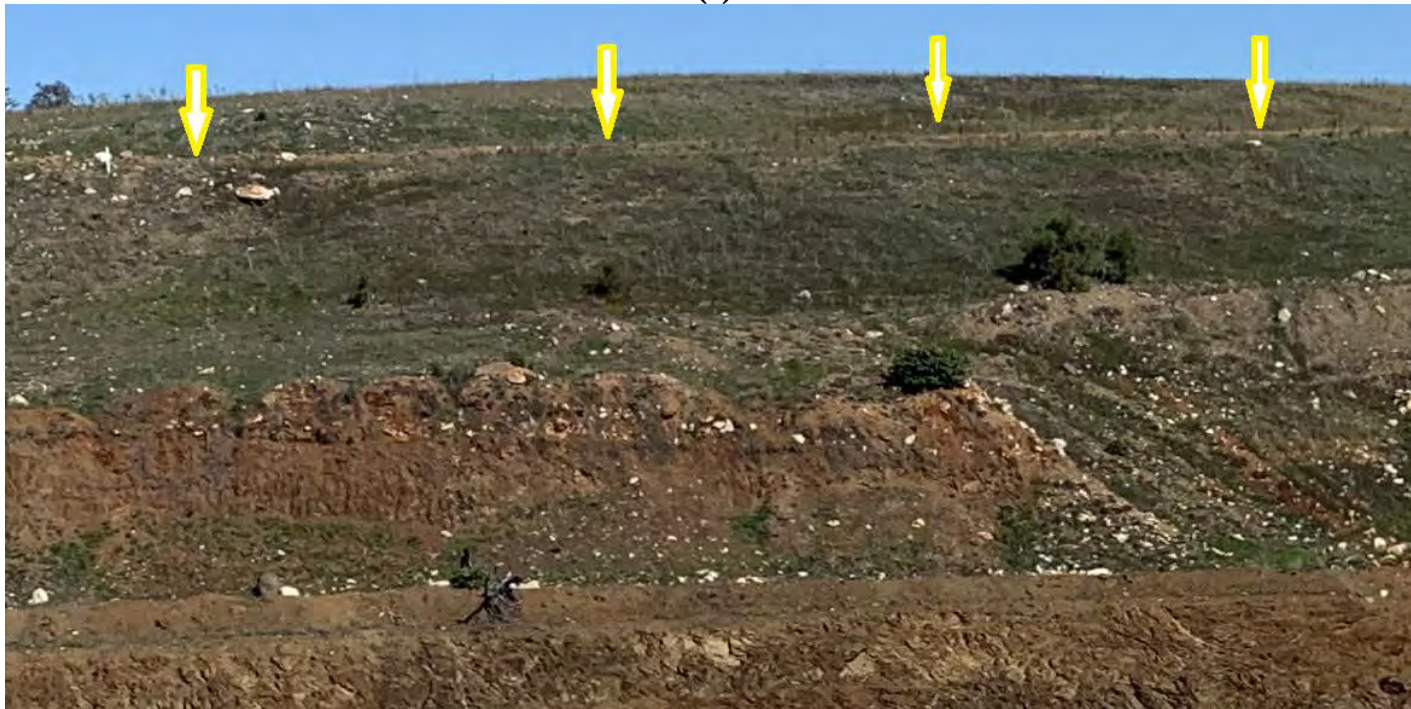
**Figure 5.** WRD 1 to the west of the East-West pit. The dump to remain in-situ. (b) The bund along the crest is inadequate as an abandonment barrier. It is to be replaced with an abandonment bund (Section 7.3.2). The bund is to tie into the bund encircling the pit at the east and west ends of the dump.

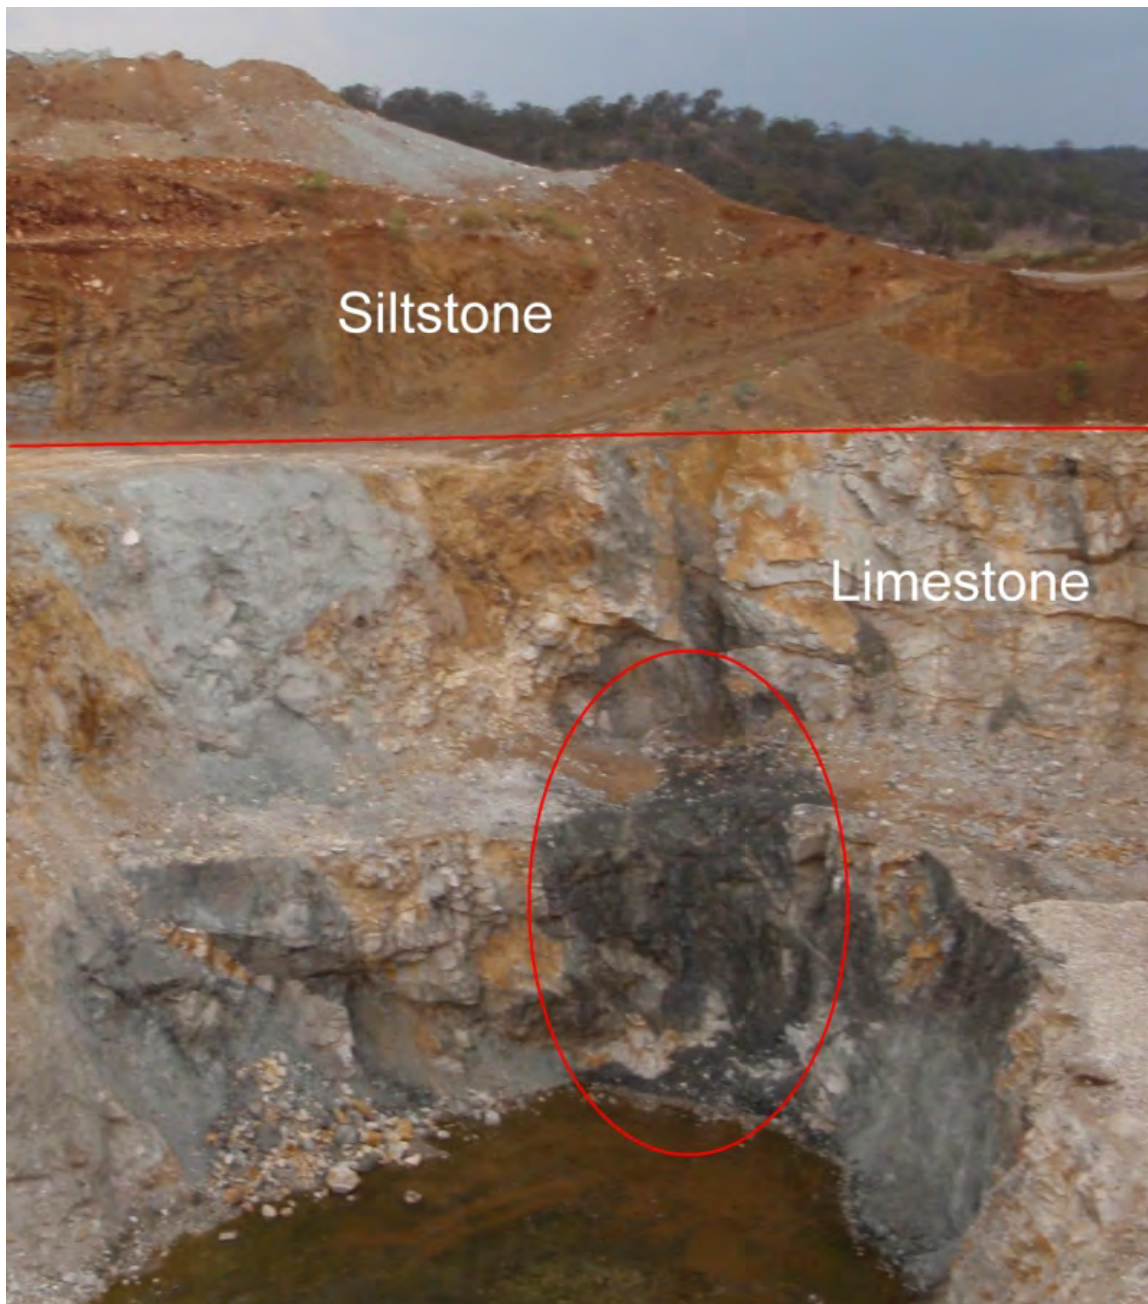
**Figure 9.** Limestone intruded by grey andesite exposed in the west wall at the north end of the East-West pit.

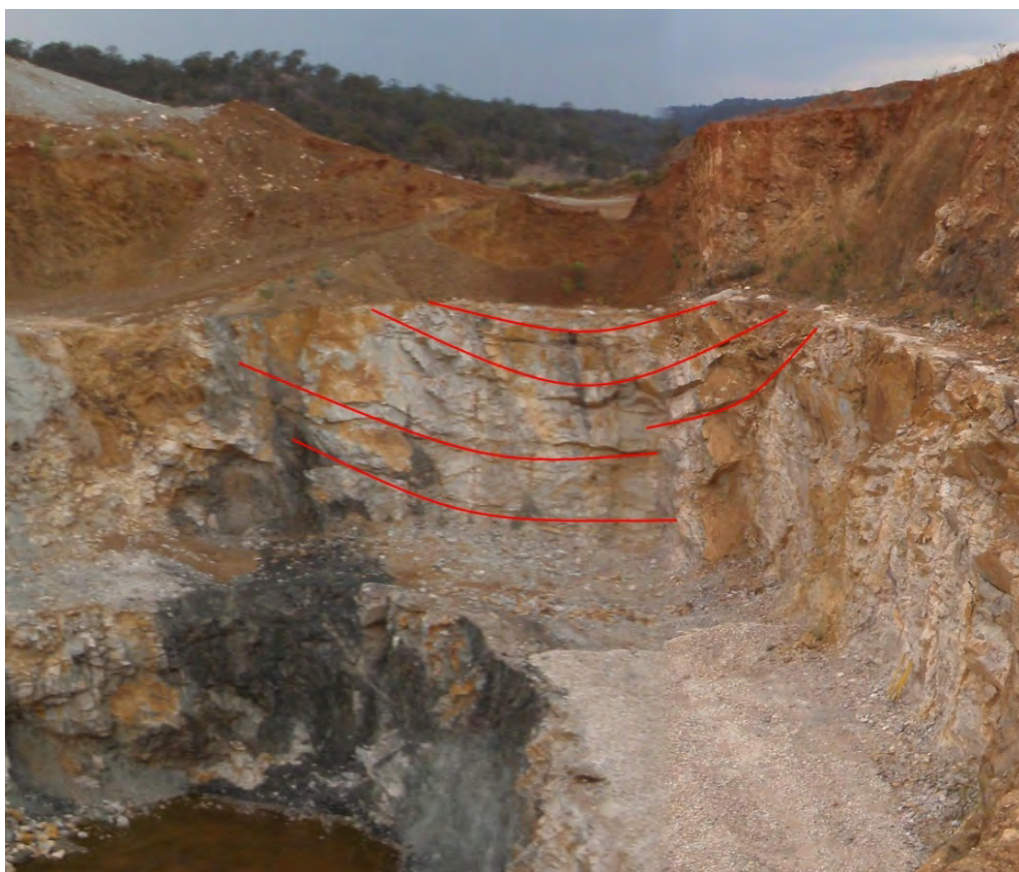
**Figure 10.** Example of synclinal fold in the upper benches at the west end of the East-West pit.

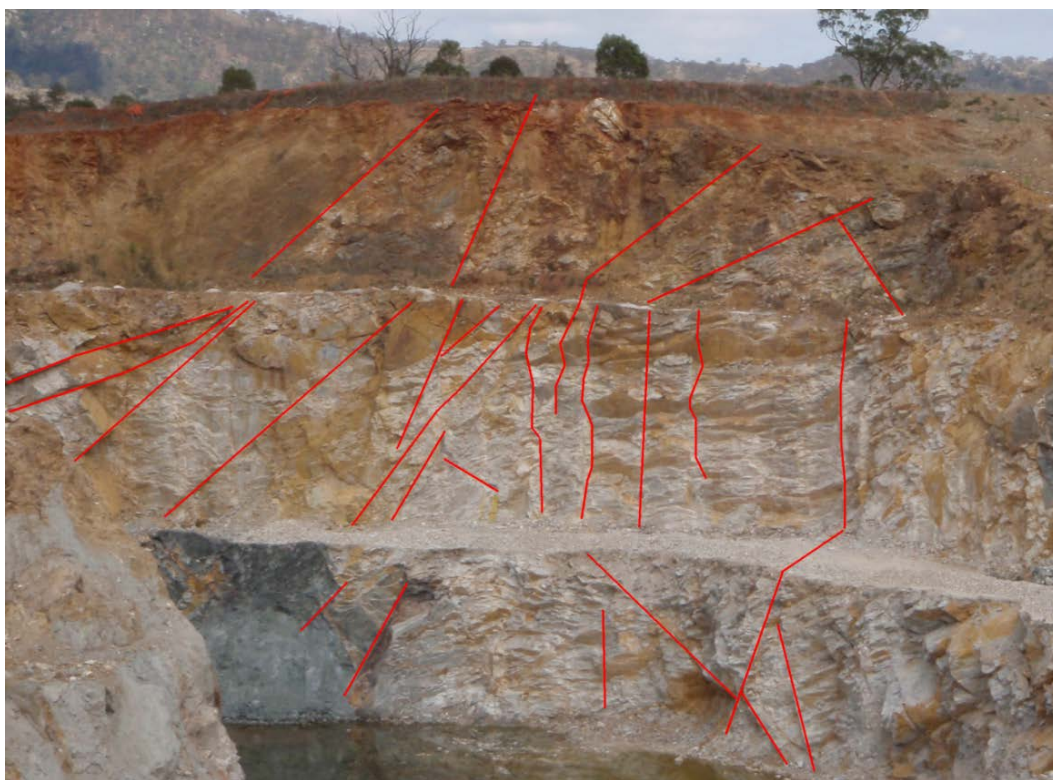
**Figure 11.** Examples of faulting exposed in the upper benches at the west end of the East-West pit.

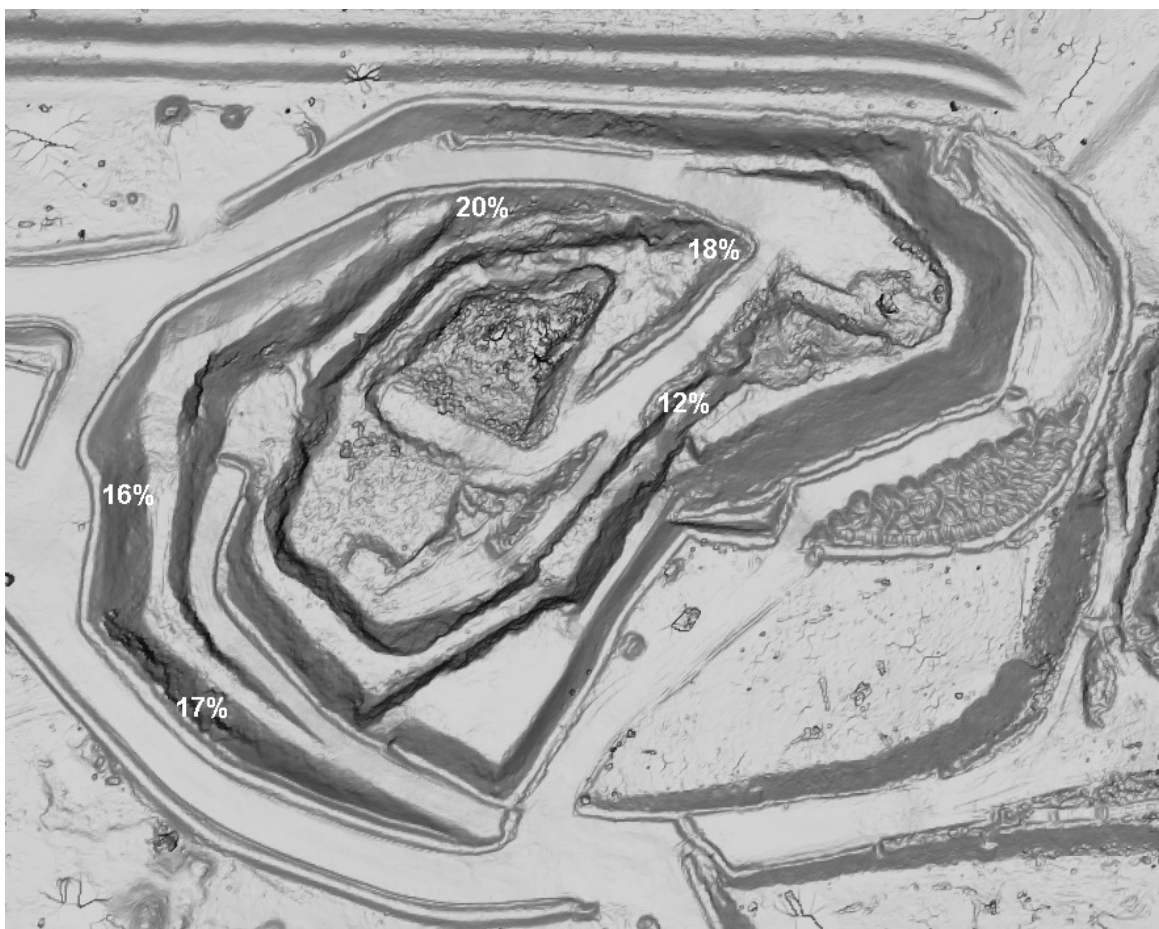
**Figure 20.** Upper bound overall scale stabilities around (PoFs) the Phoenix pit.

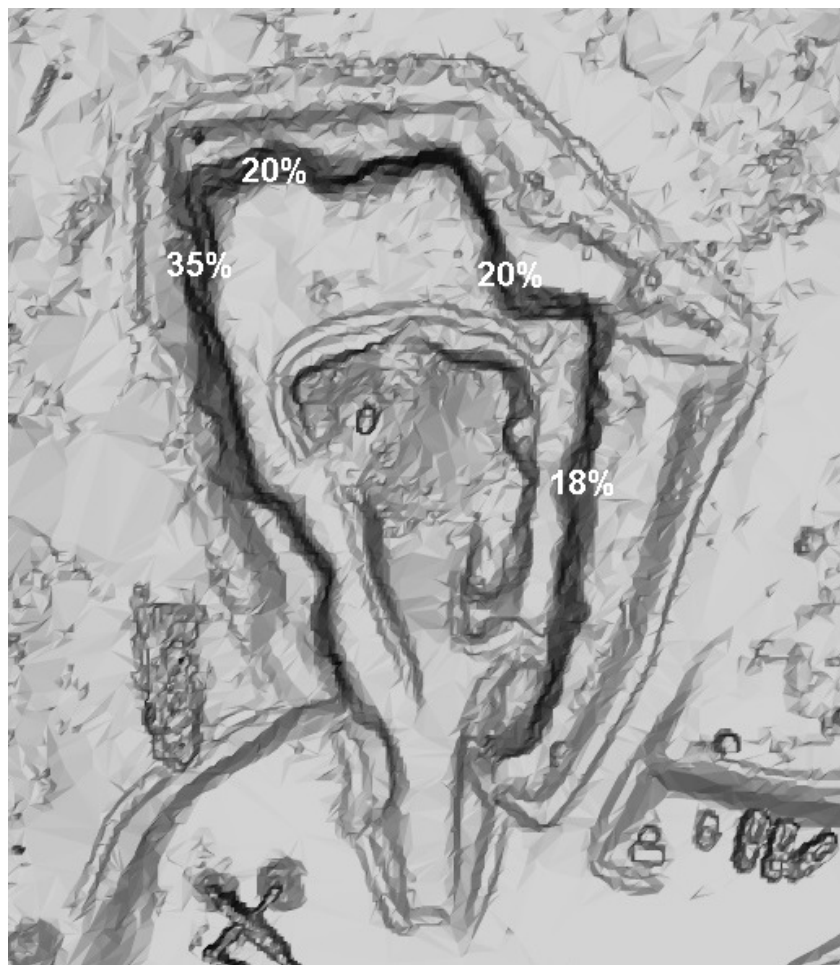
**Figure 22.** Upper bound overall scale stabilities (PoFs) around the Aspinall pit.

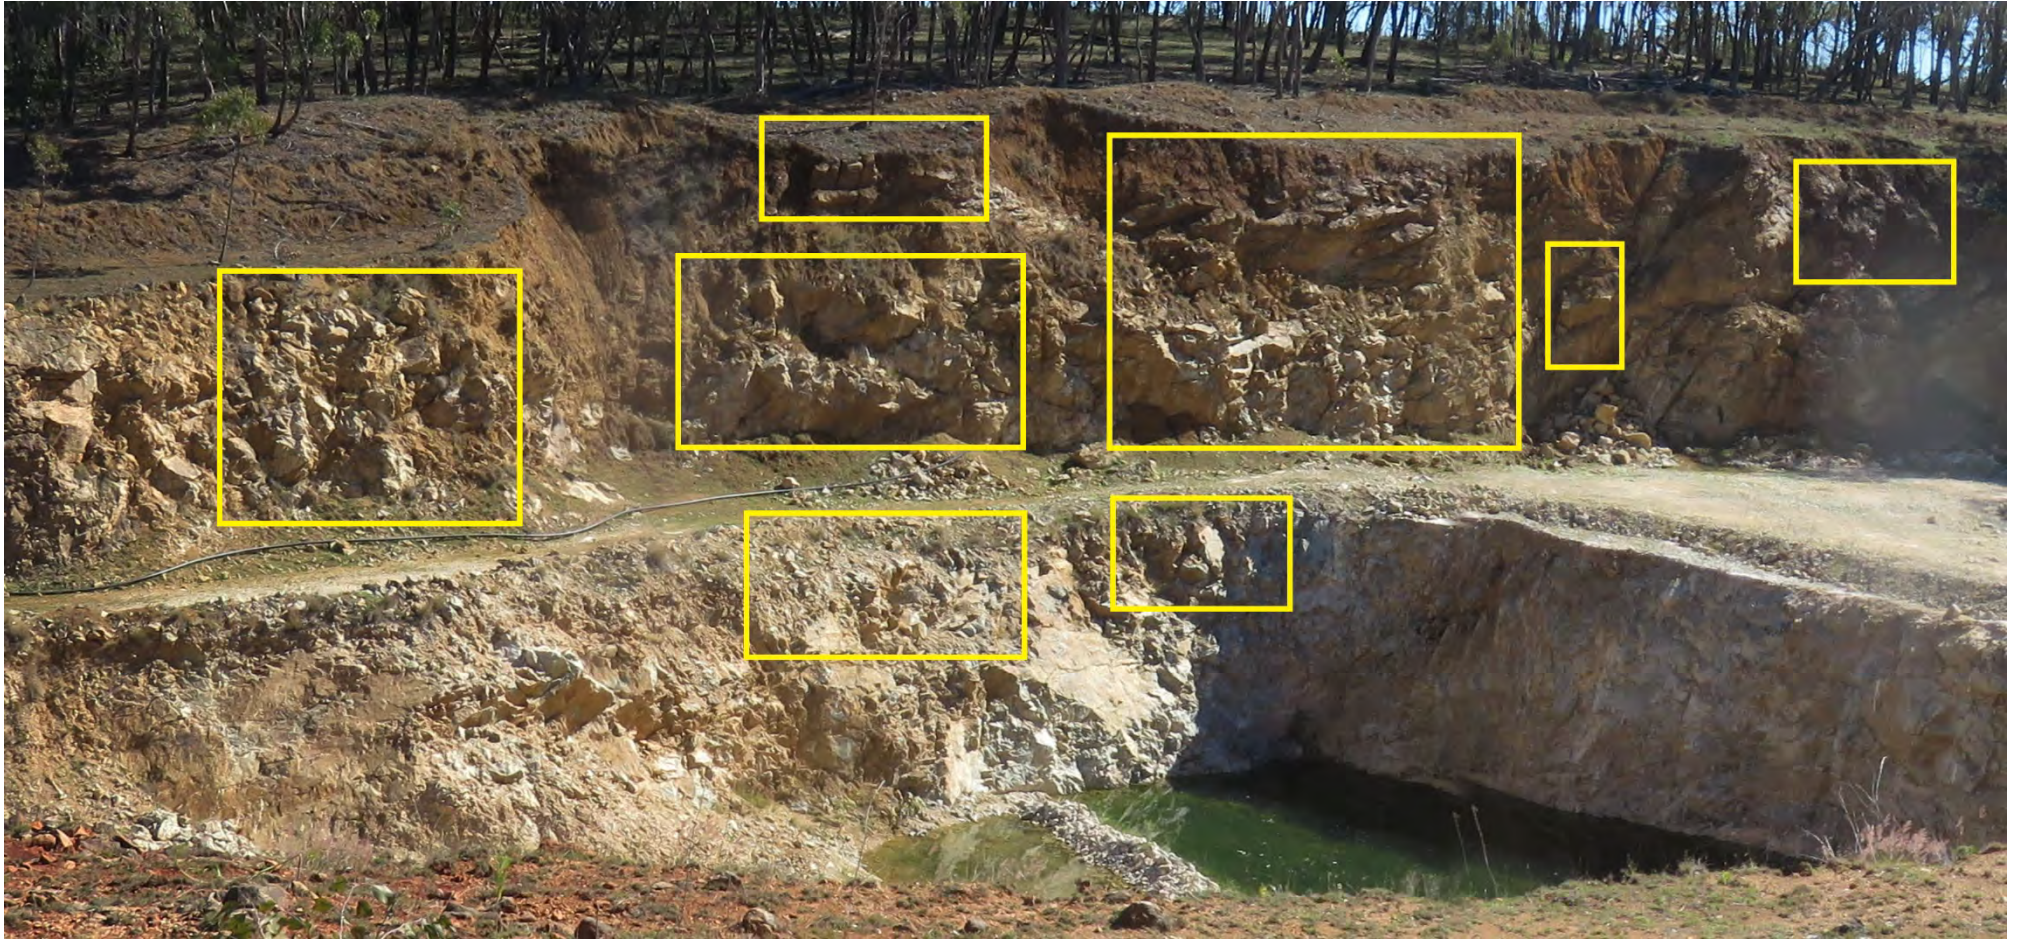
**Figure 28.** Loose rocks on the batters and overhanging and toppling rocks (highlighted) and scree on the berms on the west wall of the Aspinal pit.

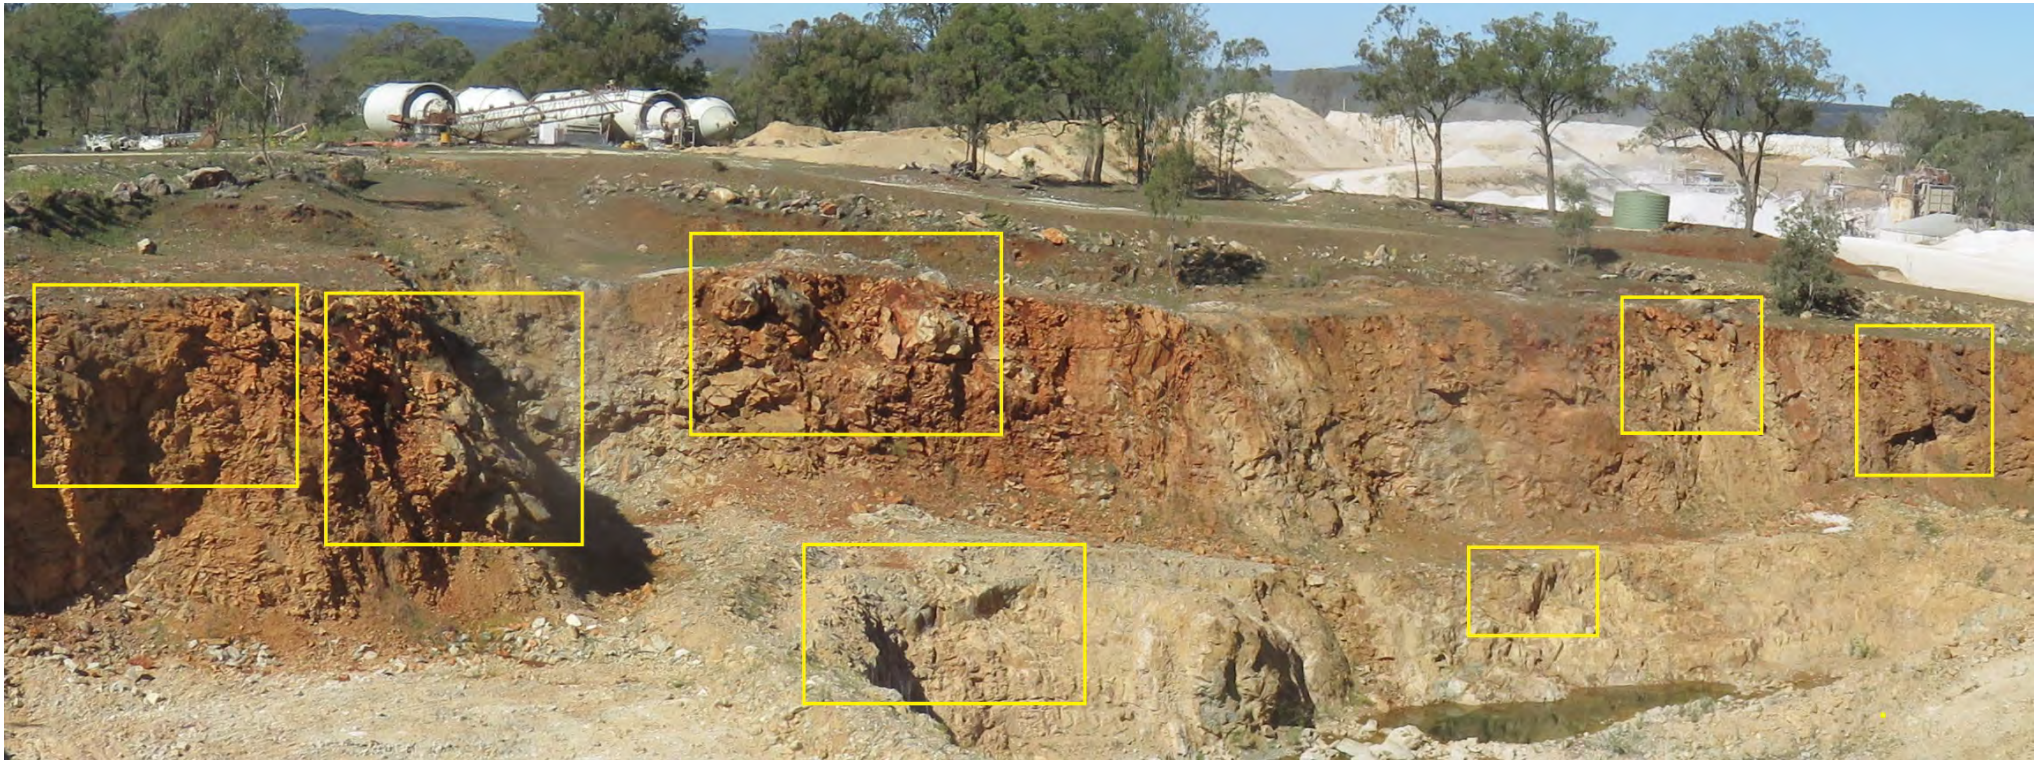
**Figure 29.** Loose rocks on the batters and overhanging rocks (highlighted) and loss of berm widths and scree on the berms on the east wall of the Aspal pit.

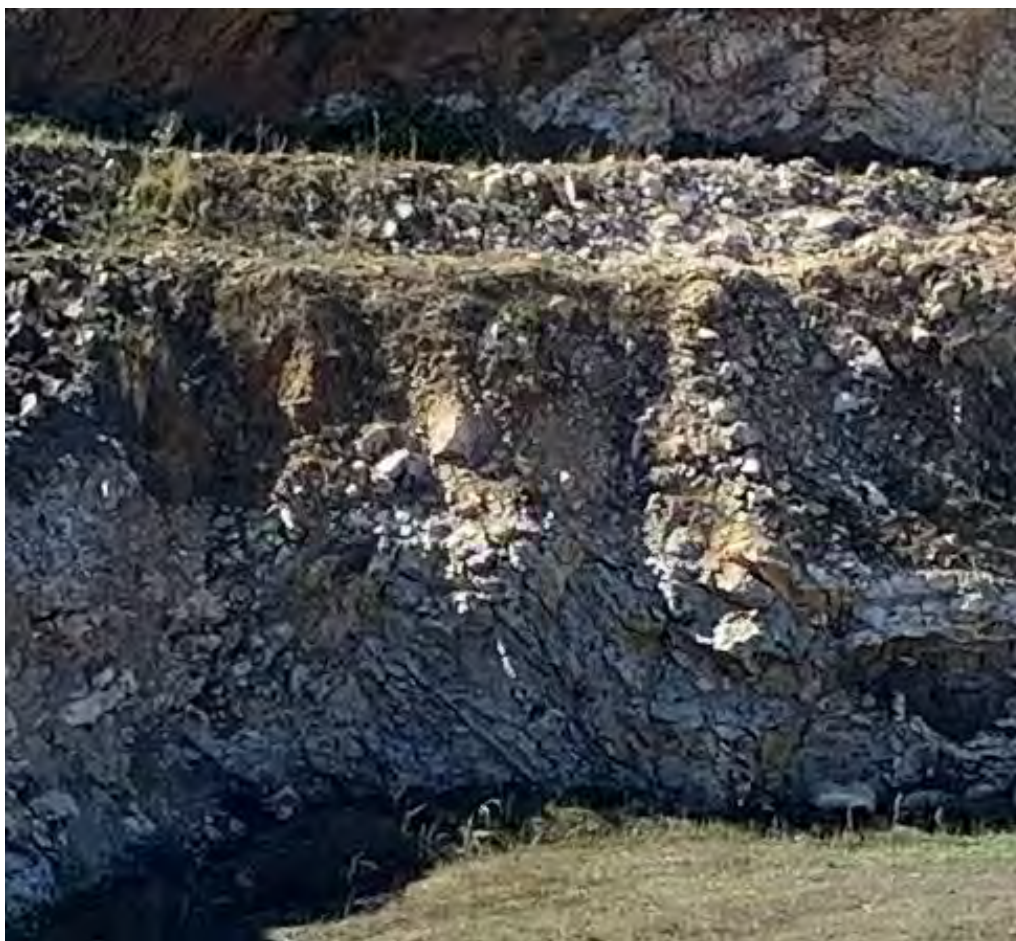
**Figure 30.** Sawtooth profile on the lower batter of the north wall of the east pit in the East-West pit due to multiple wedges sliding.

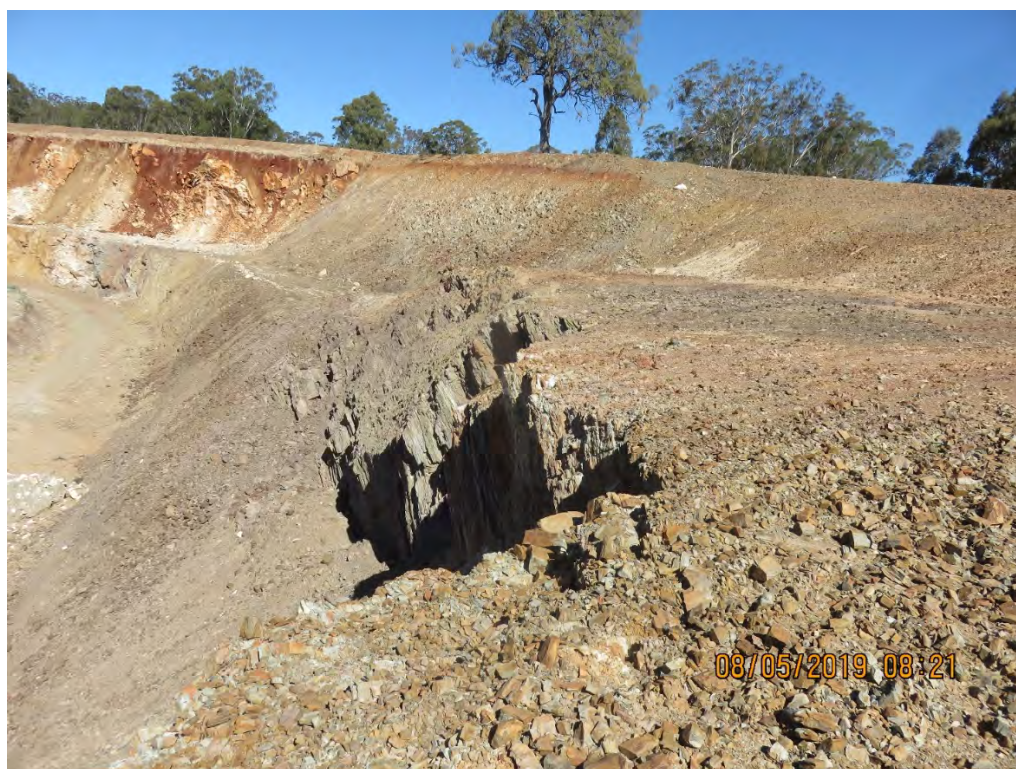
**Figure 31.** Toppling rocks on an east dipping batter on the upper bench of the Phoenix pit.

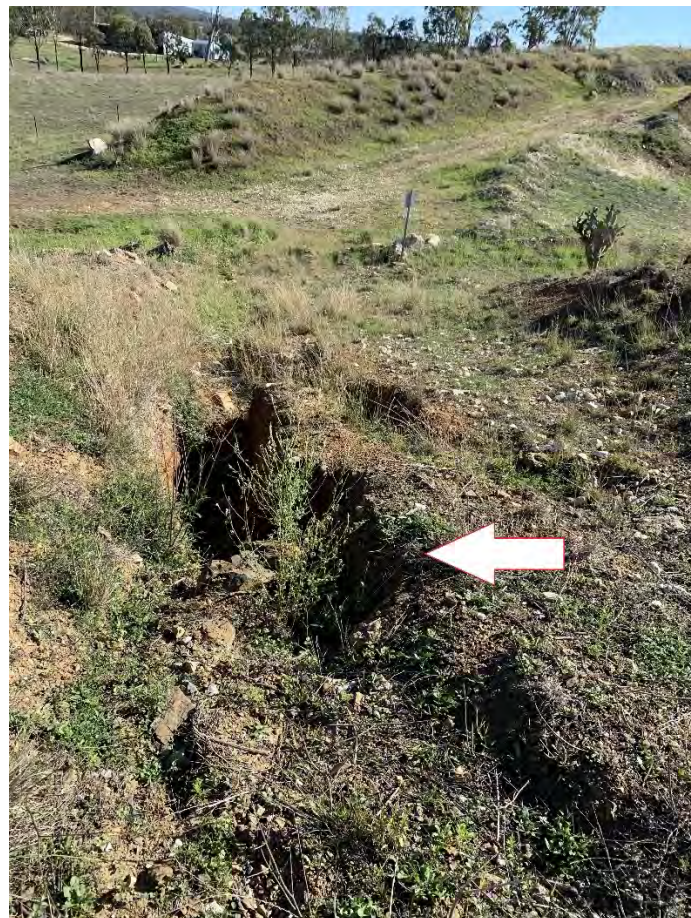
**Figure 36.** Deep gully cut by water shedding off the west end of WRD 1 is contributing to erosion of the ramp at the west end of the East-West pit. Drain will be remediated when the ramp is removed.

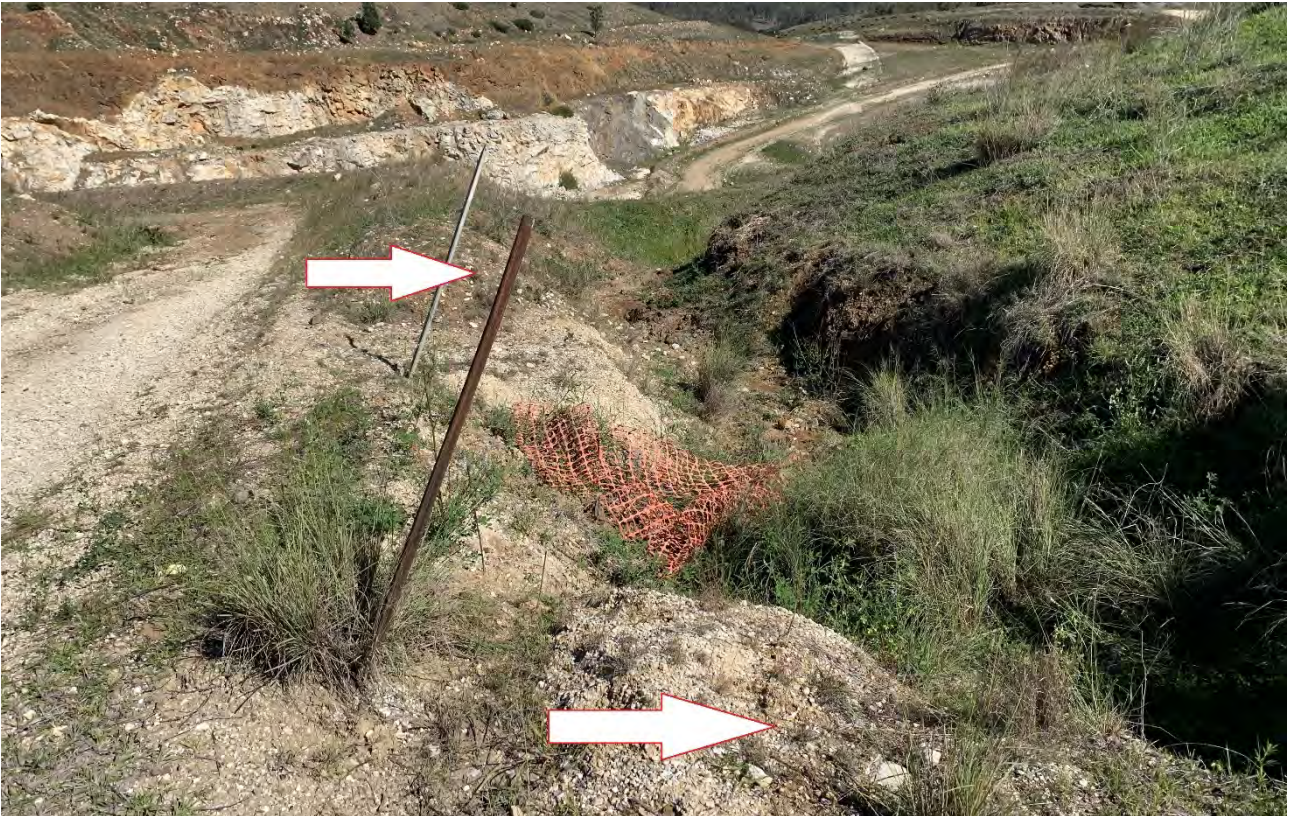
**Figure 37.** Gully cut by water shedding off the central ramp on the north wall of the East-West pit requires lining and sediment traps.

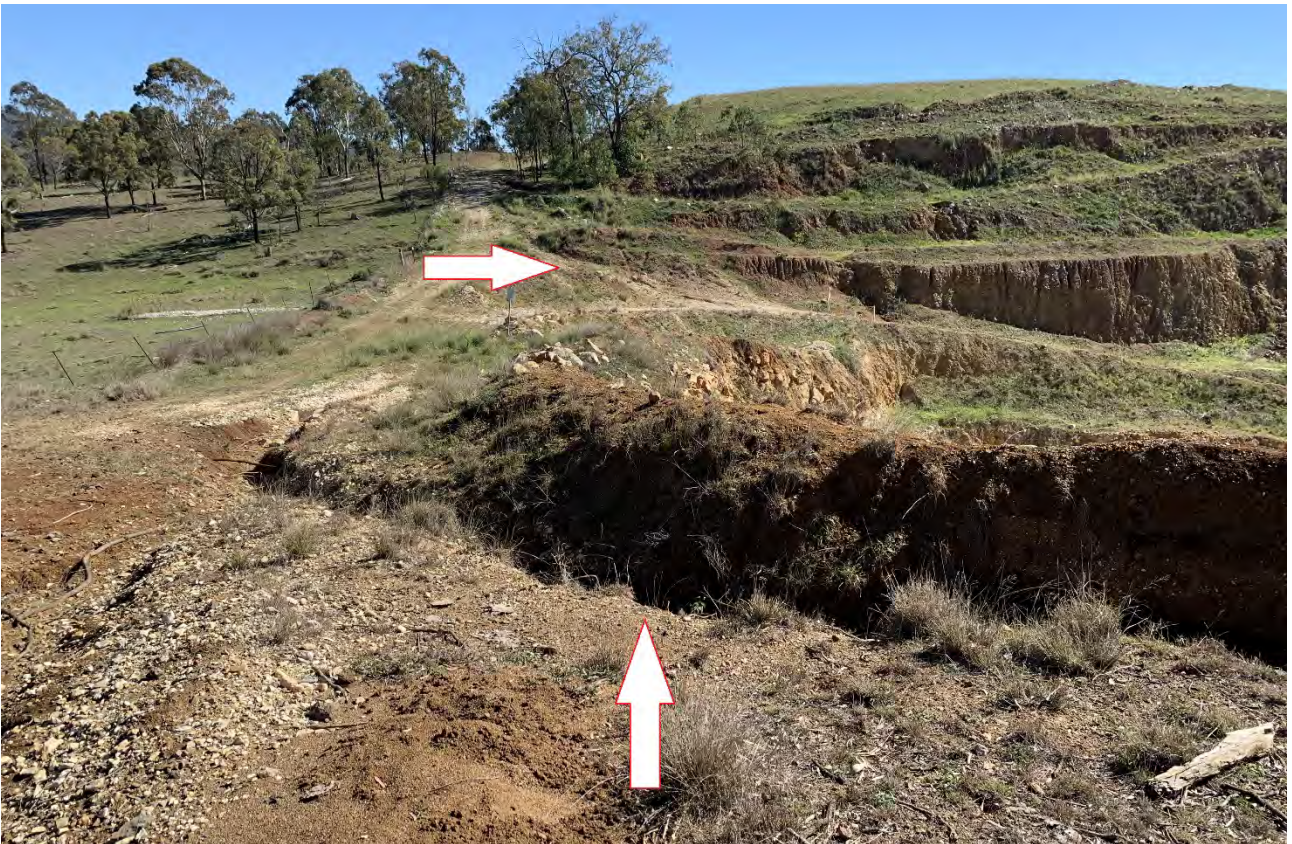
**Figure 38.** 2 x deep gullies cut by water shedding off the haul-road along the east end of the East-West pit requires repair. Haul-road to be graded to shed water to the east and ripped.
