WARWICK LIMESTONE  
MINE  
GEOTECHNICAL  
RISK ASSESSMENT AND  
MANAGEMENT  
for

| Title | Warwick Limestone Mine: Geotechnical Risk Assessment and Management |
| Date | June 2019 |

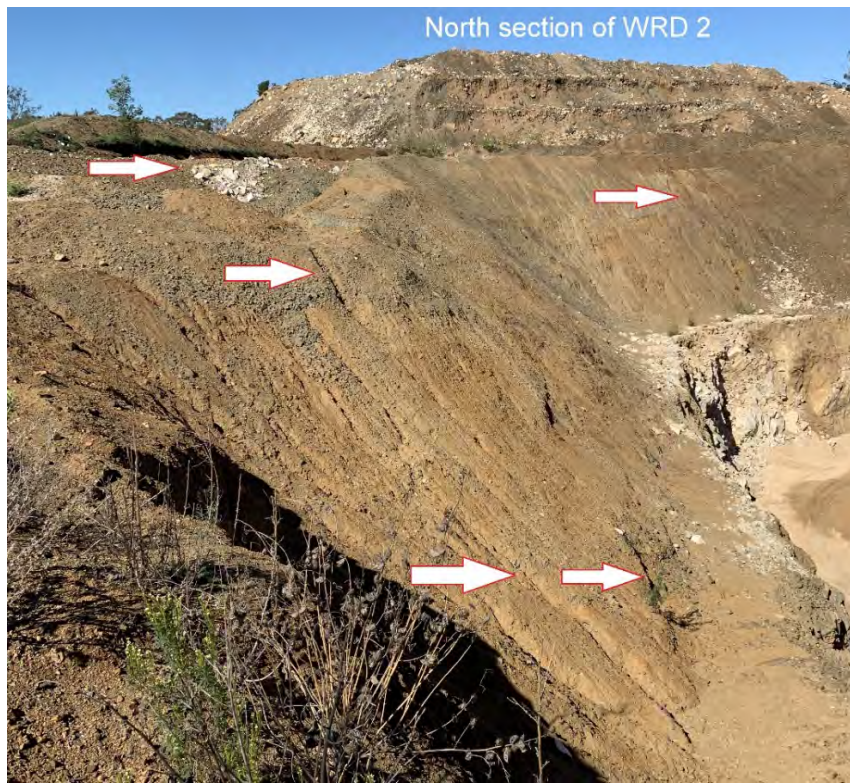
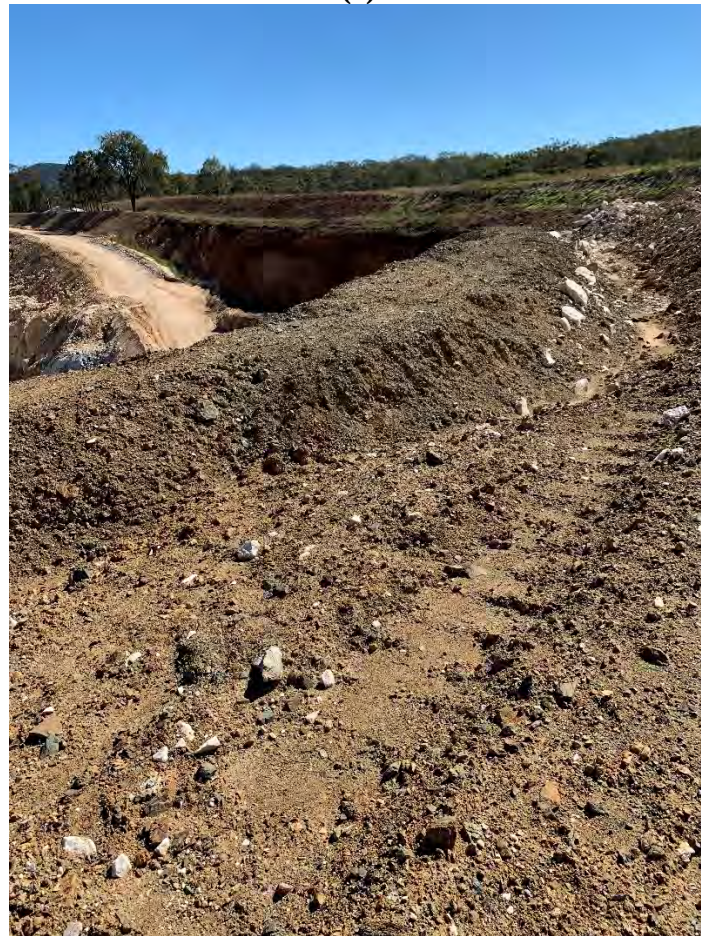
**Figure 41.** Overland flows are eroding topsoil, karst fill and extremely weathered limestones and siltstones in the upper bench at the east end of Phoenix pit (b) The bund along the crest of the is likely sufficiently high to prevent overland flows of water from flowing from behind the crest.  
Removal of the haul-road and hydroseeding is required.

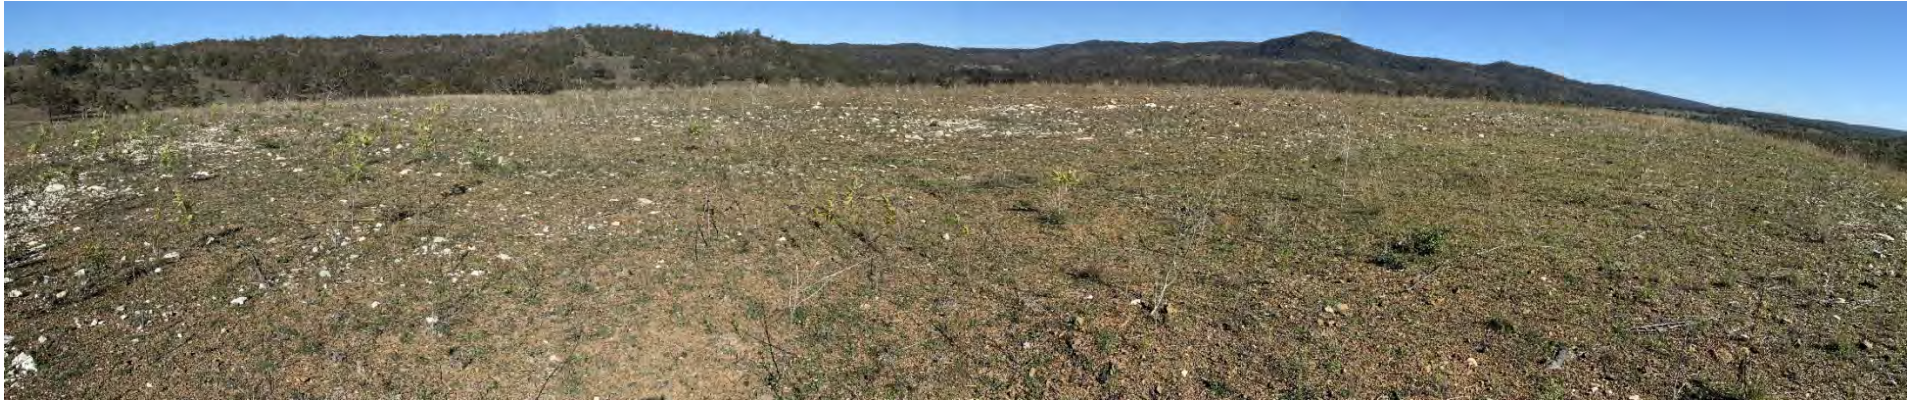
**Figure 45.** Upper surface of waste rock dump 1 (WRD 1) to the west of the East-West pit. The surface has been contoured and topsoil spread enabling a low to moderate density of grasses to establish.

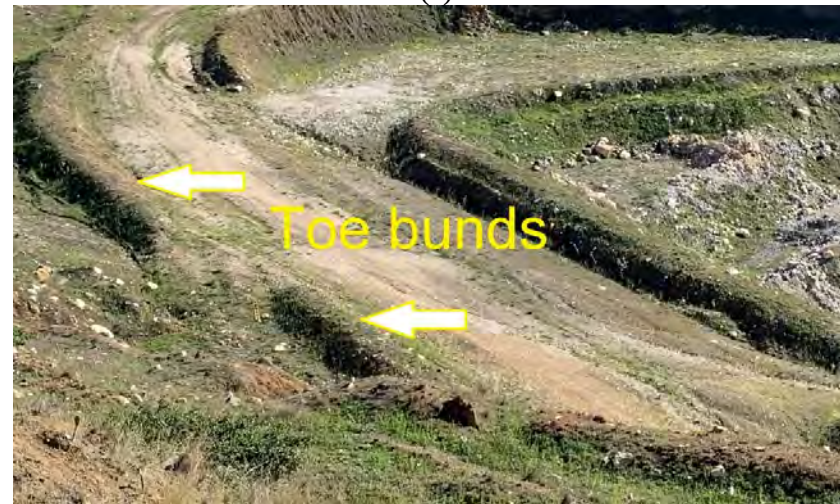
**Figure 50.** (a) If the western ramp in the East-West pit is to be retained, the heights of (b) the current toe bunds are to be increased. If the ramp is not to be retained, the surface is to be ripped and a series of low bunds are to be installed at regular intervals along contour down the inclined surface to reduce flow rates.

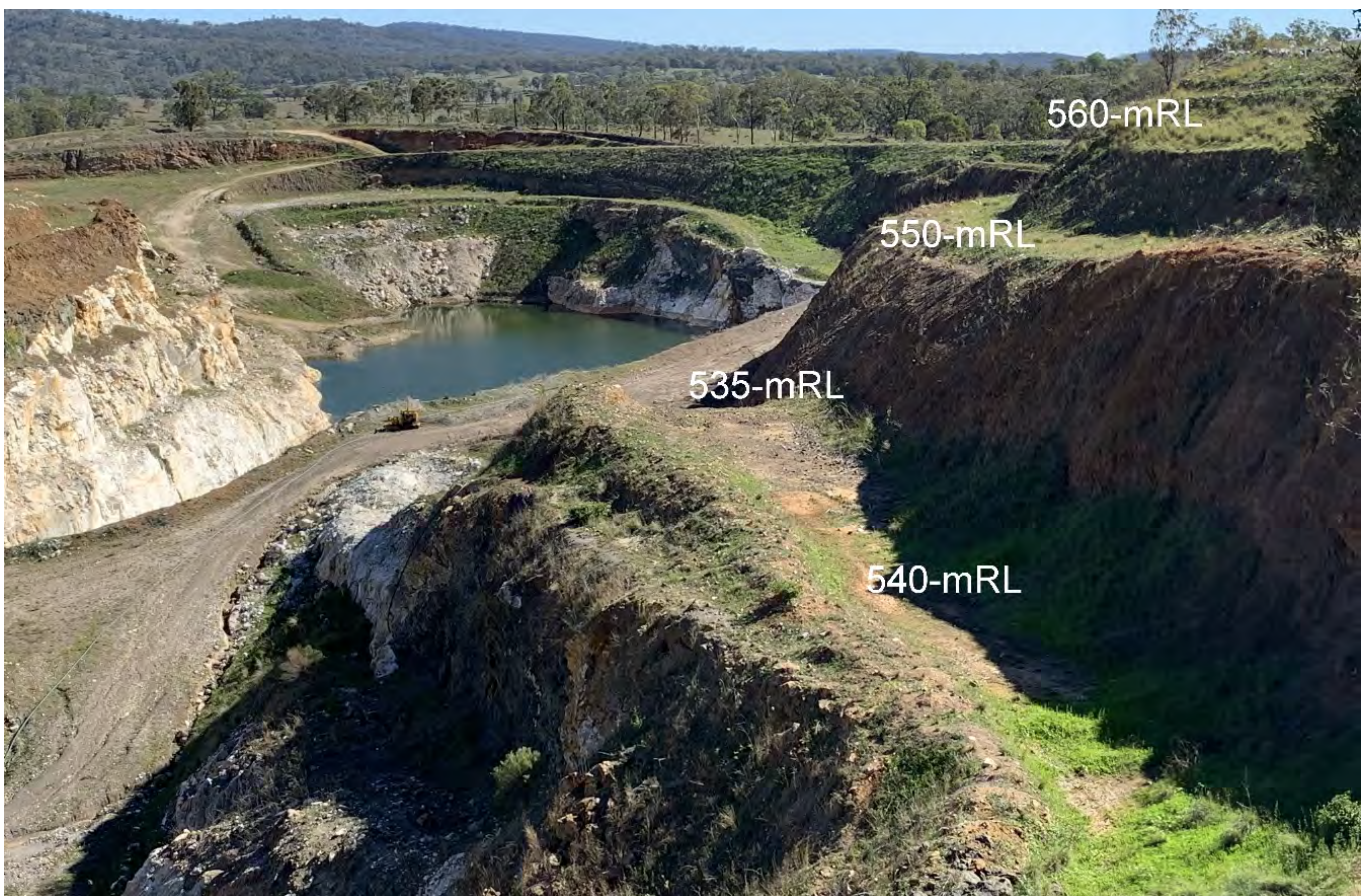
**Figure 52.** Water shedding off the 550-mRL berm is destabilising the 540-m to 550-mRL batter adjacent to the central ramp. Lined drains are required above and along the berm and down the batter.
