# PRCP schedule

## PRCP schedule P-PRCP-100751503

### PRCP schedule: P-PRCP-100751503

| Location(s) |
|---|
| Mining Lease (ML) 7459, 7460, 70049, 70326, 70365, 70366, 70367, 700061 |

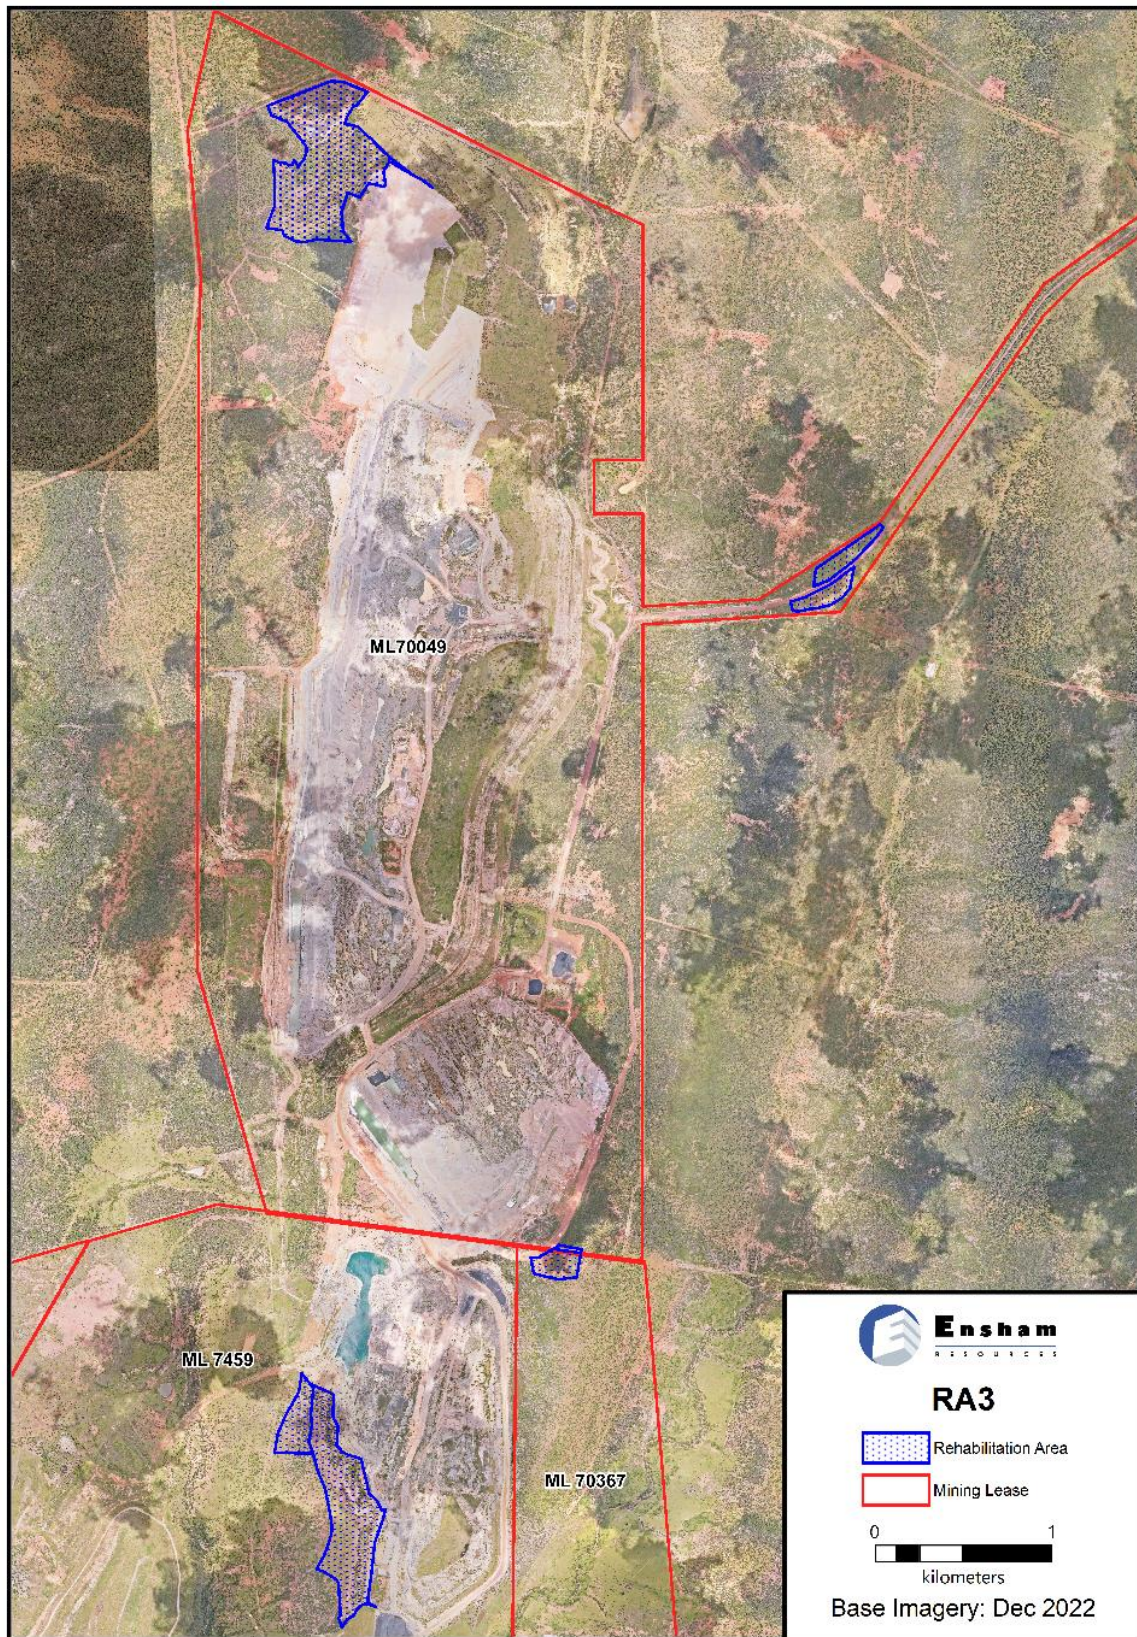
| Post-mining land uses (PMLU) | | |
|---|---|--|
| Relevant activities | Mine domain 4 – cleared areas (Figure 9-11 Rehabilitation Area 3 (RA 03)) | |

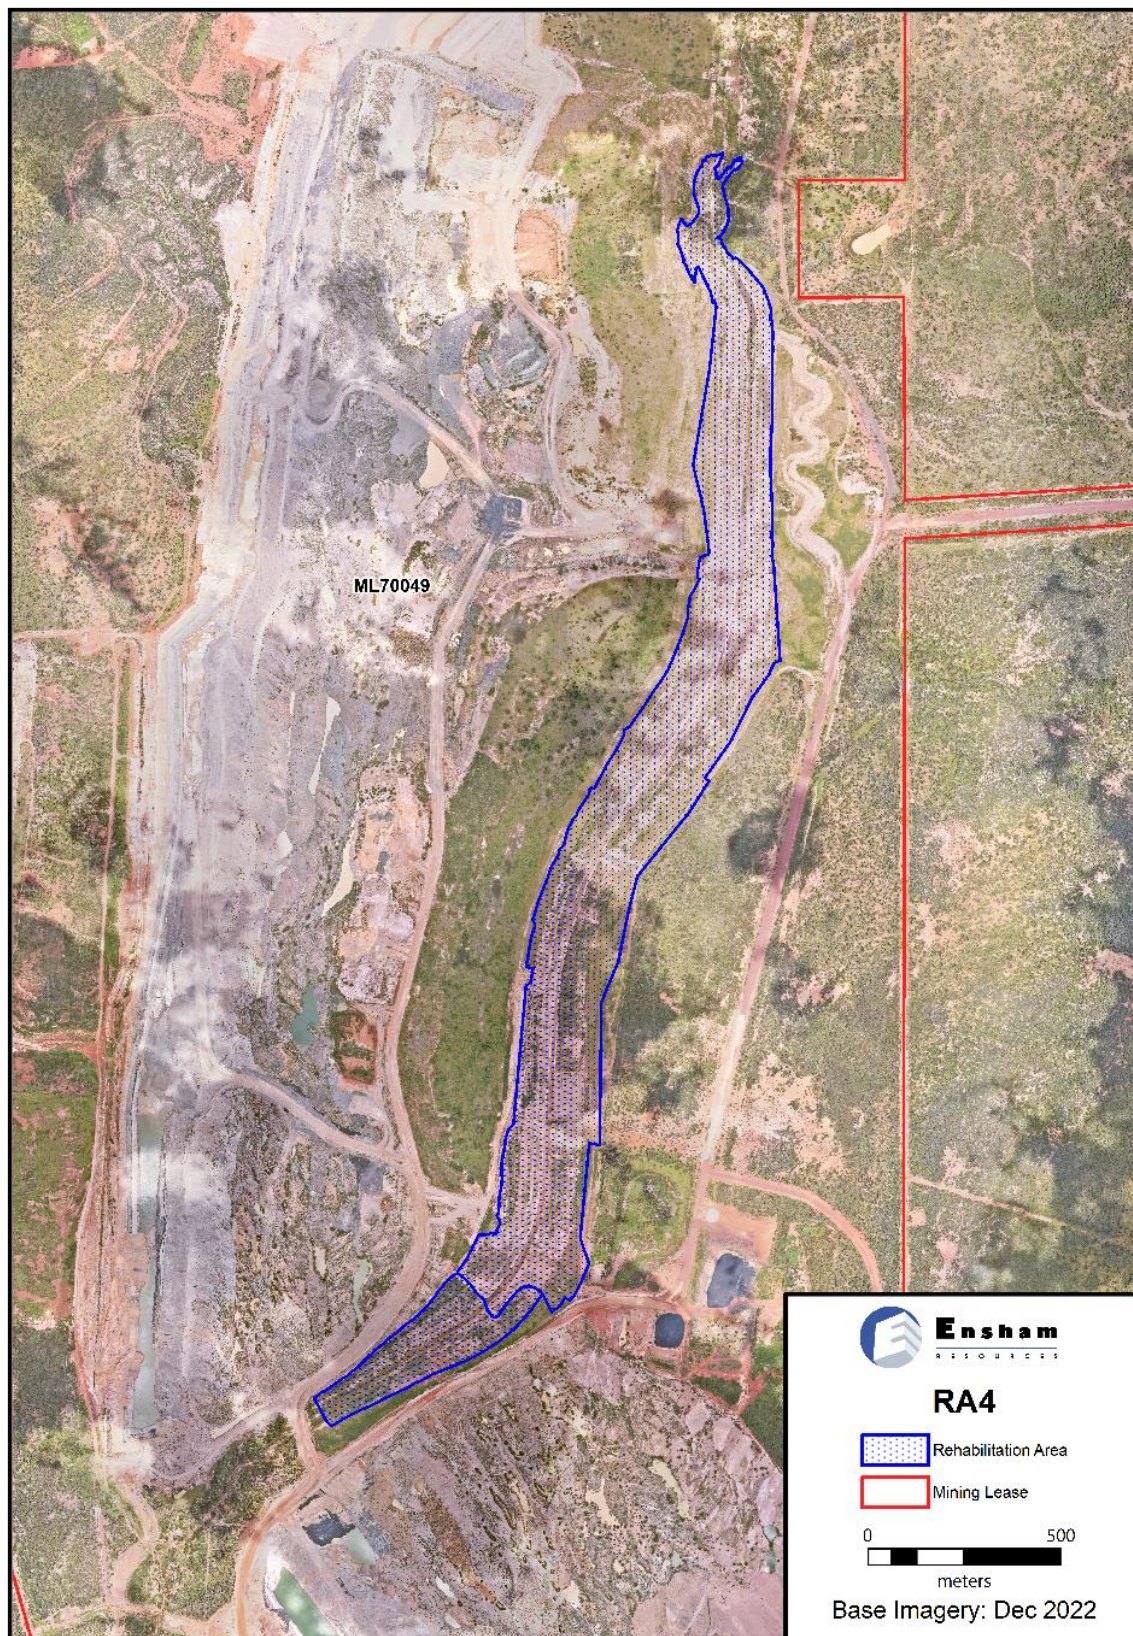
| Post-mining land uses (PMLU) | | | |
|---|---|---|--|
| Relevant activities | Mine domain 3 - Boggy creek diversion (Figure 9-12 Rehabilitation Area 4 (RA 04)) | | |

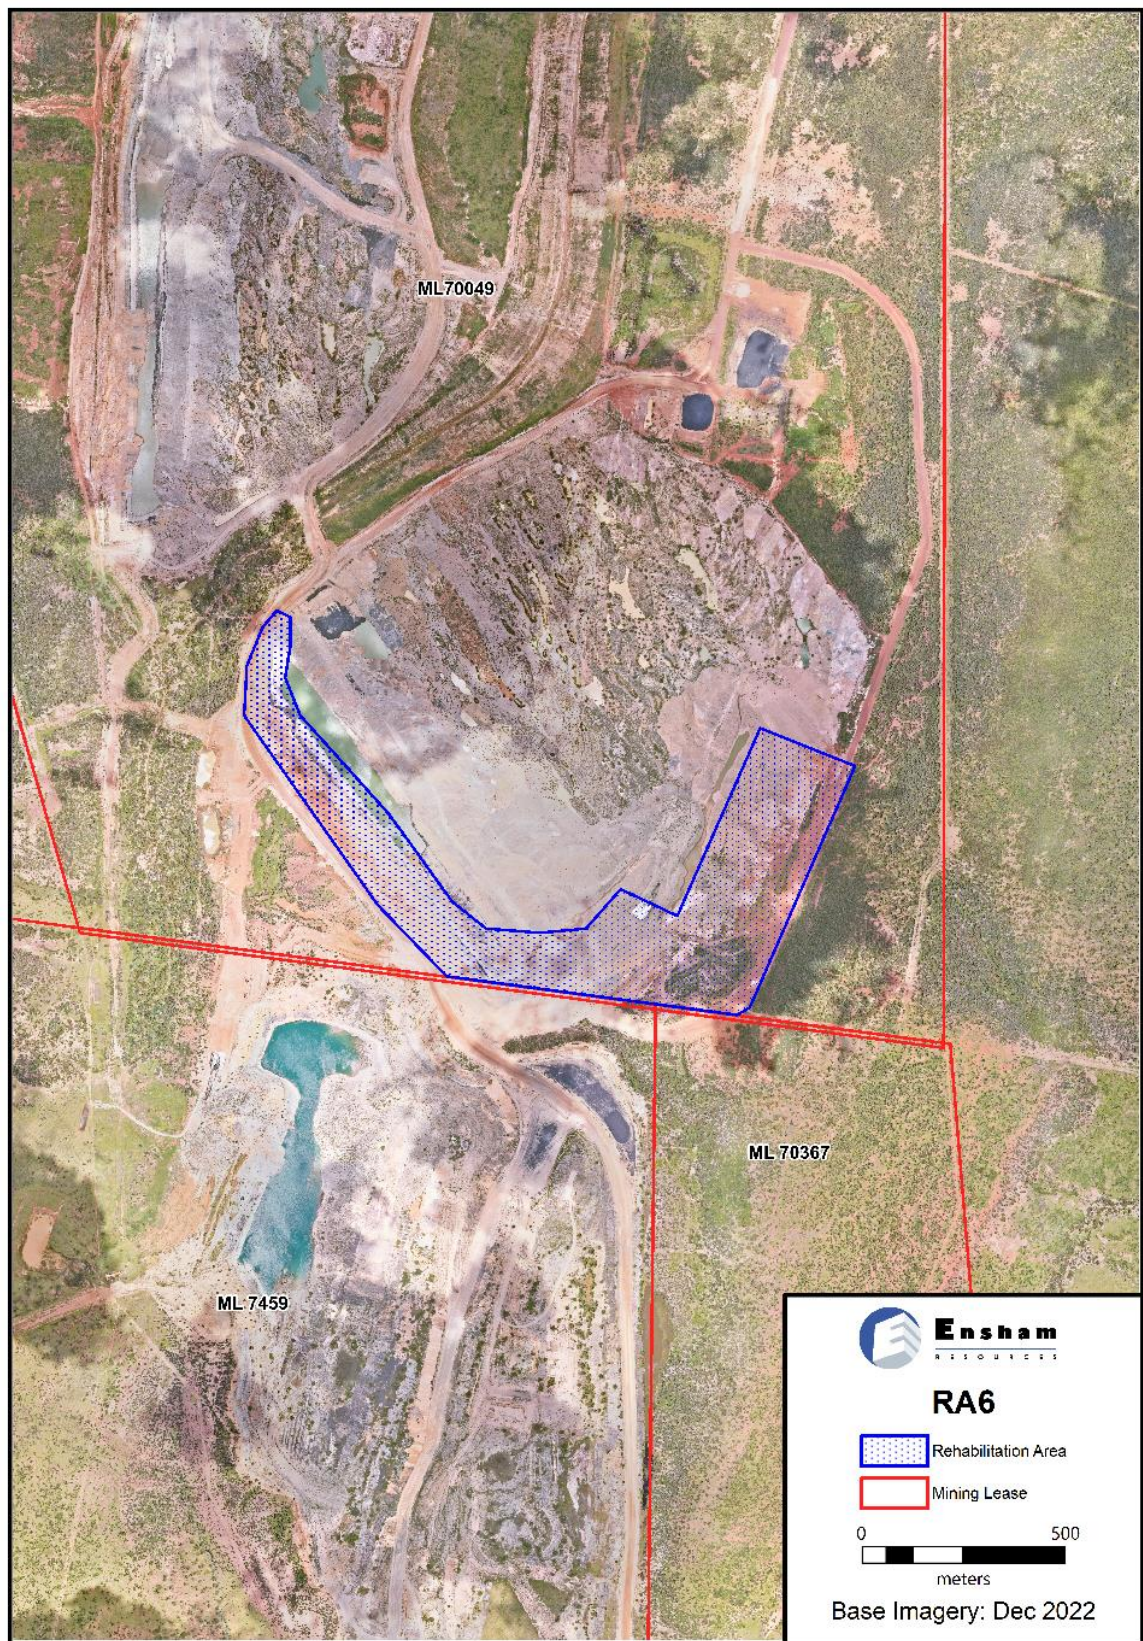
| Post-mining land uses (PMLU) | | | | | | | | | | | |
|---|---|---|---|--|--|--|--|--|--|--|--|
| Relevant activities | | Mine domain 3 – Overburden / mine disturbed areas including overburden emplacement areas, low walls, highwalls and cleared areas (Figure 9-14 Rehabilitation Area 6 (RA 06)) | | | | | | | | | |
