# PRCP schedule

## PRCP schedule P-PRCP-100761412

**PRCP schedule:** P-PRCP-100761412

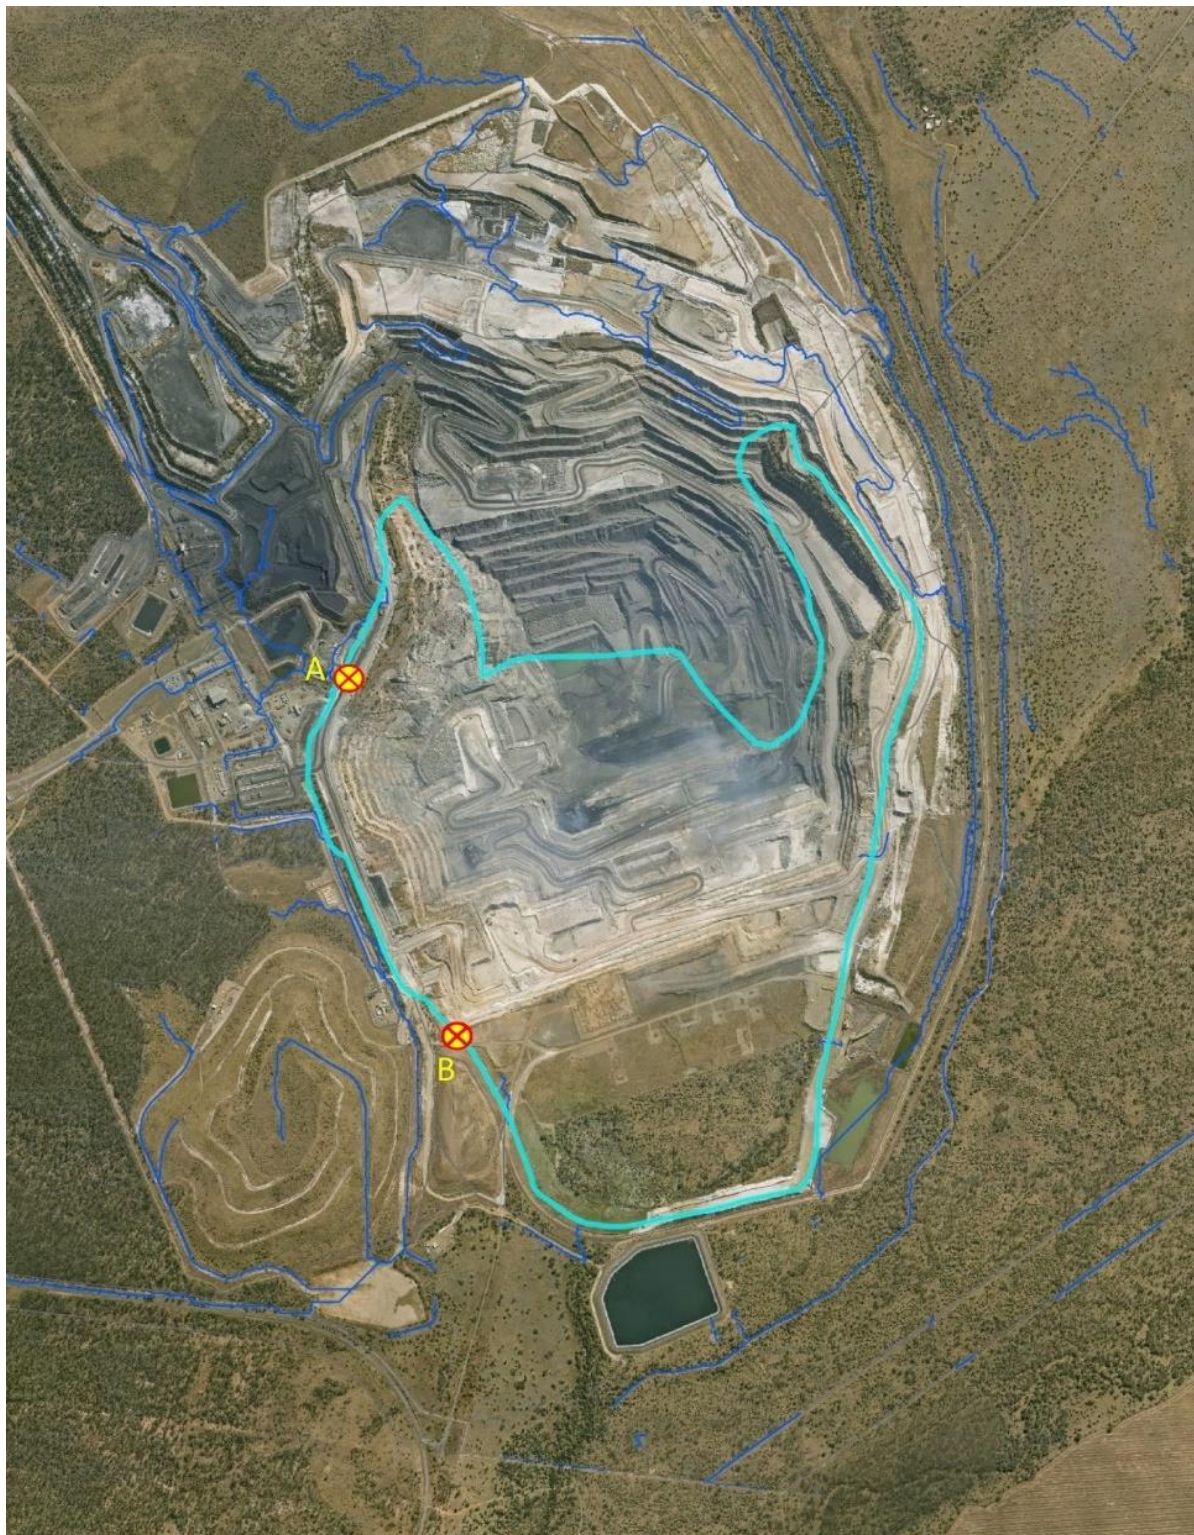
Figure 3 – Highwall segment permitted to achieve FoS  $\geq 1.3$
