LUCKY BREAK PROJECT  
POST MINE LAND USE PLAN

PREPARED FOR  
SCONI MINING OPERATIONS PTY LTD

MAY 2020

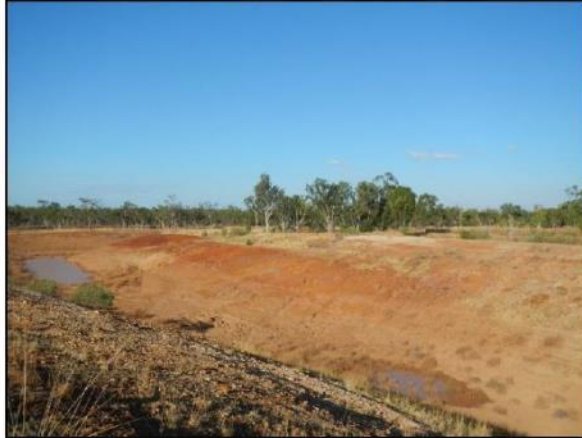
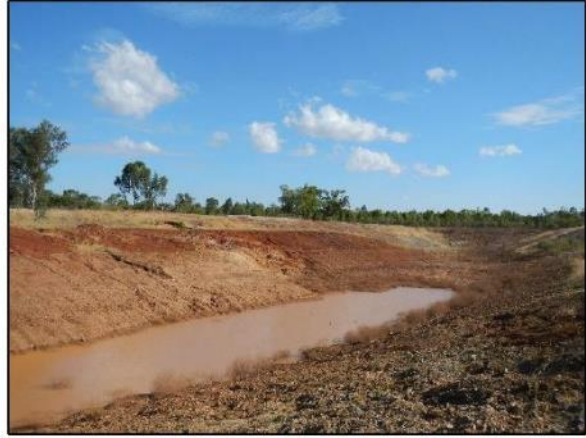
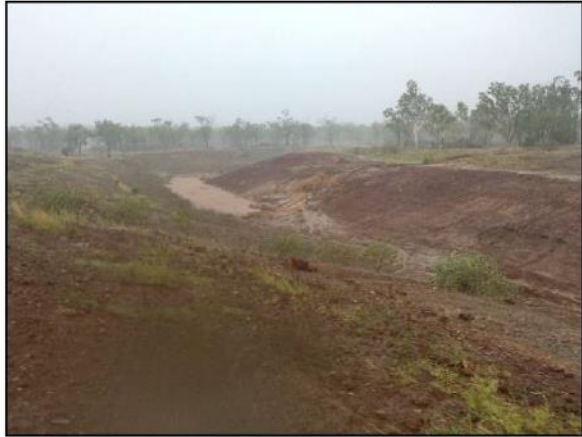
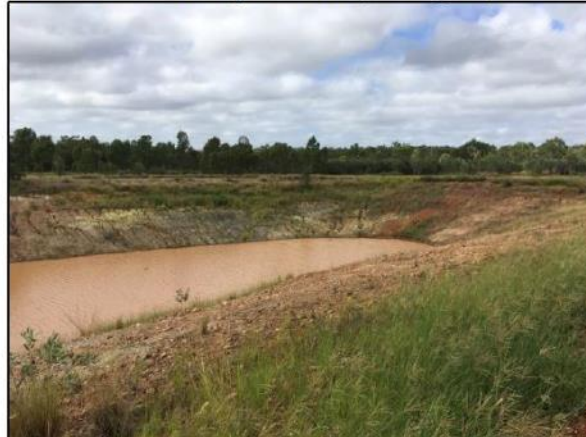
Figure 9: Photographs of site conditions at the void

The assessment of available site photos indicated that the void becomes waterfilled periodically, dependent on weather conditions. Sparse vegetation has established on the batters in the period following construction; however, erosion rills on the batter slopes suggest that water is freely draining down the batters. The associated hydrological risks and an overtopping incident that occurred in February 2019 are discussed at Section 4.1.2.

A hydrological assessment of the site to determine the potential for surface water interaction with the residual void was undertaken by ATCW (2019c). Figure 9 demonstrates hydrological conditions in the residual void as photographed at various points in time. A water balance model was developed to calculate the spill risk of the residual void and a long-term equilibrium void water level. The modelled probabilistic accumulated spill volume in the void is illustrated in Figure 10.

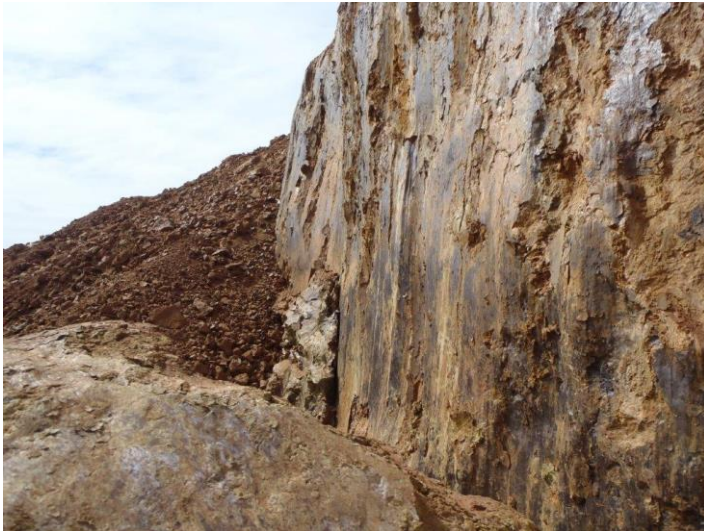
Figure 2-4 Cross-cut section of pit zone (complements of AARC 2019)

Table 2-1 and Table 2-2 presents a summary of soil types available at the site with a spatial distribution of soils shown in Figure 2-5. The Dingo Dam site is generally located within the Corea – CR3t unit which is indicative of a Cainozoic chromosol with an extremely low permeable base layer at an approximate depth of 0.5 m below ground level (mbgl). This massively structured clay layer has a permeability of 9 mm/hr or 216 mm/day infiltration potential (Figure 2-4).
