# Urquhart Bauxite Project Progressive Rehabilitation and Closure Plan

Prepared For: Department of Environment, Tourism, Science and Innovation  
Prepared by: MEC Mining with final edits by Cape Commodities  
EA Holder: Cape Commodities Pty Ltd  
Document ID: 00341455-006  
Version: 3.1  
Date of Submission: 9/06/2026

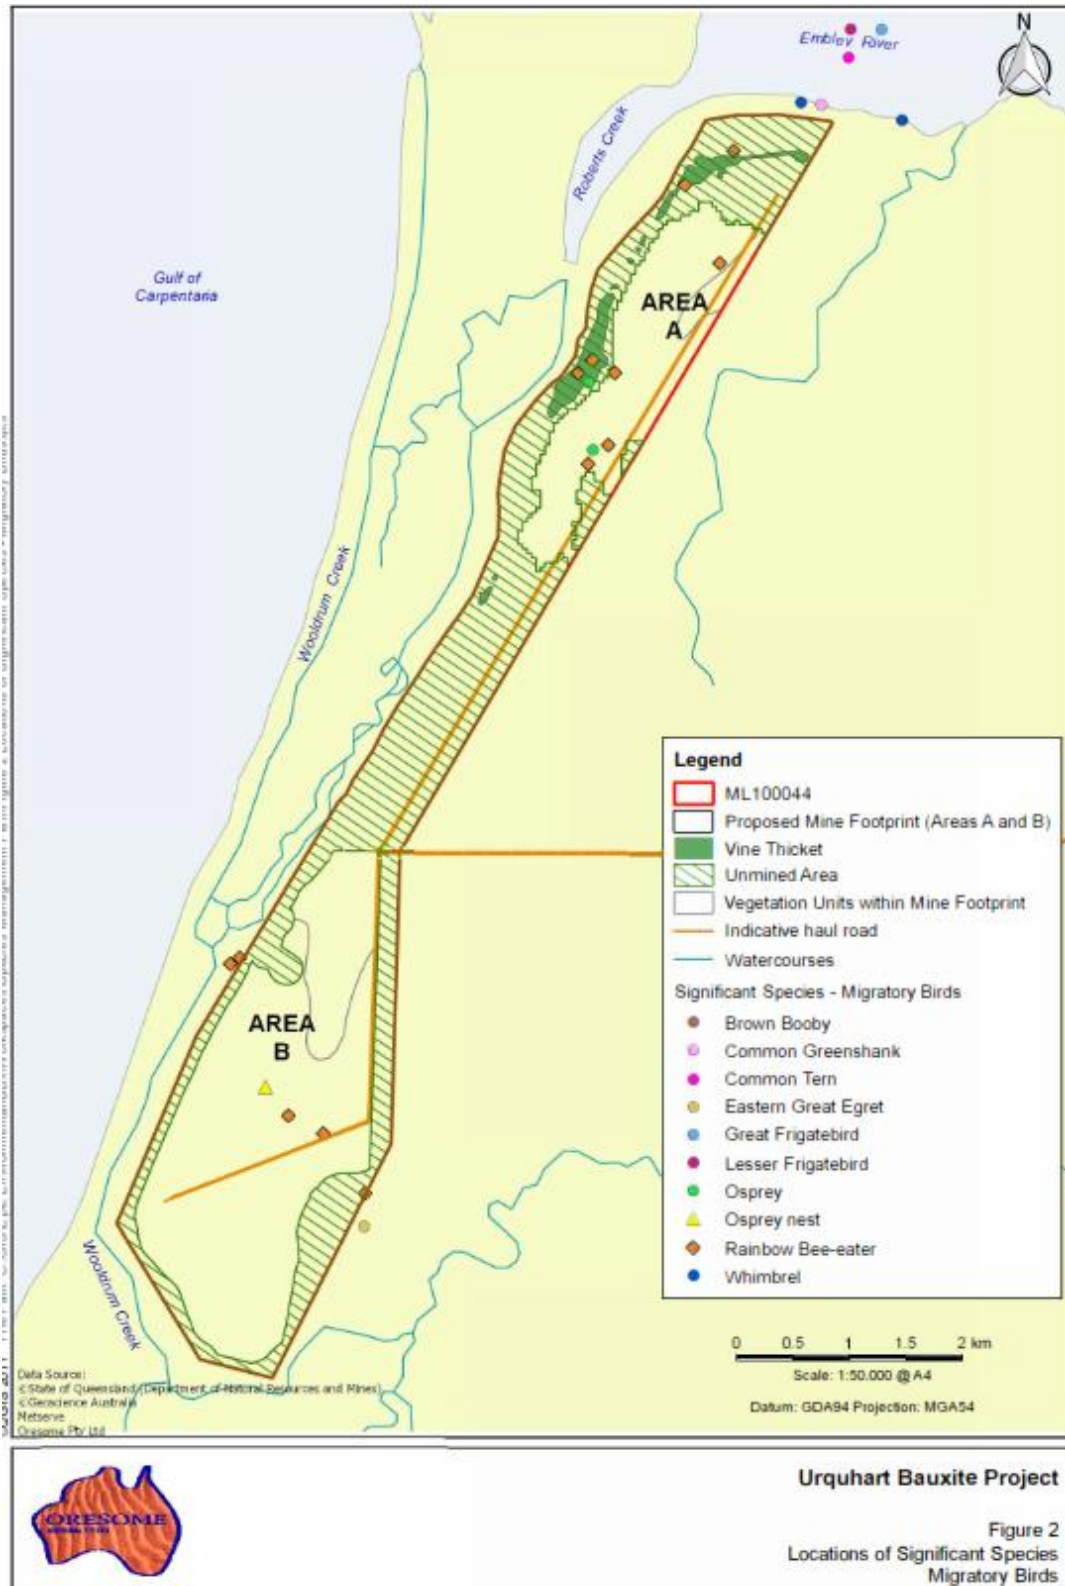
Figure 1-15 Threatened species detected during surveys within the UBxP ML

Few species of conservation significance are known to utilise *Eucalyptus tetradonta* woodlands exclusively as habitat, and no species identified from the site are restricted to this habitat. Habitats for significant species were primarily located along the coastline and in nearby vine forest and wetlands. Survey records are shown in **Figure 1-15**.

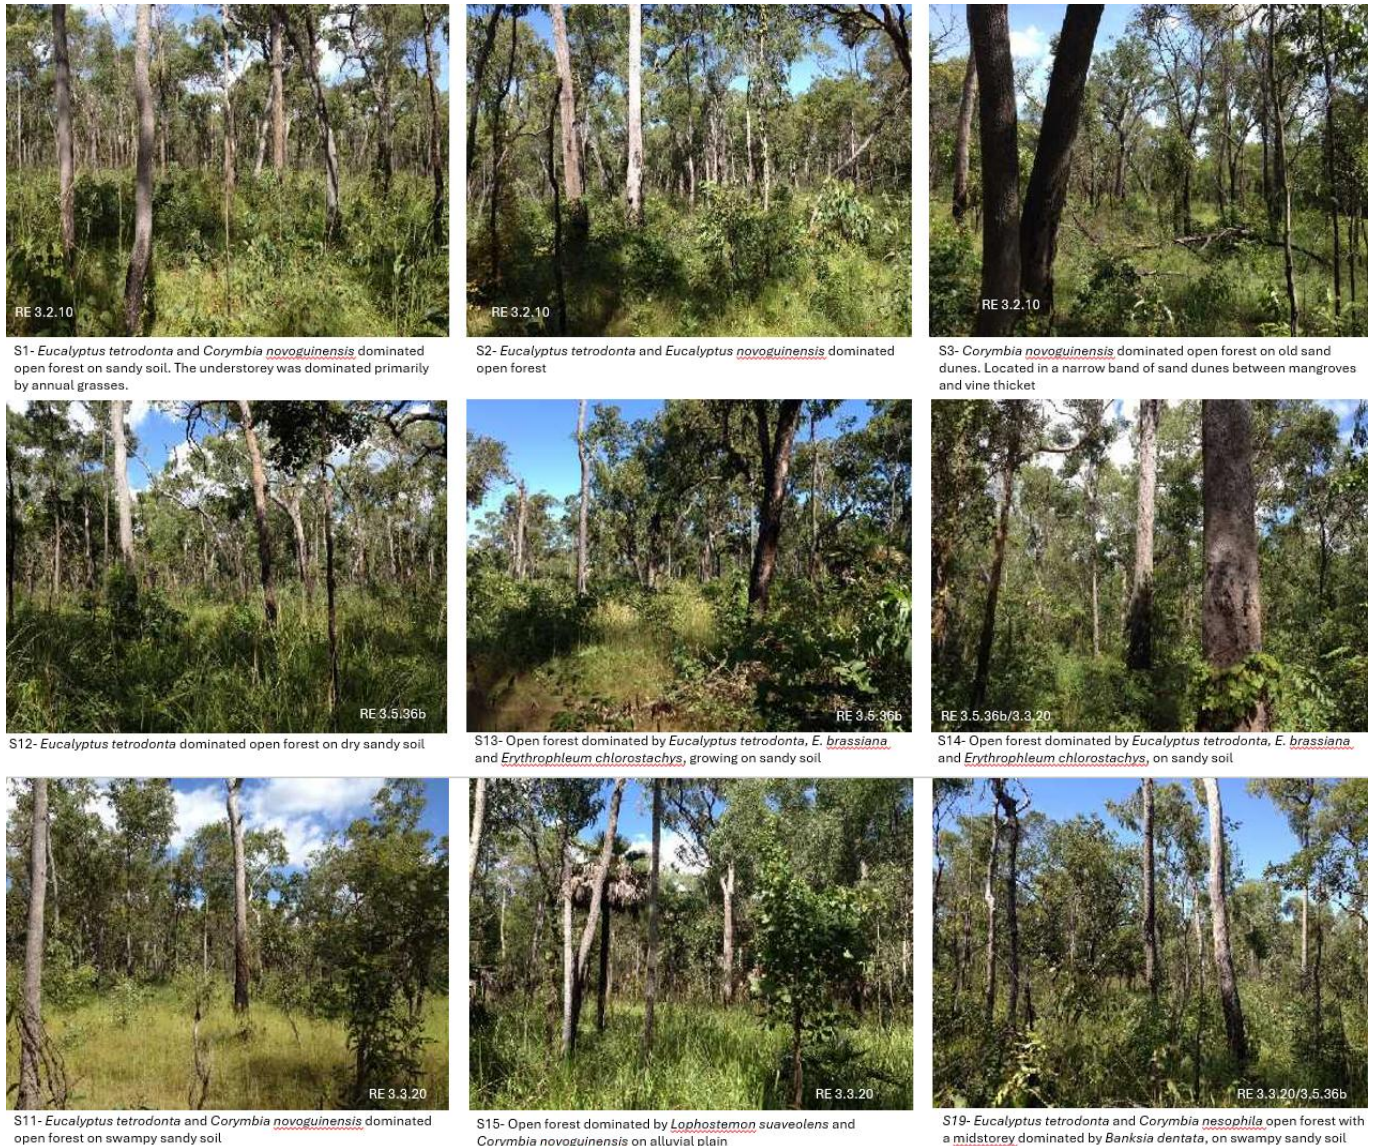
**Figure 9-2 Survey site images for reference sites**

Interim reference (analogue) sites have been selected from the 2015 secondary survey sites to represent each Regional Ecosystem (RE) type scheduled for clearing and subsequent rehabilitation within the UBxP area. These sites primarily occur within the clearing footprint (**Figure 9-1**). Images from each selected reference site are presented in **Figure 9-2**.
