## Mount Rawdon Operation

### Progressive Rehabilitation & Closure Plan

**Version 3 - Rev 2 | Submitted 24 September 2025**

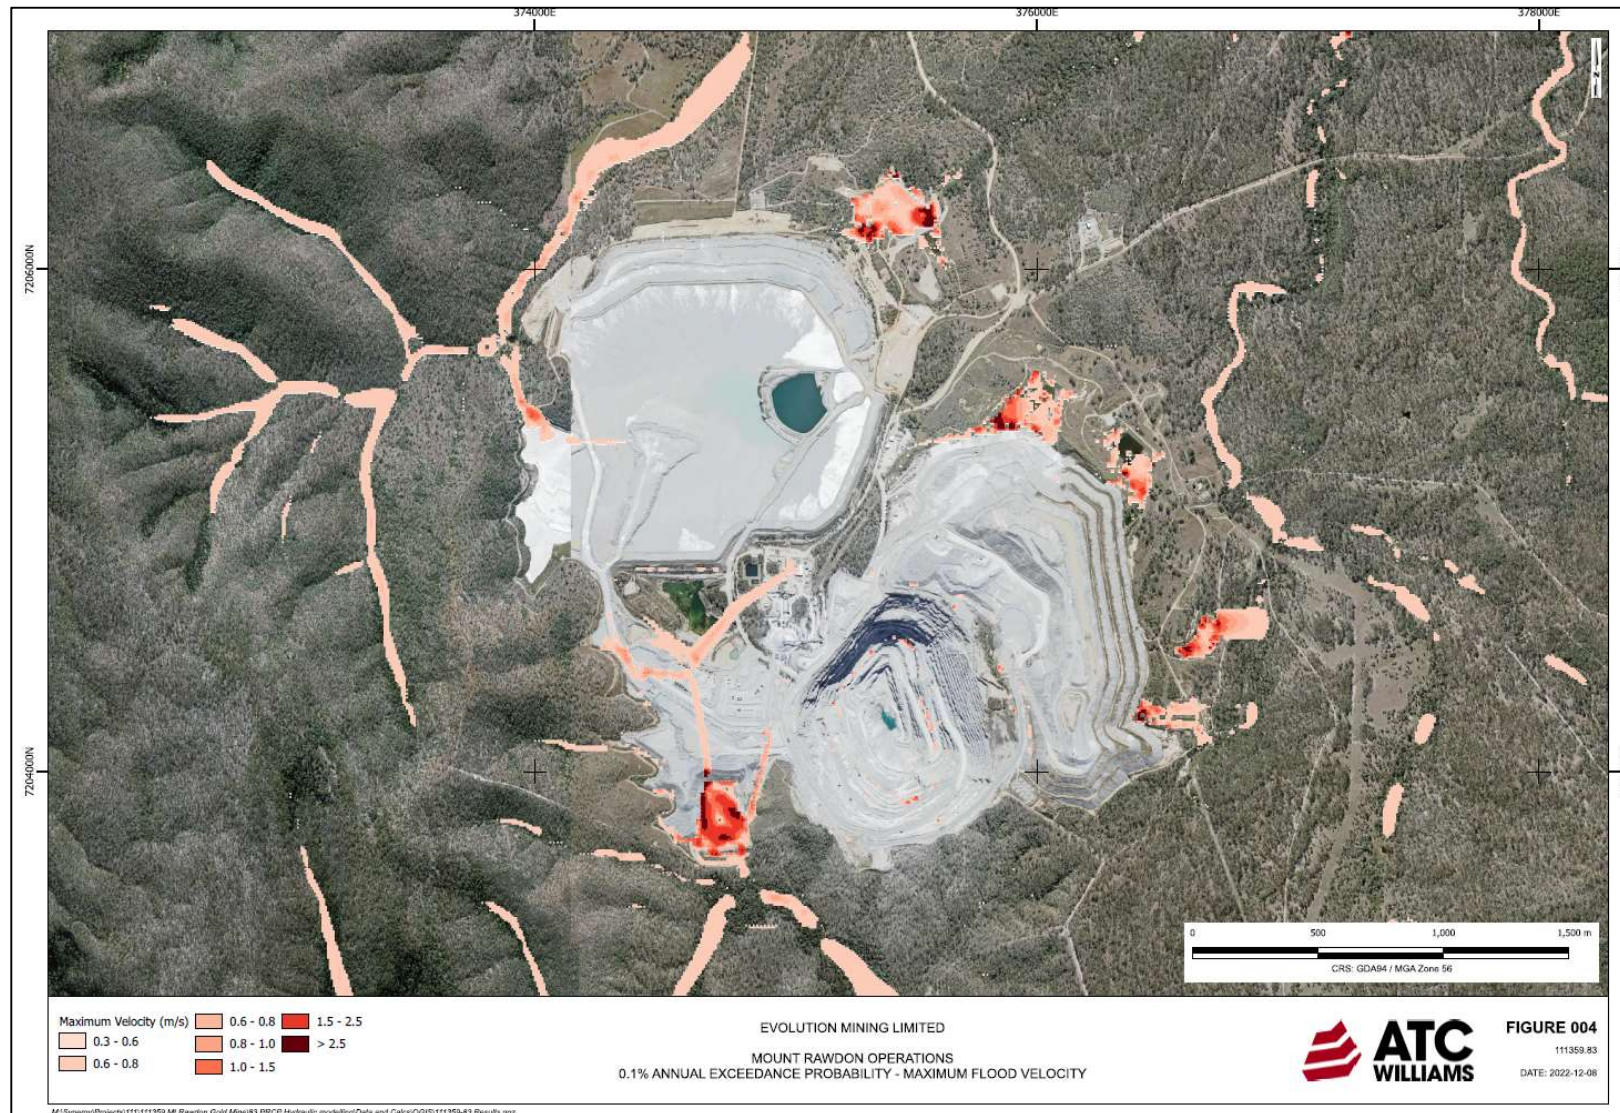
Figure 53 : Probable 1,000yr Flood (0.1% AEP) - Maximum Flood Velocity (ATCW 2023)

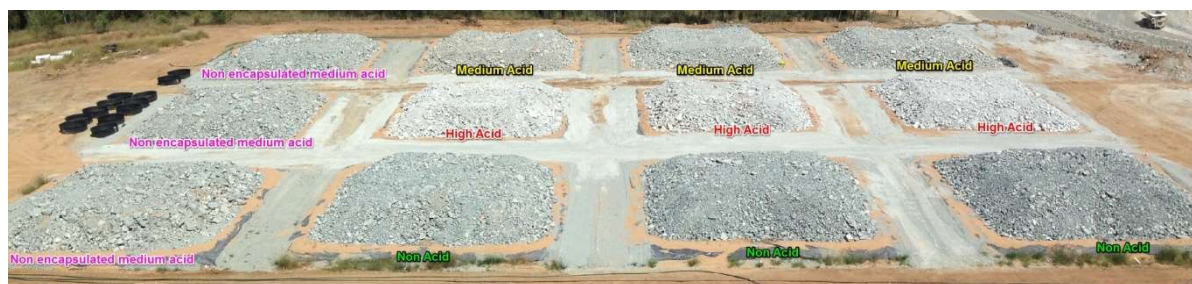
However, due to inadequacies in the design of the leachate collection (lysimeter) system below each test pile, expected long-term leachate collection was not successful in providing enough samples for a statistically significant dataset. Notwithstanding, RGS found that almost all pH values reported for leachate from all waste rock types was circum-neutral, and the leachate from the PAF High Capacity materials sporadically showing slightly acidic leachate pH which then returned to circum-neutral pH.

Figure 56 : Field waste rock lysimeter pads (ca. 2016).
