# Mount Rawdon Operations Northern Waste Rock Dump Detailed Cover System Design: Concept Study Review Report

31 May 2024

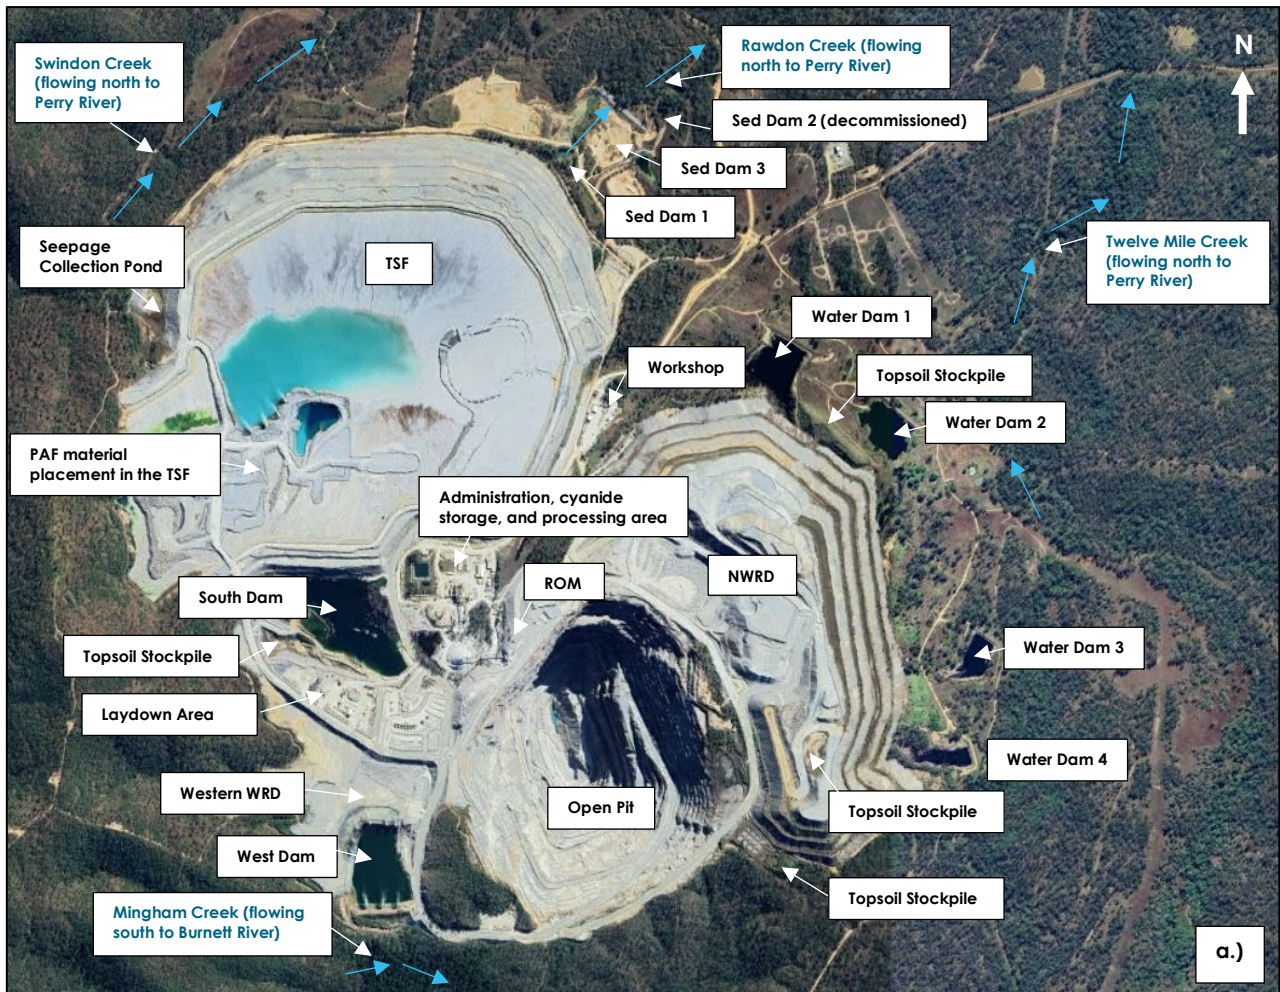
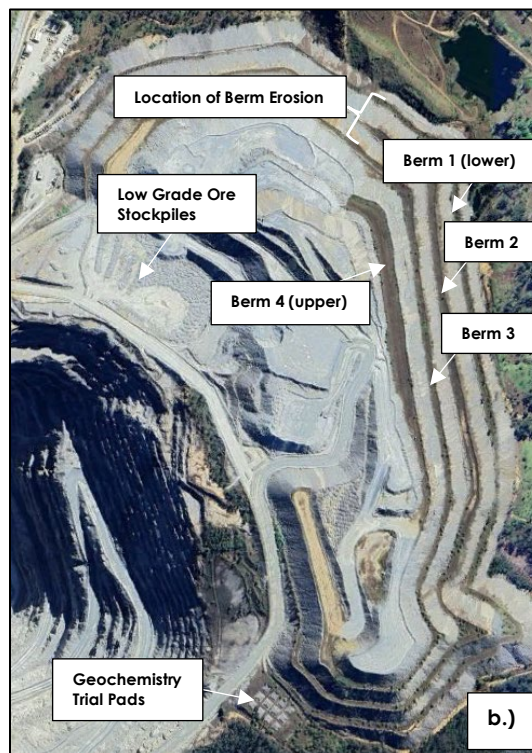
Figure 2.1: a.) Key site features at MRO, and b.) key features of the NWRD (Google Earth, 2023).

- It is worth noting that based on the assessed aerial survey, a local failure of the berms in the northern section of the NWRD has been observed. Its location is detailed in Figure 2.1b. However, details regarding the nature of the failure have not been documented in the received reports or been provided anecdotally.

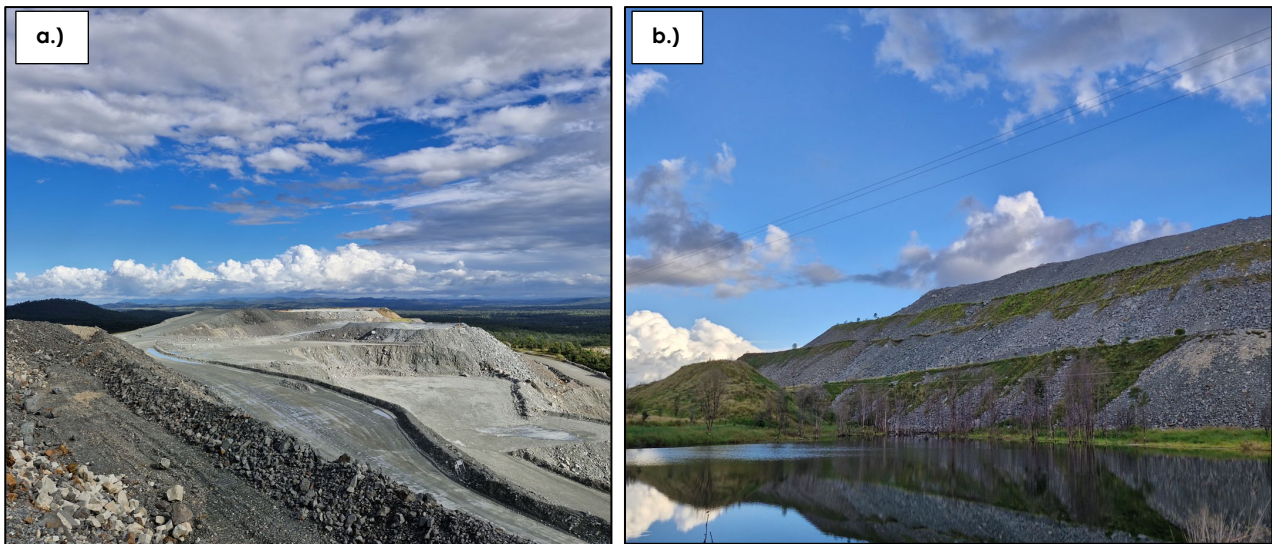
**Figure 2.2: a.) Looking south across the top-tier of the NWRD, and b.) Looking south-east towards the NWRD (Okane, 2024).**

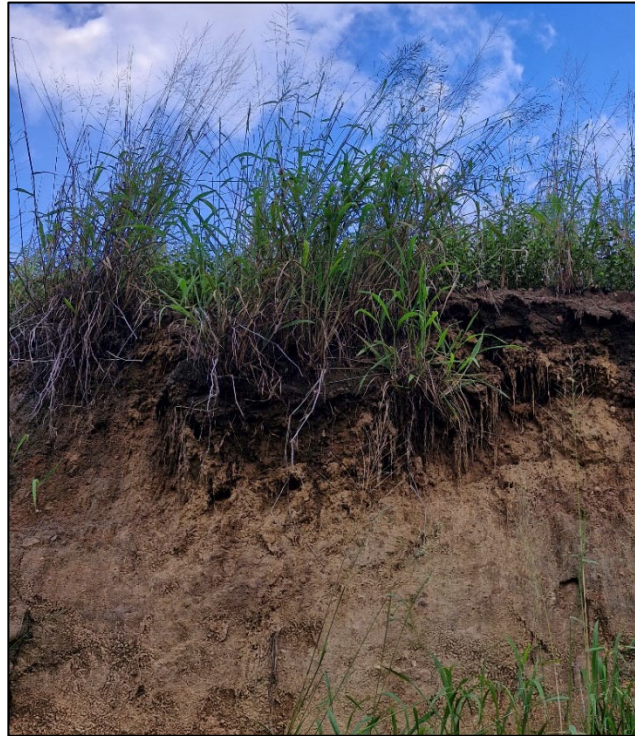
**Figure 2.6: Soil Profile from a Topsoil Stockpile (Okane, 2024)**

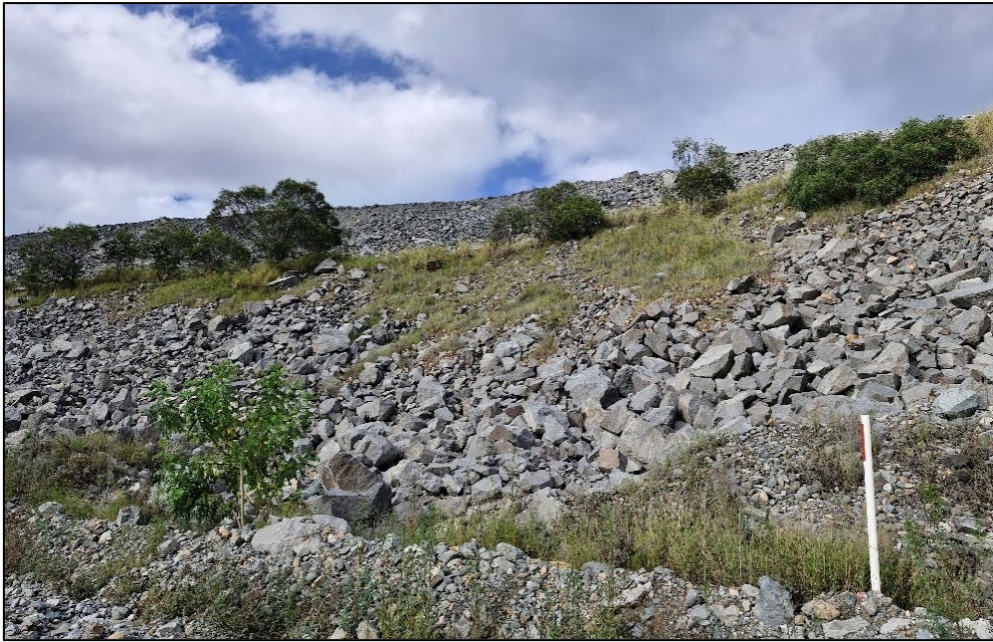
**Figure 2.7: Coarse overburden material comprising the angle of repose NWRD batters adjacent to the open pit (Okane, 2024).**

The overburden at this site consists of oxide and transition materials (Figure 2.7). Oxide overburden primarily comprises highly weathered materials with some partially weathered rock present. Transition overburden consists of weathered materials with minor partially weathered rock, along with some competent fresh rock. This fresh competent rock, found within the transition overburden, may be suitable for applications such as armouring drains or serving as rock mulch in the soil cover.

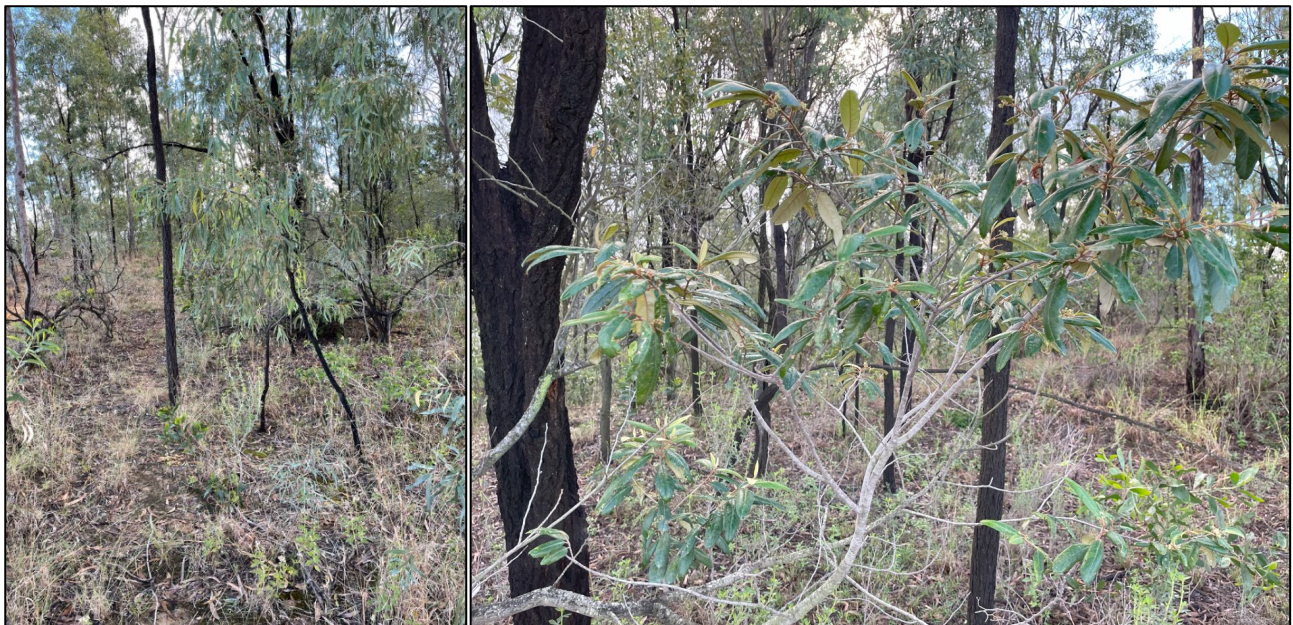
Figure 2.9: Typical natural woodland vegetation (photograph taken to the east of the administration area (25°16'01" S, 151°45'41" E)).

According to the Department of Environment, Science, and Innovation (DESI) Regional Ecosystem mapping, several Regional Ecosystems (RE's) occur within the MRO area (Figure 2.8). The RE's are all associated with remnant vegetation, however there are also numerous patches of non-remnant vegetation within the MRO area (MRO, 2022). The vegetation community is open eucalypt woodland with an understorey that is typically grassy (Figure 2.9, Figure 2.10).

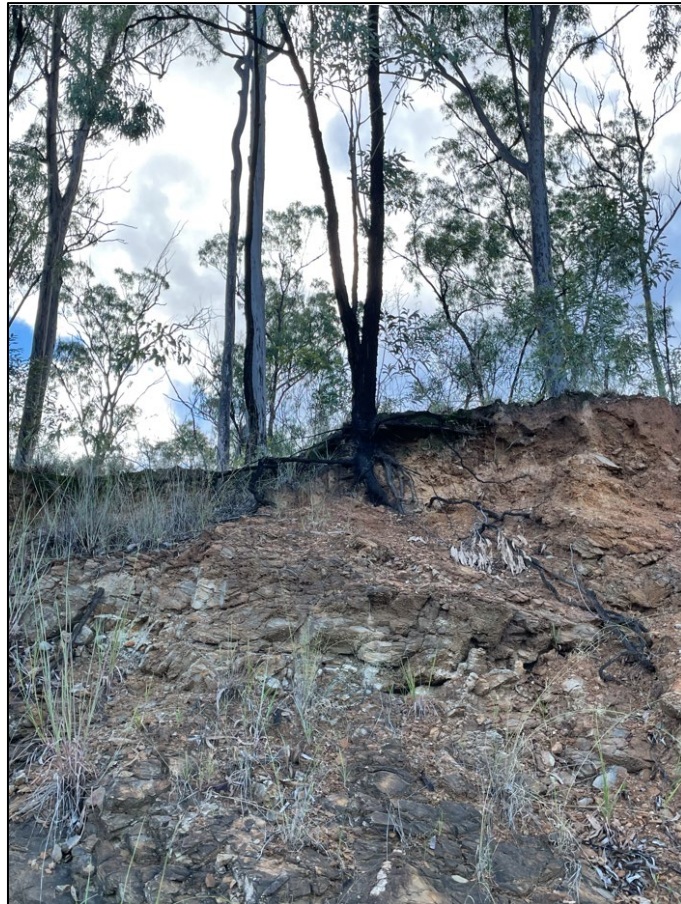
**Figure 2.10: Soil profile for naturally occurring woodland vegetation (photograph taken to the east of the administration area (25°16'01" S, 151°45'41" E)).**

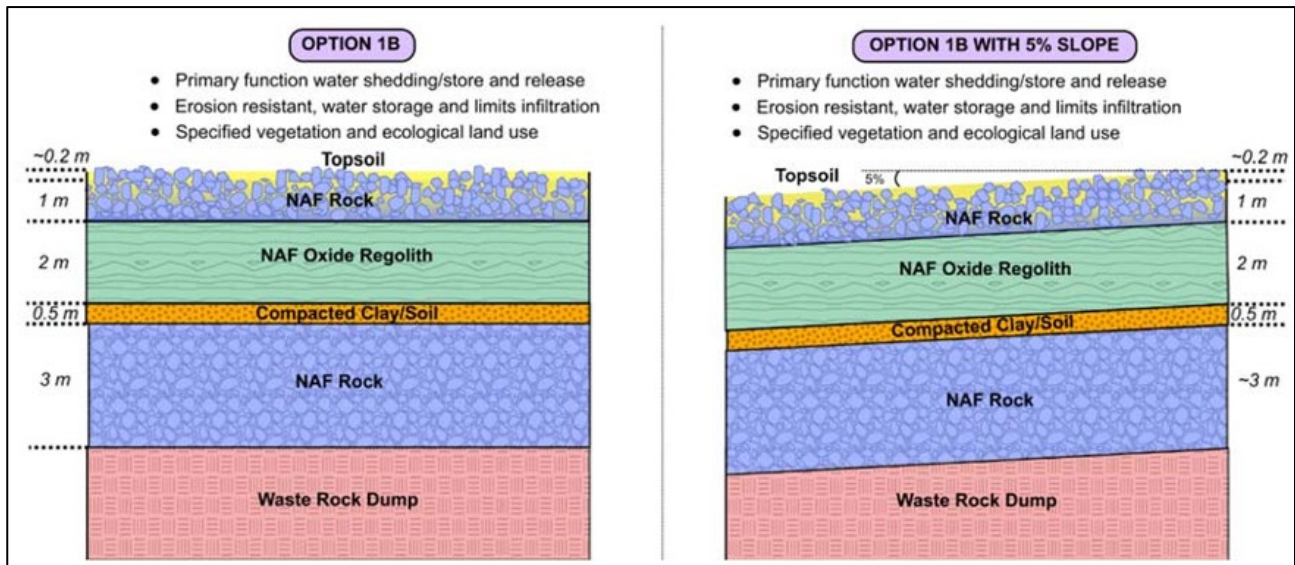
**Figure 3.33: Preferred cover system outcome design for the NWRD (RGS, 2022).**

Option 1B is recommended as the preferred configuration for the NWRD cover system, as illustrated in Figure 3.3 and consists of:

- NAF competent rock as a basal layer (up to 3.0 m).
- Low permeability clay/silt/sand (2 x 0.25 m compacted layers).
- NAF oxide regolith (up to 2.0 m).
- NAF waste rock (up to 1.0 m).
- Topsoil filling voids in the rock cover to create a rocky mulch (up to 0.2 m).

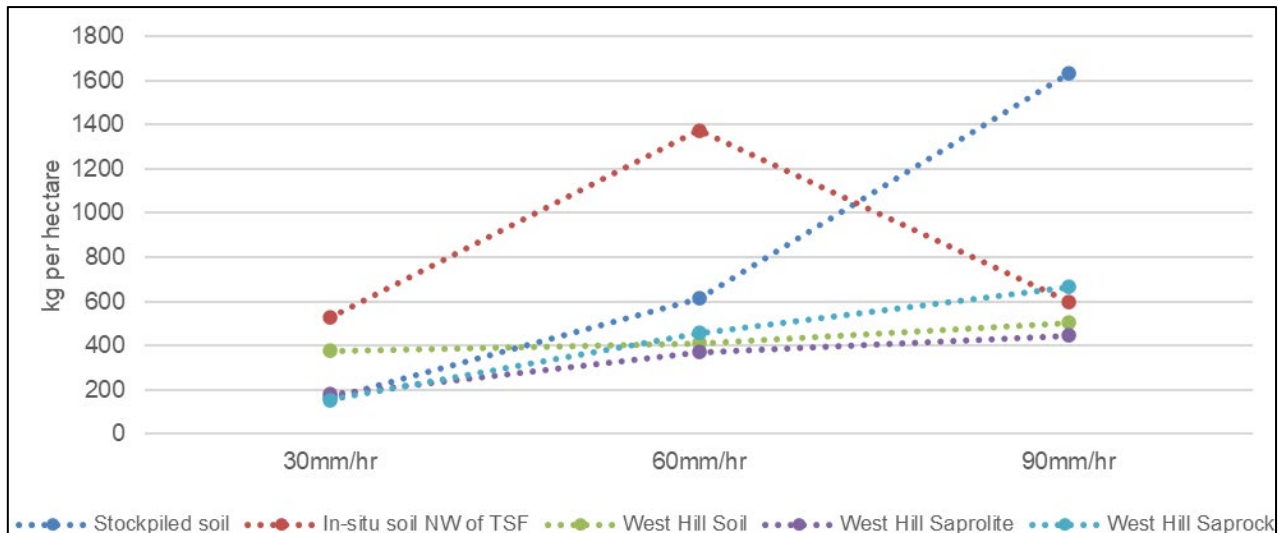
Figure 3.44: Discrete event erosion measurement (RGS, 2023a).

Key findings from the erosion assessment are presented in Figure 3.4 and Figure 3.5, with key findings consisting of:

- Erosion rates for discrete storm events varied significantly:
  - 30 mm/hr storm event resulted in erosion rates of 0.15-0.38 tonnes per hectare (t/ha).
  - 60 mm/hr storm event resulted in erosion rates of 0.37-0.61 t/ha.
  - 90 mm/hr storm event resulted in erosion rates of 0.45-1.64 t/ha.
- Cumulative erosion rates from three consecutive storm events over five days ranged from 0.99-2.50 t/ha and were strongly influenced by soil type.
- Long-term modelling indicated that with 30 % vegetation cover on an 80 m slope, erosion rates could potentially reduce to between 0.2-1.1 t/ha after five years.

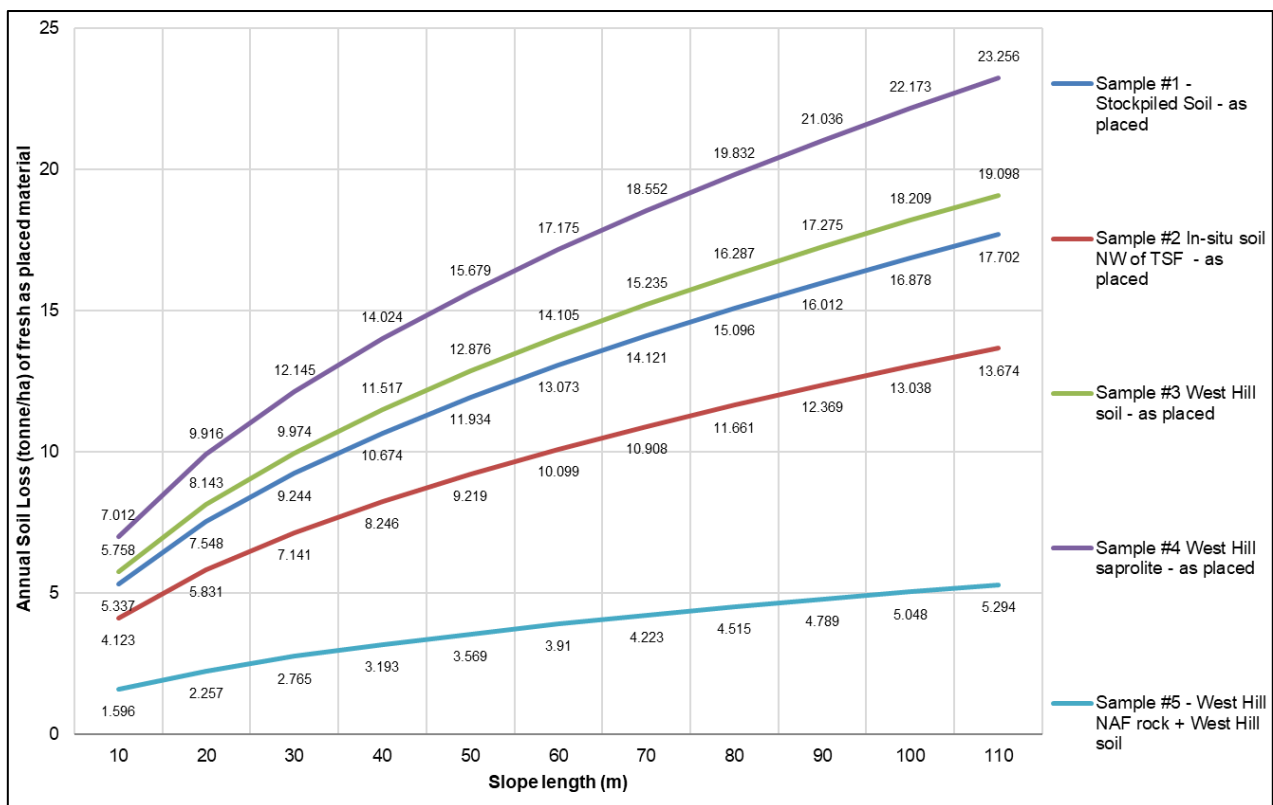
Figure 3.55: Modelled annual erosion rates for as-placed material with a 5% slope angle and slope lengths from 10 m to 110 m (RGS, 2023a).

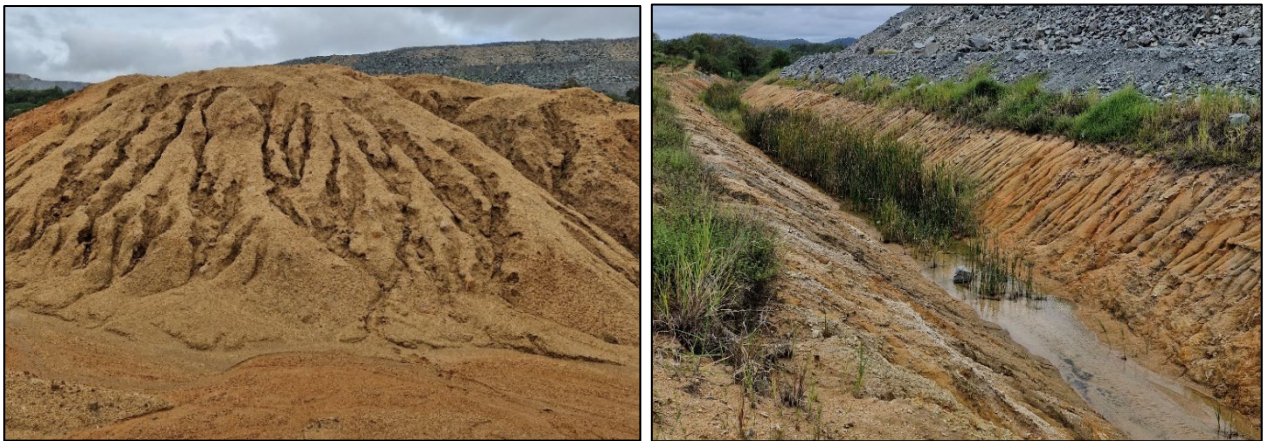
**Figure 4.3: Rill erosion on sloped soil material to the north of the TSF.**

The exchangeable sodium percentage (ESP) values in the topsoil stockpiles were greater than 10 % and did indicate the presence of sodic soils, however ESP was reported to be lower in the berm soil material (~2 %) suggesting largely non-sodic conditions. Some rill formation and dispersion of topsoil stockpile material, and material applied to drainage channels, was observed during the site visit on sloped material that was yet to support vegetation (Figure 4.3).

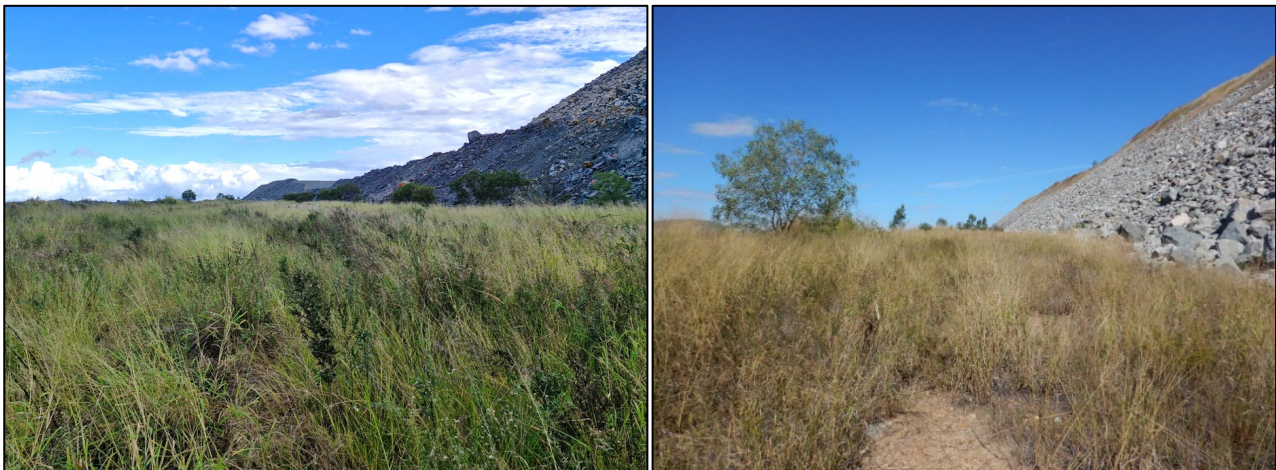
**Figure 4.4: Vegetation coverage on berm 2 during wetter conditions in April 2024 (left (Okane, 2024)) and drier conditions in May 2021 (right (RGS, 2021))**

Figure 4.4 provides an important comparison of vegetation coverage and compacted clay exposure on the NWRD berms under different weather conditions. The 2024 site visit image, taken following a period of high rainfall, shows water-logged conditions, high grass coverage, and small trees and shrubs along the batter edges, confirming ponding and higher water availability at the base of the batters. In contrast, the 2021 image shows patchy vegetation coverage and the potential for clay cracking and water infiltration with direct atmospheric exposure.

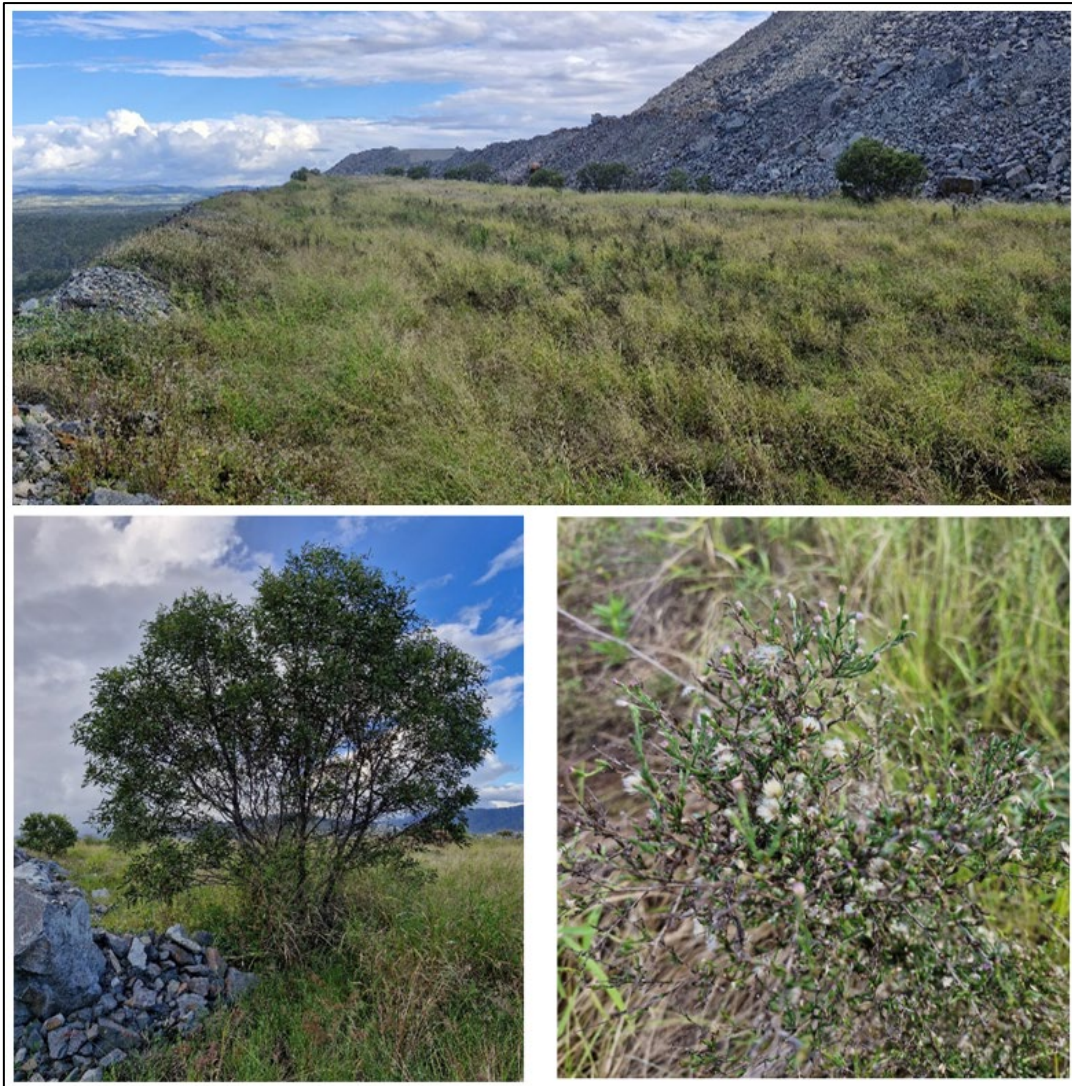
**Figure 5.2: Berm Vegetation Trial at NWRD, April 2024.**

In April 2024, a survey of the Berm Vegetation Trial at the NWRD was conducted by Okane, BGC, and site personnel (see Figure 5.2) where grasses species were noted to be the dominant with species. Acacia shrubs were observed at the toe of the upper embankment and the crest, possibly due to the drier conditions within those areas. Surface water pooling within the centre of the berm was observed with 100 % ground cover.
