**EVOLUTION MINING LIMITED**  
ABN: 74 084 669 036

**Mount Rawdon Operation**  
**Tailings Storage Facility**  
**Field Cover System Trials**  
**Detailed Design Report**

111359-100R04-REV0  
DECEMBER 2024

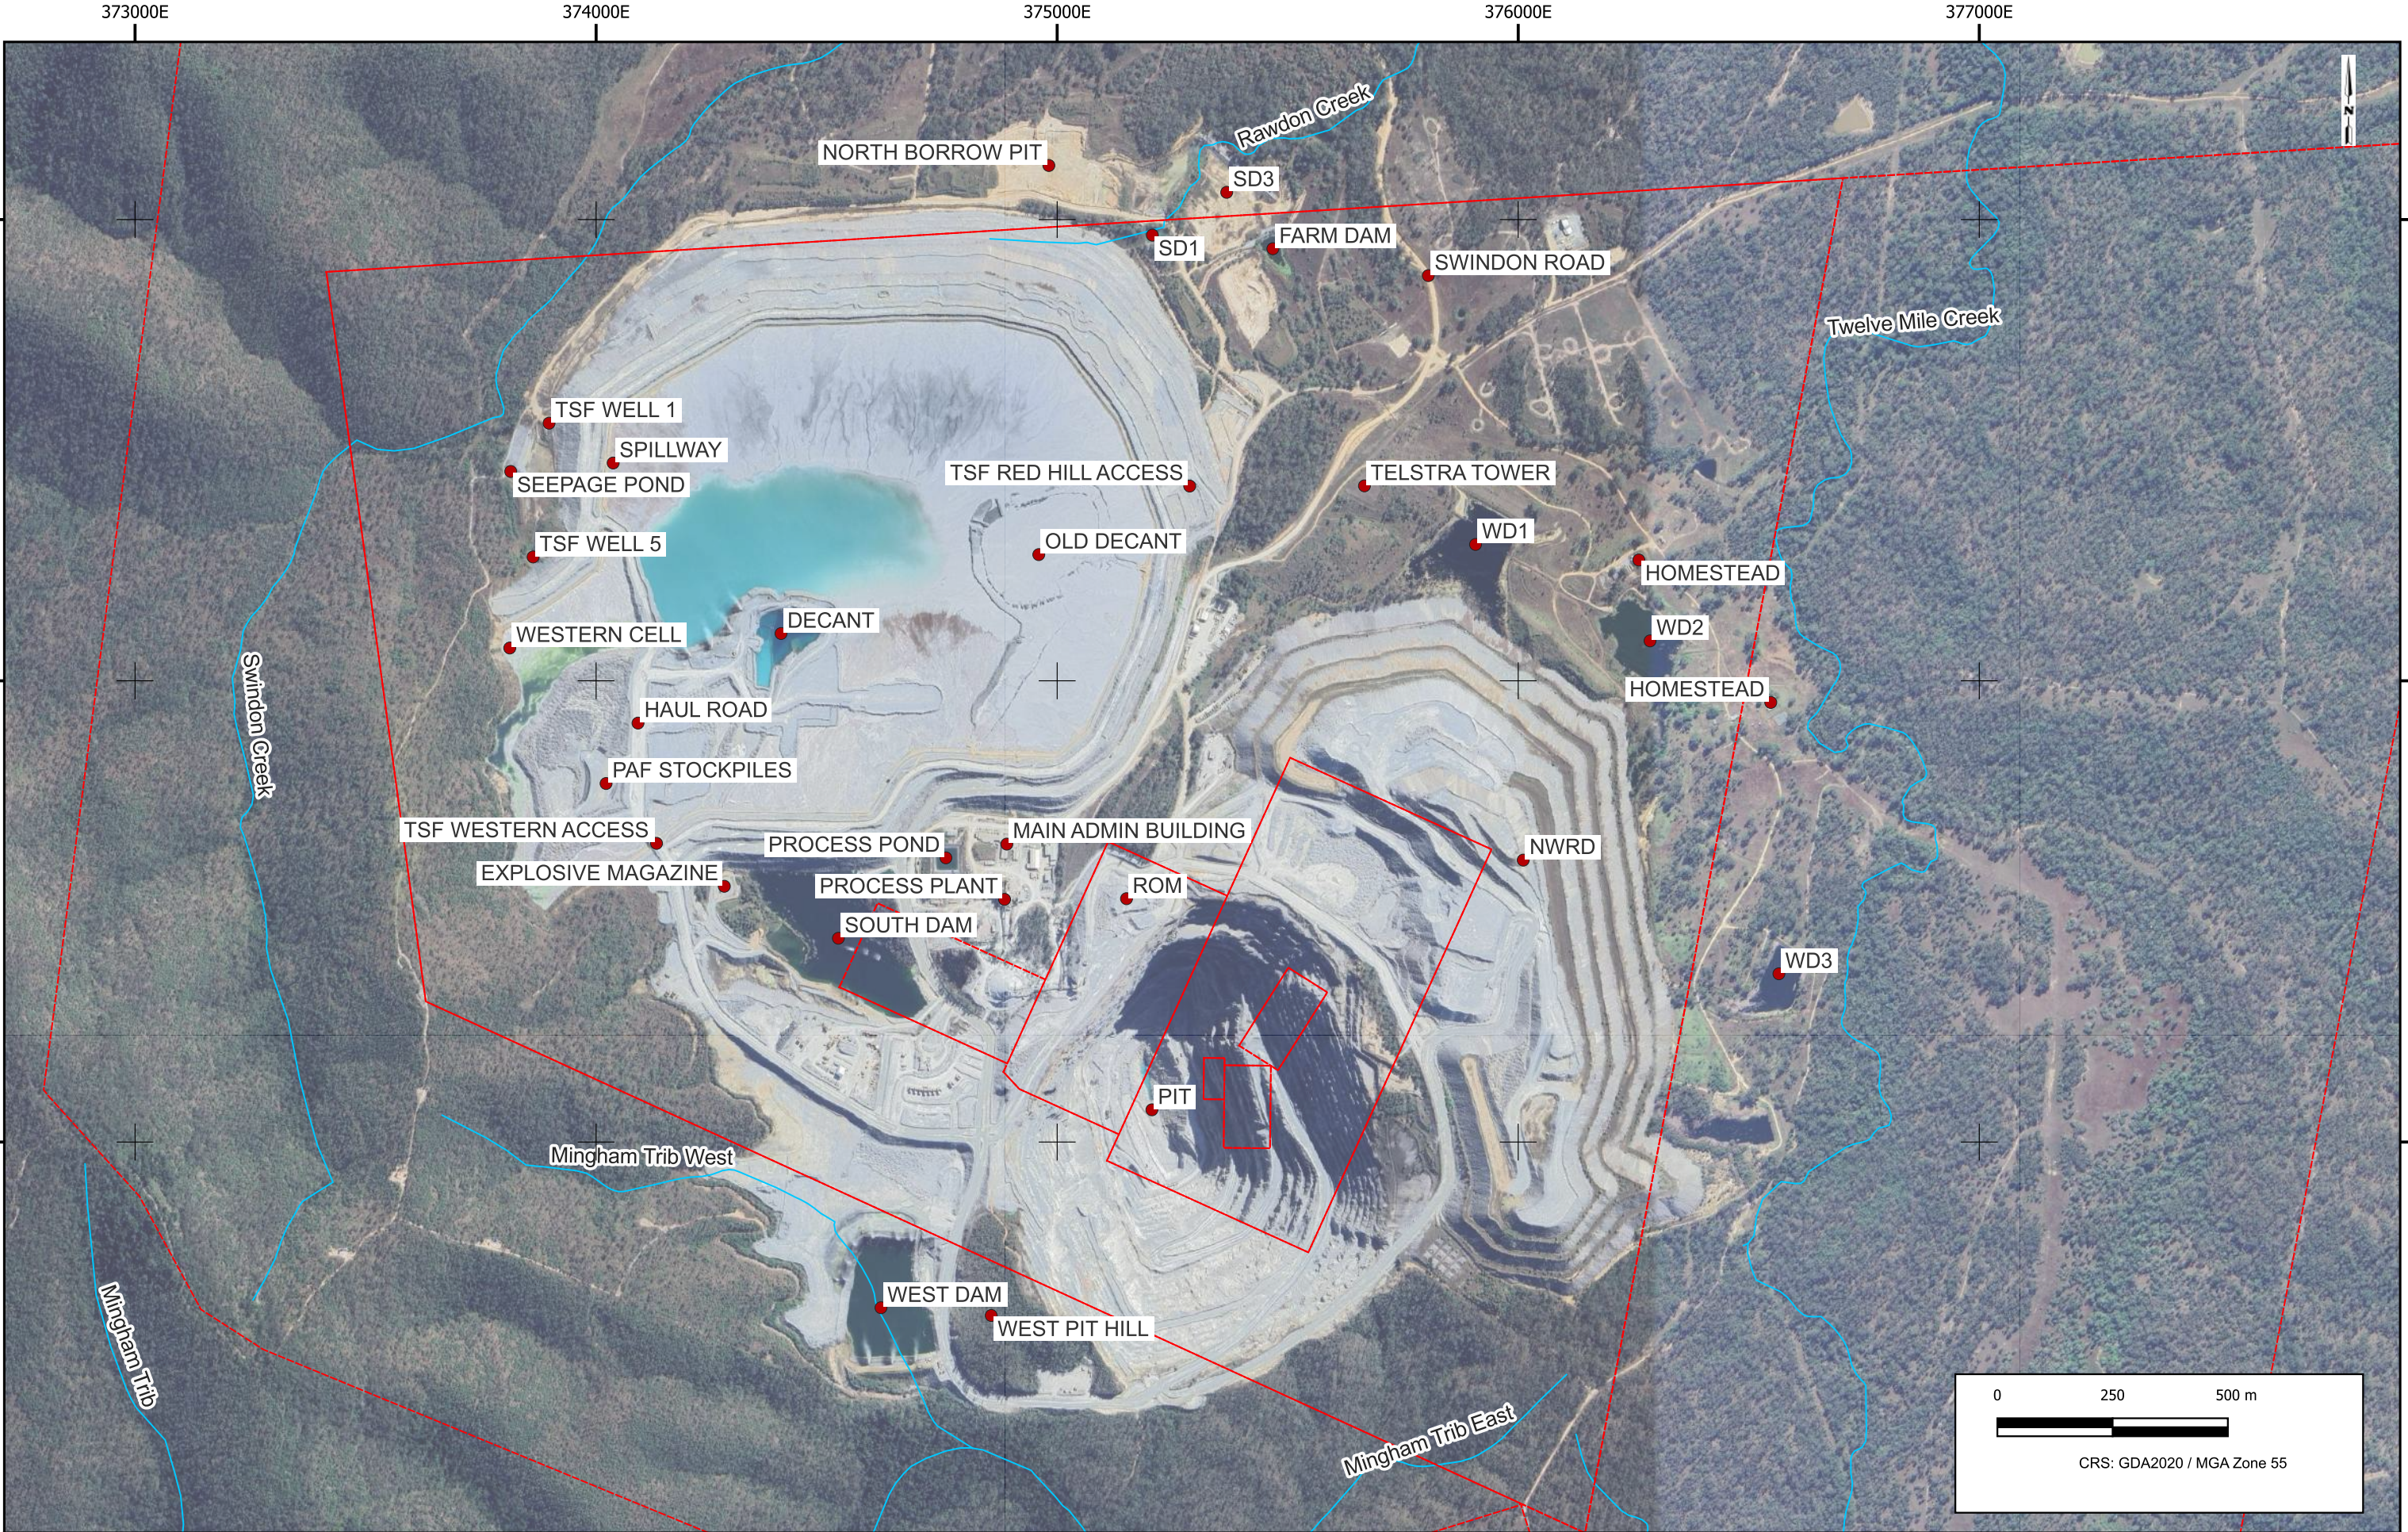
**FIGURE 003**

The site investigation included six geotechnical boreholes drilled to maximum depth of 50 m below existing ground level (BH01 to BH06) and 40 test pits (TP01 to TP40), which were excavated to depths ranging between 0.6 m to 5.3 m below existing ground level (refer **FIGURE 003**). The site investigation focussed on the deeper layers and not on the nearer surface soils.

In 2013, Northern Resource Consultants Pty Ltd completed a soil and land suitability assessment for the West Dump development south of the TSF [19]. Test pits were excavated at six locations (Pit 1, Pit 2, Pit 3, Pit 4, Pit 5, and Pit 6) up to 2 m depth. These test pit locations are shown in **FIGURE 003**. Thirteen samples were analysed for a range of agronomic chemical parameters but did not include Soil Water Characteristic Curve's (SWCC's) or other physical parameters.

RGS and ATCW identified four potential borrow areas where six test pits and six drilling locations were selected (refer **FIGURE 003**). Six sub samples were analysed for a range of parameters but did not include SWCCs.

In 2016, 14 soil profiles, up to 0.8 m, in six investigation areas to the east and north of the TSF were described by NRC for their potential irrigation capability [21] (refer **FIGURE 003**). Twelve samples were recovered and analysed for a range of agronomic chemical parameters.

In 2023, SLR Consulting Australia Pty Ltd (SLR) undertook field sampling for soil monitoring as part of the Annual Irrigation Management and Monitoring Program (IMMP) Report [23]. The soil monitoring sites were selected based on areas identified as the land on site receiving mine affected water for irrigation. Five test pits were excavated (refer **FIGURE 003**).
