# PROGRESSIVE REHABILITATION AND CLOSURE PLAN

## GURULMUNDI BENTONITE MINE

**GURULMUNDI BENTONITE MINE –  
PROGRESSIVE REHABILITATION AND  
CLOSURE PLAN**

16 MARCH 2026

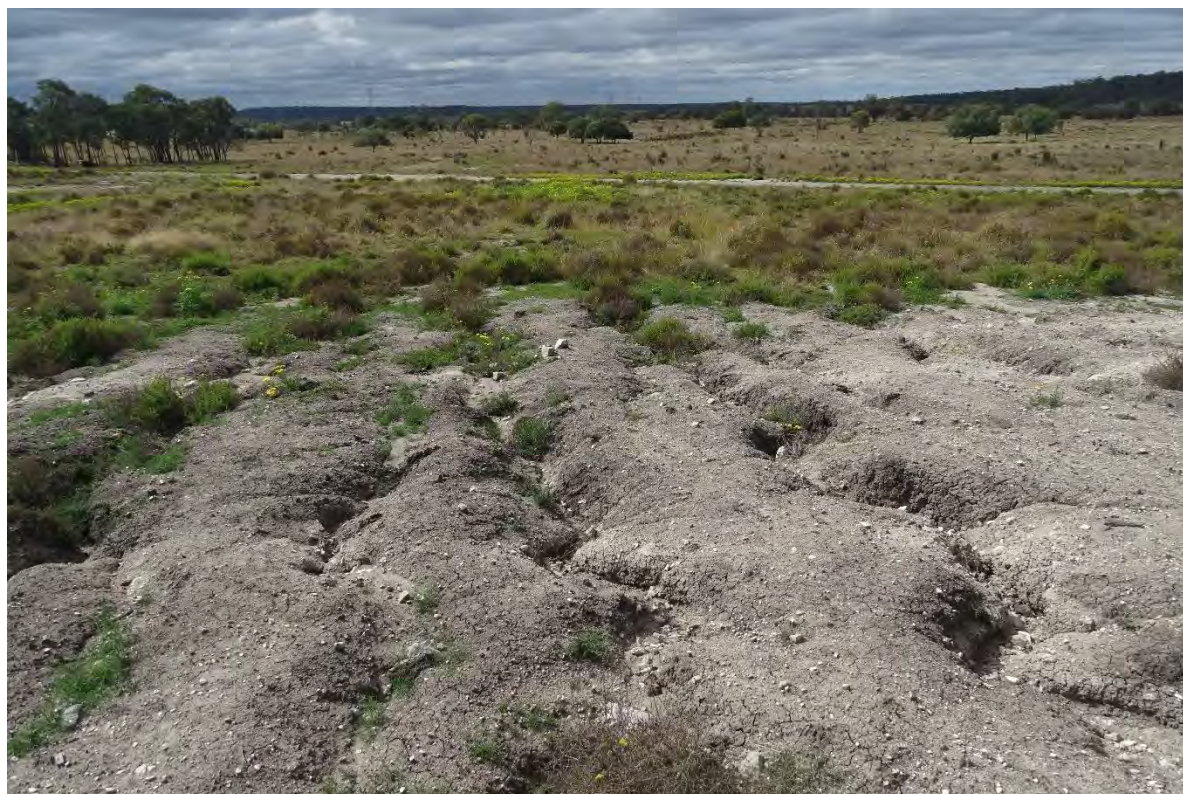
**Figure 2: Photo of uncertified rehabilitation area**

An assessment of an uncertified rehabilitation area (refer Detailed descriptions/chemistry map for locations) was made. Soil surfaces were black heavy clays with calcium carbonate presence observed. The area was actively eroding with deep rills observed (refer Figure 2).

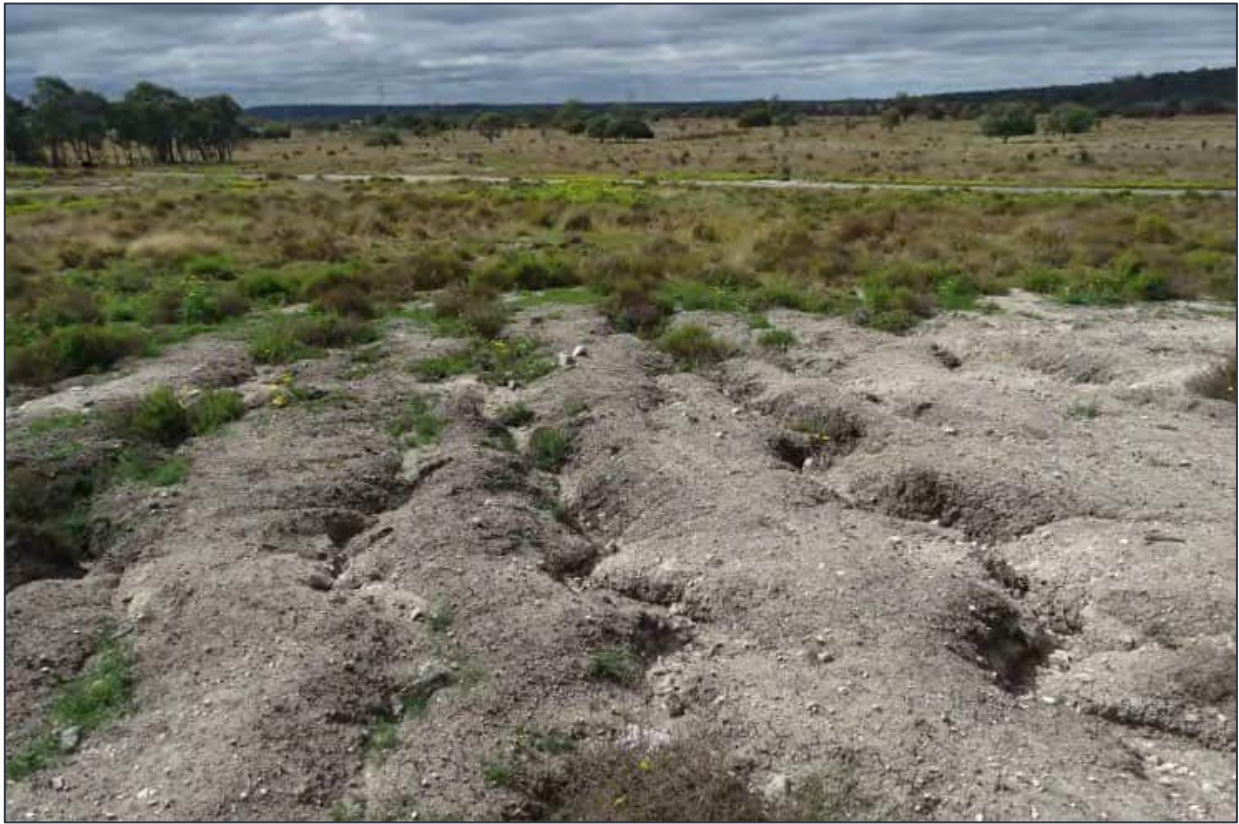
**Figure 7: Deep rill erosion observed in an area of uncertified rehabilitation (RAGS2\_1)**

| Ground cover had improved after a period of frequent and sufficient rainfall; following this cover has become patchy exposing the ground to erosion and the development of rills ( <b>Figure 7</b> ). Vegetation cover is estimated to be approximately 50% throughout the areas (Error! Reference source not found. & <b>Figure 10</b> ). A seeding campaign may be required to overseed patchy areas to improve vegetation cover and species diversity. 'Able to sustain an agreed post-mining land use' acceptance criteria is not achieved. | |

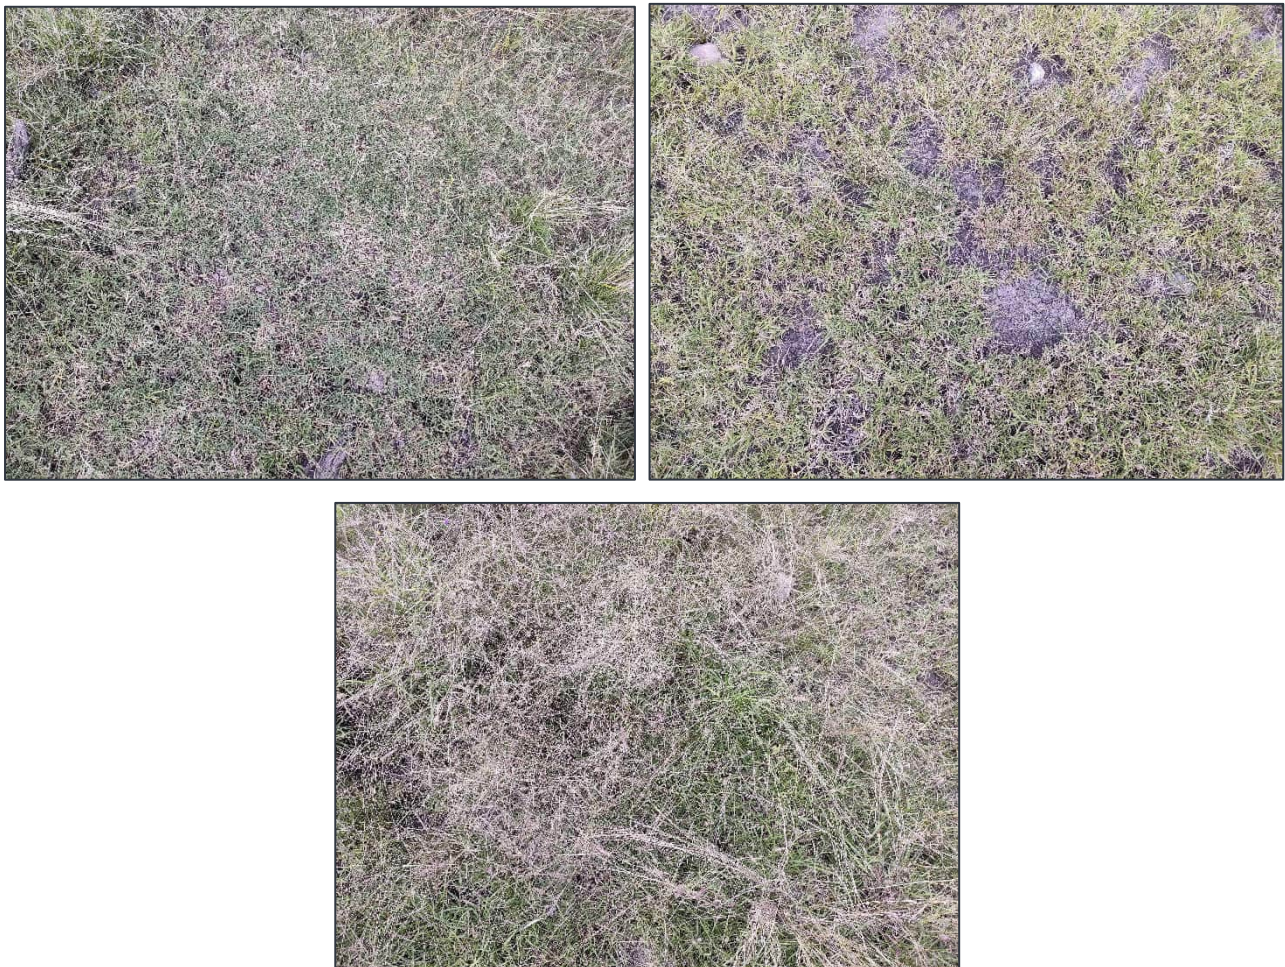
Figure 13: Sample photos of ground cover condition within RAGS3\_1
