# TRANSITIONAL PROGRESSIVE REHABILITATION AND CLOSURE PLAN

## ALICE RIVER GOLD PROJECT

PREPARED FOR  
PACGOLD Limited

13 February 2026

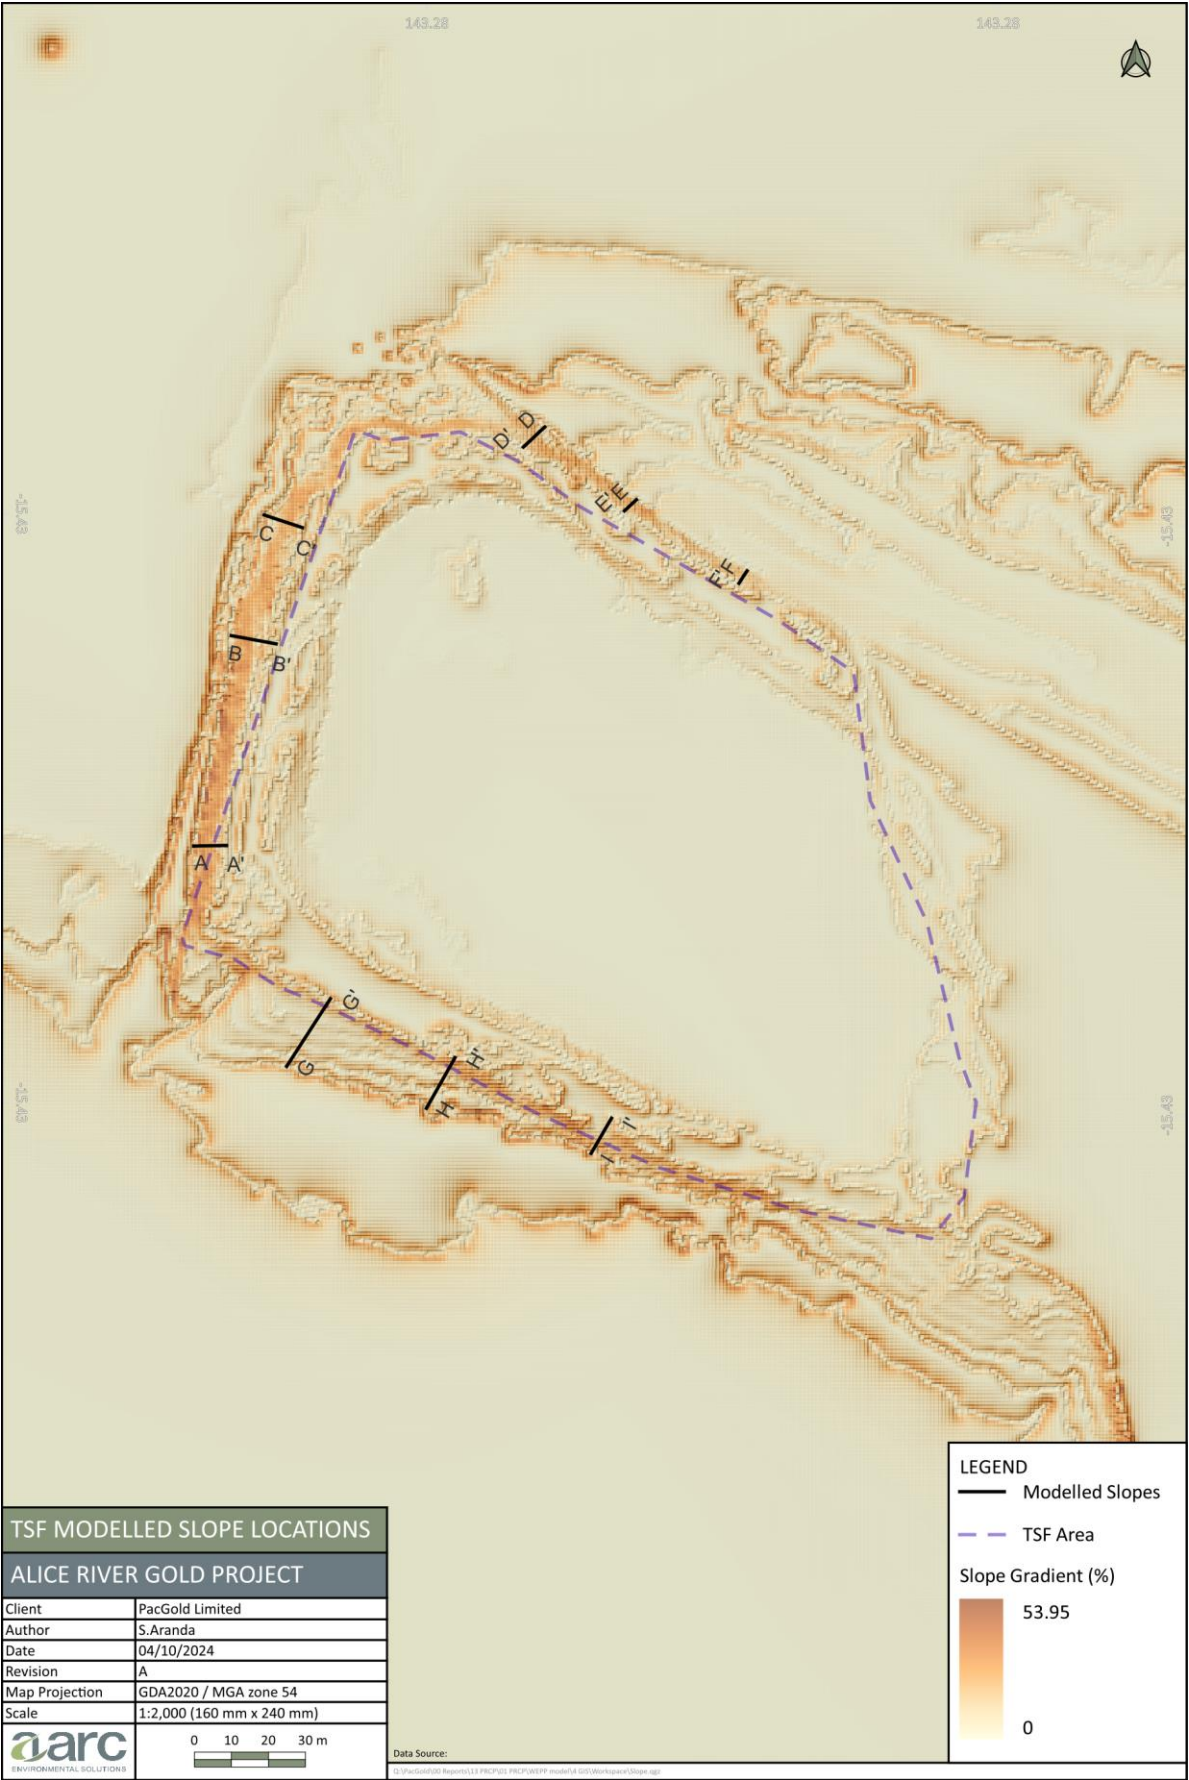
Figure 5: Location and slope gradient of modelled slopes

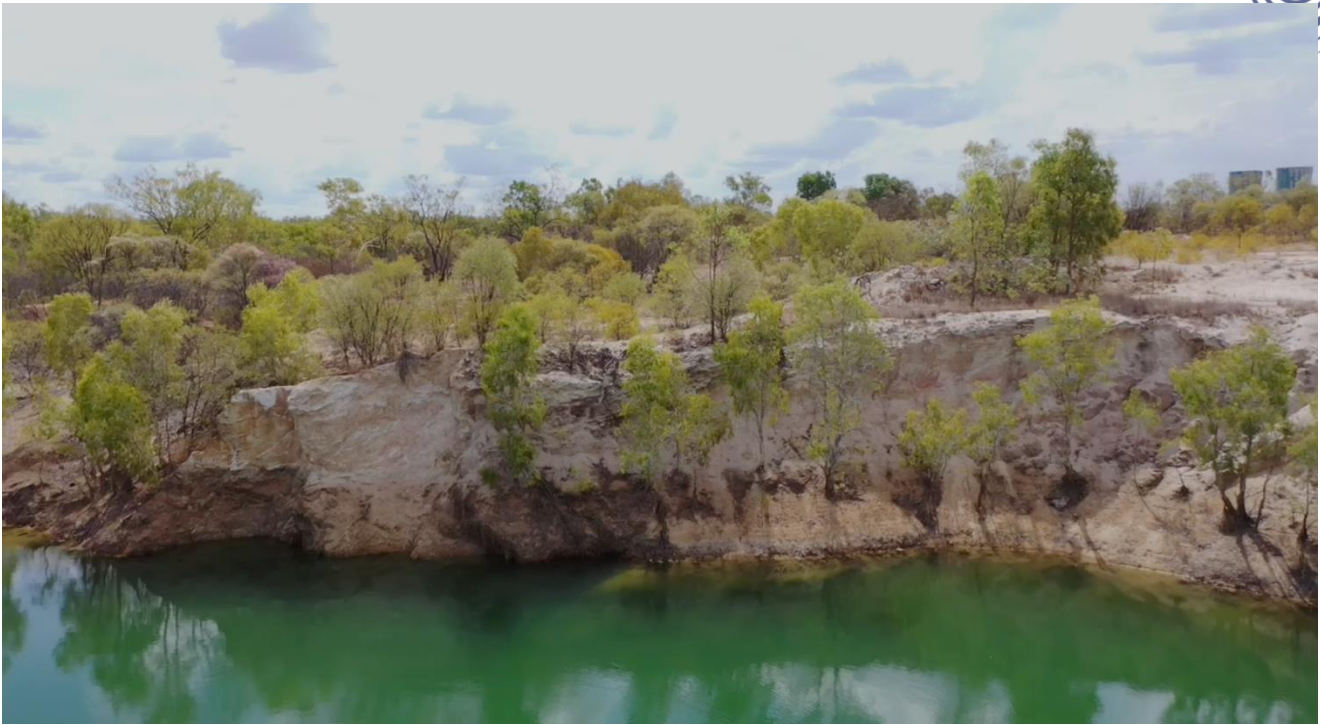
*Figure 33 - View of water level and weathering in Alice Queen pit walls*
