# Lake Lindsay Coal Mine

Progressive Rehabilitation and Closure Plan

**Issue:** 04

**Date:** 3 November 2025

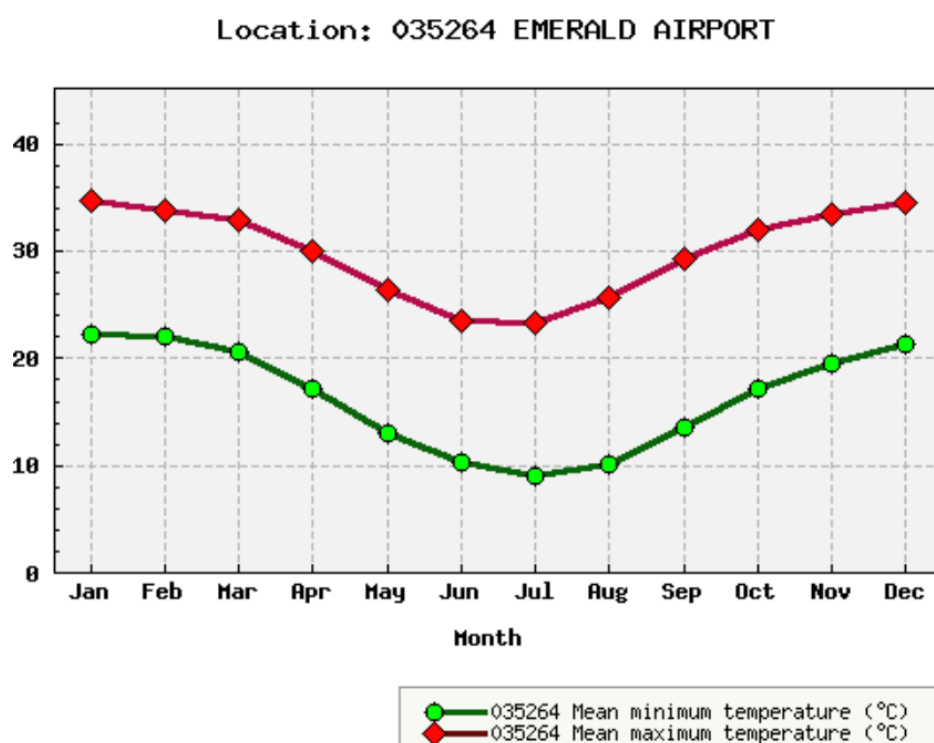
*Figure 7 Monthly Mean Maximum and Minimum Temperature from the Emerald Airport (1992-2022) (Source: BoM, accessed on 25 June 2025)*

Mean temperature variations across the year are taken at Emerald Airport BoM weather station (**Figure 7**). The mean maximum temperature is 30°C, with highest temperature recorded at 34.7°C in January. The mean minimum temperature is 16.4°C, with lowest recorded temperature at 9.1°C in July. Rainfall generally occurs between October to March with an annual rainfall of 610.3 millimetres (mm) (BoM, 2025). Winds are typically south-easterly and consist of a light-to-moderate gust.

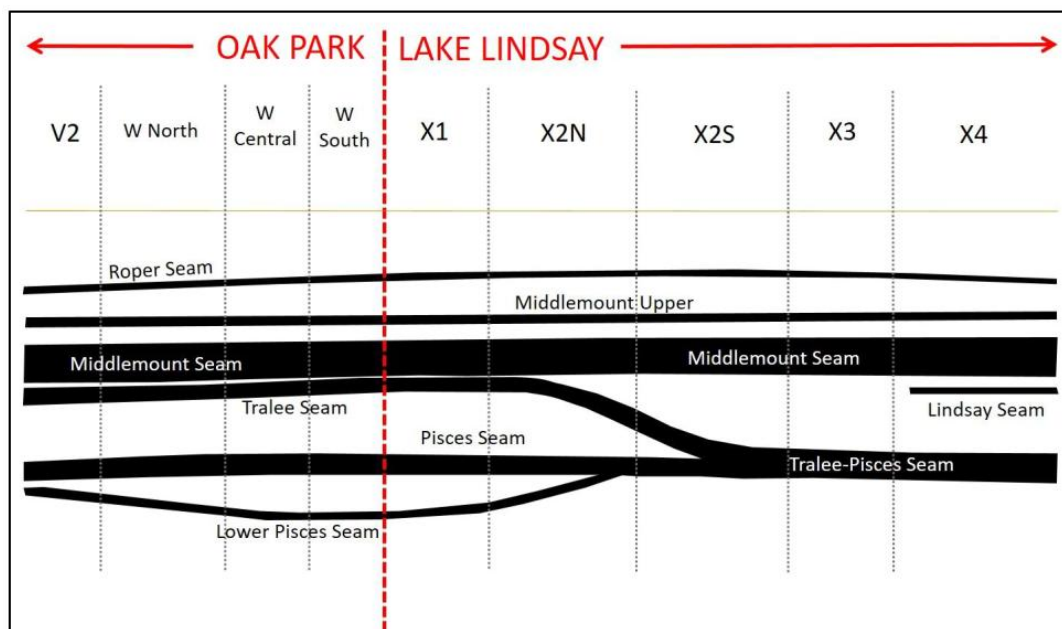
Figure 17 Coal Seam Overview (Source: Anglo American, 2020)

Locally, the economic coal seams at LLM are the Middlemount, Tralee and the Pisces coal seams (**Figure 17**). These seams are characterised by complex splitting and coalescing, which, combined with extensive faulting, can make it difficult to distinguish individual coal seams in certain areas. The Permian stratigraphic sequence strikes north–south and dips eastward at angles of approximately 1 to 10 degrees.

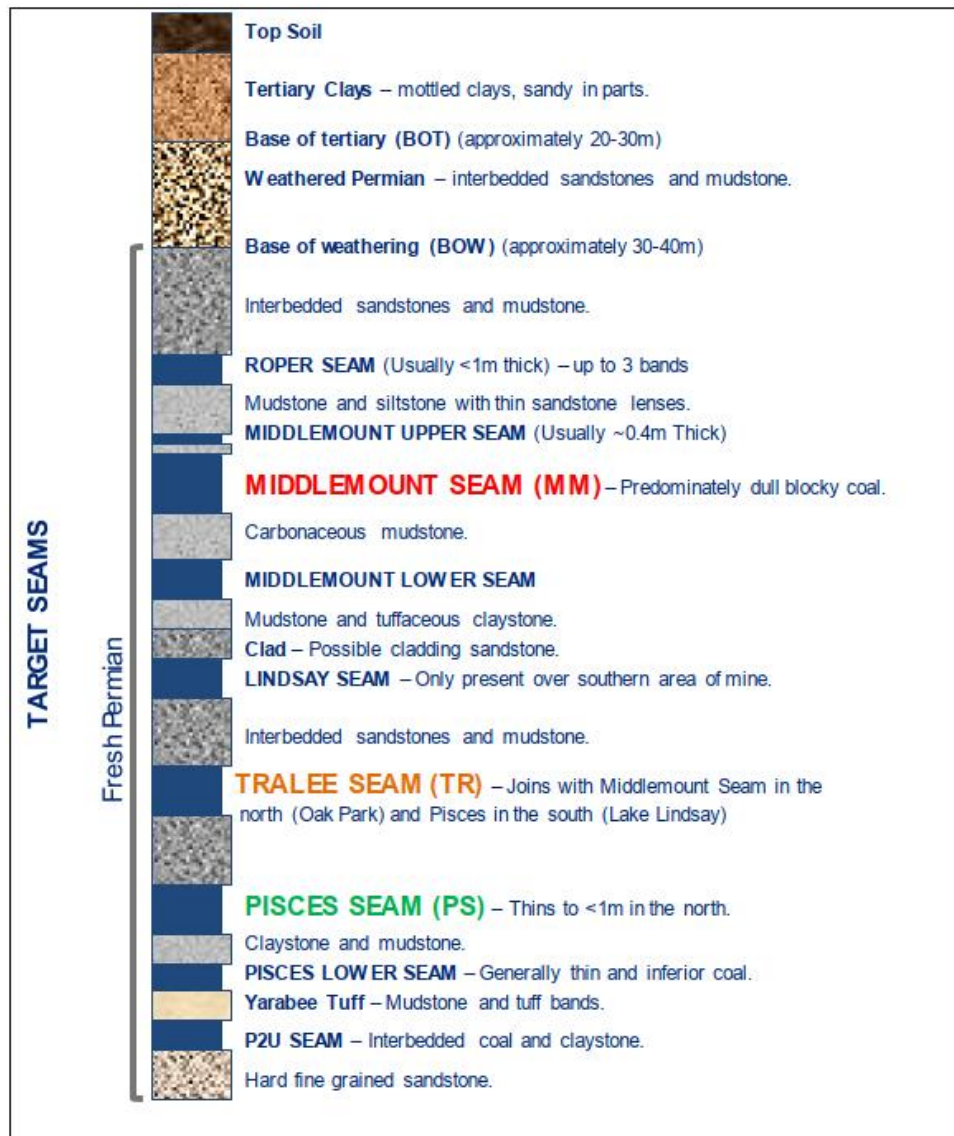
Figure 18 LLM Stratigraphic Section (Source: Anglo American, 2020a)

The main stratigraphic units at LLM (AGE, 2021a) are summarised (**Table 9**). A stratigraphic column showing the coal seams of interest in LLM is provided (**Figure 18**) (Anglo American, 2020a).

- To the southwest of LLM, the Burngrove Formation is exposed and can be found beneath the Rangal coal Measures at a certain depth. This Burngrove Formation is composed of gray lithic sandstone and siltstone, with the inclusion of certain coal deposits. Within the Burngrove Formation at LLM, the coal seams named Pisces 2, Barwon, and Girrah Seams are present. Notably, the Girrah Seam holds a thickness ranging from 15 to 20 m.

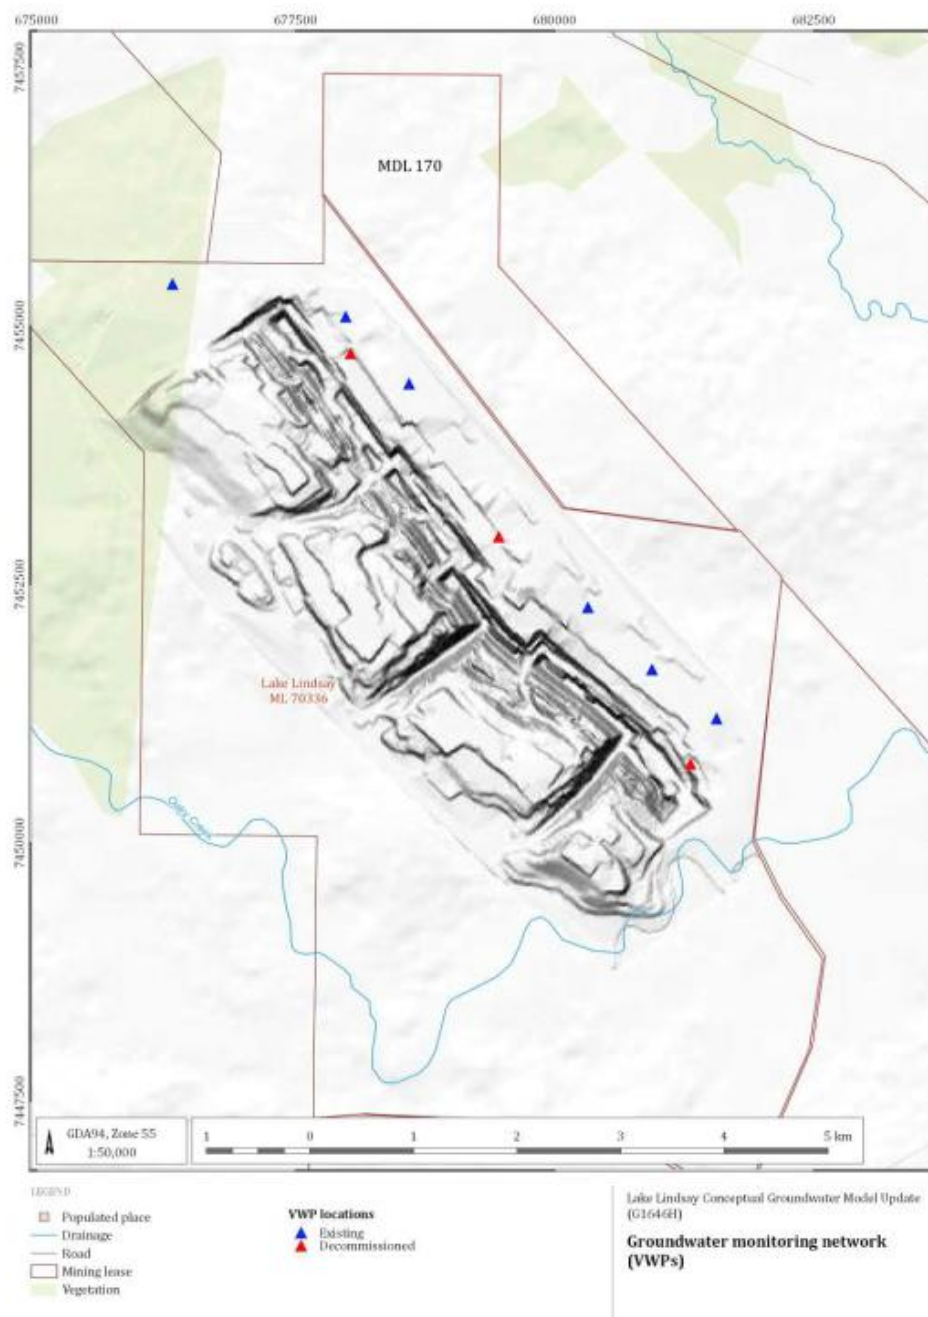
Figure 19 Location of Groundwater Monitoring Network (Source: AGE, 2021b)

- Site investigations were undertaken within 4 boreholes (RDL3579A, LDL3598, LDL3604 and RDL3613) in the highwall of the LLM pit in September 2018. This included permeability testing of geological strata and the boreholes being equipped with multilevel VWPs (LLEX19\_R\_009A, LLEX19\_Q\_003, LLEX19\_Q\_005 and LLEX19\_R\_032) (AGE, 2021b); and
- 2 multilevel VWPs were installed in bore LDL3800 and RDL3806 at LLM in November 2020 and equipped with multilevel VWPs (LLEX20\_Q\_005 and LLEX20\_R\_006) (AGE, 2021b).

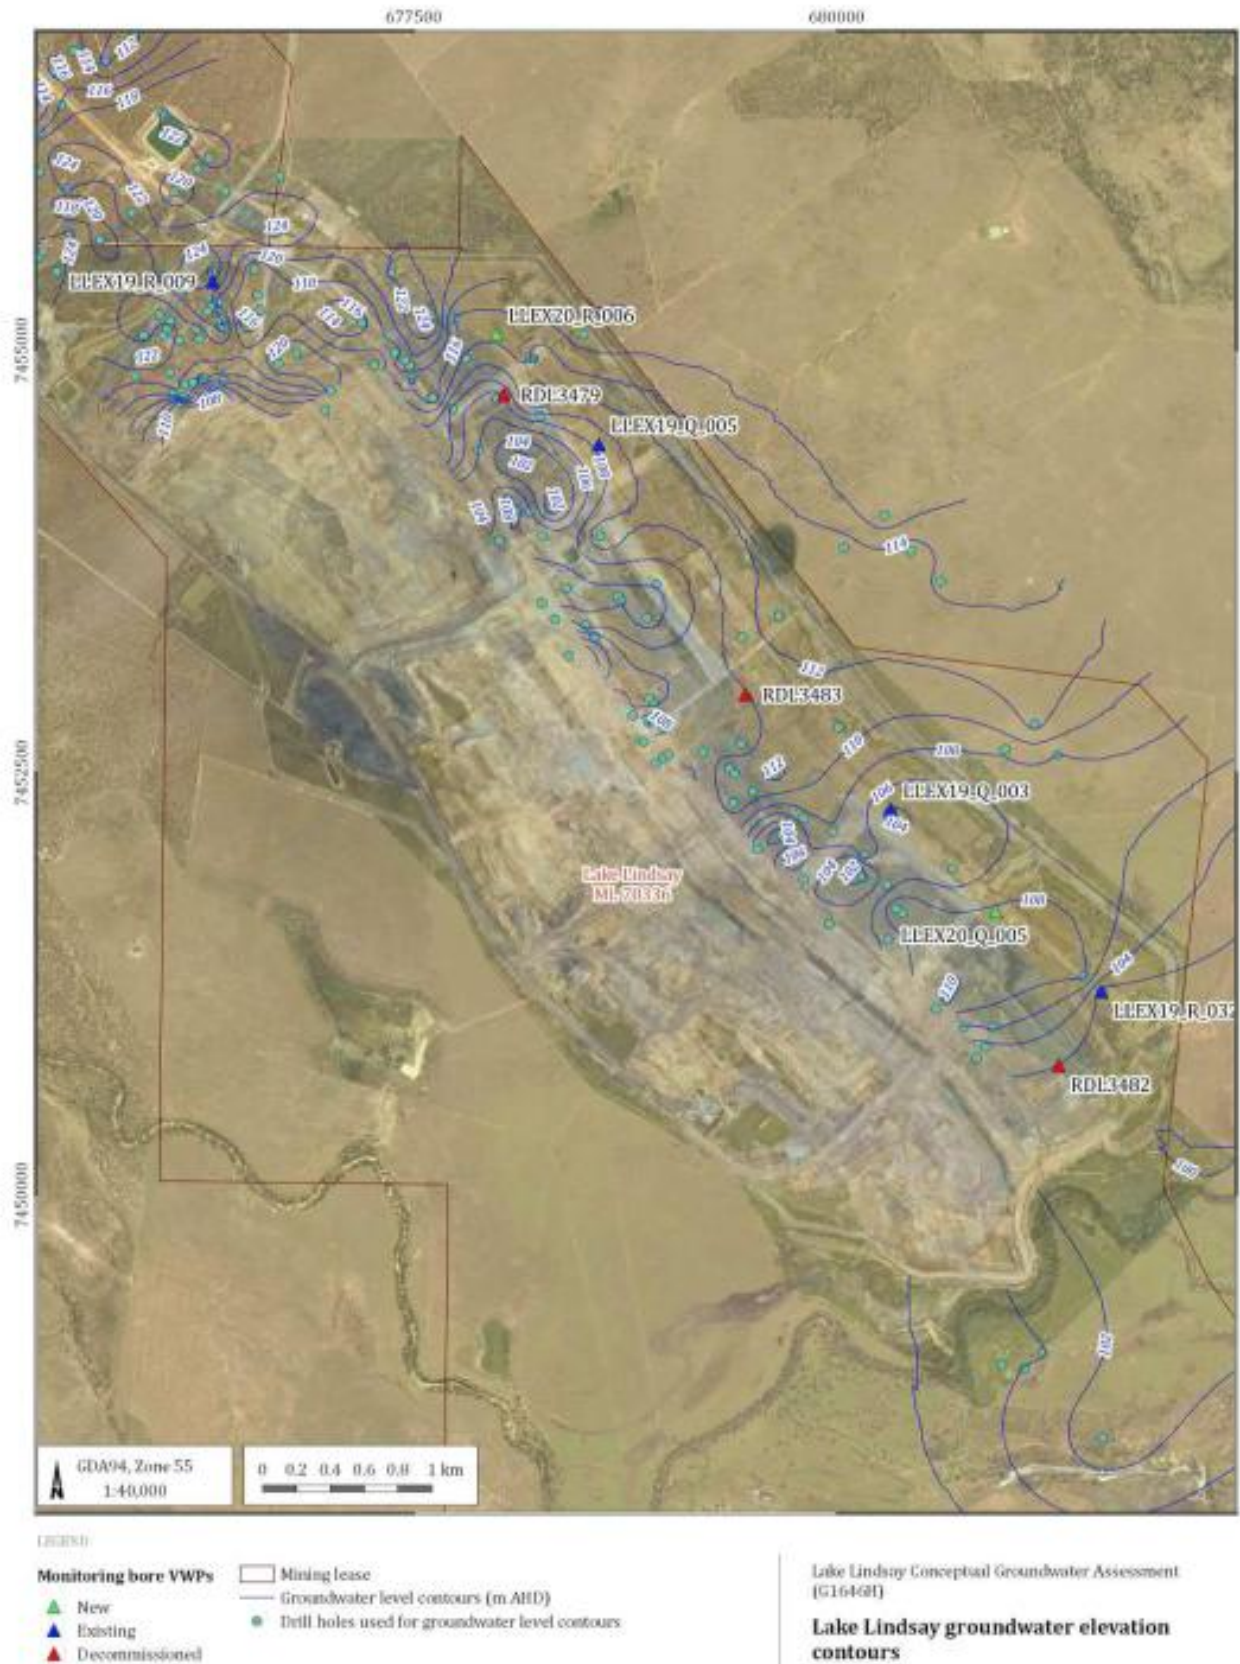
Figure 20 Groundwater Elevation Contours (Source: AGE, 2021b)

Regional groundwater flow in the Tertiary sediments is directed toward the southeast. Groundwater flow within the Permian coal seams is influenced by local geomorphology and structural geology, including faults. Groundwater flow across the Jellinbah Fault is uncertain. However, vertical displacement along the fault is interpreted to have juxtaposed the Rangal Coal Measures coal seams against lower permeability Fort Cooper Coal Measures and Burngrove Formation interburden, resulting in hydraulic compartmentalisation and impeded groundwater movement. Other mapped faults in the area may have similar hydraulic effects.

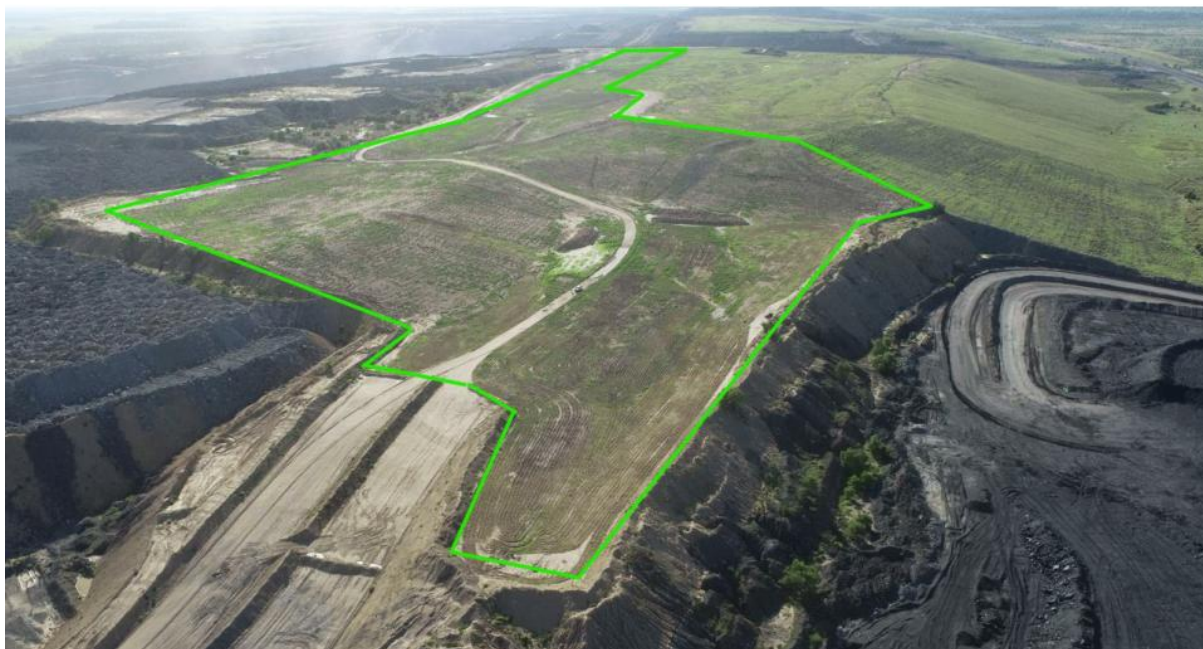
*Figure 25 Aerial Image of Rehabilitation Area X2S (Source: Anglo American, 2024)*

Aerial examples of the revegetation from surveys provides aerial images of rehabilitation area X2S (**Figure 25**) and spoil rehabilitation area X3 (**Figure 26**). The images show established vegetation on the spoil slopes.

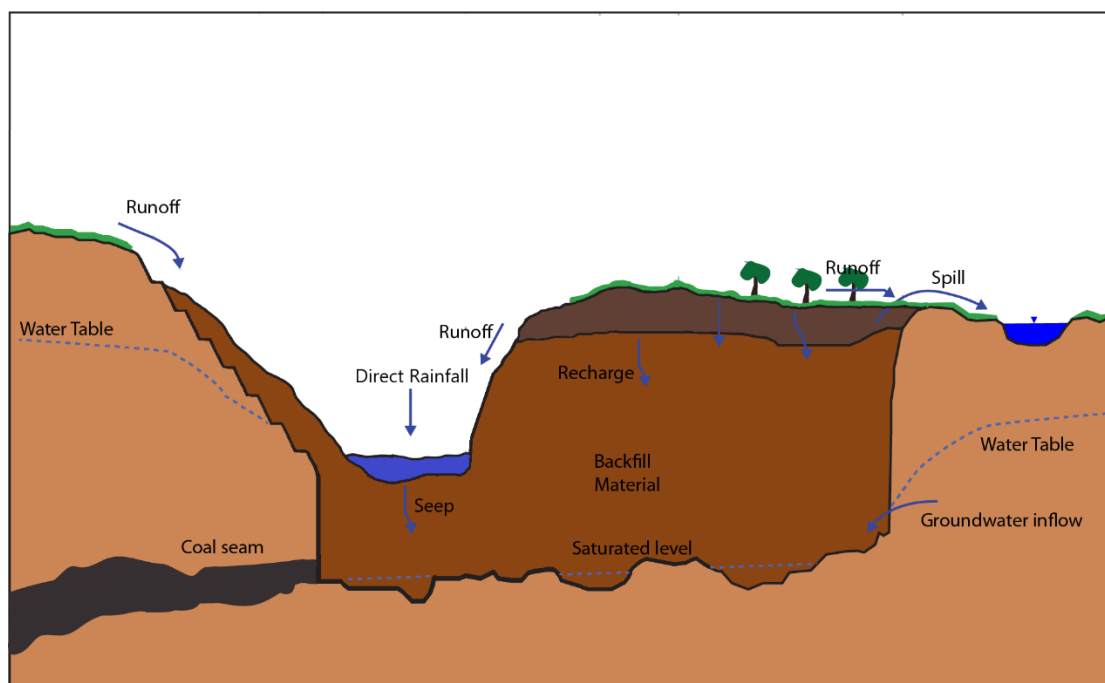
Figure 37 Conceptual Model of Typical Residual Void (Source: SLR, 2025d)

- Evaporation, if an open water surface has established;
- Seepage to the underlying backfill material, until this is fully saturated;
- If the water level in the void exceeds that of the surrounding water table, water can seep out from the void to the surrounding aquifer systems; and
- Overtopping or spilling if the accumulated volume exceeds the storage capacity.

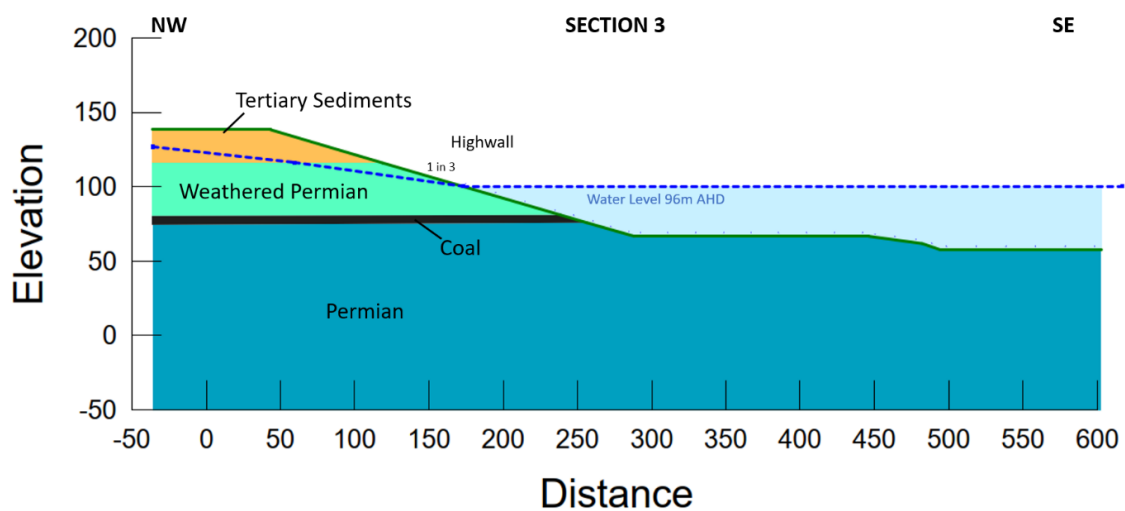
Figure 44 Section 3 Geotechnical Model (Source: Minserve, 2023)

The model considered:

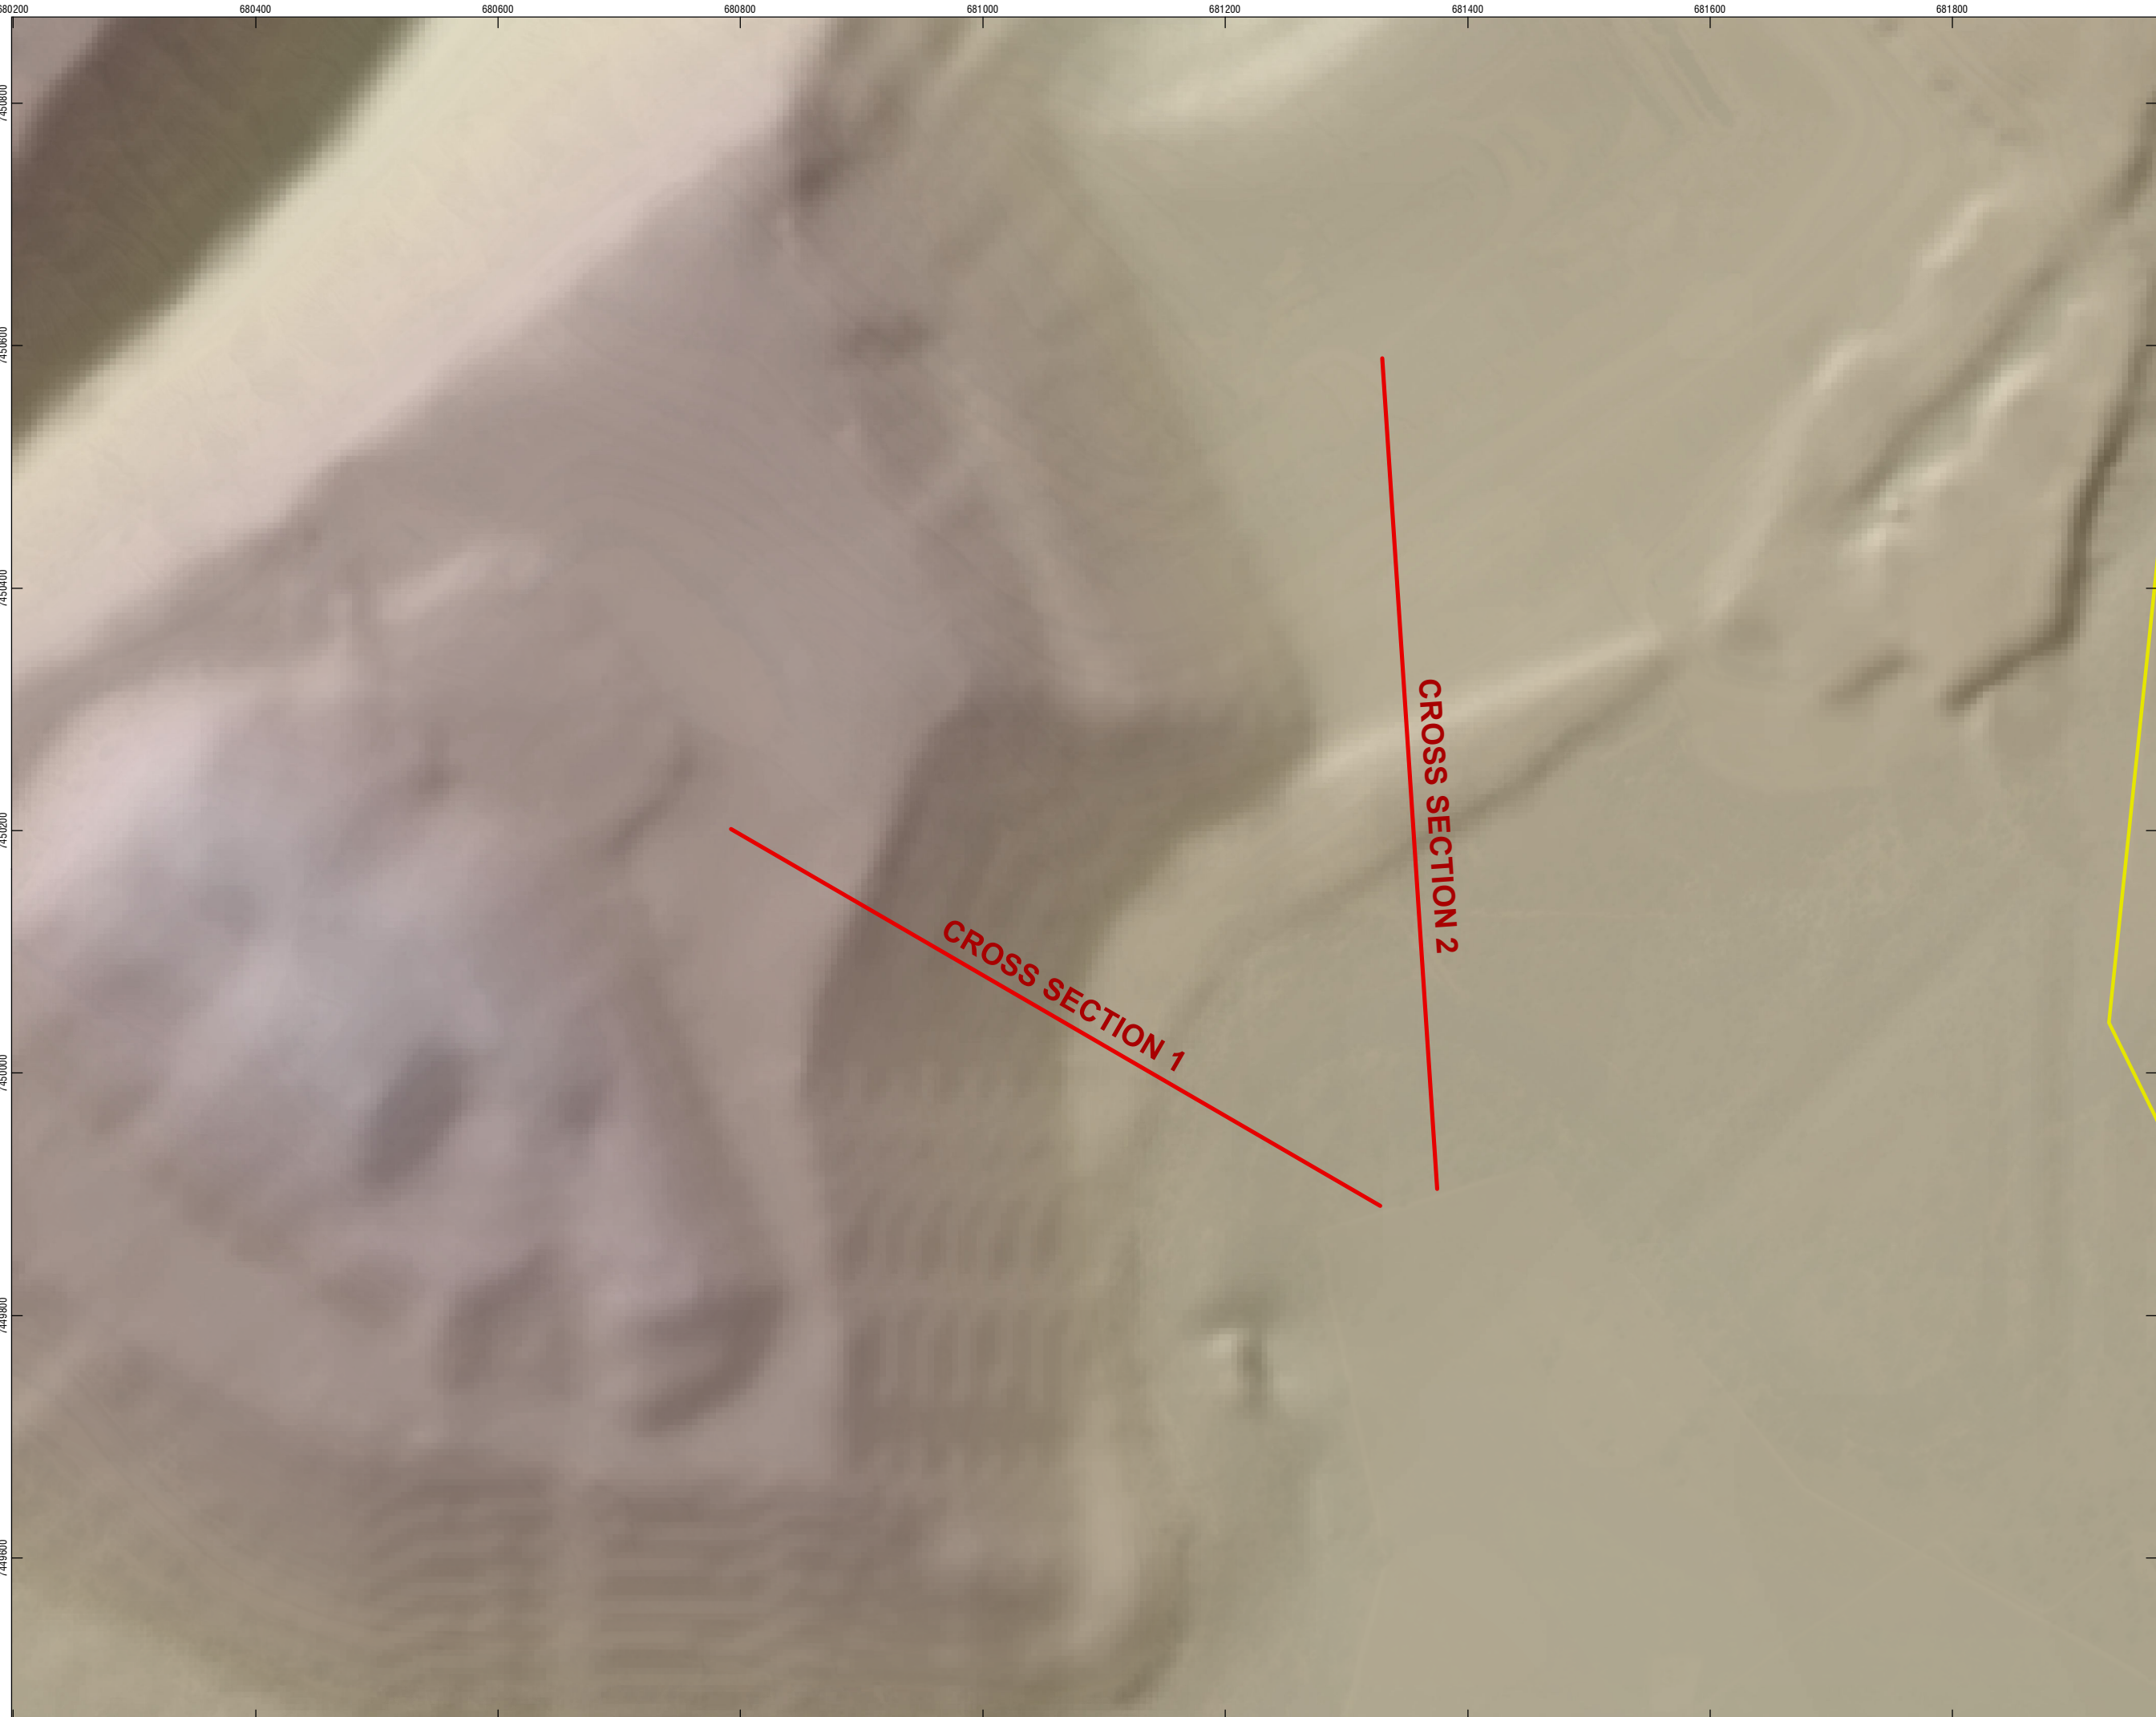
*Figure 46 Oaky Creek Levee in Operational Phase - Cross Section 1  
(Source: Red Earth Engineering, 2022)*

Cross-section 1 includes flood height and velocity results which runs across Oaky Creek and up onto the spoil slope in operational phase (**Figure 46**). The operational levee is depicted within the purple box and consists of two berms with a drainage channel in between. The same cross section profile for the final landform shows that the operational has been consumed and merged into the surrounding final landform (**Figure 47**).

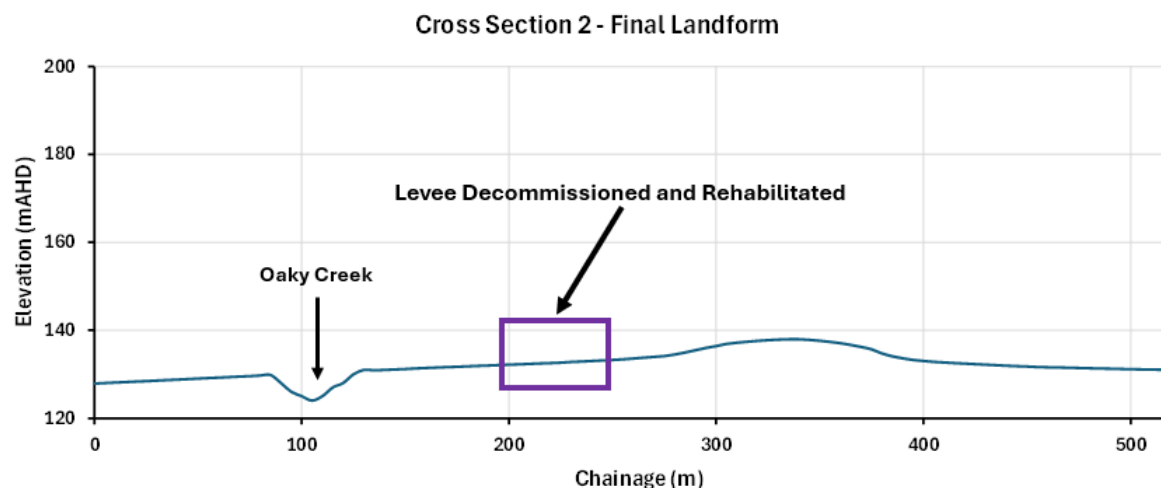
*Figure 48 Decommissioned and Rehabilitated Oaky Creek Levee - Cross Section 2  
(Data from Final Landform by Minserve, 2023)*

A second cross-section (cross-section 2) (**Figure 48**) through the operational levee also shows that it has been decommissioned and integrated into the final landform.
