# Ardmore Start-Up Operation - Progressive Rehabilitation and Closure Plan

*Mining Lease 5542 (Environmental Authority BRMN0037)*

**Golder Associates Pty Ltd**

21463804-001-R-Rev0

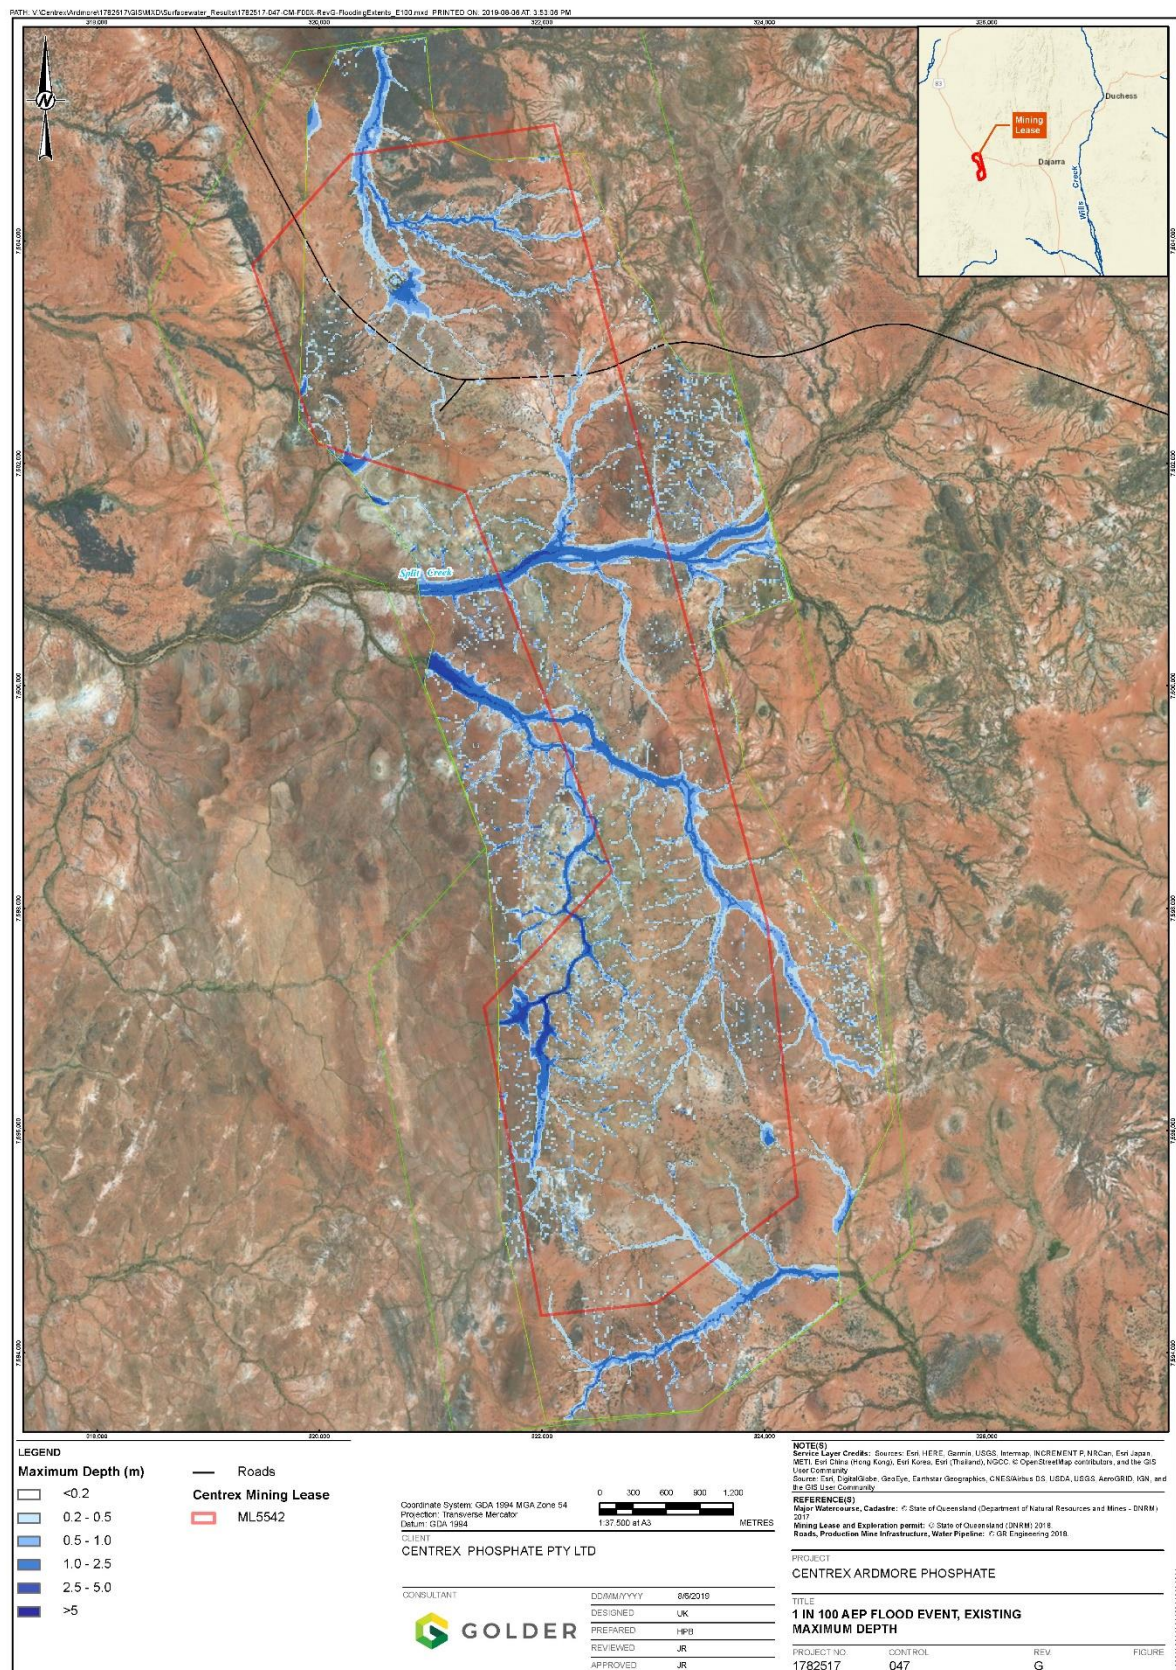
Figure 9: Surface water flooding extent (1:100 AEP)

Peak event modelling uses design rainfalls, topography, and catchment development to simulate catchment runoff. To estimate peak runoff values at the site, methodology prescribed in Australian Rainfall and Runoff (ARR) 2016 (Ball et al., 2019) was used. For Annual Exceedance Probability (AEP), 1:100, a range of durations and an ensemble of 10 rainfall temporal patterns per duration was modelled to assess the critical duration and corresponding peak flow (Figure 9). The mine design and infrastructure layout has been designed to avoid surface water drainage lines and minimise potential for adverse impacts to mine infrastructure and to downstream watercourses.

The site is located within a flat area with no significant water courses. Watercourses are ephemeral and only flow after heavy rainfall which also causes local flooding (Figure 11). The mine design and infrastructure layout has been designed to avoid surface water drainage lines and minimise potential for adverse impacts to mine infrastructure and to downstream watercourses. As shown in Figure 11, the Start-up Operation is not located near or on a 1:100-year flooding extent.

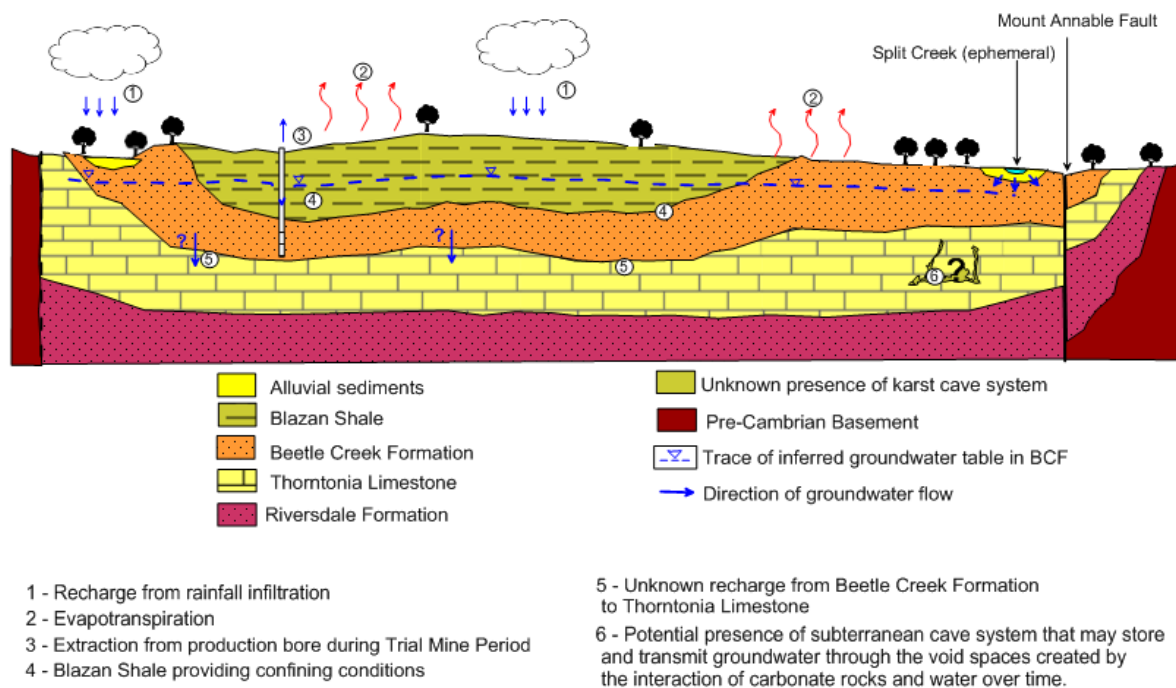
Figure 15: Conceptual hydrogeological cross section northern part of ML (N-S)

The description of groundwater conditions and the HCM has been developed for the ML, with a particular focus on the Northern zone (Figure 15) as this is where groundwater extraction activities will take place during the Full-scale Operation and it is where the groundwater exists beneath the ML. A HCM is provided for the Southern Zone in Figure 16, where the Start-up Operation will occur.

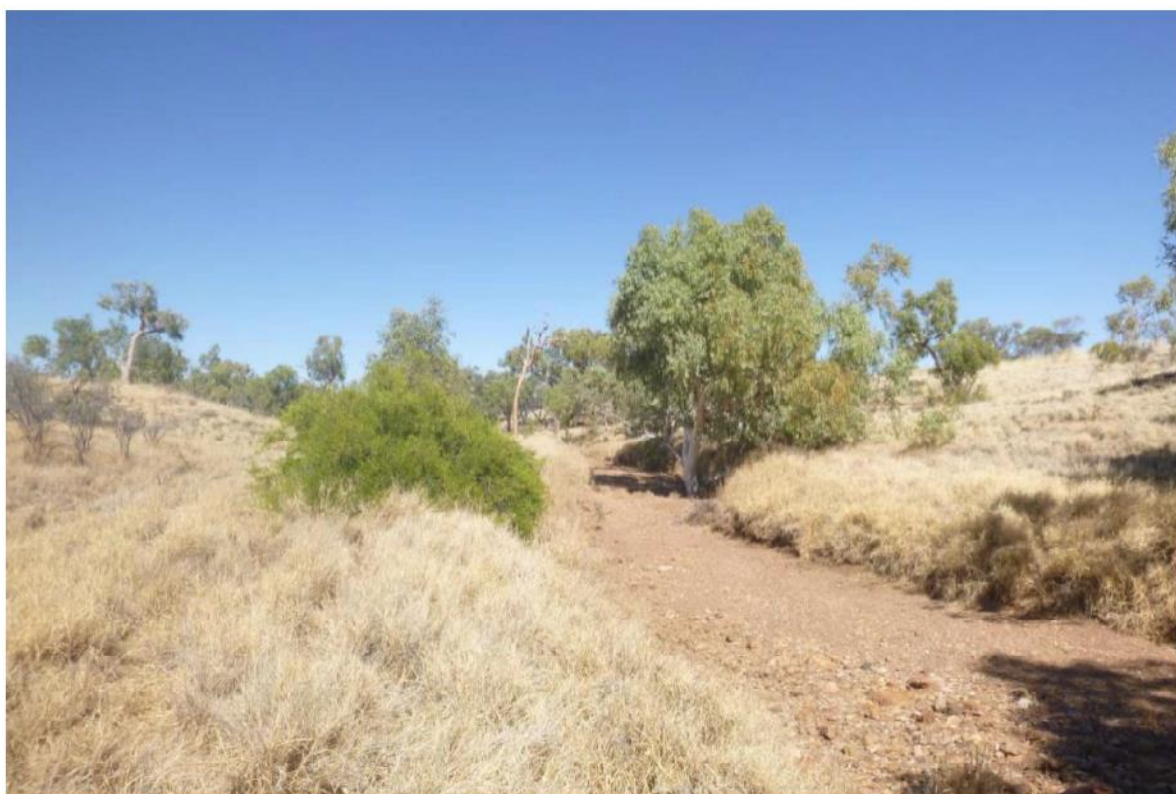
**Figure 23: Narrow RE1.3.7b Riparian Community with Buffel Grass invasion**

The introduced pasture grass, Buffel Grass (*Cenchrus ciliaris*) has invaded all riparian areas within ML5542, and this competition with native species has greatly reduced the biodiversity values of the riparian communities, particularly RE 1.3.7b (see Figure 22 and Figure 23). The invasive Mimosa Bush (*Vachellia farnesiana*\*) is commonly present in the shrub layer on the margins of riparian areas. Like Buffel Grass, Mimosa Bush is not a prohibited or restricted invasive plant in Queensland under the Biosecurity Act 2014, nor is it a declared weed within the Cloncurry Shire. While the canopy of the riparian community remains relatively intact, the biodiversity values of the understorey layers are severely degraded. Similarly, the REs away from the watercourses exhibit similar, albeit lesser, levels of degradation.

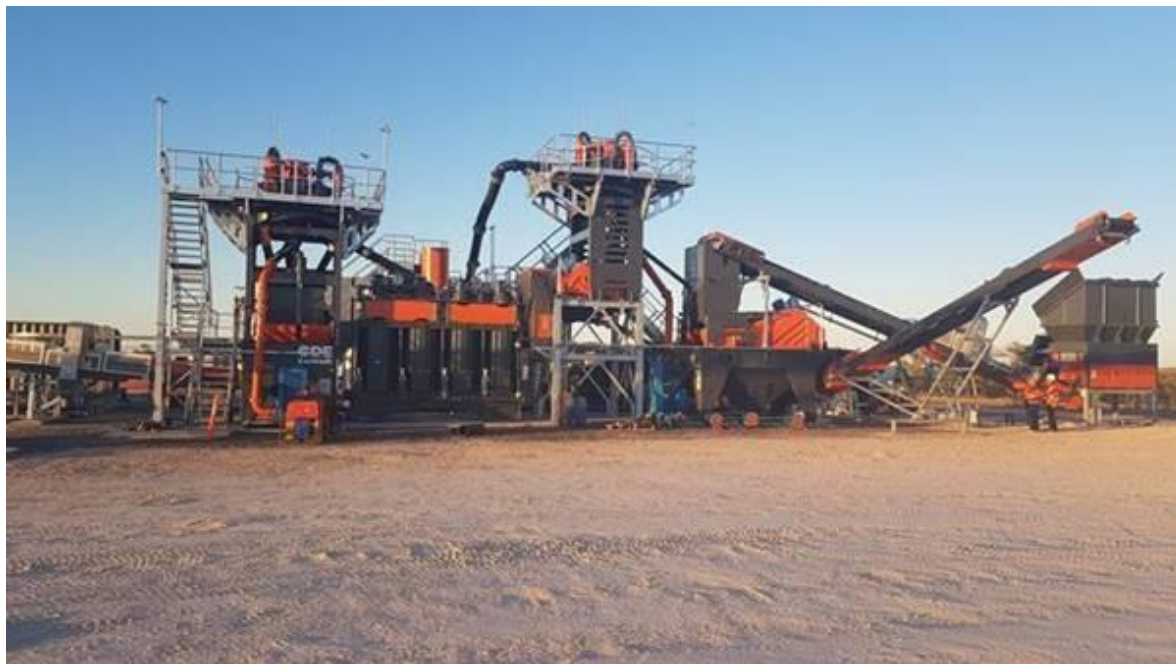
**Figure 26: Processing plant area**

The Project consists of a demonstration processing plant (Figure 26) and a small-scale open pit to be constructed within the Southern zone of the ML. The pit approved under the EA is approximately 100 m wide, 140 m long and 10 m deep.

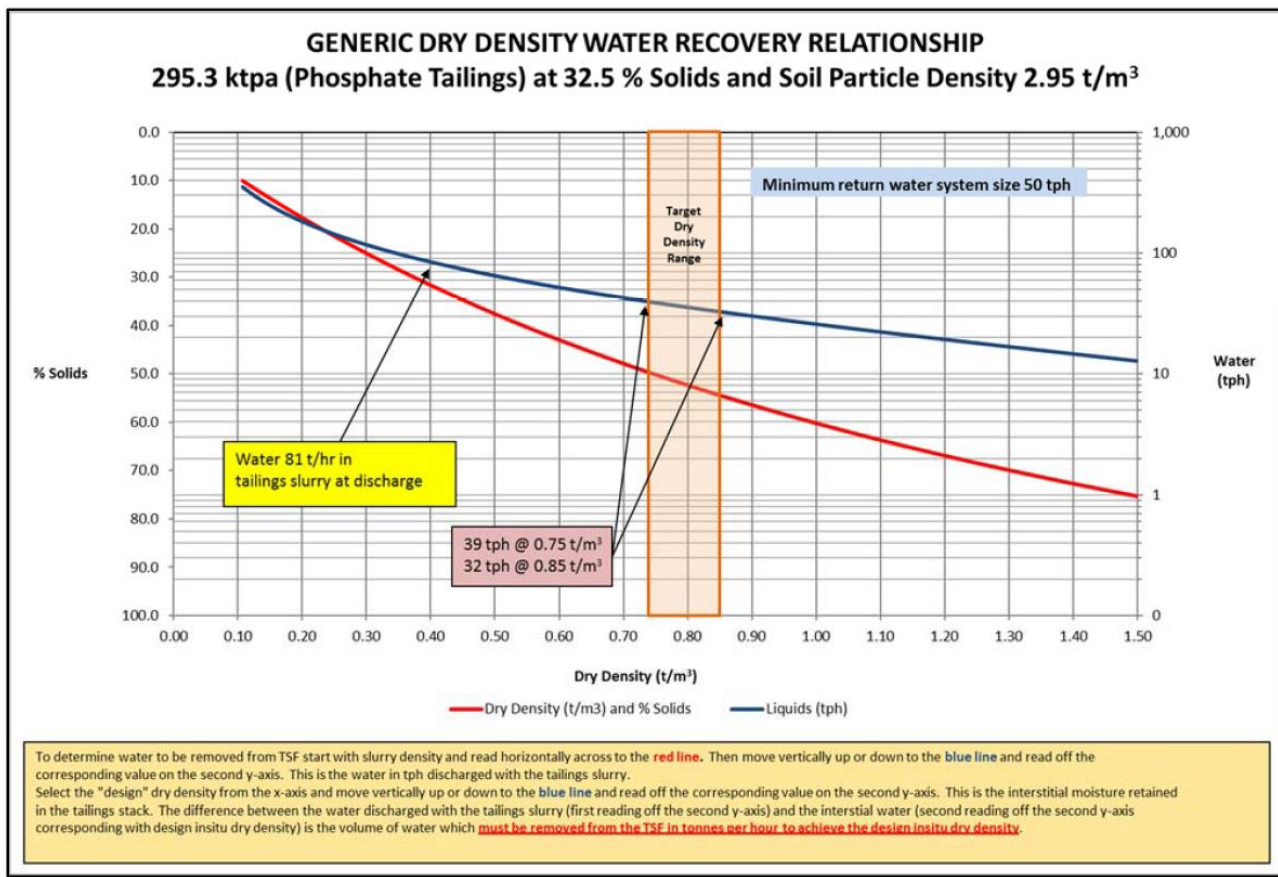
**Figure 33: Generic moisture density curve at zero air voids for 800 ktpa**

The geotechnical tailings testwork undertaken by TriLab Pty Ltd in Brisbane comprised of the following tests:

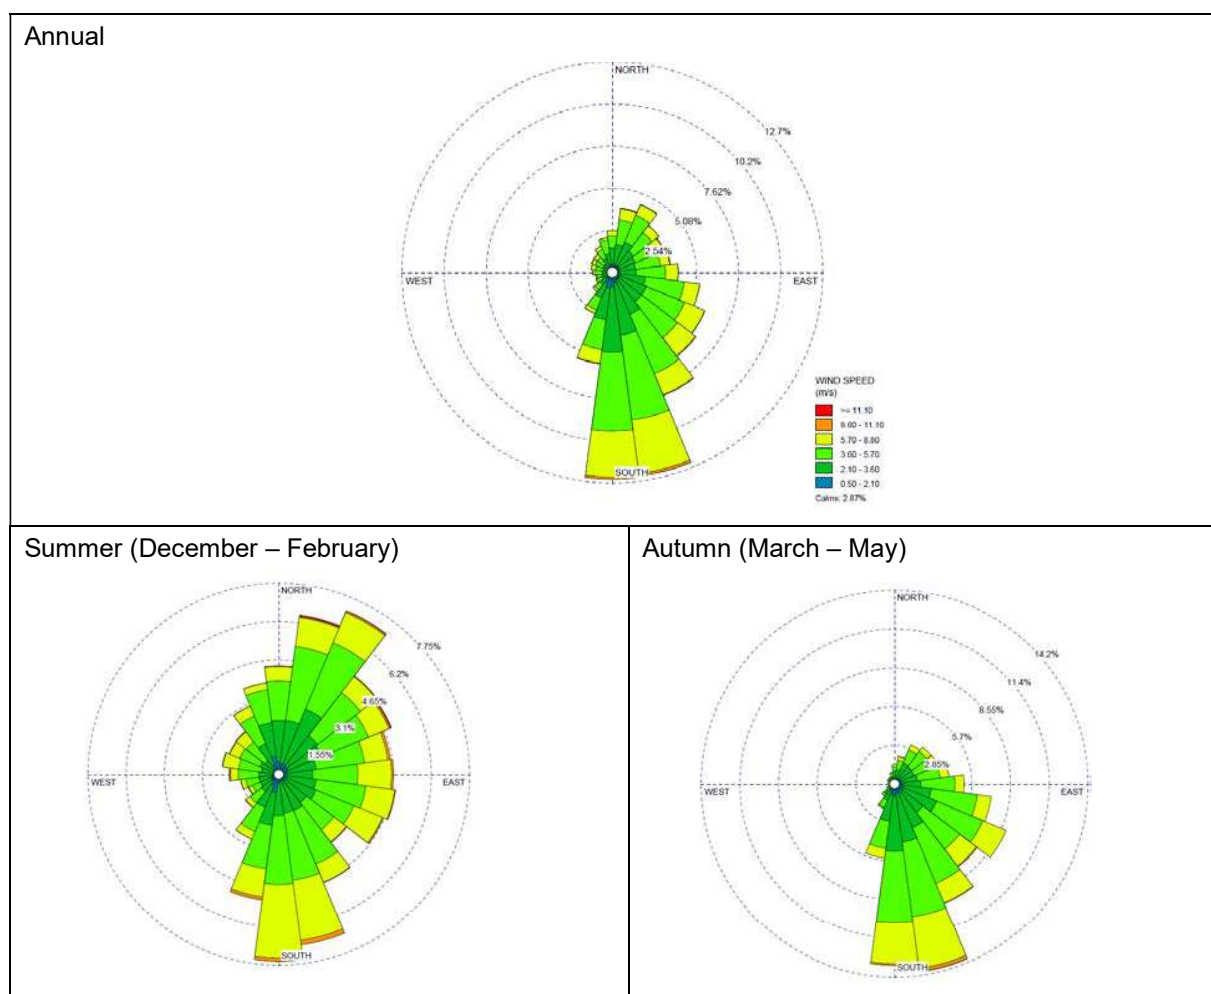
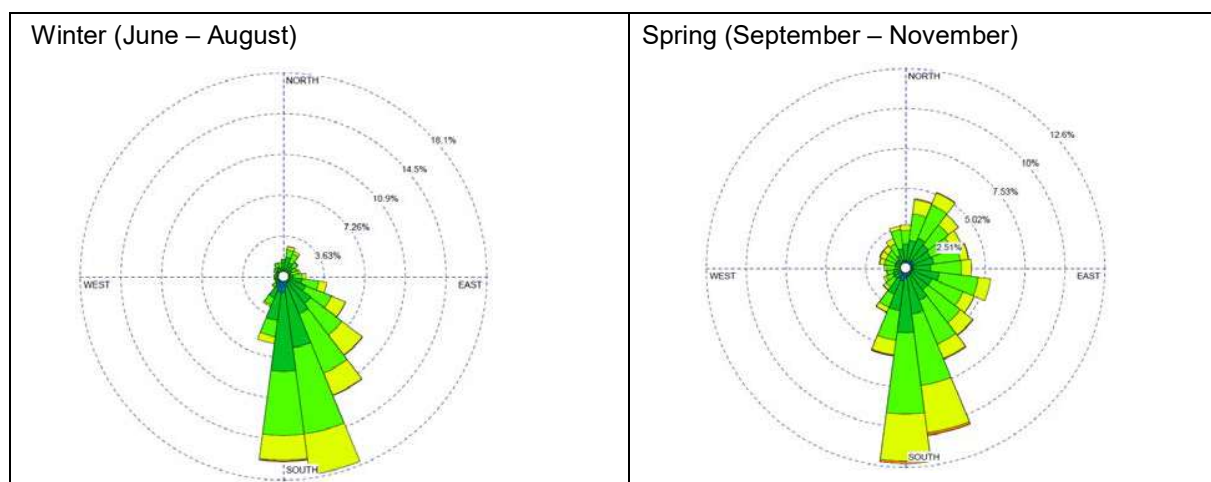
| Depth | Lithology |

The wind rose plots indicate that the prevailing wind condition is blowing from a south, south-easterly direction, towards the nearest sensitive receptor (Ardmore homestead) See Figure 13.

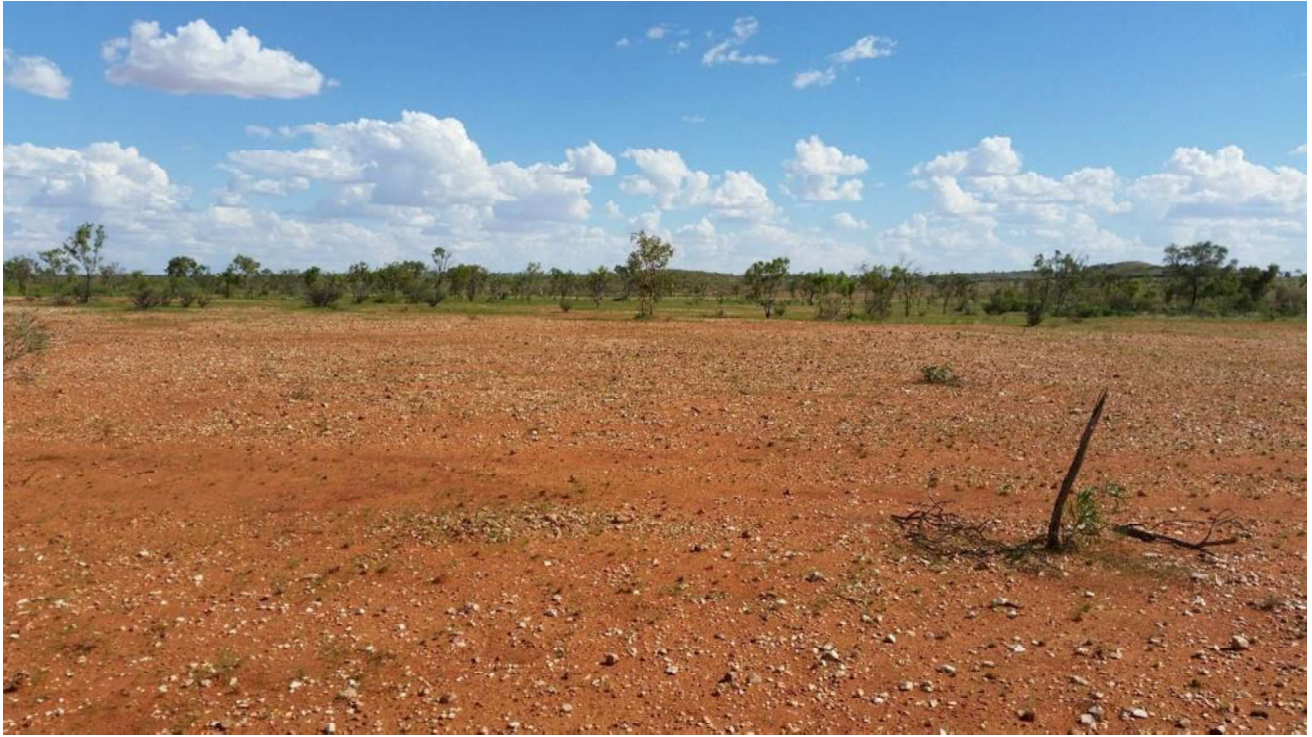
**Plate 4: Location of Test Pit TP08**

The test pit logs and soil profile photographic log are provided in Appendix A. Plate 4 and Plate 5 provide the location of TP08 which is located close to the Project area.

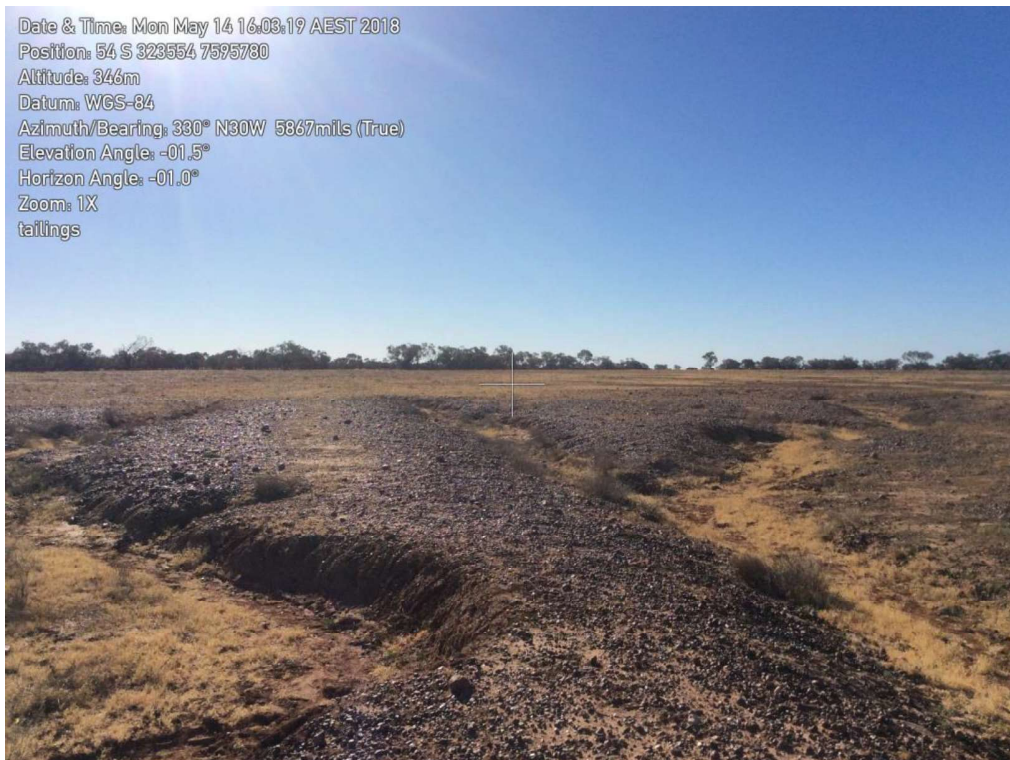
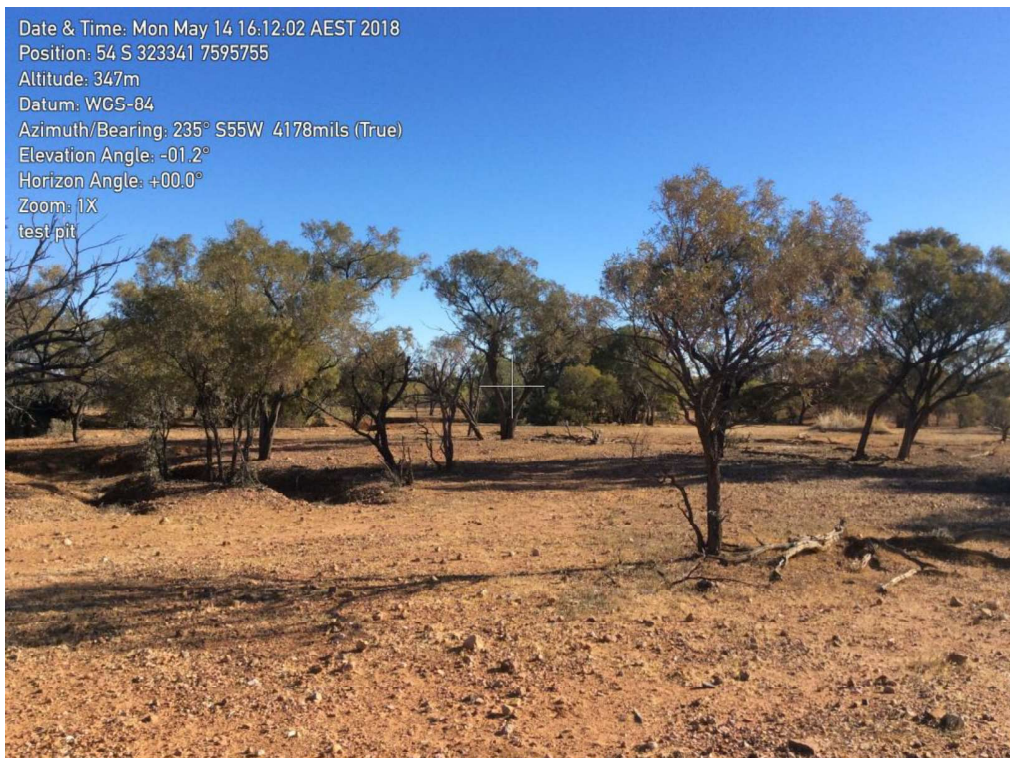
The environmental values present within the direct vicinity of the proposed start-up operation location were predominately very sparse with limited to no habitat values, on RE 14.9.12x4a/4.9.10b. Vegetation comprised a sparse ecotonal mix of *Acacia cambagei* and *Corymbia terminalis* very open woodland on skeletal soils, with large portion of the proposed start-up location containing only a sparse groundcover of *Enneapogon polyphyllus* (Plate 19 and Plate 20).

**Plate 19: Current Site Condition – TSF Location facing North-West**

**Plate 20: Current Site Condition – Test Pit Location facing South-West**

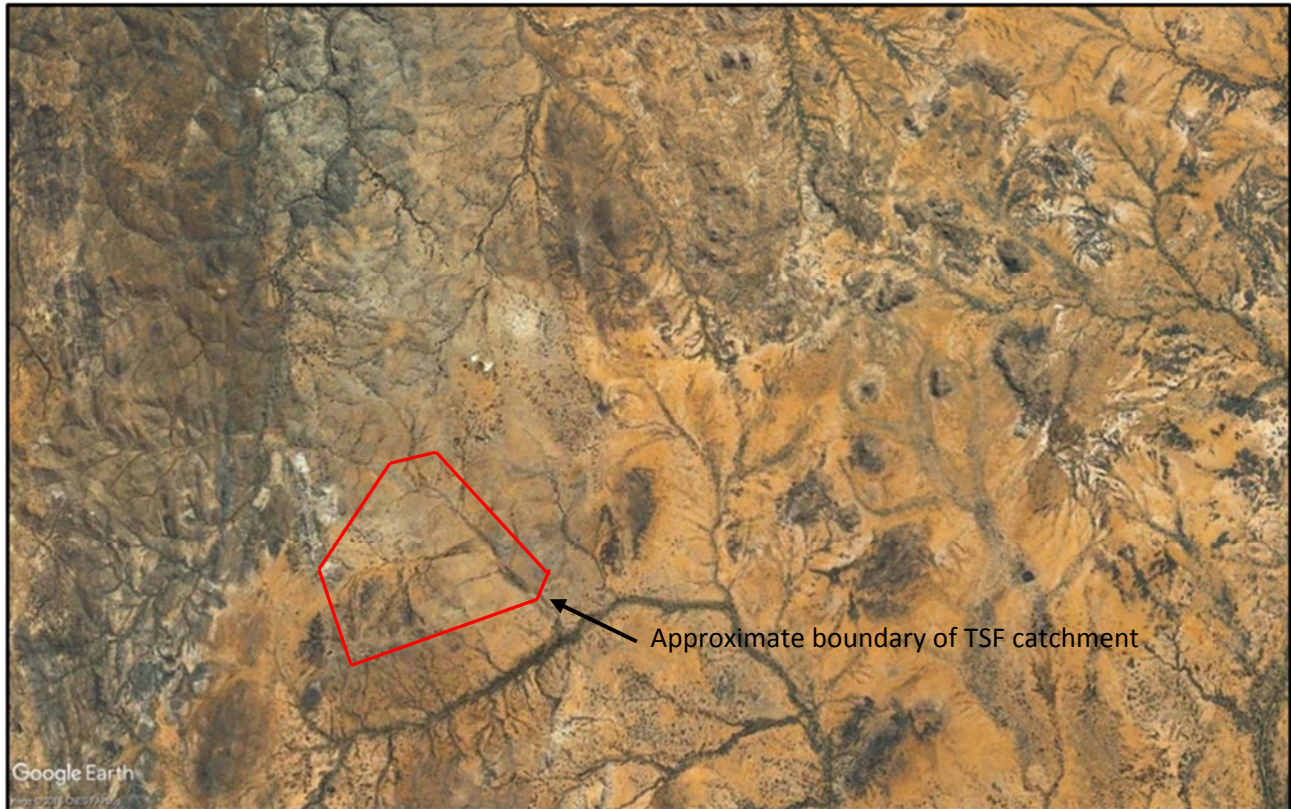
**Figure 5-1 – TSF location**

At the TSF site, there are ephemeral drainage channels from the west and north running through it. The main north-south drainage channel is through the proposed borrow pit area and extends from the proposed northern embankment towards the main southern embankment. The channel varies in width from a metre between the hills up to approximately 10 m in relatively flat areas.

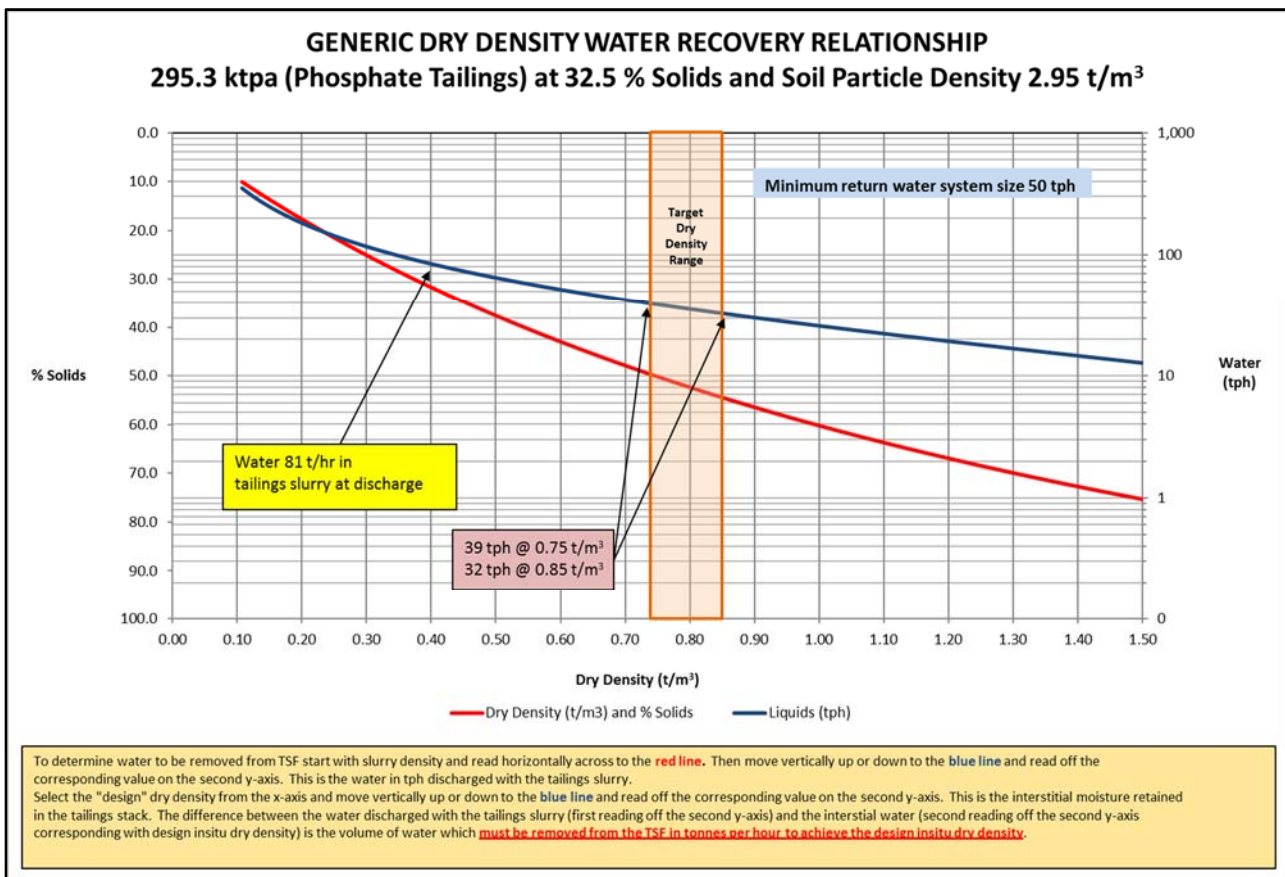
Figure 5-2 – Generic moisture density curve at zero air voids for 800 ktpa

The generic dry density ratio for the tailings produced from the 800 ktpa process plant, with a target for the ultimate insitu dry density of 0.75 t/m<sup>3</sup> to 0.85 t/m<sup>3</sup>, is presented as Figure 5-2. Water release and recovery to achieve an insitu dry density of 0.75 t/m<sup>3</sup> is 50 tph.

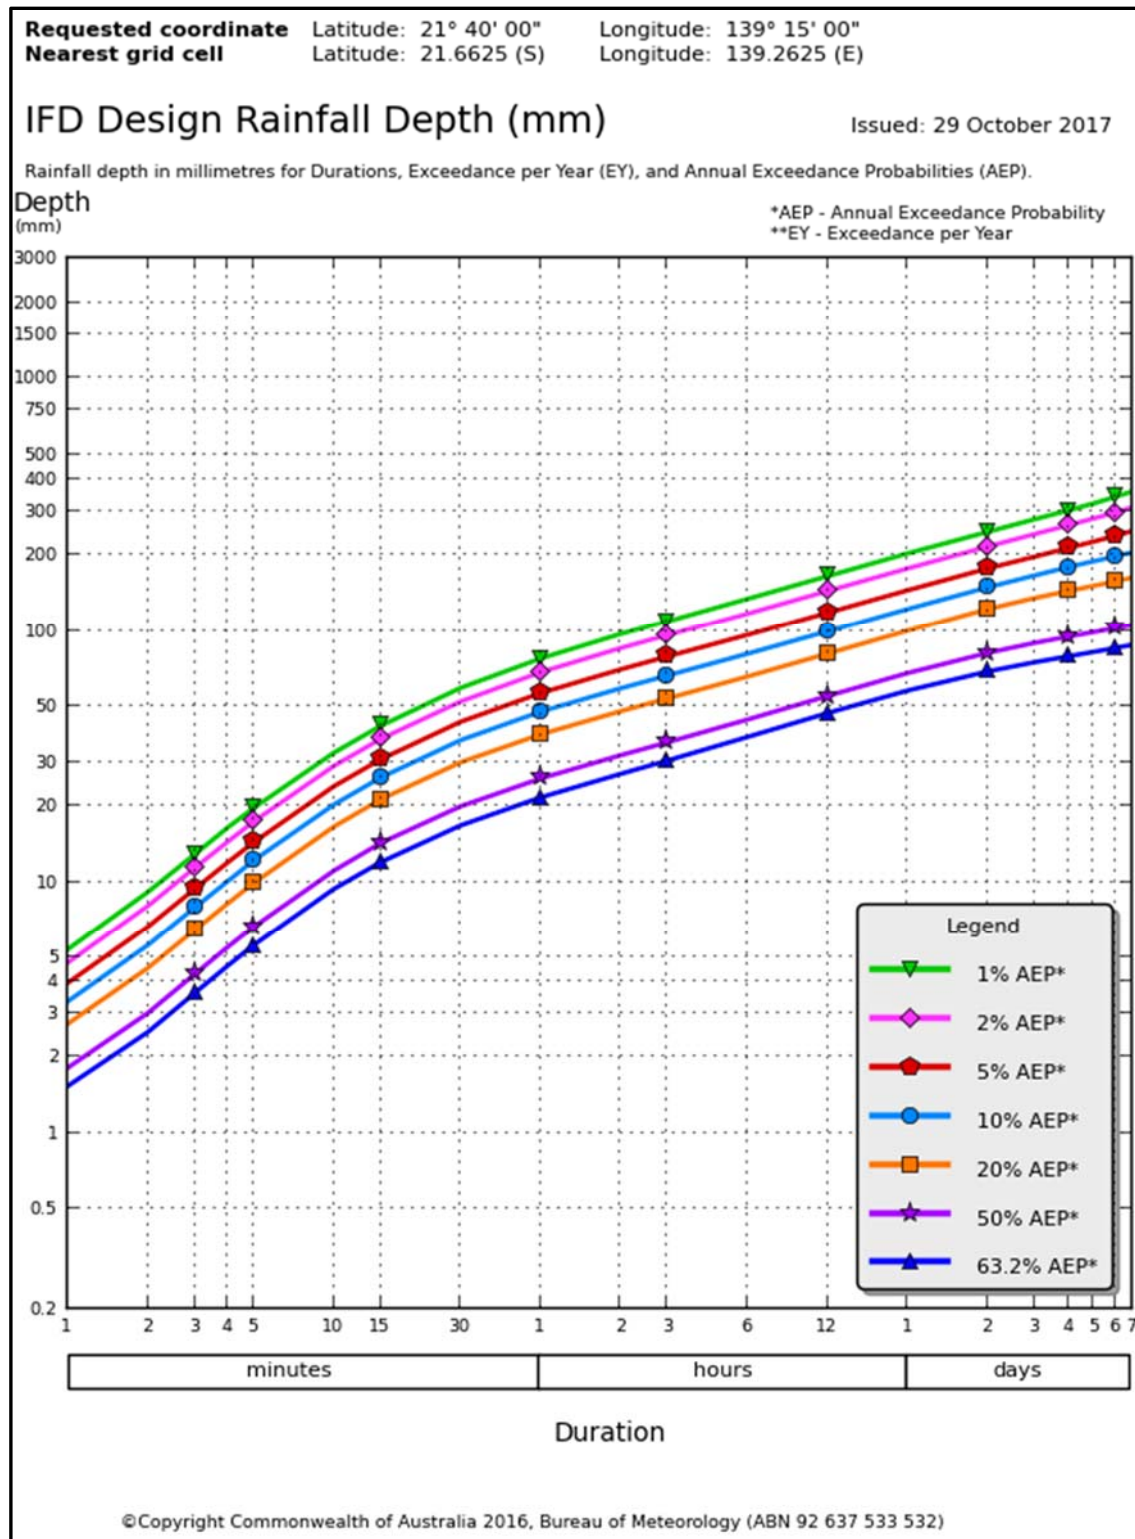
**Figure 6-1 – Rainfall Intensity Frequency Duration**

<sup>\*</sup> The 20% AEP IFD **does not** correspond to the 5-year Average Recurrence Interval (ARI) IFD. Rather it corresponds to the 4.48 ARI.

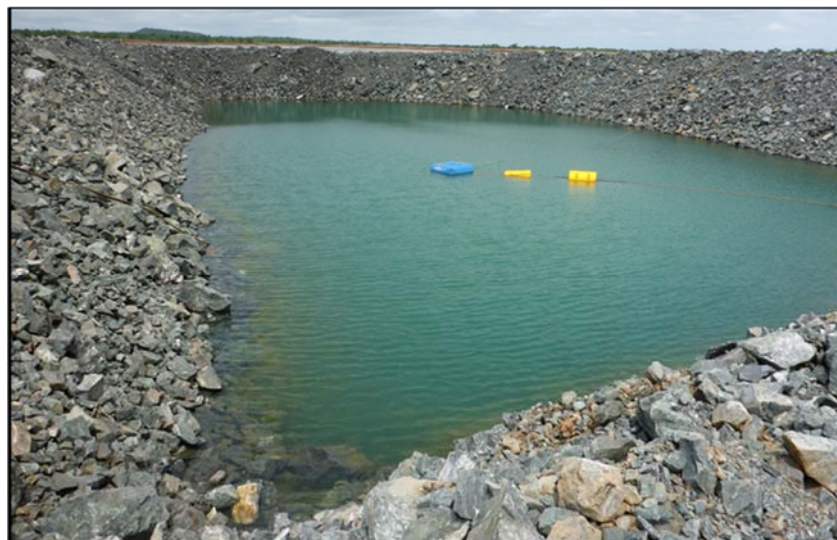
**Figure 7-2 – Rock ring with submersible decant pumps**

The decant is to be raised in conjunction with the raising of the perimeter embankments. Figure 7-2 shows a typical rock ring filter. The benefits of implementing a well-formed rock ring filter decant arrangement are as follows:

- The clarity of the water within the rock ring is a function of the thickness of the filter walls. Typically, the perimeter of the rock ring has a crest width of not less than 5 m excluding windrows.
- The rock ring is an efficient filter system, where the surface area of the rock (width and diameter within the ring) forms circuitous flow paths, which reduce the 'flow velocities' through the filter wall allowing the fines (silt and clay sized fraction) to settle out.
- The presence of the rock does not allow turbulence (wave action) to propagate through the filter wall and the area within the ring is sufficiently small to minimise the potential risk of wave action forming within the rock ring.

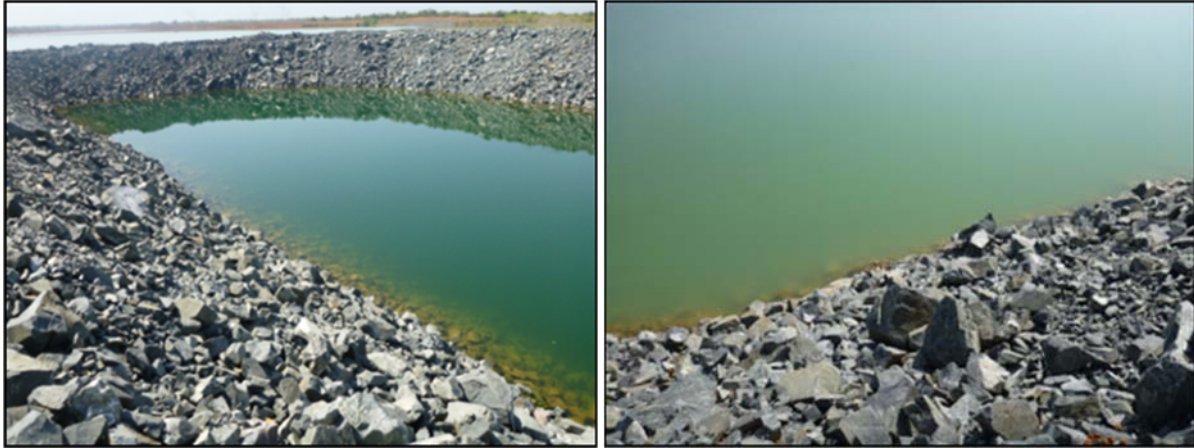
**Figure 7-3 - Supernatant water inside the rock ring (left) and outside the rock ring (right)**

The clarity of the water within the rock ring (inside the filter) would be less than could otherwise be achieved without such a structure. The photographs in Figure 7-3 show the difference in the clarity of the supernatant water inside and outside the rock filter wall.

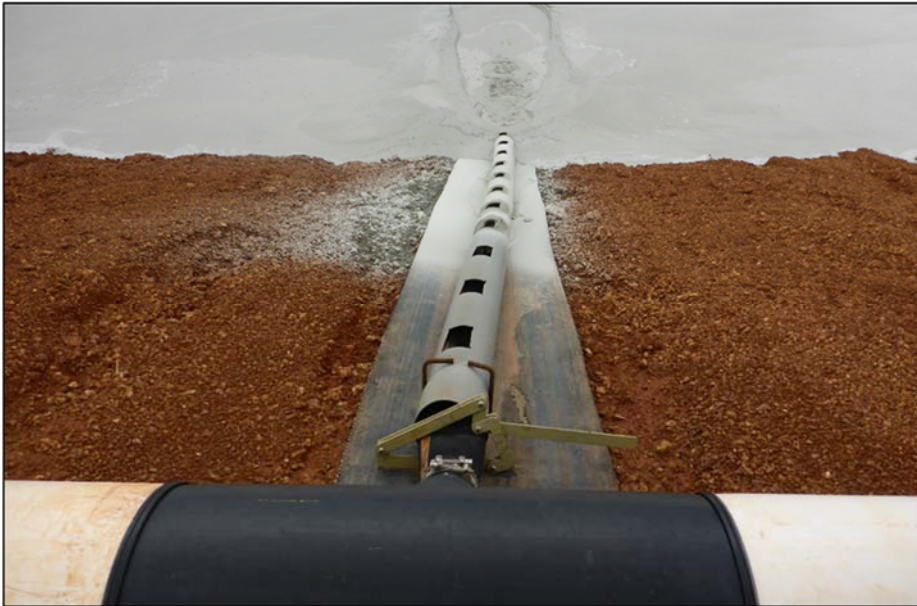
Figure 7-4 – Typical Conductor Pipe

Tailings deposition would occur from the perimeter embankment with spigot intervals of not less than 25 m and not more than 50 m. Conductor pipes laid on old conveyor belt pieces, similar to the style of conductor pipe shown in Figure 7-4 and Figure 7-5 below are recommended to ensure that tailings discharged from the perimeter are deposited onto the tailings beach with minimal potential for erosion of the adjacent embankment. The diameter of the conductor pipe has to be designed to suit the size of the tailings distribution pipeline and the conveyor matting, to be placed down the embankment, also has to be adjusted to suit the size of the conductor pipe. Some operations may require not less than three (3) pieces of conveyor matting in the vicinity of the conductor pipe to provide sufficient erosion protection to the adjacent embankment.

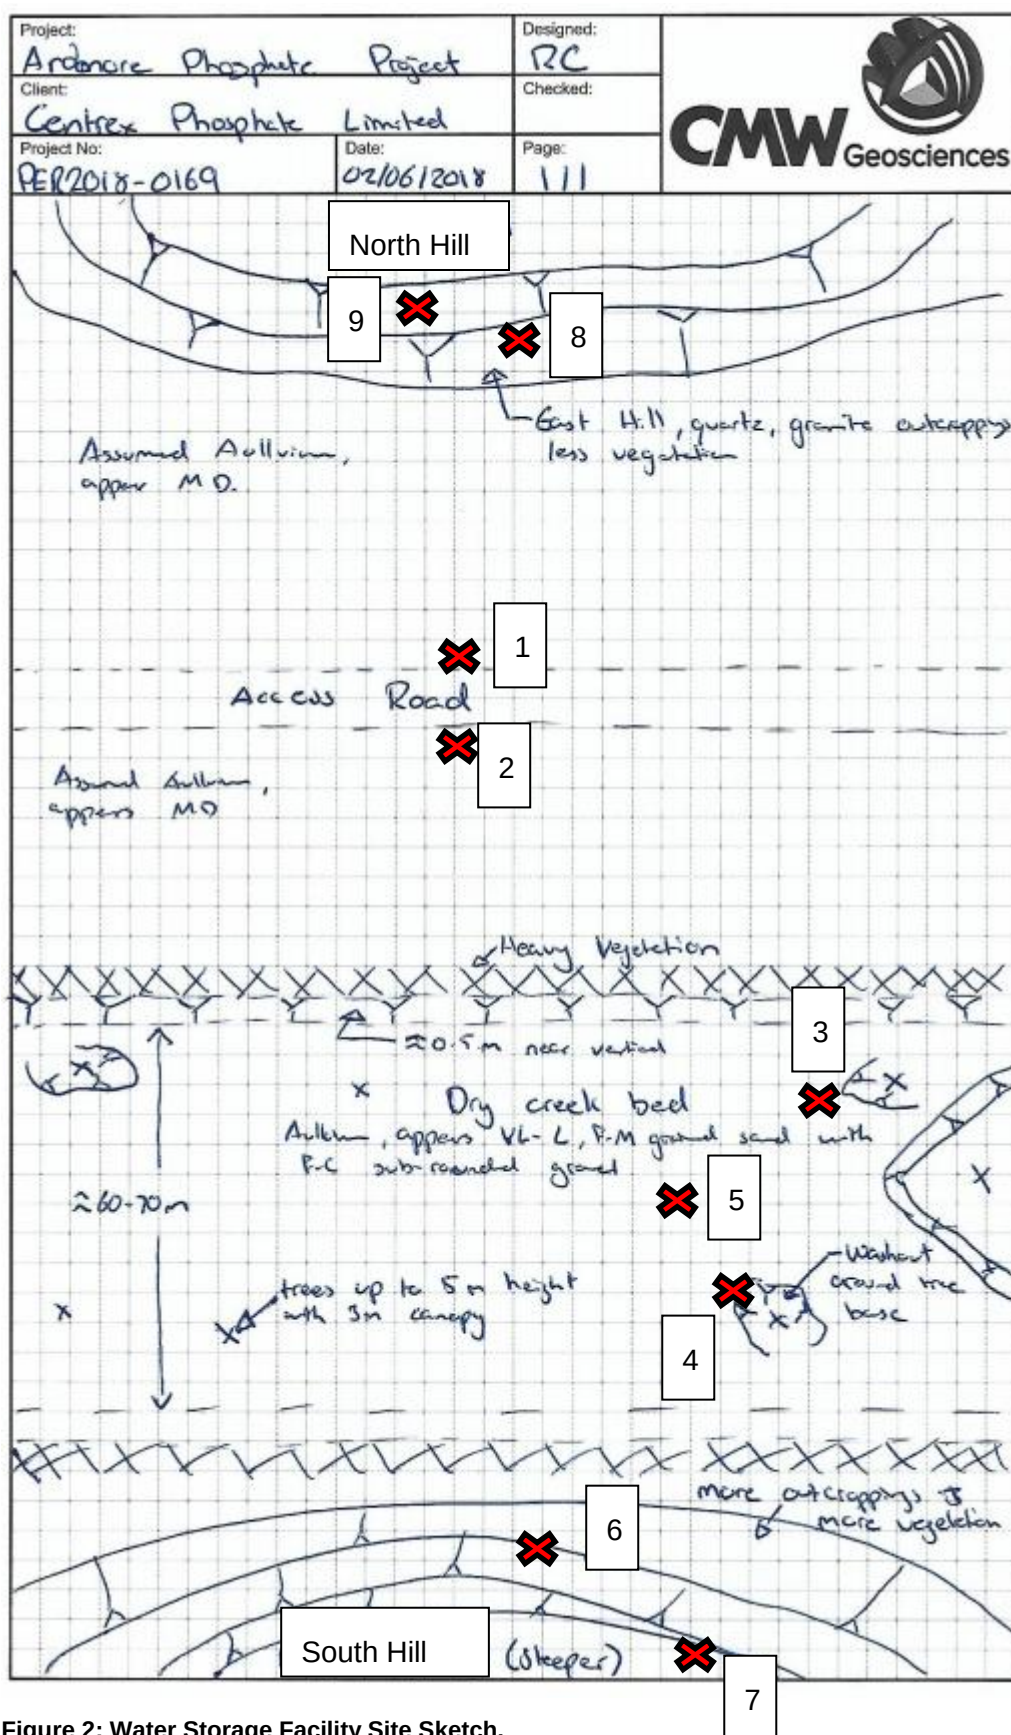
Figure 2: Water Storage Facility Site Sketch.

It is understood the dam will bridge between the two-existing hills, denoted North and South Hill, and will be approximately 300m in length and 4 to 5m in height. Due to lease constraints for the area, no intrusive investigation was undertaken during the site visit.

As depicted in the site sketch above, a large dry creek (at the time of the site visit) up to 70 metres wide lies between the two hills. The dry creek (Split Creek) mainly consisted on what appears to be very loose to loose fine to medium grained alluvium sand, with fine to coarse sub rounded gravels. Without any intrusive investigation the depth of this material is unknown, from site observations, of the wash out around the existing trees and around the banks it is anticipated that the material thickness is greater than one metre. Figure 3 taken facing east within the dry creek, presents the typical washout around existing tree observed. The rocks in the lower right corner of the photograph are transported, with site 4 in Appendix C presenting the typical rocks encountered within the creek bed.

Towards the North hill away from the creek bed, the alluvium, appears medium dense to dense with less vegetation and more granite outcroppings the further towards the eastern hill. The South hill has significant more vegetation and outcroppings compared to the eastern hill and is slightly steeper. Appendix C presents annotated site photographs at the locations shown in Figure 2.

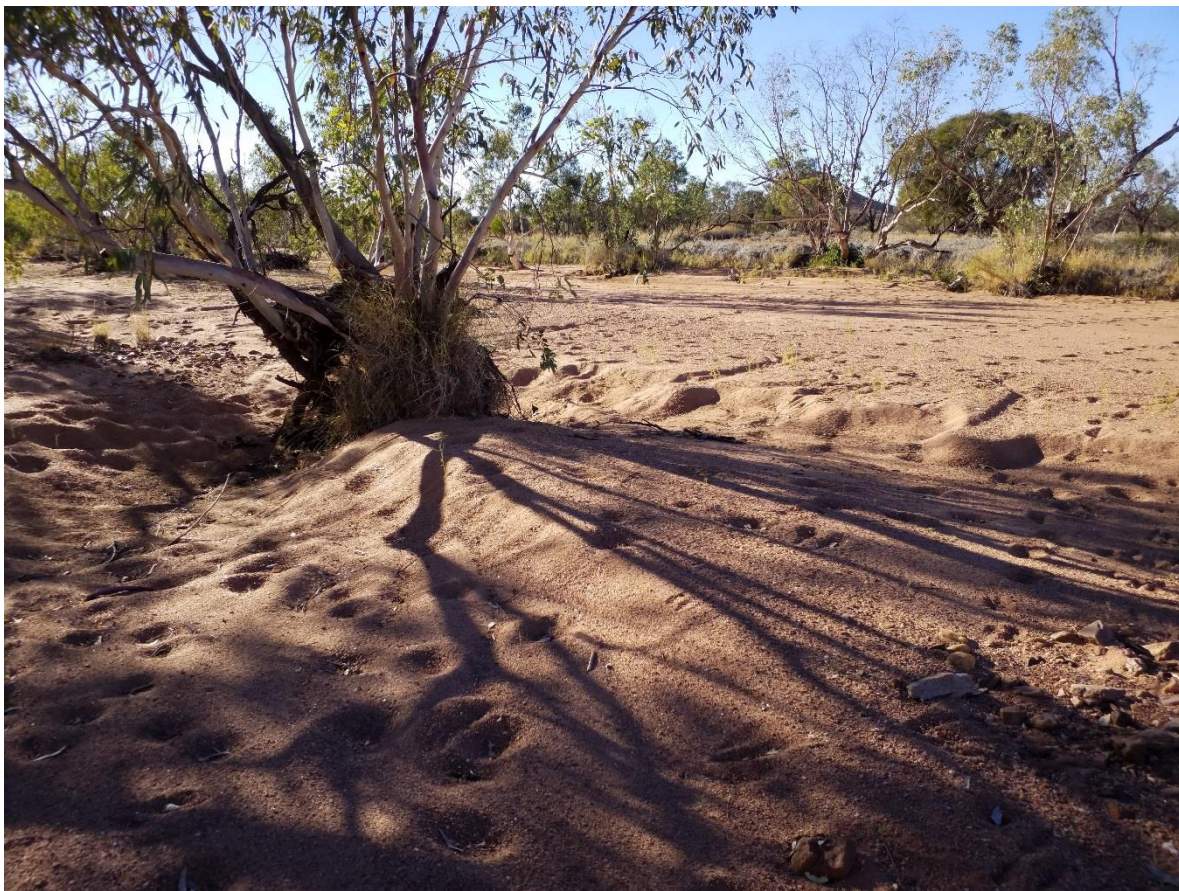
**Figure 3: Washout around existing tree, within creek at water storage facility.**

Rock outcroppings were observed along the existing faces of both hills, which in future will be the water storage facility embankments. Along the South hill slope, siltstone rock outcropping was observed as shown in Appendix C site 6. Granite outcroppings were observed along the existing slope of the North hill.

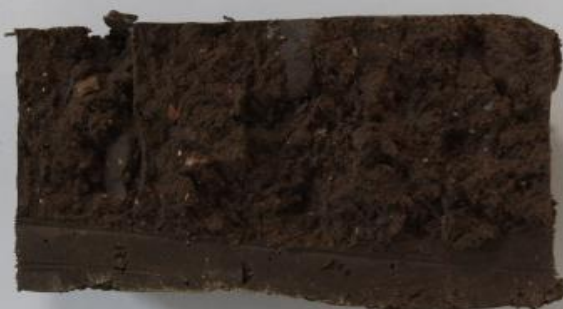
| <b>BOREHOLE:</b> | BR02 | <b>DEPTH:</b> | 0.60-1.10 |

| <b>PROJECT:</b> | PER2018-0169 - Ardmore Phosphate Project | <b>AFTER TEST</b> | |

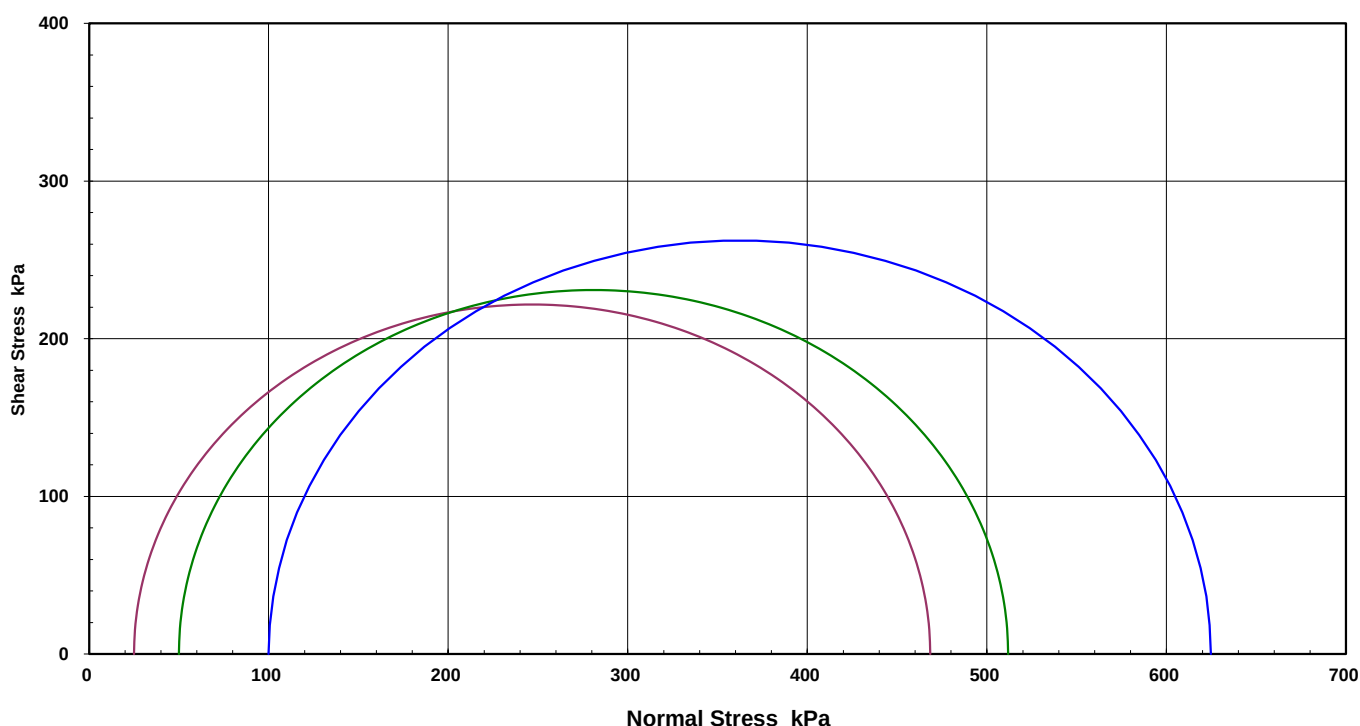
### Mohr Circle Diagram

| | | <b>Cohesion C (kPa)</b> | | 161.4 | 132.8 | 141.6 |

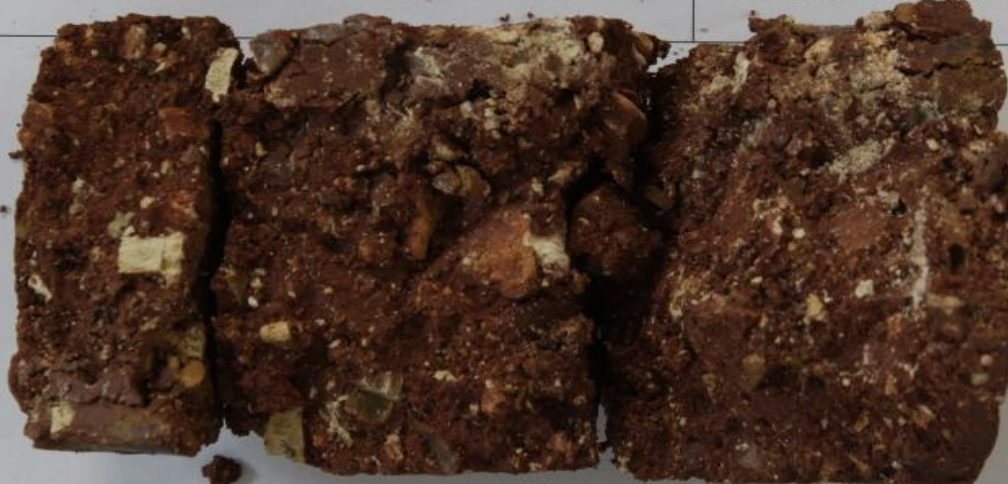
| <b>BOREHOLE:</b> | BR18 | <b>DEPTH:</b> | 0.50-1.00 |

| <b>PROJECT:</b> | PER2018-0169 - Ardmore Phosphate Project | | <b>AFTER TEST</b> |

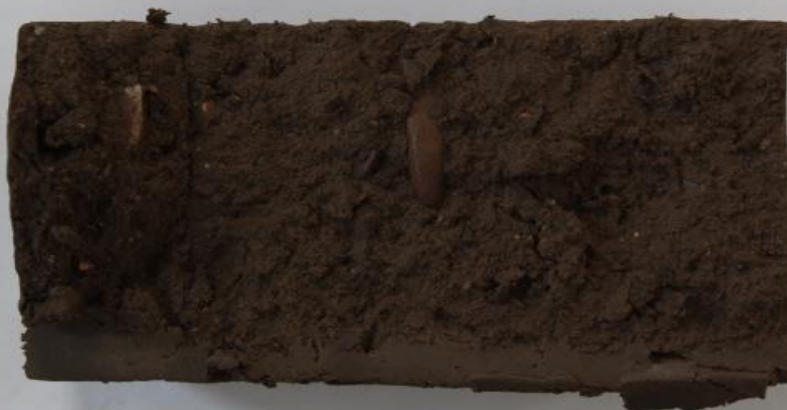
| <b>BOREHOLE:</b> | BR02 | <b>DEPTH:</b> 0.60-1.10 |

| <b>PROJECT:</b> | PER2018-0169 - Ardmore Phosphate Project | <b>AFTER TEST</b> |
