# Ardmore Start-Up Operation - Progressive Rehabilitation and Closure Plan

*Mining Lease 5542 (Environmental Authority BRMN0037)*

**Golder Associates Pty Ltd**

21463804-001-R-Rev0

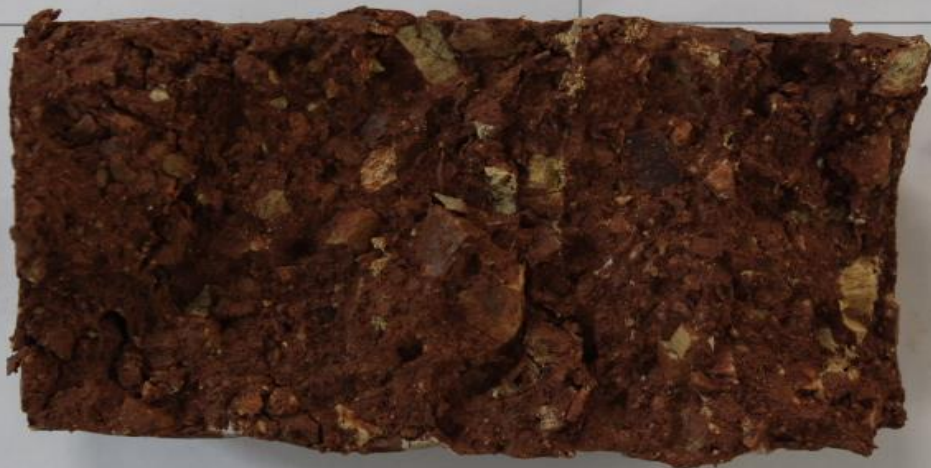
| <b>BOREHOLE:</b> | BR18 | <b>DEPTH:</b> 0.50-1.00 |

| <b>PROJECT:</b> | PER2018-0169 - Ardmore<br>Phosphate Project | <b>AFTER TEST</b> |

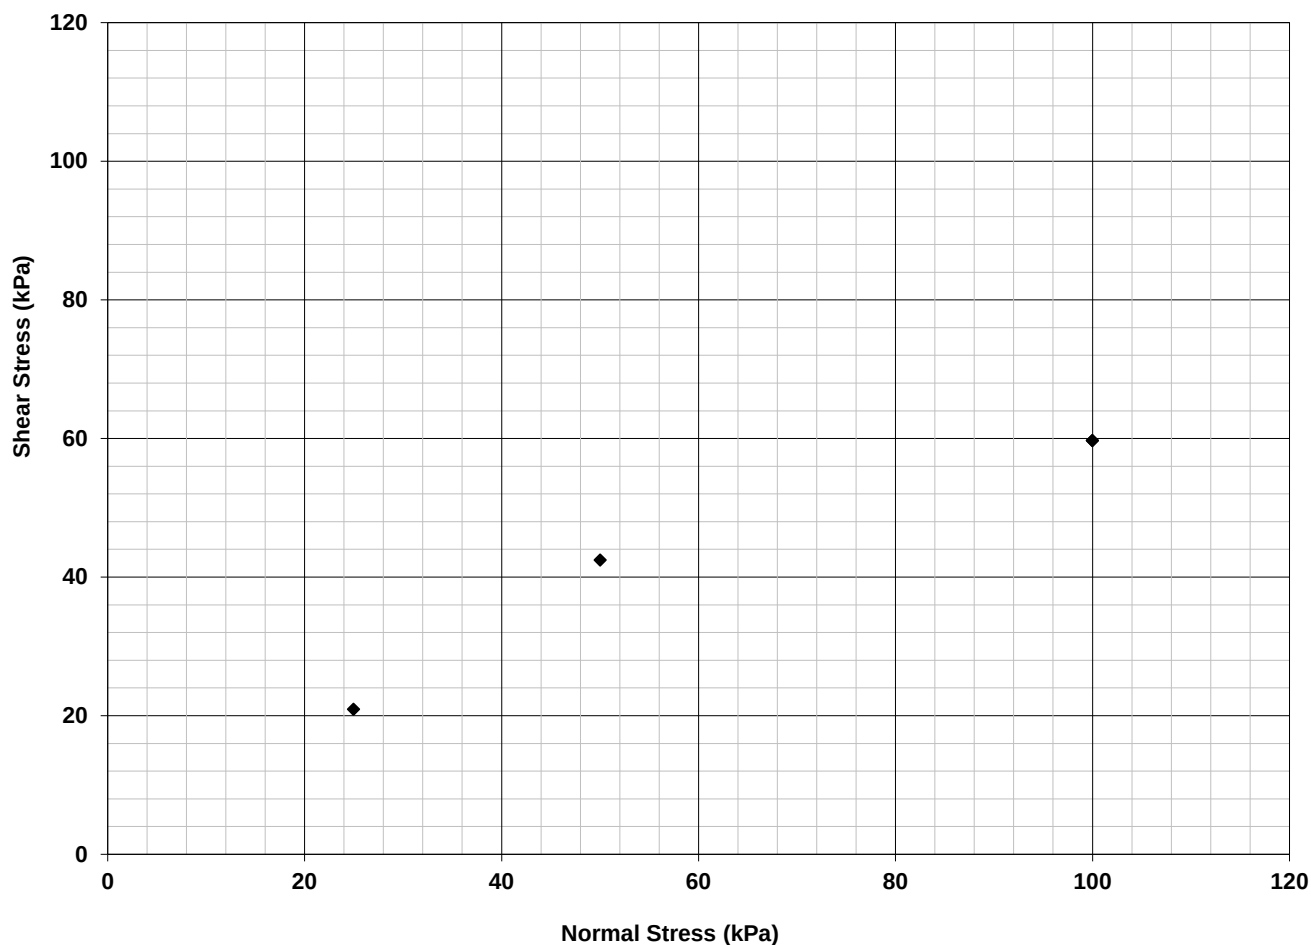
### Residual - Normal Stress vs Shear Stress

**Shear Angle (°)**
**26.2**
**Cohesion (kPa)**
**12.3**
**R<sup>2</sup>**
**0.968**

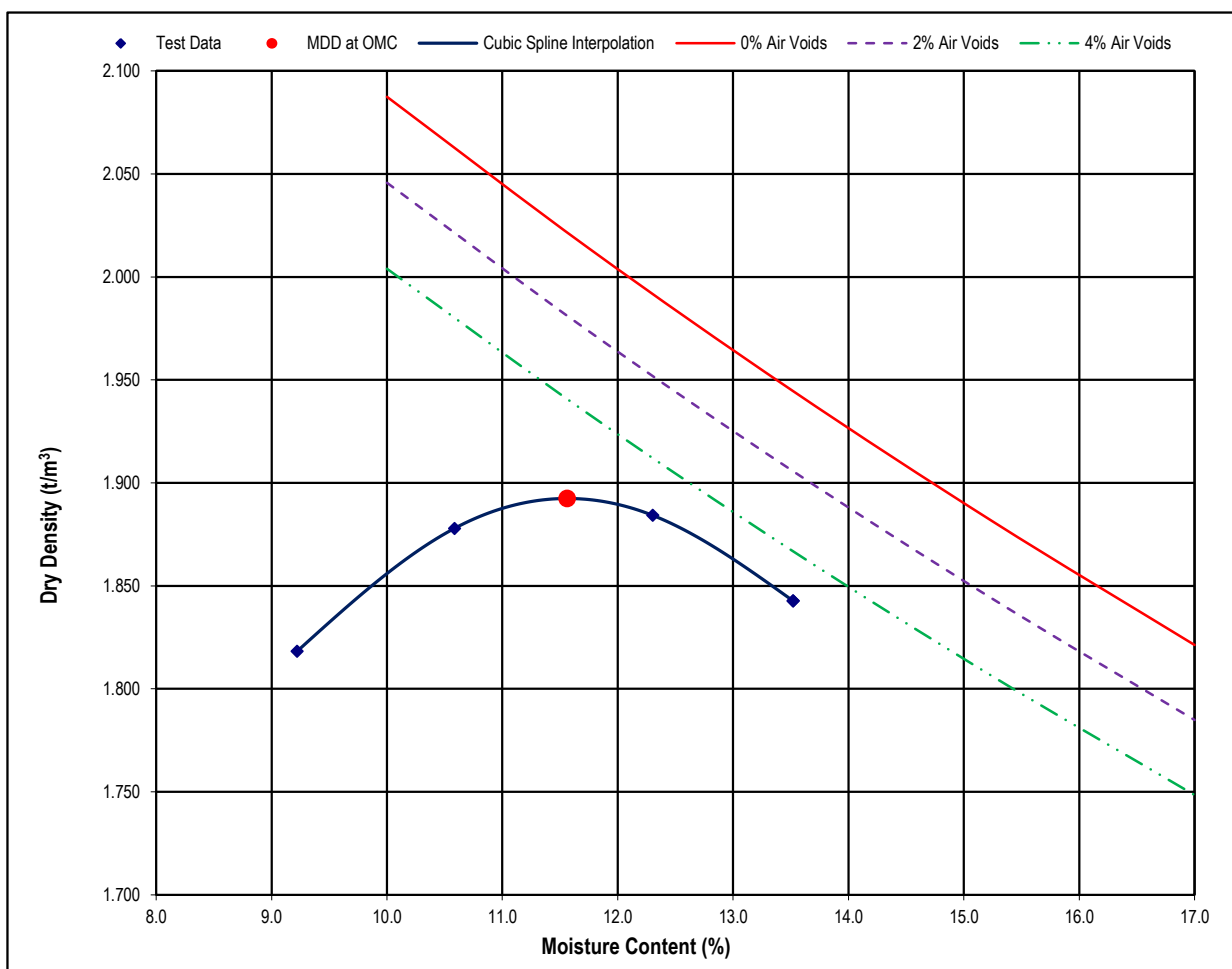
| <b>Client ID</b> | AR01 | <b>Depth (m)</b> | 0.30-0.70 |

| <b>Maximum Dry Density (t/m<sup>3</sup>)</b> | 1.89 | <b>Optimum Moisture Content (%)</b> | 11.6 |

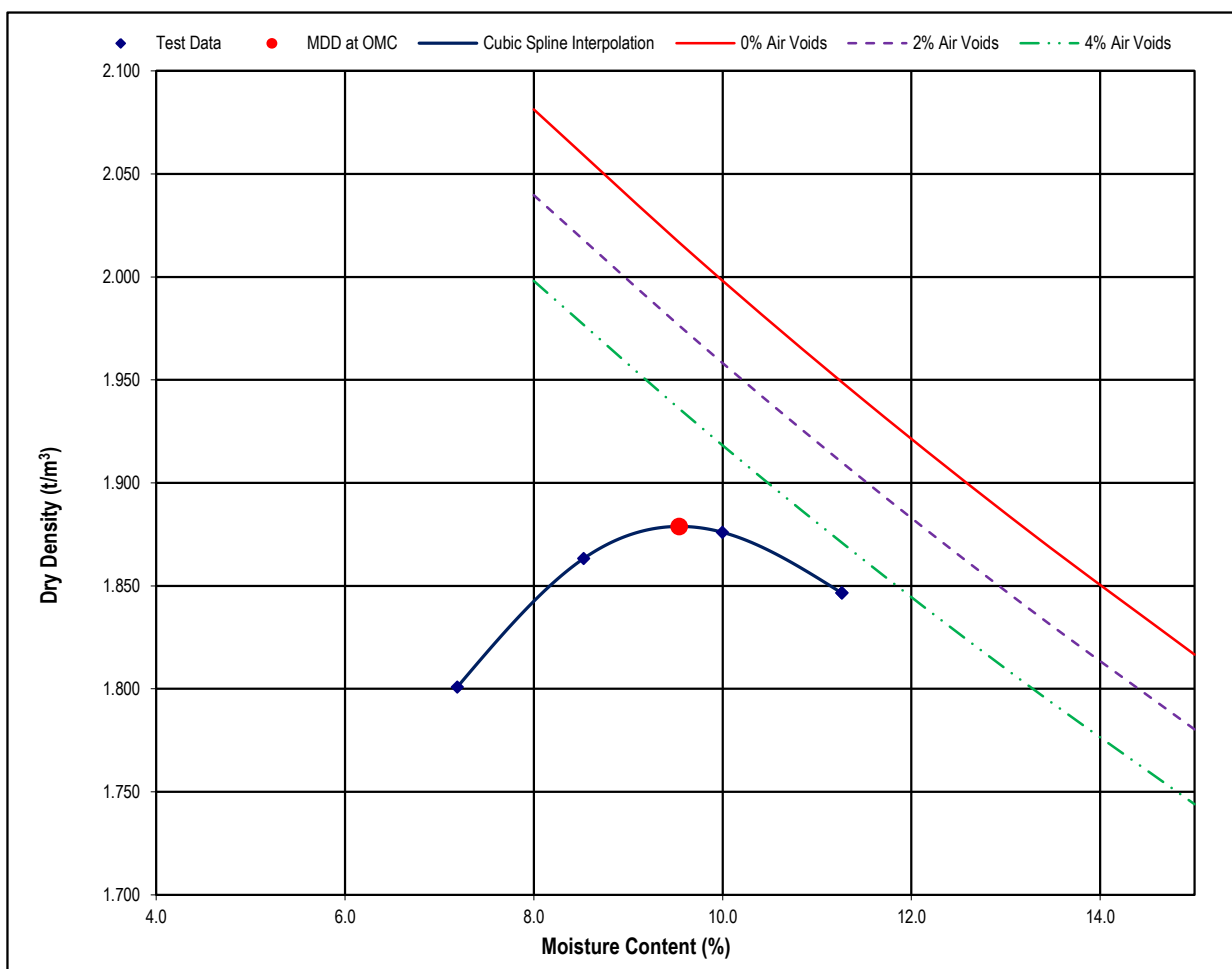
| <b>Client ID</b> | AR02 | <b>Depth (m)</b> | 0.20-0.70 |

| <b>Maximum Dry Density (t/m³)</b> | 1.88 | <b>Optimum Moisture Content (%)</b> | 9.5 |

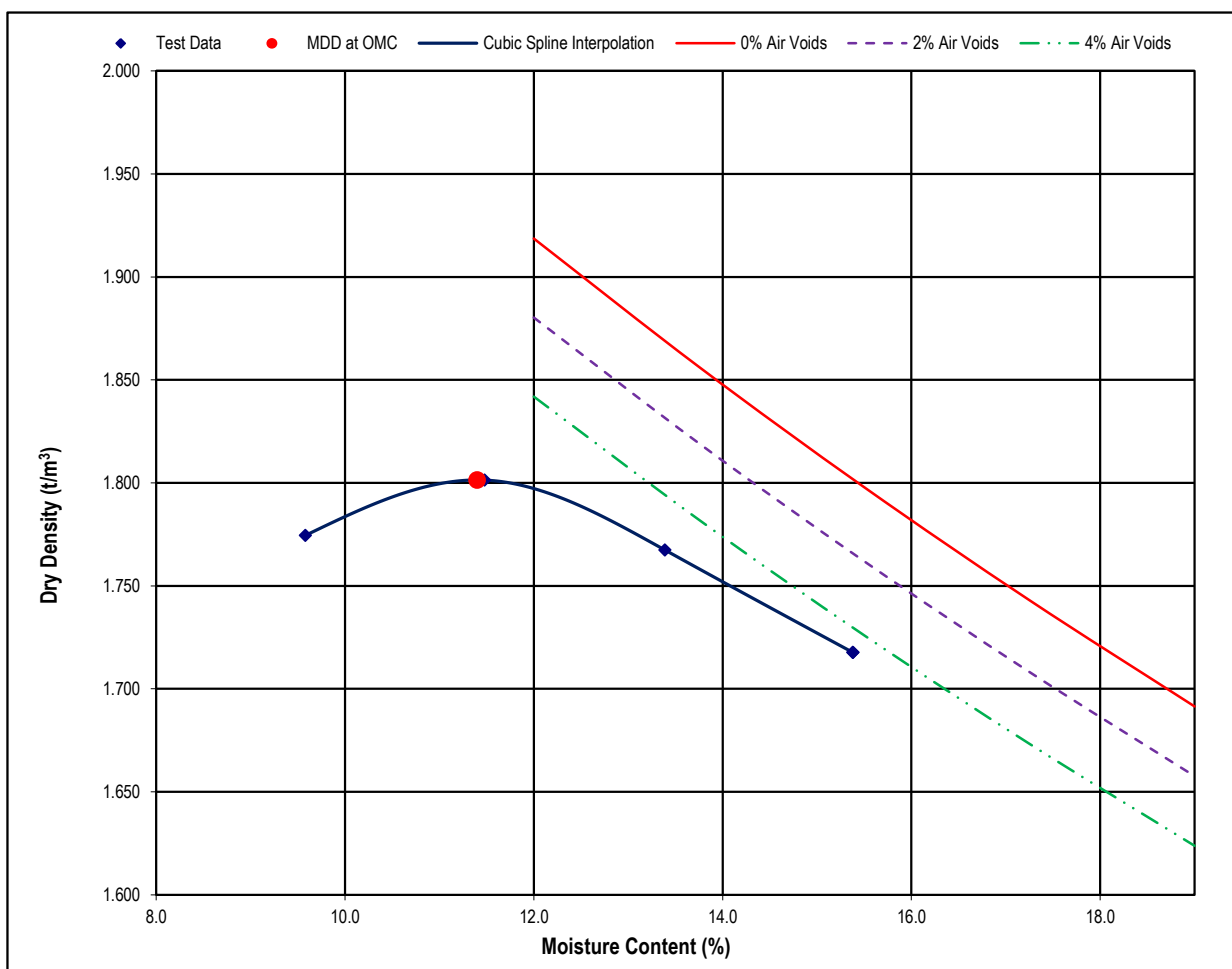
| <b>Client ID</b> | AR04 | <b>Depth (m)</b> | 0.10-0.60 |

| <b>Maximum Dry Density (t/m³)</b> | 1.80 | <b>Optimum Moisture Content (%)</b> | 11.4 |

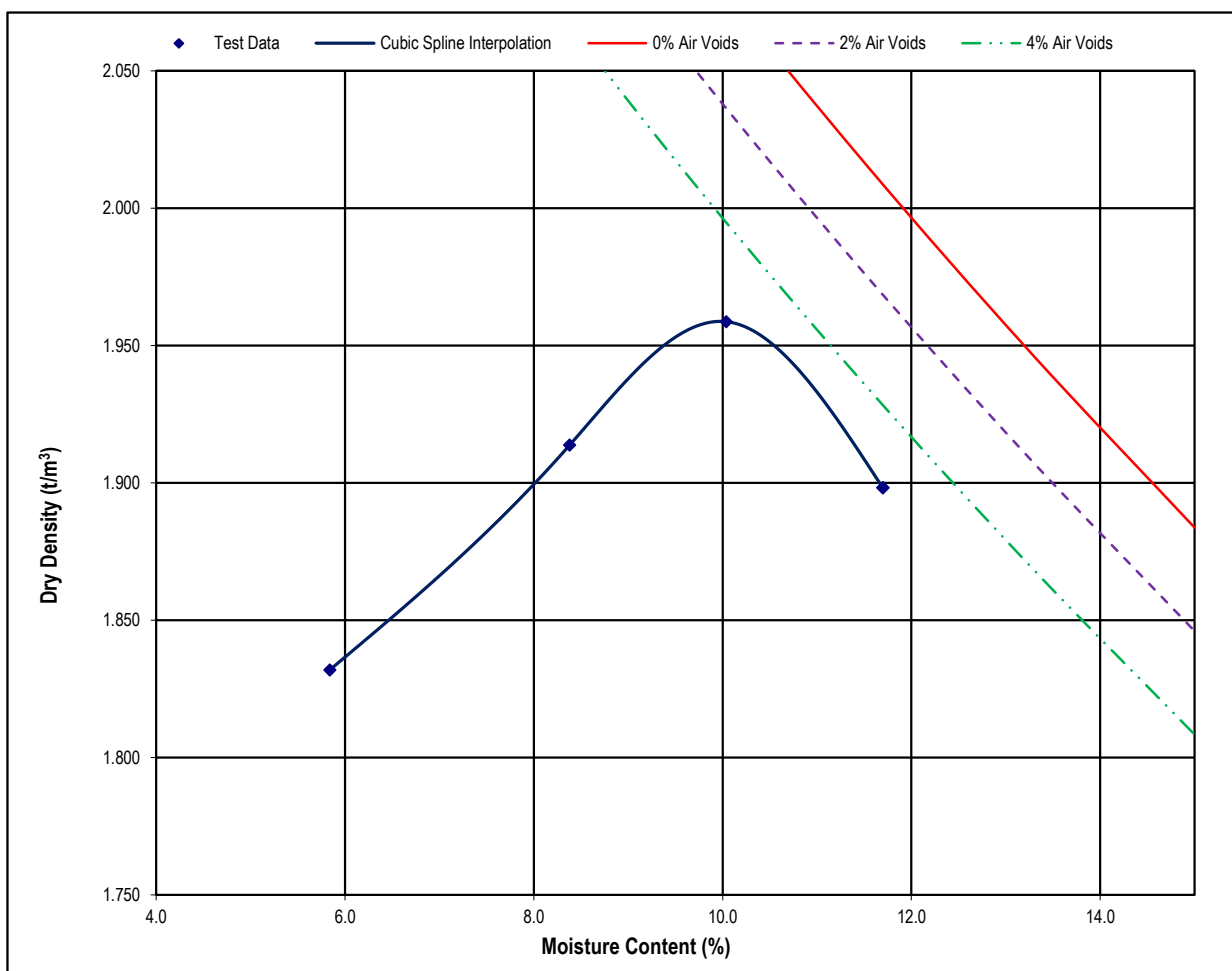
| <b>Client ID</b> | BR01 | <b>Depth (m)</b> | 0.20-0.70 |

| <b>Maximum Dry Density (t/m³)</b> | 1.96 | <b>Optimum Moisture Content (%)</b> | 10.0 |

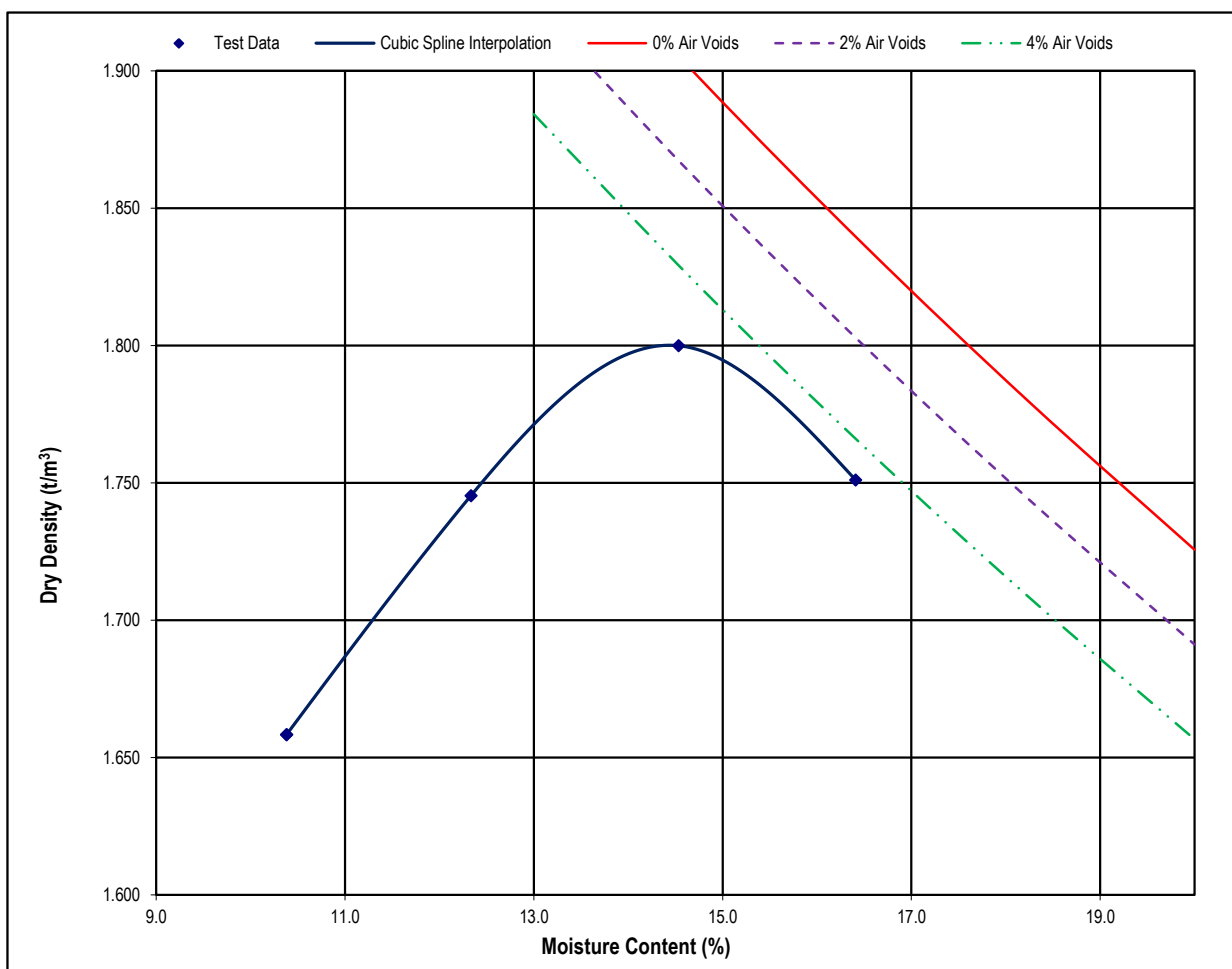
| <b>Client ID</b> | BR02 | <b>Depth (m)</b> | 0.60-1.10 |

| <b>Maximum Dry Density (t/m³)</b> | 1.80 | <b>Optimum Moisture Content (%)</b> | 14.4 |

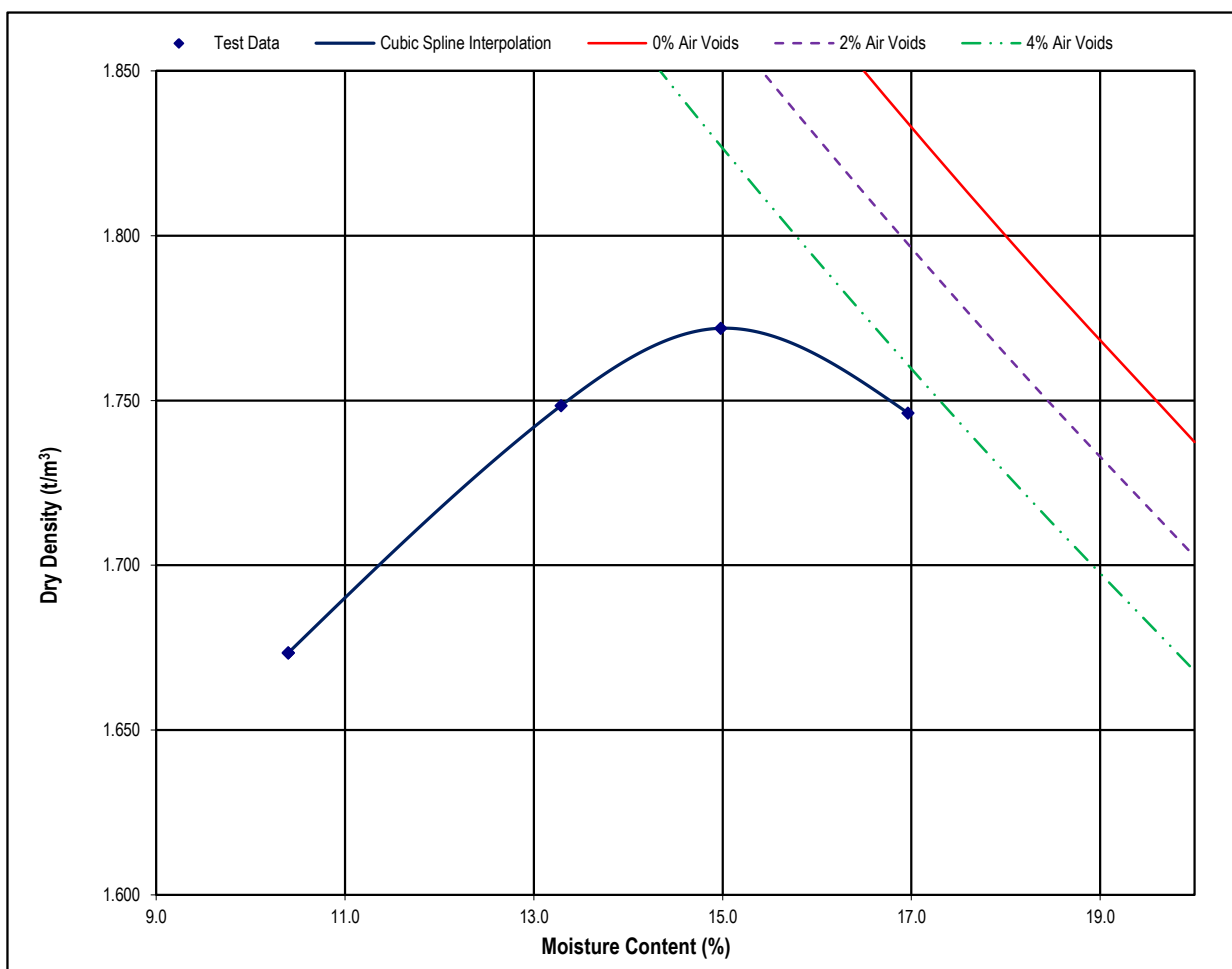
| <b>Client ID</b> | BR04 | <b>Depth (m)</b> | 1.10-1.70 |

| <b>Maximum Dry Density (t/m³)</b> | 1.77 | <b>Optimum Moisture Content (%)</b> | 15.0 |

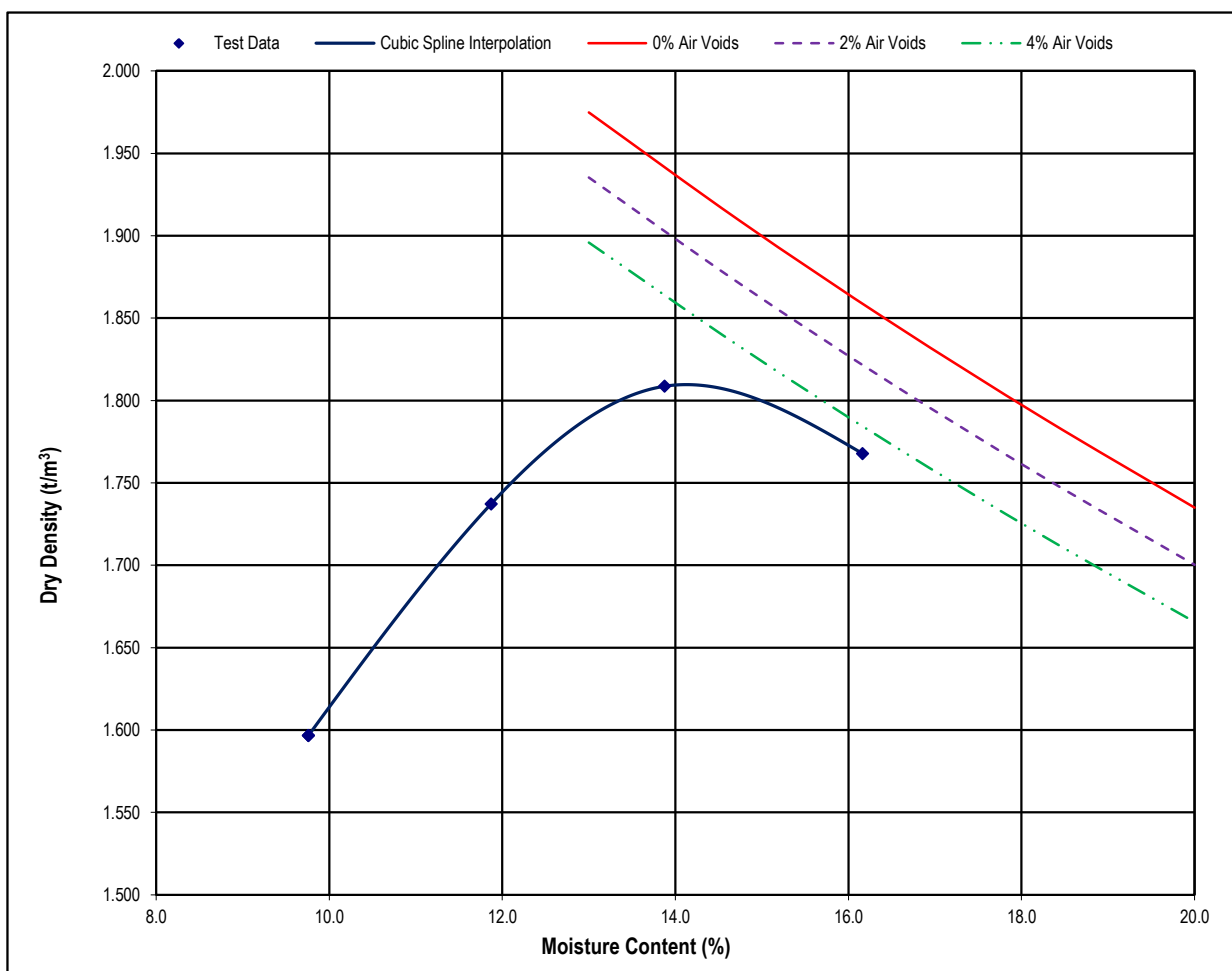
| <b>Client ID</b> | BR07 | <b>Depth (m)</b> | 0.00-0.50 |

| <b>Maximum Dry Density (t/m³)</b> | 1.81 | <b>Optimum Moisture Content (%)</b> | 14.1 |

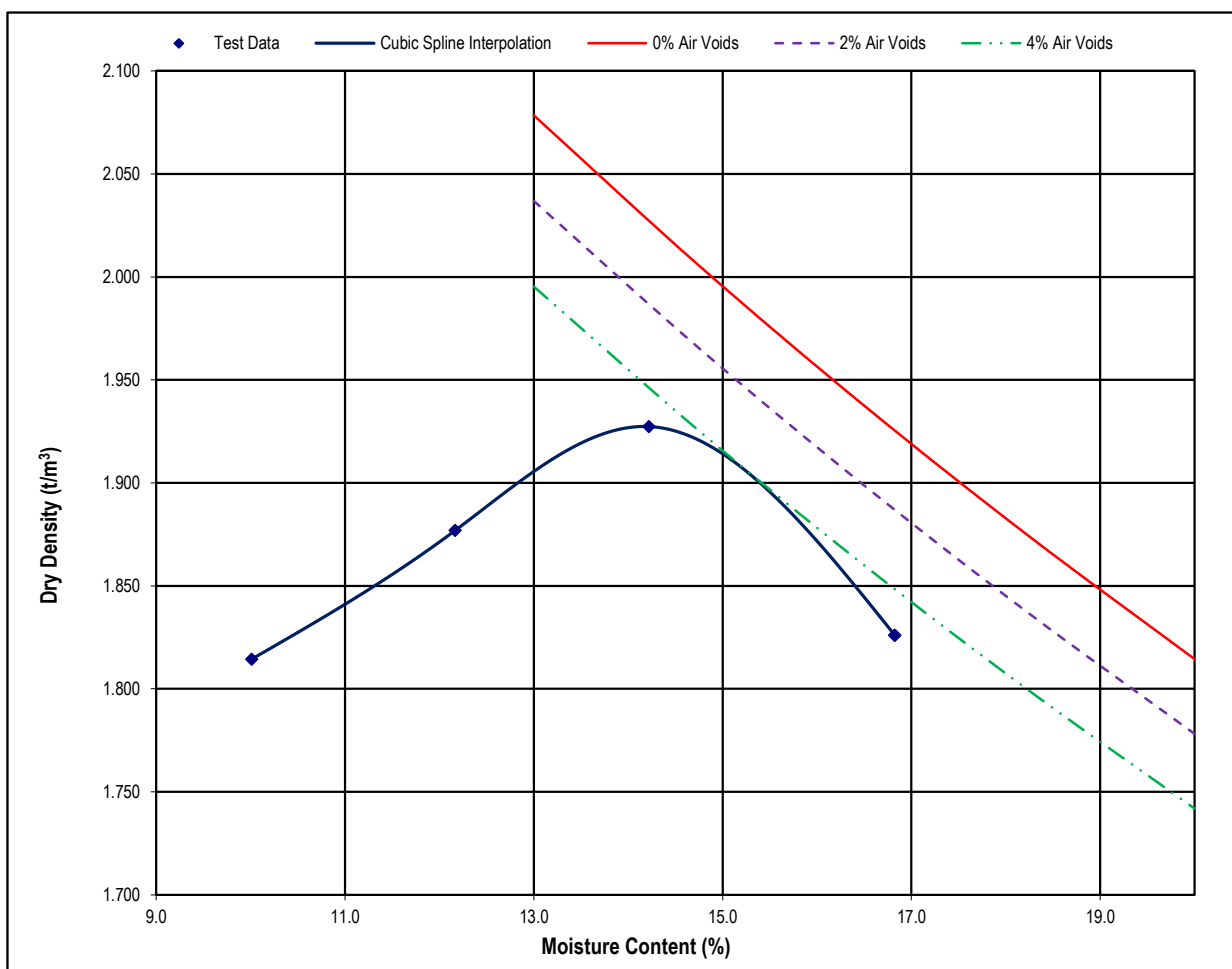
| <b>Client ID</b> | BR08 | <b>Depth (m)</b> | 0.50-1.00 |

| <b>Maximum Dry Density (t/m<sup>3</sup>)</b> | 1.93 | <b>Optimum Moisture Content (%)</b> | 14.2 |

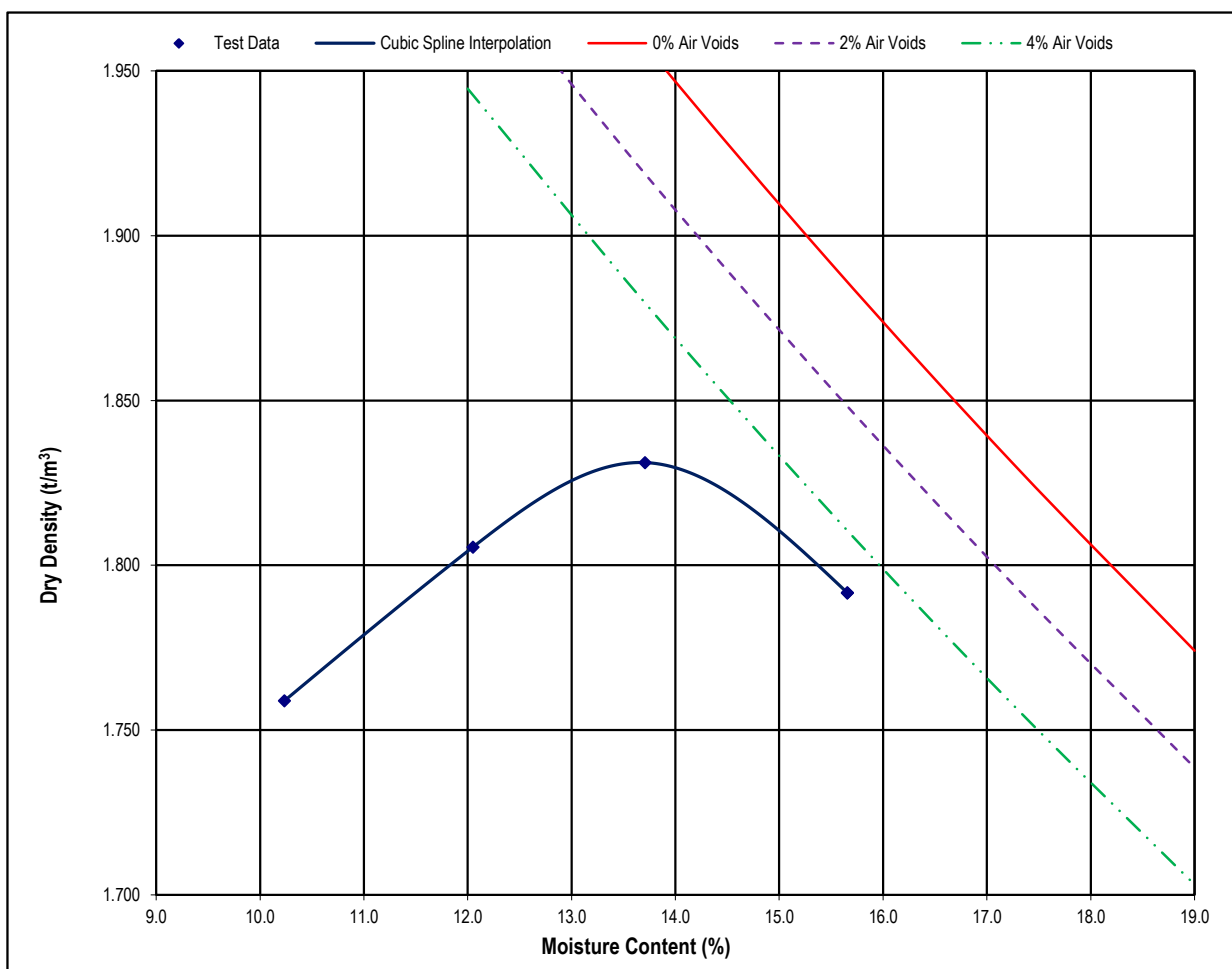
| <b>Client ID</b> | BR12 | <b>Depth (m)</b> | 0.30-0.80 |

| <b>Maximum Dry Density (t/m³)</b> | 1.83 | <b>Optimum Moisture Content (%)</b> | 13.7 |

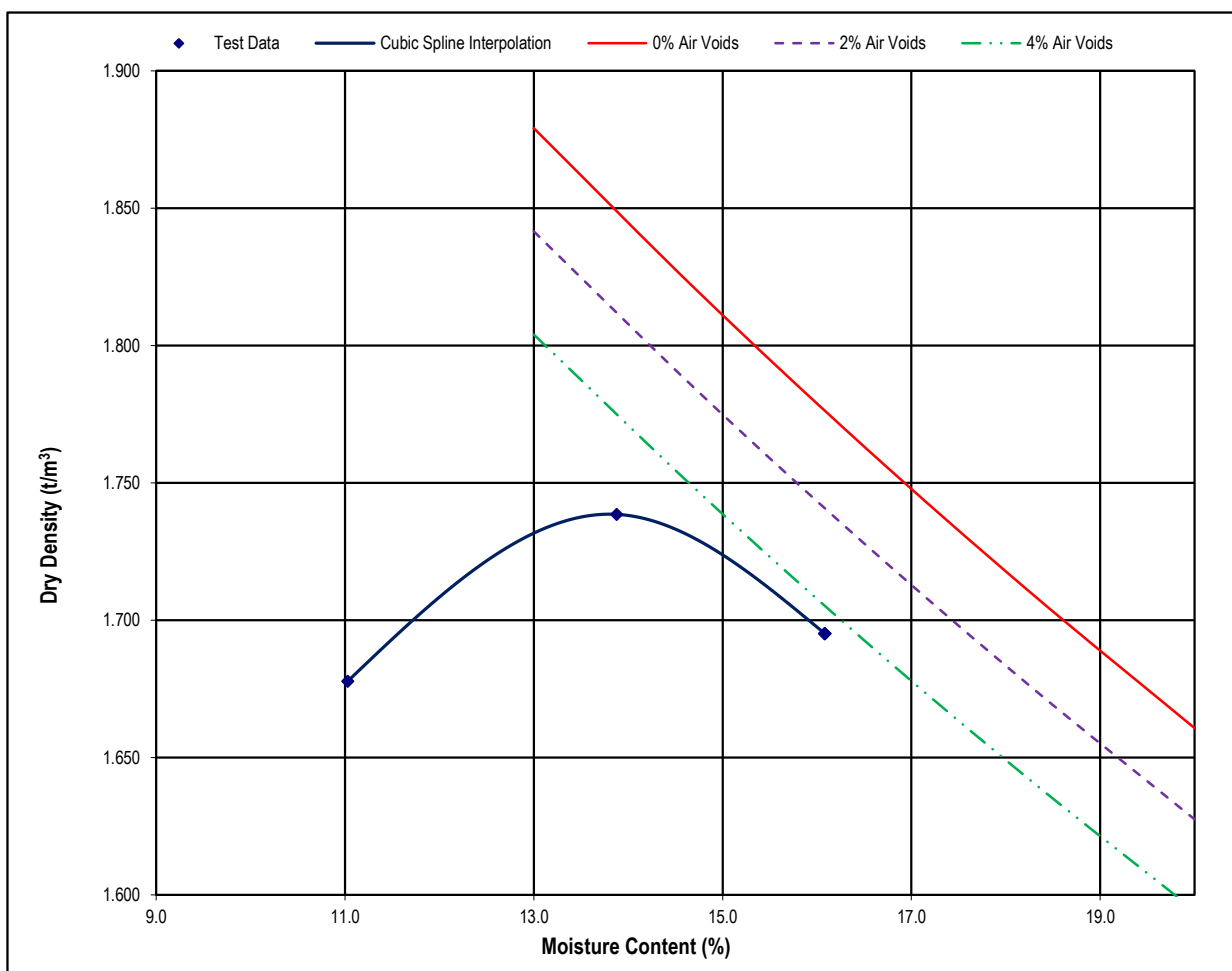
| <b>Client ID</b> | BR18 | <b>Depth (m)</b> | 0.50-1.00 |

| <b>Maximum Dry Density (t/m³)</b> | 1.74 | <b>Optimum Moisture Content (%)</b> | 13.8 |

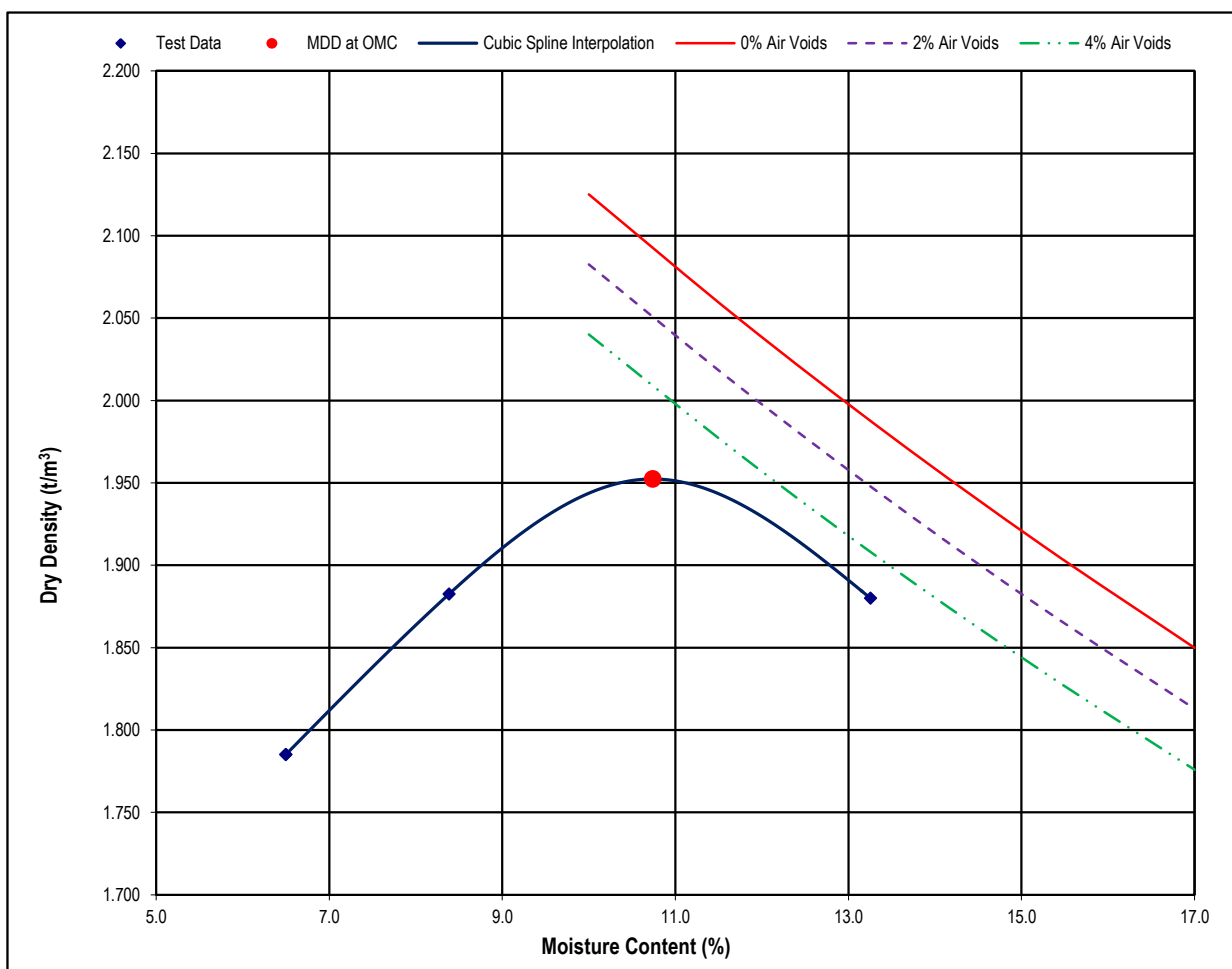
| <b>Description</b> | Clayey GRAVEL - red/brown | | |

| <b>Maximum Dry Density (t/m³)</b> | 1.95 | <b>Optimum Moisture Content (%)</b> | 10.7 |

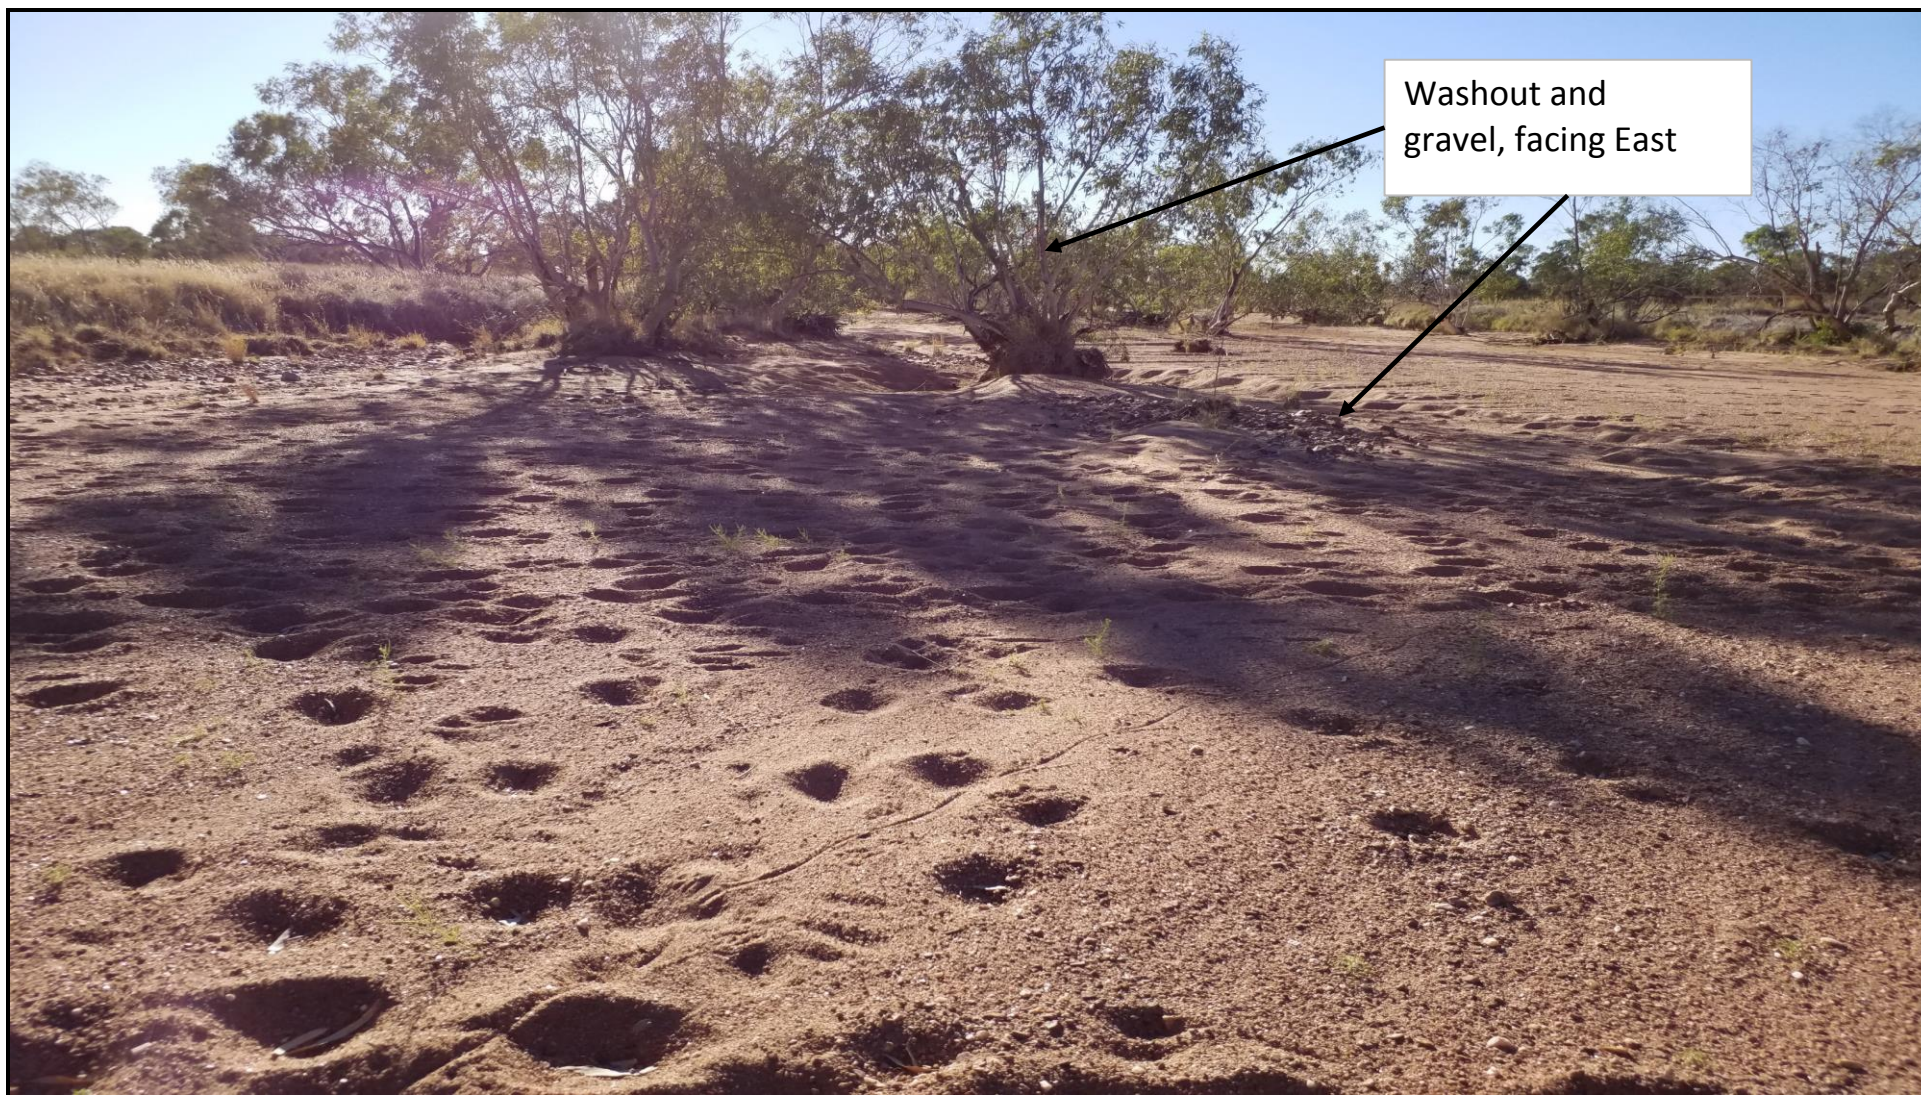
| TITLE: | <b>Site 2</b> | DATE: | 3/07/2018 | SHEET: | A4 |

Washout and  
gravel, facing East

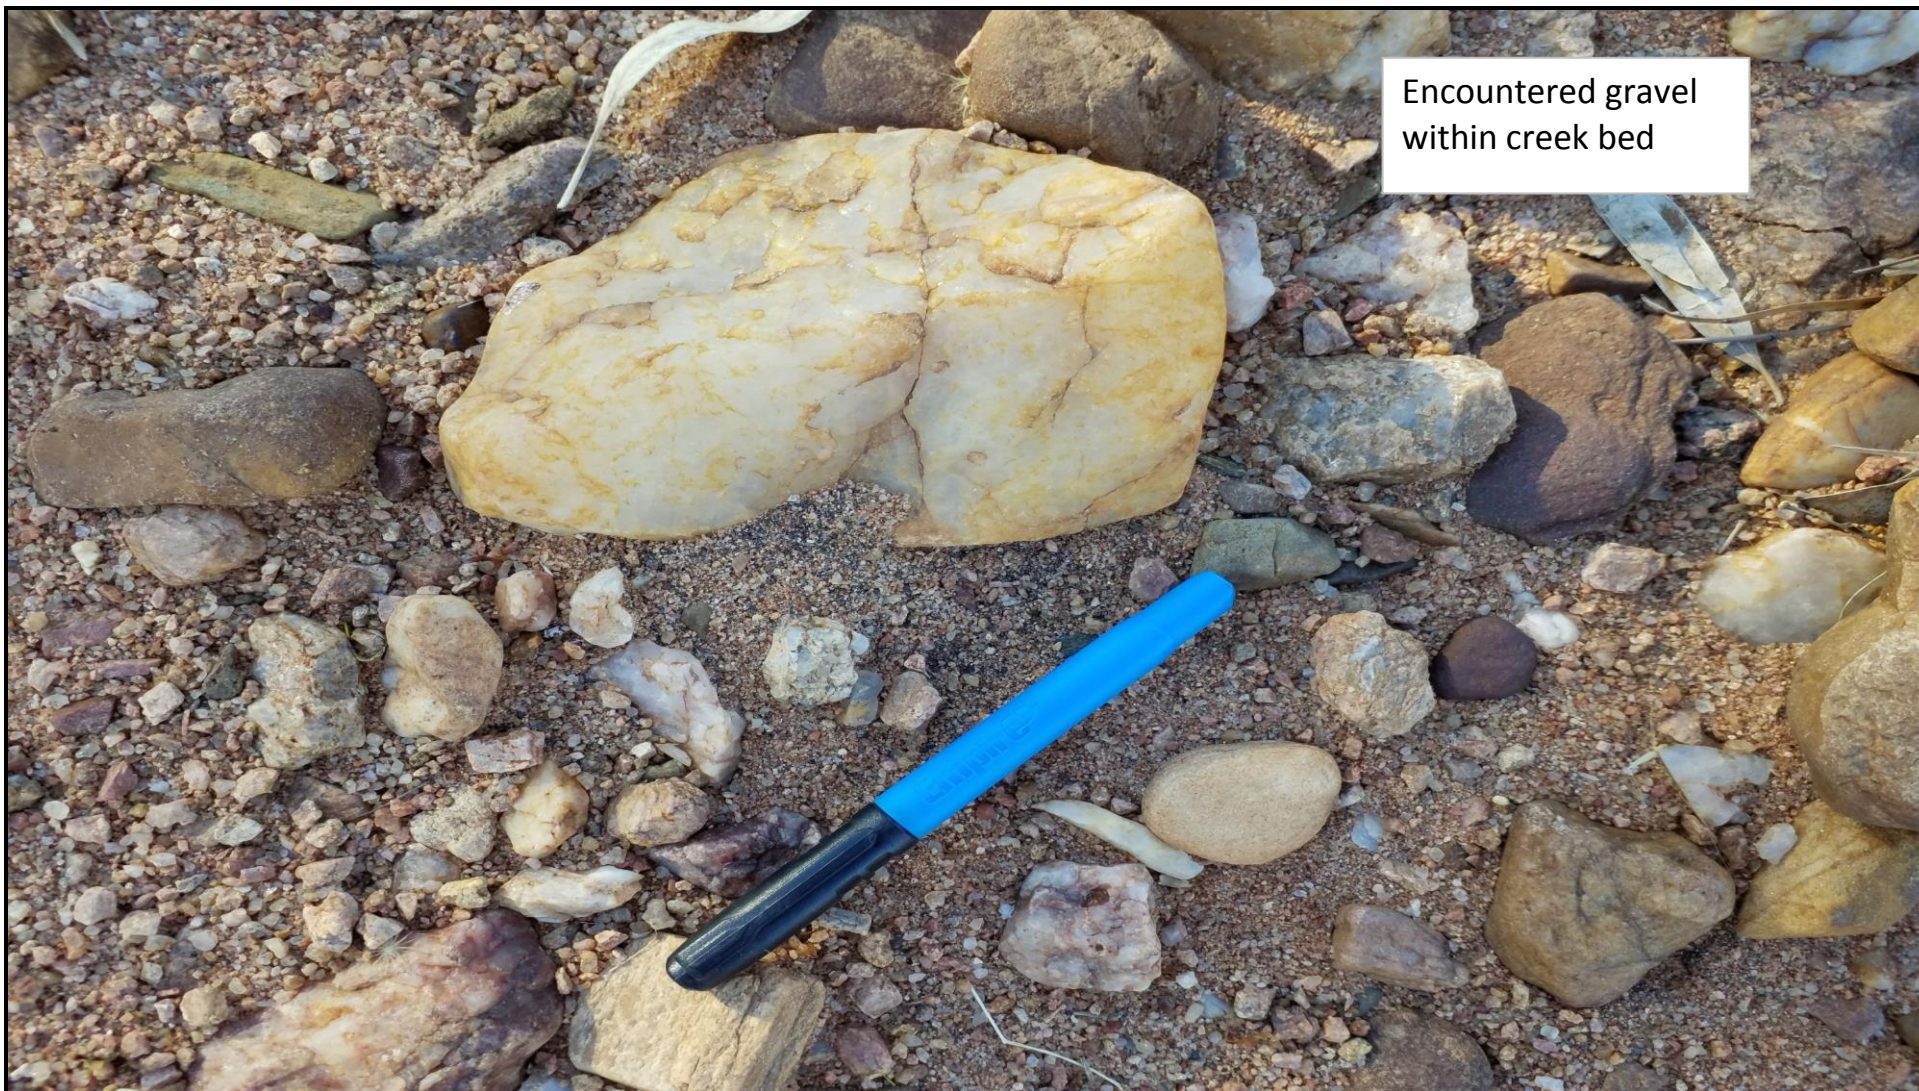
| TITLE: <b>Site 3</b> | DATE: 3/07/2018 | SHEET: A4 |

Encountered gravel  
within creek bed

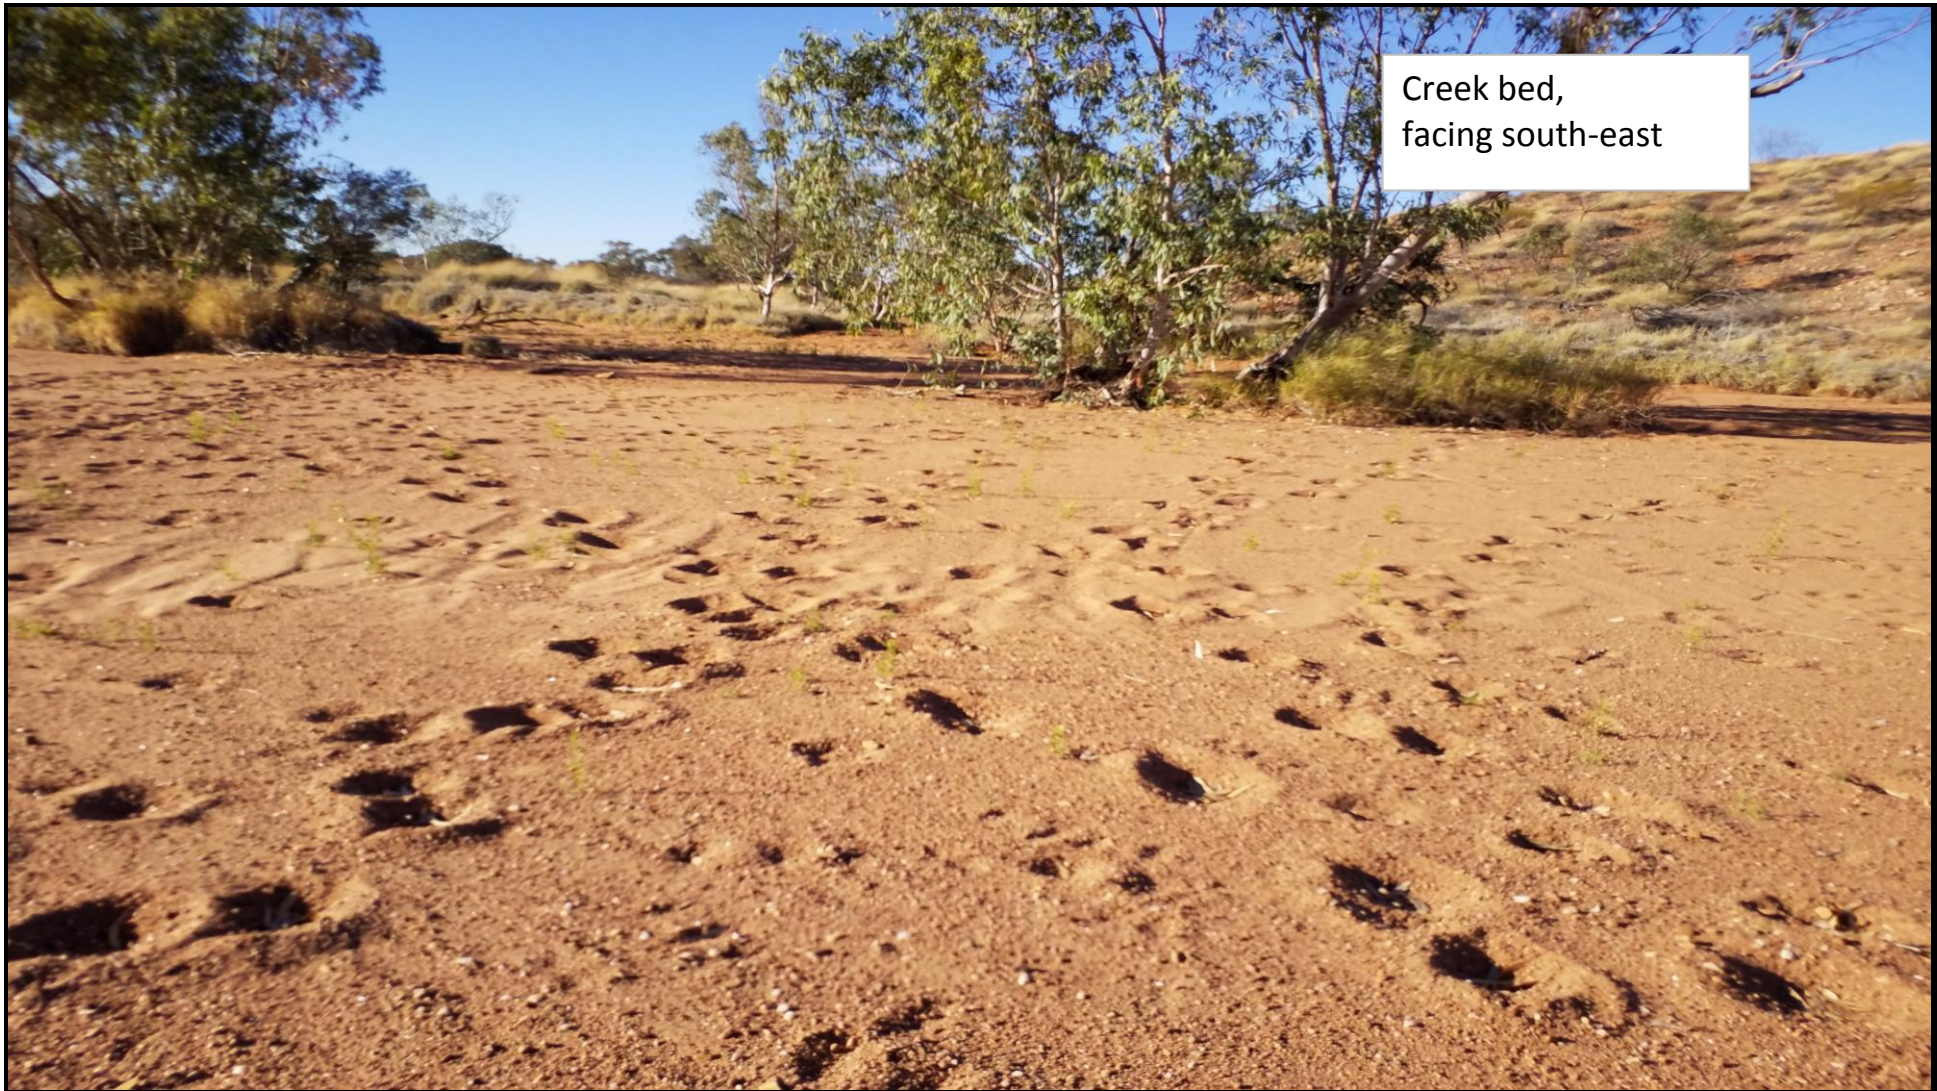
| | TITLE: <b>Site 4</b> | DATE: 3/07/2018 | SHEET: A4 |

Creek bed,  
facing south-east
