# Ardmore Start-Up Operation - Progressive Rehabilitation and Closure Plan

*Mining Lease 5542 (Environmental Authority BRMN0037)*

**Golder Associates Pty Ltd**

21463804-001-R-Rev0

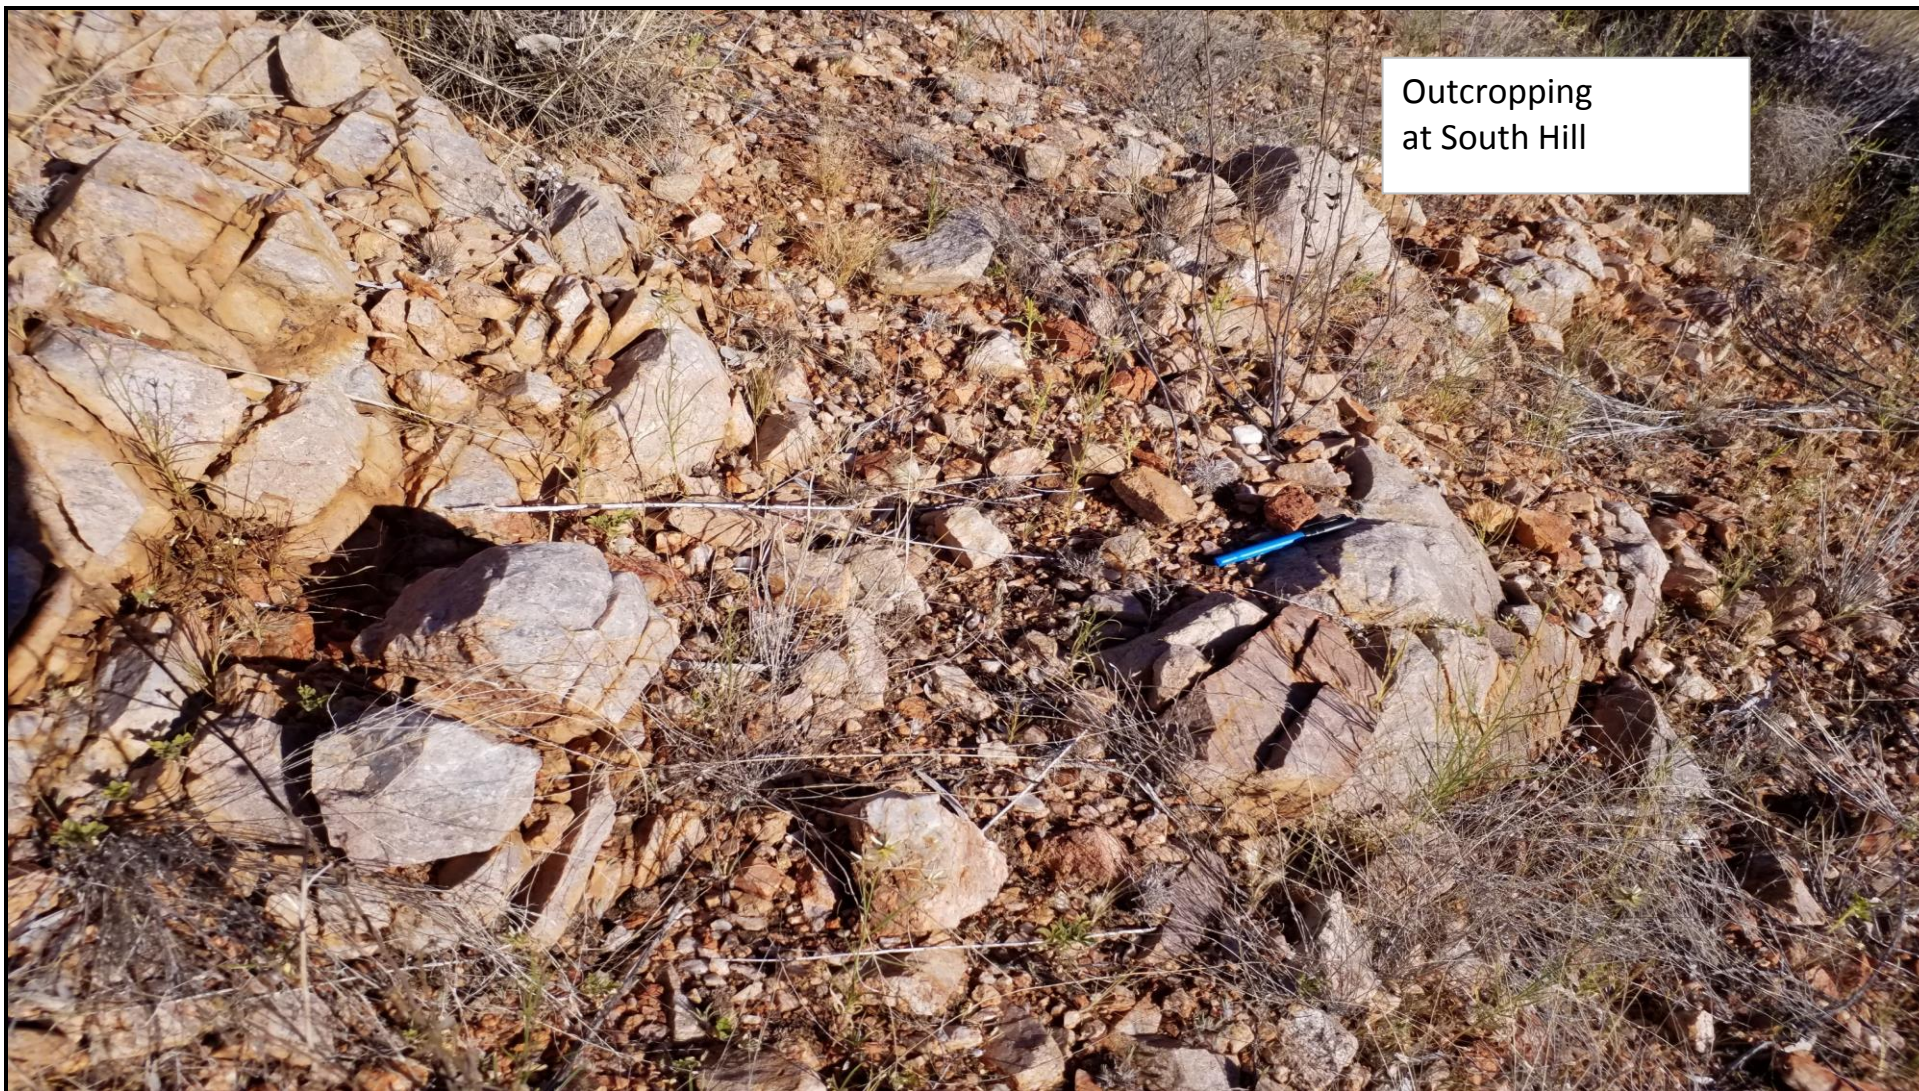
| | TITLE: | Site 5 | DATE: | 3/07/2018 | SHEET: | A4 |

Outcropping  
at South Hill

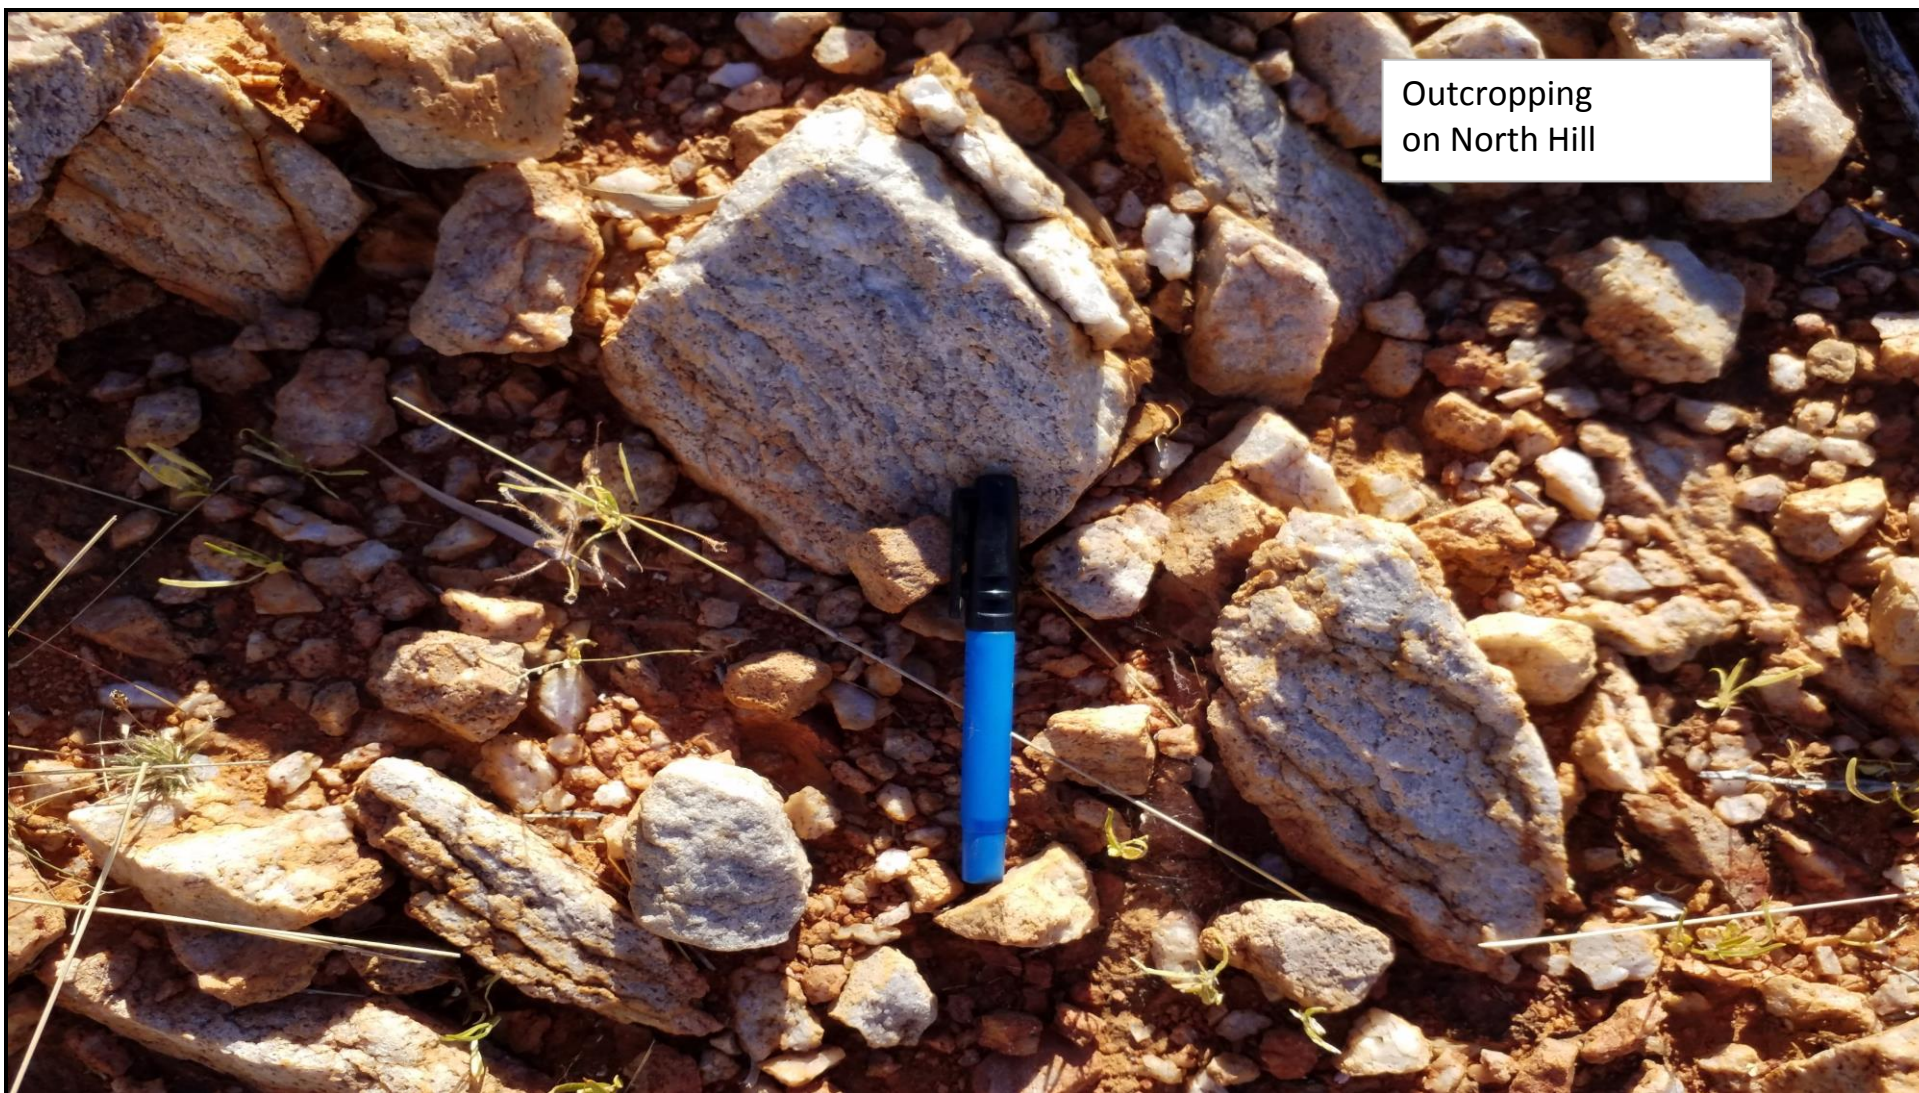
Outcropping  
on North Hill
