# PROGRESSIVE REHABILITATION AND CLOSURE PLAN New Oakleigh Mine

PREPARED FOR  
New Hope Group

01 JUNE 2022

| <b>Report Title:</b> | Progressive Rehabilitation and Closure Plan |

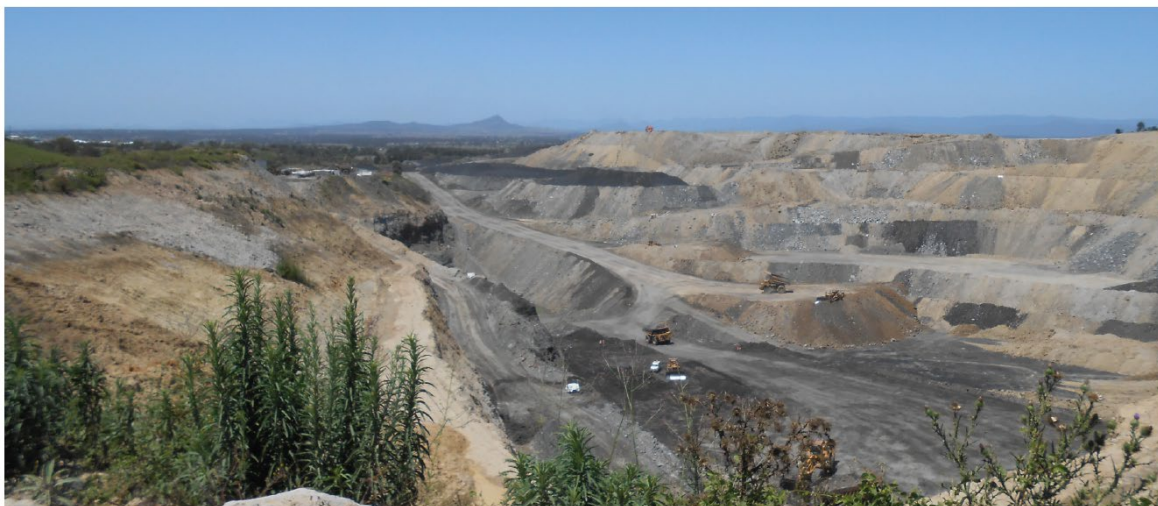
Figure 15: Oakleigh West: pre-rehabilitation—pit depth of approximately 90 m (2012)

natural topography. The recontoured surface was spread with topsoil, either directly or from existing topsoil stockpiles. Landforms were seeded with pasture species to suit the post mining land use. Native ecosystem rehabilitation areas were subsequently established and have undergone progressive revegetation since 2001. Rehabilitation works at Oakleigh West finished in early 2016.

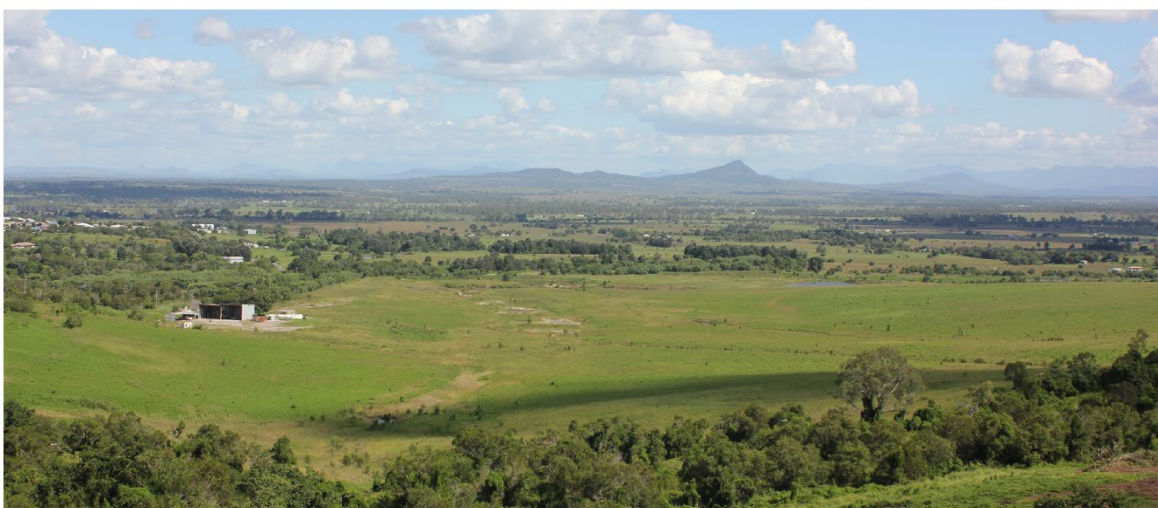
Figure 16: Oakleigh West: Post-rehabilitation—established grazing PMLU (2017; note retained infrastructure)

Existing built infrastructure includes a short partially bitumen-sealed and gravel access track, concrete slabs, relocatable shed and an above ground diesel storage tank. A number of small water storage dams are to be retained for stock watering purposes as per the Landholder Agreement (NHG 2021a, Appendix H). The concrete plant pad is to be retained to support the future grazing management activities. A set of cattle yards has been installed to assist with current grazing activities. The above ground diesel storage tank is to be retained and transferred to the landholder to support the grazing PMLU.

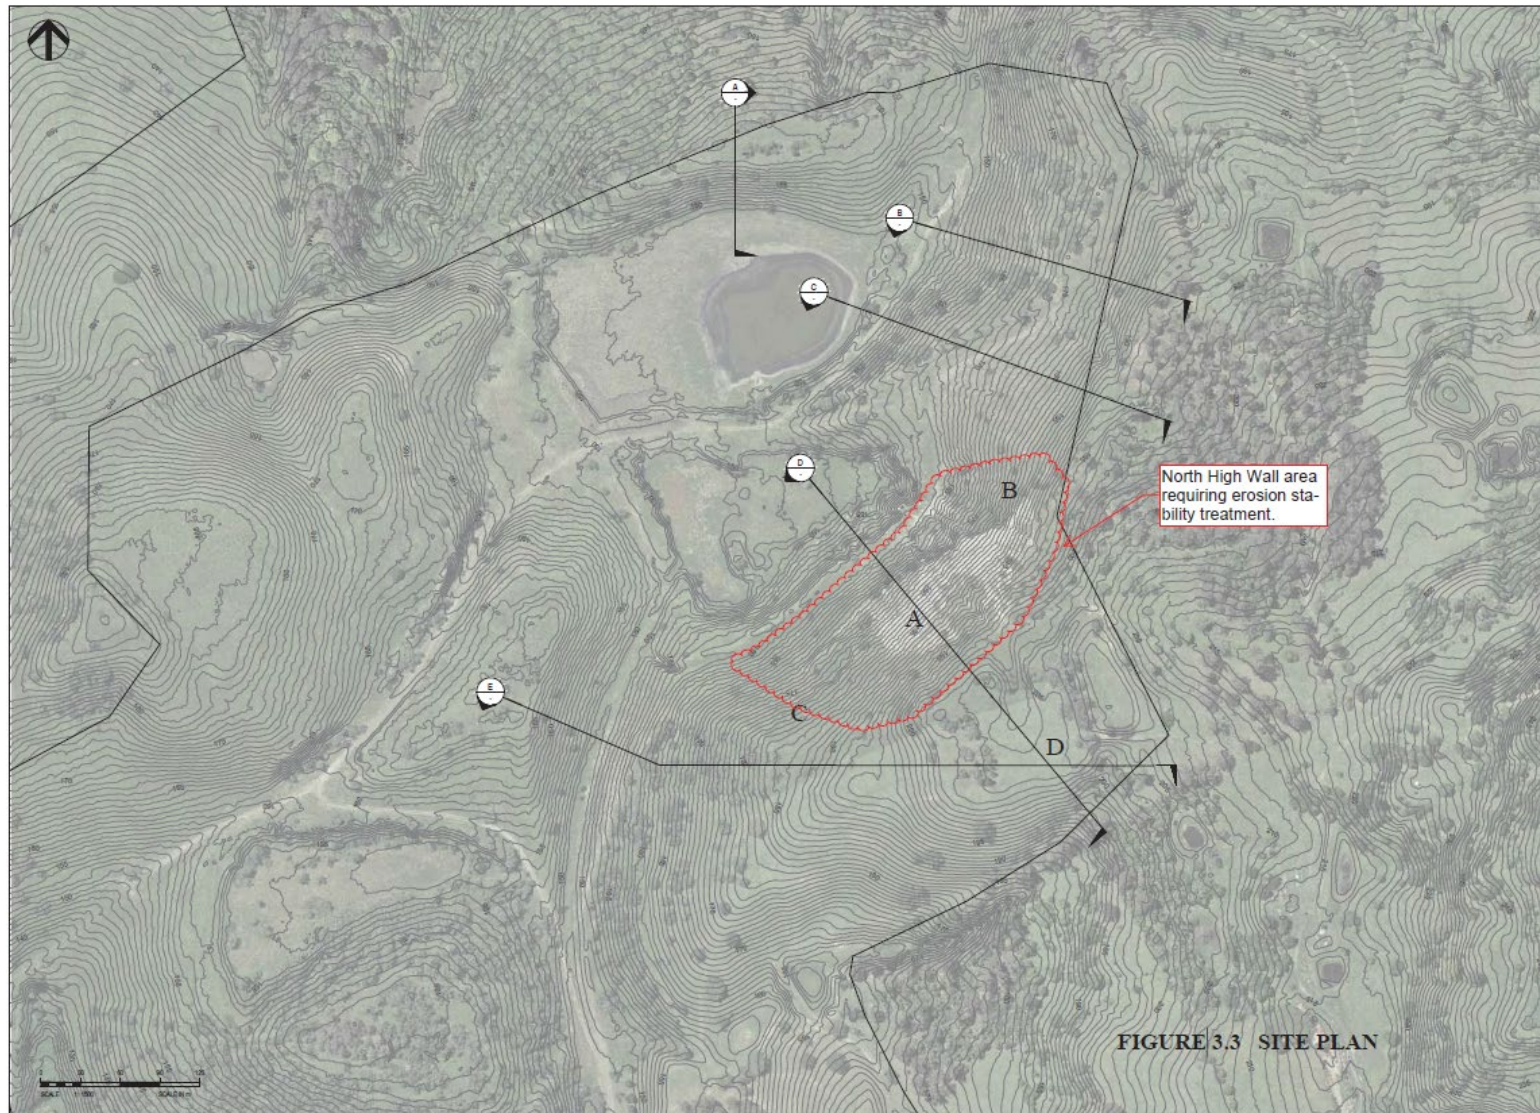
Figure 18: General boundary and cross-sections assessed of the Northern Highwall area

The assessment indicated that the prevailing slope of the northern highwall area is a relatively consistent 23%-25% gradient through previously rehabilitated and adjacent vegetated land (equivalent to 13°-14°). However, some localised short slopes exist which may exceed 33% (18°) – principally within Area A – shown in Figure 18.

To ensure these assessment outcomes are met, landform stability completion criteria for the North highwall area conform with the design slope criteria of achieving a minimum FOS of 1.5 (KBR 2020). Specifically, to satisfy the stable milestone (RM2), the North highwall landform is to be constructed to slope gradients of less than 40%, with the exception of slopes in Area A, which may exceed 40%. Despite the steep gradient of this slope, it has been demonstrated that erosion in Area A is inactive or slow and the erosional stability is likely to be achieved at the existing gradient with the application of specific surface treatments (i.e., erosion protection measures combined with revegetation) (Houghton 2020). To achieve the 'stable' milestone (RM2), the north highwall shall be vegetated and assessed by a suitably qualified person as stable with a minimum FOS of 1.5.

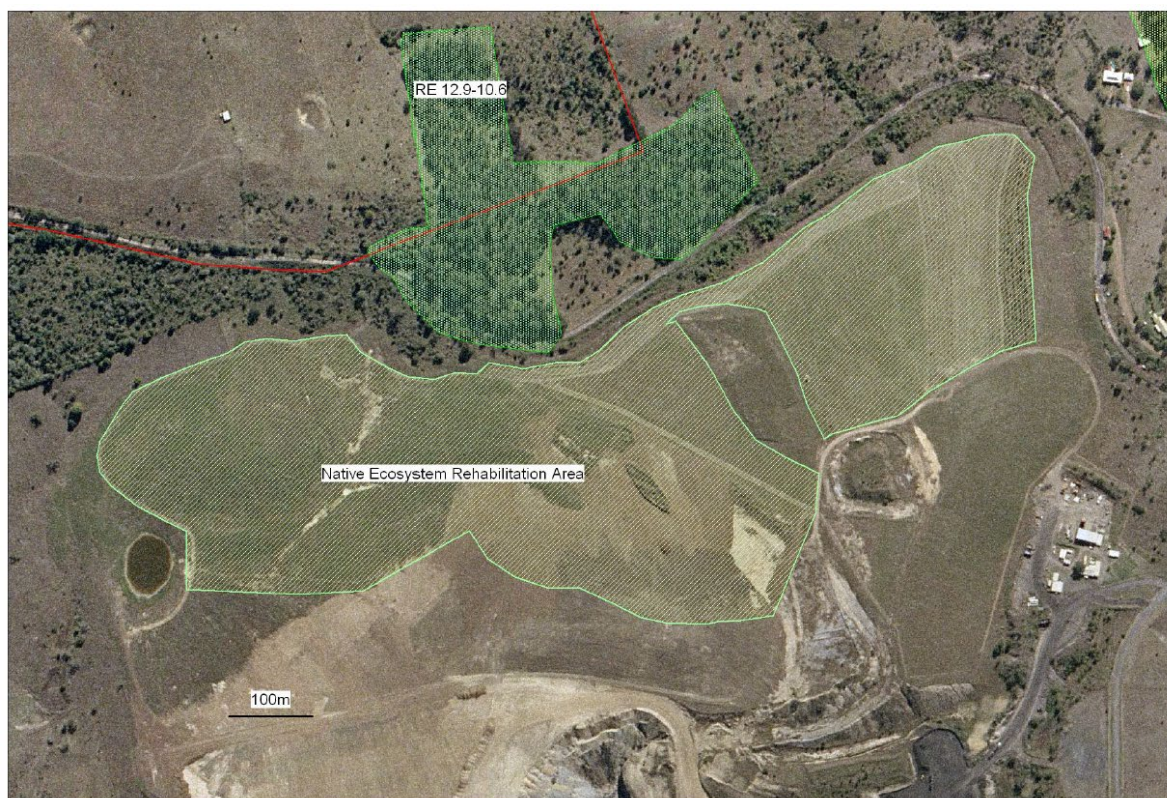
Figure 24: Native Ecosystem rehabilitation and analogue site (RE 12.9-10.6) (NOC 2007)

The native ecosystem rehabilitation area at Oakleigh West is shown in Figure 24. This area has been progressively rehabilitated in a series of five blocks. These blocks were planted with trees and shrubs in stages between 2001 and 2008 followed by seeding. All seeds and plants were locally sourced and grown. The native ecosystem analogue site is shown as the remnant RE 12.9-10.6 polygon in Figure 24. This analogue site was previously nominated in the BTEQ (2005) report, submitted to satisfy EA condition F6.
