PROGRESSIVE REHABILITATION AND CLOSURE PLAN New Oakleigh Mine

PREPARED FOR
New Hope Group

30 SEPTEMBER 2021

| Document ID/Ref. | 20210930 New Oakleigh PRCP_V9.2_FINAL.pdf |

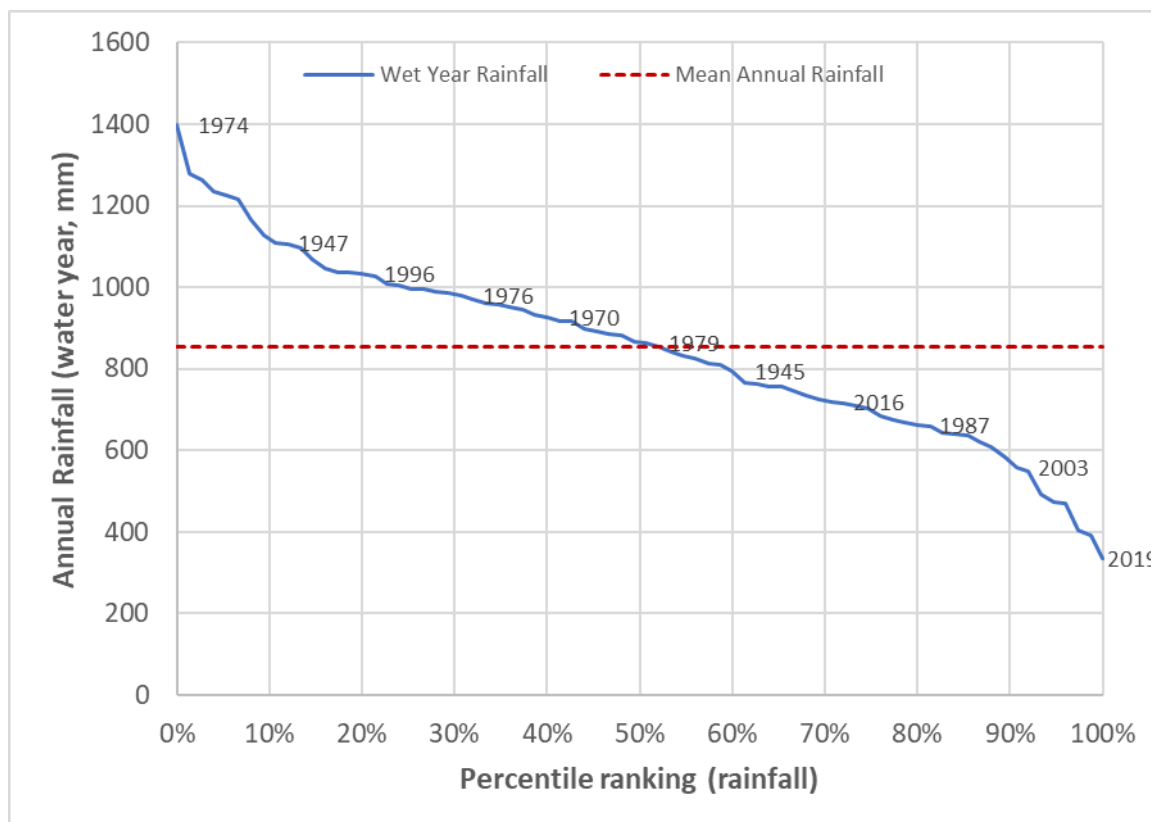
Figure 5: Percentile ranking of wet year data from Amberley Station

The climate of the Project region is subtropical, with warm to hot, wet summers and cool dry winters (NHCA 2002 [Appendix H]). Climate data is drawn from the Amberley weather station (Station Number: 040004), as it is the closest weather station to the site that has both rainfall and temperature data available. Average temperatures in the region range from 5.4°C–31.2°C (BOM 2021). The average annual rainfall for the area is 852.6mm. Rainfall occurs predominantly in the summer months of December, January and February, which averages approximately 118 mm per month of rainfall (BOM 2021). Potential evaporation in the Rosewood region averages more than two times the expected annual precipitation, which averages approximately 1,700 mm/year (GHD 2012). Figure 5 highlights the significant variation of wet year average rainfall that can occur.

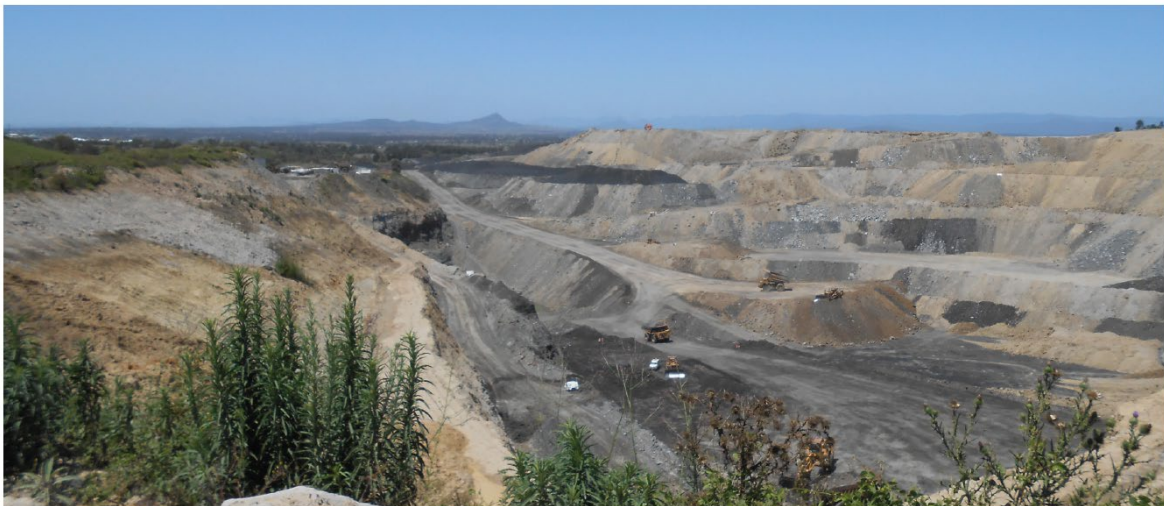
Figure 14: Oakleigh West: pre-rehabilitation—pit depth of approximately 90 m (2012)

Due to concerns raised through the community consultation program, the residual void at Oakleigh West was progressively backfilled using mined spoil, and as a result, no final void remains. The final landform was constructed to create a landform comparable to the original topography and blends into the surrounding natural topography. The recontoured surface was spread with topsoil, either directly or from existing topsoil stockpiles. Landforms were seeded with pasture species to suit the post mining land use. Native ecosystem rehabilitation areas were subsequently established and have undergone progressive revegetation since 2001. Rehabilitation works at Oakleigh West finished in early 2016.

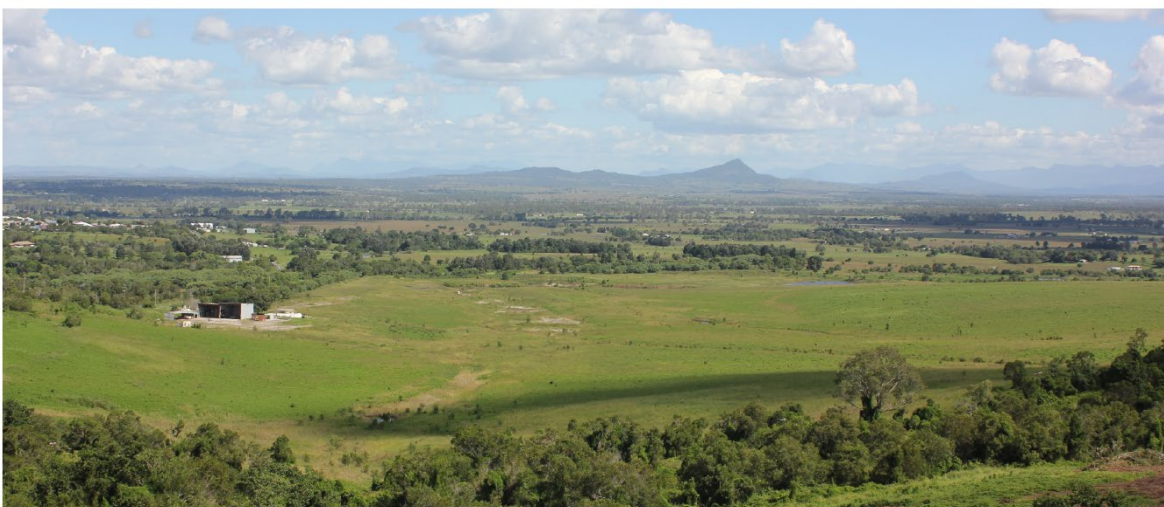
Figure 15: Oakleigh West: Post-rehabilitation—established grazing PMLU (2017; note retained infrastructure)

Existing built infrastructure includes a short partially bitumen-sealed and gravel access track, concrete slabs, relocatable shed and an above ground diesel storage tank. A number of small water storage dams are to be retained for stock watering purposes as per the Landholder Agreement (NHG 2021a, Appendix H). The concrete plant pad is to be retained to support the future grazing management activities. A set of cattle yards has been installed to assist with current grazing activities. The above ground diesel storage tank is to be retained and transferred to the landholder to support the grazing PMLU.

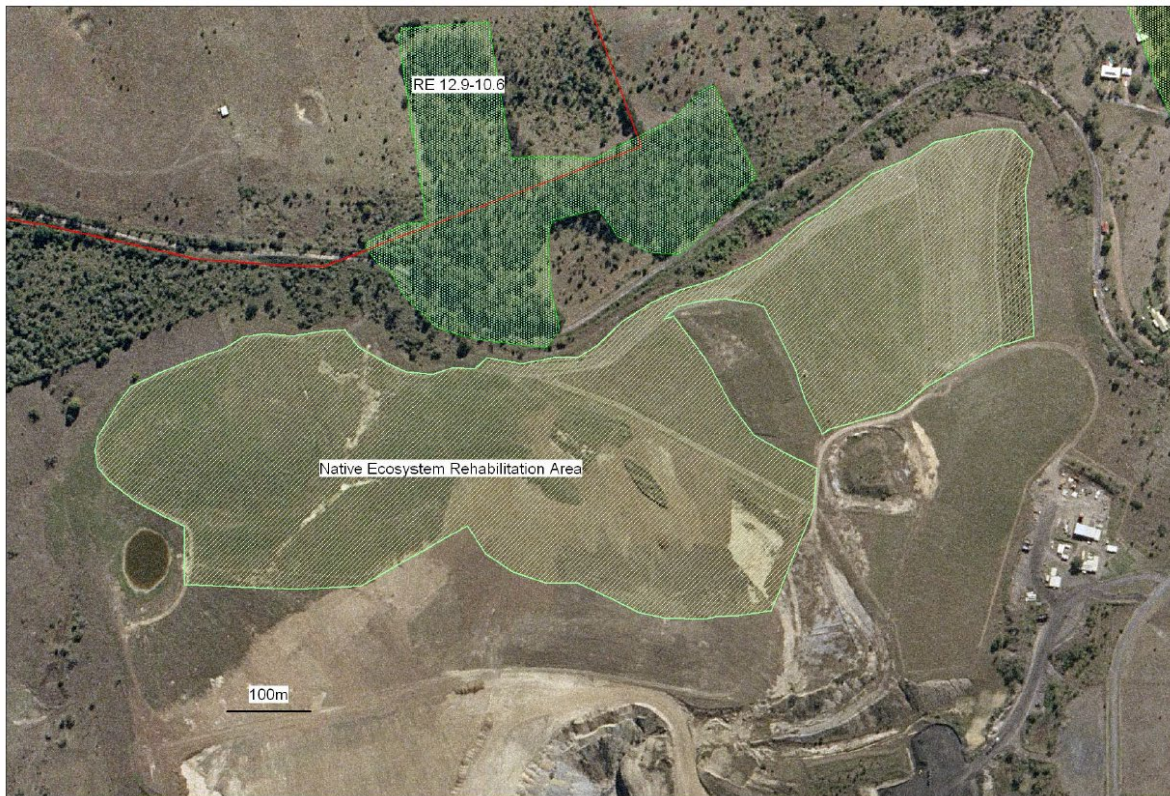
Figure 23: Native Ecosystem rehabilitation and analogue site (RE 12.9-10.6) (NOC 2007)

The native ecosystem rehabilitation area at Oakleigh West is shown in Figure 23. This area has been progressively rehabilitated in a series of five blocks. These blocks were planted with trees and shrubs in stages between 2001 and 2008 followed by seeding. All seeds and plants were locally sourced and grown. The native ecosystem analogue site is shown as the remnant RE 12.9-10.6 polygon in Figure 23. This analogue site was previously nominated in the BTEQ (2005) report, submitted to satisfy EA condition F6.
