New Hope Coal Australia
Report for Preliminary Mine
Closure Study - New Oakleigh
Hydrogeological Desktop
Assessment

June 2012

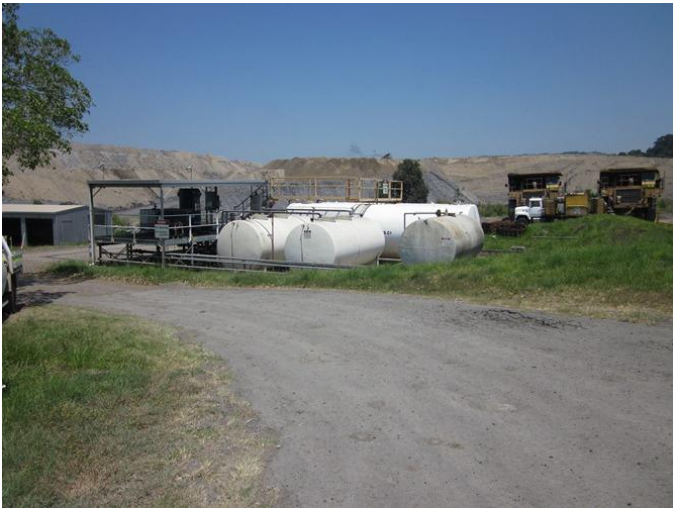
Photograph 7 – West Pit fuel farm with 5 above ground storage tanks observed (15/11/11).

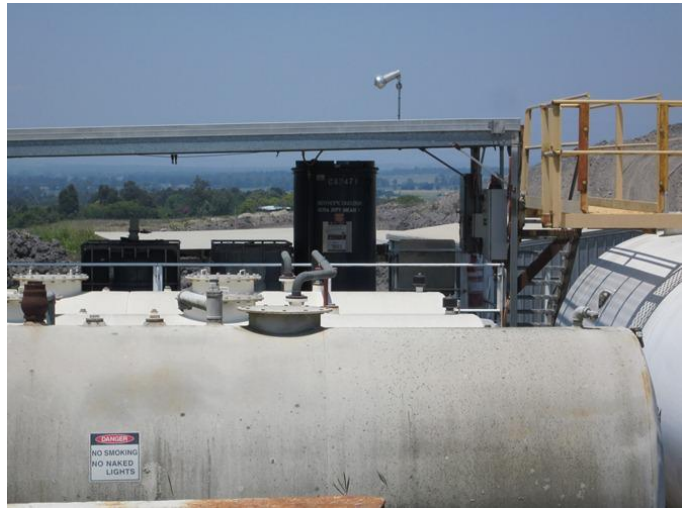
Photograph 8 – Zoomed in shot of fuel farm showing other fuel storage under roofing (15/11/11).

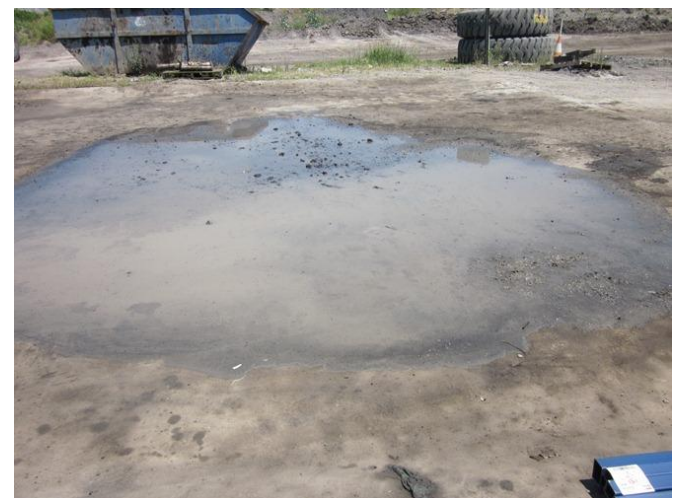
Photograph 12 – Wash down bay hardstand area with fine sediments observed on the surface (15/11/11).

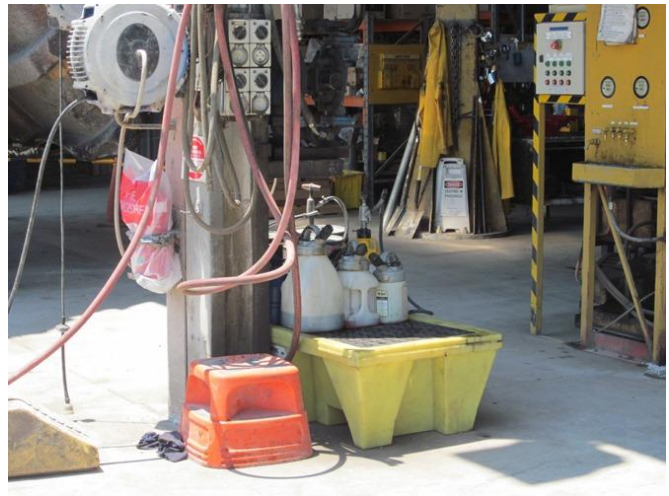
Photograph 22 – Small volumes of chemicals stored in proximity to the servicing area, observed relatively clean floors (15/11/11).

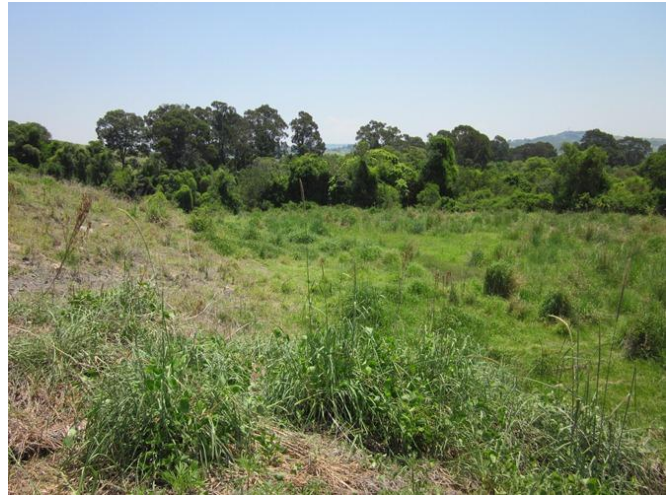
Photograph 62 – Stark differences observed in the grass cover near to the seepage site (15/11/11).

Additional water stored within these pits or uncompacted fill / spoil at the surface has probably increased pore pressures in these shallow soils, resulting in surface seepage of water to the north of the North Pit. Depending on water quality, this surface seepage has the potential to cause salinity management issues as the seepage water evaporates.

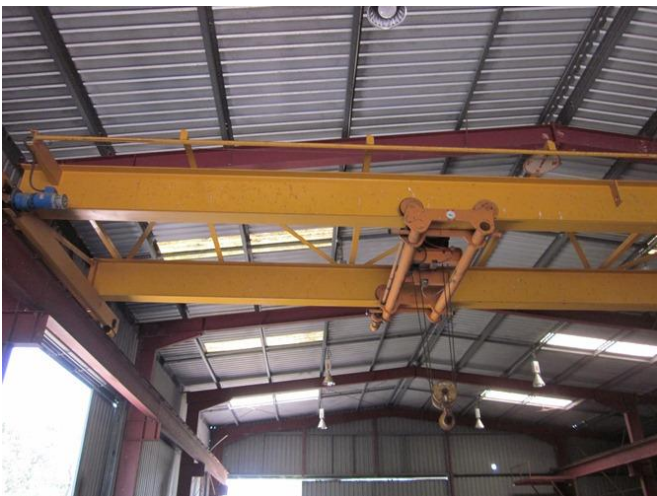
Photograph 63 – Overhead gantry crane in the large workshop building, known as the Operations workshop (15/11/11).
