# PROGRESSIVE REHABILITATION AND CLOSURE PLAN New Oakleigh Mine

PREPARED FOR  
New Hope Group

01 JUNE 2022

| <b>Report Title:</b> | Progressive Rehabilitation and Closure Plan |

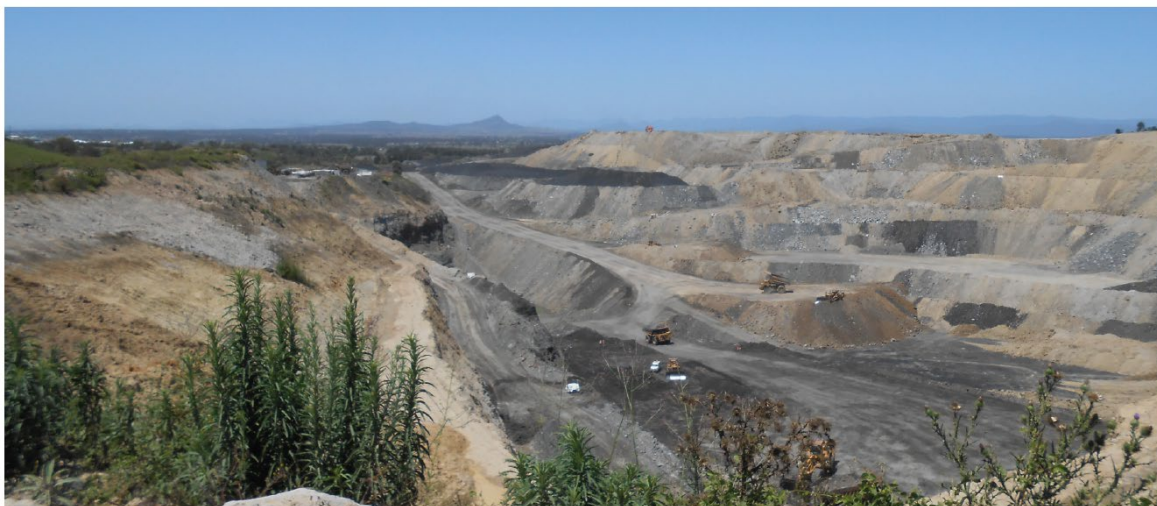
Figure 15: Oakleigh West: pre-rehabilitation—pit depth of approximately 90 m (2012)

natural topography. The recontoured surface was spread with topsoil, either directly or from existing topsoil stockpiles. Landforms were seeded with pasture species to suit the post mining land use. Native ecosystem rehabilitation areas were subsequently established and have undergone progressive revegetation since 2001. Rehabilitation works at Oakleigh West finished in early 2016.

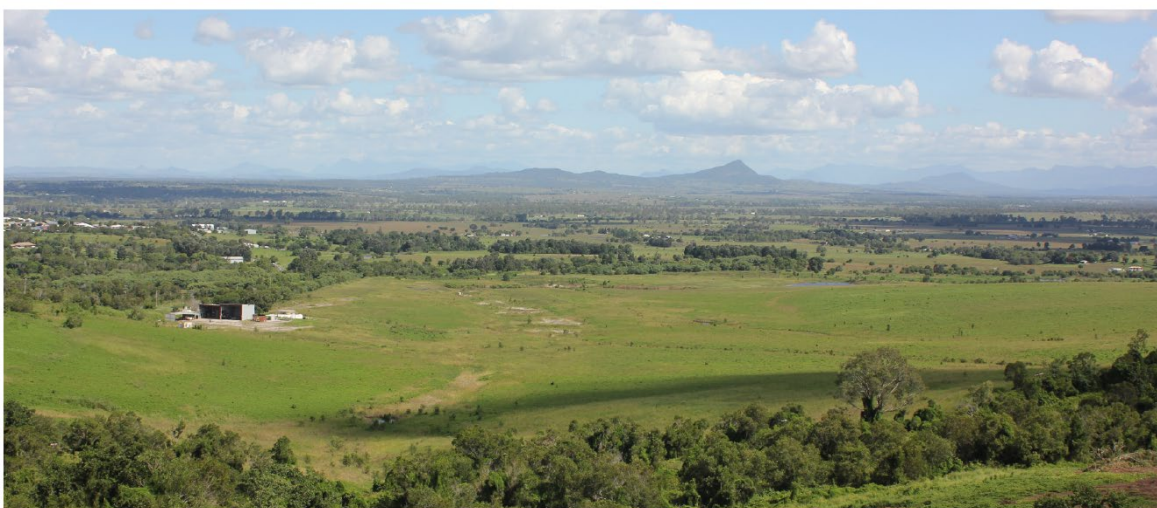
Figure 16: Oakleigh West: Post-rehabilitation—established grazing PMLU (2017; note retained infrastructure)

Existing built infrastructure includes a short partially bitumen-sealed and gravel access track, concrete slabs, relocatable shed and an above ground diesel storage tank. A number of small water storage dams are to be retained for stock watering purposes as per the Landholder Agreement (NHG 2021a, Appendix H). The concrete plant pad is to be retained to support the future grazing management activities. A set of cattle yards has been installed to assist with current grazing activities. The above ground diesel storage tank is to be retained and transferred to the landholder to support the grazing PMLU.
