# PROGRESSIVE REHABILITATION AND CLOSURE PLAN New Oakleigh Mine

PREPARED FOR  
New Hope Group

01 JUNE 2022

<b>Project Name:</b>	<b>New Oakleigh Mine</b>
<b>Report Title:</b>	Progressive Rehabilitation and Closure Plan
<b>Client:</b>	New Hope Group
<b>Project Manager:</b>	Stuart Ritchie
<b>Document ID/Ref.</b>	20210930 New Oakleigh PRCP_V9.2_FINAL.pdf
<b>Date of Submission:</b>	30 September 2021
<b>Tenure Nos.:</b>	ML4568, ML4584, ML4675, ML4683, ML4698, ML4699, ML50175
<b>EA Reference:</b>	EPML00350213
<b>EA Holder Name:</b>	New Oakleigh Coal Pty Ltd
<b>EA Holder Contact Details:</b>	Level 16, 175 Eagle Street, Brisbane, QLD 4000 Ph: 07 3418 0575

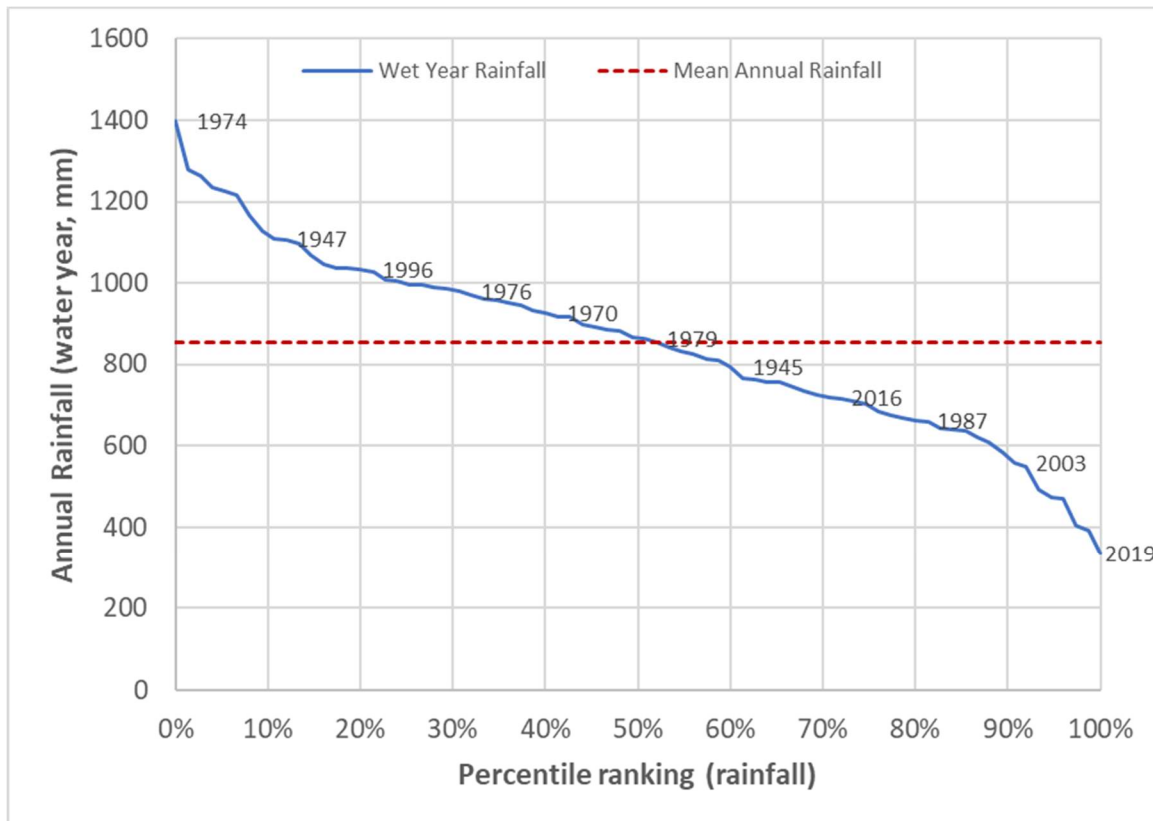
Figure 5: Percentile ranking of wet year data from Amberley Station

The climate of the Project region is subtropical, with warm to hot, wet summers and cool dry winters (NHCA 2002 [Appendix H]). Climate data is drawn from the Amberley weather station (Station Number: 040004), as it is the closest weather station to the site that has both rainfall and temperature data available. Average temperatures in the region range from 5.4°C–31.2°C (BOM 2021). The average annual rainfall for the area is 852.6mm. Rainfall occurs predominantly in the summer months of December, January and February, which averages approximately 118 mm per month of rainfall (BOM 2021). Potential evaporation in the Rosewood region averages more than two times the expected annual precipitation, which averages approximately 1,700 mm/year (GHD 2012). Figure 5 highlights the significant variation of wet year average rainfall that can occur.

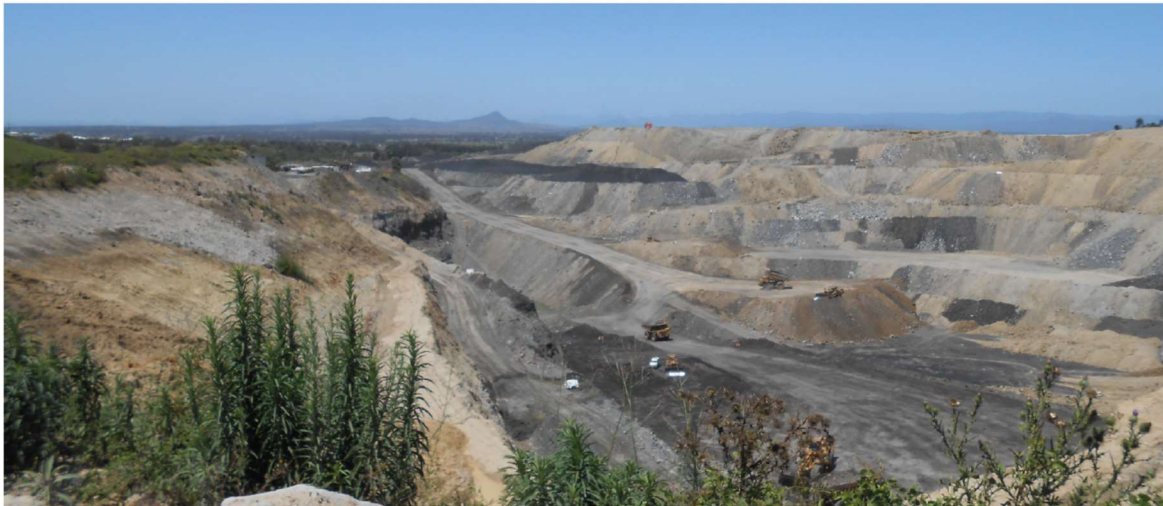
Figure 15: Oakleigh West: pre-rehabilitation—pit depth of approximately 90 m (2012)

Due to concerns raised through the community consultation program, the residual void at Oakleigh West was progressively backfilled using mined spoil, and as a result, no final void remains. The final landform was constructed to create a landform comparable to the original topography and blends into the surrounding natural topography. The recontoured surface was spread with topsoil, either directly or from existing topsoil stockpiles. Landforms were seeded with pasture species to suit the post mining land use. Native ecosystem rehabilitation areas were subsequently established and have undergone progressive revegetation since 2001. Rehabilitation works at Oakleigh West finished in early 2016.

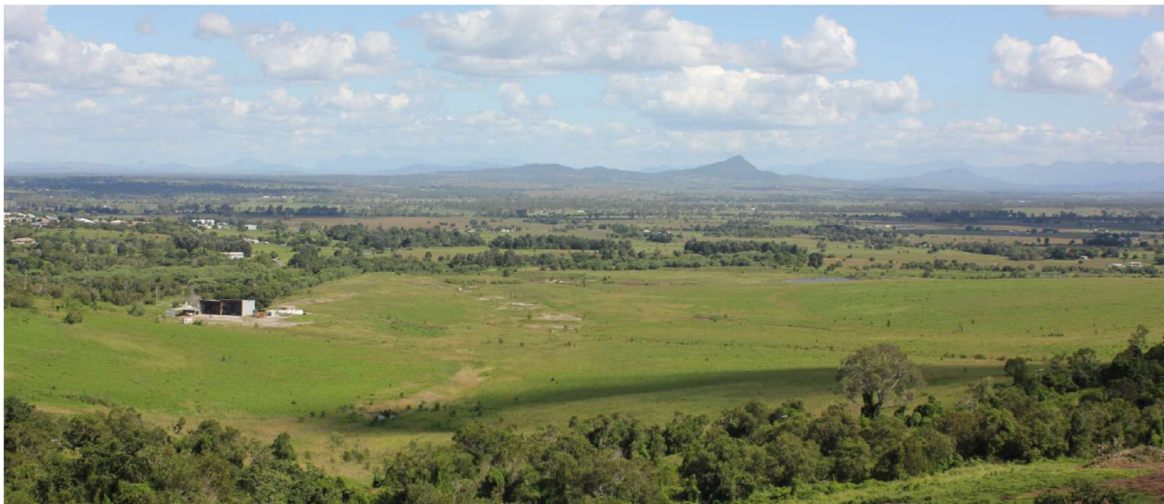
Figure 16: Oakleigh West: Post-rehabilitation—established grazing PMLU (2017; note retained infrastructure)

Existing built infrastructure includes a short partially bitumen-sealed and gravel access track, concrete slabs, relocatable shed and an above ground diesel storage tank. A number of small water storage dams are to be retained for stock watering purposes as per the Landholder Agreement (NHG 2021a, Appendix H). The concrete plant pad is to be retained to support the future grazing management activities. A set of cattle yards has been installed to assist with current grazing activities. The above ground diesel storage tank is to be retained and transferred to the landholder to support the grazing PMLU.

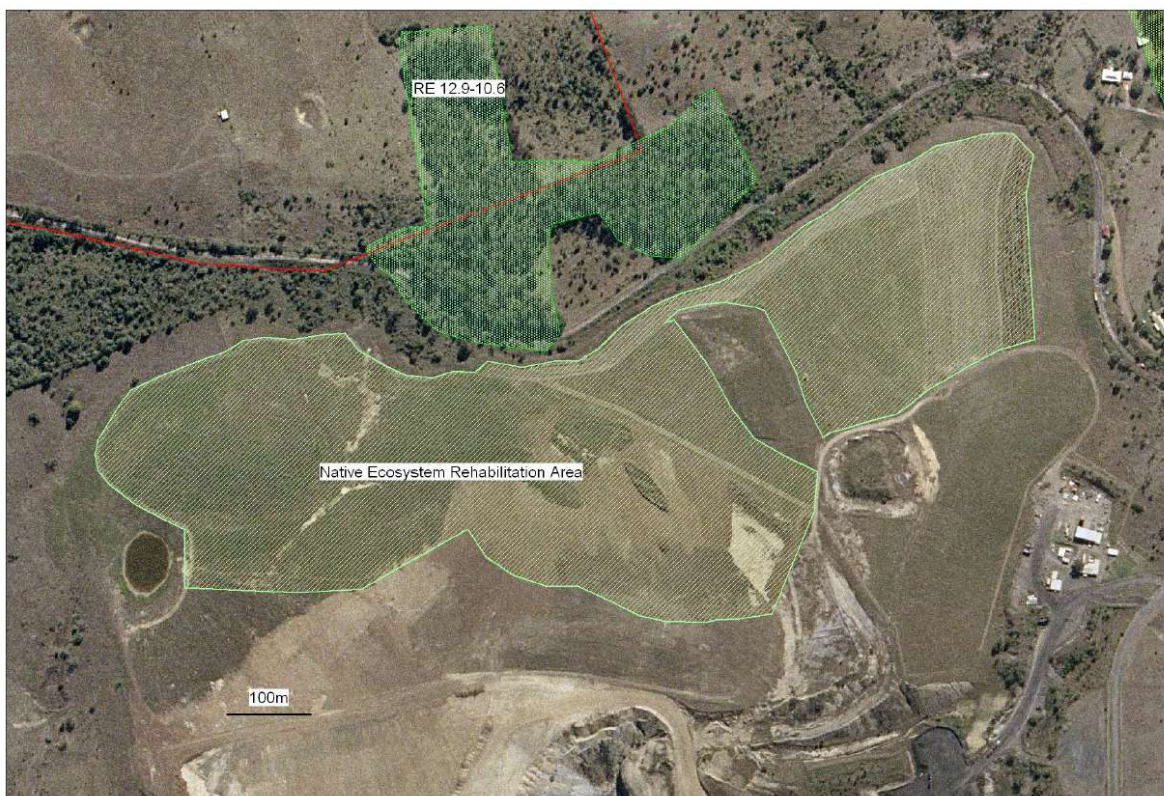
Figure 24: Native Ecosystem rehabilitation and analogue site (RE 12.9-10.6) (NOC 2007)

The native ecosystem rehabilitation area at Oakleigh West is shown in Figure 24. This area has been progressively rehabilitated in a series of five blocks. These blocks were planted with trees and shrubs in stages between 2001 and 2008 followed by seeding. All seeds and plants were locally sourced and grown. The native ecosystem analogue site is shown as the remnant RE 12.9-10.6 polygon in Figure 24. This analogue site was previously nominated in the BTEQ (2005) report, submitted to satisfy EA condition F6.
