## **New Hope Coal Australia**

### **Report for Preliminary Mine Closure Study - New Oakleigh Hydrogeological Desktop Assessment**

June 2012

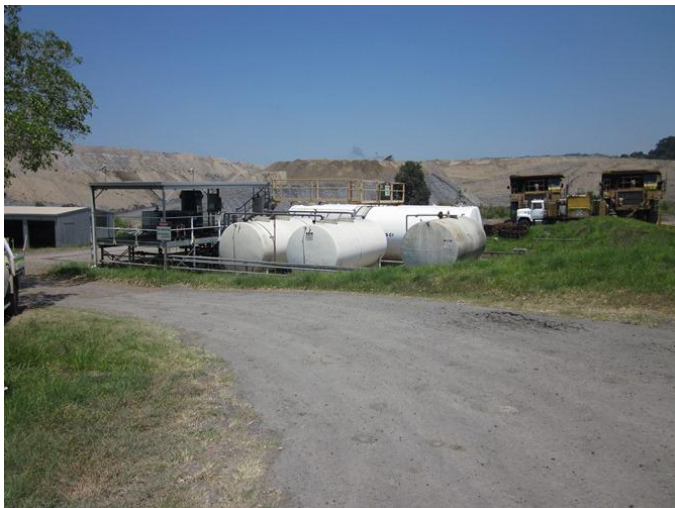
Photograph 7 – West Pit fuel farm with 5 above ground storage tanks observed (15/11/11).

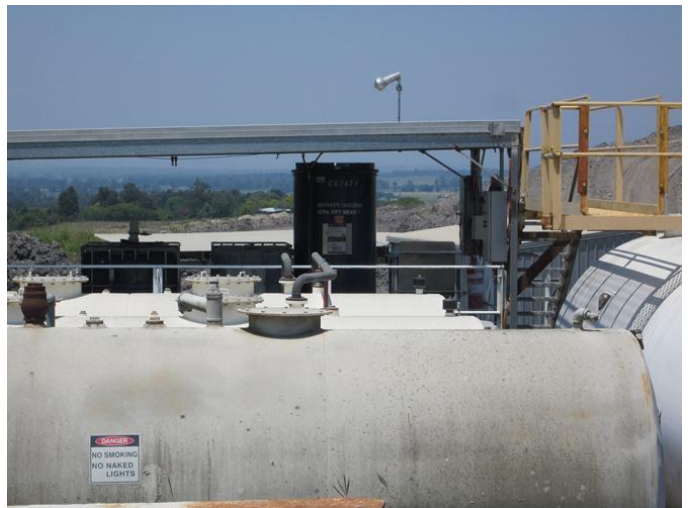
Photograph 8 – Zoomed in shot of fuel farm showing other fuel storage under roofing (15/11/11).

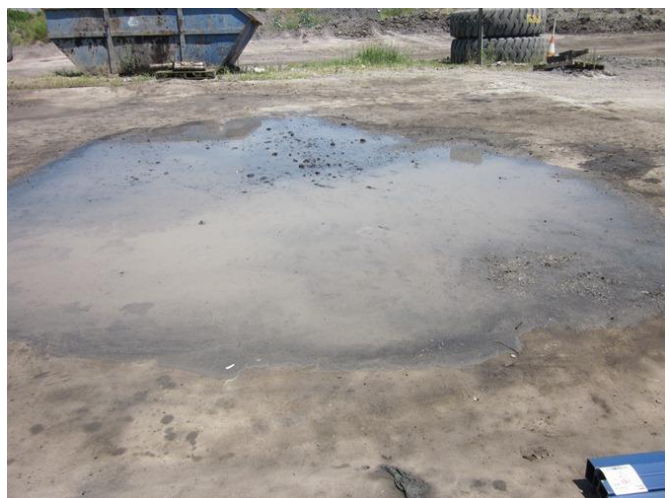
Photograph 12 – Wash down bay hardstand area with fine sediments observed on the surface (15/11/11).

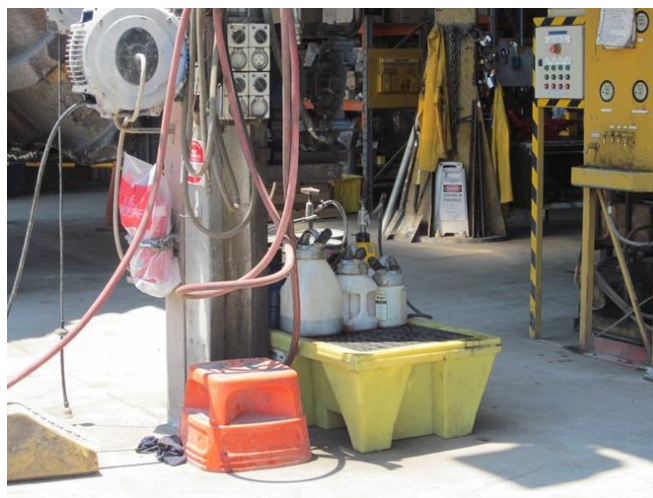
Photograph 22 – Small volumes of chemicals stored in proximity to the servicing area, observed relatively clean floors (15/11/11).

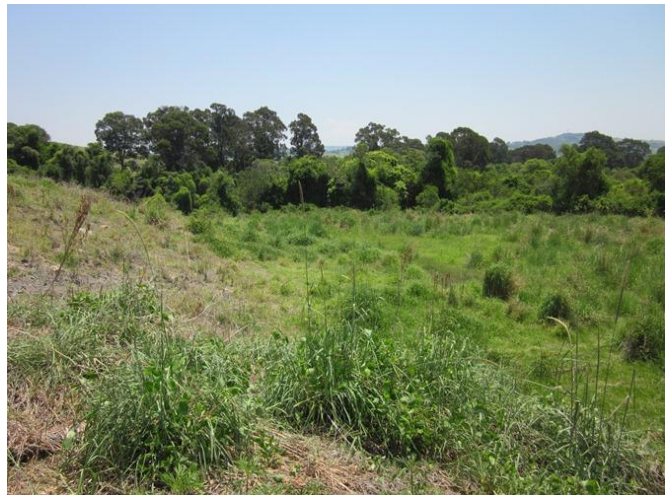
Photograph 62 – Stark differences observed in the grass cover near to the seepage site (15/11/11).

Additional water stored within these pits or uncompacted fill / spoil at the surface has probably increased pore pressures in these shallow soils, resulting in surface seepage of water to the north of the North Pit. Depending on water quality, this surface seepage has the potential to cause salinity management issues as the seepage water evaporates.
