Murgon Operations Progressive Rehabilitation and Closure Plan

Version:	2.0
Document reference:	18614
Date of submission:	18 March 2022
Tenure:	ML50111
EA Holder:	GRAYMONT (NSW) PTY LTD
EA reference	EPML00352613
EA Contact:	Michelle Muir HSE Specialist Northern Level 9 118 Mount Street North Sydney NSW 2060 Australia M +61 429 985 534

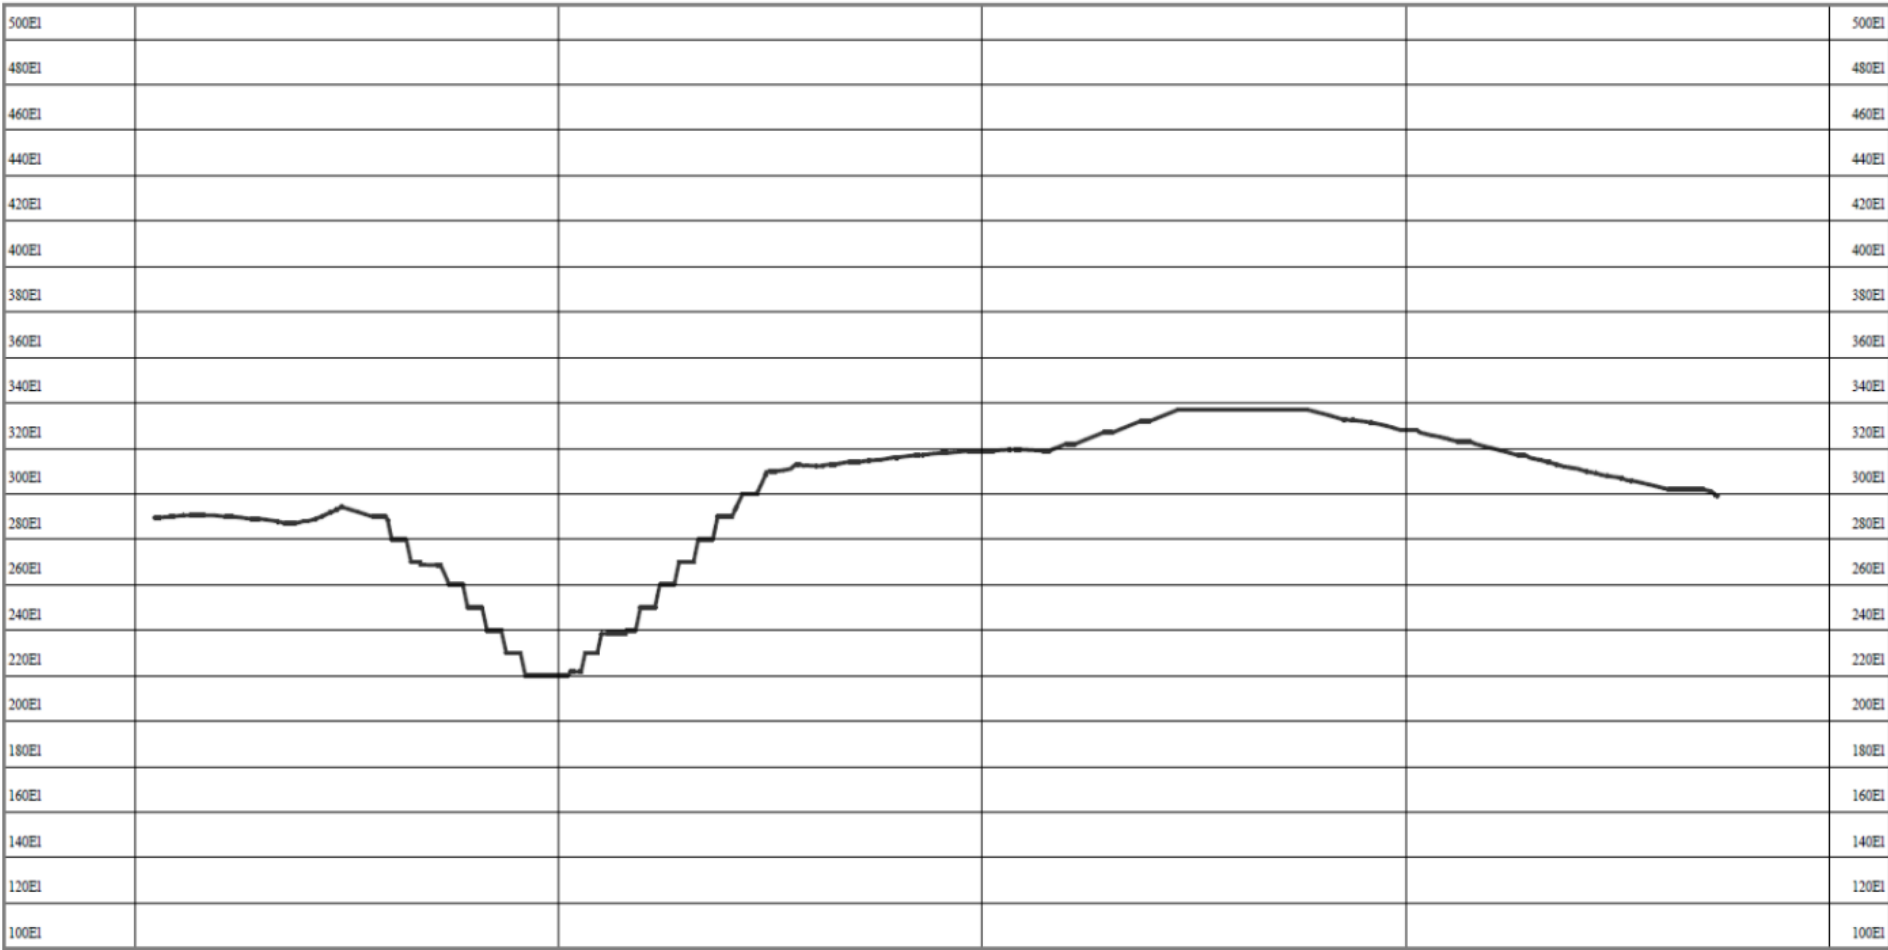
Figure 28 Final landform section view showing RL on the y axis (Source: Graymont)

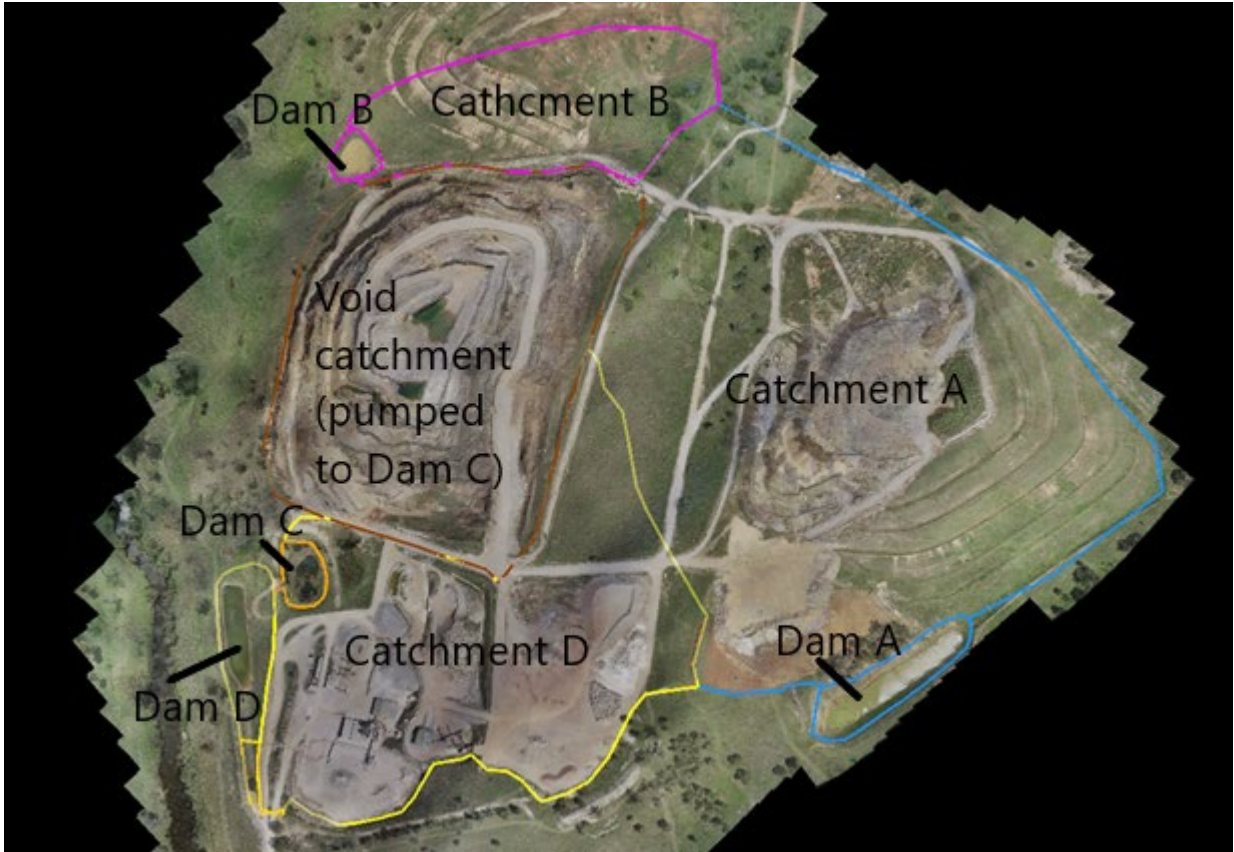
Figure 30 Operational sediment dams and catchments (Source: Graymont)

Based on the topography of site, there are currently four catchments, being Catchment A, Catchment B, Catchment C and Catchment D. All four catchments have an associated sediment dam with the purpose to contain any drainage from operational areas associated with the catchment area. As per the EA, sediment dams A, B and D have been designed to hold a 1 in 10-year 24 hour storm ARI event. Sediment dam C does not receive direct run-off and does not need to be designed to a specific design event. It provides only temporary storage for water pumped from the void (used for process make up water etc).

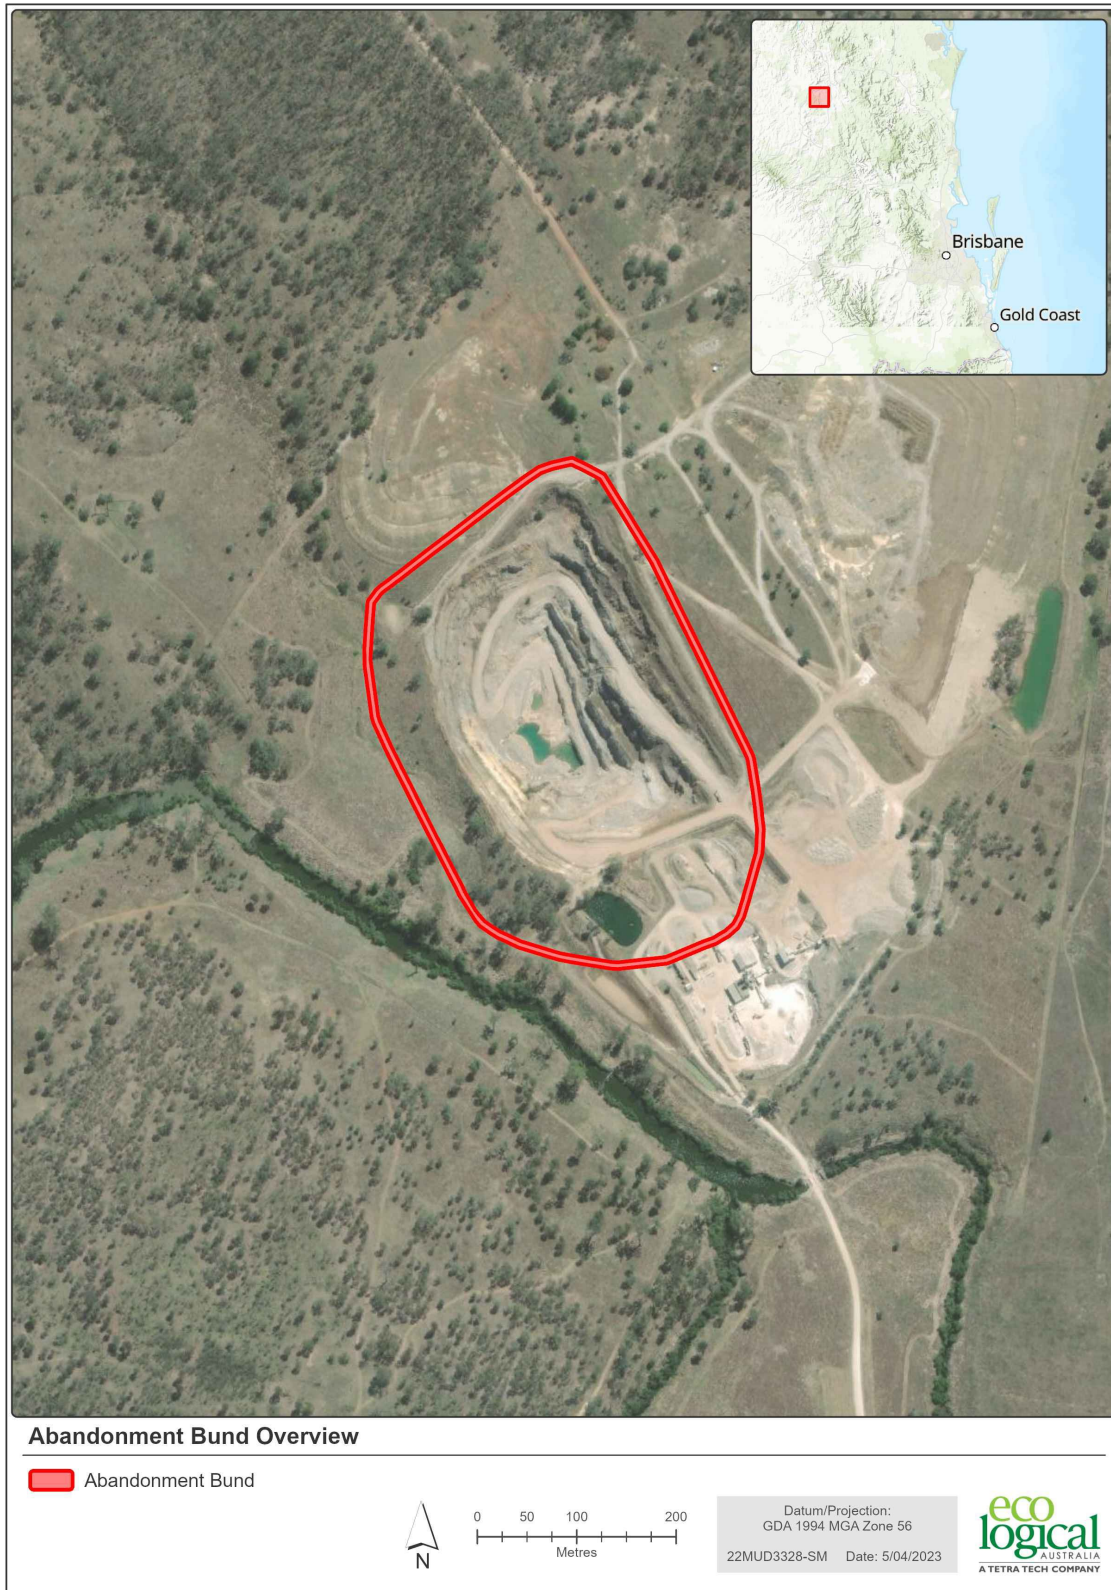
Figure 33: Abandonment bund location

The specific location of the bund is presented in Figure 33. The bund will be fully outside the zone of geotechnical instability and will not interfere with normal riparian flows.

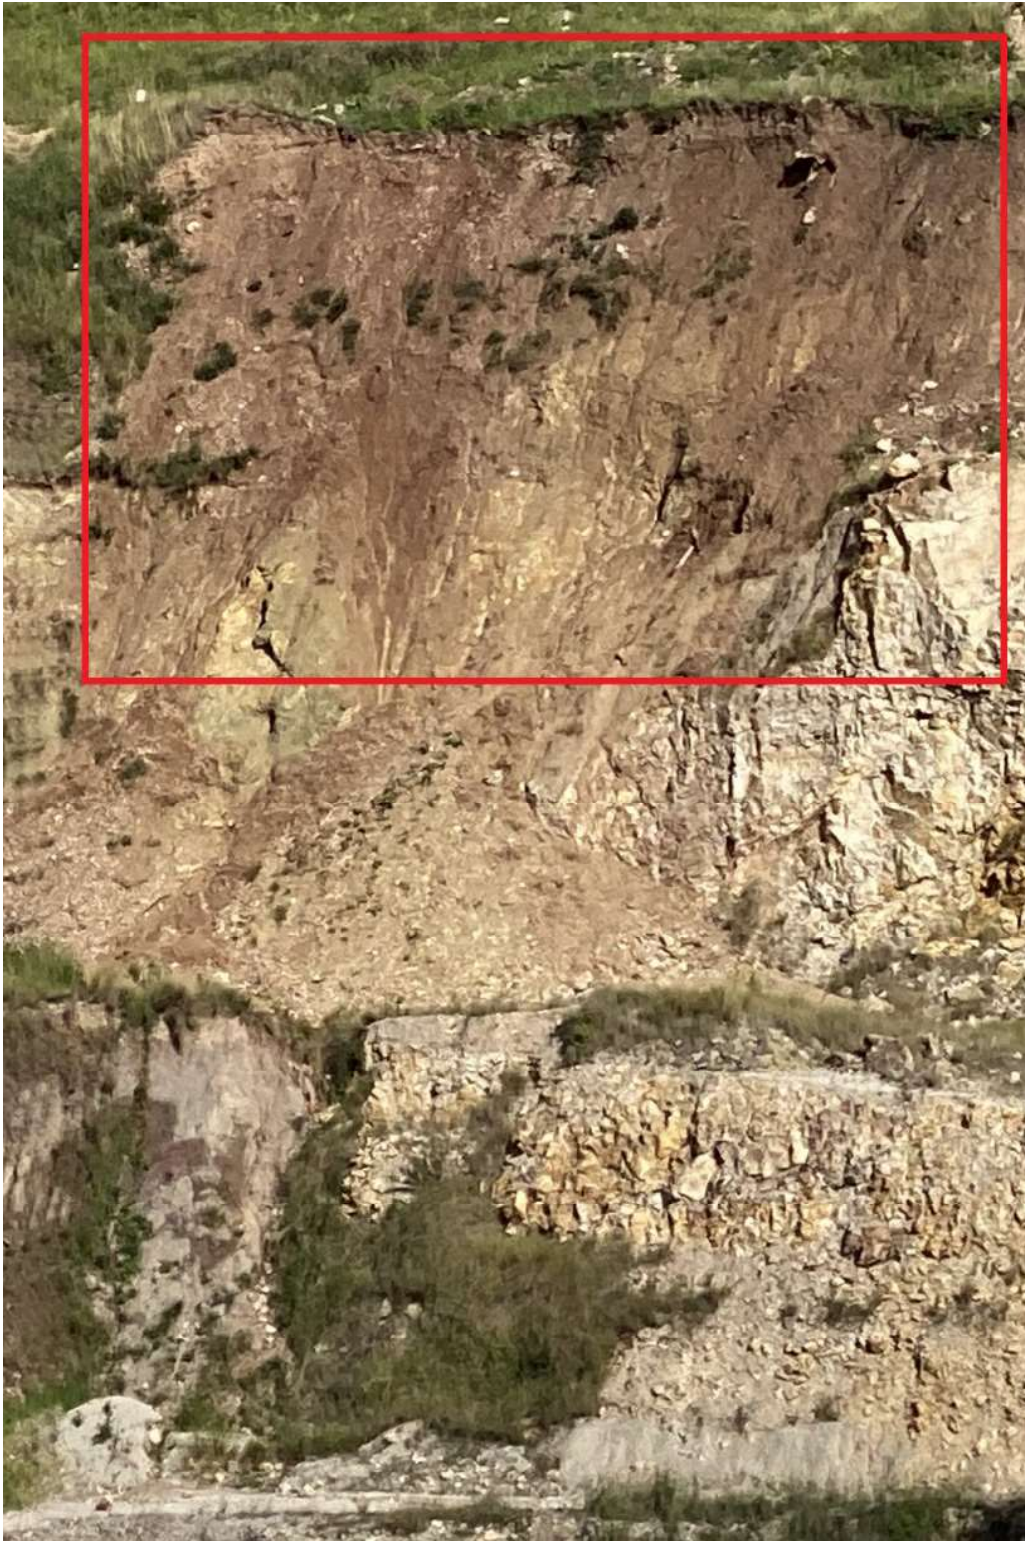
Figure 9. Typical bench scale rotational sliding failure through weathered andesite on the north wall.

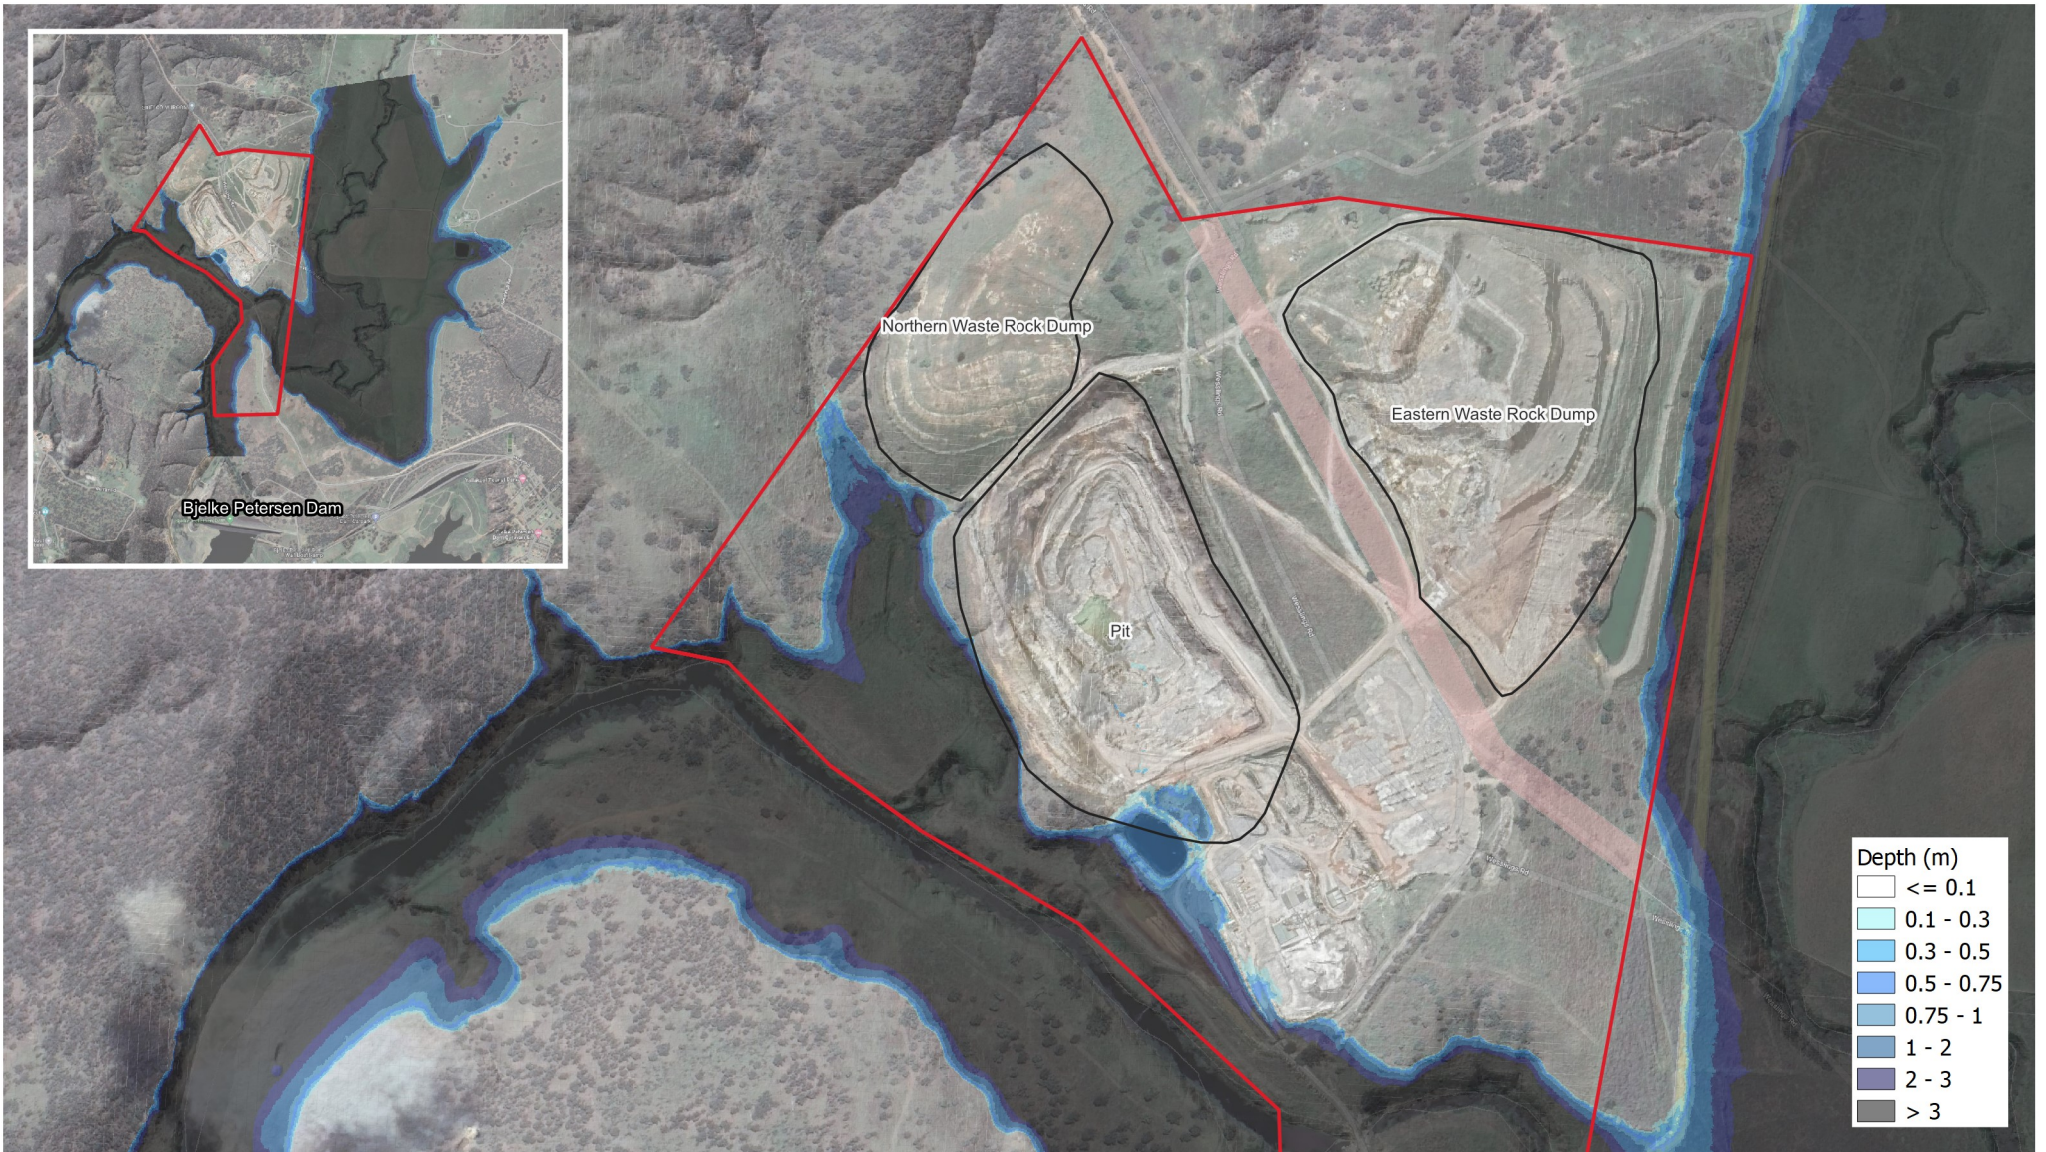
Map 04: 1%AEP with existing terrain flood depth

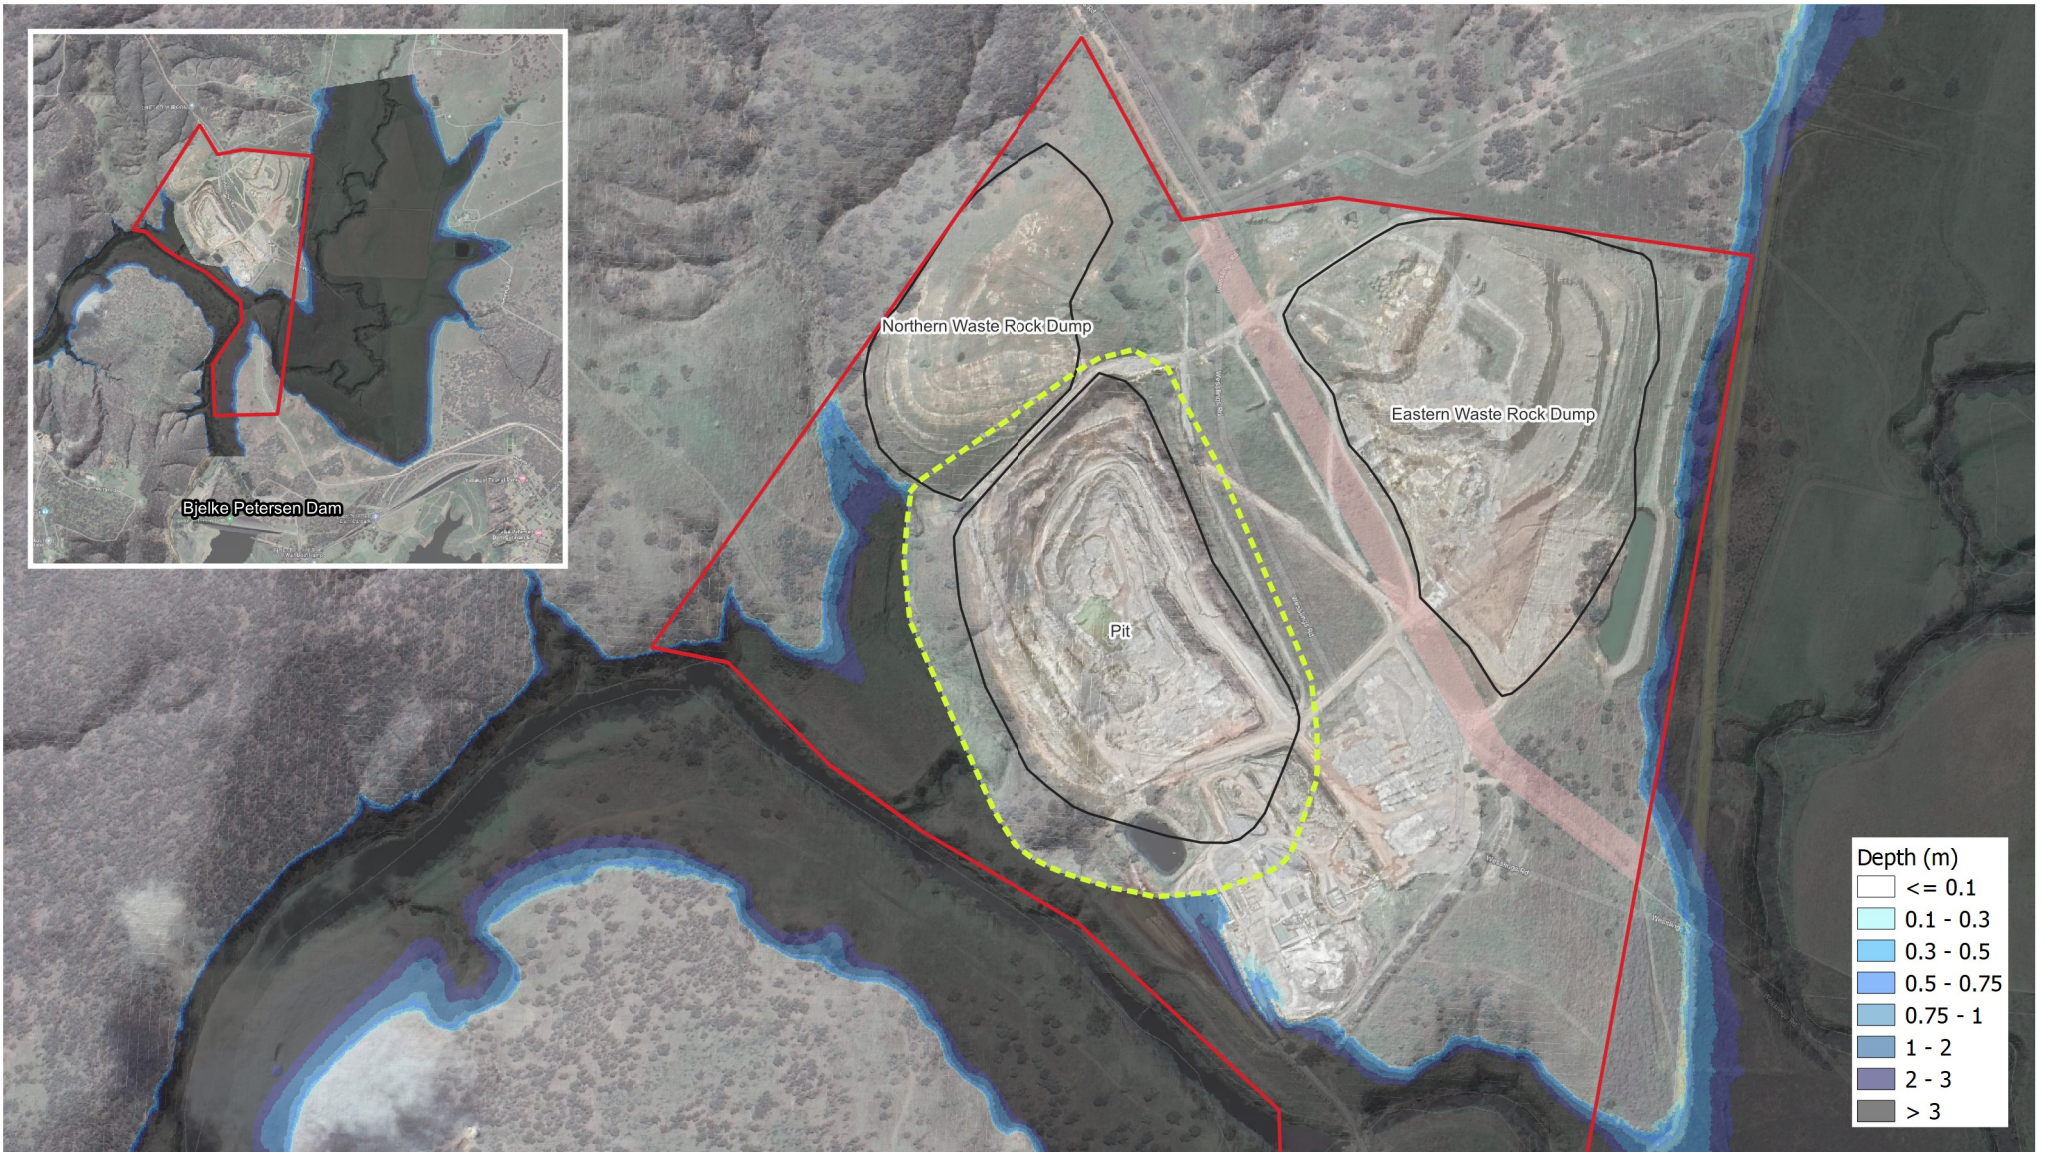
Map 05: 1%AEP after abandonment bund flood depth

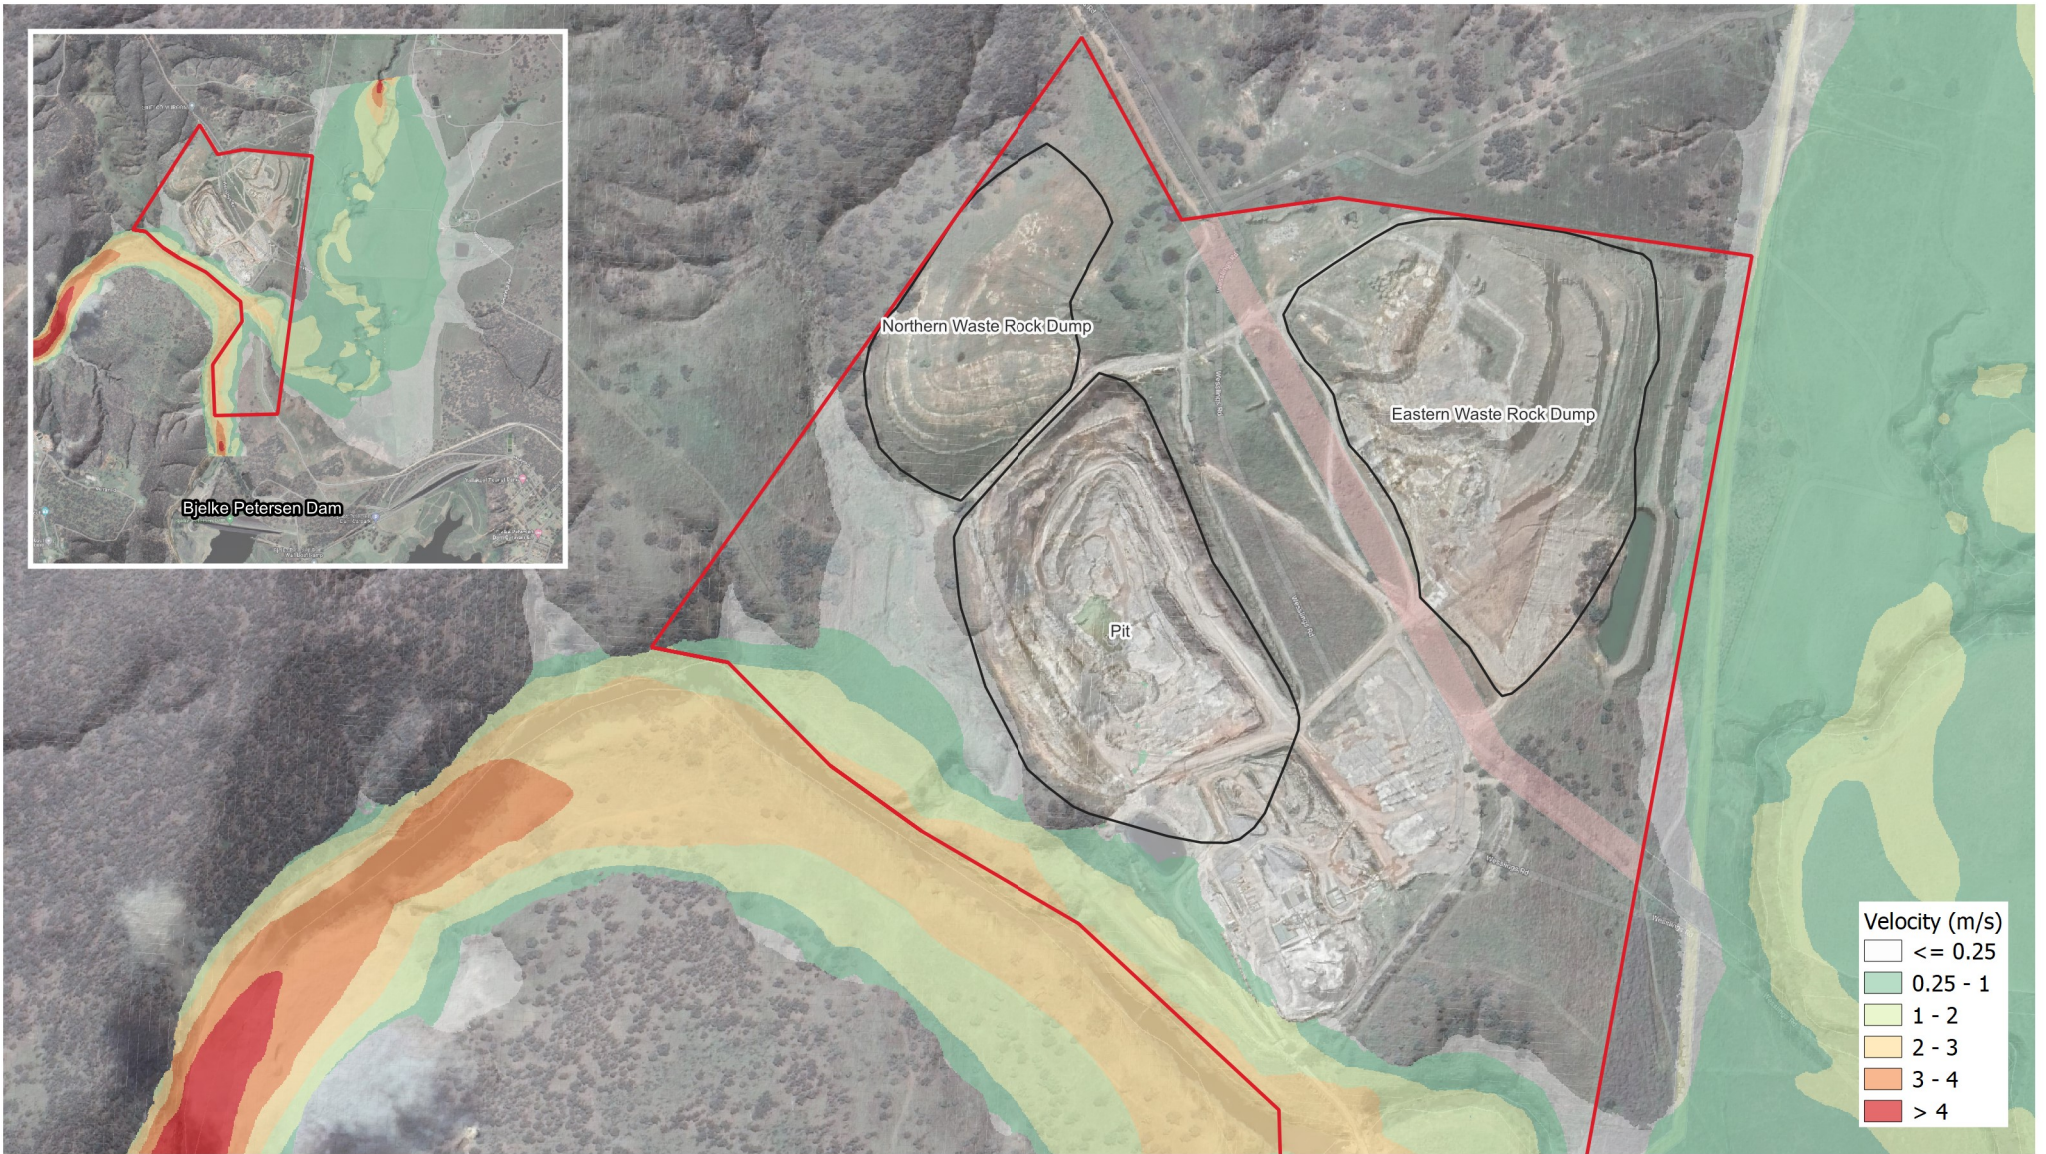
Map 06: 1%AEP with existing terrain flood velocity

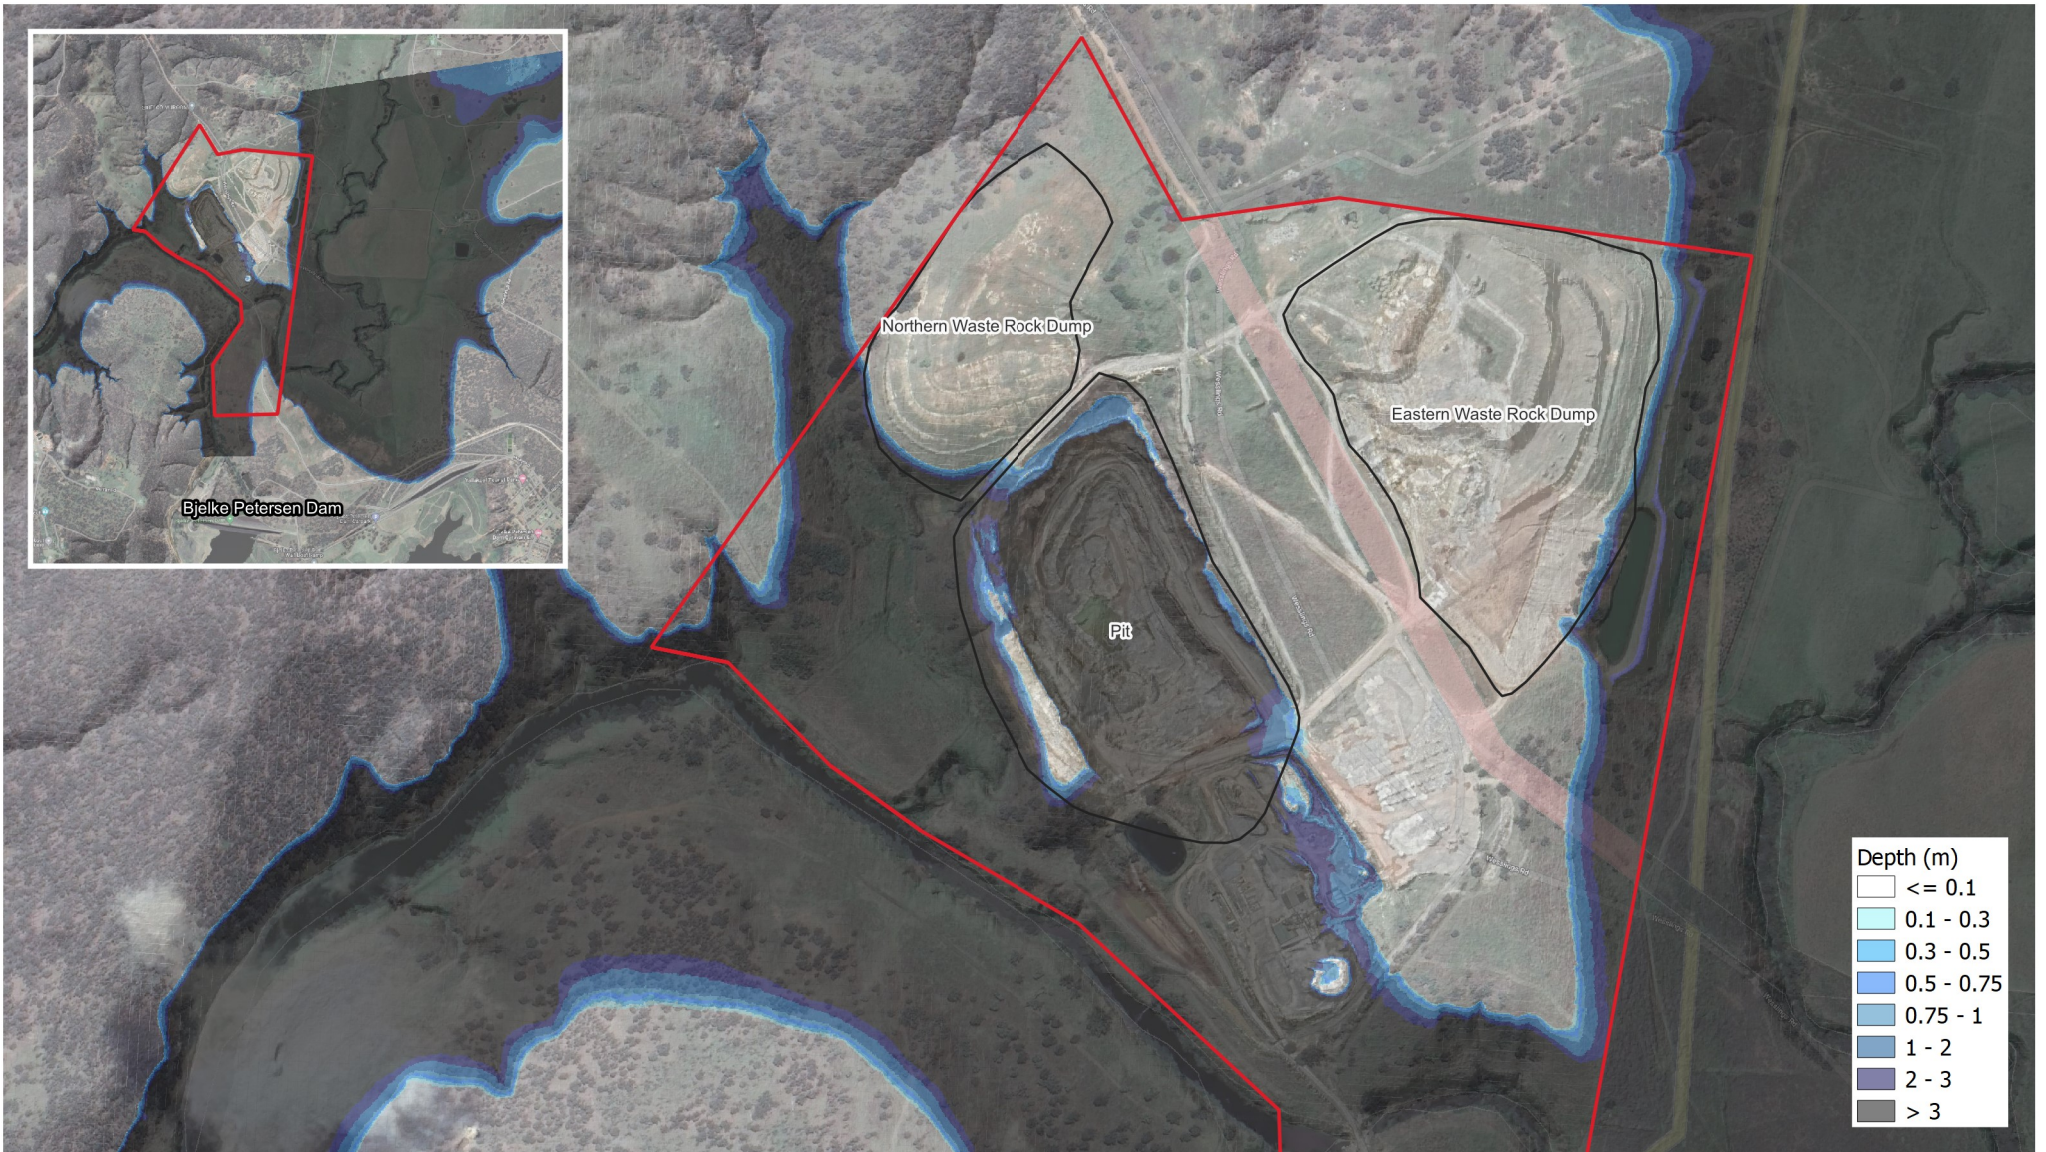
Map 10: PMF with existing terrain flood depth

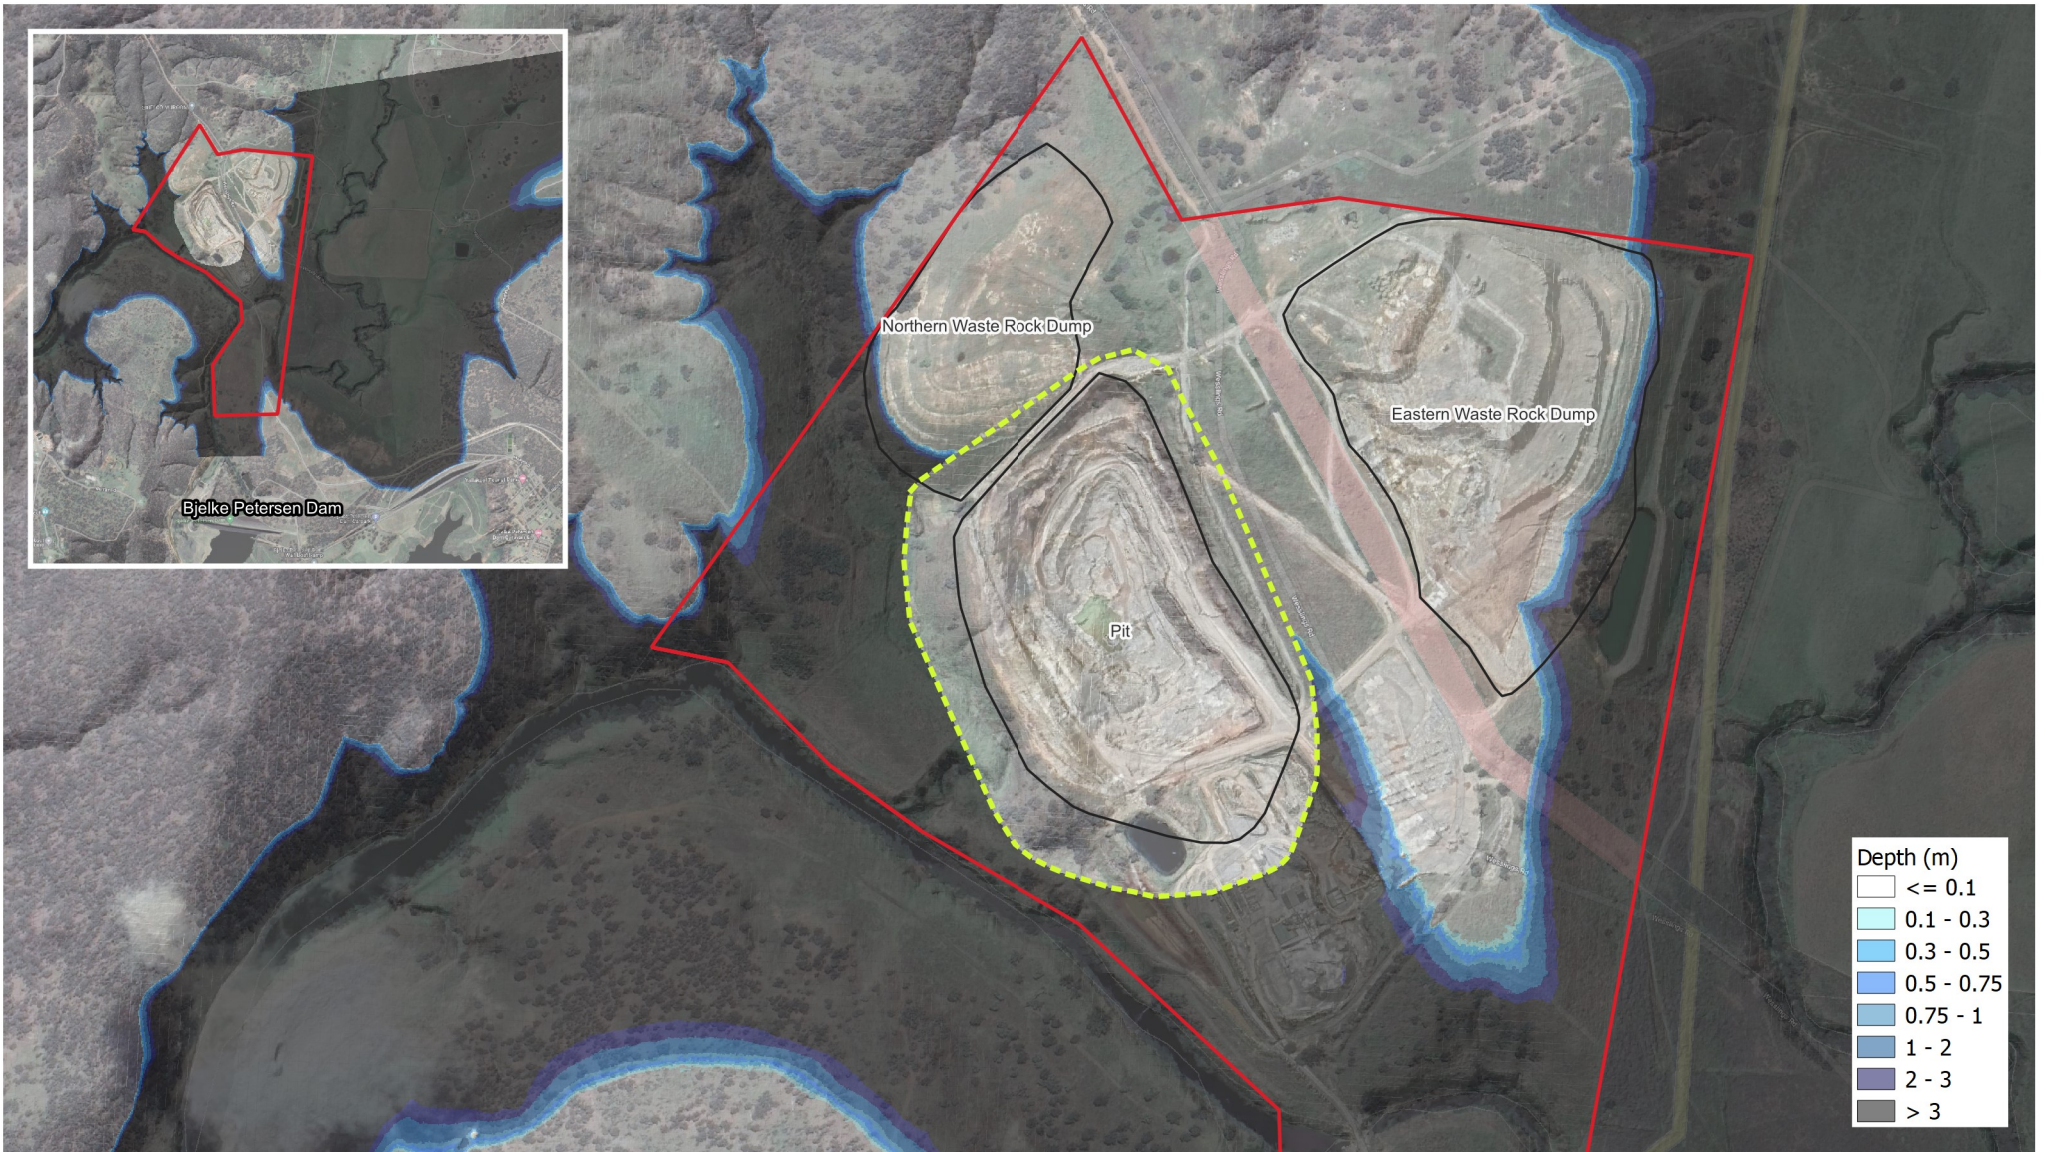
Map 11: PMF after abandonment bund flood depth

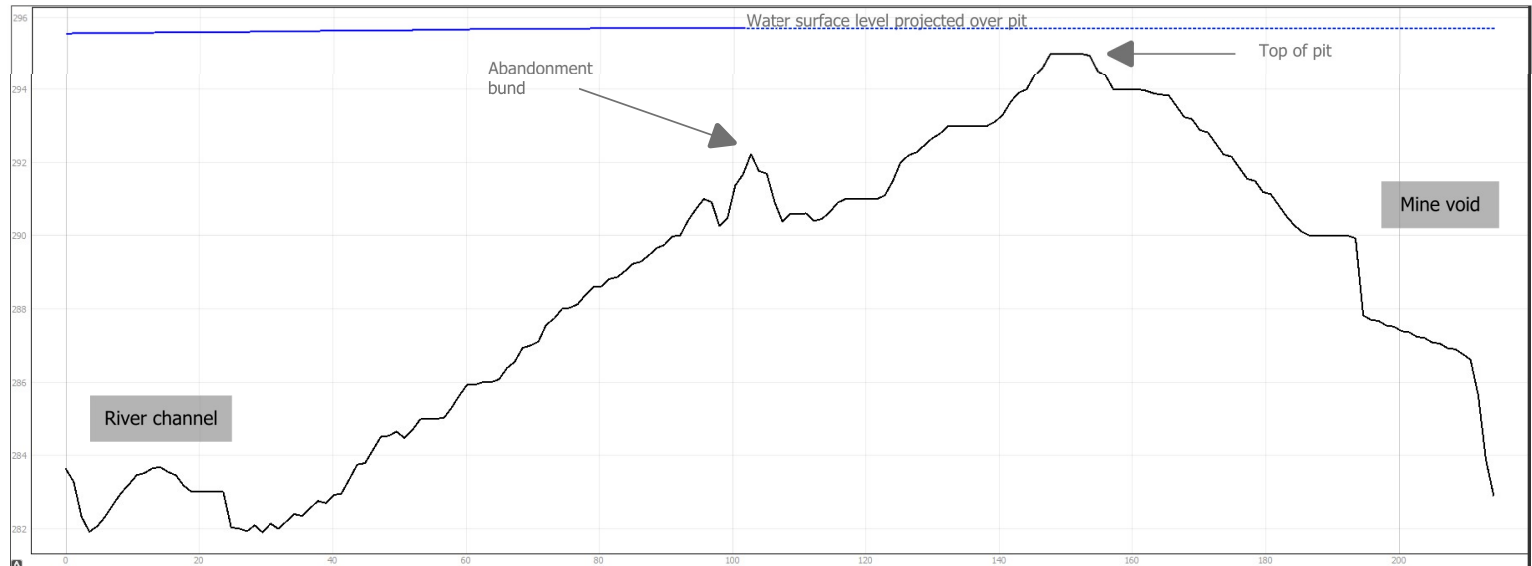
Map 16: Section A - 1%AEP after abandonment bund flood depth
