# PROGRESSIVE REHABILITATION AND CLOSURE PLAN

## AGRIPOWER AUSTRALIA LIMITED CONJUBOY DIATOMACEOUS EARTH PROJECT (ML 10279)

AGP008\_V01  
27 APRIL 2021  
VERSION 01

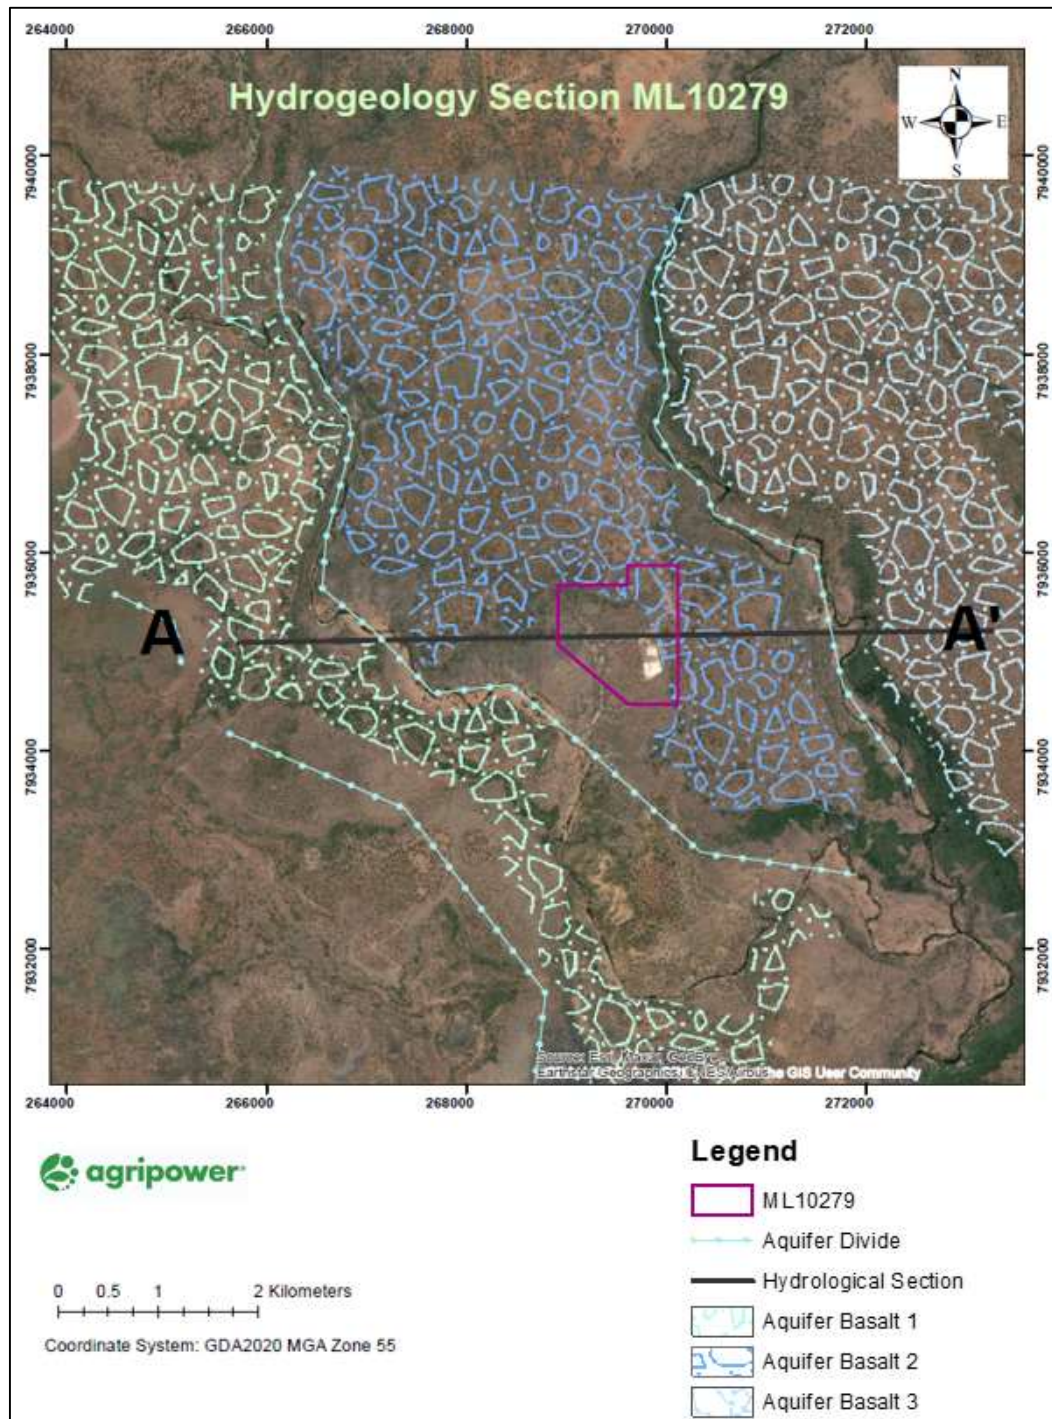
**Figure 3 Hydrogeological section location, and aquifers on the Conjuboy Project (ML10279)**

Diatomite is known to be highly porous, but its permeability is limited, owing to its very fine-grained nature. Although the diatomite deposit will become saturated by recharge events, it is not considered to represent a significant aquifer unit and is unlikely to permit further vertical infiltration of groundwater. It is considered that the mining operation will not change the chemistry of the groundwater due to the low permeability and neutral nature of the Diatomite.

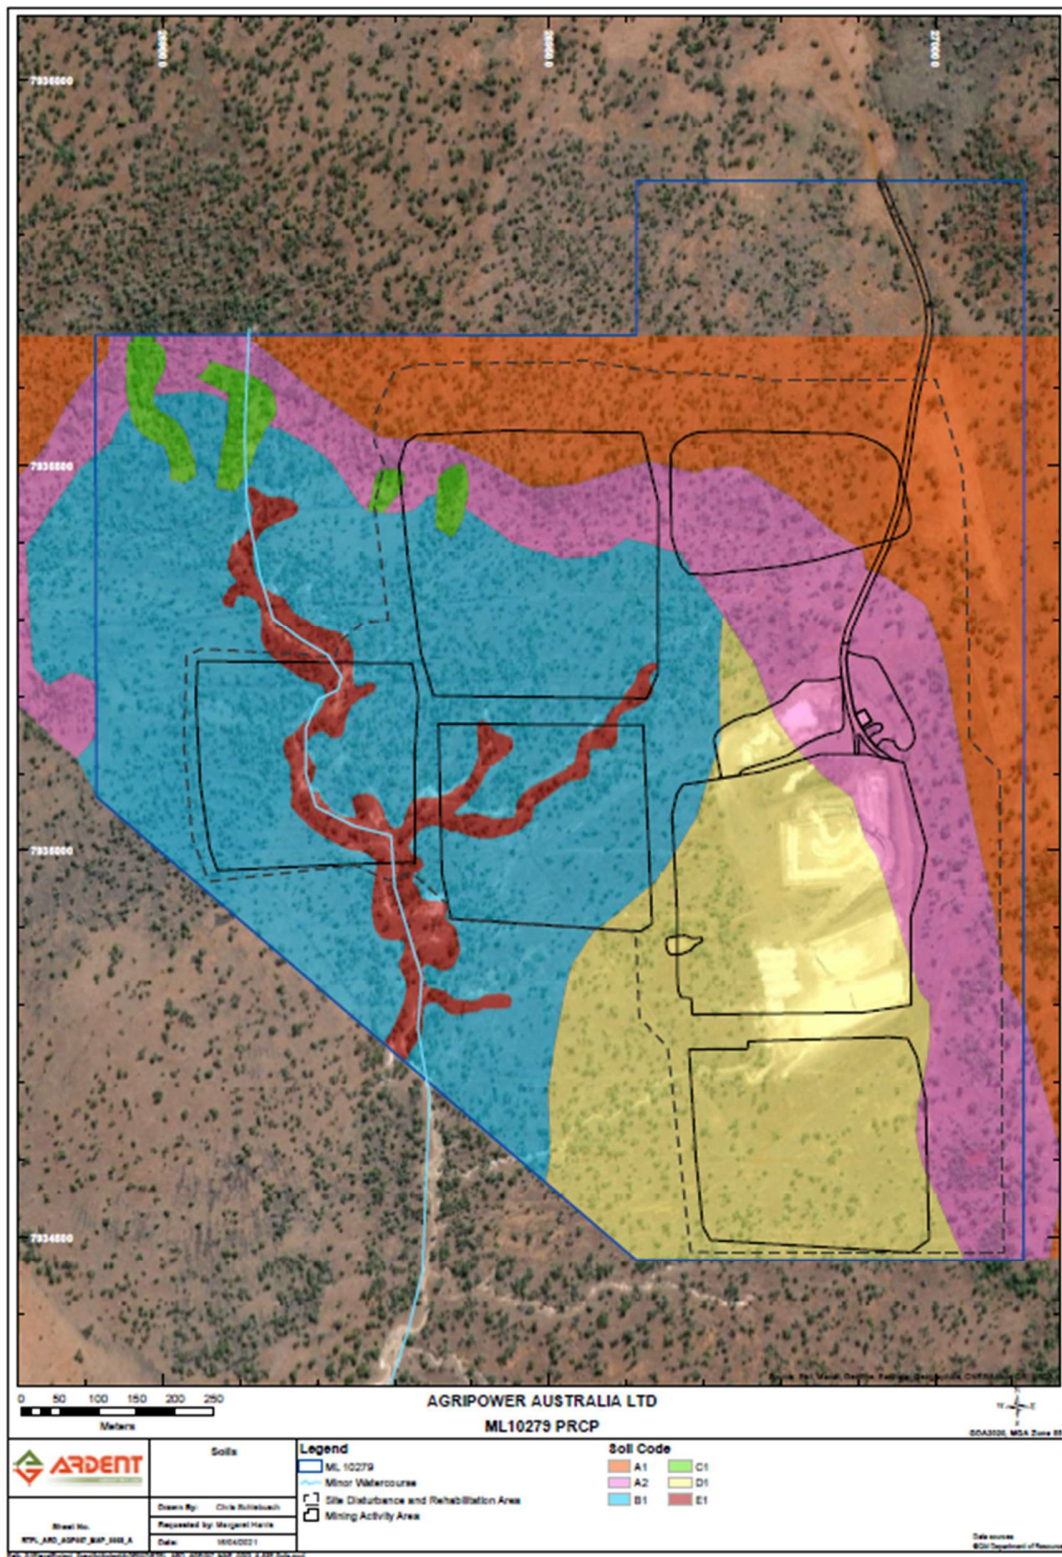
Figure 4: Soil Types over ML 10279

Salvageable surface soils exist on site (30-40cm thick) are collected and stockpiled on site ready to be used in rehabilitation. Some subsoils are sodic and potentially dispersive and are unsuitable for use in rehabilitation and should not be exposed unnecessarily. The distribution of soil types is shown in Figure 4.

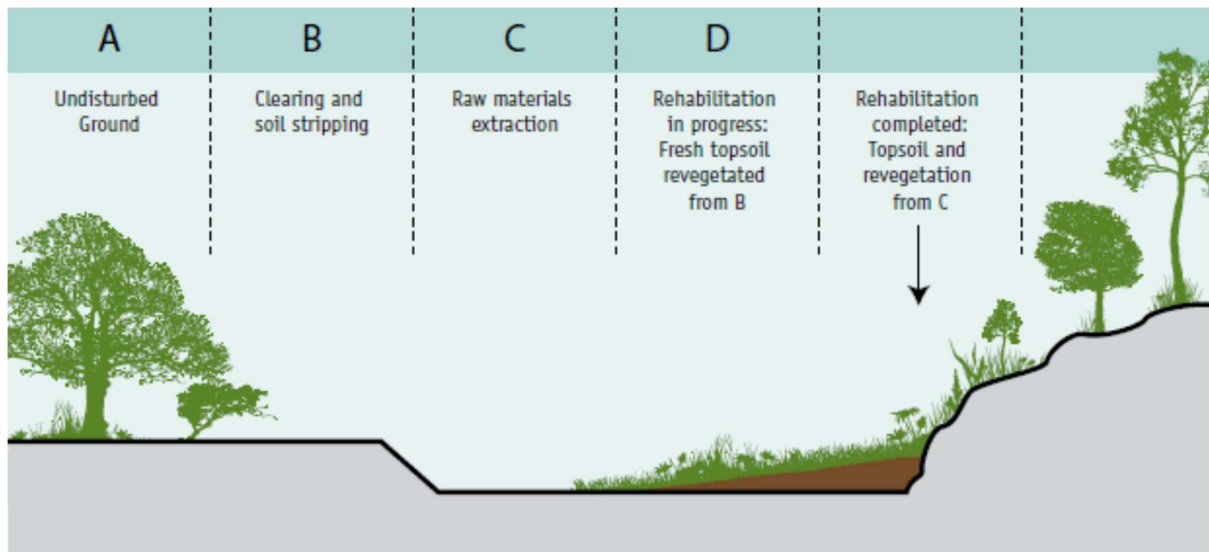
**Figure 7: Schematic of pit backfilling and rehabilitation**

A schematic of the final profile is shown below in Figure 7.

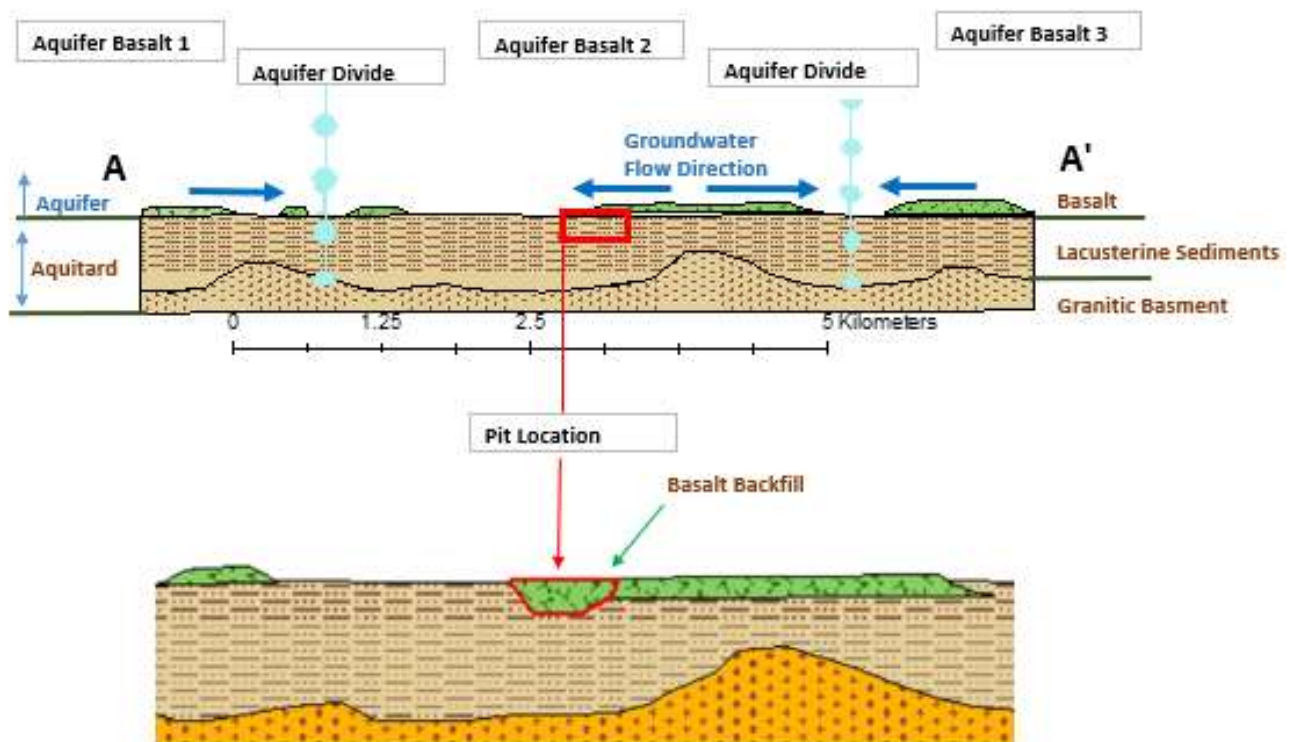
**Figure 9 Cross Section of geology and aquifer.**

Appendix 1 contains reproductions of the baseline assessment of the site including a description of the hydrogeological setting of ML10279. Figure 9 shows a schematic of the backfilled pit within the geological landscape.

Backfill of the pit will be formed from the local basalt and lacustrine sediment overburden replacing the diatomaceous earth and clay that forms the relatively impervious aquitard below the water table.

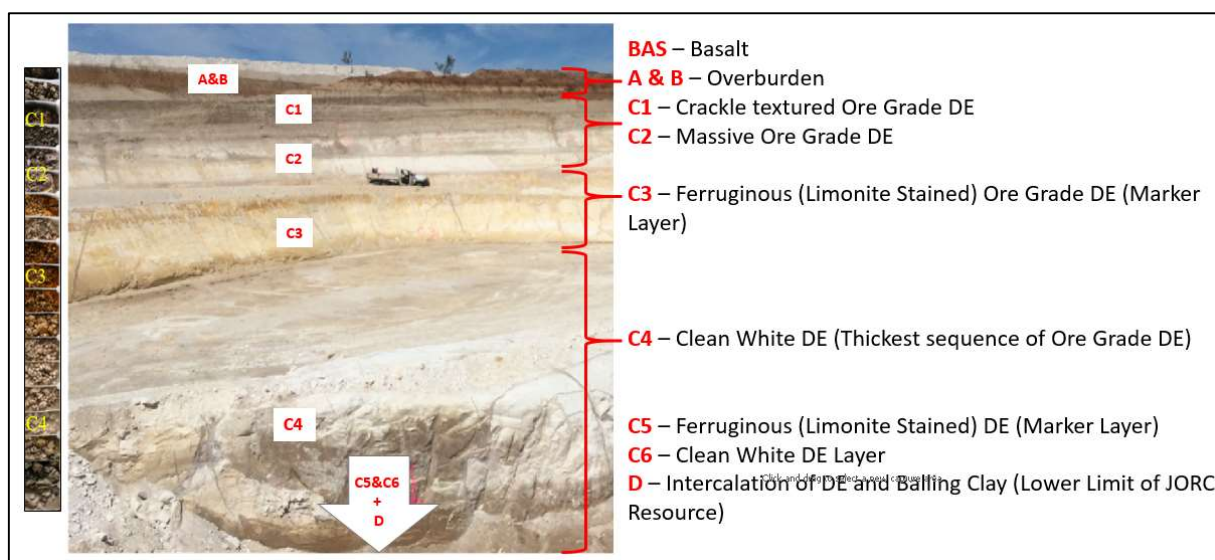
**Figure 10 Lithology of the Gildale pit showing diatomaceous earth and clay.**

At the pit location groundwater occurs in quantities to be described as an aquifer to several metres before clay levels in the underlying diatomite become relatively impermeable as indicated in the figure below.

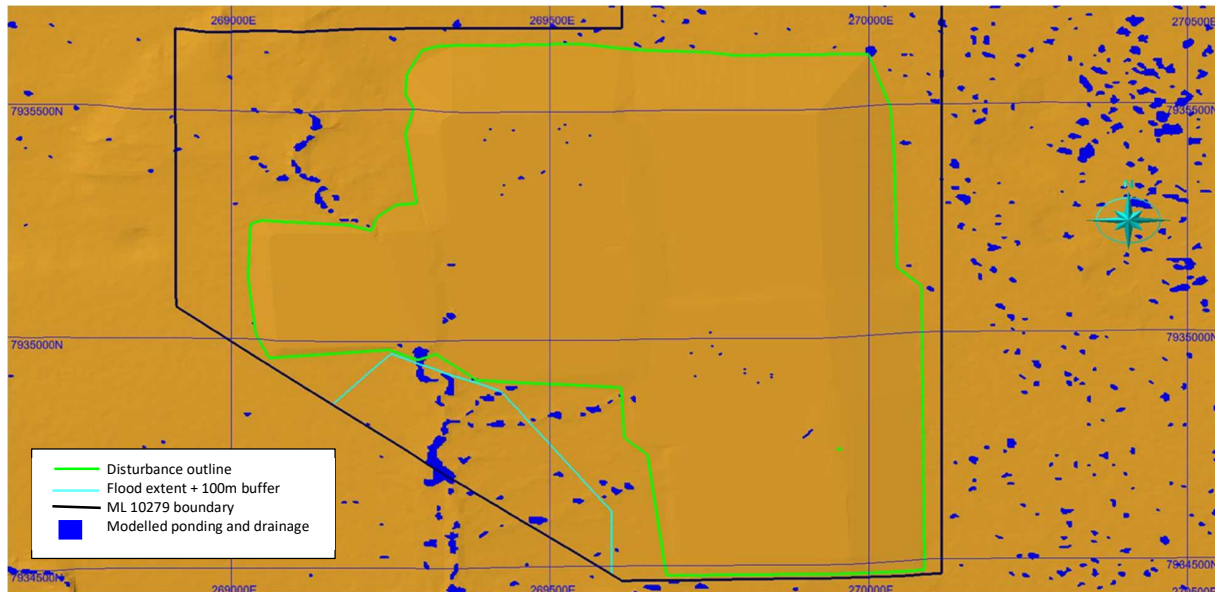
**Figure 11: Drainage and ponding of final landform footprint**

*Note: Natural ponding in areas not disturbed (Black – ML10279 boundary, Green – Area of disturbance, Blue – Ponding and drainage)*

The final landform design drainage analysis in 3D Dig shows that the backfilled pits will be free draining in the landscape as shown in Figure 11 below.

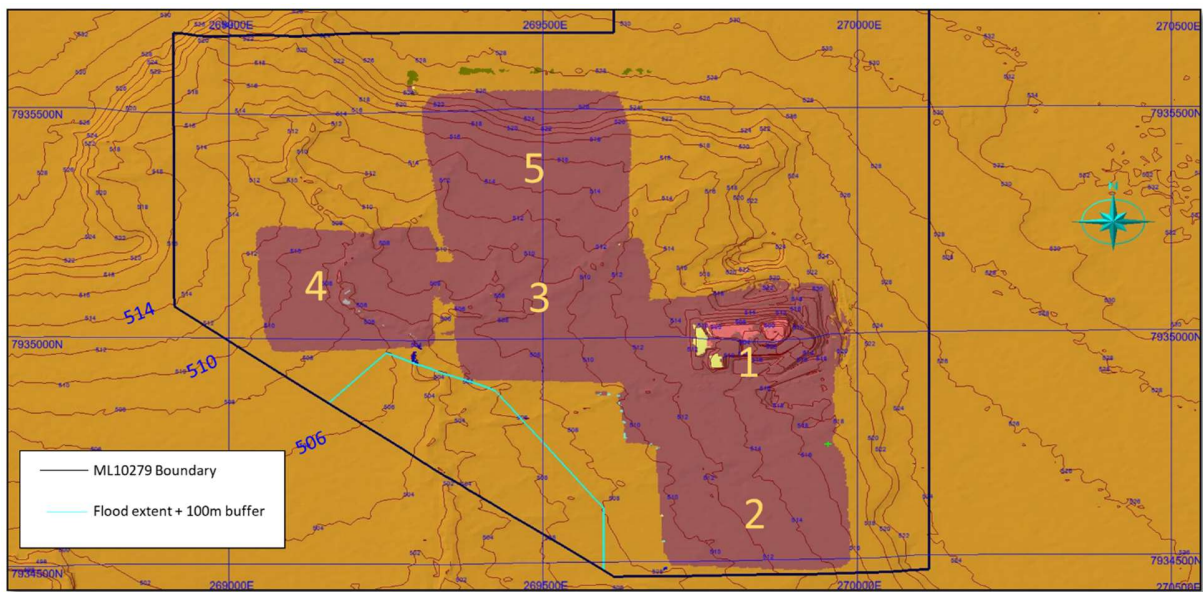
**Figure 12 Mine void footprint overlay on pre-mining contours**

The contours of the pre-mining landscape include a step down to the resource location which determines the grade direction for the post-mining landform design.

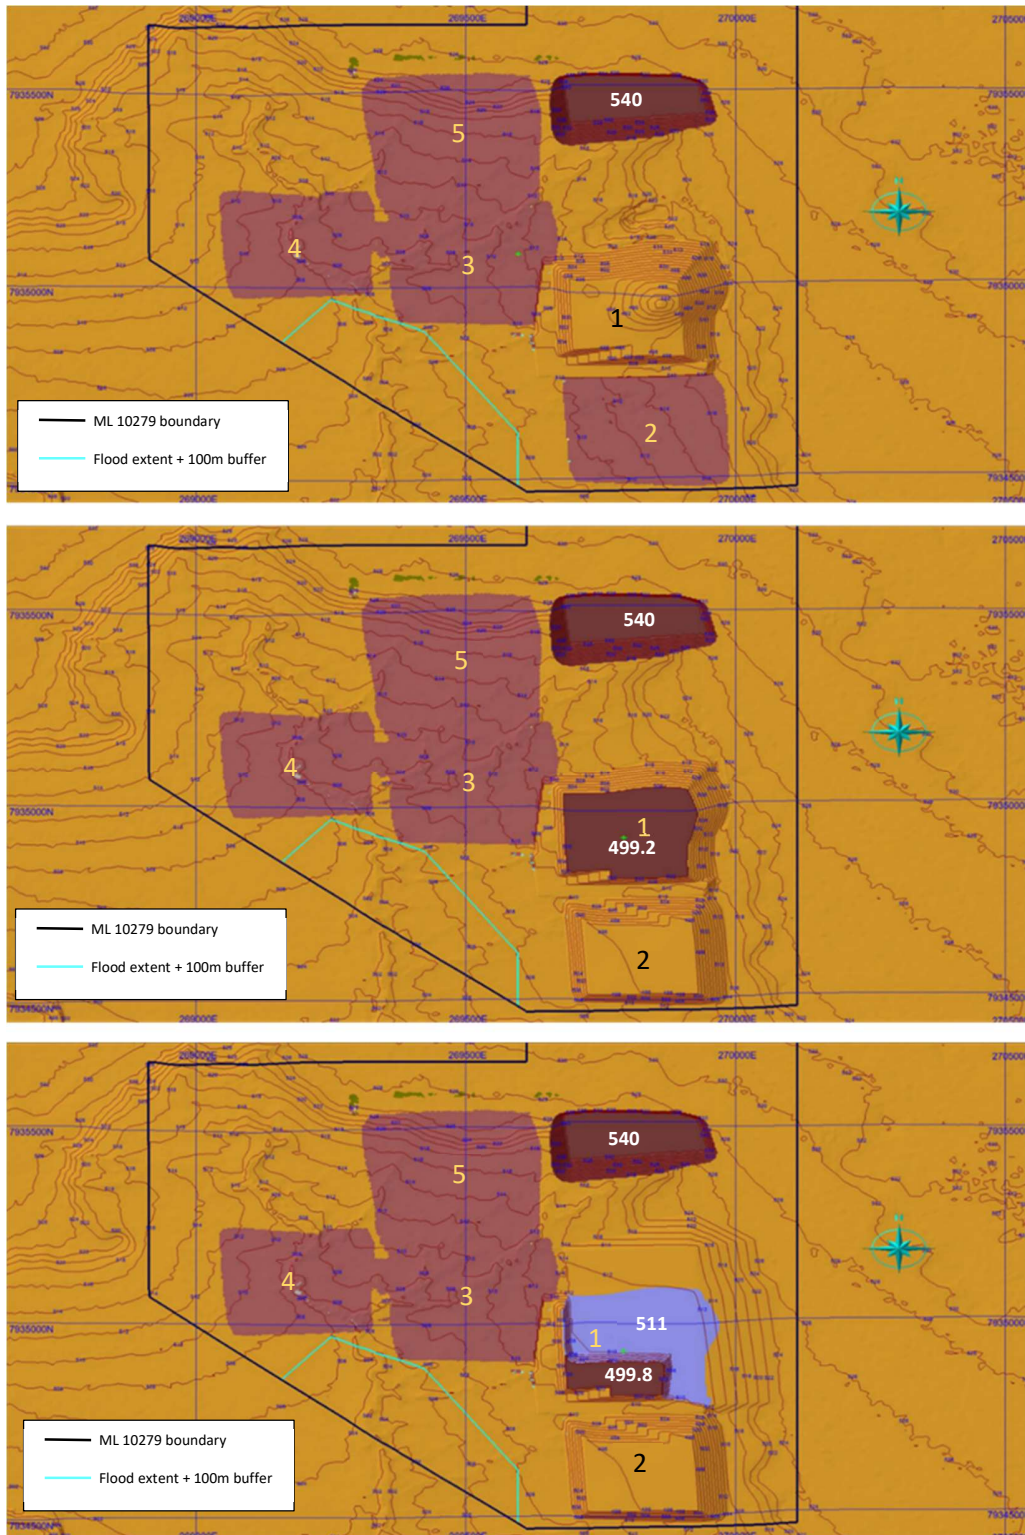
Figure 13: Sequence Pit 1 and Pit 2 development

The sequence of mining (Pit 1 to Pit 5) in a stepwise manner to allow for the surface placement of ore and waste until the receiving void is safe to receive wastes directly. The waste of Pit 1 will be stockpiled to the north of the excavation. Pit 2 waste returned to Pit 1 will be placed to uniform depth with initial campaign wastes following. Commencement of Pit 3 will initiate backfilling of Pit 2. The surface stockpile of waste will be exhausted by this stage and direct placement of waste to Pit 2 and Pit 3 will commence at the initiation of Pit 4. The initiation of Pit 5 will commence the completion of Pit 3 and the shallower Pit 4. Waste excess from Pit 5 and adjoining pit wall will be dozed to create a continuous contour landscape. Backfilled material integrity is expected to be enhanced by the retention of internal wall divisions between pit developments.

The progression of pit development and rehabilitation is shown in the images below.

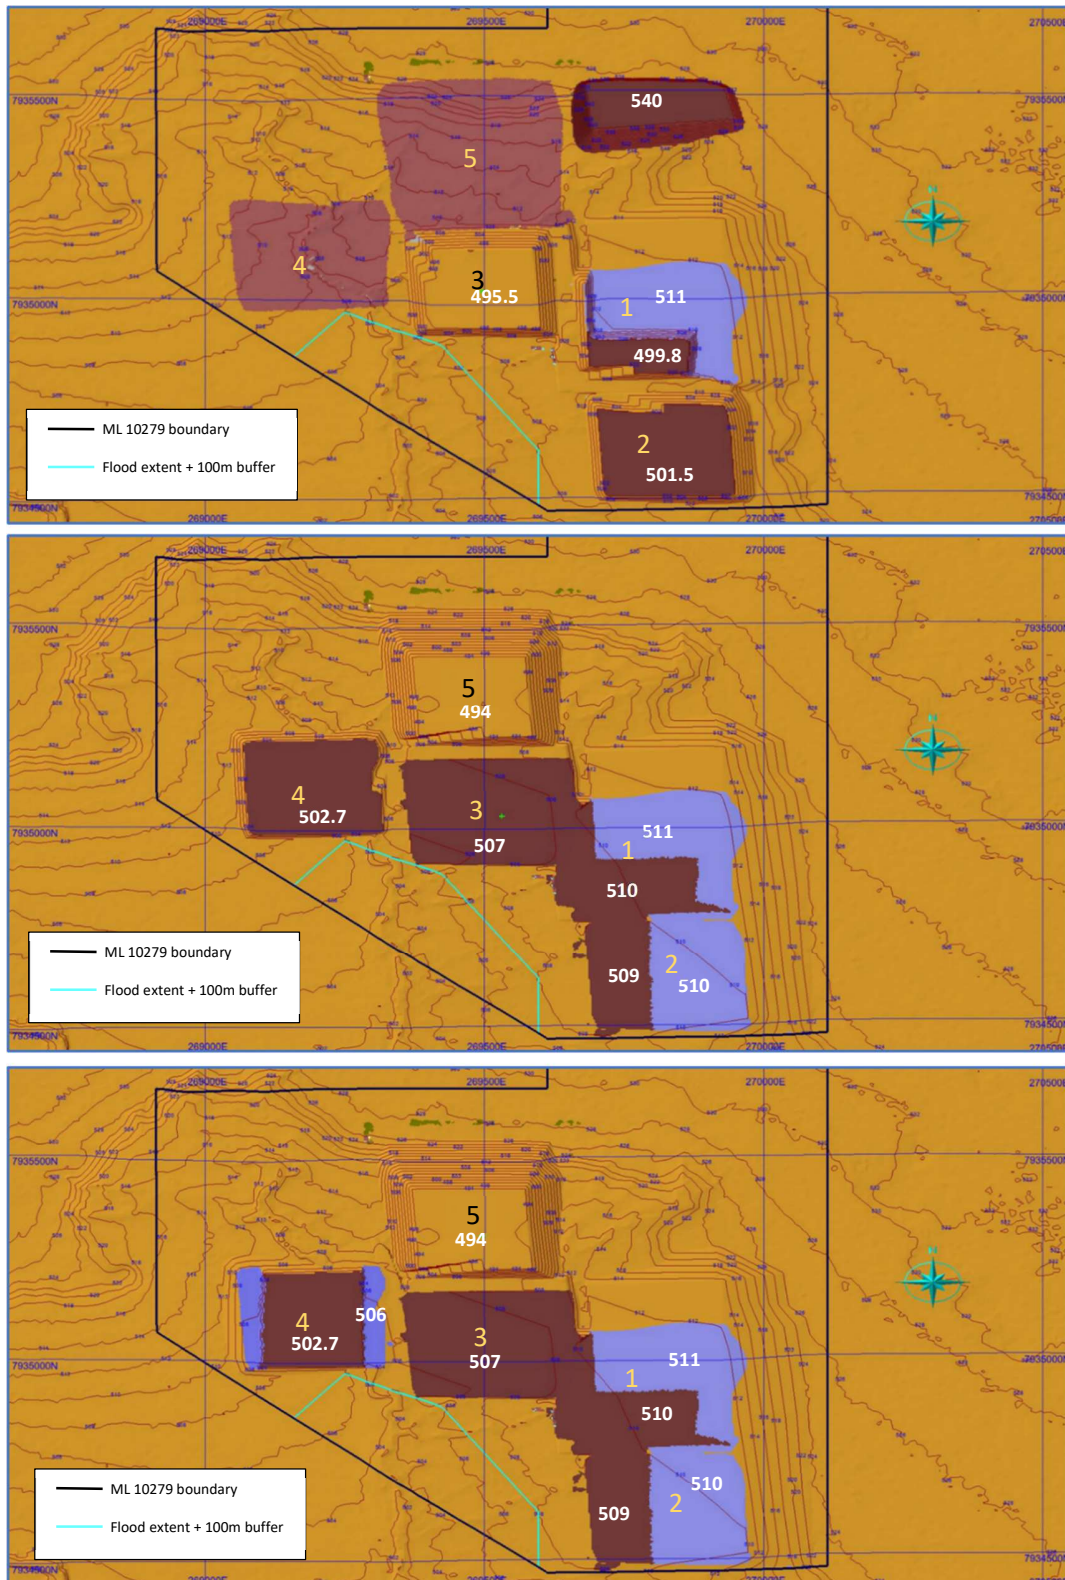
Figure 14 Backfilling sequence for Pits 1-4

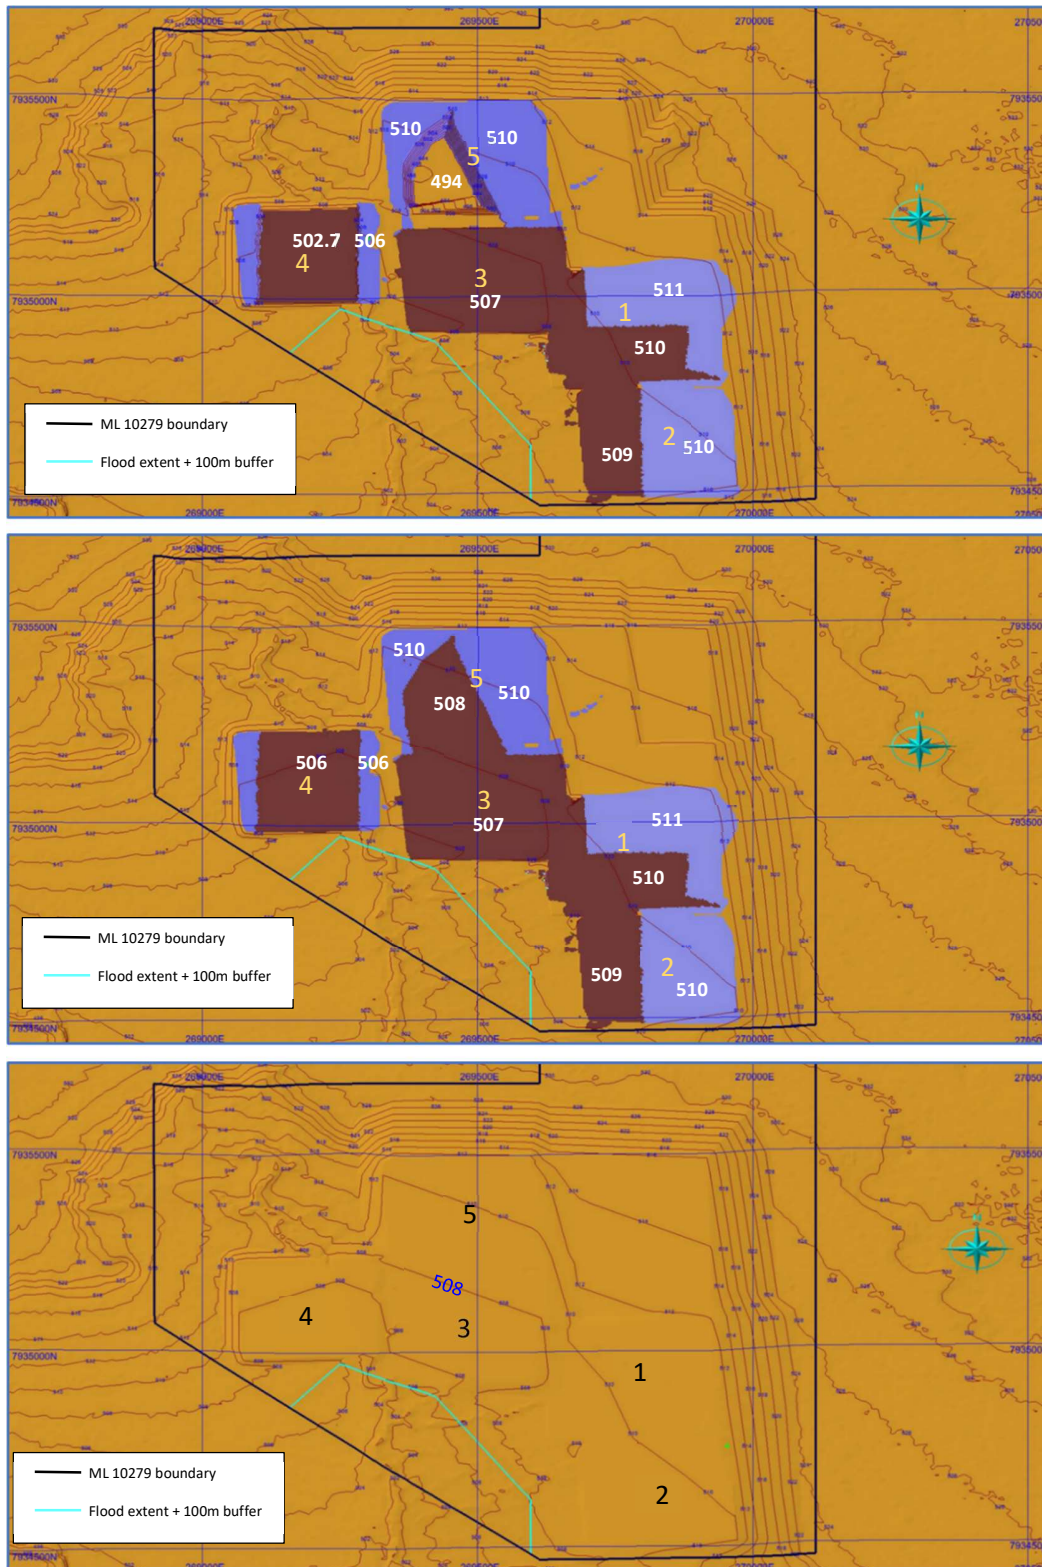
Figure 15 Pit 5 backfill and final landform profile

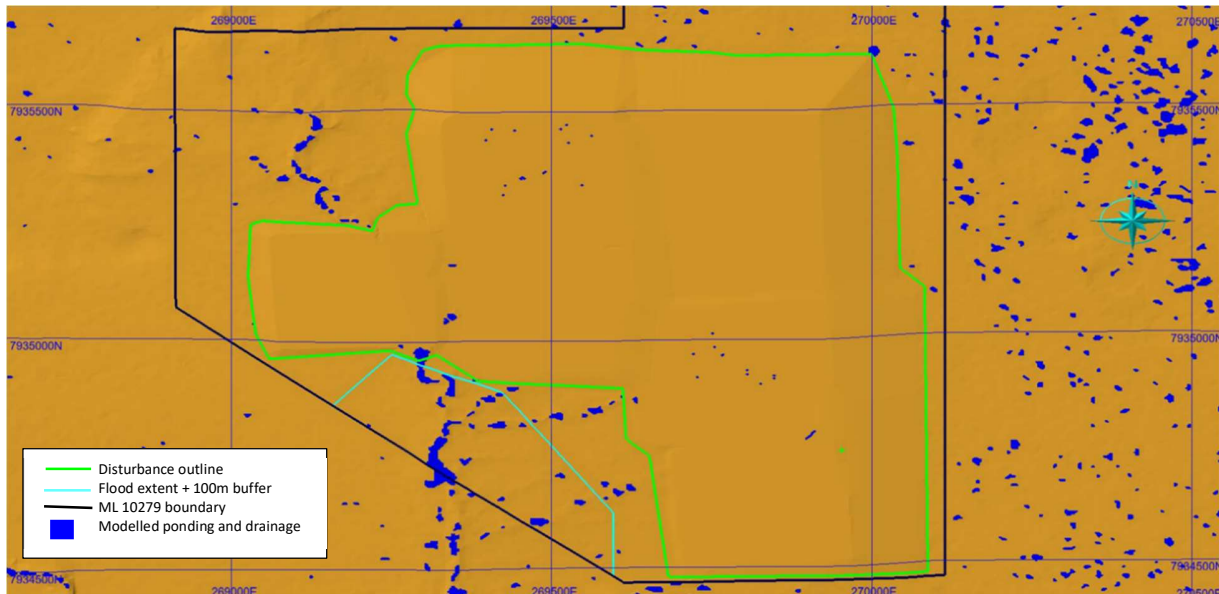
Figure 16 Drainage analysis of final landform design in 3D Dig

The final landform design meets the design criteria of slopes of <10 degrees and water-shedding (non-ponding) landform. The cross-sections below illustrate the slope and drainage analysis of the design meeting the criteria. The cross-section images include the pre-mine profile, void exhaustion profile and backfilled and reprofiled lines through Pits 1, 3 and 4 (Figure 17), Pits 3 and 5 (Figure 18) and Pits 1 and 2 (Figure 19) with vertical exaggeration (x3) to emphasise the landform for illustrative purposes.

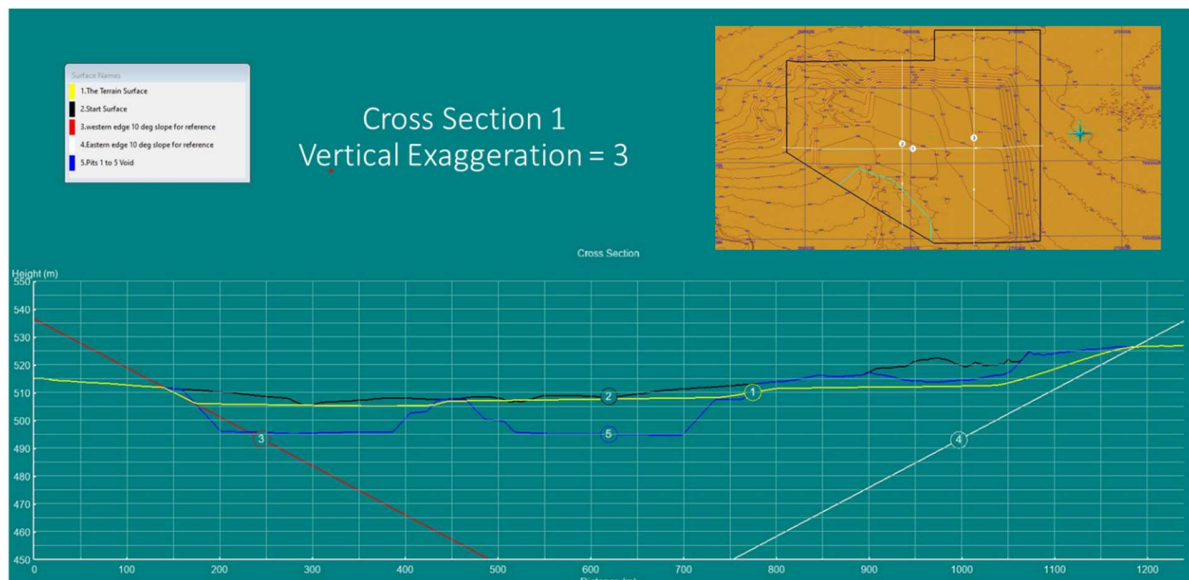
Figure 17 Cross-section Pits 1, 3 and 4

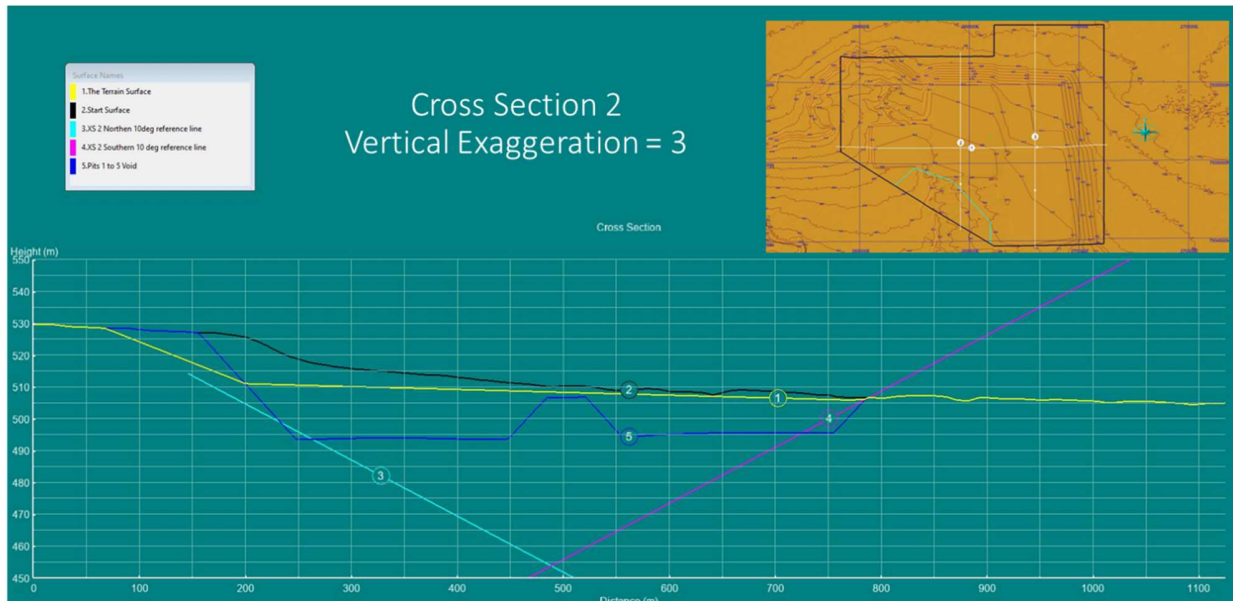
Figure 18 Cross-section Pits 3 and 5

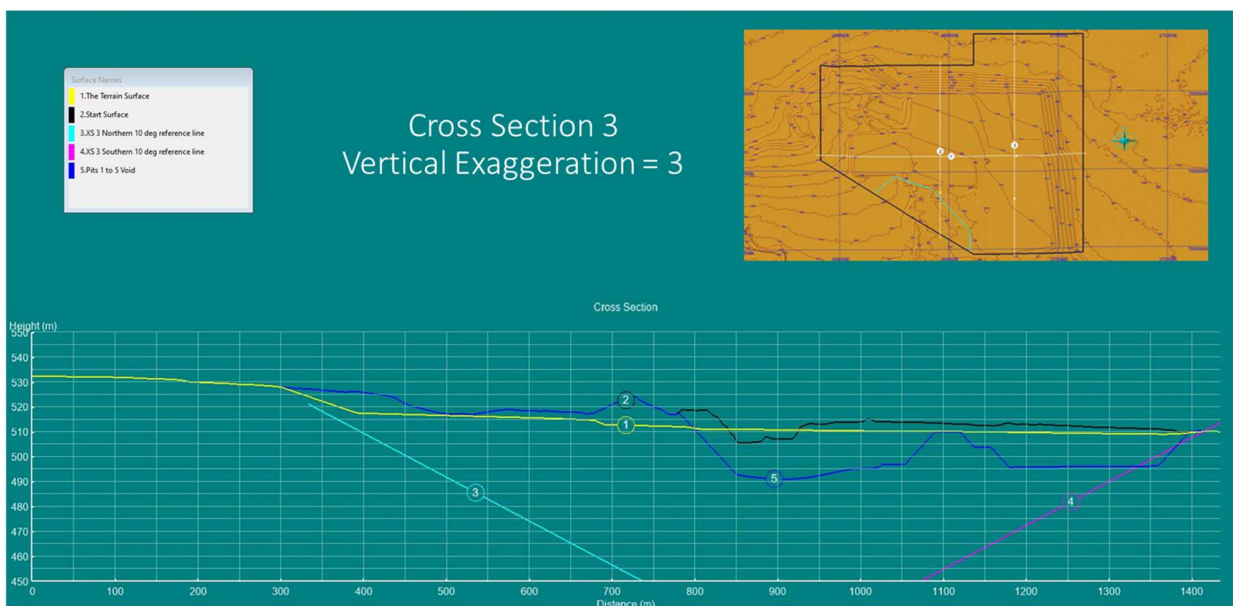
Figure 19 Cross-section Pits 1 and 2

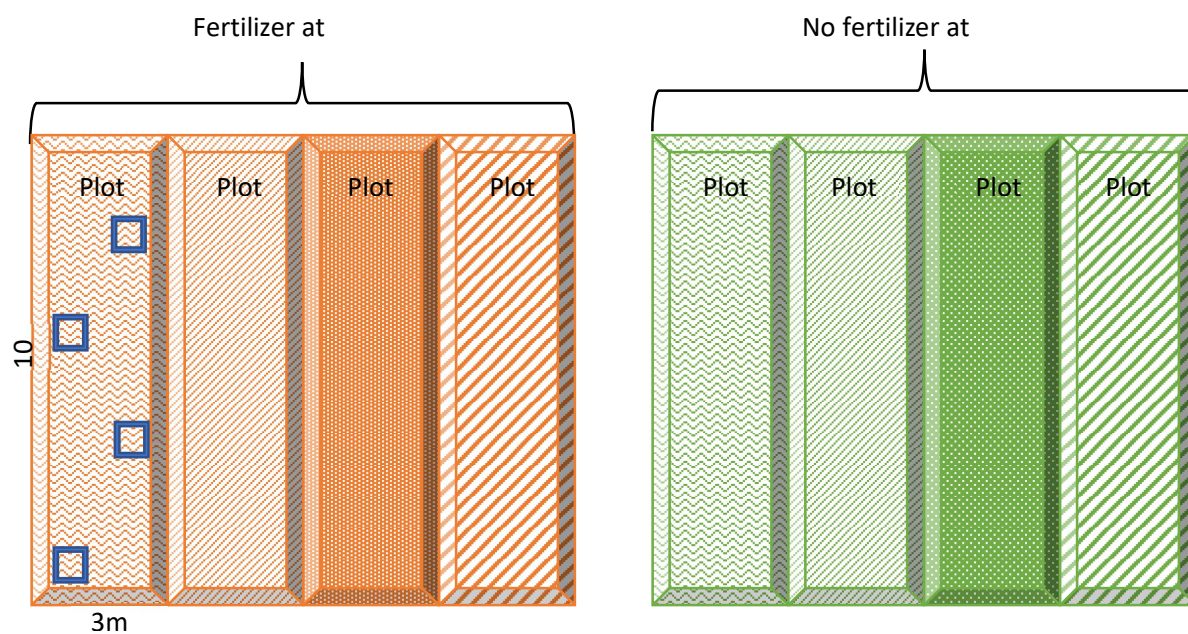
A trial plot layout to example such as below:

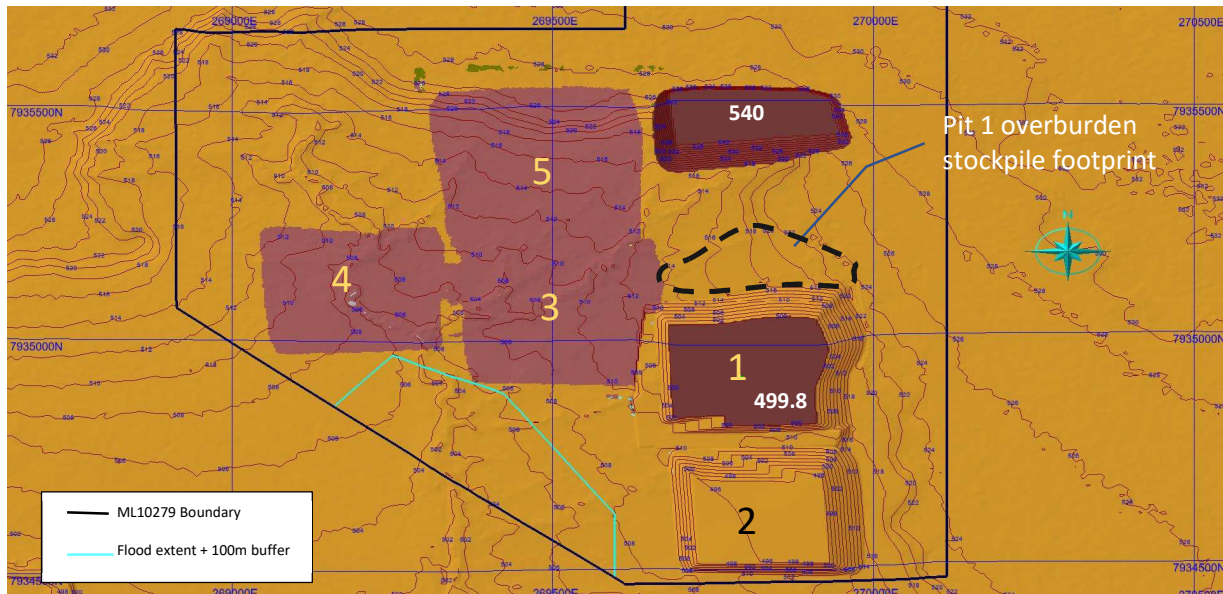
Figure 20: Suitable location for rehabilitation trial 2

- *Heteropogon contortus*
- *Heteropogon triticeus*
- *Themeda triandra*
- *Grewia retusifolia*

At a rate of 3kg/ha per species to 2 non-consecutive sections of 20m x 5m width and apply no seed mix to the intervening sections. Gypsum to be applied at one section of ripped and seeded and one section of ripped only.

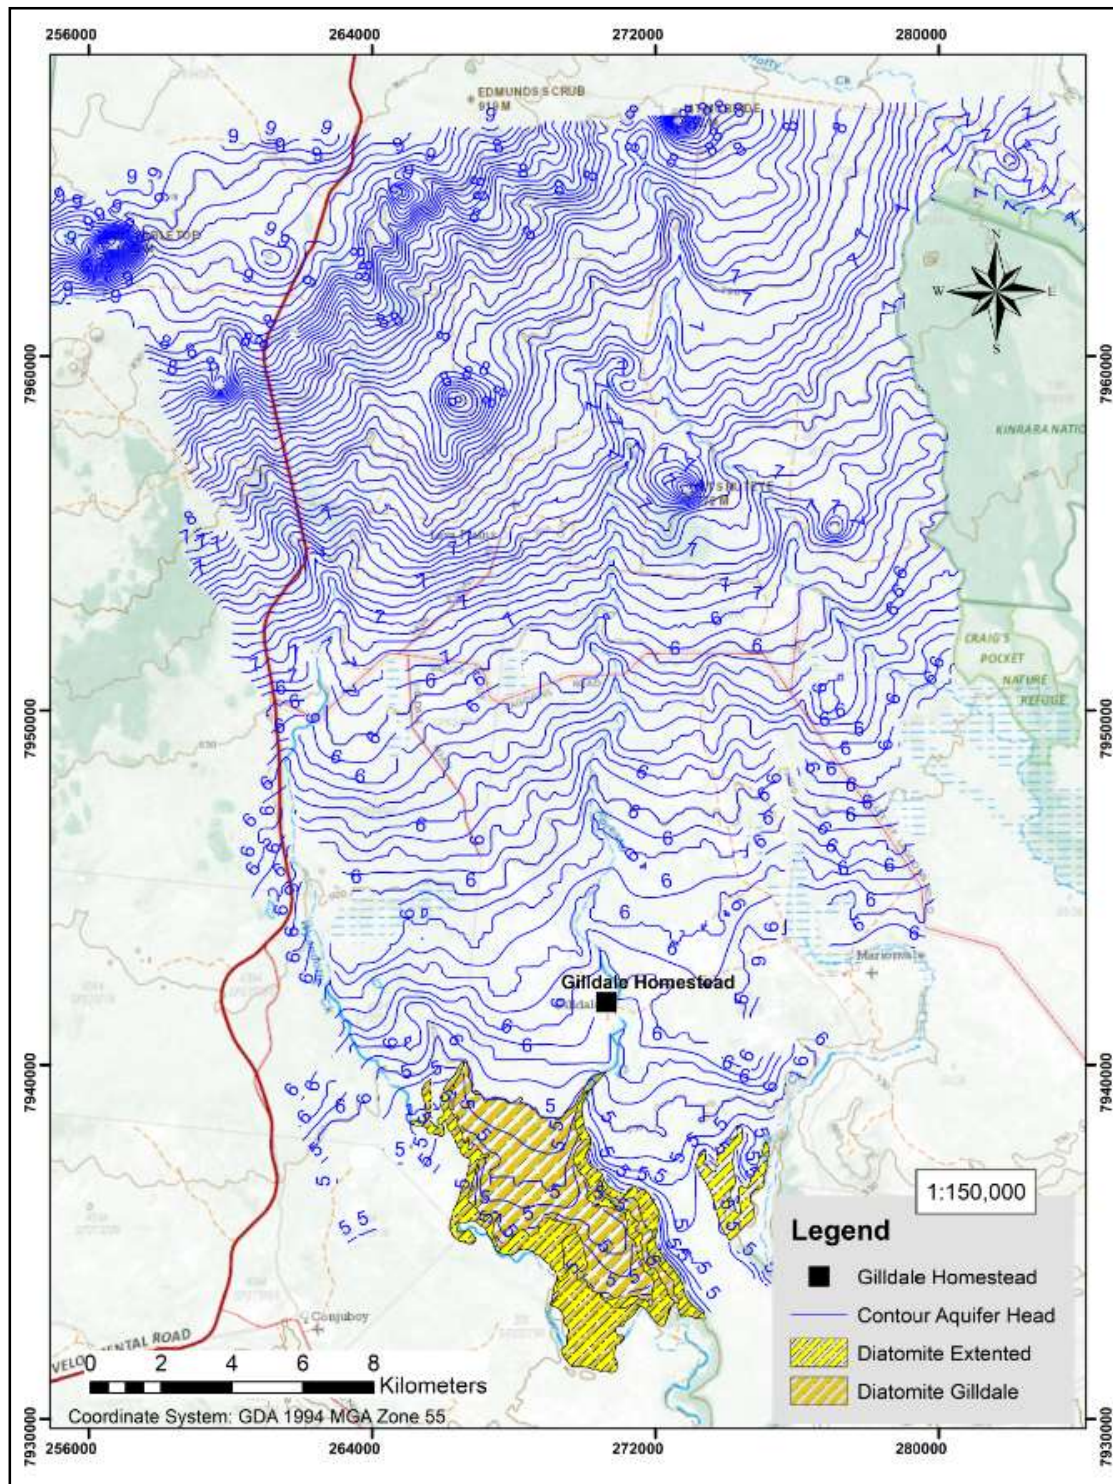
Figure 1 Groundwater Head Value contours for basaltic aquifer (including Diatomite) Gilldale.

Modelling for Darcy Flow and Direction in figure # provided below the best indication for drill locations, this model is based on using surface flow, topography and basalt depth as the most obvious course to locate paleochannels where groundwater is likely to flow to and be found.

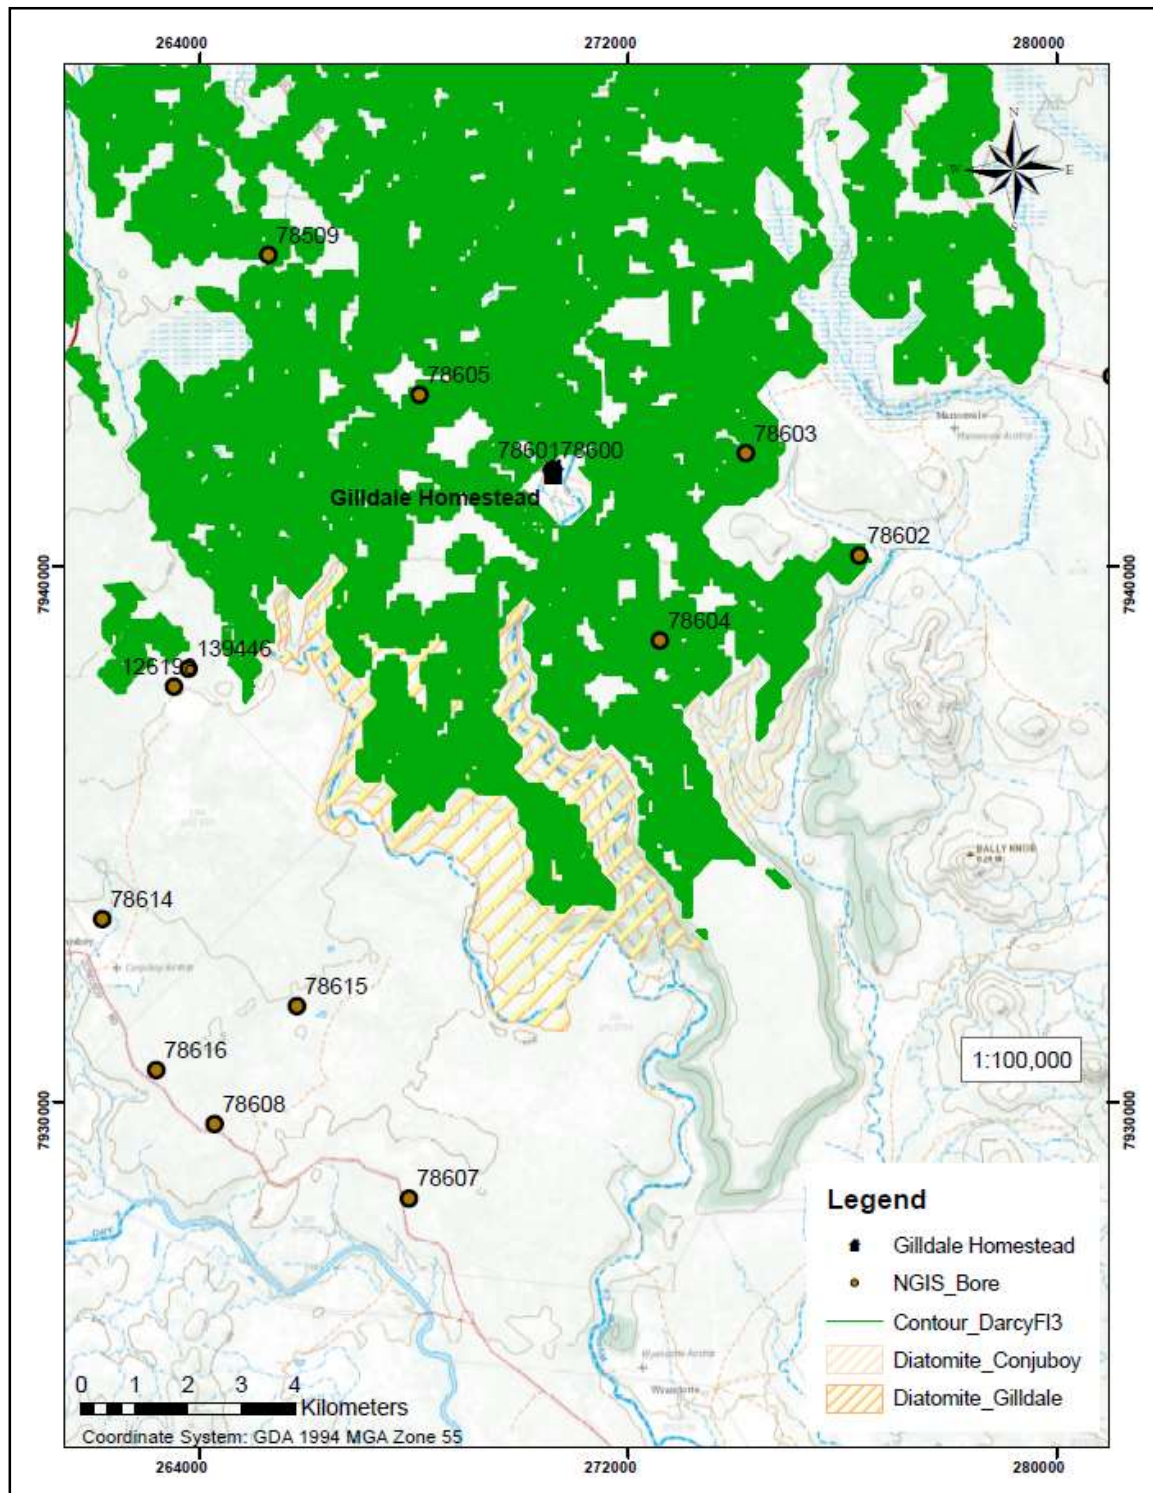
Figure 2 Indicated groundwater locations contoured in light green based on Darcy modelling.

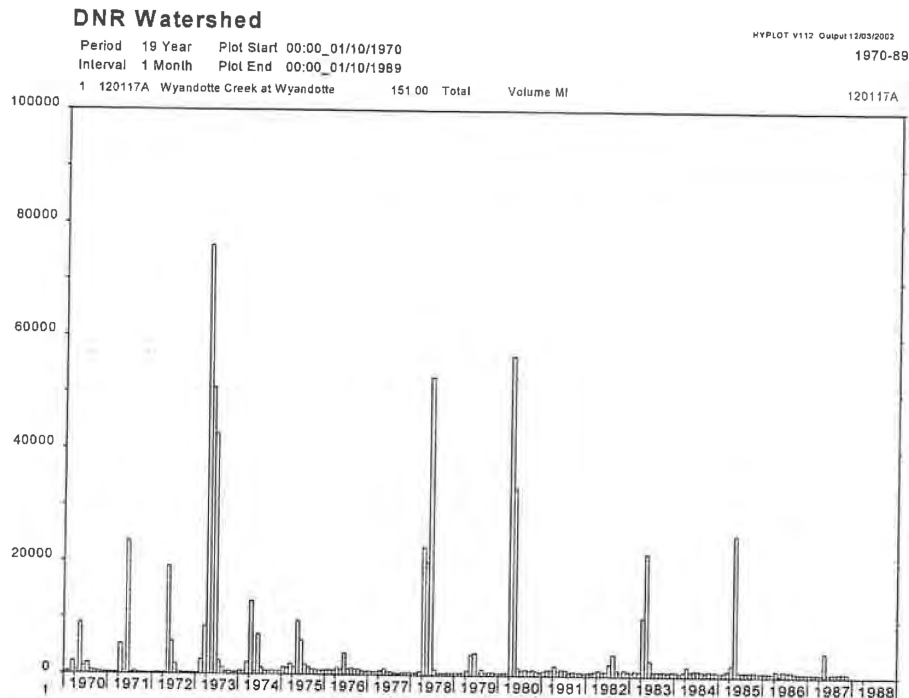
**Figure 5.1: Mean monthly flow in ML at GS 120117A**  
(source NRM Watershed website)

The mean monthly flow for the period of record at GS 120117A is presented graphically in Figure 5.1 below.

It can be seen from Figure 1 that, in most years, summer monthly flows generally range from around 10 000 to 25 000ML. It is expected that flows such as these would not inundate the mining site.
