# PROGRESSIVE REHABILITATION AND CLOSURE PLAN

## AGRIPOWER AUSTRALIA LIMITED CONJUBOY DIATOMACEOUS EARTH PROJECT (ML 10279)

AGP008\_V01  
27 APRIL 2021  
VERSION 01

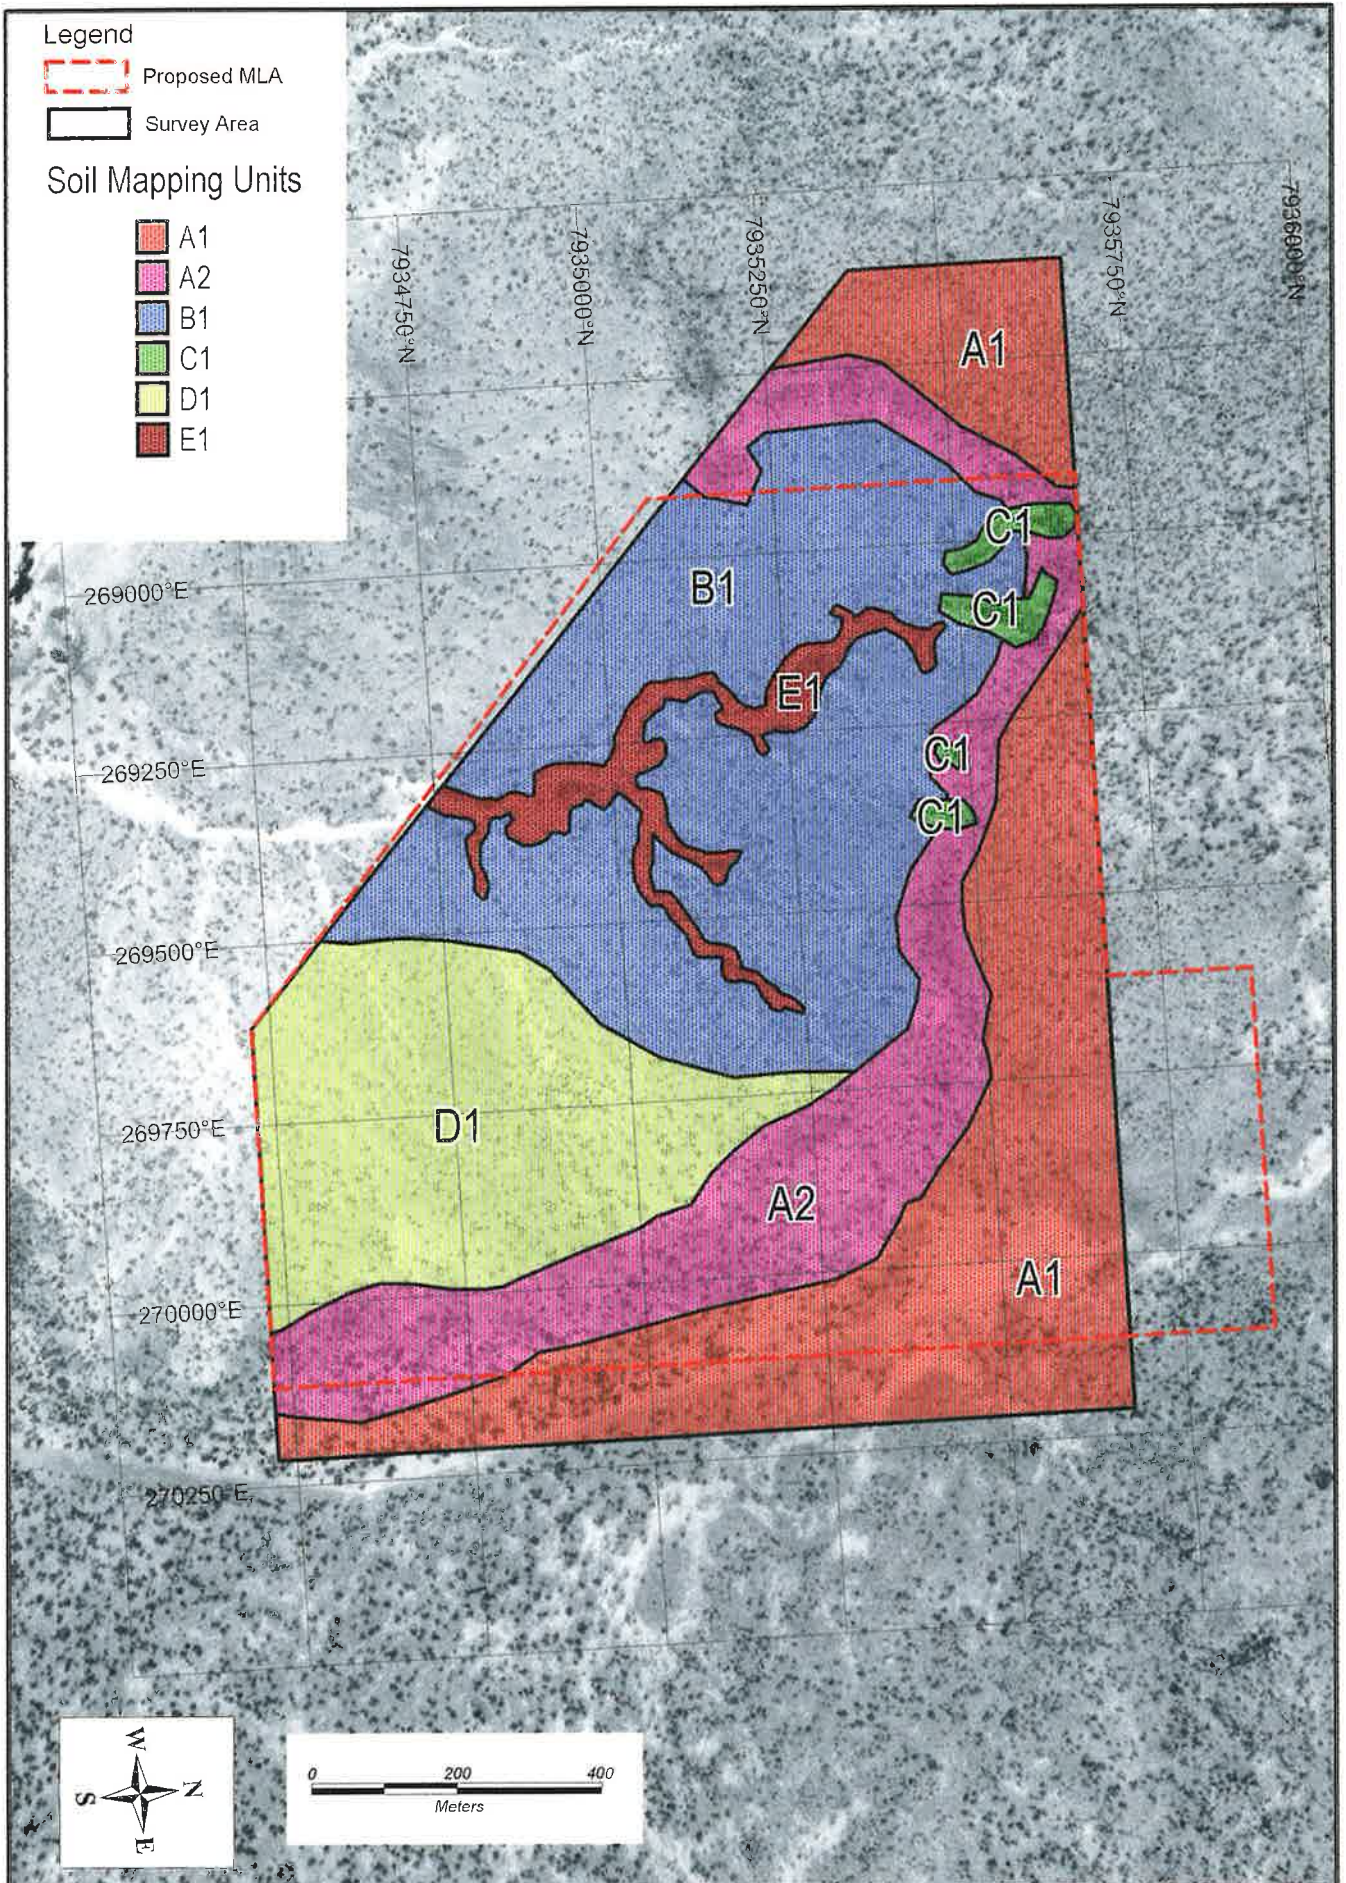
PROJECT: Conjuboy Diatomite Project  
TITLE: Distribution of soil mapping units

- Red Ferrosol (A1) – red clay soils on basalt (very dark brown, very slightly stony light firm clay),
- Red Ferrosol/Rudosol (A2) – stony red clay soils on basalt (very dark brown very slightly stony light soft clay),
- Black Vertosol (B1) – Dark cracking clay (dark grey stone-free medium very strong clay),
- Tenosol/Calcarosol (C1) – Shallow grey silt loam under tea trees (light greyish brown weak silt loam),
- Red Vertosol (D1) – Red/brown cracking clay (very dark brown, very slightly stony light very strong clay) and
- Tenosol (E1) – greyish brown weak silt loam.

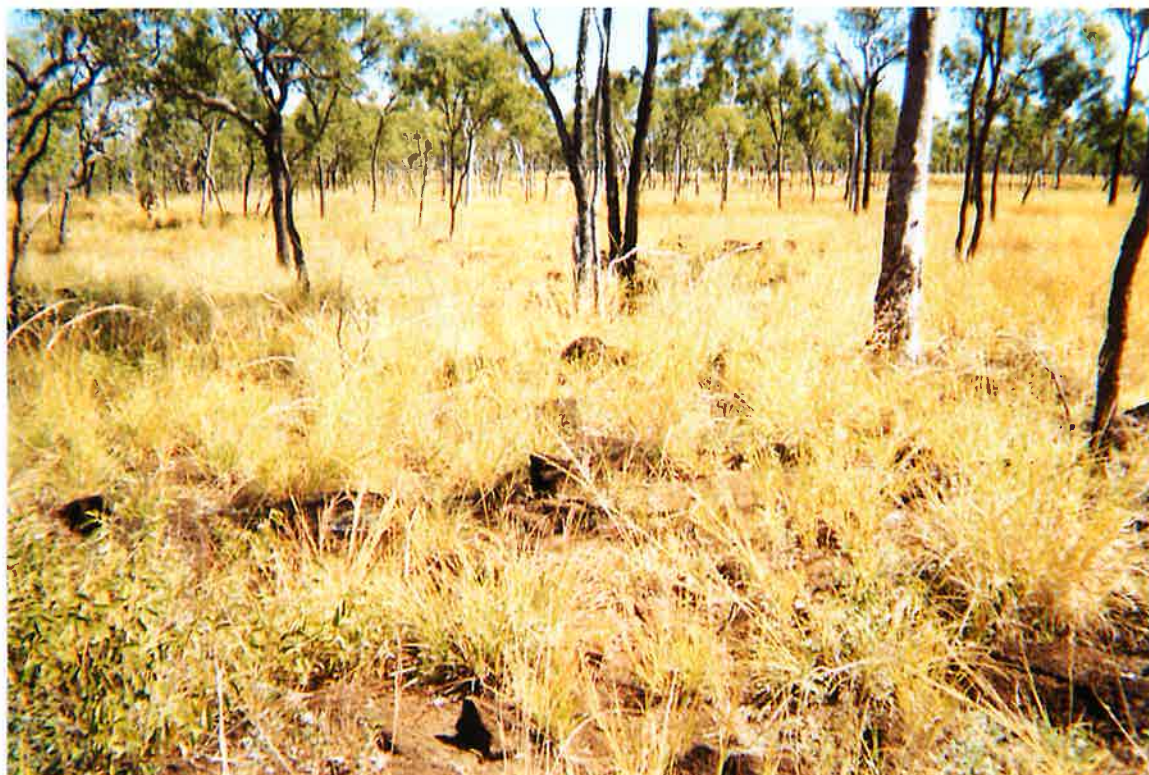
**Plate 2.1: Typical soil surface and vegetation – Mapping Unit A1**

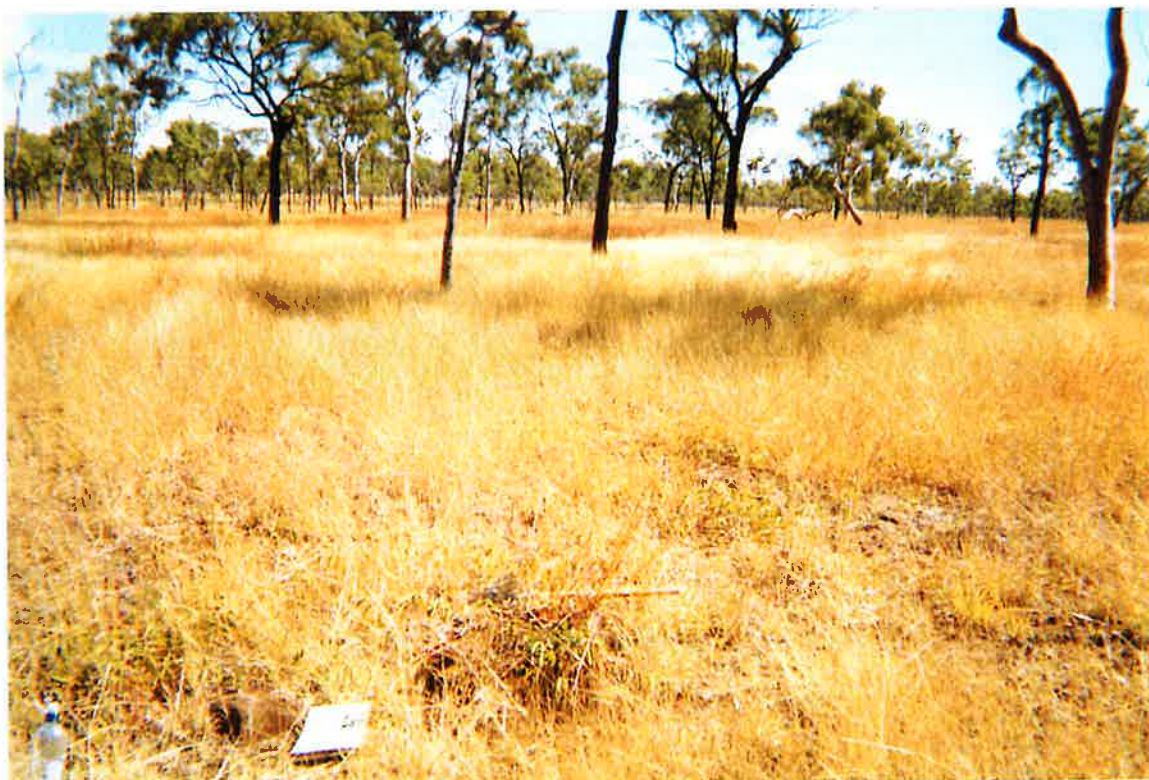
**Plate 2.2: Typical soil surface and vegetation – Mapping Unit A1**

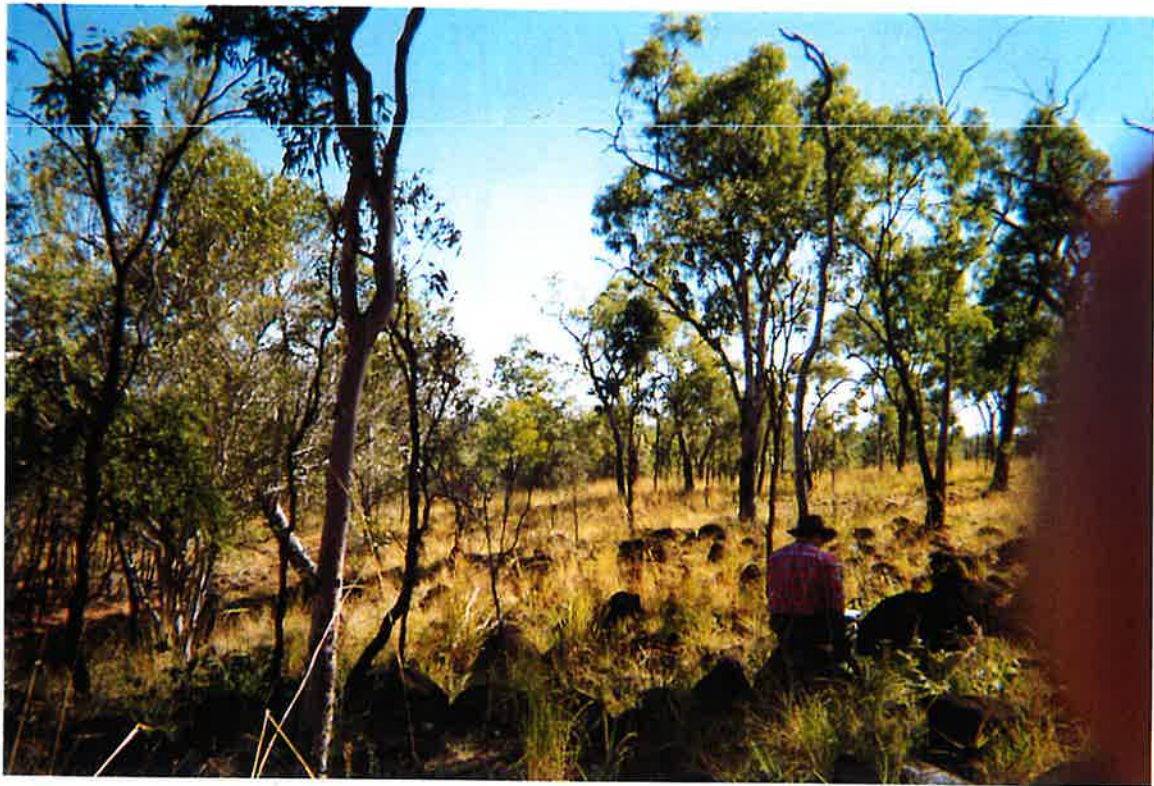
**Plate 2.3: Typical landscape – Mapping Unit A2**

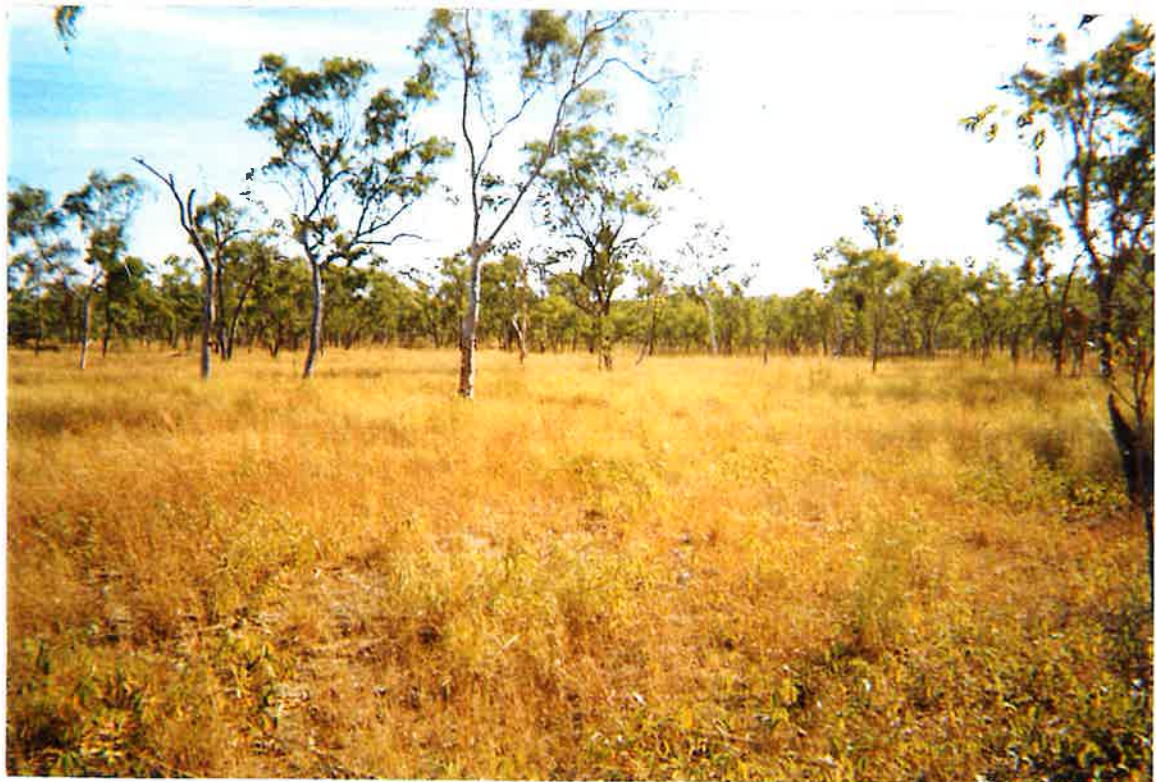
**Plate 2.5: Severe cattle treading (poaching) – Unit C1 (Observation Site 17)**

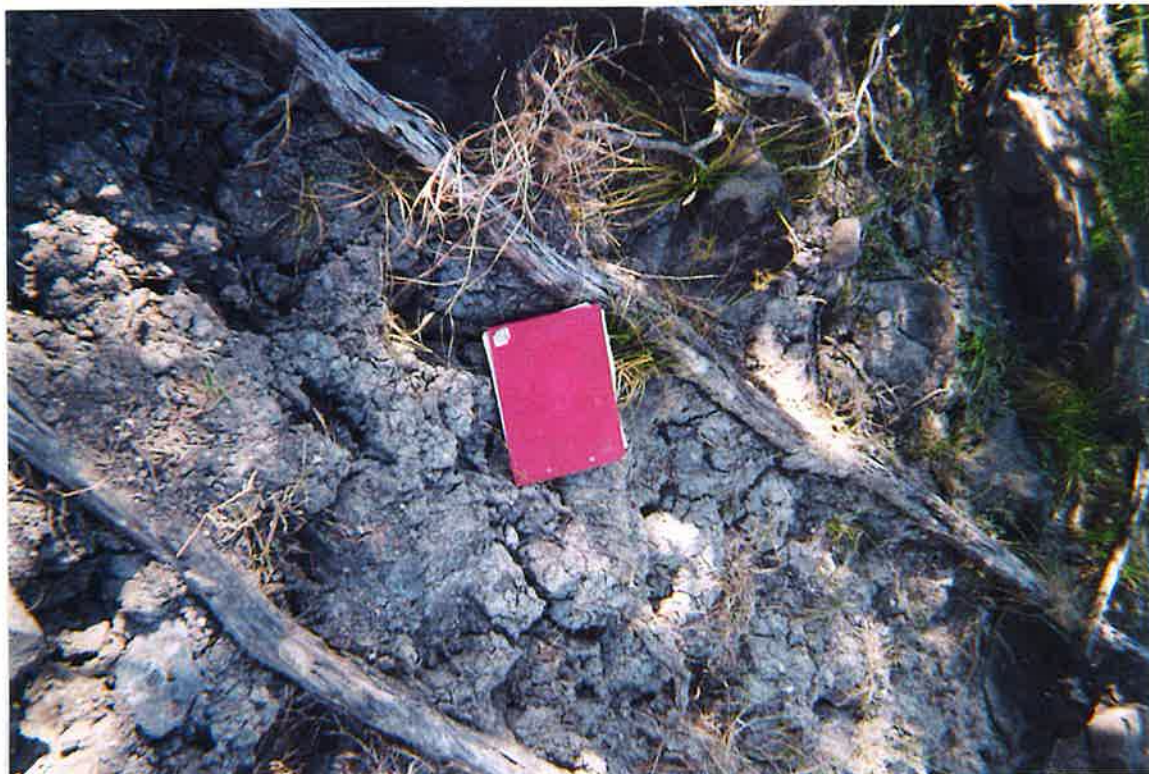
**Plate 2.6: Mapping Unit D1 – subsoil structural units and soil surface**

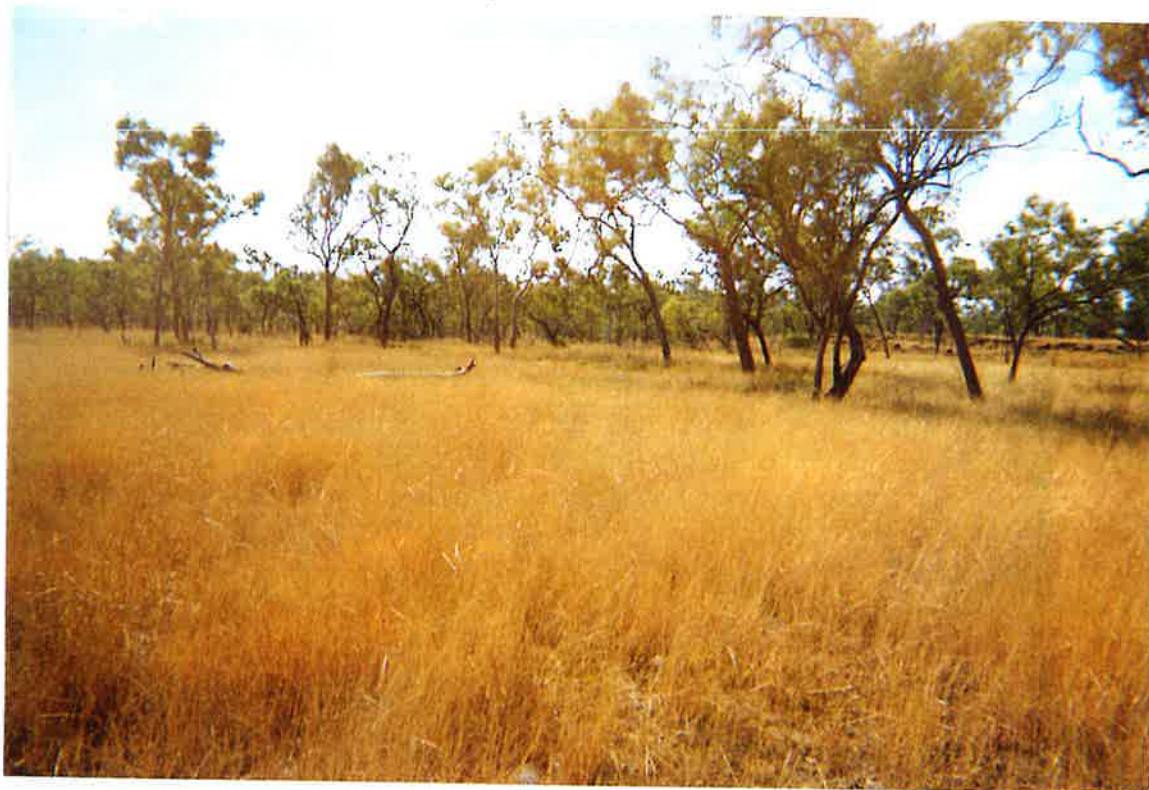
**Plate 2.7: Typical vegetation – Mapping Unit D1**

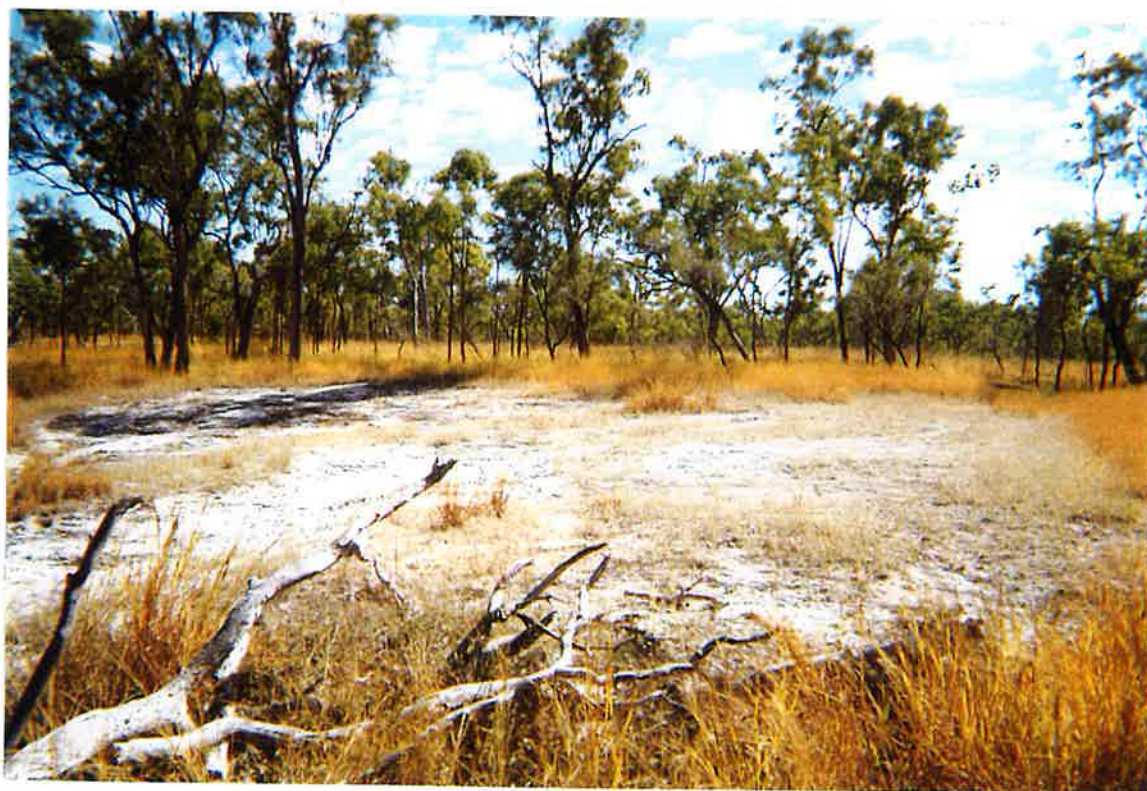
**Plate 2.8: Mapping Unit E1 (Site 15a)**

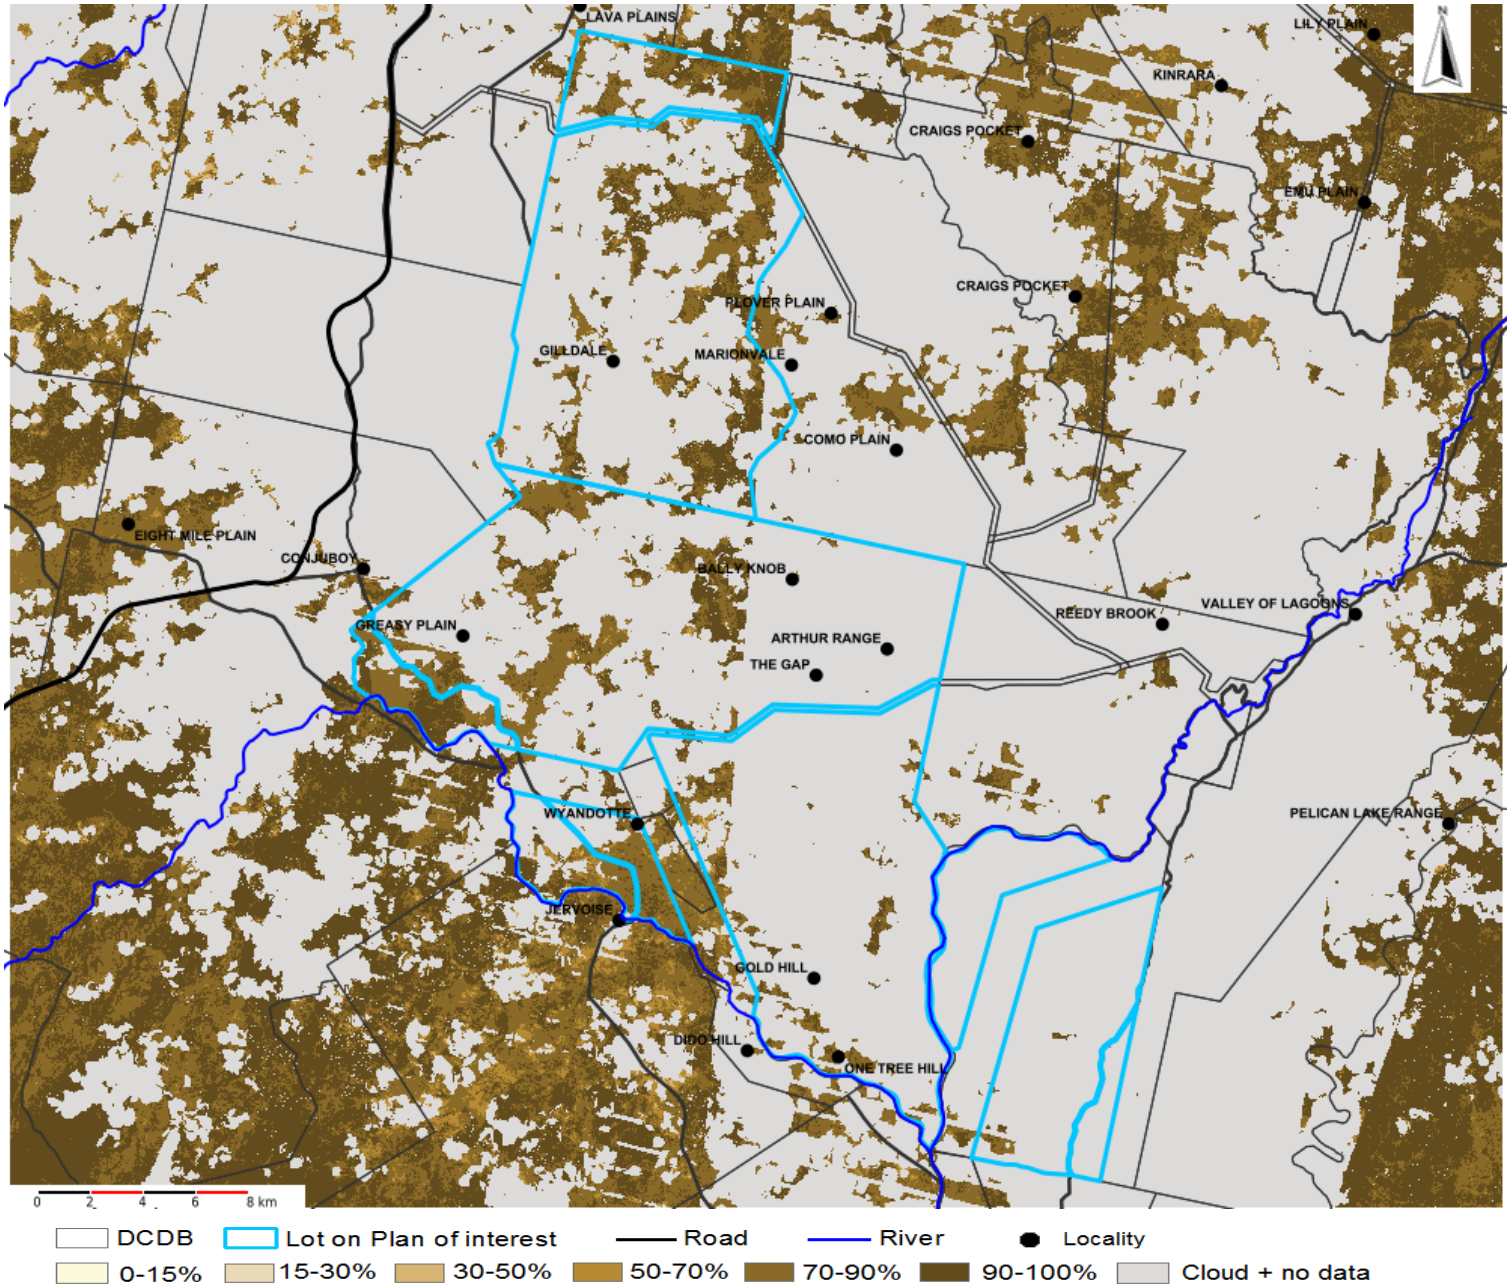
## Ground cover map (The image is for March 2019)

The monthly ground cover map shows the level of ground cover for areas on the Lot on Plan with less than 60% tree cover. The image is for March 2019. The percentage of the total area of the Lot on Plan for 6 ranges of ground cover levels are summarised below:

| Cover levels | <15% | 15 - 30% | 30 - 50% | 50 - 70% | 70 - 90% | >90% |
|---|---|---|---|---|---|---|
| Percentage out of the total area | 0.0 | 0.0 | 0.3 | 3.1 | 54.7 | 41.9 |

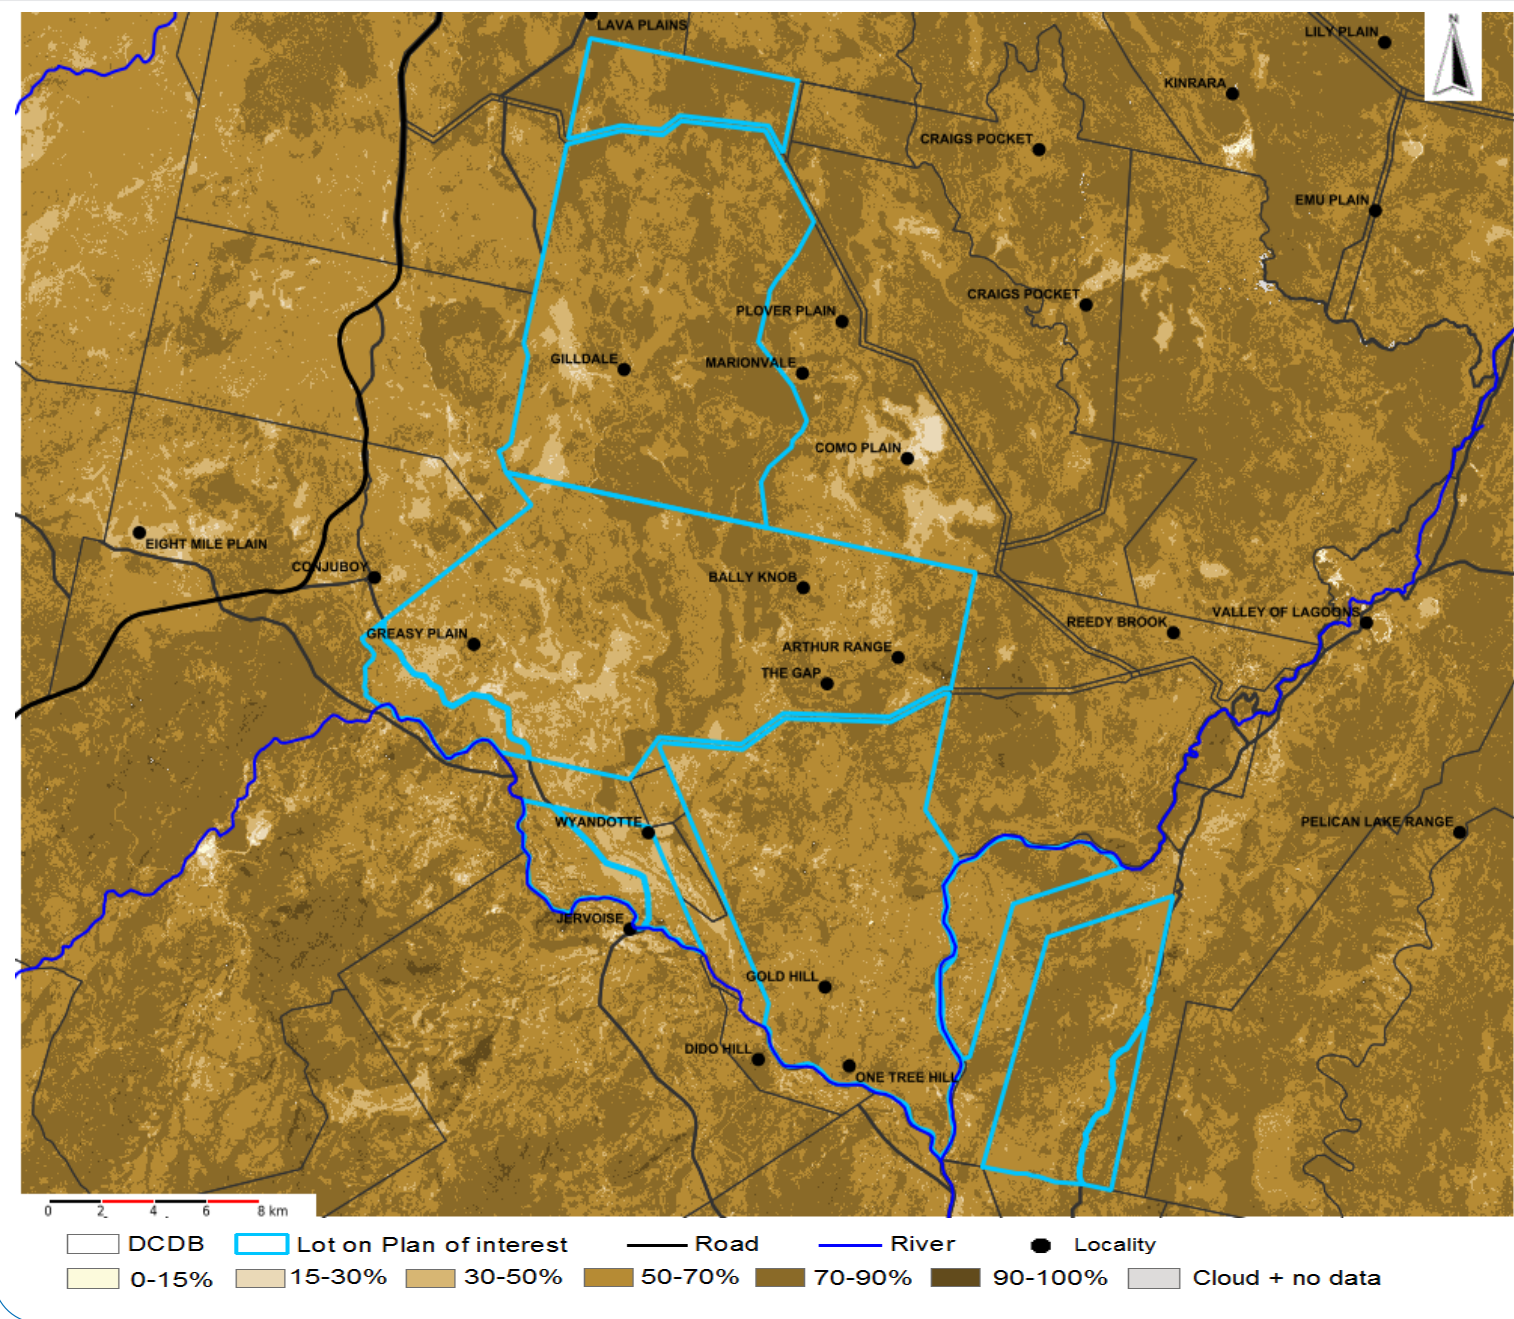
Minimum ground cover map for 1990 to 2016

The minimum ground cover map shows the lowest level of cover for the Lot on Plan which has been measured in the period 1986 to 2016. This map is useful for showing areas that may be vulnerable to low ground cover. The percentage of the total area of the Lot on Plan for 6 ranges of minimum ground cover levels are summarised below:

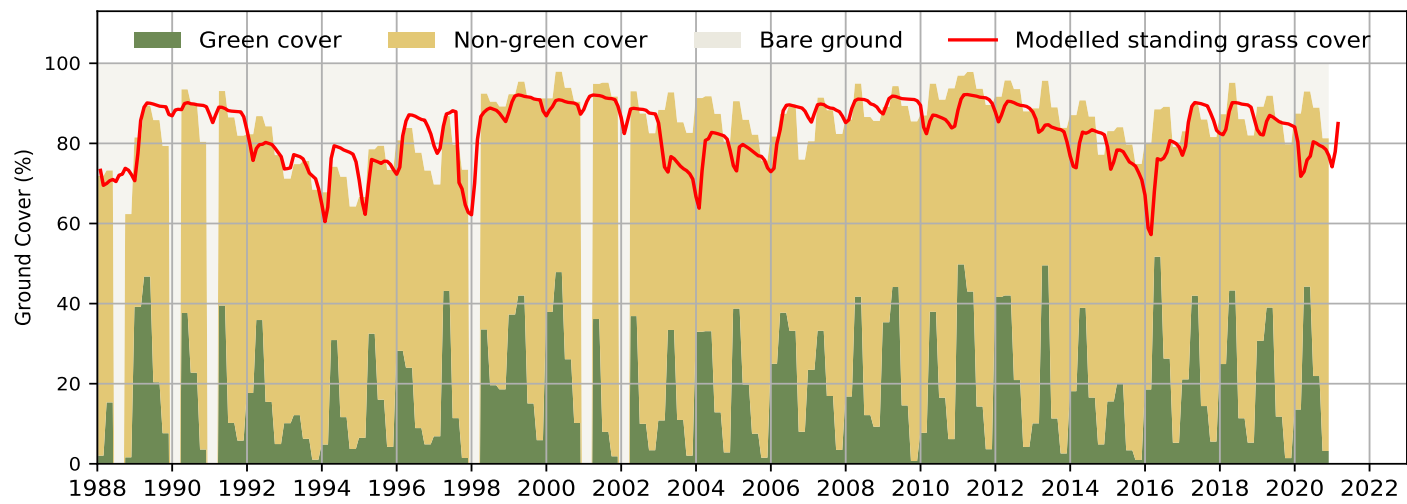
Seasonal ground cover time series graph

The time series graph shows the seasonal levels of ground cover for the Lot on Plan from 1988 to present. The ground cover level is also separated in the green and non-green components of the total level of ground cover. Gaps may occur on the graph where there was insufficient satellite data to derive a valid seasonal estimate of ground cover (e.g. due to persistent cloud over a season). The solid red line on the graph represents modelled seasonal average standing grass cover for the Lot on Plan. This is derived from the AussieGRASS model. It is included to provide an indication of the amount of the measured ground cover that is likely to be standing grass cover. The satellite-derived estimates of ground cover include all cover components, and therefore does not distinguish between standing grass cover and litter on the ground, particularly in the non-green component.

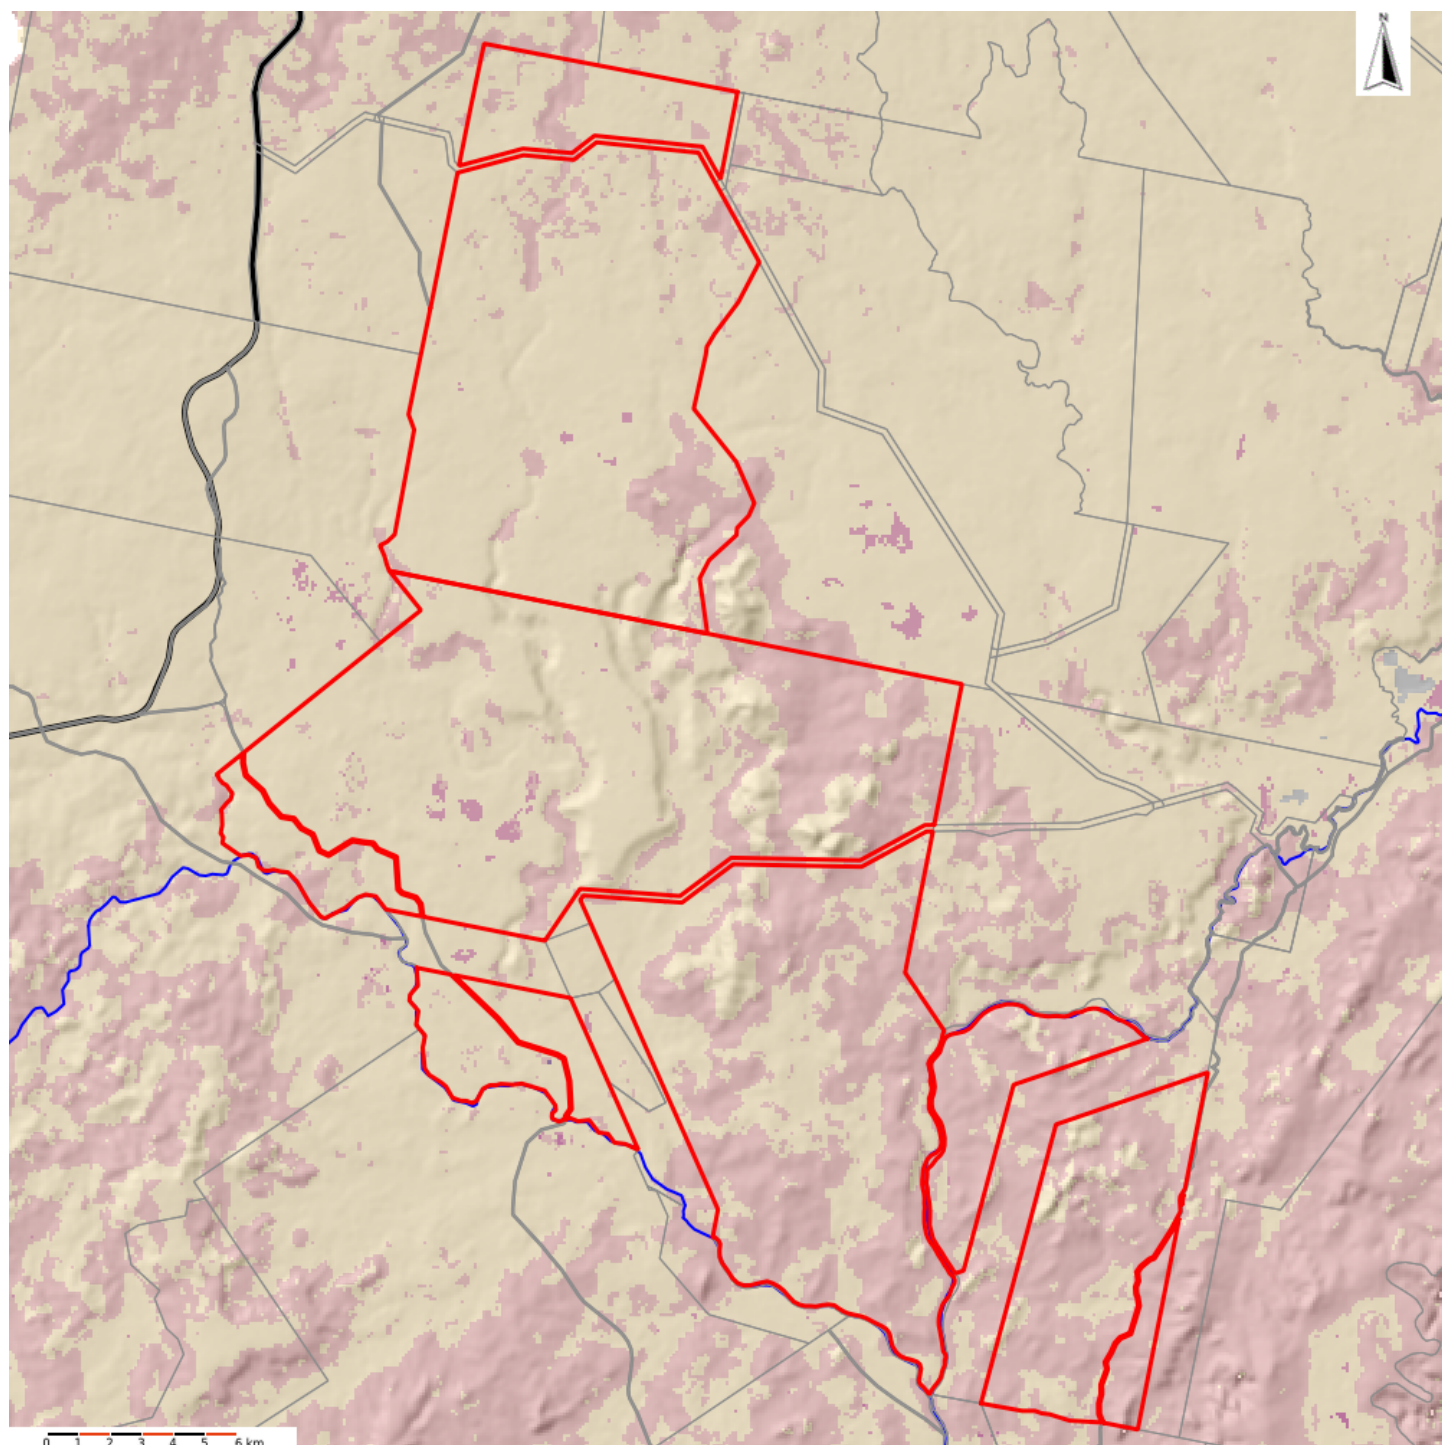
## Map 1 - Overall soil erodibility ranking

Soils have been ranked into five broad categories of erodibility (very low to very high). They have been derived from a combination of surface soil stability and subsoil erodibility. The table on the first page shows the possible combinations. Using the Table in the About the Maps section and Maps 2 and 3, you can determine the soils likely to occur.

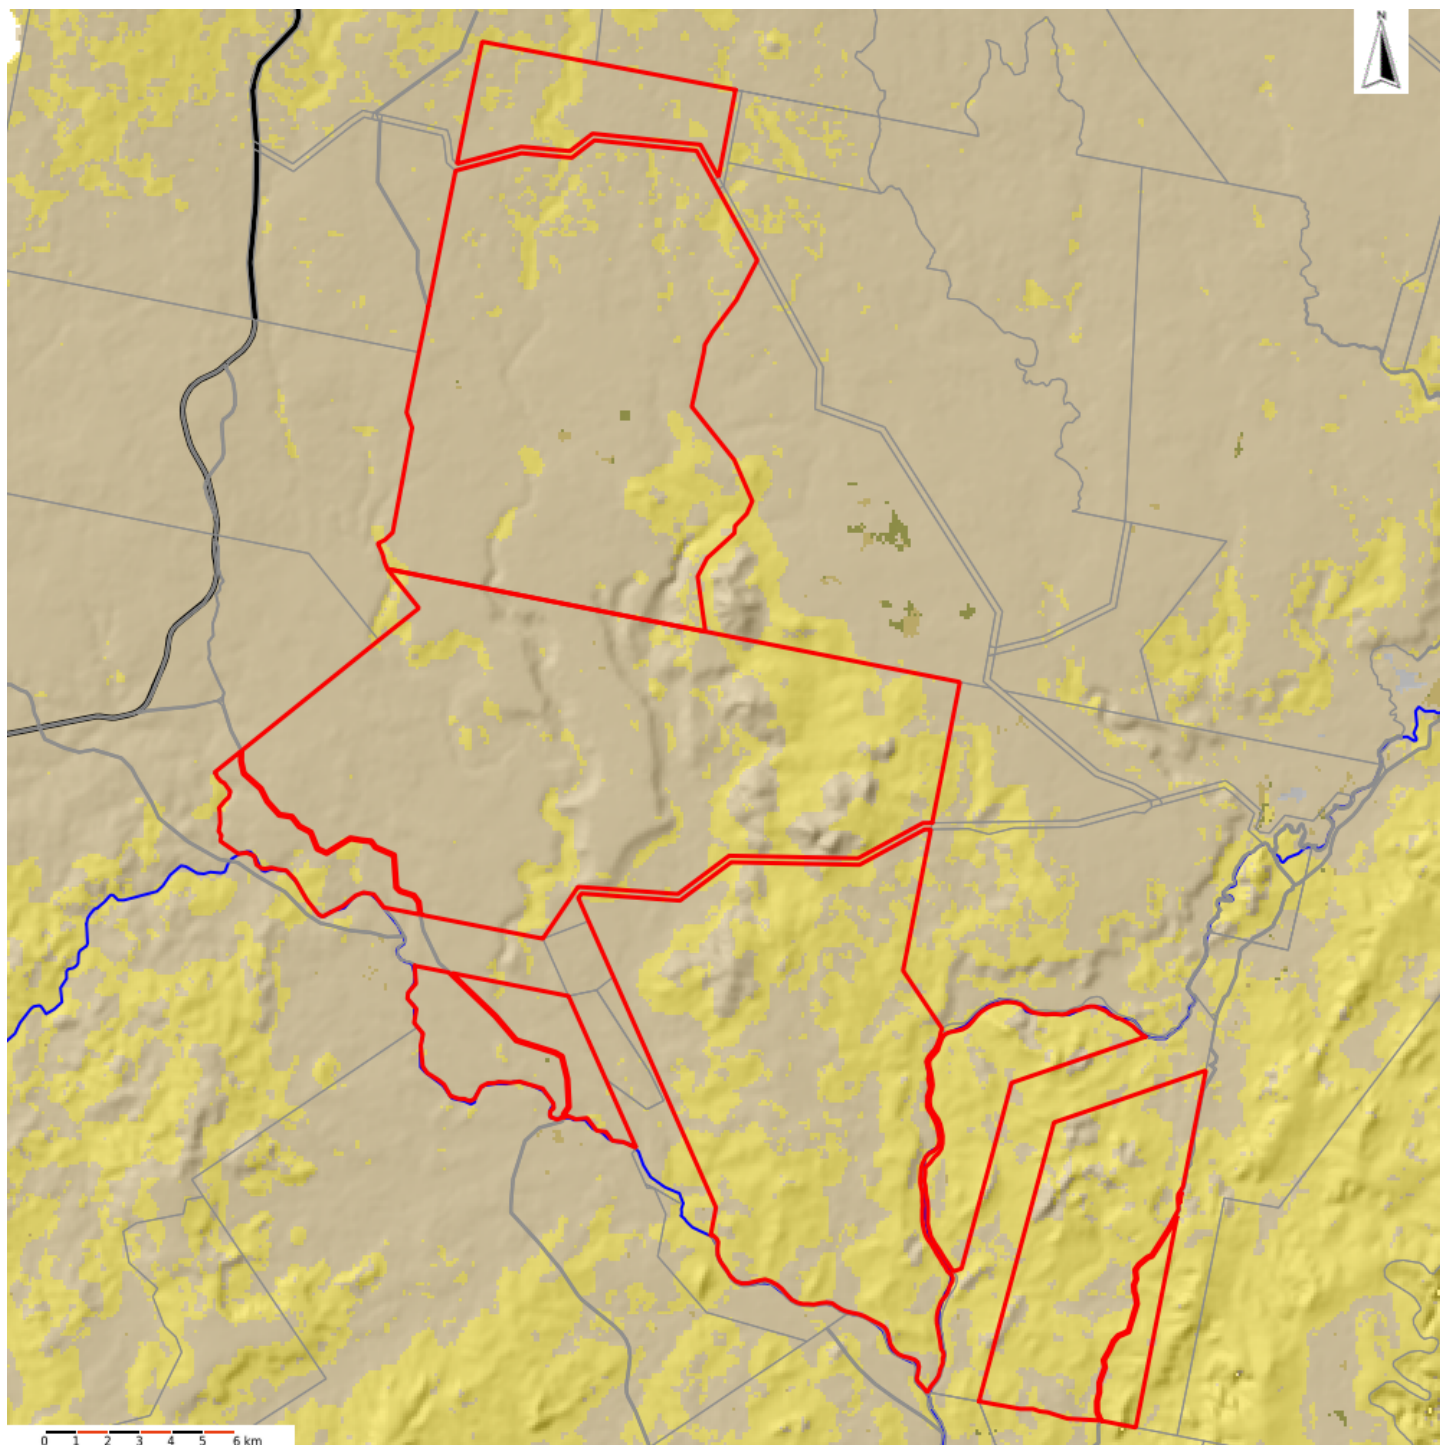
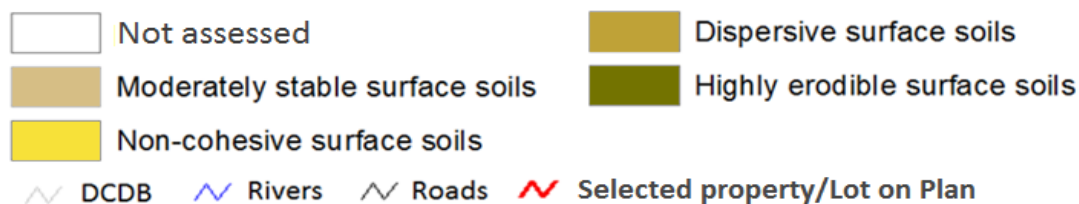
## Map 2 - Surface soil stability

1. Moderately stable surface soils are usually structured and resilient to degradation .
2. Non-cohesive surface soils are sandy soils that are not structured or only weakly so and non-cohesive. These soils are easily eroded.
3. Dispersive surface soils are loamy or clayey soils that are sodic, hardsetting and are likely to disperse in water.
4. Highly erodible surface soils are clayey soils that are sodic and dominated by shrink/swell clays that readily disperse.

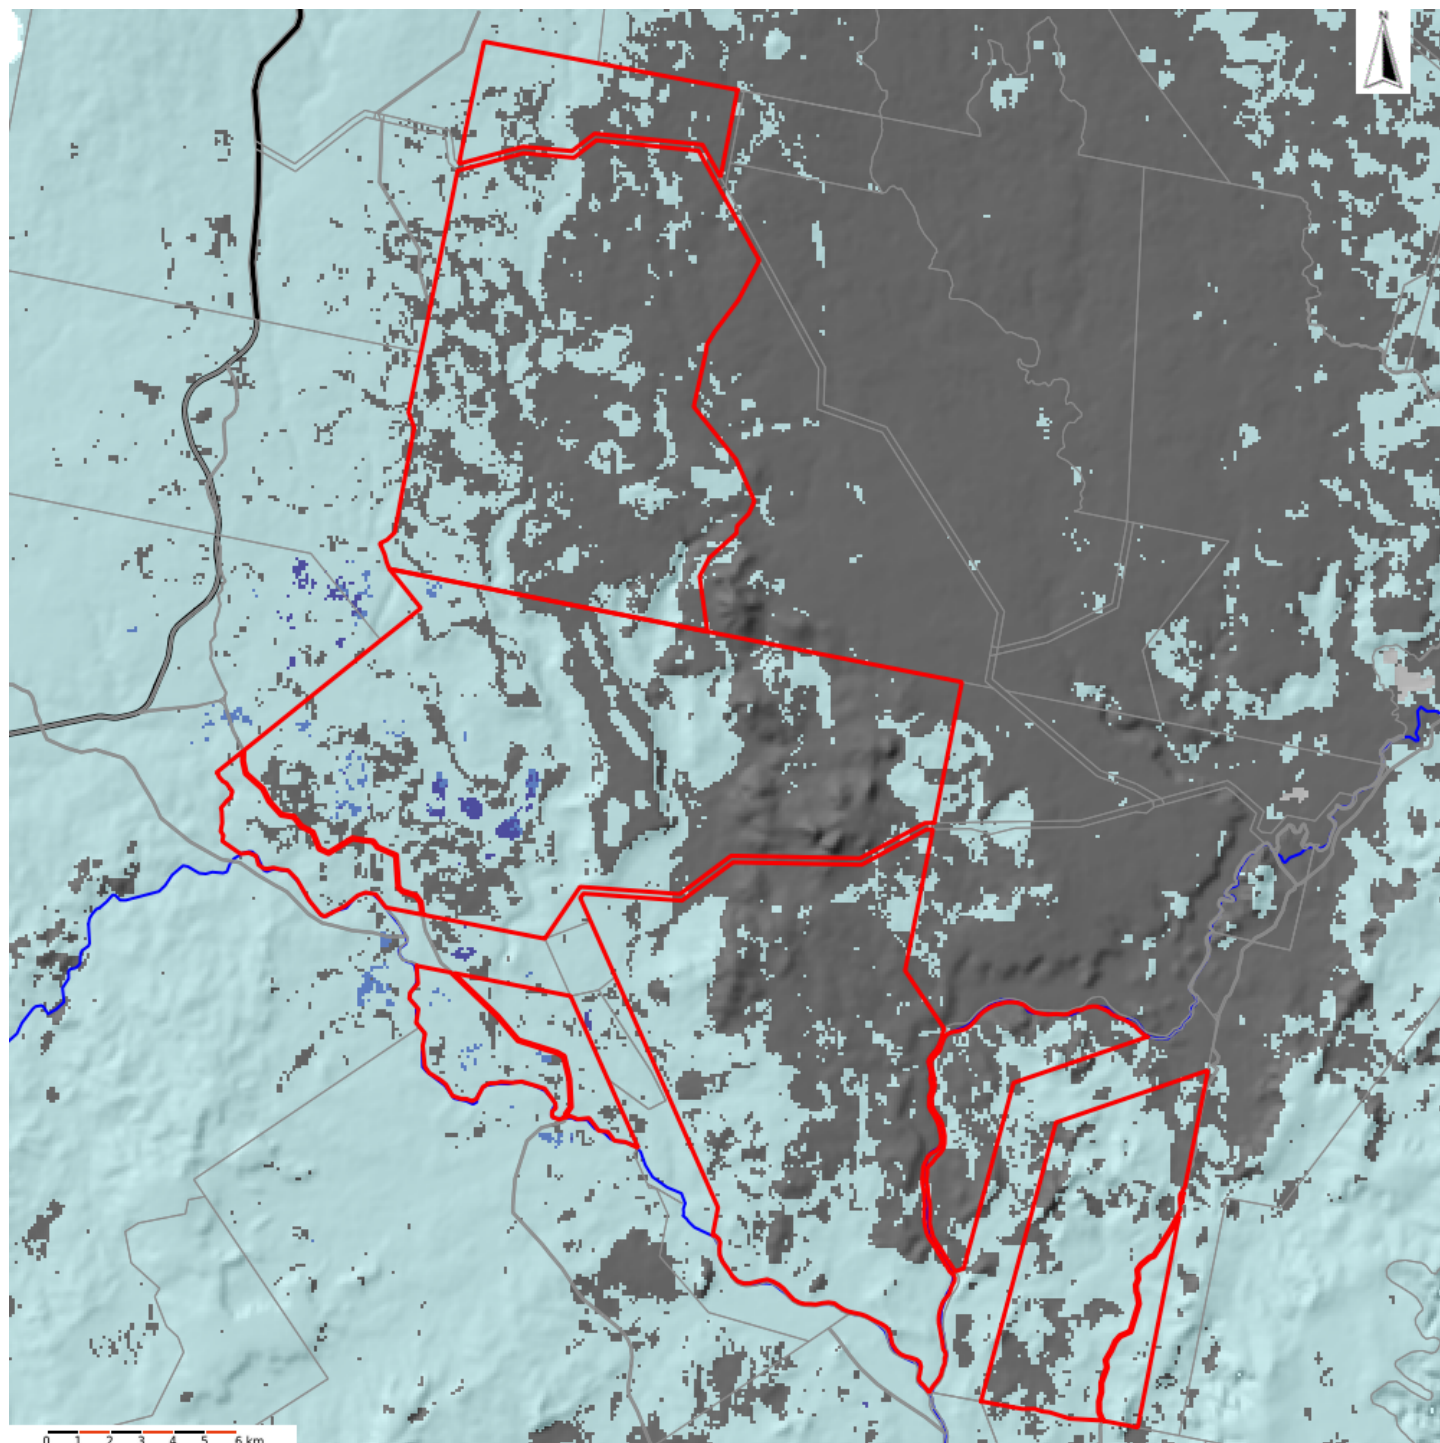
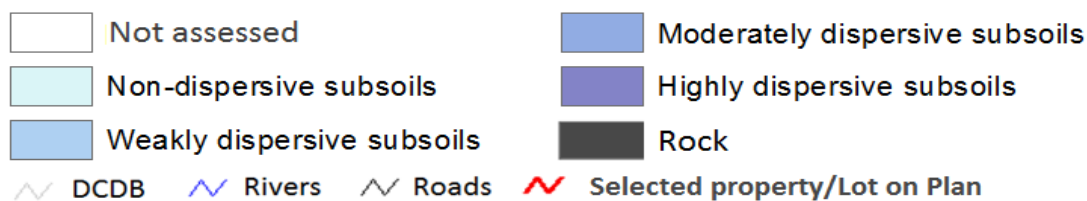
## Map 3 - Subsoil dispersibility

1. Non-dispersive subsoils that are non-sodic or only weakly sodic and are unlikely to disperse.
2. Weakly dispersive subsoils are sodic subsoils that are saline or dominated by carbonate nodules that prevent these subsoils from dispersing readily.
3. Dispersive subsoils are sodic subsoils that disperse readily.
4. Highly dispersive subsoils are sodic subsoils that are also dominated by magnesium ions that enhance the dispersive affect.

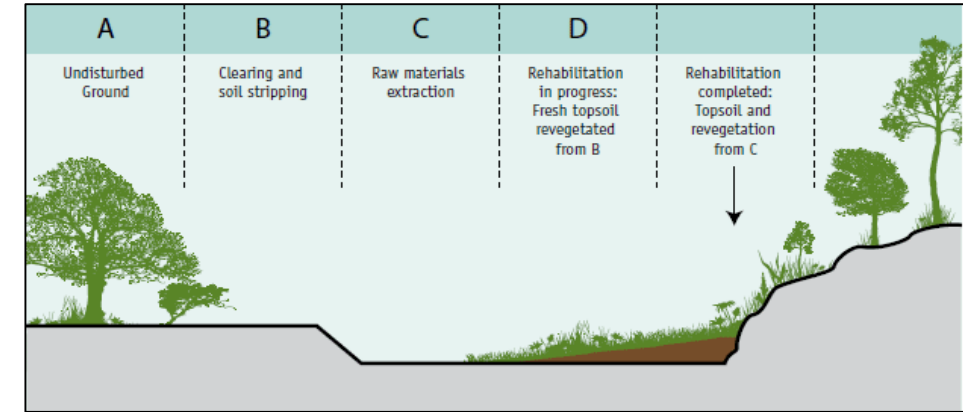
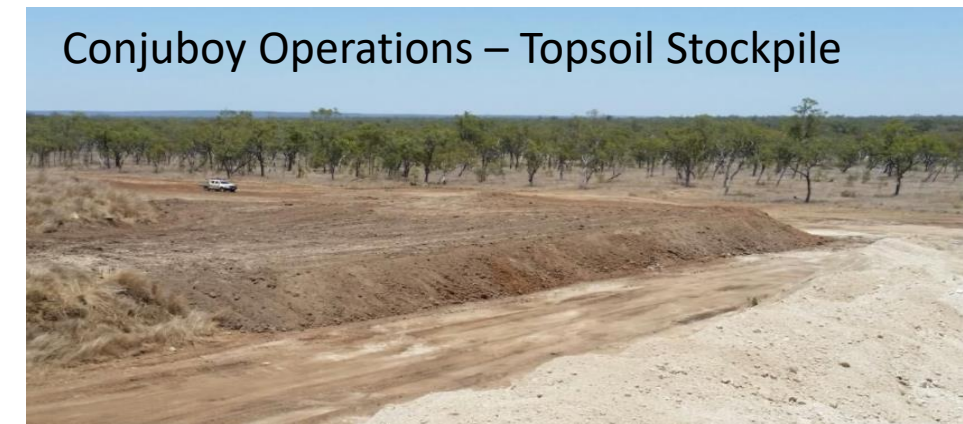
Once the open pit develops and the mining face has been determined to be far enough ahead of the rehabilitation area, the stockpiled overburden is pushed back into the open pit with a dozer. The slopes are then re-contoured to less than 10 degrees to control surface runoff and to ensure a stable slope remains. Topsoil is then spread to a depth of 150 millimetres before the area is contour ripped, fertilised and seeded with local native bush species comprising grasses, groundcovers, shrubs and trees.
