# PROGRESSIVE REHABILITATION AND CLOSURE PLAN

## AGRIPOWER AUSTRALIA LIMITED CONJUBOY DIATOMACEOUS EARTH PROJECT (ML 10279)

AGP008\_V01  
27 APRIL 2021  
VERSION 01

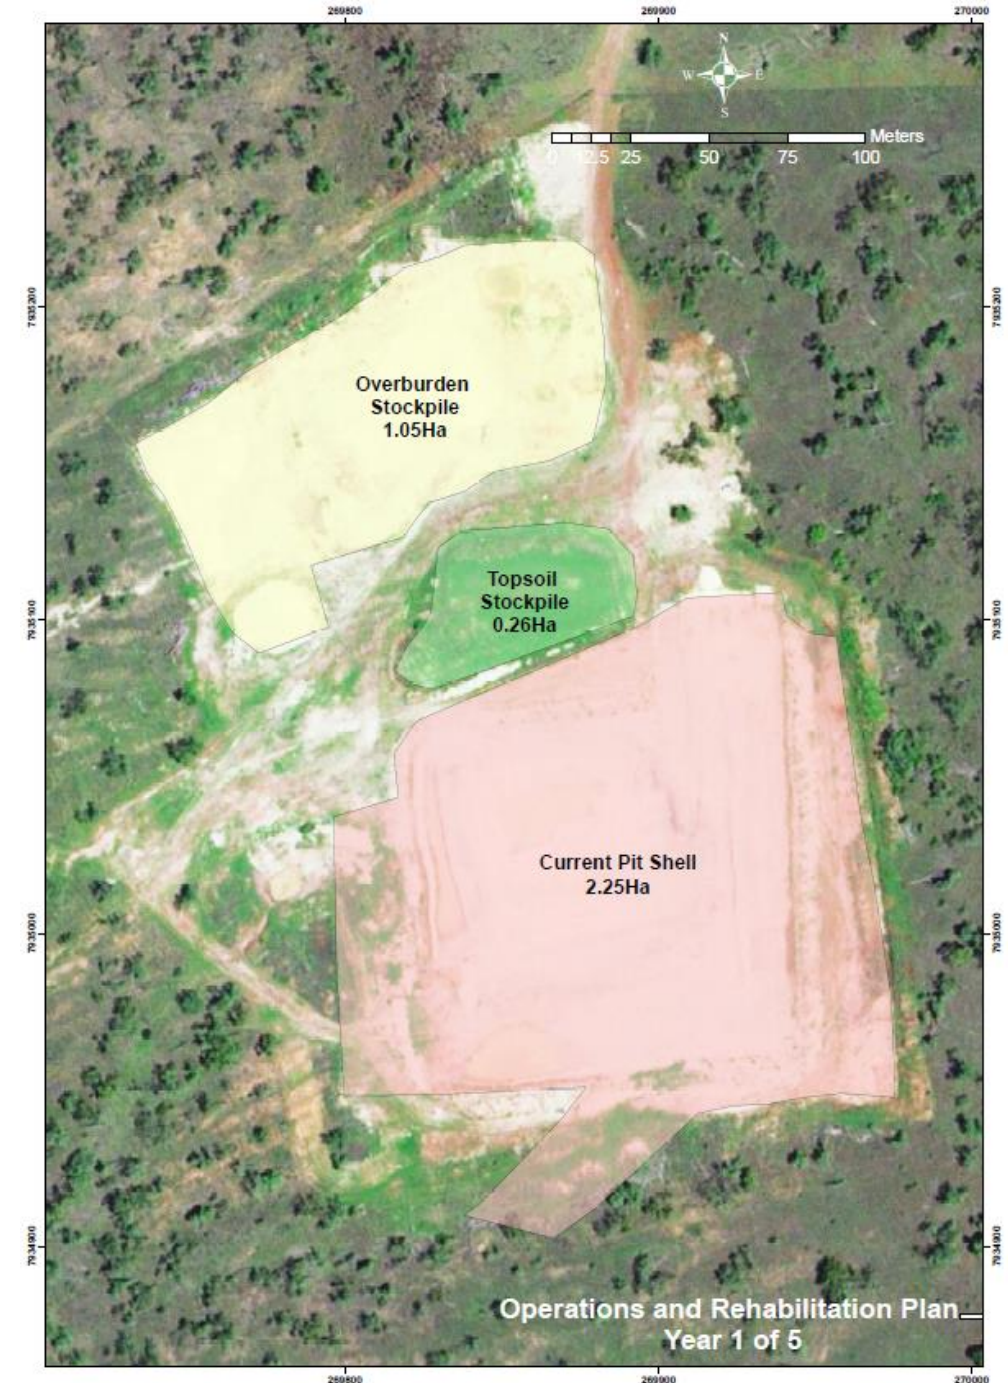
### Rehabilitation Program – Year 1 of 5

- Mining will continue from current pit extents
- Ore stocks will be removed from Mine to Plant site
- No further overburden or topsoil removed and stockpiled
- No rehabilitation as work plan still operating in open pit extents

Total Area Rehabilitated – 0 Ha

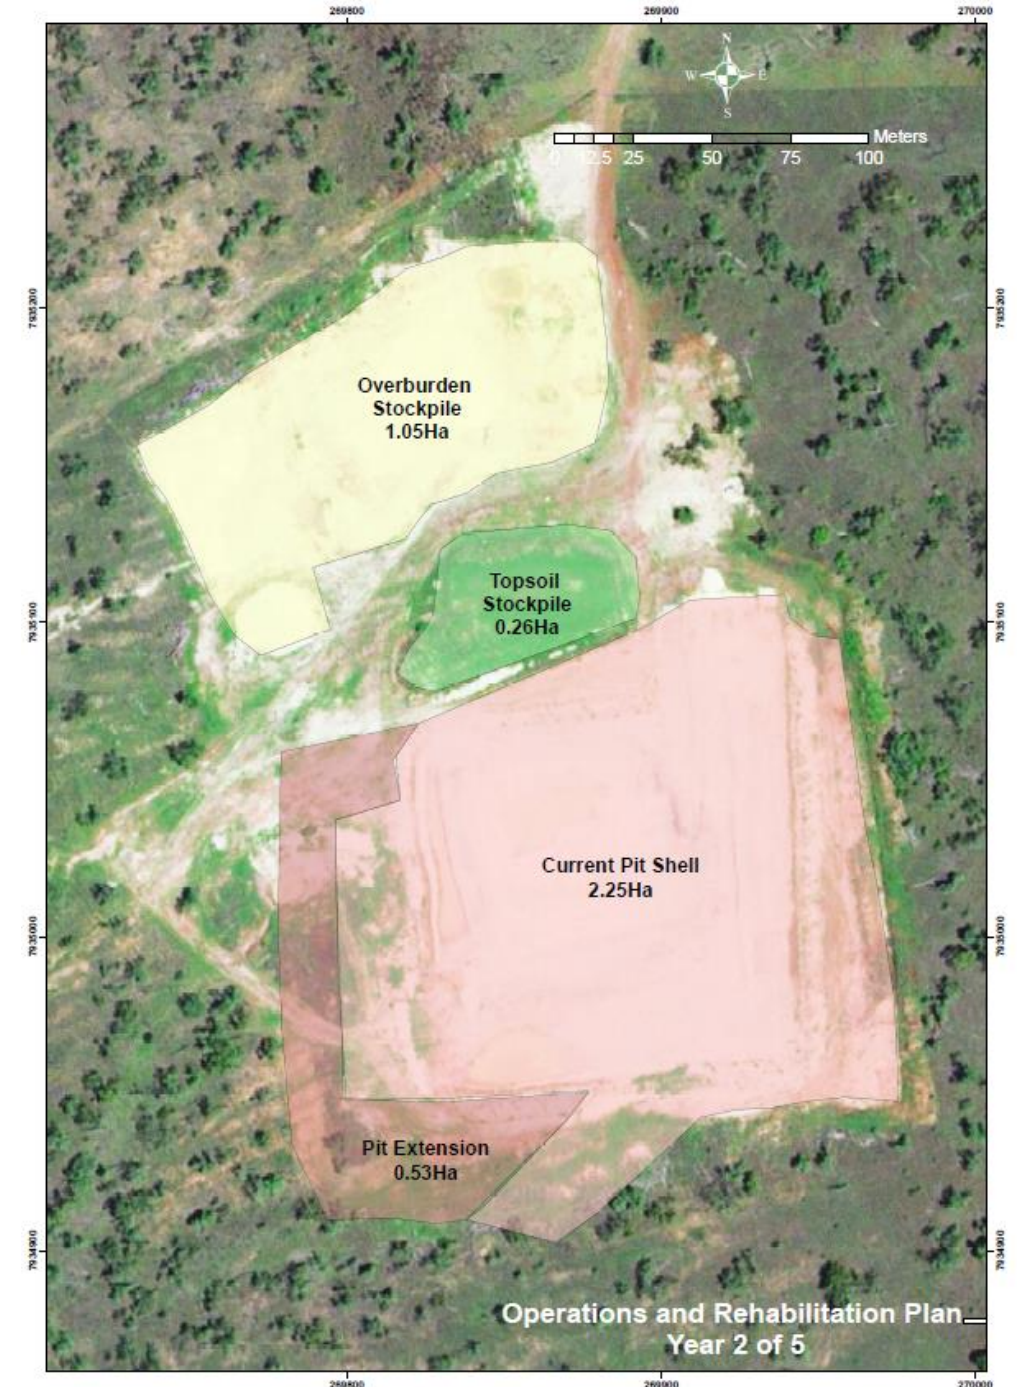
### Rehabilitation Program – Year 2 of 5

- A further 0.53Ha of clearing will occur to east of mining pit
- Topsoil will be removed and stockpiled on current topsoil stockpile
- Overburden will be removed and stockpiled on current overburden stockpile
- Mining of ore will continue from expanded open pit
- Ore stocks will be removed from Mine to Plant site
- No rehabilitation as work plan still operating in open pit extents

Total Area Rehabilitated – 0 Ha

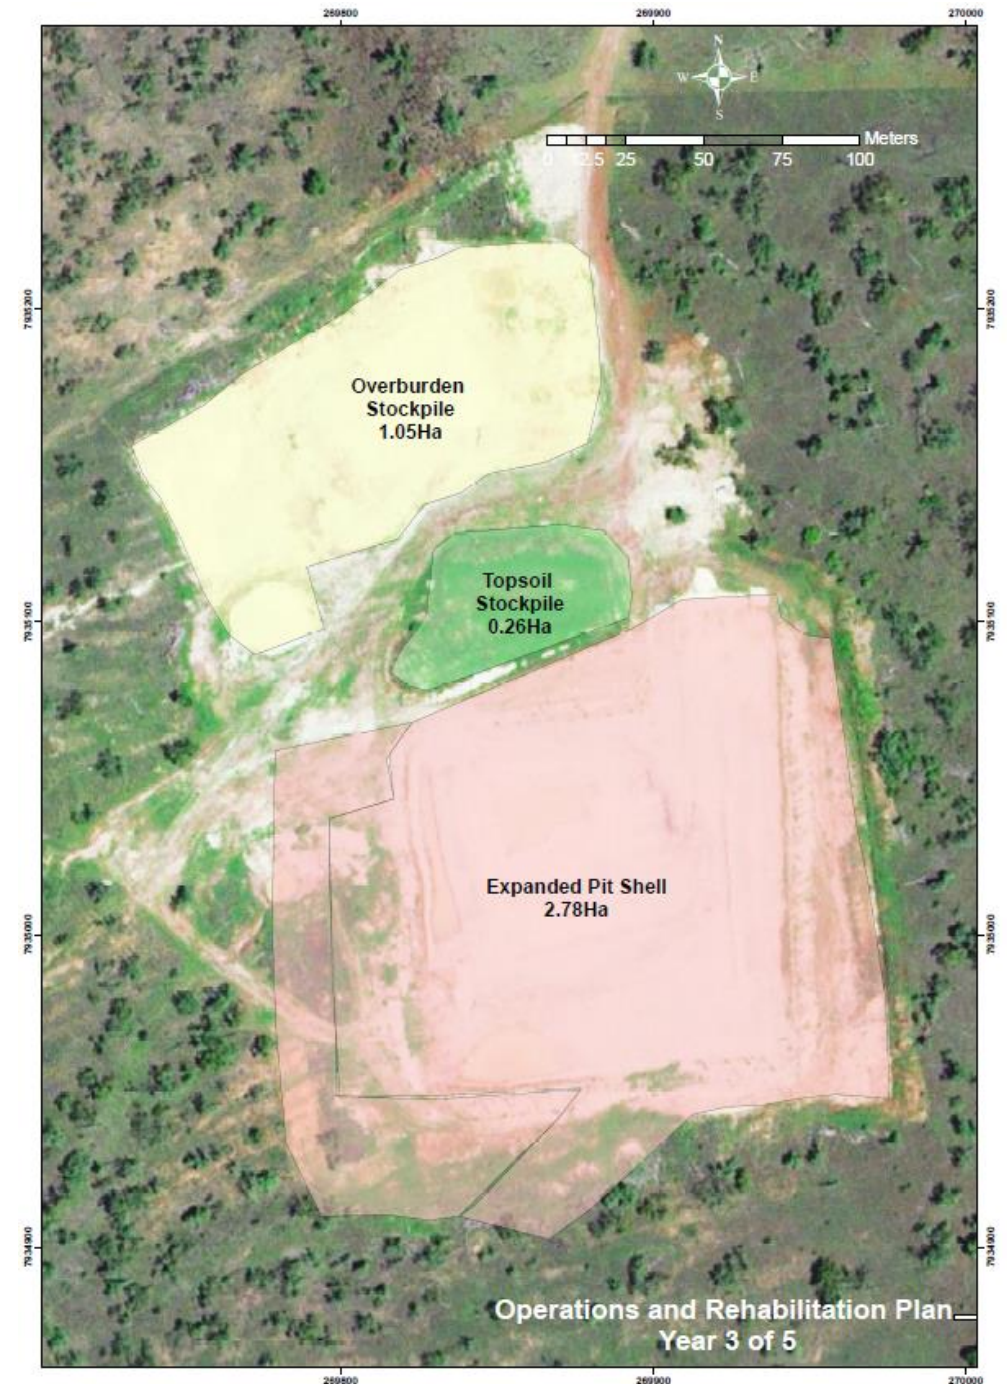
## Conjuboy Operations – ML10279 Rehabilitation Program – Year 3 of 5

Total Lease Area - 133Ha  
Total Disturbed Area - 4.66Ha  
Percentage of Lease Area Disturbed - 3.5%

- Mining of ore will continue from expanded open pit
- Ore stocks will be removed from Mine to Plant site
- No further overburden or topsoil removed and stockpiled
- No rehabilitation as work plan still operating in open pit extents

Total Area Rehabilitated – 0 Ha

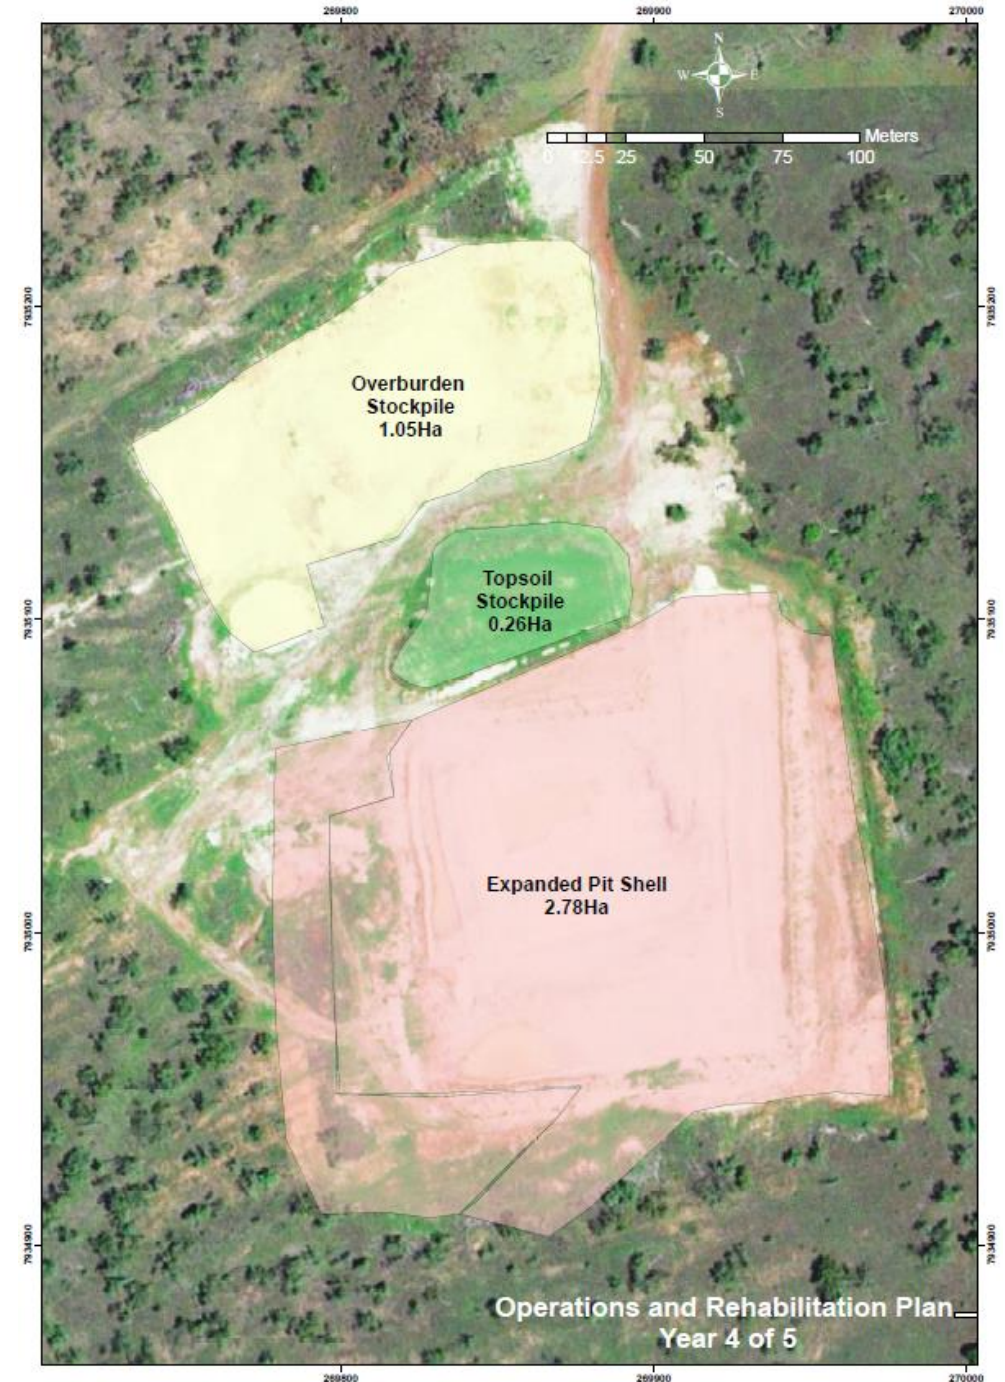
### Rehabilitation Program – Year 4 of 5

- Mining of ore will continue from expanded open pit
- Ore stocks will be removed from Mine to Plant site
- No further overburden or topsoil removed and stockpiled
- No rehabilitation as work plan still operating in open pit extents

Total Area Rehabilitated – 0 Ha

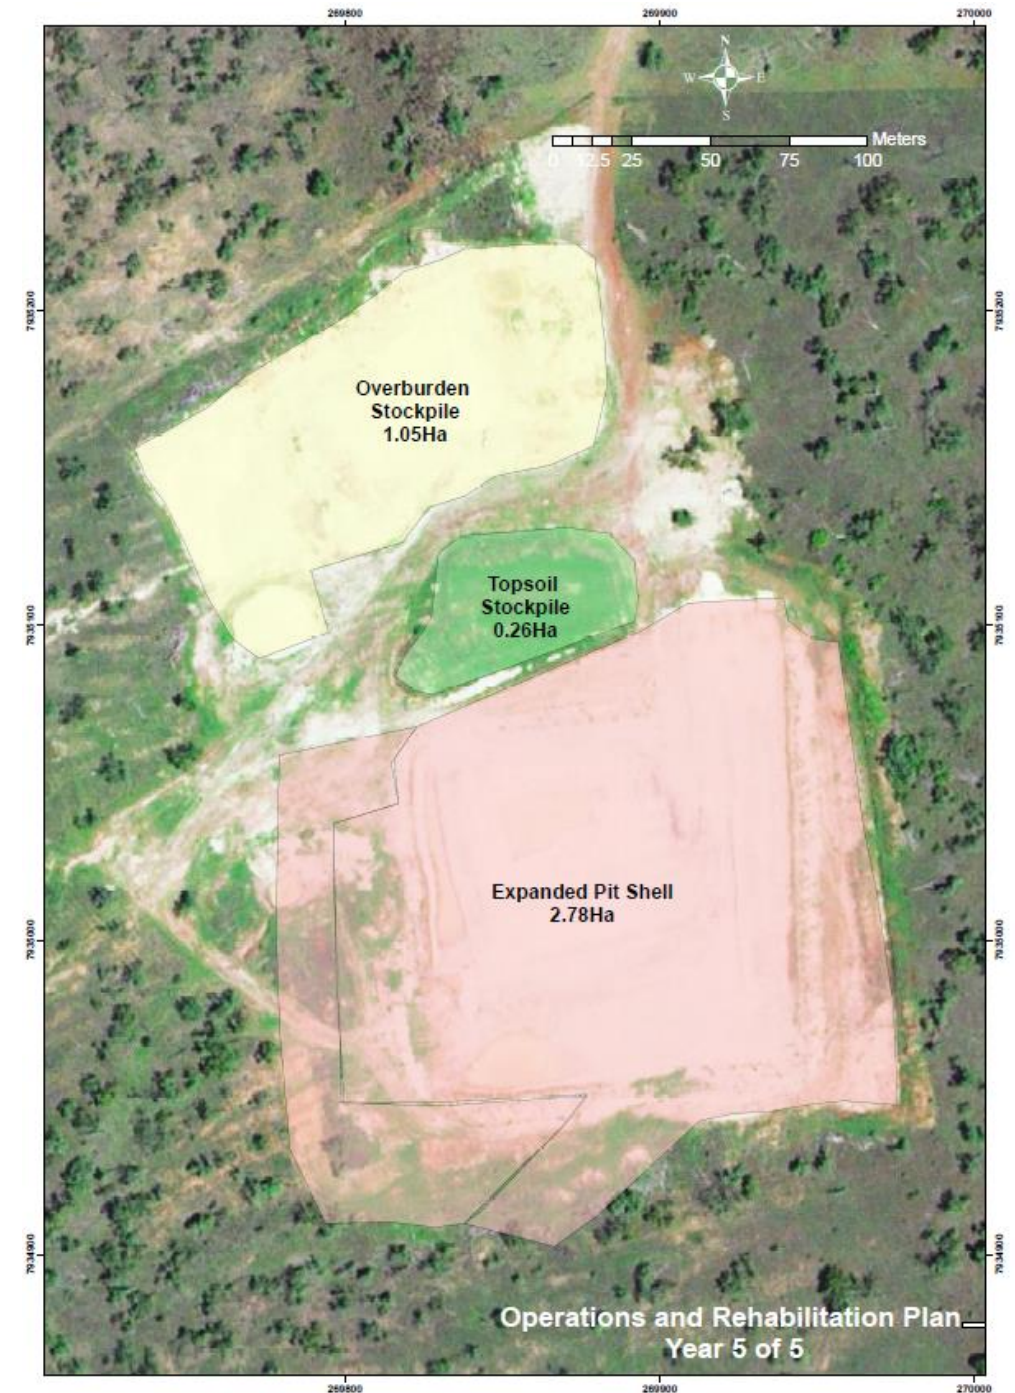
## Conjuboy Operations – ML10279 Rehabilitation Program – Year 5 of 5

Total Lease Area - 133Ha  
Total Disturbed Area - 4.66Ha  
Percentage of Lease Area Disturbed - 3.5%

- Mining of ore will continue from expanded open pit
- Ore stocks will be removed from Mine to Plant site
- No further overburden or topsoil removed and stockpiled
- No rehabilitation as work plan still operating in open pit extents

Total Area Rehabilitated – 0 Ha

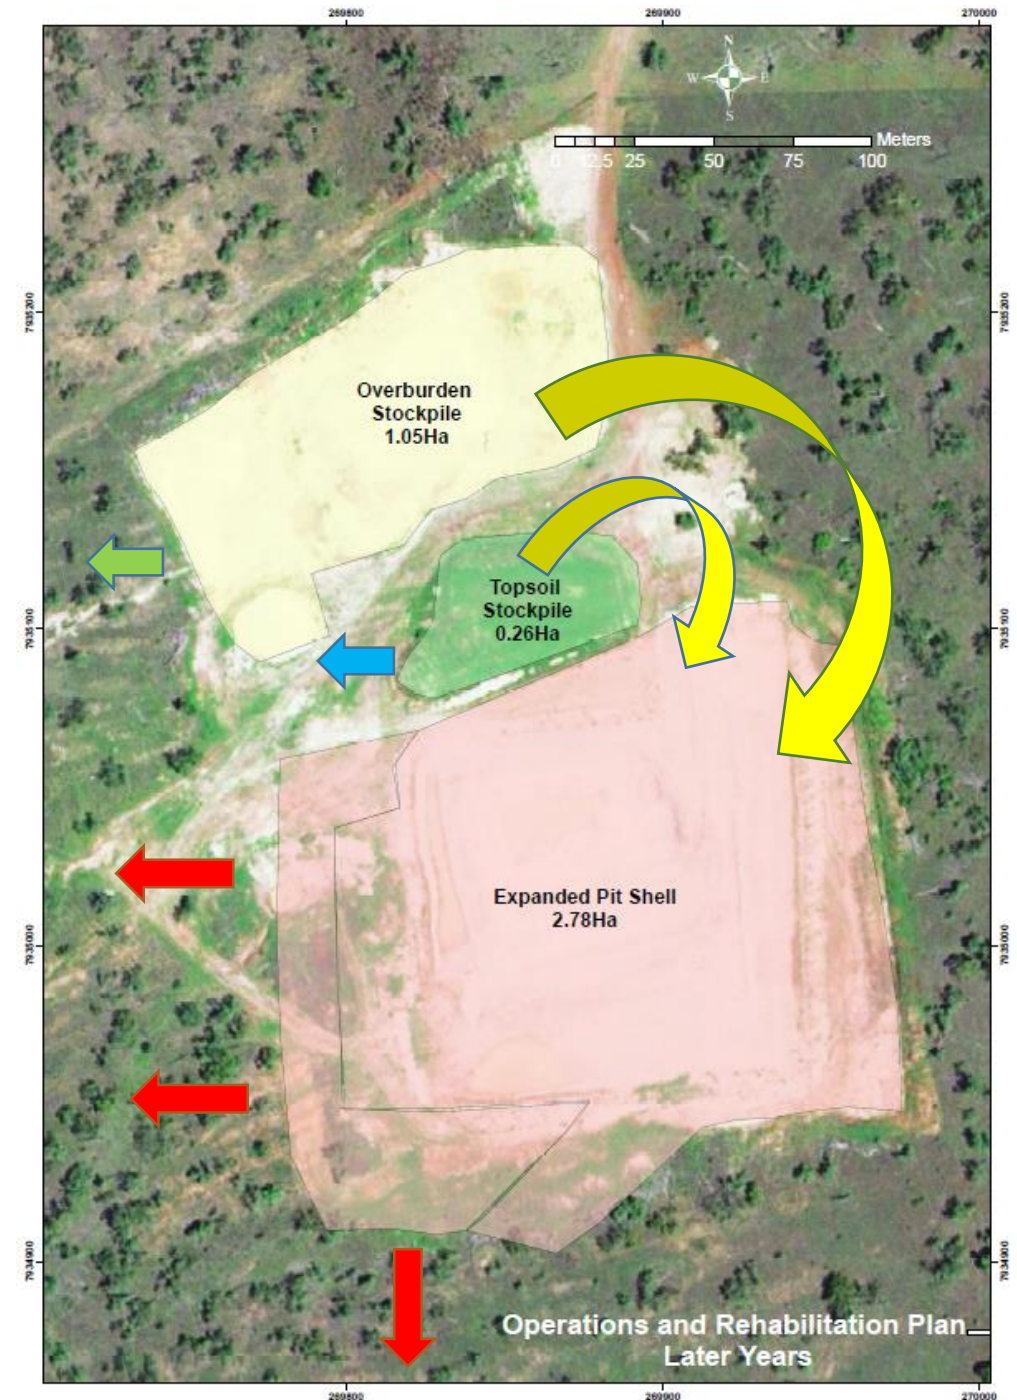
### Rehabilitation Program – Following Years (outside of PoOPS scope)

- Pit expansion in later years of operation (>3Ha) – Red Arrows
- Ore stocks will be removed from Mine to Plant Site
- Overburden or topsoil removed and stockpiled as pit expands – Green and Blue Arrows
- As pit expands and the longwall is developed the overburden and topsoil is pushed back into the back end of the open pit (approx. 100m push length with a dozer) – Yellow Arrows

Total Area Rehabilitated – Ongoing as longwall develops. Push length remains at 100m

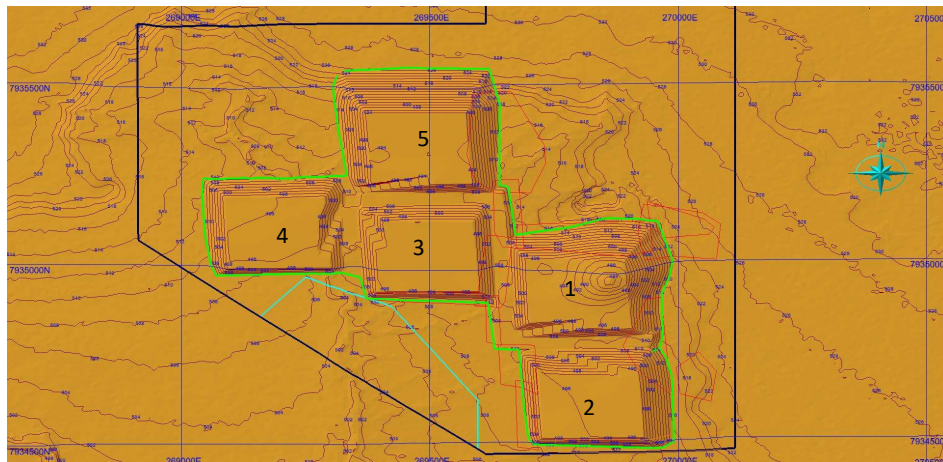
## Final Surface

- The next set of images have been provided to illustrate that if the pits were left un-rehabilitated, there would be ponding.

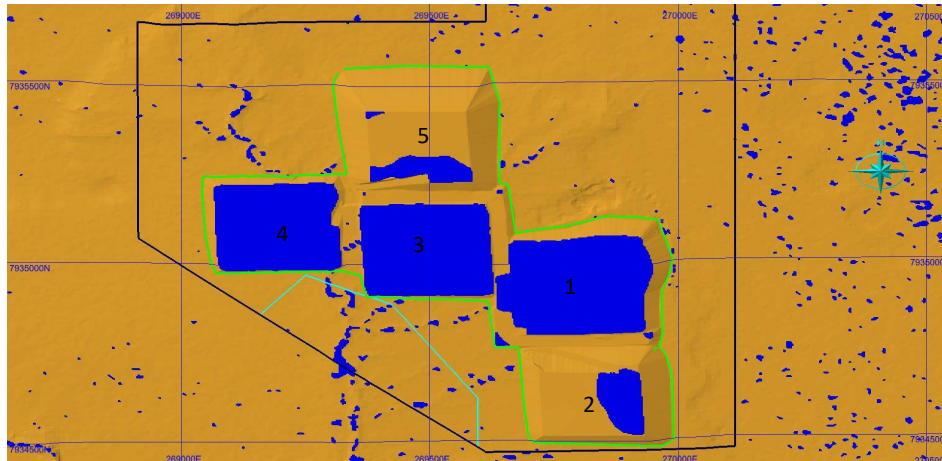
## Final Surface- No backfilling

The drainage analysis in 3D Dig indicates there is ponding in each pit.

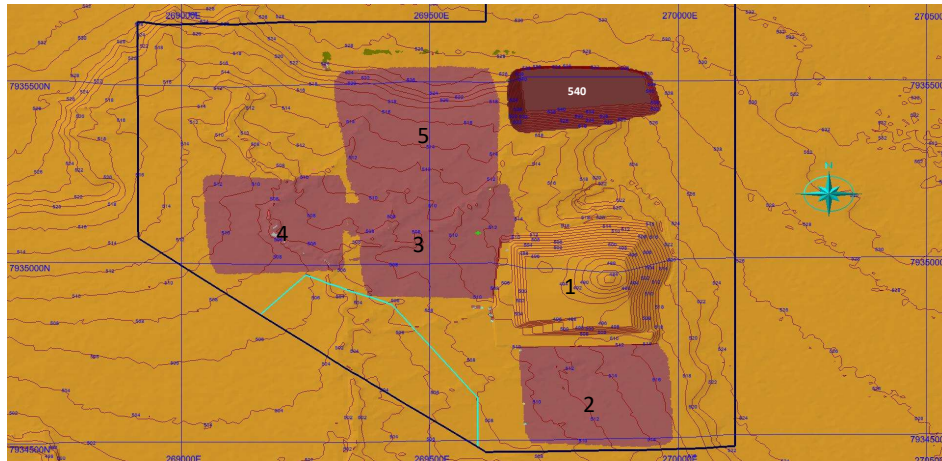
Staging Step 01.bit

In Step 01, Pit 1 has been mined.  
Volume of Waste = 474.4 Kbcm.  
Volume dumped = 616.7 Klcm.

The waste from Pit 1 has been stockpiled to the north of Pit 1.  
It has been placed further than the dozer push limit that is seen in Step XX.  
Ore is assumed to be stockpiled pit-side and processed off site.

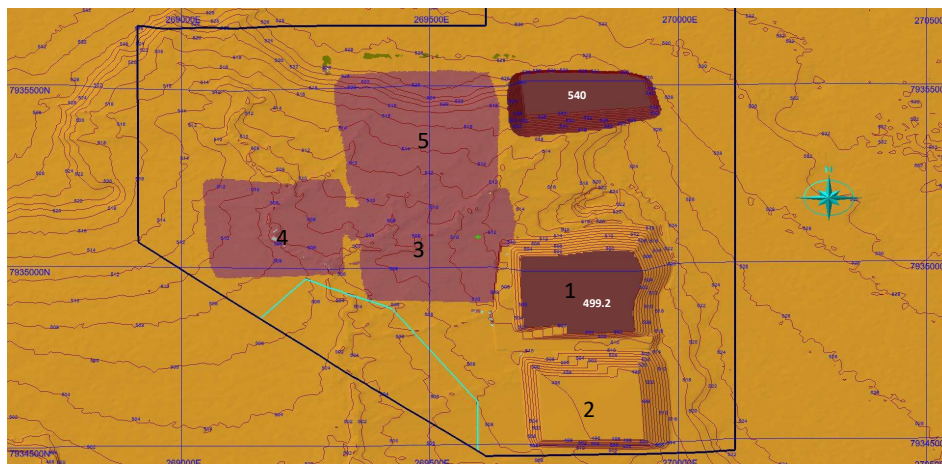
Staging Step 02.bit

The waste from Pit 2 has been placed in the base of Pit 1.

Ore is assumed to be stockpiled pit-side and processed off site.

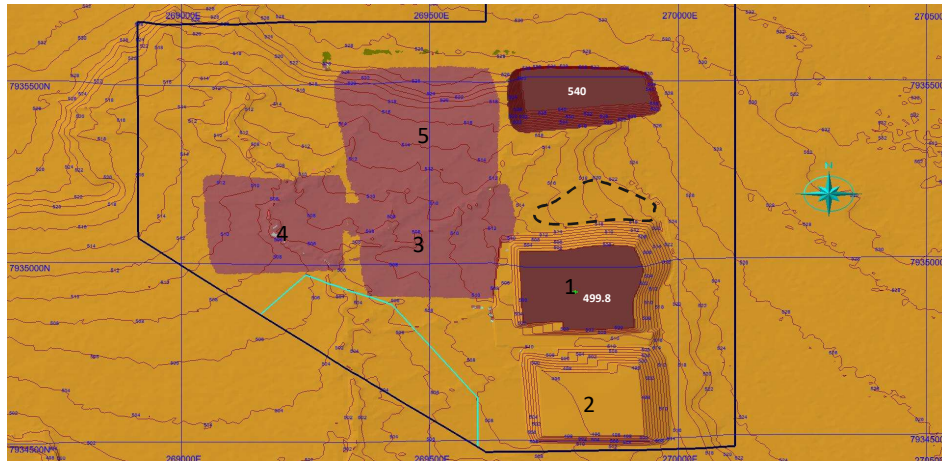
Staging Step 03.bit

In Step 03, the previously stockpiled waste has been placed into Pit 1.  
Volume of Waste = 34.2 Klcm.  
Volume dumped = 268.5 Klcm.

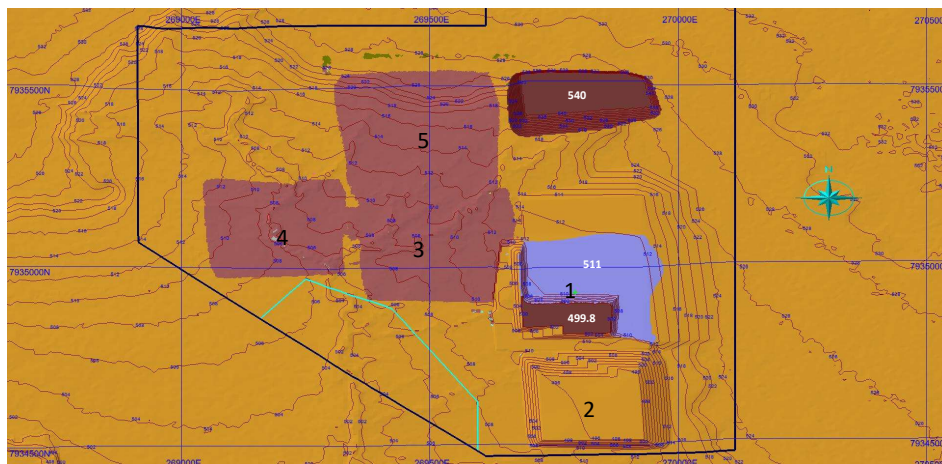
Staging Step 04.bit

In Step 04 I have dozer pushed the Eastern and Northern extents of Pit 1 as shown in the image below.  
Volume - Insitu Waste Dozed = 370.2 Klcm.  
Volume dumped = 481.3 Klcm.

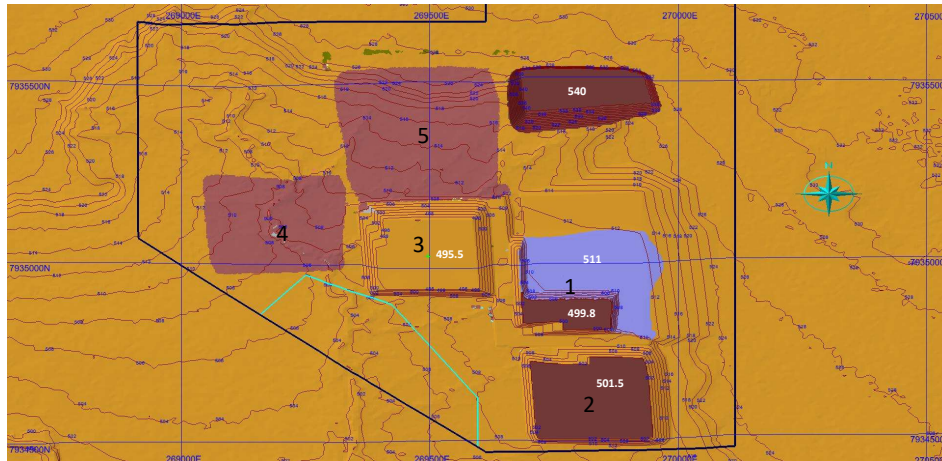
Staging Step 05.bit

The waste from Pit 3 has been placed in the base of Pit 2.

Ore is assumed to be stockpiled pit-side and processed off site.

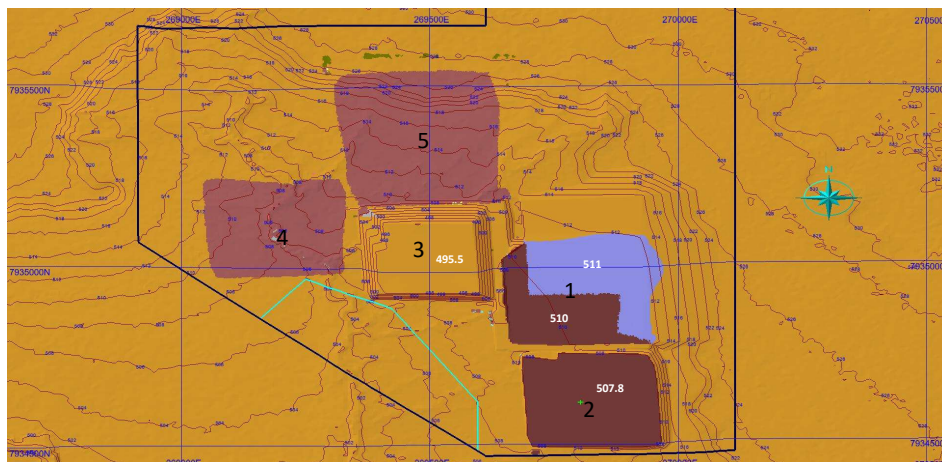
Staging Step 06.bit

Volume dumped = 229.6 Kbcm.

Pit 1 has now reached the final reshaped surface.

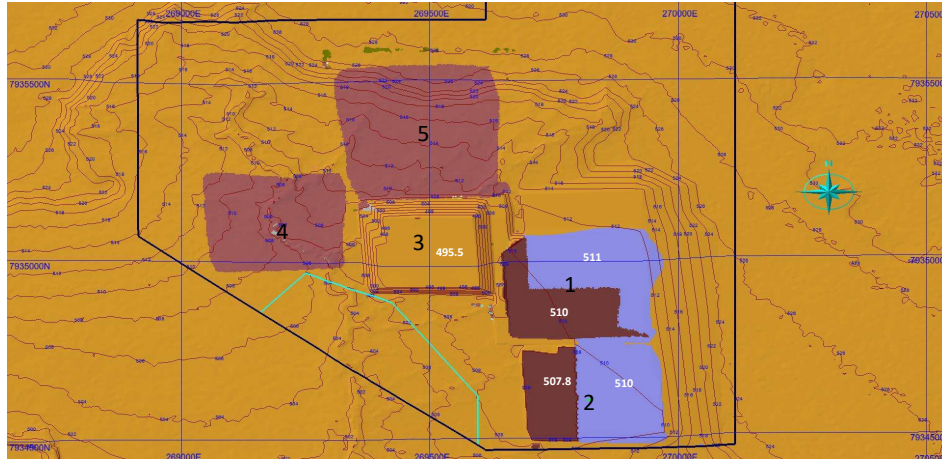
Staging Step 07.bit

In Step 07 I have dozer pushed the Eastern extent of Pit 2 as shown in the image below.  
Volume - Insitu Waste Dozed = 71.7 Klcm.  
Volume dumped = 93.2 Klcm.

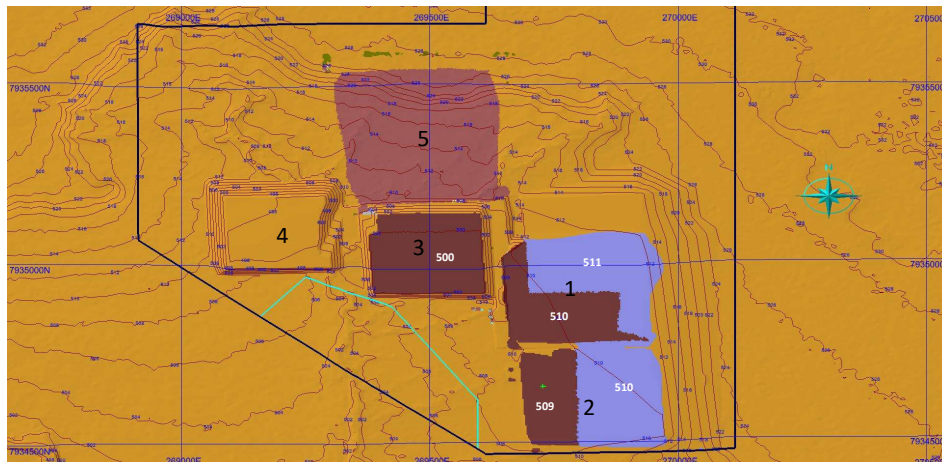
Staging Step 08.bit

The waste from Pit 4 has been placed inside Pit 2 to reach the rehab level in Pit 2, and the remainder has been placed in Pit 3.

Ore is assumed to be stockpiled pit-side and processed off site.

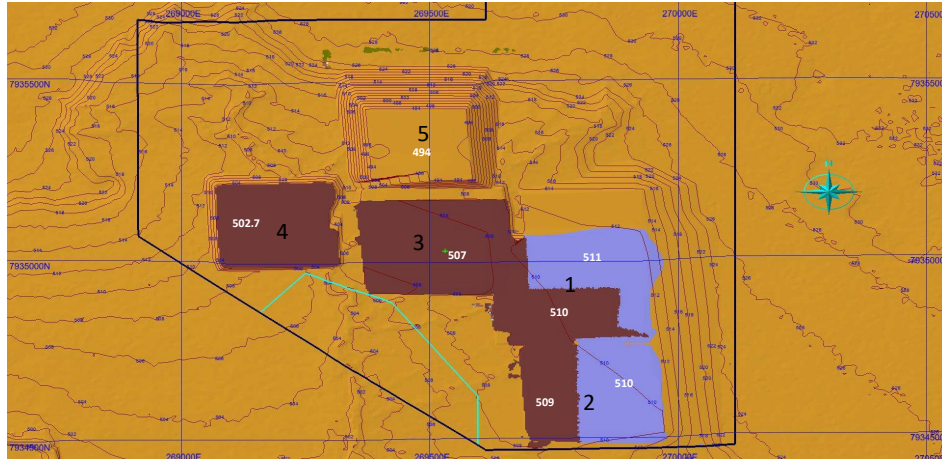
Staging Step 09.bit

The waste from Pit 4 has been placed inside Pit 3 to reach the rehab level in Pit 3, and the remainder has been placed in Pit 4.

Ore is assumed to be stockpiled pit-side and processed off site.

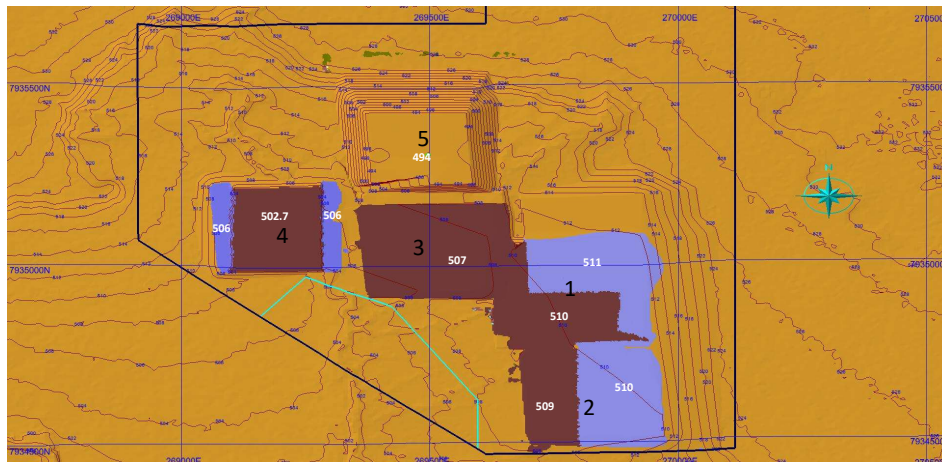
Staging Step 10.bit

In Step 10 I have dozer pushed the edges of Pit 4 as shown in the image below.  
Volume - Insitu Waste Dozed = 34.8 Klcm.  
Volume dumped = 45.2 Klcm.

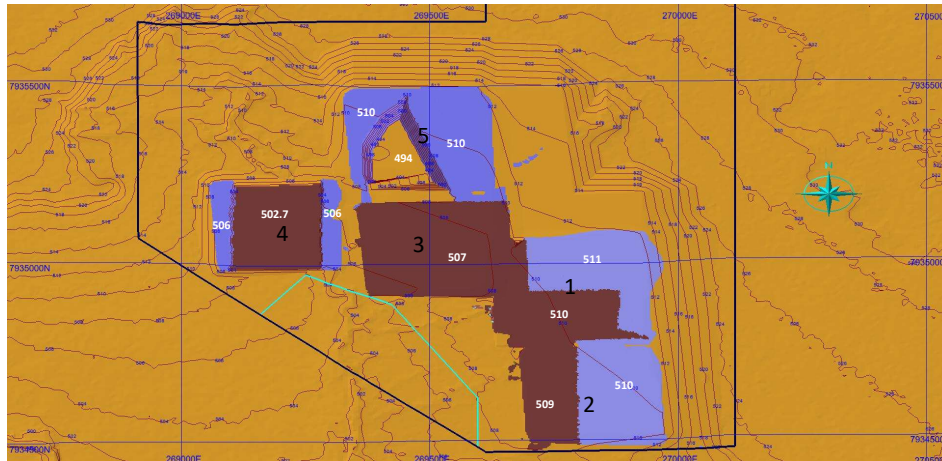
Staging Step 11.bit

In Step 11 I have dozer pushed the edges of Pit 5 as shown in the image below.  
Volume - Insitu Waste Dozed = 495.1 Klcm.  
Volume dumped = 643.7 Klcm.

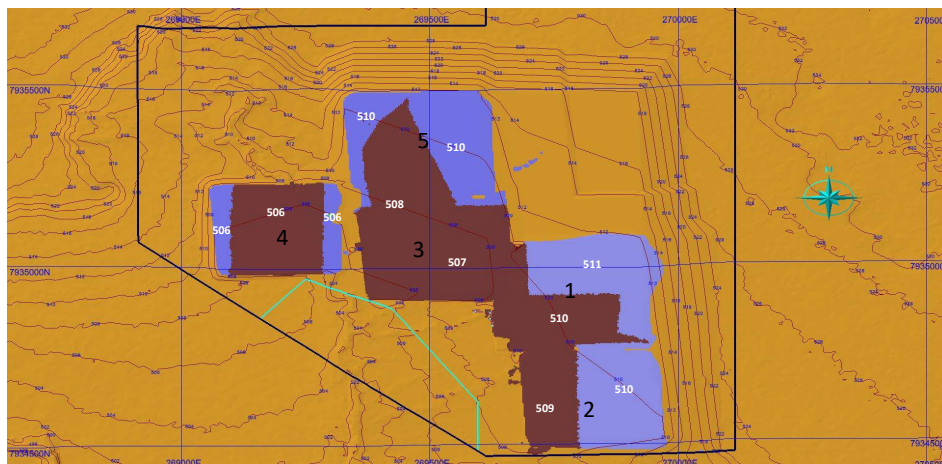
## Step 12

In Step 11 dozer pushed the edges of Pit 5 as shown in the image below.  
Volume - Insitu Waste Dozed = 495.1 Klcm.  
Volume dumped = 643.7 Klcm.

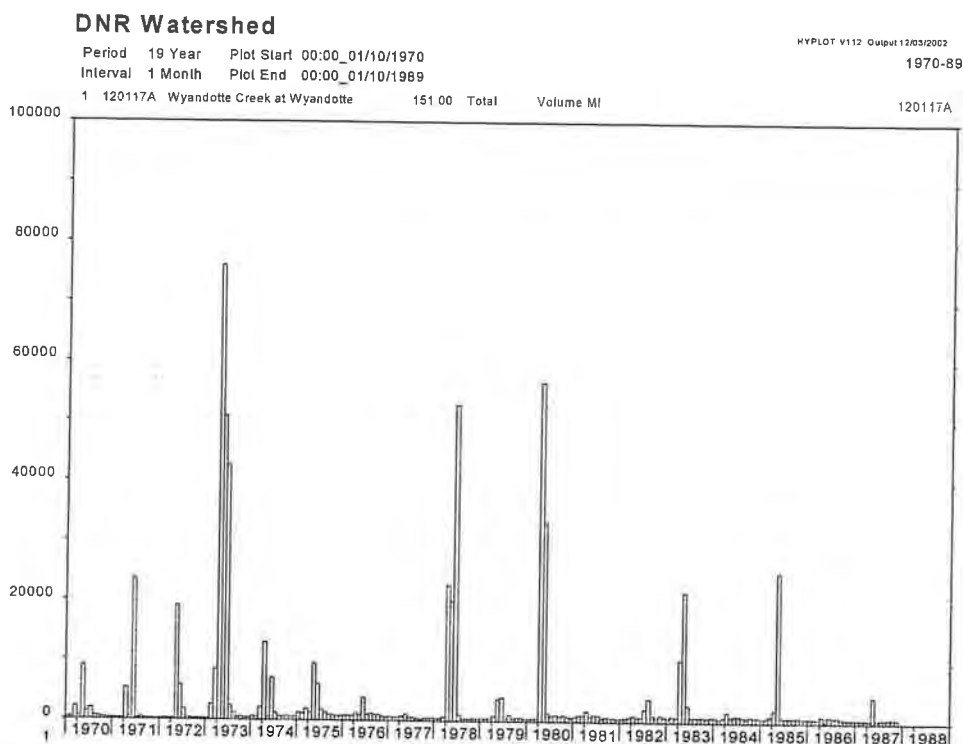
**Figure 5.1: Mean monthly flow in ML at GS 120117A**  
(source NRM Watershed website)

The mean monthly flow for the period of record at GS 120117A is presented graphically in Figure 5.1 below.

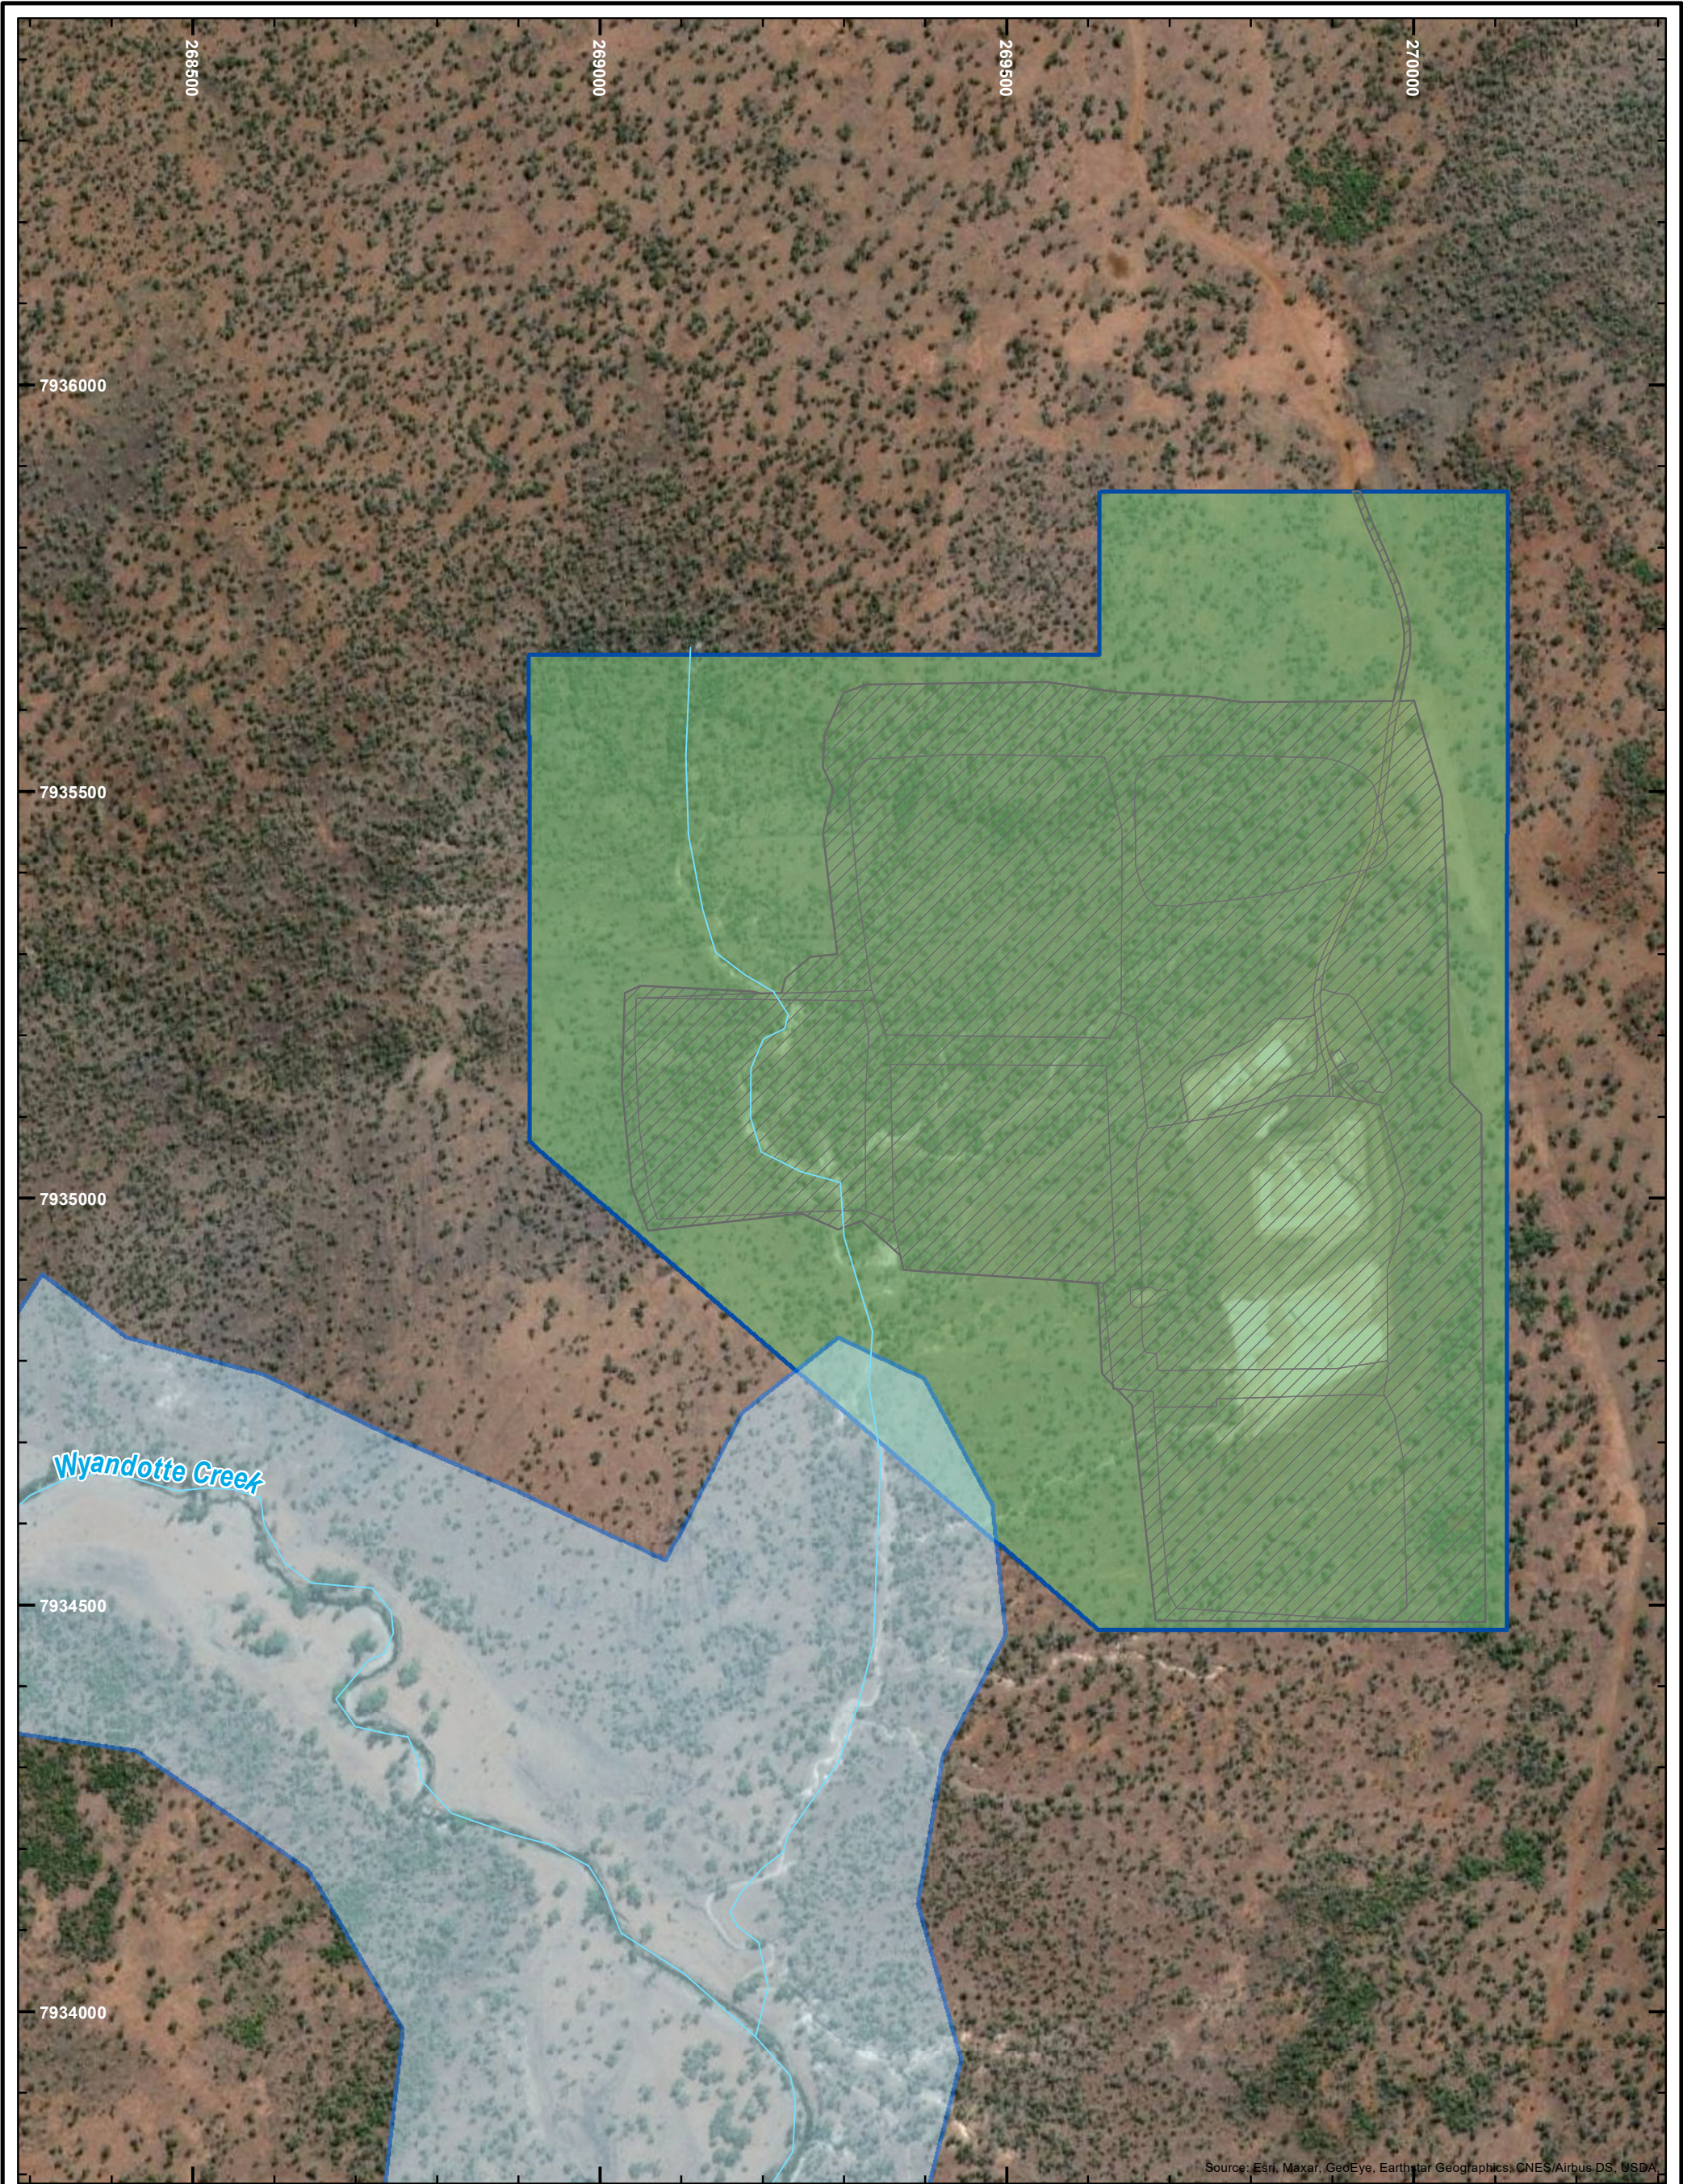
| <div><div><div></div><div>ARDENT</div><div>GROUP PTY LTD</div></div></div> | Final Site Design | | <div>Legend</div> <div><div><div></div>ML 10279</div><div><div></div>Minor Watercourse</div><div><div></div>Queensland Floodplain Assessment Overlay</div><div><div></div>Site Disturbance and Rehabilitation Area</div><div><div></div>Post Mining Land Use - Grazing</div></div> | |
