# Australian Journal of Soil Research

## **Impact of vegetative cover and slope on runoff, erosion, and water quality for field plots on a range of soil and spoil materials on central Queensland coal mines**

*C. Carroll, L. Merton, and P. Burger*

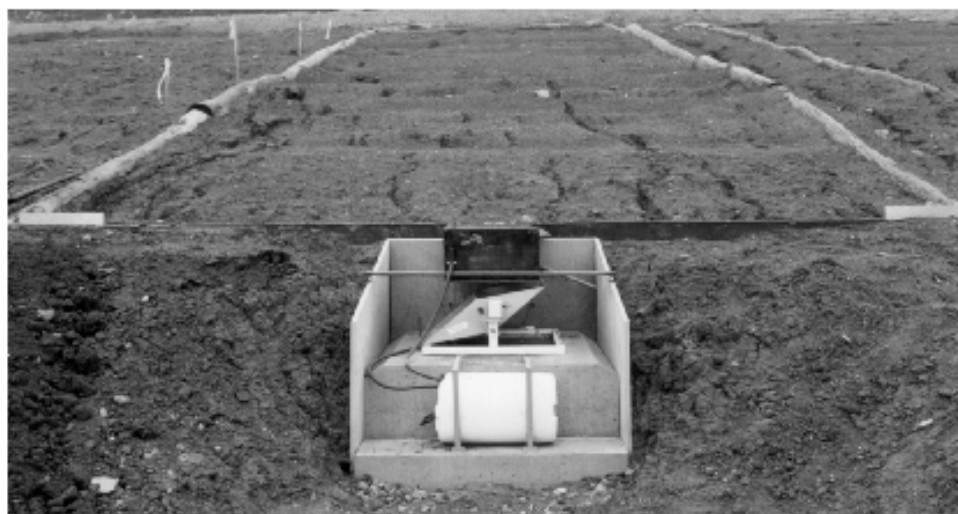
**Fig. 2.** Erosion plot and runoff tipping bucket; suspended sediment collected in 20-L plastic drum, via 1-mm slot in 10-cm upright copper pipe (left of tipping bucket).

Runoff was measured using a tipping bucket (7.47 L capacity) (Fig. 2). Total runoff and runoff rates were determined by recording the number of tips per min on a data logger. Total tips were also recorded on a mechanical counter.
