**Sustainability Indicators  
for Coal Mine Rehabilitation**

**C7006  
April 2001**

## ACARP C7006 Report

Queensland Department of Natural Resources and Mines

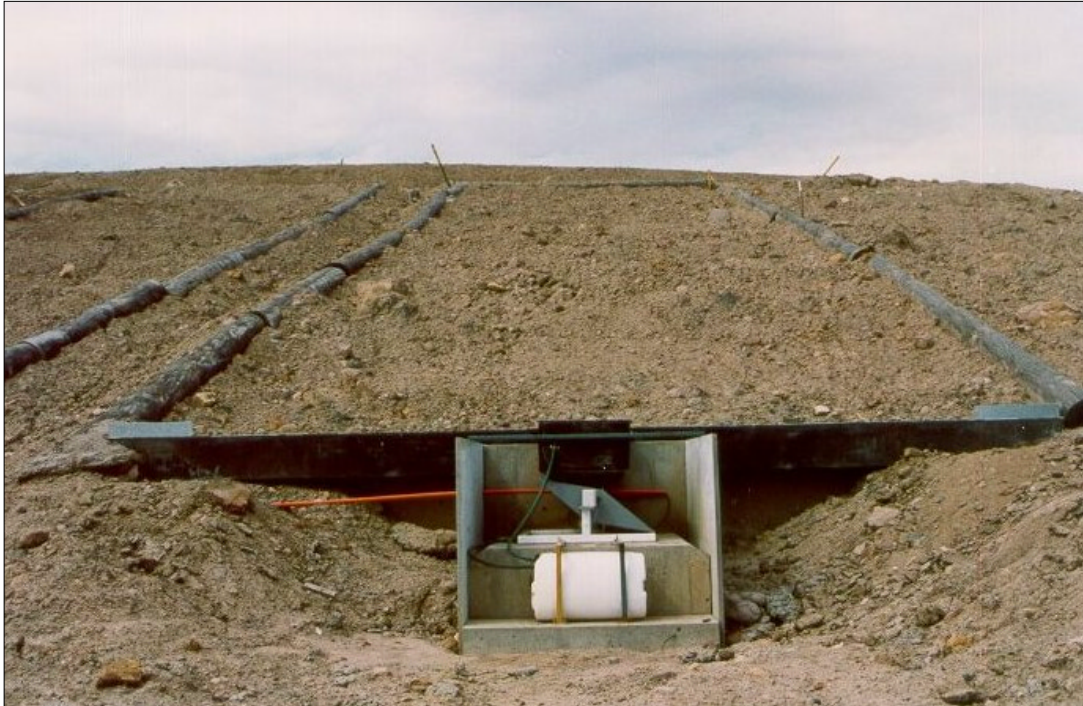
### *Effects of no Vegetative Cover on 30% Spoil Gradient*

**Photo 3.** Year 1993. 0% Vegetative Cover

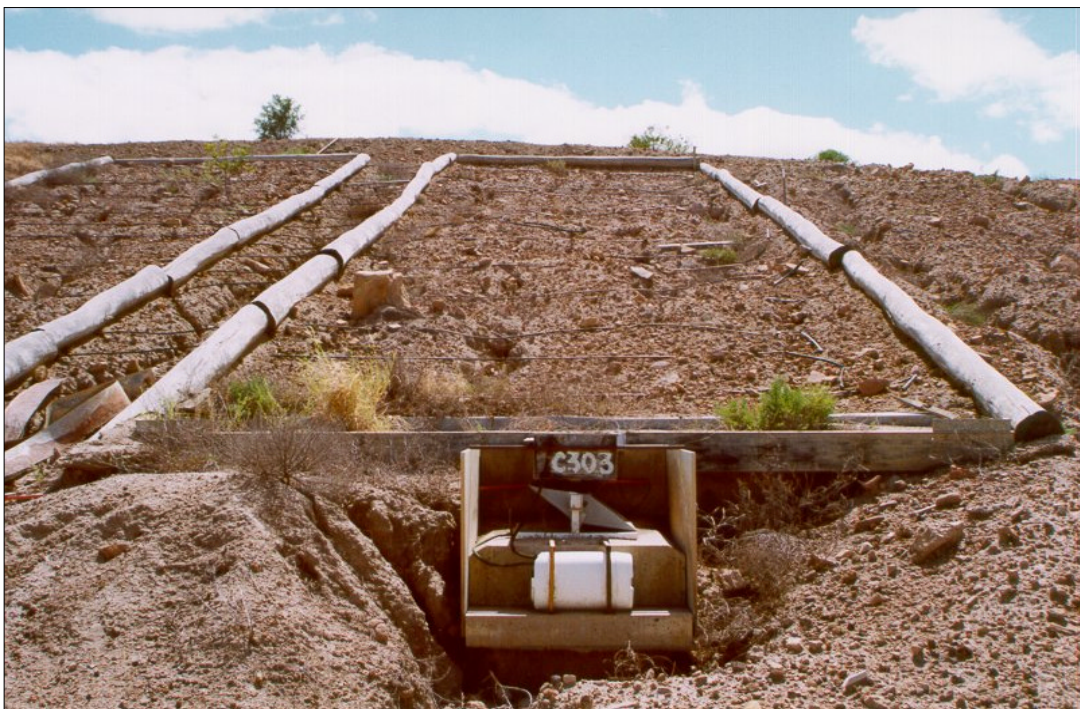
**Photo 4.** Year 2000. 0% Vegetative Cover

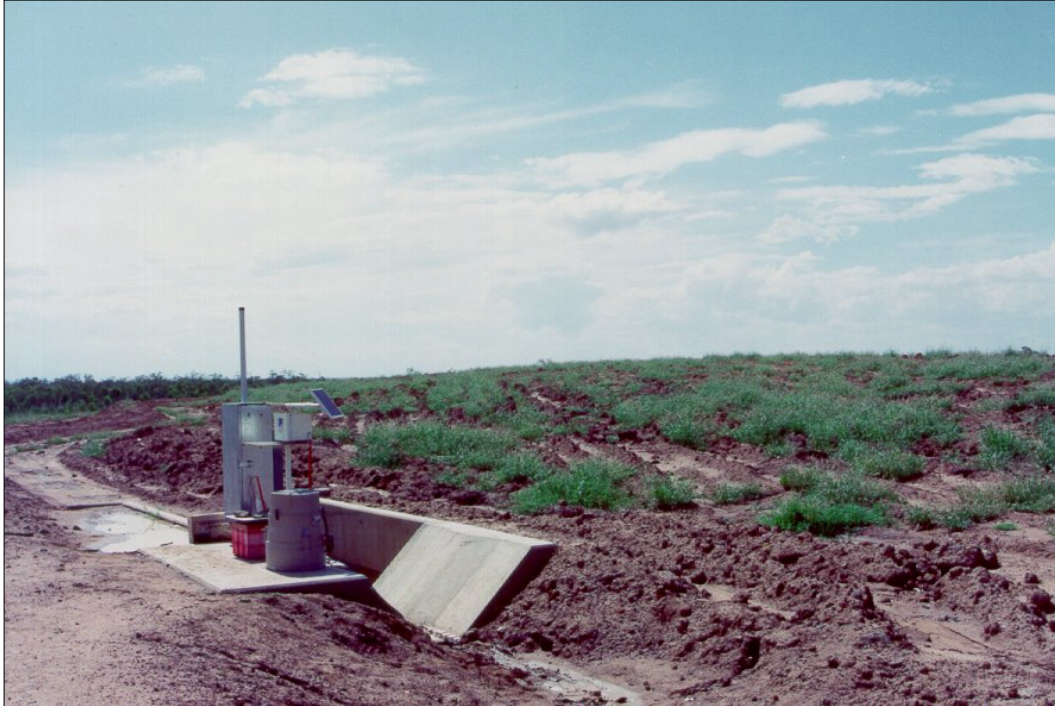
**Photo 11.** Year 1993. 44% vegetative cover.

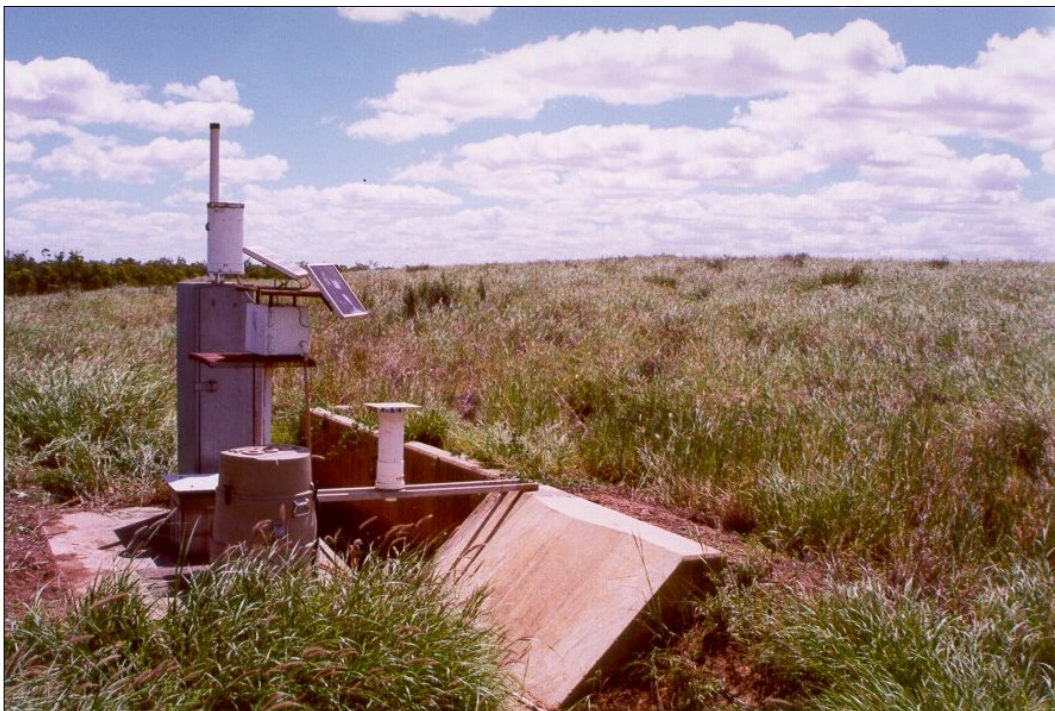
**Photo 12.** Year 2000. 83% vegetative cover.

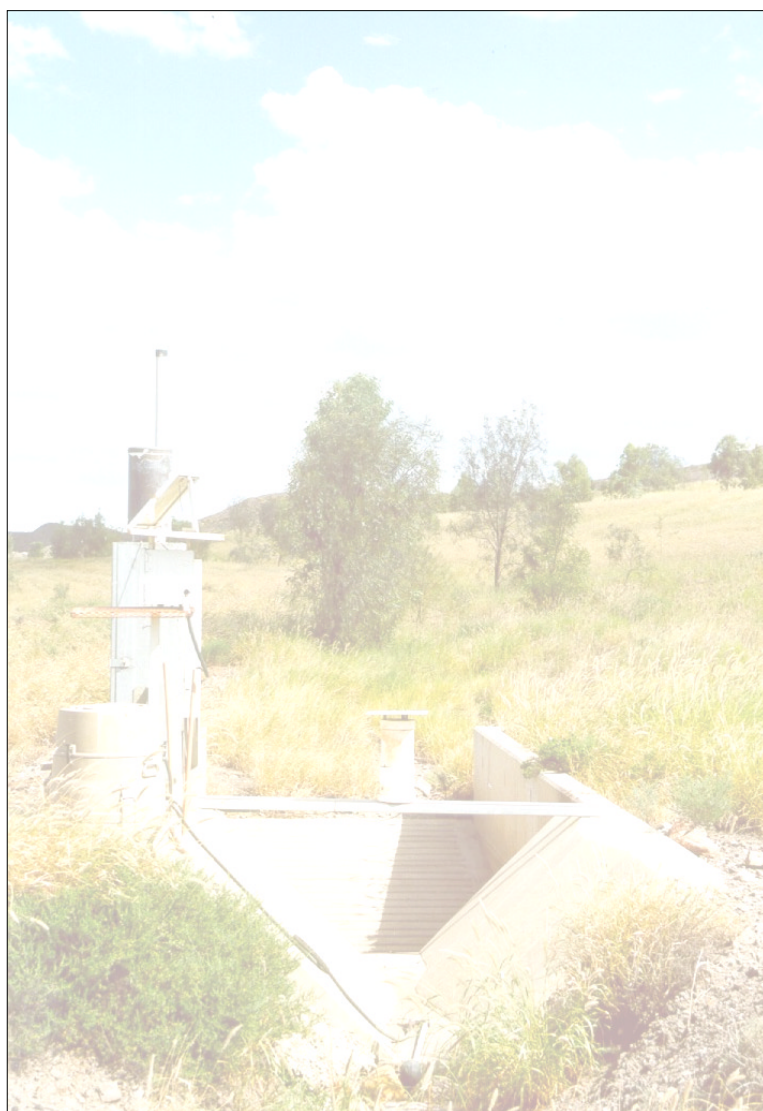
**Figure 16.** Annual runoff, sediment loss and average runoff EC for Curragh Catchments A, B and C.

There has been a corresponding reduction in runoff EC from 300  $\mu\text{S}/\text{cm}$  in Year 1 , to approximately 100  $\mu\text{S}/\text{cm}$  in Year 6 (Figure 16) as cover increased. Standing pasture yields in year 6 were 10.6, 8.5 and 7.0 t/ha from catchment A, B and C respectively.

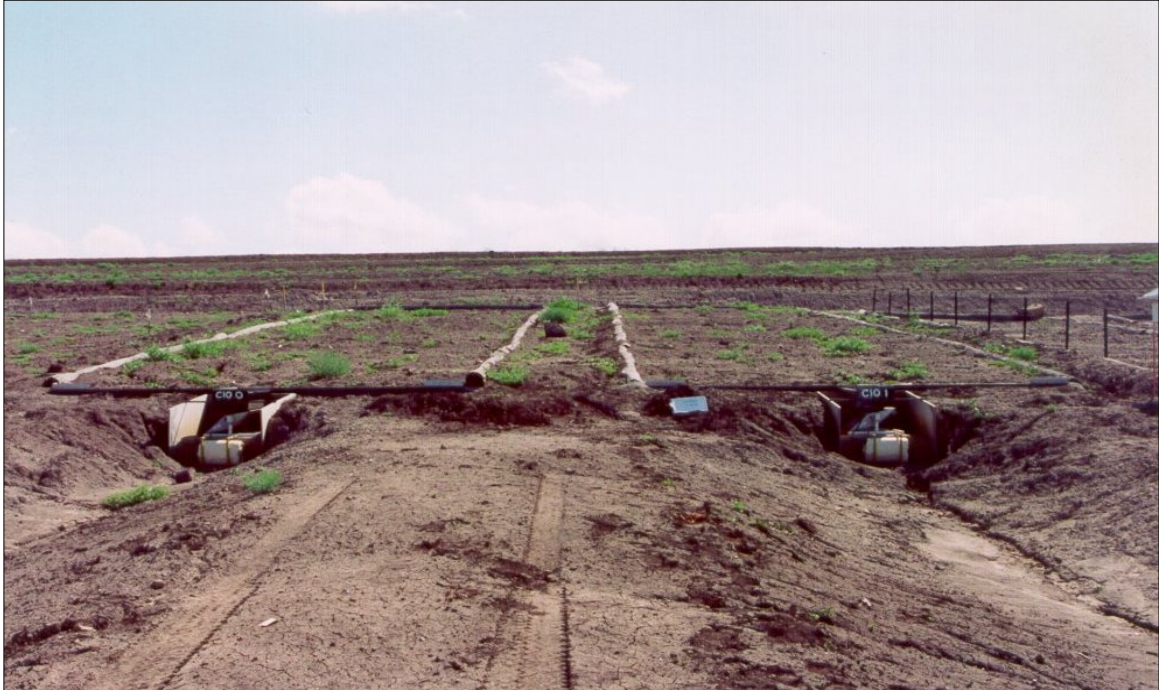
### *Pasture on 10% Topsoil Gradient*

**Photo 1:** Year 1993. 3% Vegetative Cover

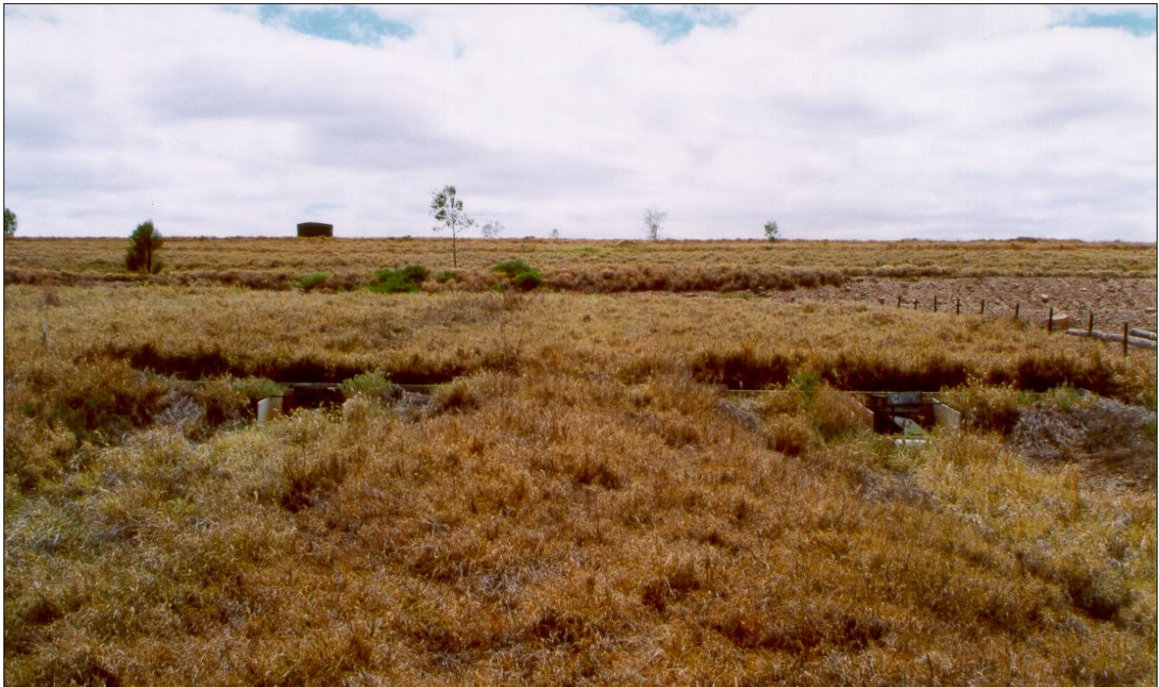
**Photo 2:** Year 2000. 100% buffel Cover on both tree and pasture plots.

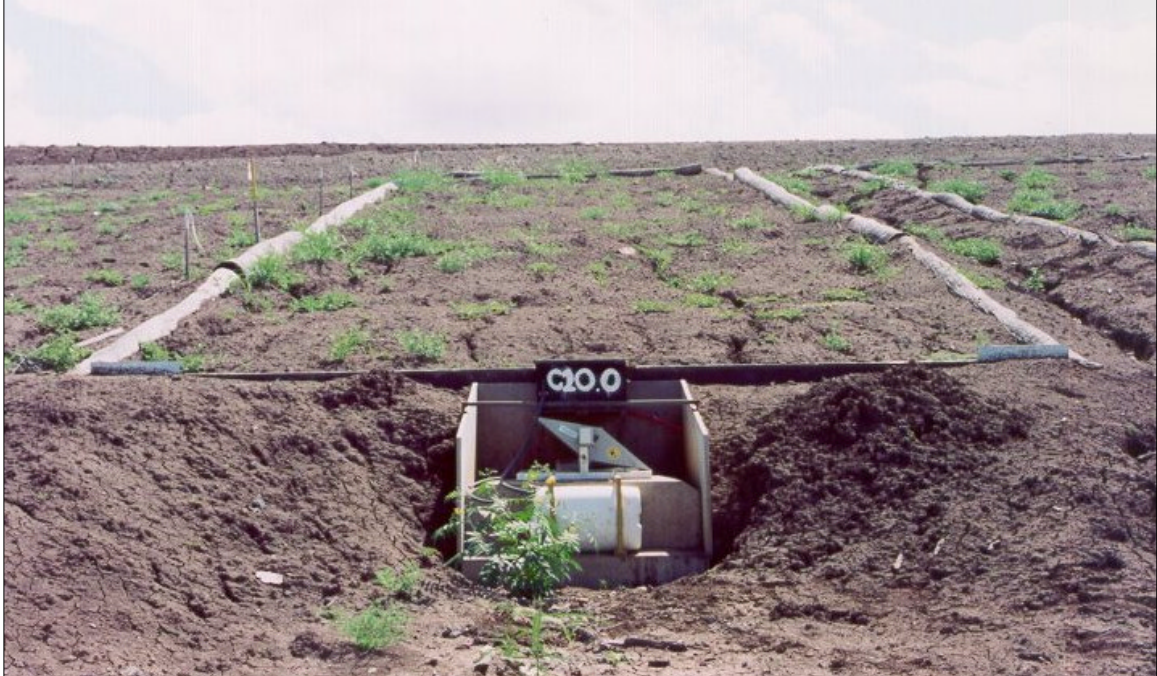
*Pasture on 20% Topsoil Gradient*

**Photo 3:** Year 1993. 7% Vegetative Cover

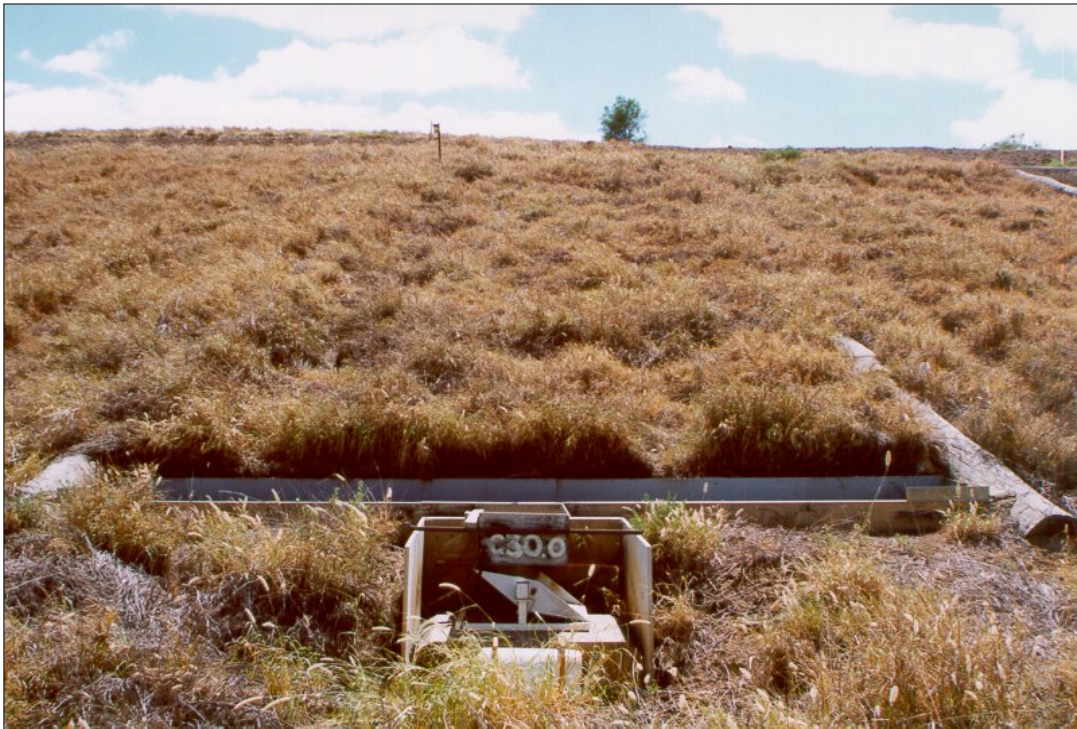
**Photo 6:** Year 2000. 100% Vegetative Cover

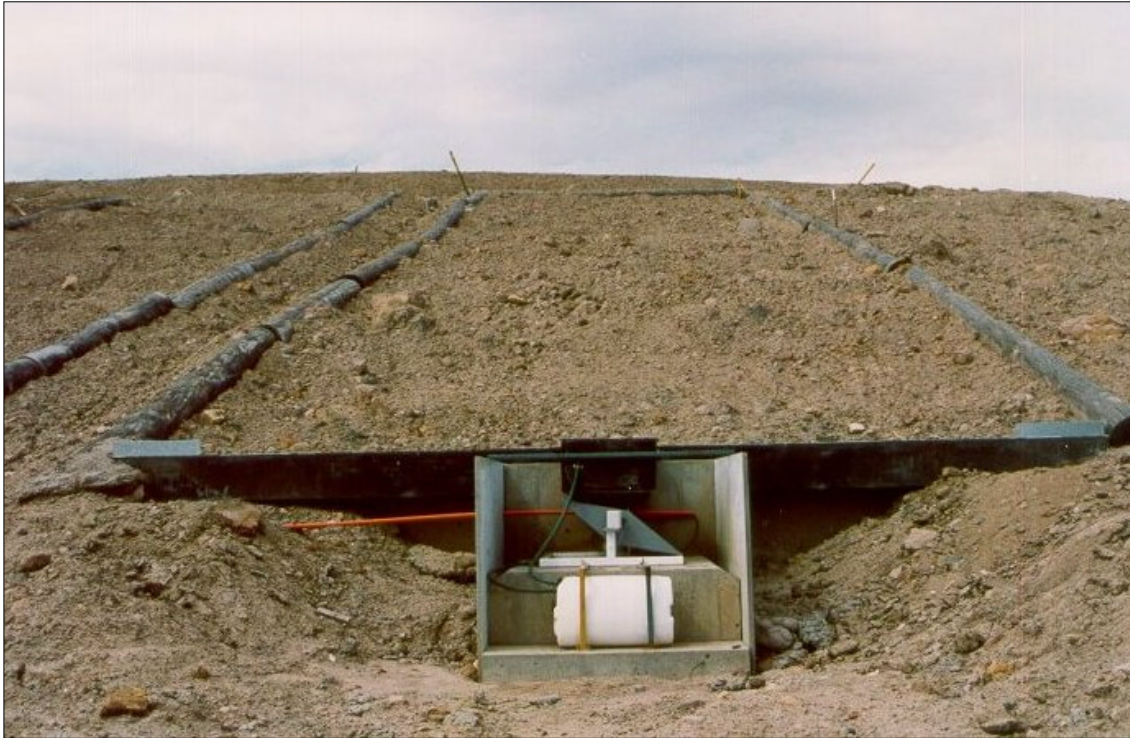
*Effects of no Vegetative Cover on 30% Spoil Gradient*

**Photo 7:** Year 1993. 0% Vegetative Cover

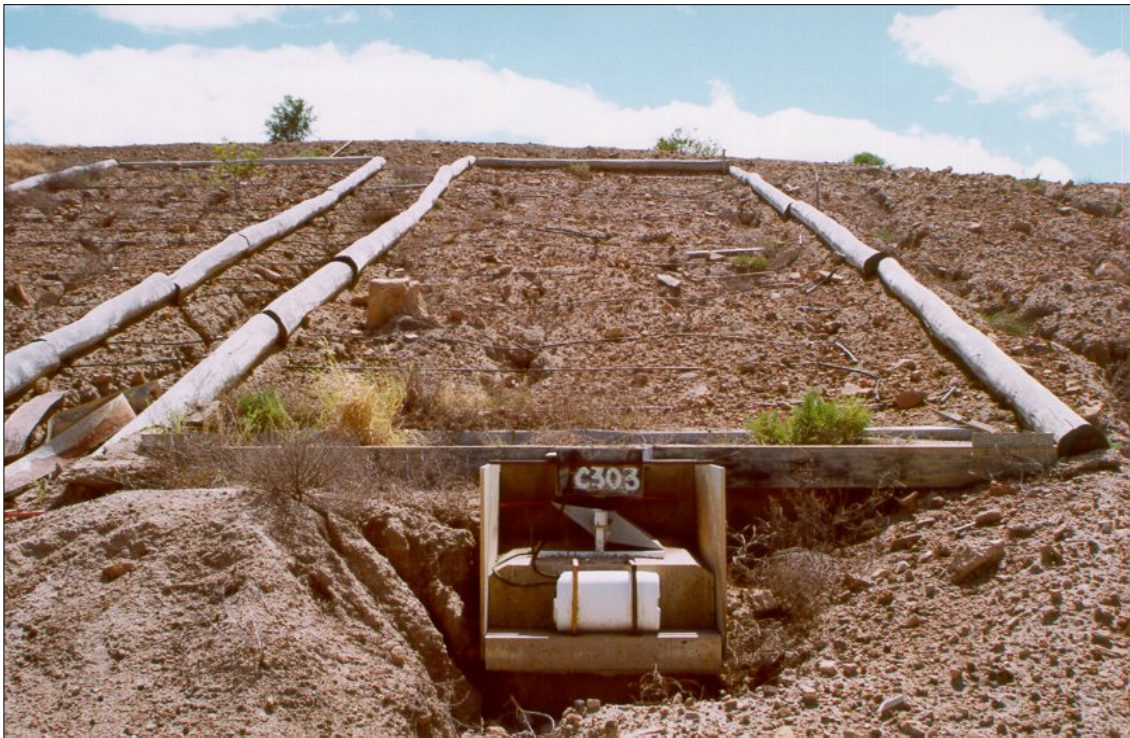
**Photo 8:** Year 2000. 0% Vegetative Cover

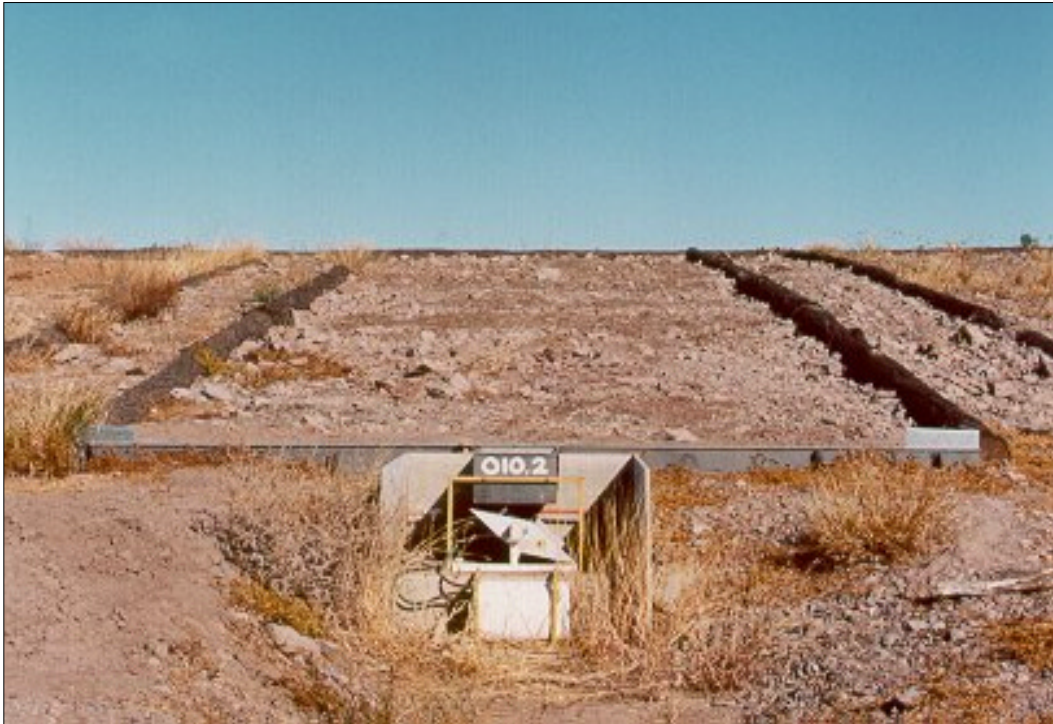
*Tree Growth On 10% Spoil Gradient*

**Photo 3:** Year 1993. 0% Vegetative Cover

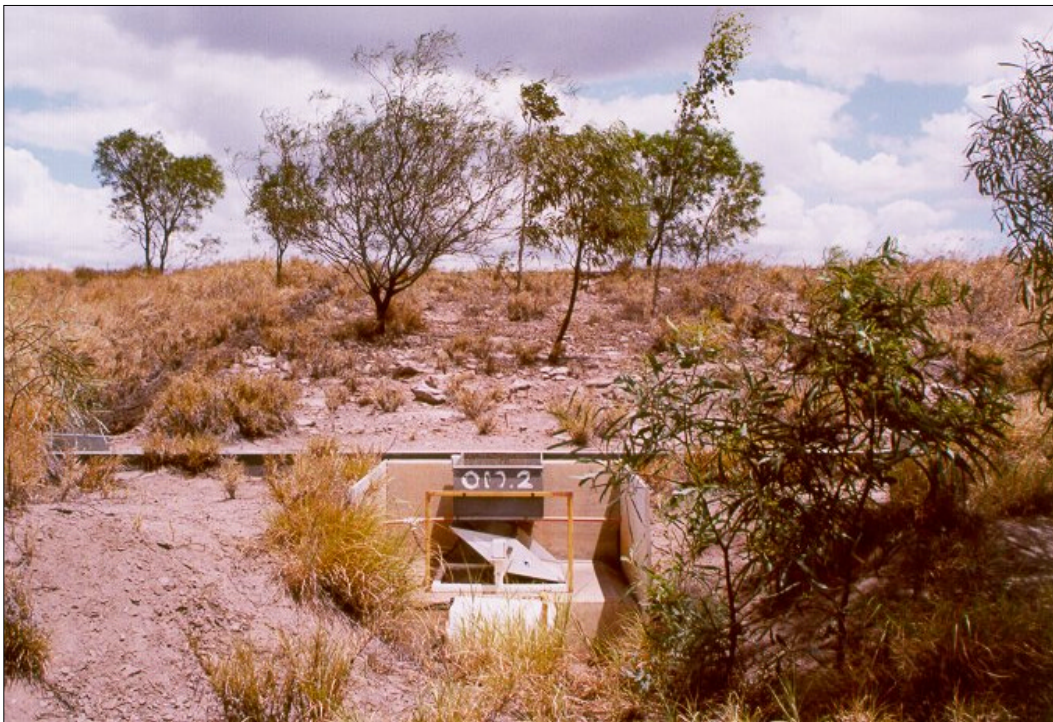
**Photo 4:** Year 2000. 7% Vegetative Cover.

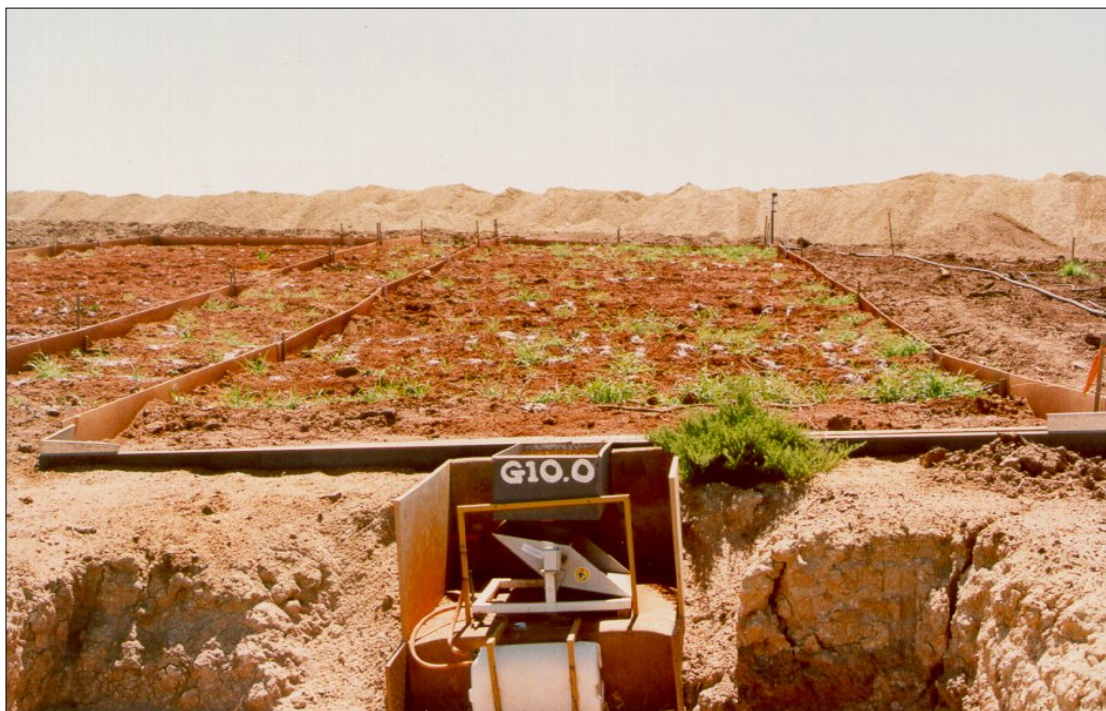
### *Pasture On 10% Topsoil Gradient*

**Photo 1:** Year 1993. 2% vegetative cover

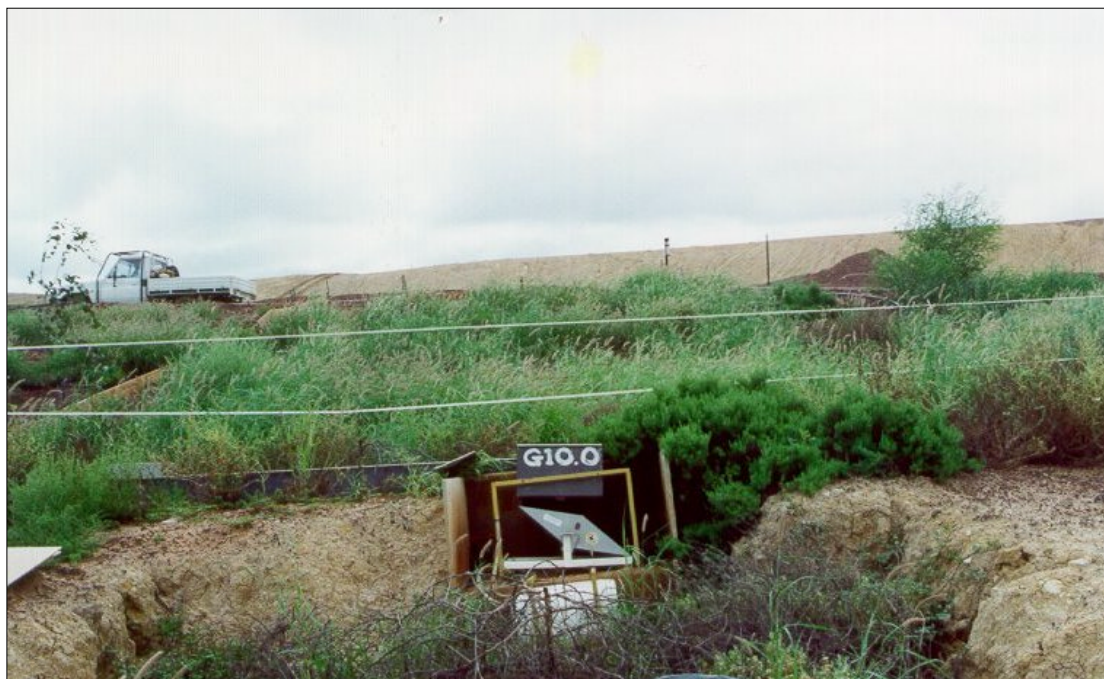
**Photo 2:** Year 1997. 26% vegetative cover

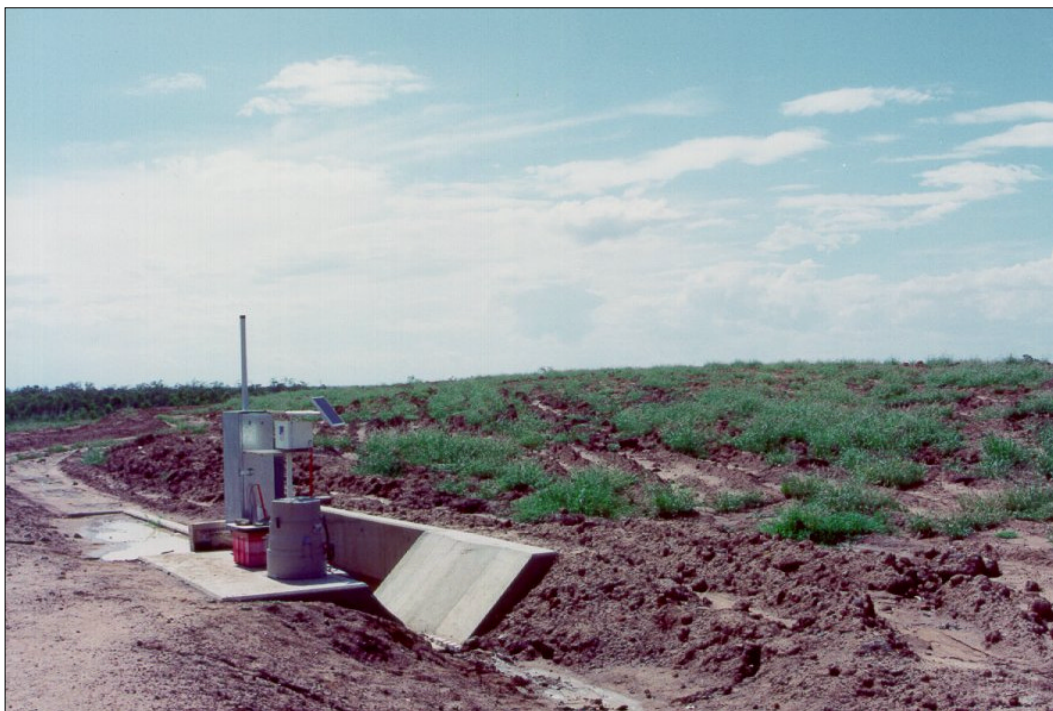
**Photo 13:** Year 1993. 44% vegetative cover.

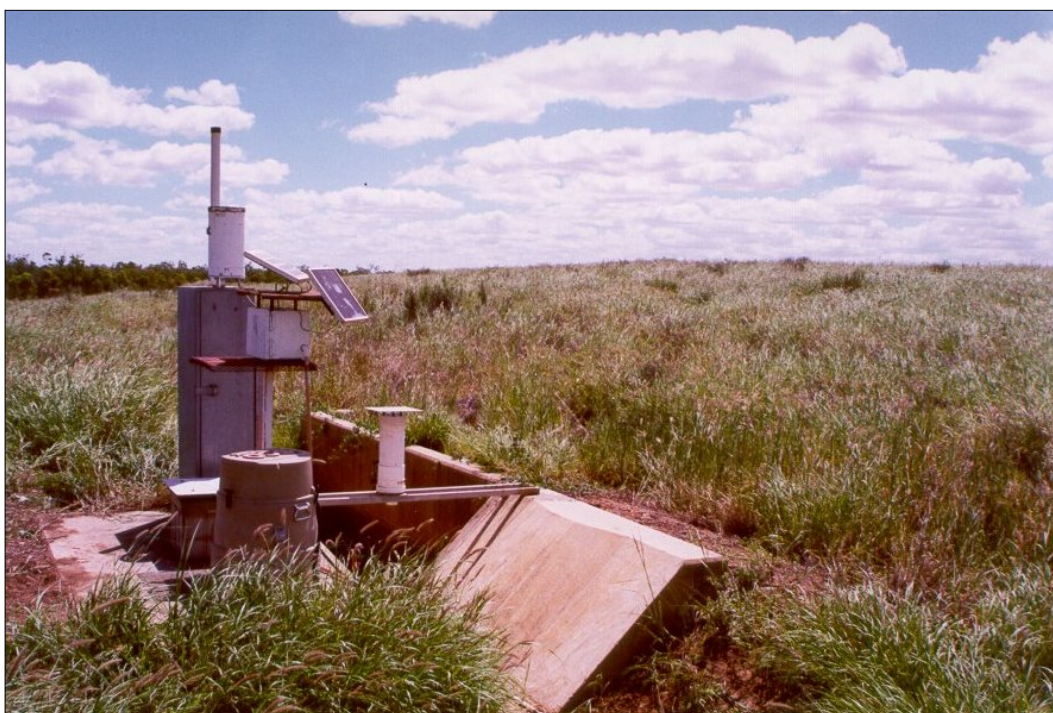
**Photo 14:** Year 2000. 83% vegetative cover.

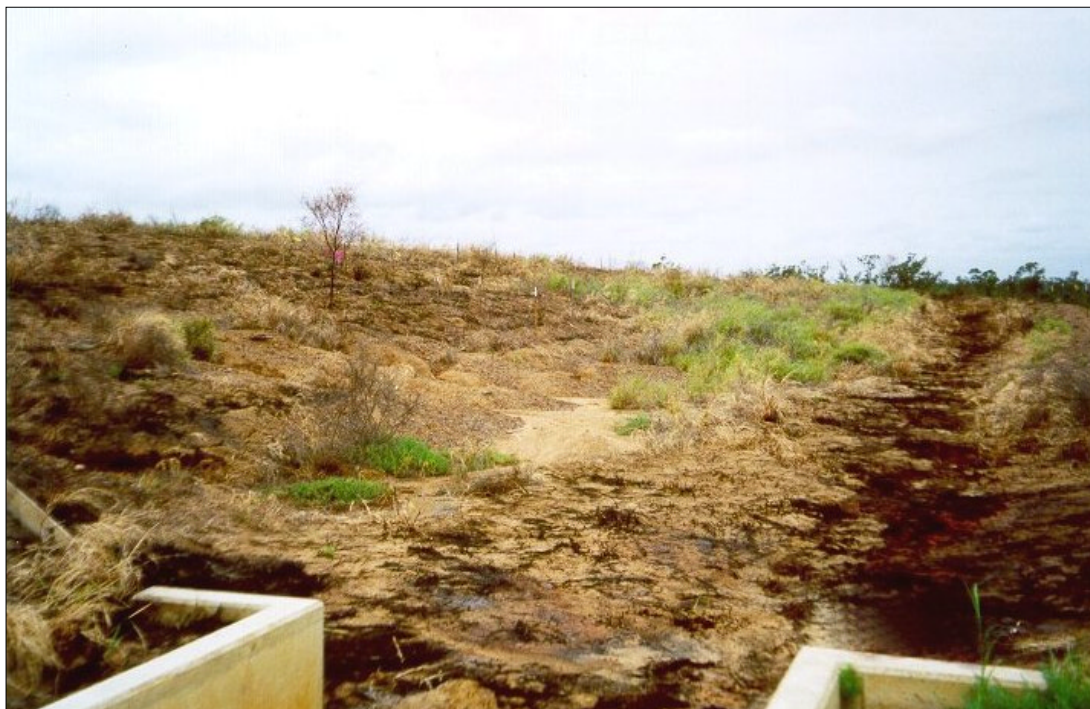
**Photo 17:** December 1999, 1 week after burn. 10% vegetative cover.

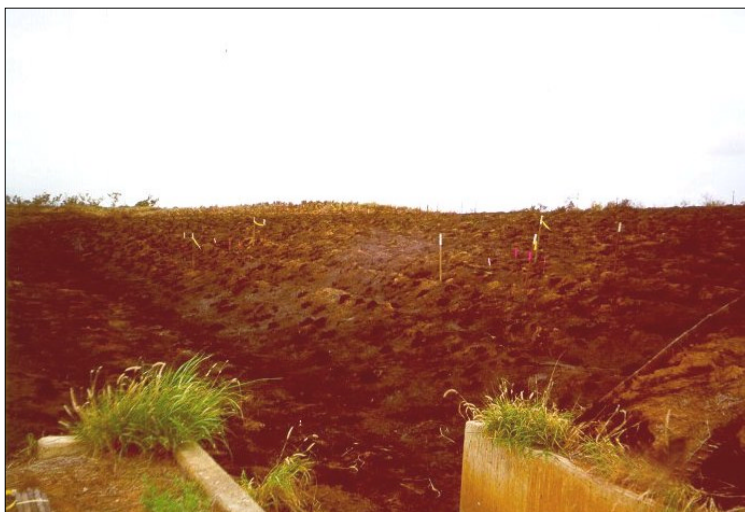
**Photo 19:** December 1999.

1 week after burn.

13% vegetative cover.

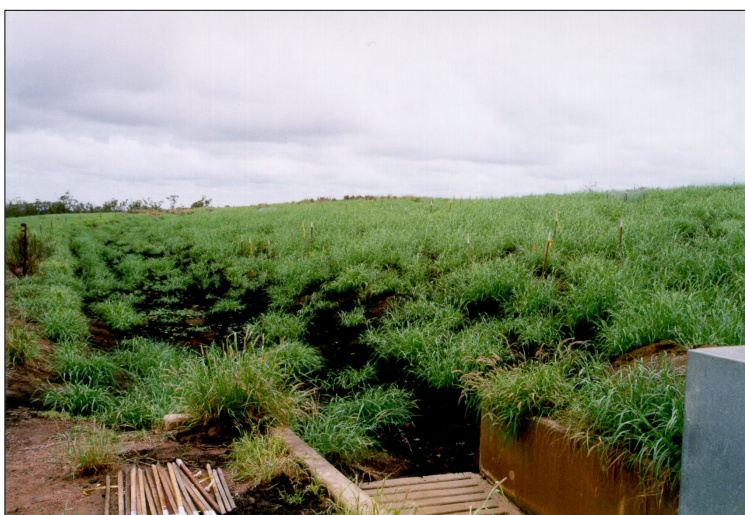
**Photo 20:** January 2000.

1 month after burn.

39% vegetative cover.

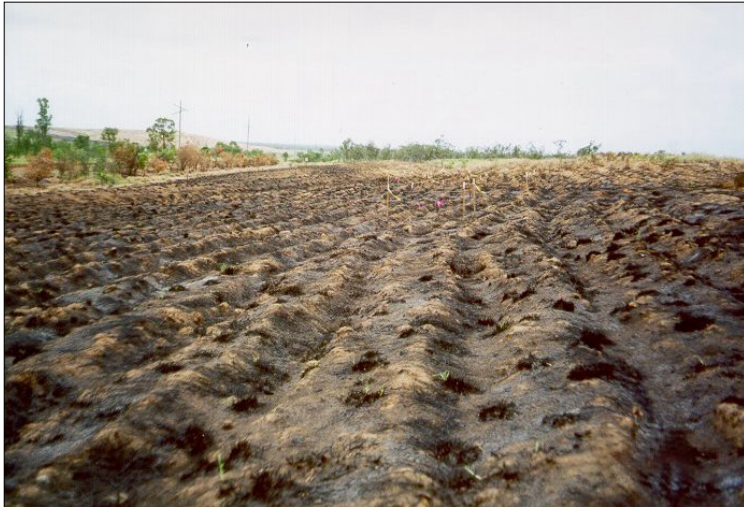
**Photo 22:** December 1999.

1 week after burn.

13% vegetative cover.

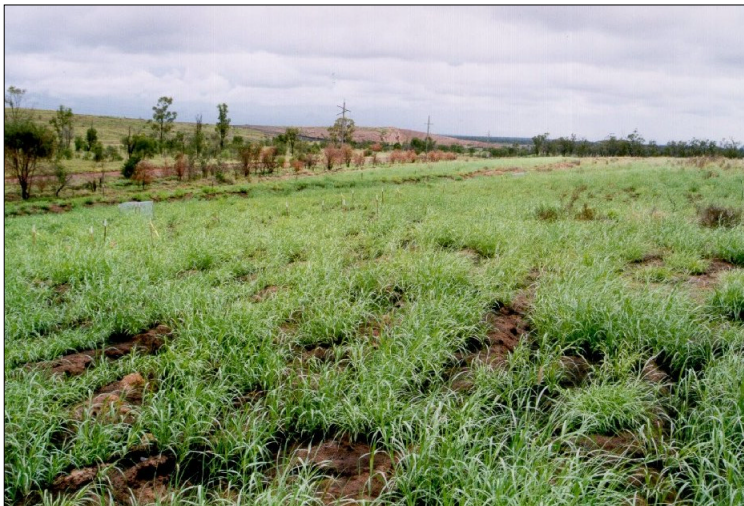
**Photo 23:** January 2000.

1 month after burn.

39% vegetative cover.

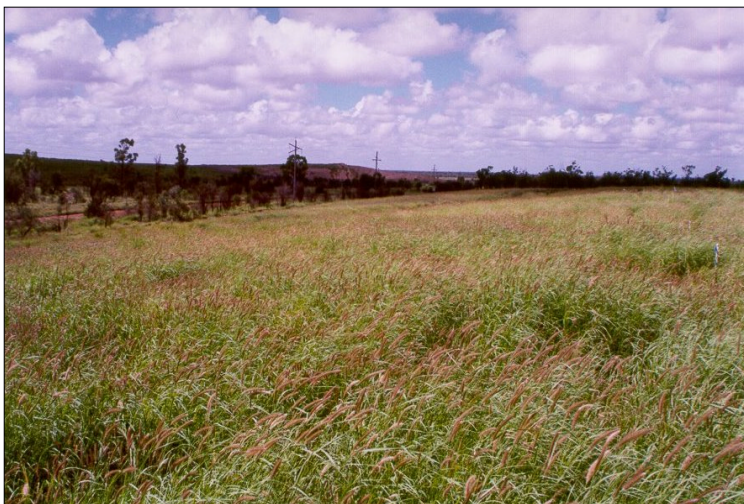
**Photo 24:** March 2000.

3 months after burn.
